ALASKA DEPARTMENT OF FISH AND GAME
Habitat Division

Denali Highway Reconnaissance - September 9-11, 1986

SUBJECT: Denali Highway
Drainage Structure
Recon.

September 9-11, A. Townsend and K. Talbert conducted field reviews on drainage structures along the Denali Highway from milepost 0 to 104. Review sheets were completed for 15 streams either documented to have fish or suspected to have fish because of the habitat quality. This information is enclosed for your files.

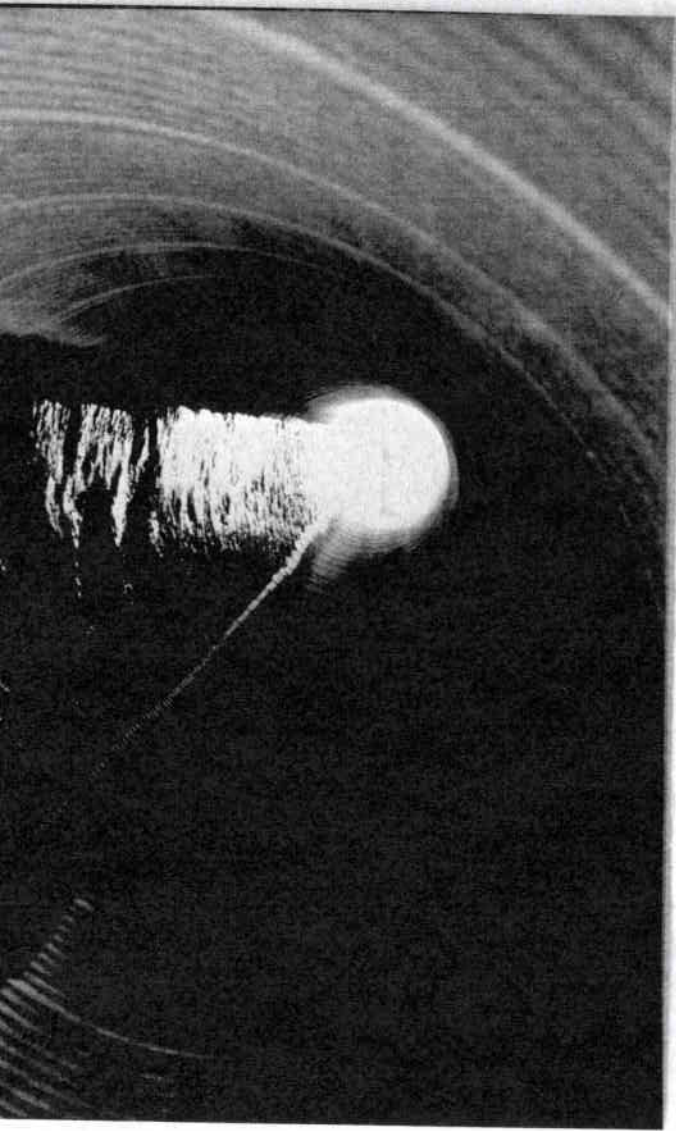
CMP OUTLET - Both perched 12 in., water 9 in. deep in CMP, plunge pool approx. 4 ft diameter at each pipe, rip rap scoured from both pipes.

13A

inside of CMP

(SHORT TERM) - Construct outlet apron (rock) 12-15' square at each pipe and up into pipe 6-12 in. deep.

(LONG TERM) - Reset both pipes.

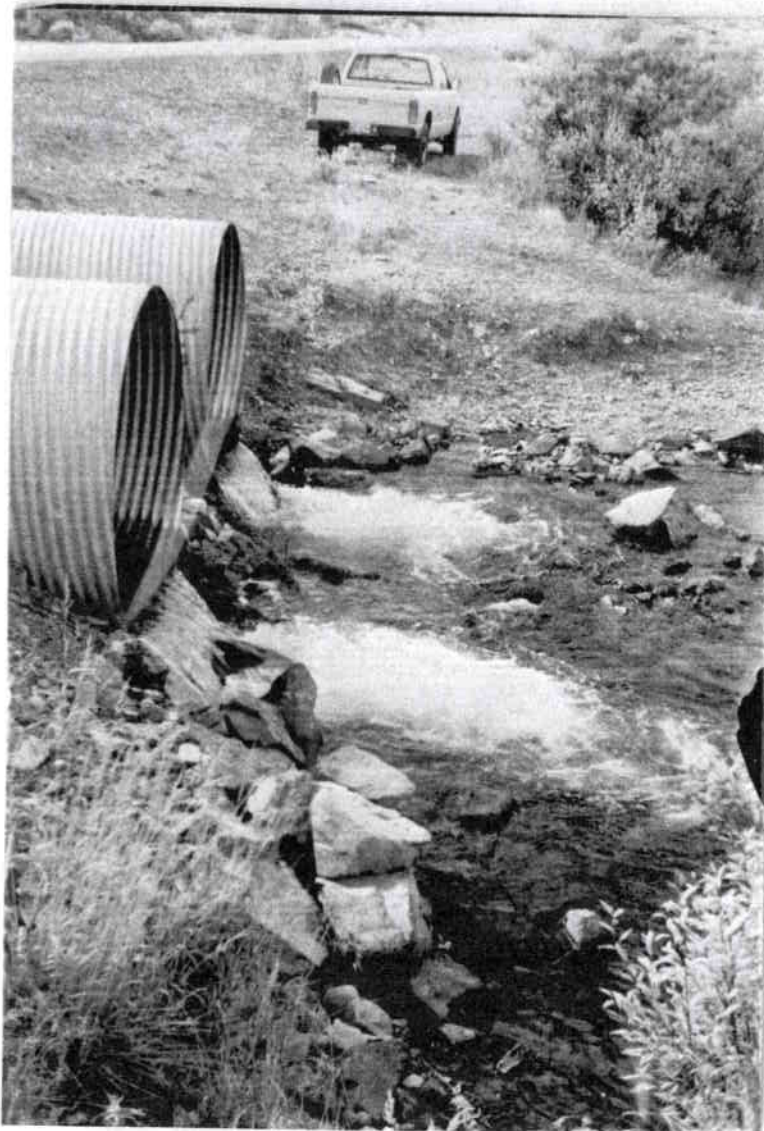
12A

FISH PASSAGE BARRIERS - Perched culverts 12 in. above pool surface

2-72" cnp's

Side view of outlets

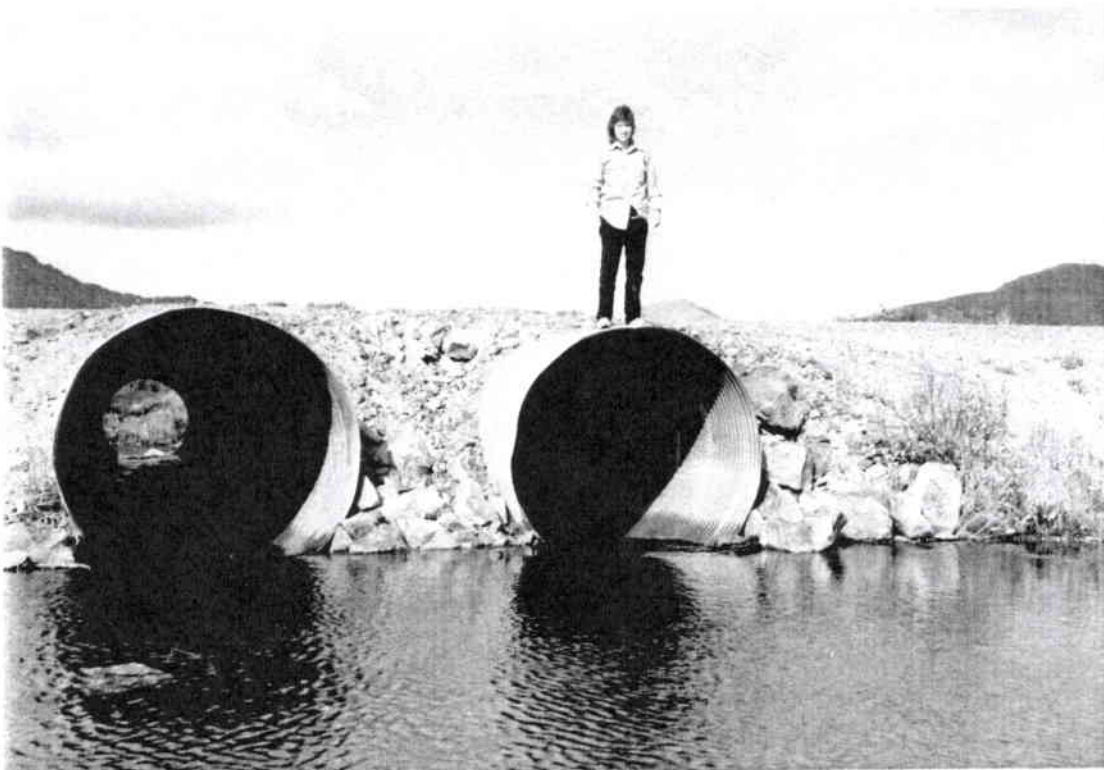
14A

CMP INLET - Approx. 12 in. drop (head), ponding upstream (pic 14).

2-72" CMP's inlets

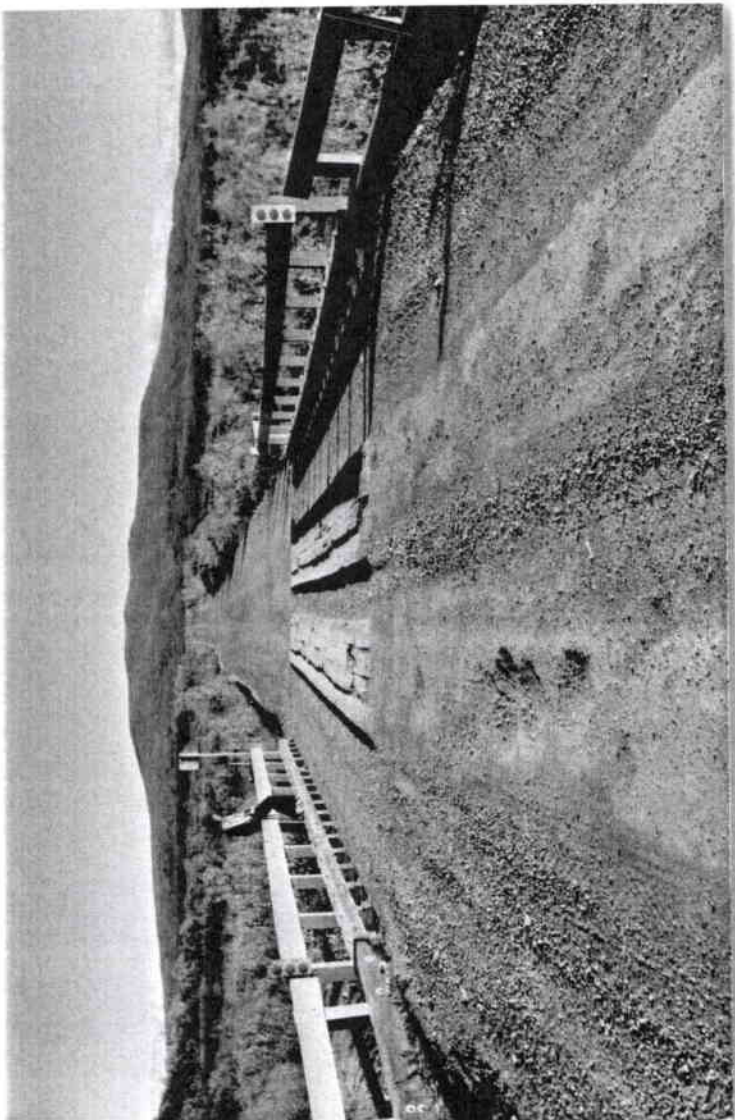
15A

OBSERVATIONS: Flow 35-40 cfs est., cobble to boulder bottom
- ~~should not~~ be culverted, dense willow bank cover. Bridge
alignment good.

bridge

LONG TERM - New bridge when required.

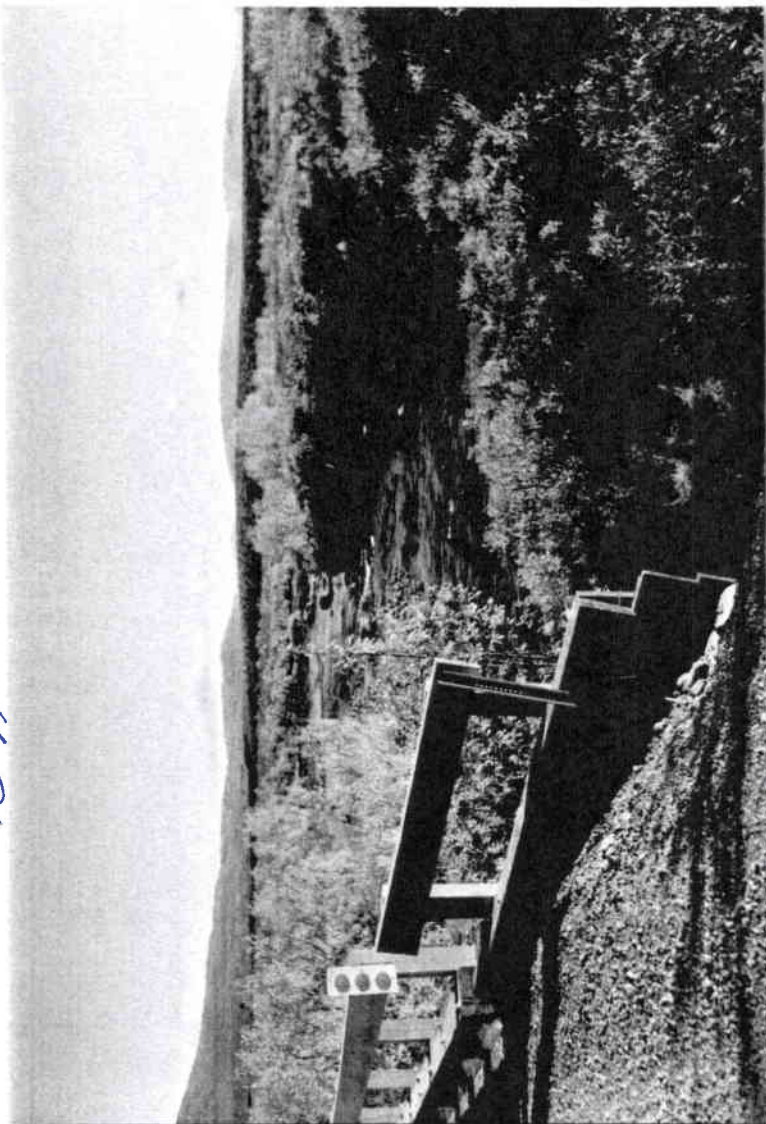
16A

Downstream from bridge

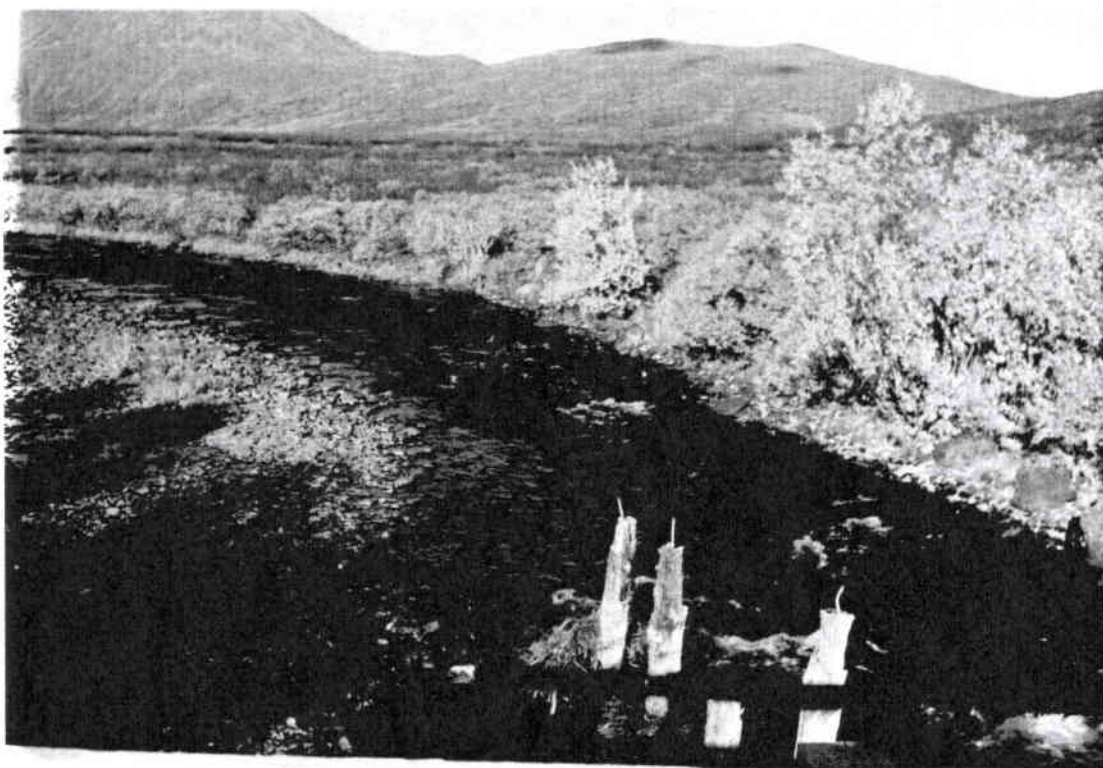
17A

upstream

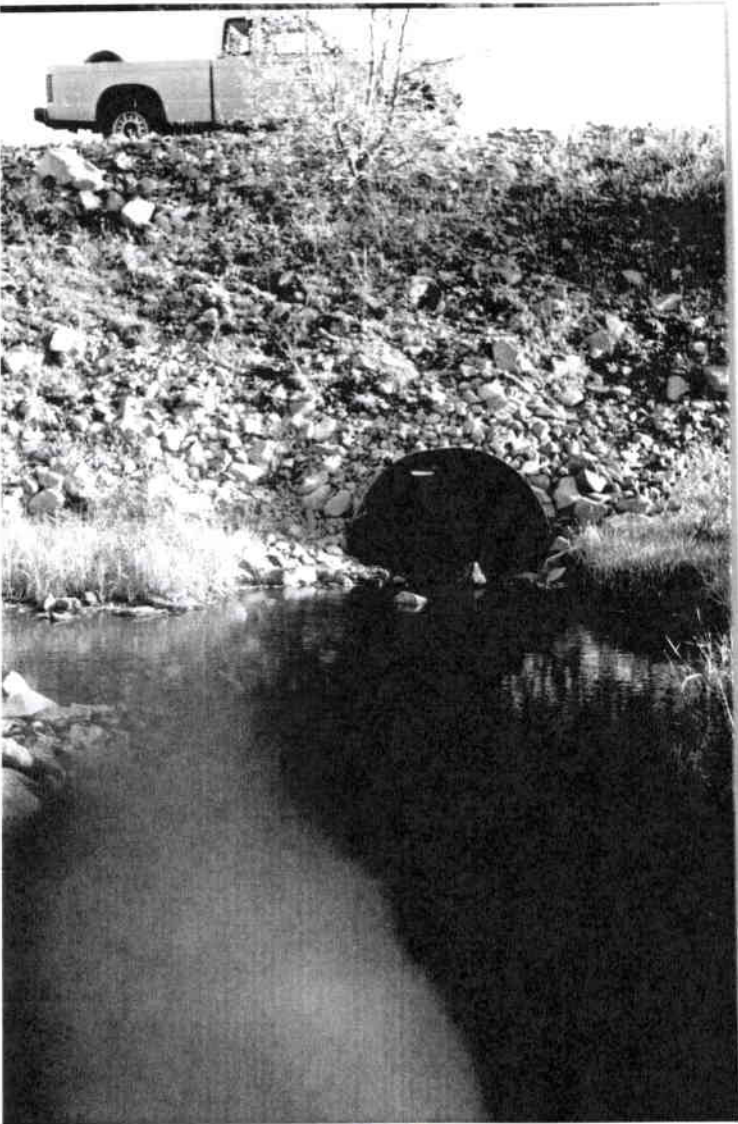
21A

CMP OUTLET - Uptilted 1-2" no barrier, 50% bottom cover (gravel) in CMP.

Unnamed Creek
Denali Hwy MP 33.3
9-9-86
Jennard / Gilbert
outlet 34"x54" arch emp
and finger tip

LONG TERM - Replace prior to road resurface.

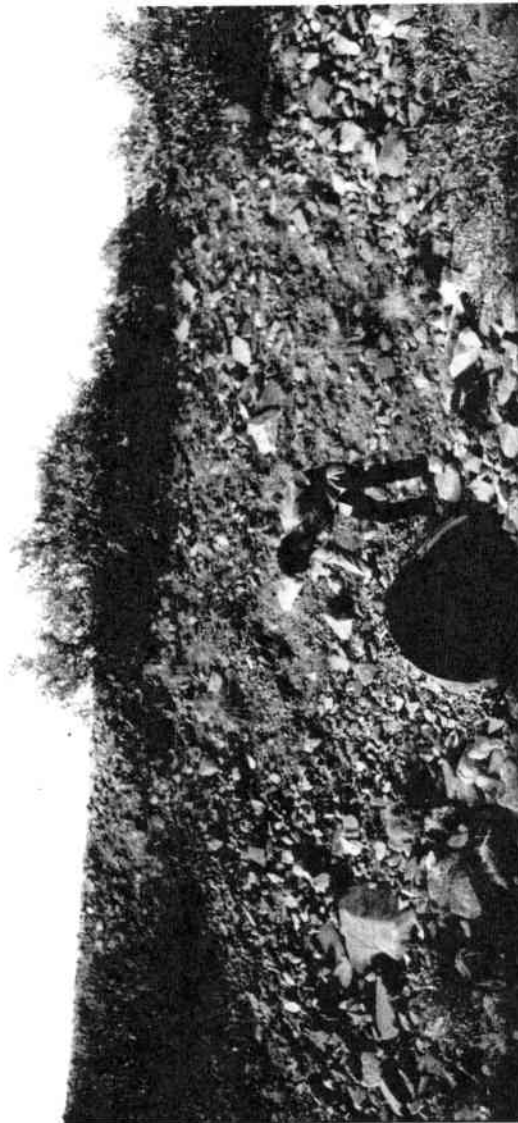
18A

CMP INLET - Uptilted 8-10" but no barrier.

Unnamed Creek
Denali Hwy MP 33.3
9-9-86
Jennard / Gilbert
inlet 34"x54" arch emp

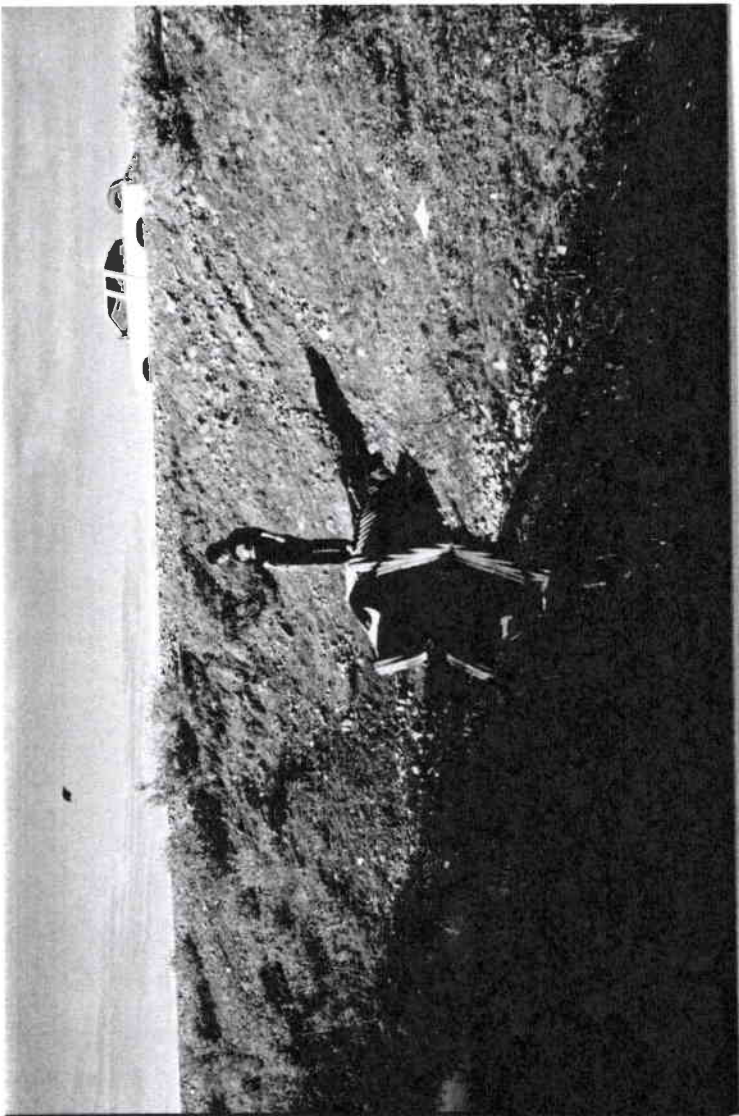
22A

CMP INLET - Badly torn and bent, 18 in. fall into CMP, small
woody trash collected on lip, approx. 4-5 cfs est.

FISH PASSAGE BARRIERS - CMP inlet (partial)

inlet with cumped edges

SHORT TERM - Replace 10' of inlet

LONG TERM - Increase pipe size

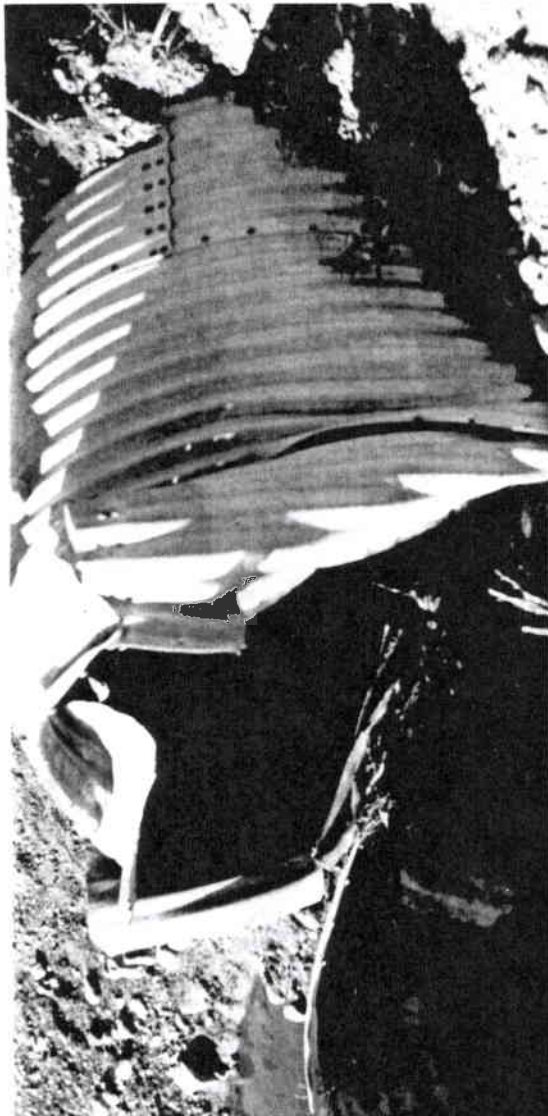
23A

inlet with cumped edges and collected
debris

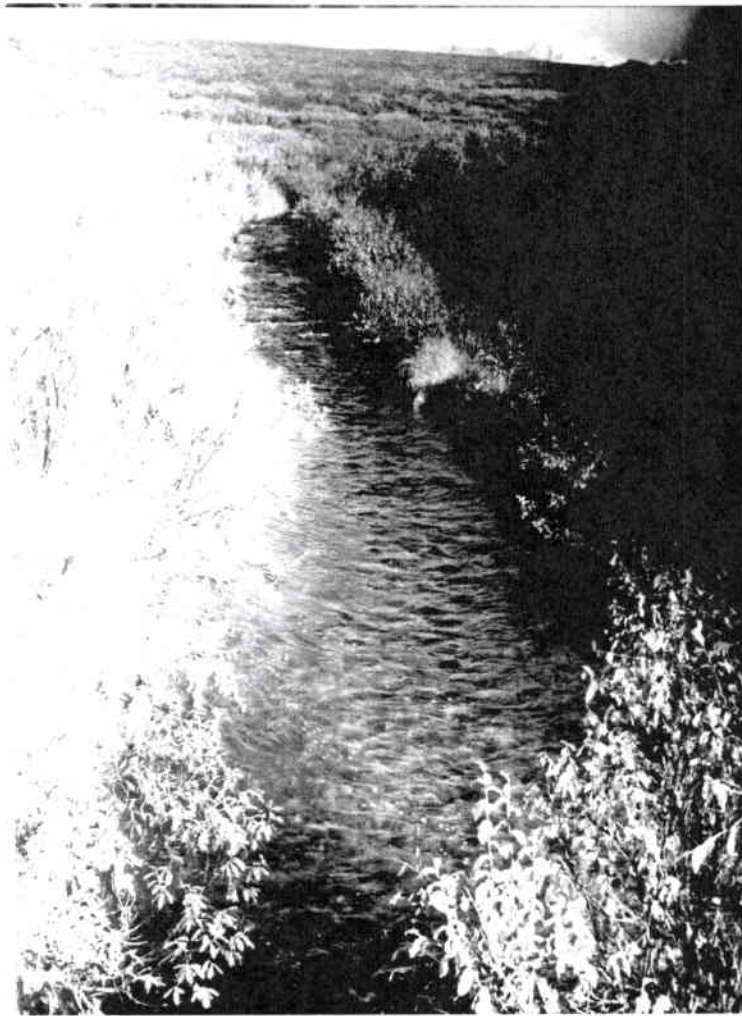
00

CMP INLET - Lip section upthrust several inches (5-6"?) about 12" hydraulic jump but little to no ponding.

115" W x 126" h ellipse C.M. multiplate

lip upthrust (ice jacking??)

RECOMMENDATIONS - Increase structure size with invert burial or bridge.

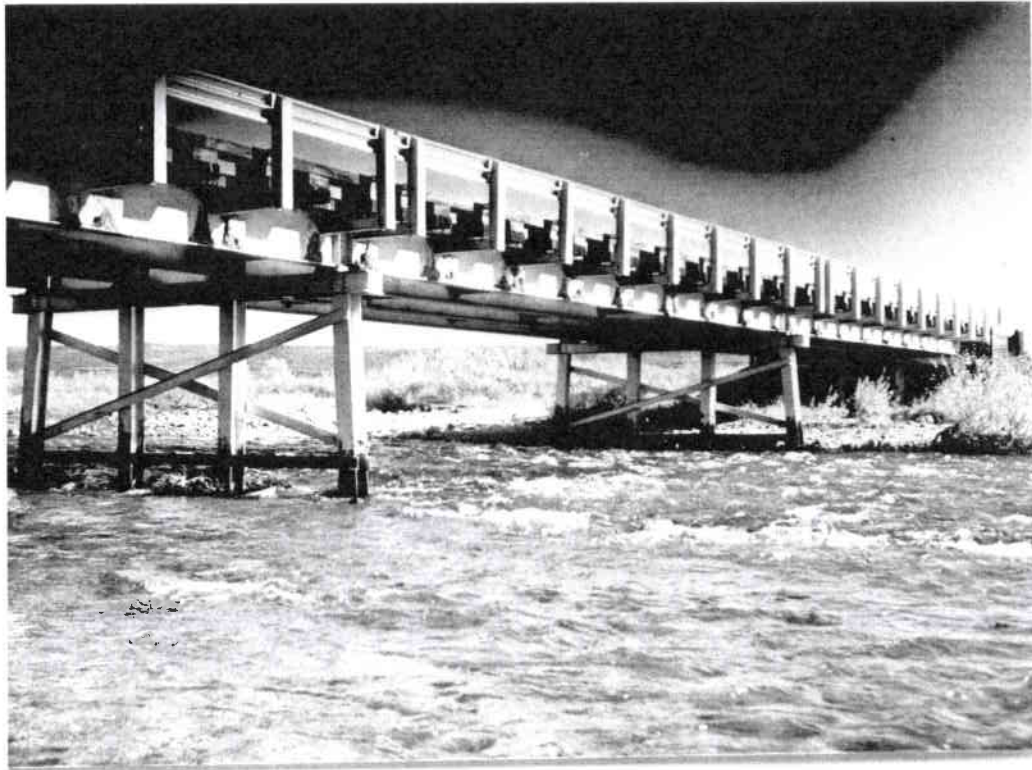
0A

Two steel piers (H-beam) in channel single lane bridge, good alignment, good floodplain spanning. Pullout with restroom present on west bank.

View toward NE

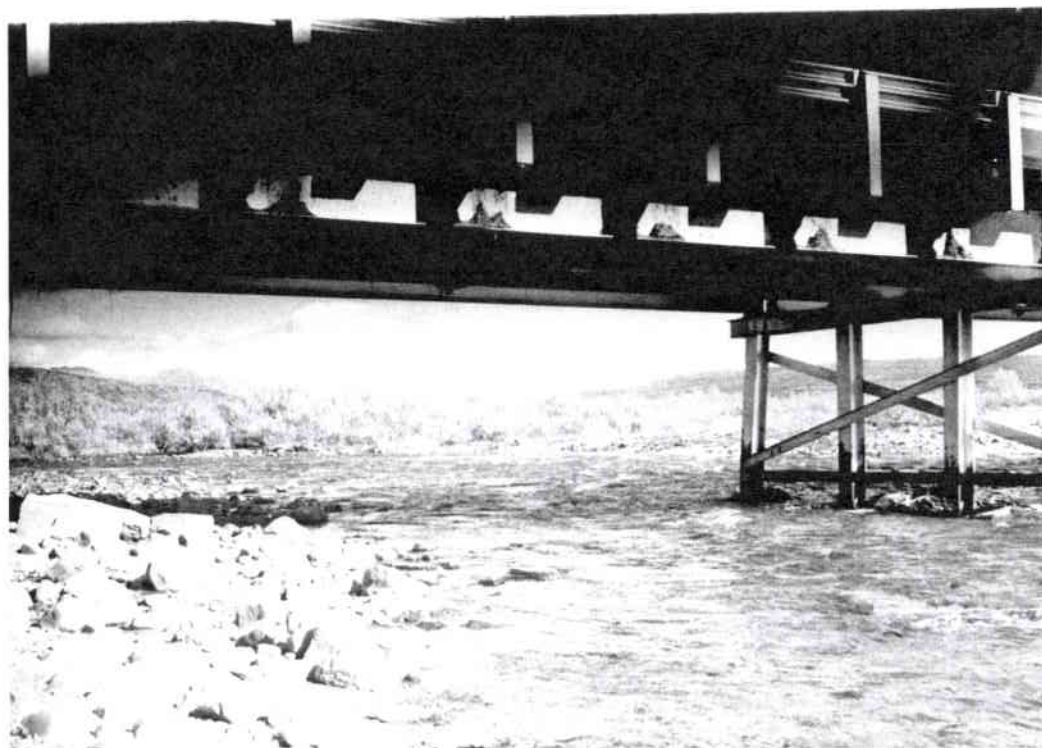
1A

View toward NNE

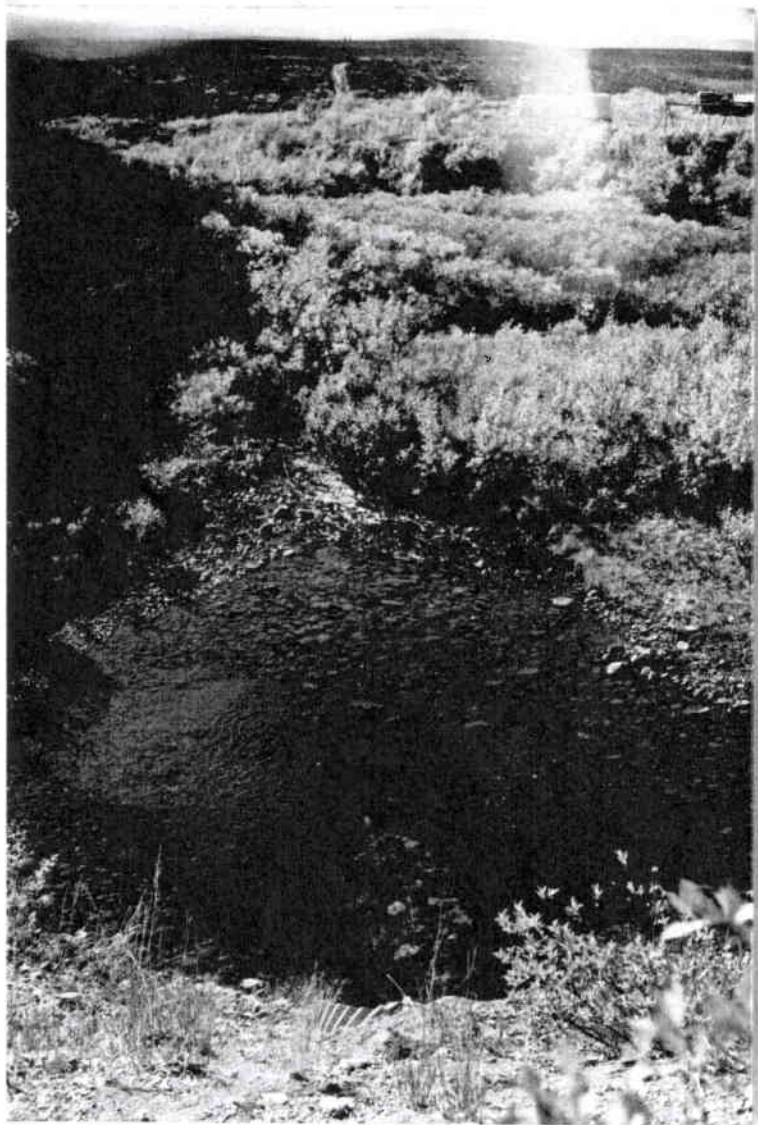
6A

CMP OUTLET - Good burial depth, outlet pool gravel with cobble/algae line thru water approx. 2' deep (pic 6)

downstream view from road

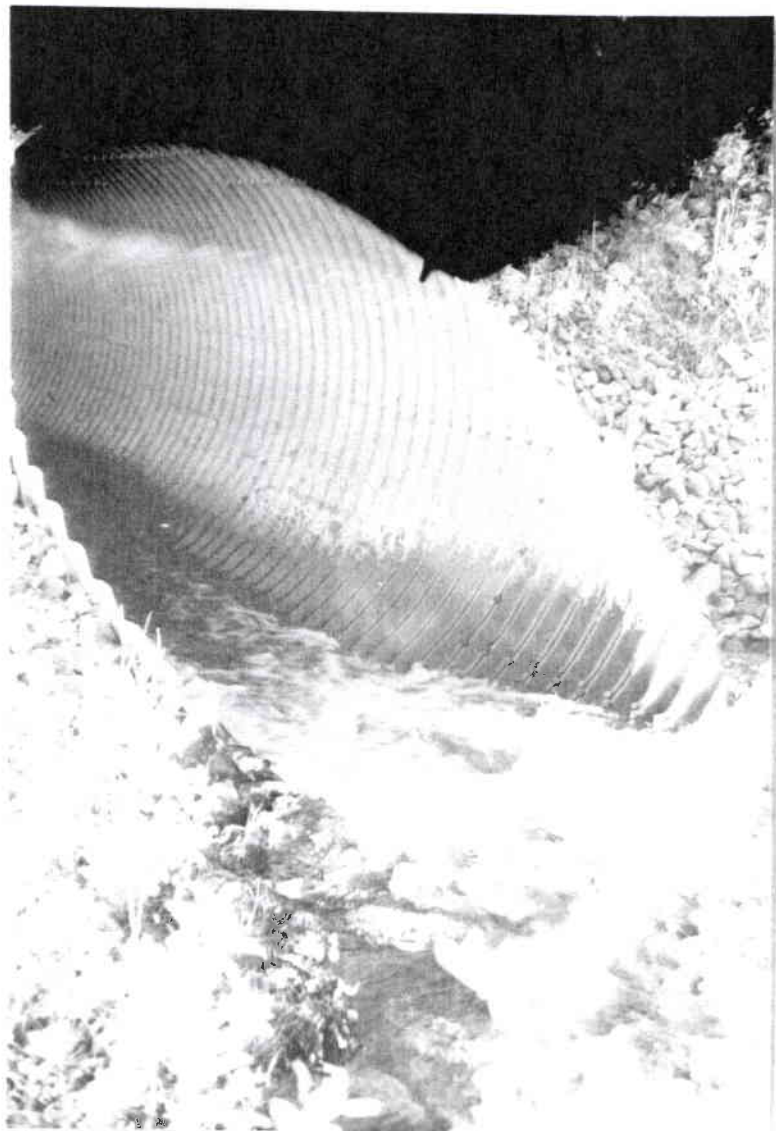
4A

CMP INLET - Cobbles in inlet, lip slightly upthrust, lip 12" below streambed, gravel-cobble substrate at inlet, approx. 5 cfs.

FISH PASSAGE BARRIERS - Inlet partial, beaver pond 100' above inlet (double level-each about 3' high) (pic 3, 4).

9-10-86
Townsend / Talbert
culvert inlet

SHORT TERM - clean out inlet

LONG TERM - reset with deeper burial, may require larger pipe

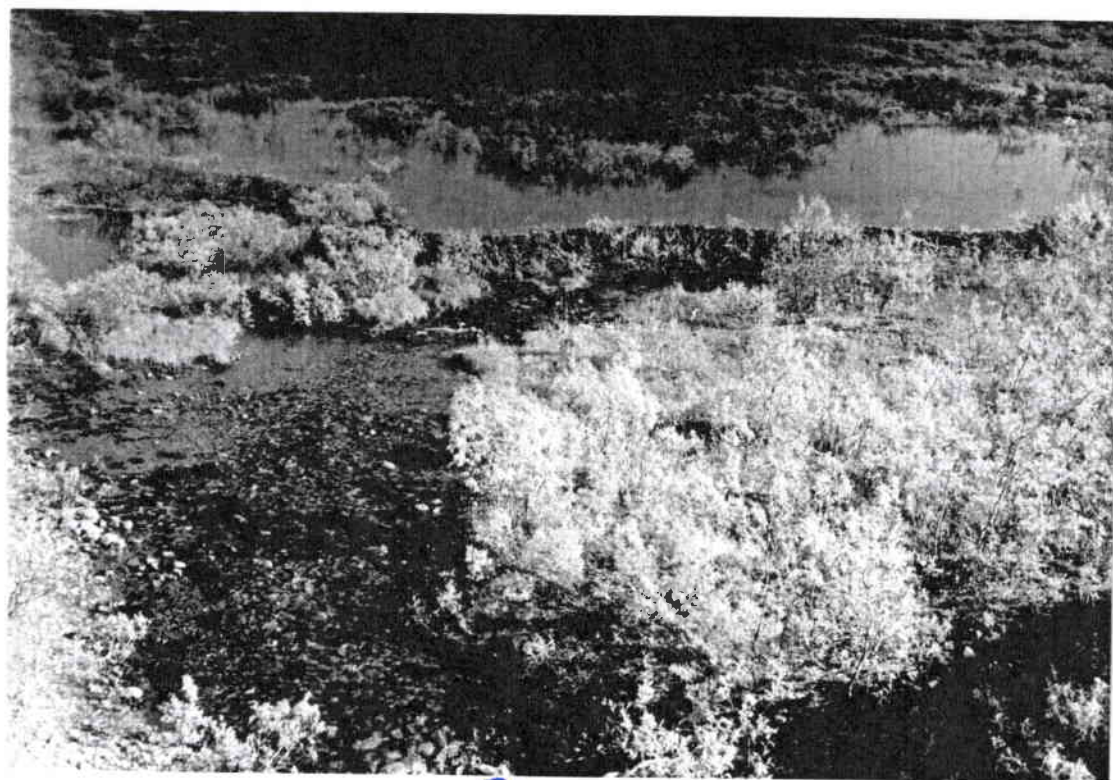
3A Unnamed Cr MP 59.8
9-10-86
upstream view from cmp

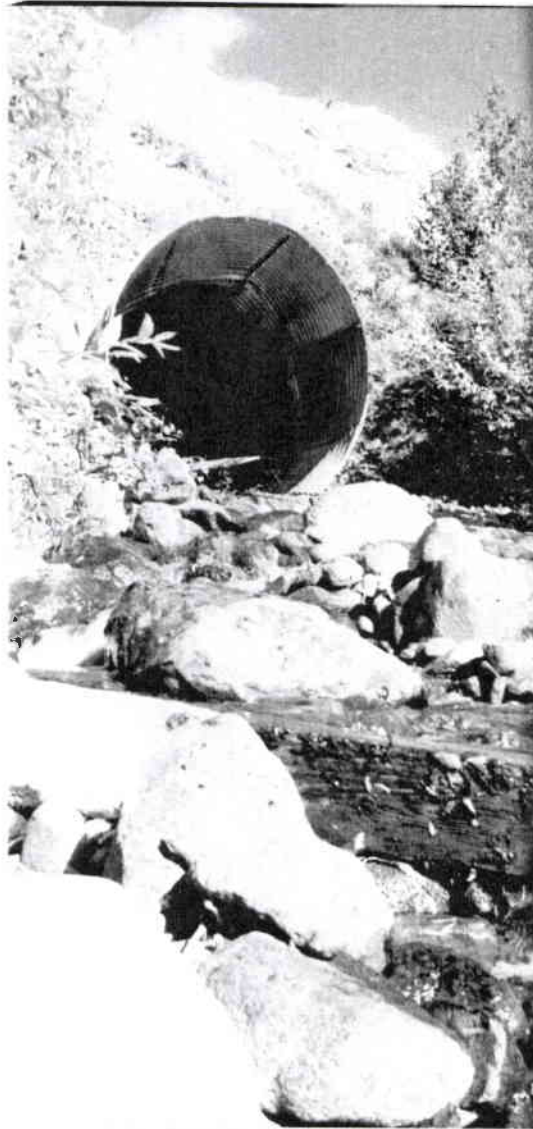
9A

CMP OUTLET - Set at streambed level (culvert set flatter slope than stream slope)

culvert outlet

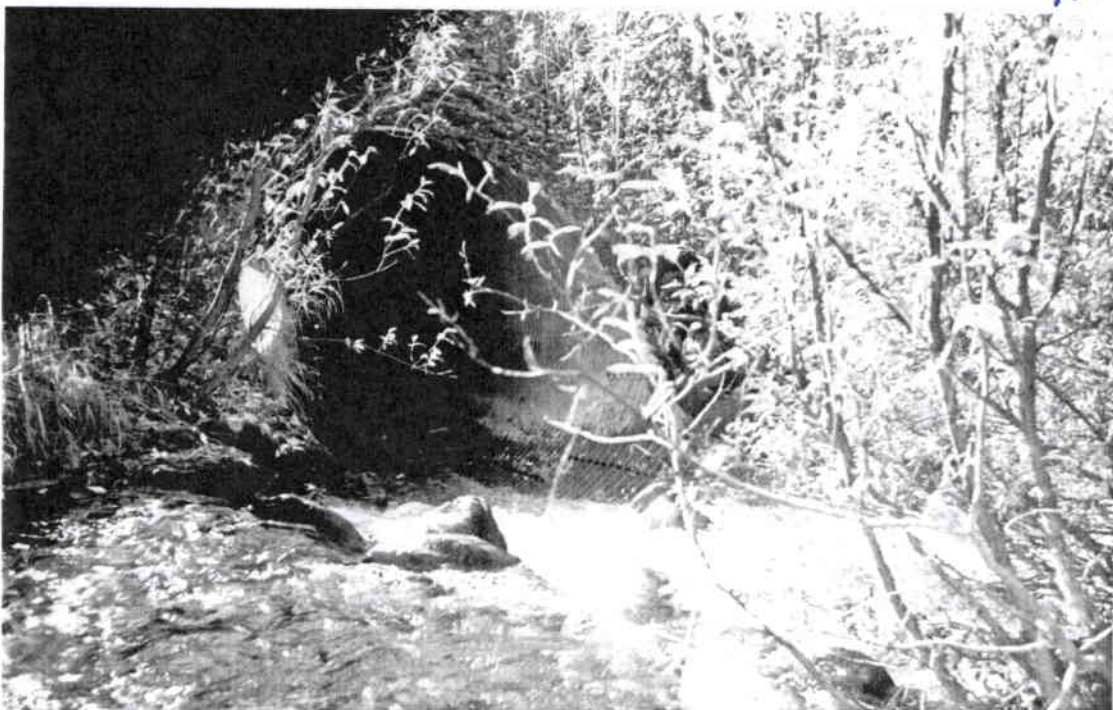
7A

CMP INLET - Cobble/boulder stepped, steep mountain stream 18" below streambed, slightly upthrust.

FISH PASSAGE BARRIERS - Velocity (approx. 5 fps) in pipe and may be in natural stream (2-3' steps over boulders).

cmp inlet

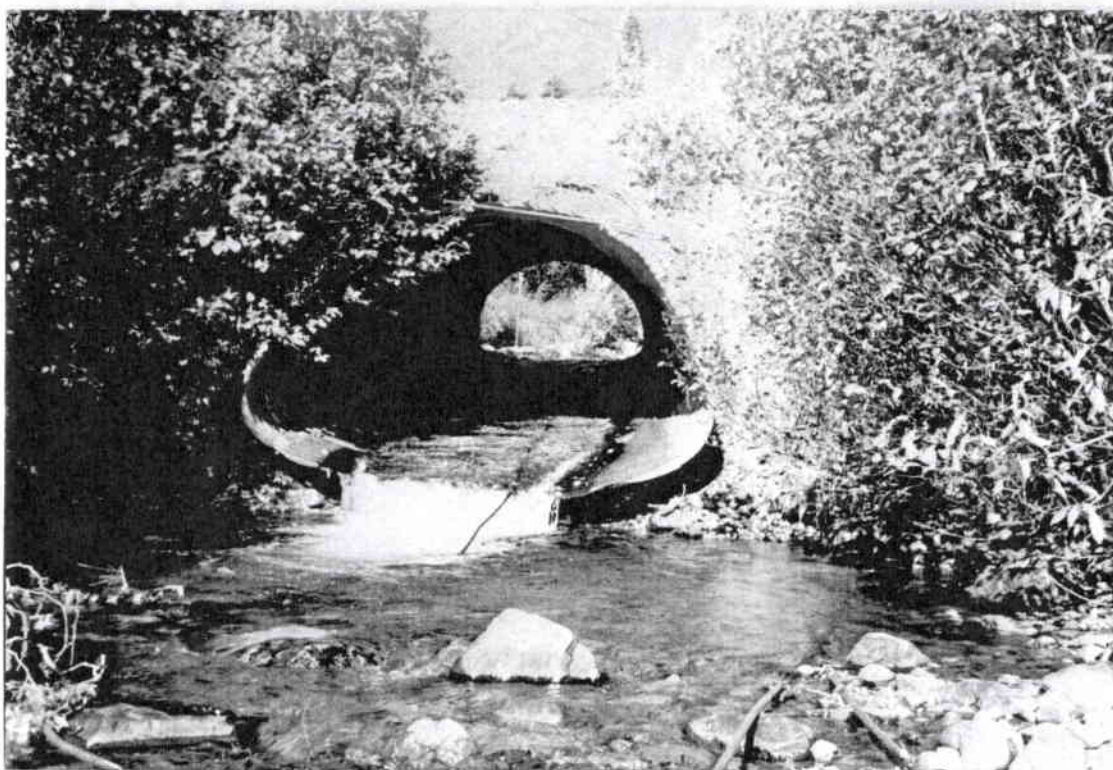
CMP OUTLET - Perched approx. 14 in above pool surface, scour pool 4+' deep x 12' wide x 12' long.

FISH PASSAGE BARRIERS - Culvert at about 3-4% grade (est.)

cmp outlet

SHORT TERM - install angular 100# + rip rap apron if fish documented

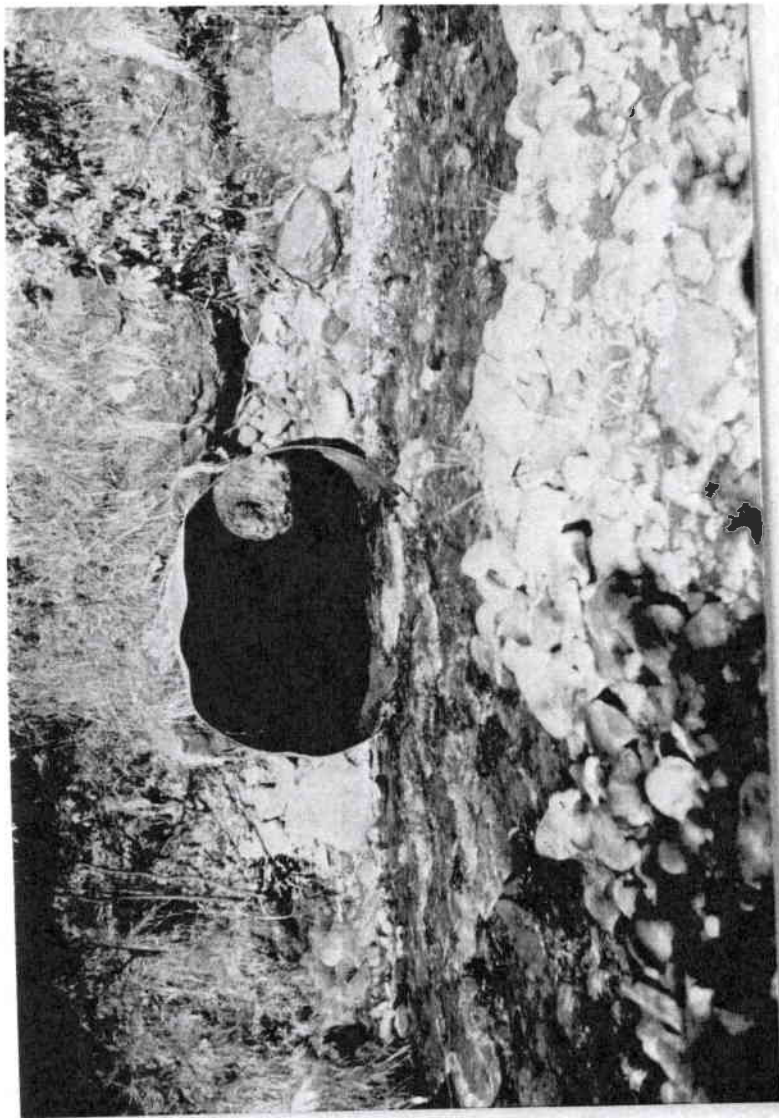
17A

CMP INLET - Cobble build-up 12-15" in front of CMP (left) 15-18" (right), 7-10 cfs left, 2-3 cfs right

FISH PASSAGE BARRIERS - CMP outlets and boulder pile and inlets

Left culvert inlet

SHORT TERM - No cure

LONG TERM - bridge

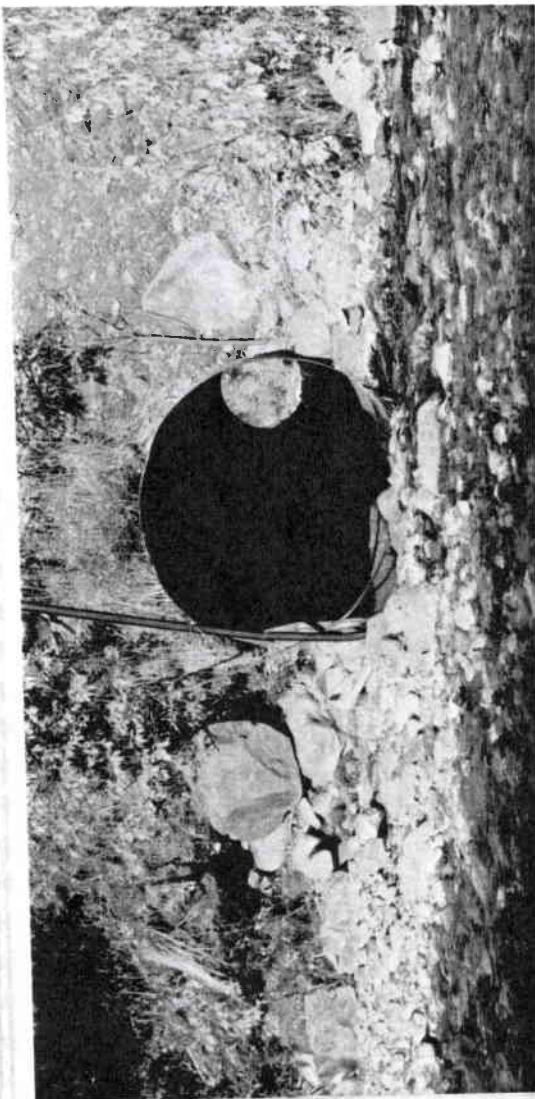
18A

Right Culvert inlet

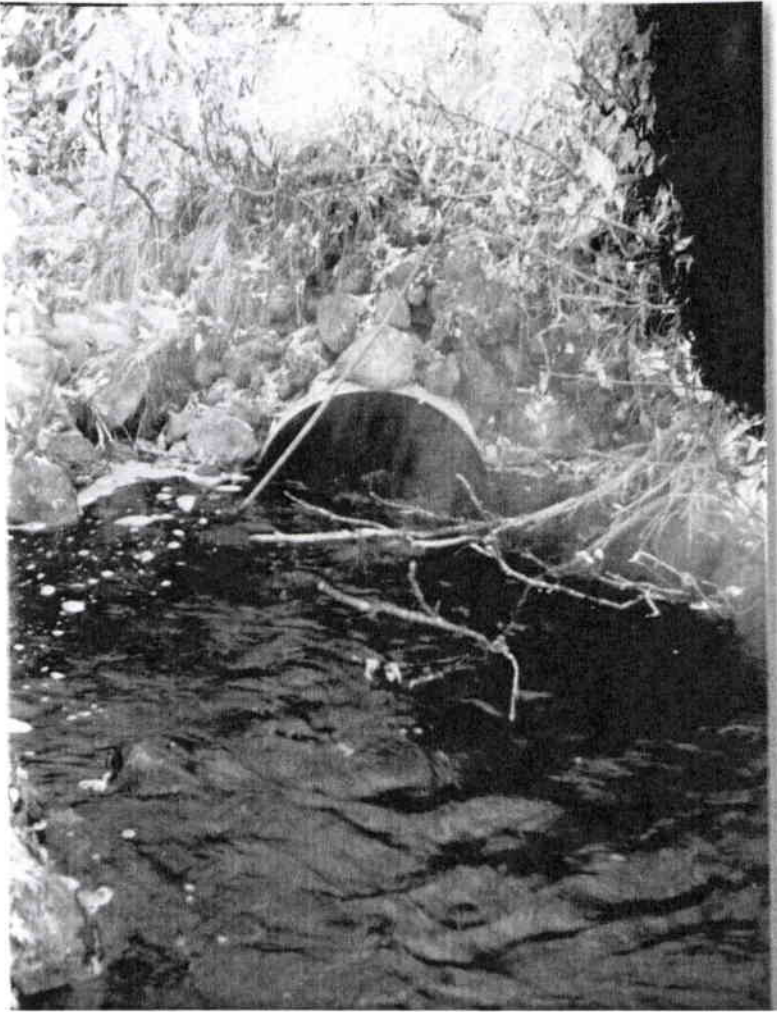
20A

CMP OUTLET - $\frac{1}{2}$ submerged, scour pool 6' wide x 10' long x 2' deep, outwash riffle passable. Overflow approx. 10' above serviceable CMP.

Culvert outlet

LONG TERM - replace with larger culvert

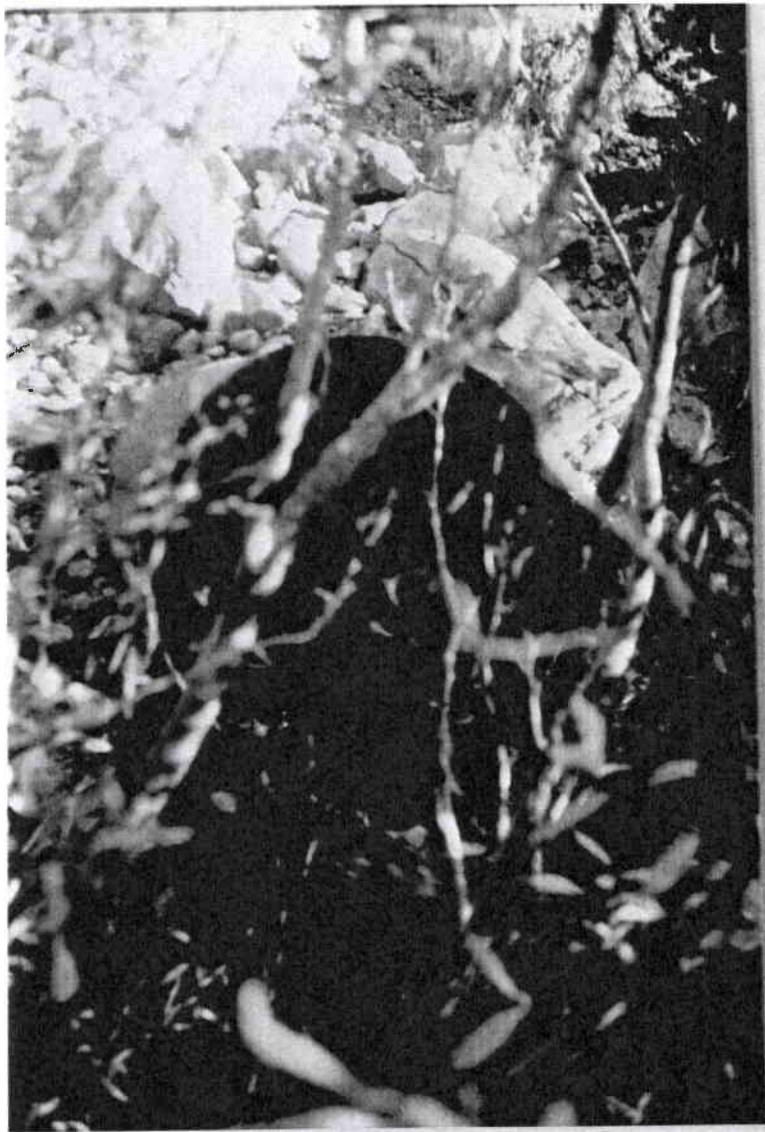
2A

CMP INLET - Up thrust 8-10", cobble-boulder, low step, heavily canopied over with alder and willow. First 15' of CMP steep and fast.

FISH PASSAGE BARRIERS - Inlet velocity first 15', outlet perched.

culvert inlet

SHORT TERM - no fix feasible (replace)

LONG TERM - replace with larger CMP

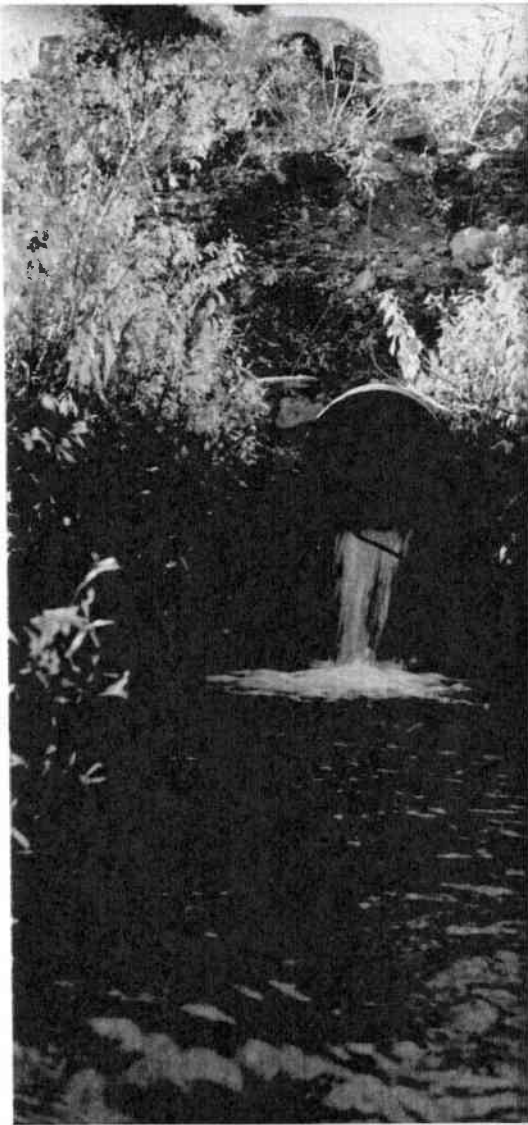
5A

CMP OUTLET - Perched 4-5', plunge pool 8' long x 6' wide x 2 $\frac{1}{2}$ ' deep, cobble-gravel bottom - not overly swift stream (medium velocity mountain stream).

culvert outlet

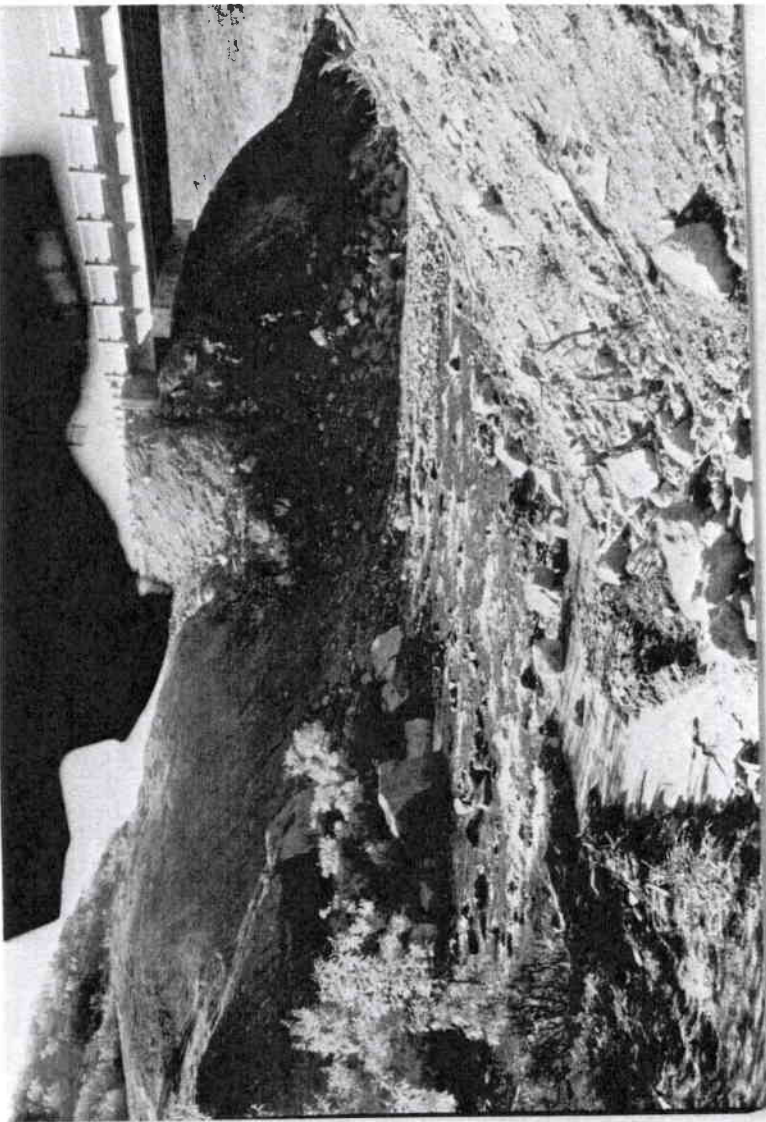
9A

OBSERVATIONS: Poor bank stabilitation, good channel spanning by new bridge - no apparent channel disturbance except for minor rip rap encroachment on west bank, poor revegetation (just coming up - late seeding?)

View from base of waste area → upstream
note sediment channel in dozer track
directly to creek.

SHORT TERM - armor base of waste material and construct catch basin for sediment. Redo seeding.

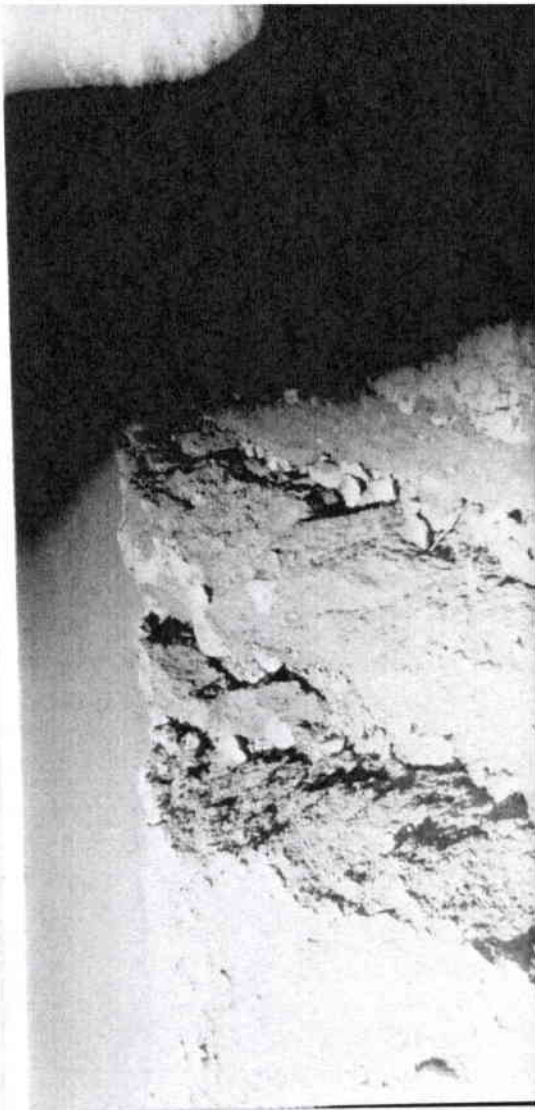
8A

erosion on waste material

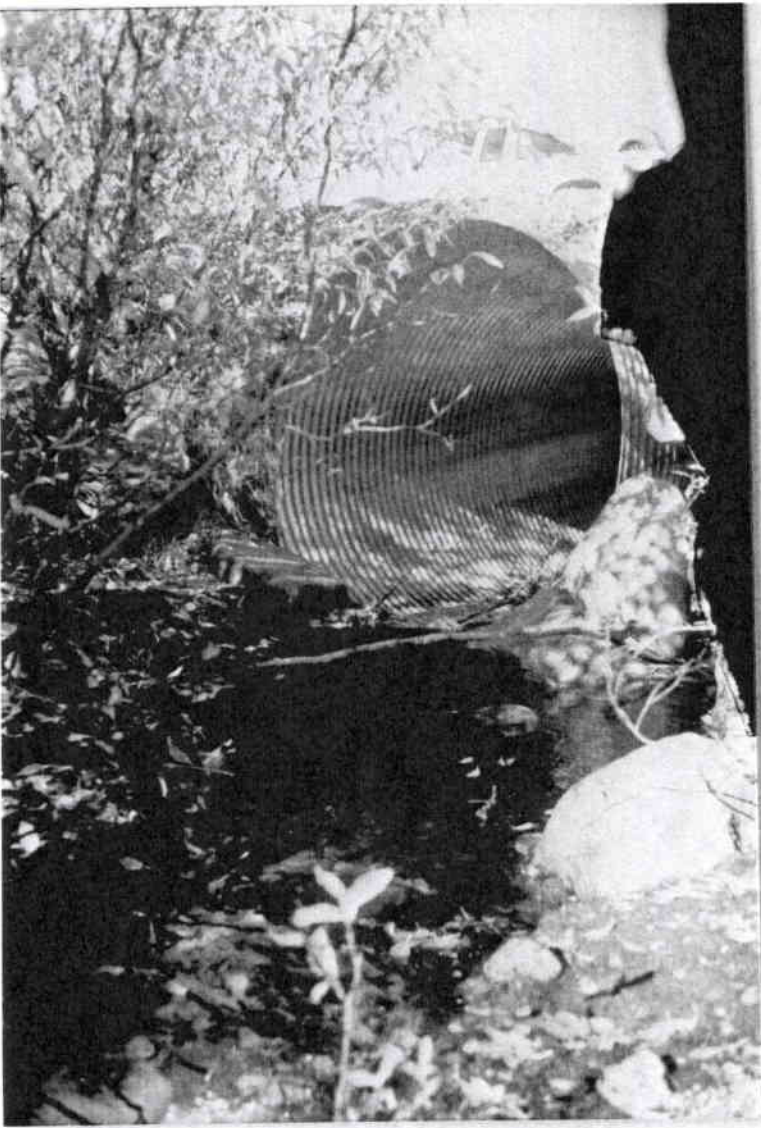
12A

CMP INLET - West pipe 6" below stream bed with boulder armor on sides, gravel stream bed (2 cfs) appears to be off-channel. East pipe (20' separation) in channel, set 12" deep, approx. 5 cfs with boulder side armor-gravel bottom-pipes bare inside.

W. Culvert inlet

LONG TERM - much larger culverts with 20% buried
