ALASKA DEPARTMENT OF FISH AND GAME
Habitat Division

Denali Highway Reconnaissance - September 9-11, 1986

SUBJECT: Denali Highway
Drainage Structure
Recon.

September 9-11, A. Townsend and K. Talbert conducted field reviews on drainage structures along the Denali Highway from milepost 0 to 104. Review sheets were completed for 15 streams either documented to have fish or suspected to have fish because of the habitat quality. This information is enclosed for your files.

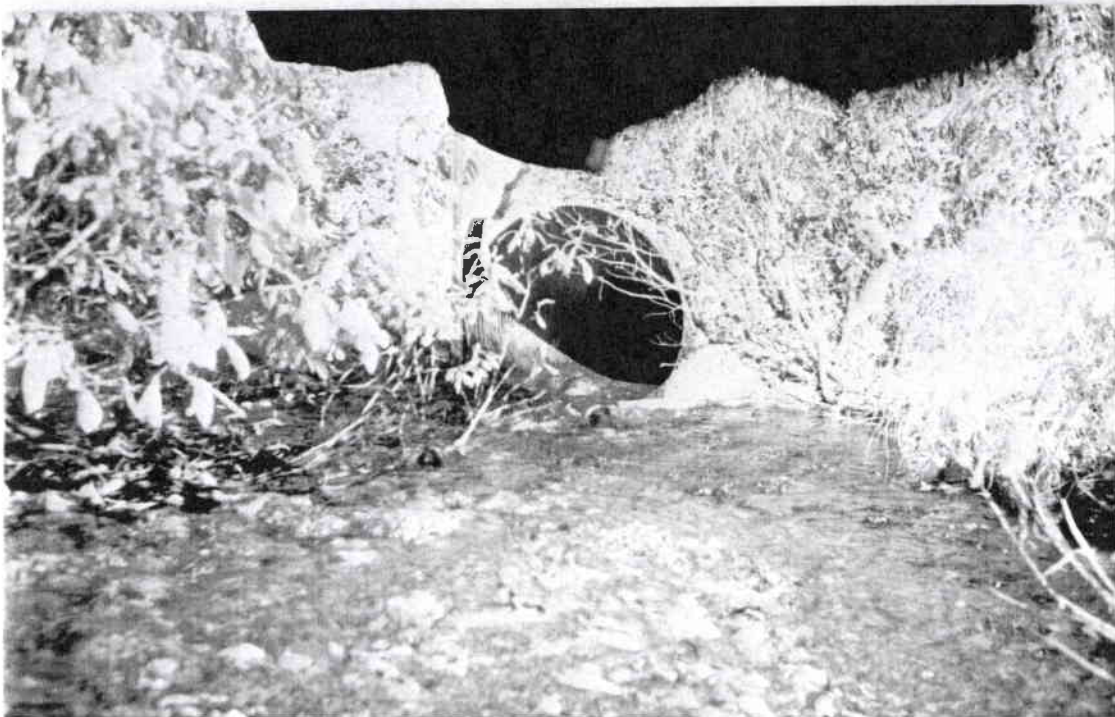
CMP INLET - West pipe 6" below stream bed with boulder armor on sides, gravel stream bed (2 cfs) appears to be off-channel. East pipe (20' separation) in channel, set 12" deep, approx. 5 cfs with boulder side armor-gravel bottom-pipes bare inside.

13A E cmp inlet

LONG TERM - much larger culverts with 20% buried

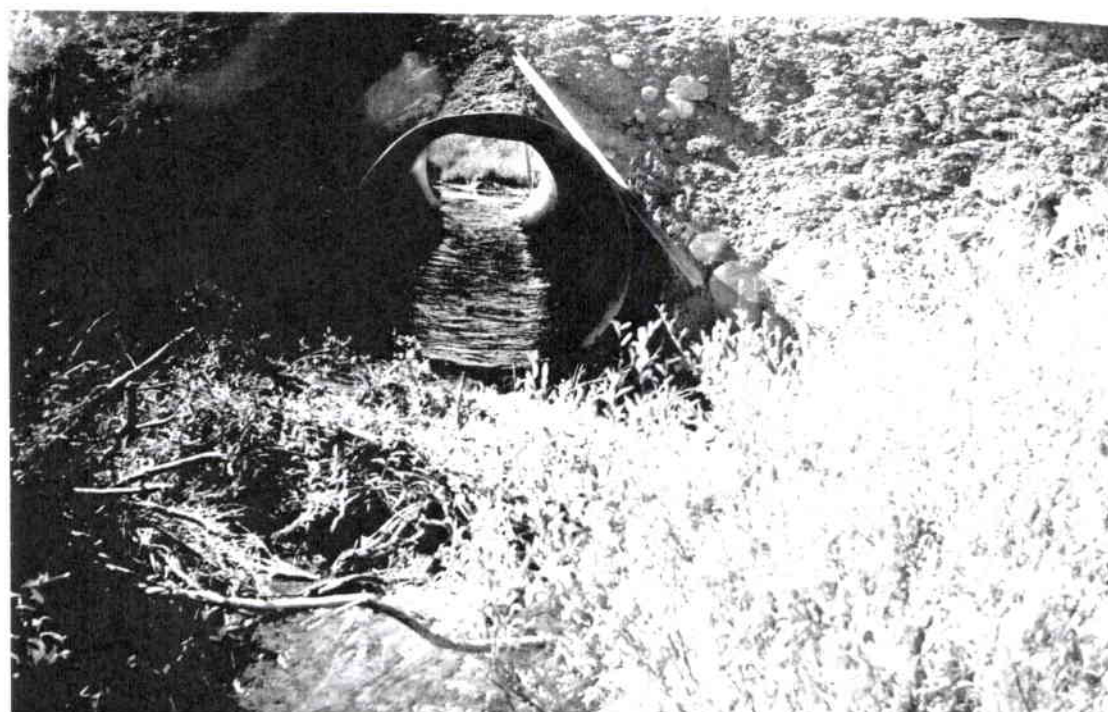
CMP OUTLET - Beaver debris splits channel; pipe set at stream bed, water approx. 6" deep in pipe.

21A cmp outlet

LONG TERM - remove old shoofly road, culvert scraps, install larger CMP.
