Source Water Assessment

A Hydrogeologic Susceptibility and
Vulnerability Assessment for
Trail Lake Lodge and Motel
Drinking Water System,
Moose Pass, Alaska
PWSID # 240804.001

DRINKING WATER PROTECTION PROGRAM REPORT # 358
Alaska Department of Environmental Conservation

By URS Corporation

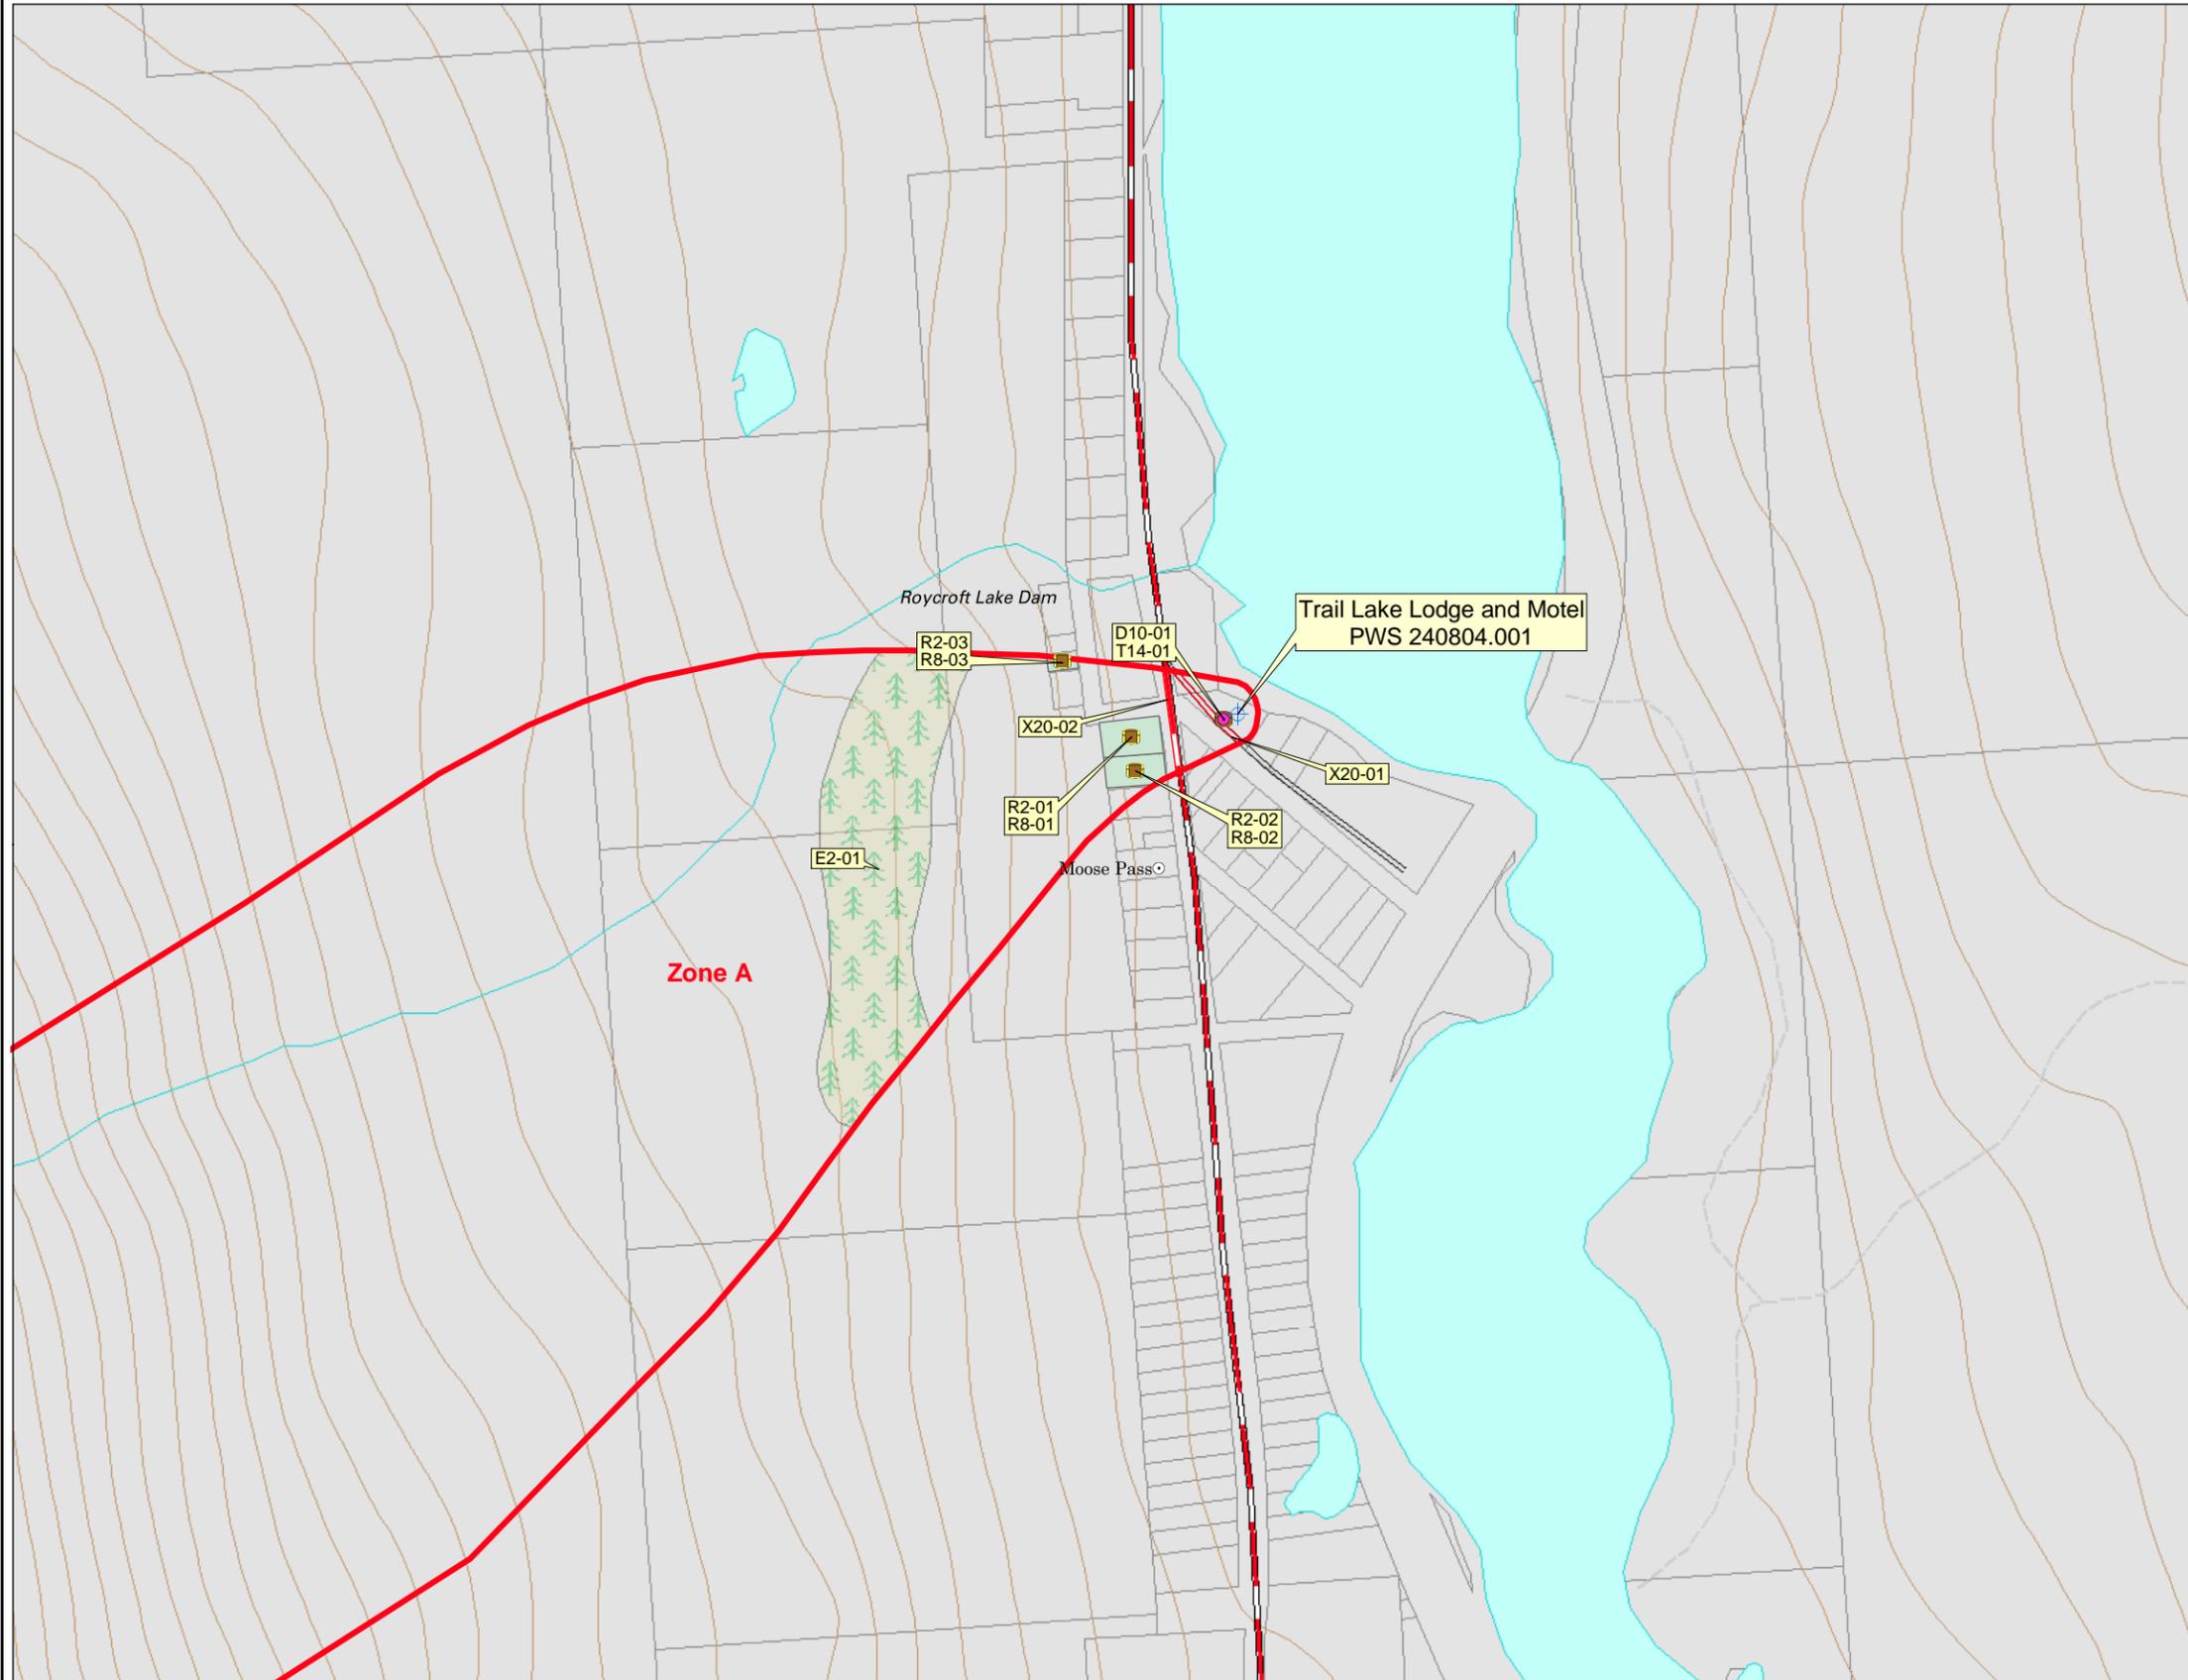
Trail Lake Lodge and Motel Drinking Water Protection Area and Potential and Existing Contaminant Sources (Map 2)

The aboveground heating oil tanks located in Zone A form the greatest risk for volatile organic chemicals.

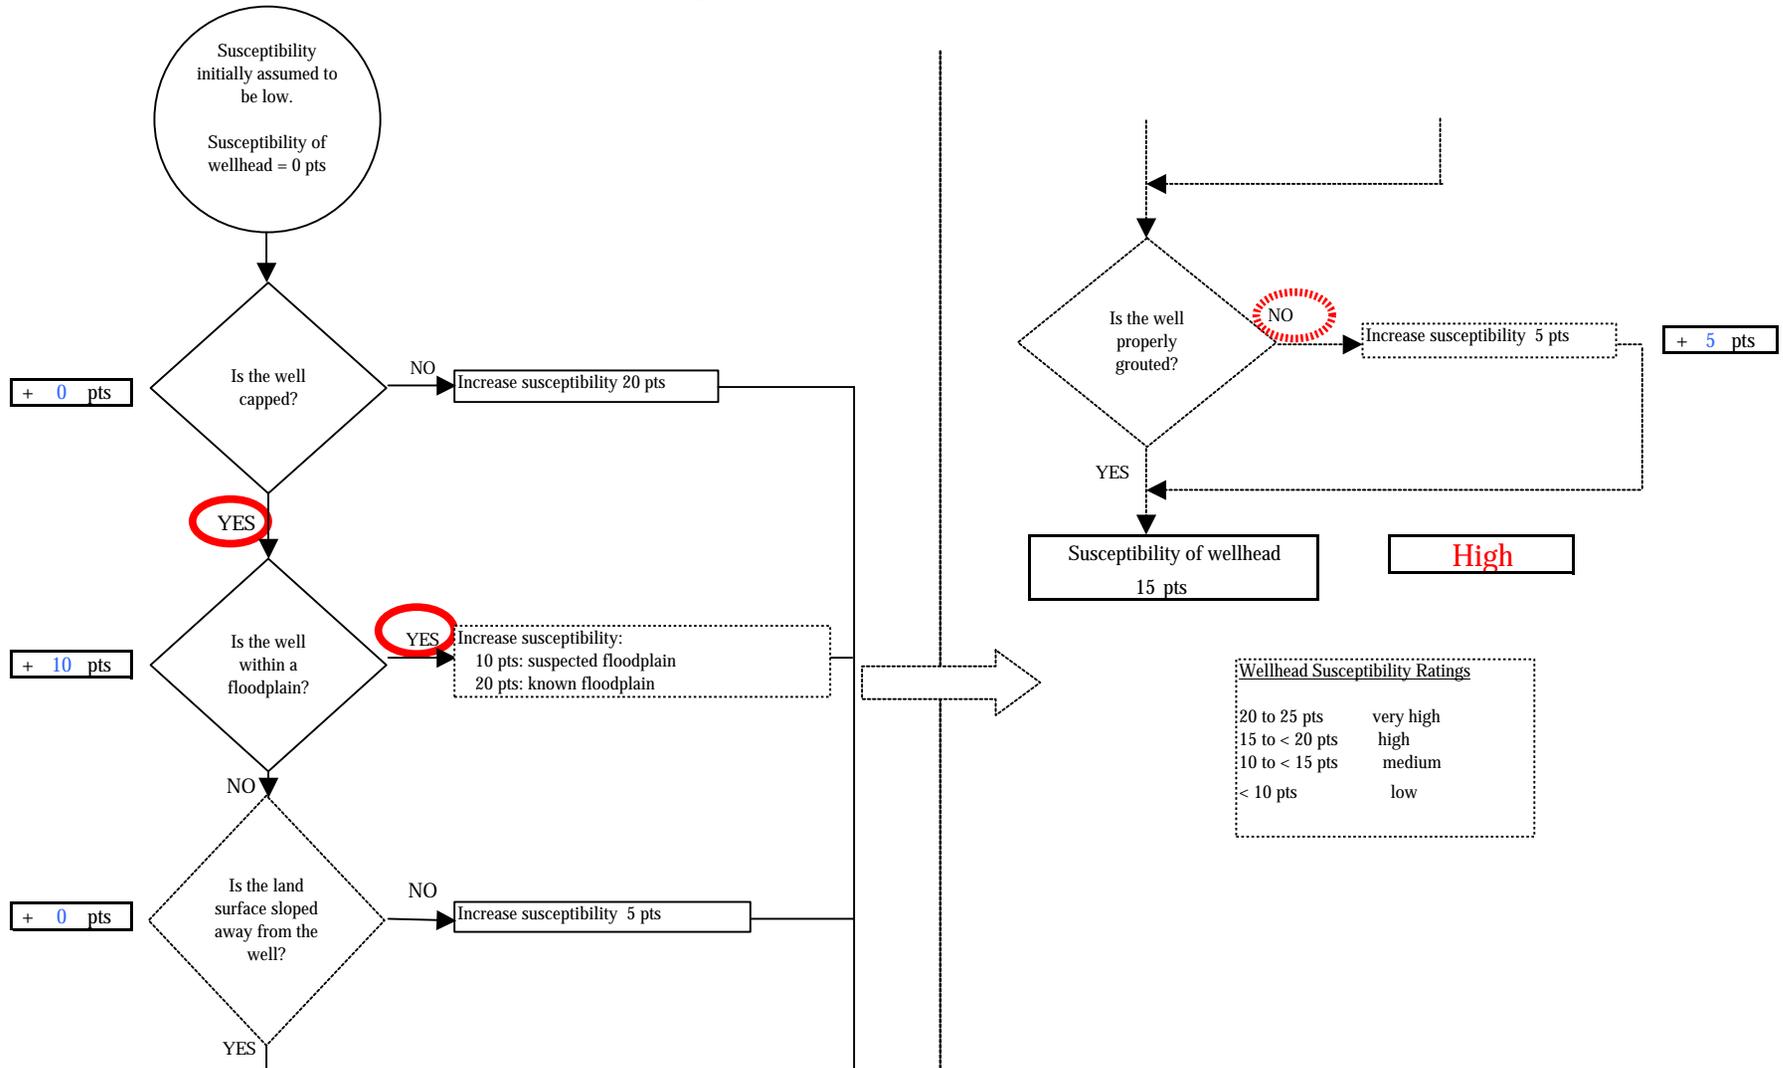
Chart 1. Susceptibility of the wellhead - Trail Lake Lodge and Motel (240804.001)

The well for Trail Lake Lodge and Motel is completed in an unconfined aquifer setting. Because an unconfined aquifer is recharged by surface water and precipitation that migrates downward from the surface, contaminants at the surface have the potential to adversely impact this aquifer. Table 2 shows the Overall Susceptibility score and rating for Trail Lake Lodge and Motel.

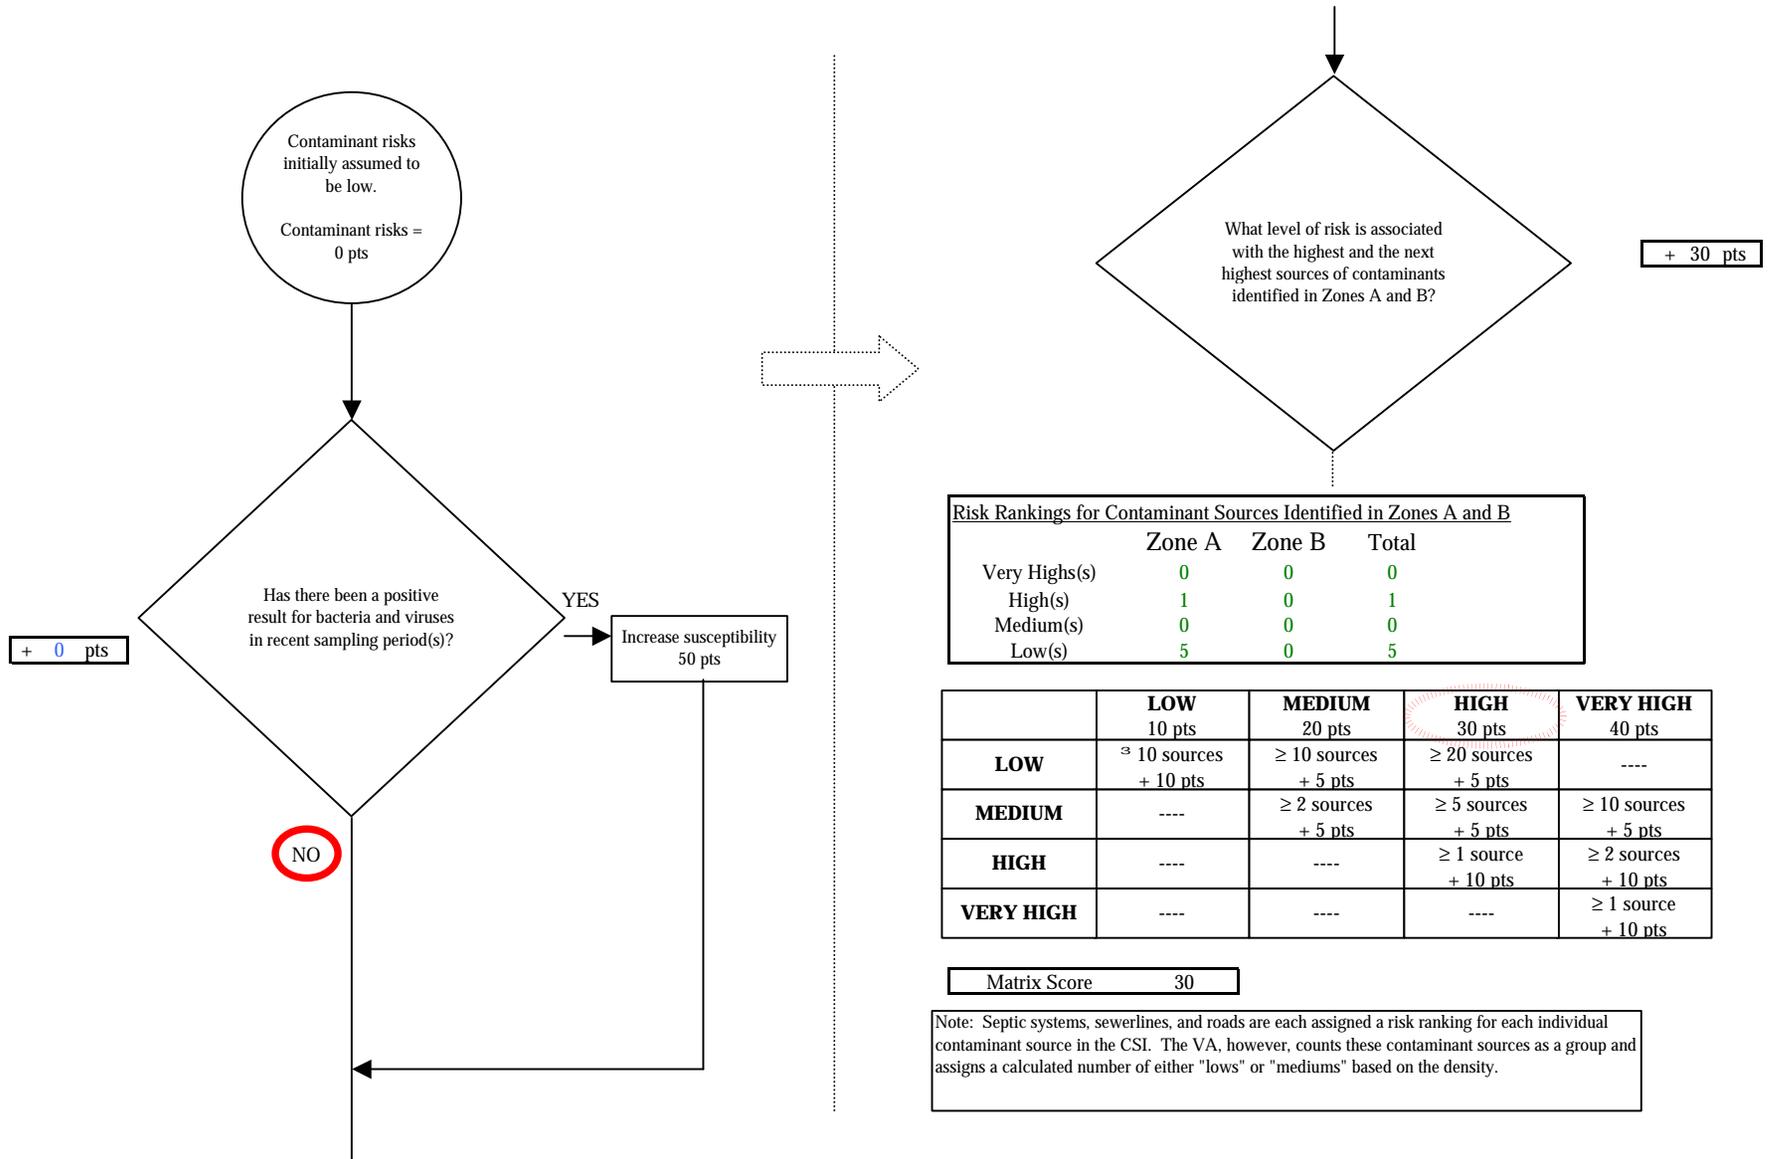
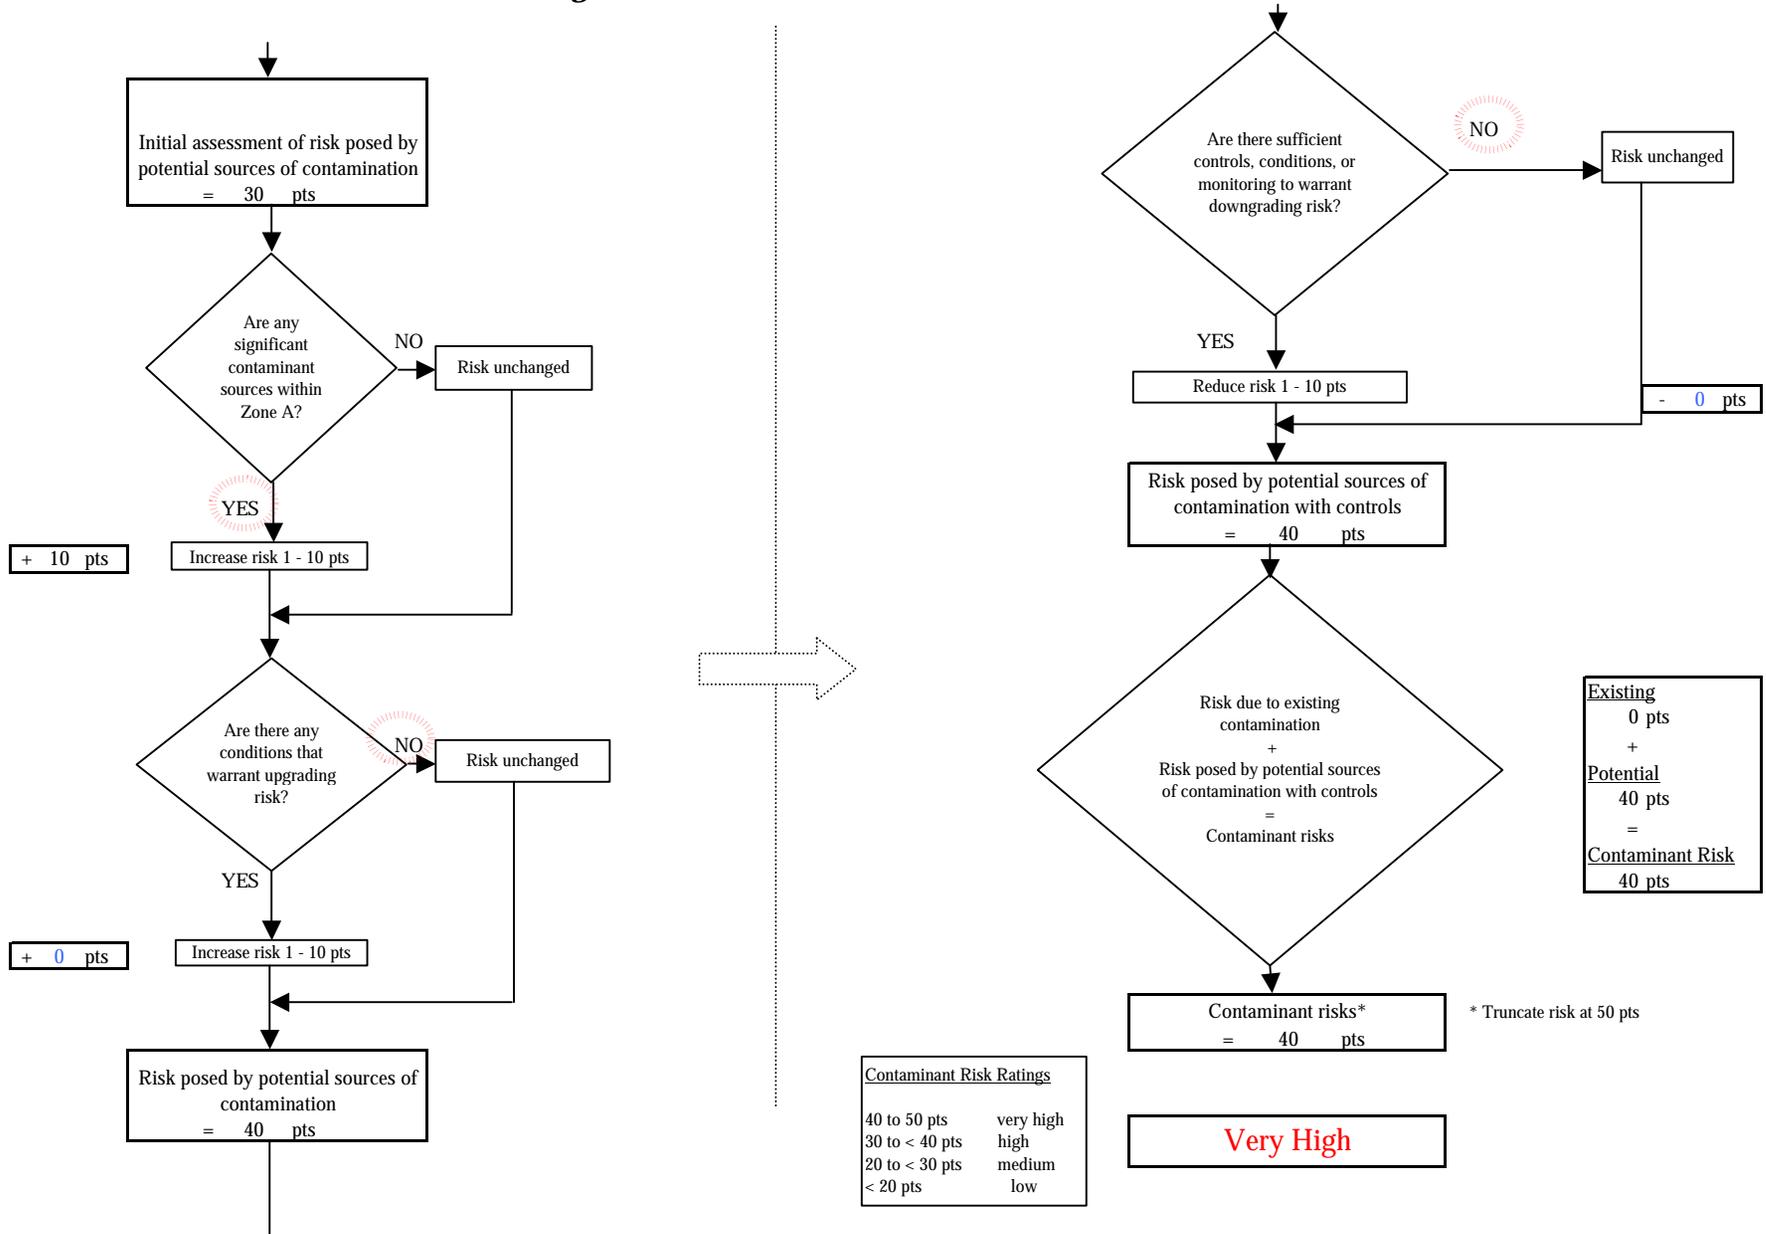
Chart 3. Contaminant risks for Trail Lake Lodge and Motel (240804.001) - Bacteria & Viruses

The large capacity septic system, logging activities, 1.03 acres of residential areas, residential septic systems, and paved highways or roads create a risk increase for the bacteria and viruses, and nitrates and nitrites contaminant categories

Only a small amount of bacteria and viruses are required to endanger public health. Bacteria and viruses have not been detected during recent water sampling of the system at Trail Lake Lodge and Motel.

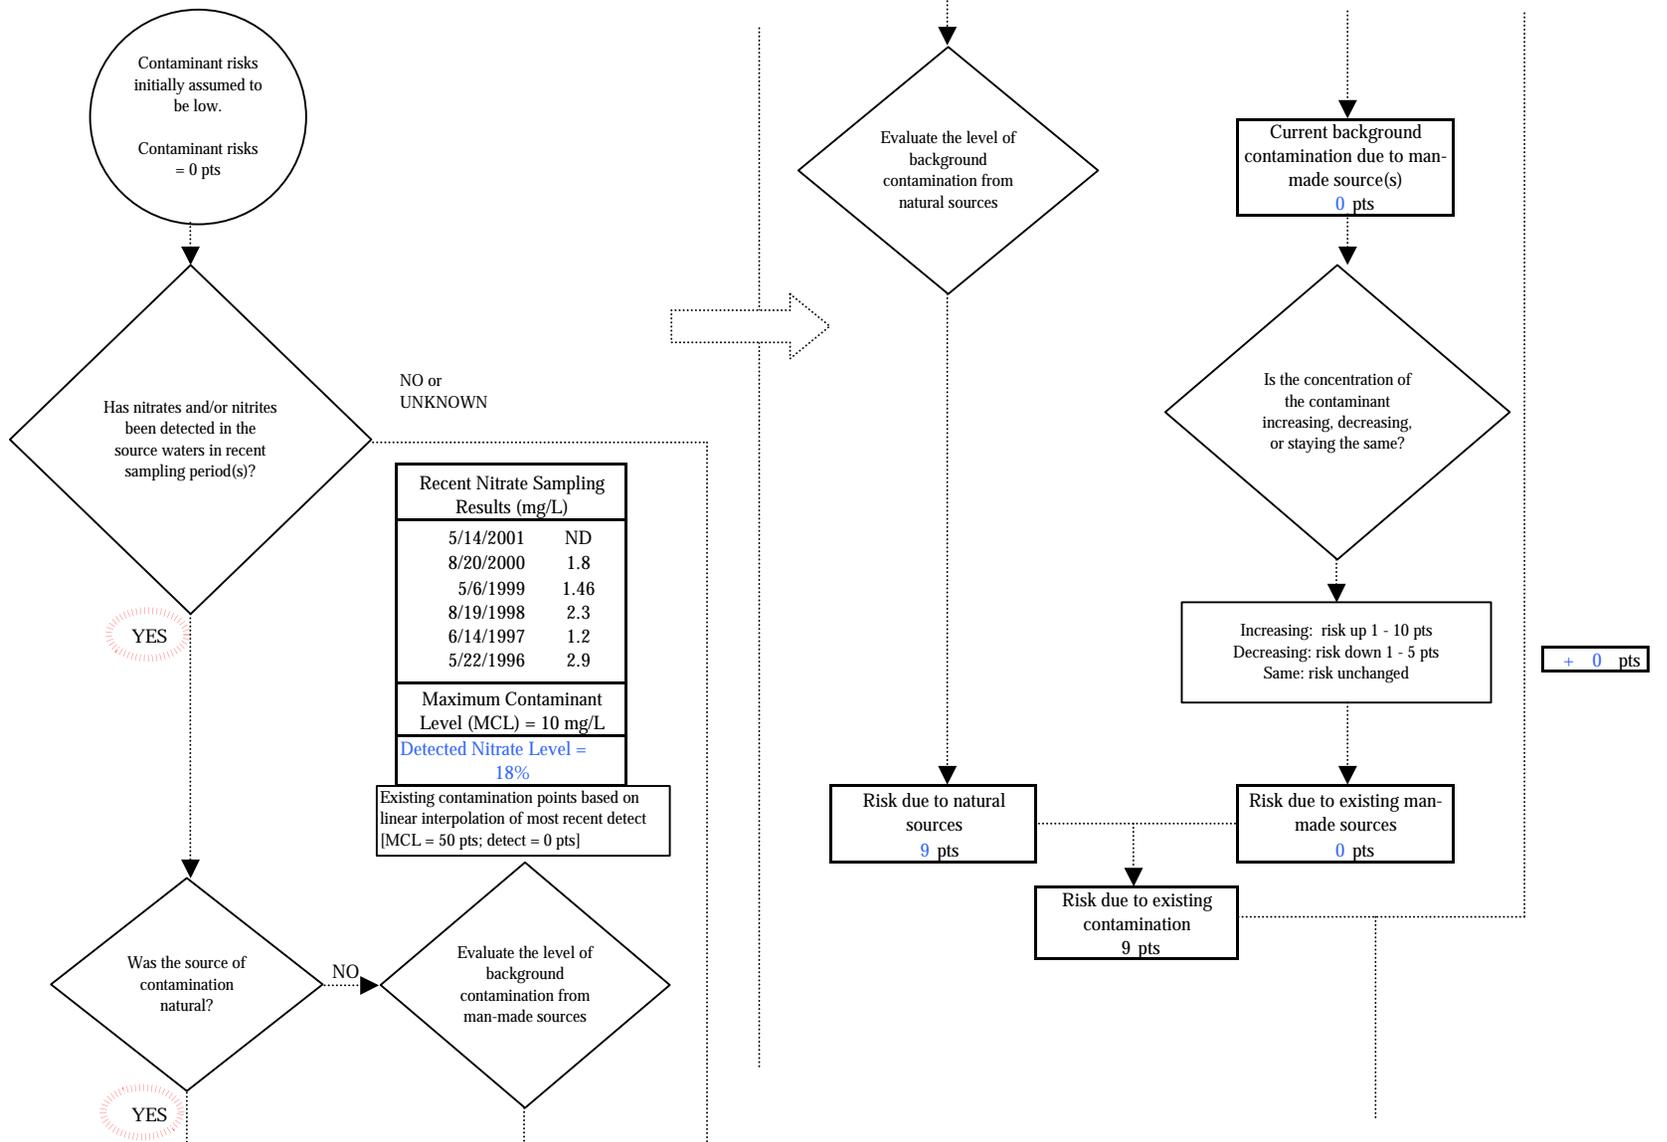
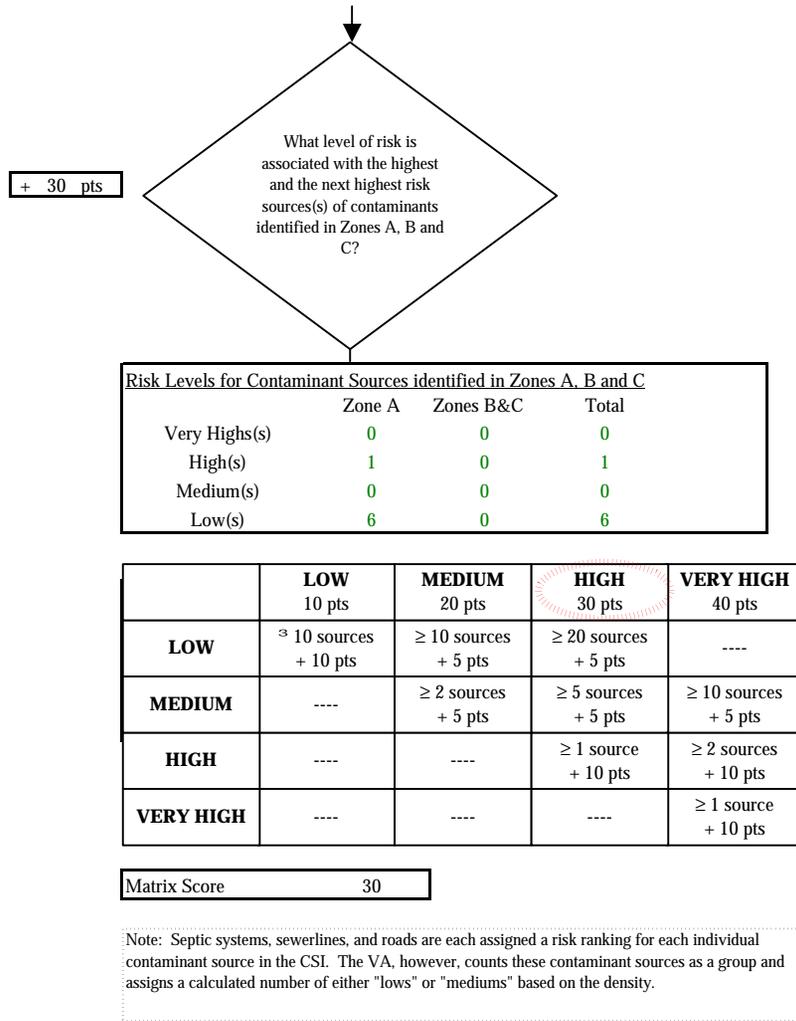
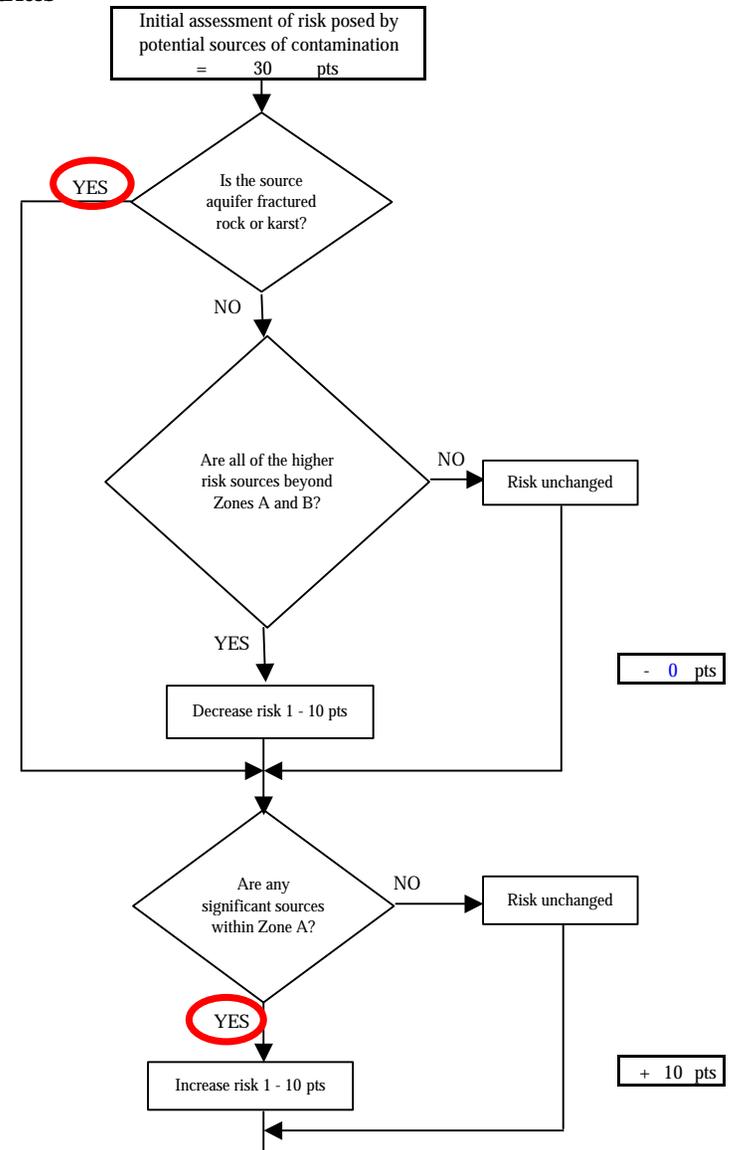
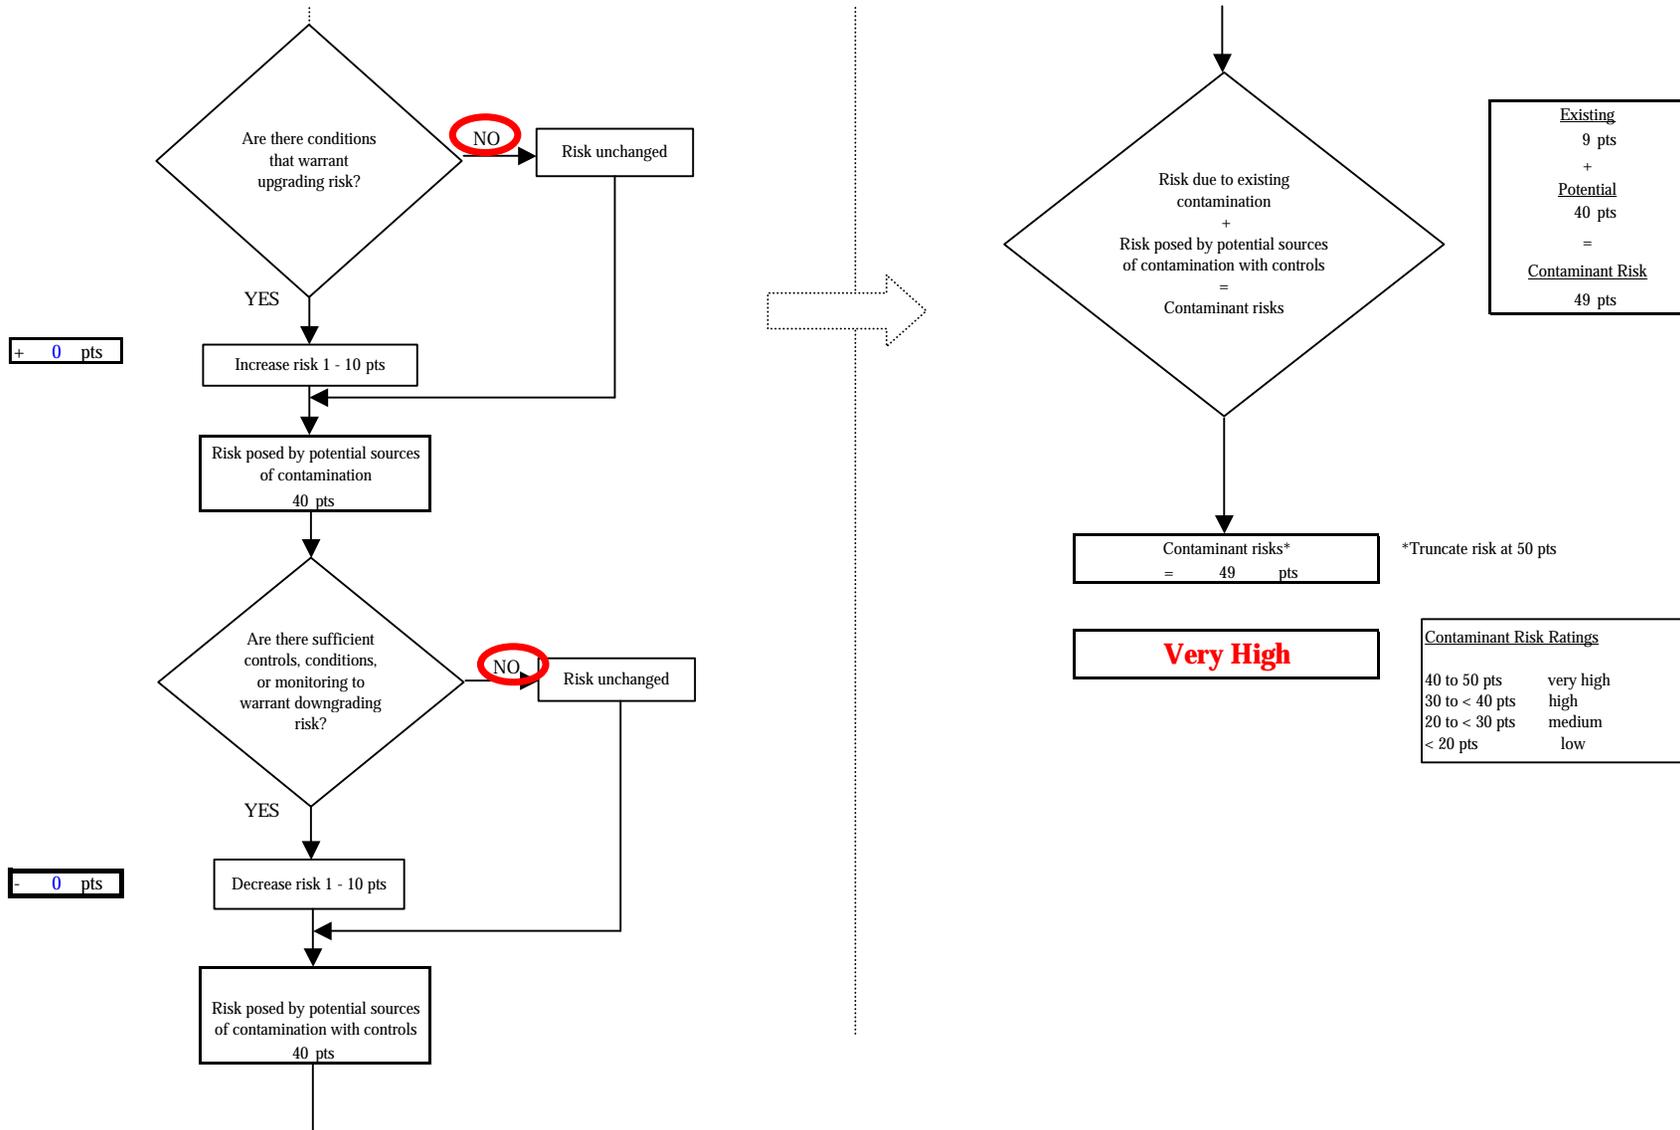
Chart 5. Contaminant risks for Trail Lake Lodge and Motel (240804.001) - Nitrates and Nitrites

Sampling history for Trail Lake Lodge and Motel well indicates that low concentrations of nitrate have been detected (See Chart 5 - Contaminant Risks for Nitrates and/or Nitrites in Appendix D). Existing nitrate concentration is approximately 1.8 mg/L or 18% of the Maximum Contaminant Level (MCL) of 10mg/L. The MCL is the maximum level of contaminant that is allowed to exist in drinking water and still be consumed by humans without harmful health effects. Due to the high solubility and weak retention by soil, nitrates are very mobile, moving at approximately the same rate as water. Though existing nitrate contamination was detected at the site, concentrations remain at very safe levels with respect to human health.
