Fishery Data Series No. 14-45

Fish Passage Assessment of Culverted Road Crossings in King Salmon, Naknek, and Dillingham: 2012-2013

December 2014

Alaska Department of Fish and Game

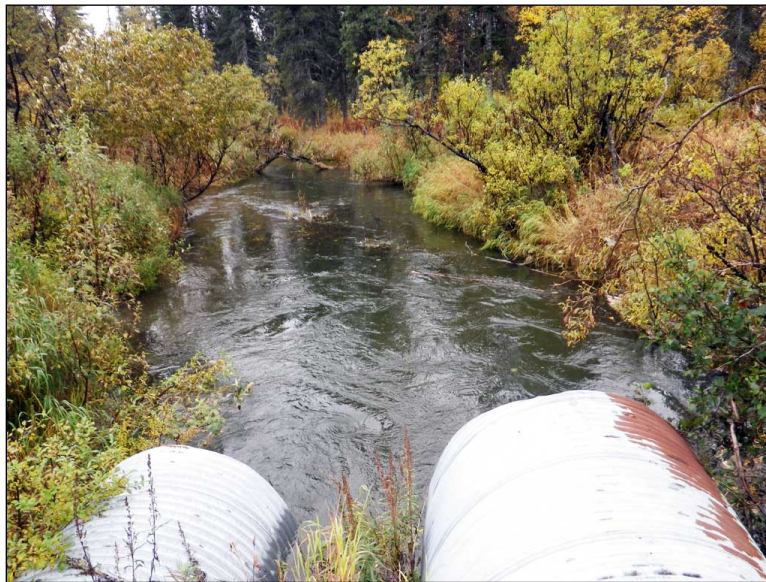
Site #30303067 and Site #30303068 are both located on unnamed creeks on Snake Lake Road. Both of these crossings consist of undersized culverts with high water velocities and associated scour and channel impacts. Site #30303068 is on AWC stream 325-20-10030-2024-3100, and is cataloged for coho salmon rearing. Site #30303067 is on a large unmapped stream that appears to be a tributary to AWC stream 325-20-10030-2024-3100.

Figure 8.—Site #30303067 showing undersized culverts on a tributary to the Snake River, Dillingham.

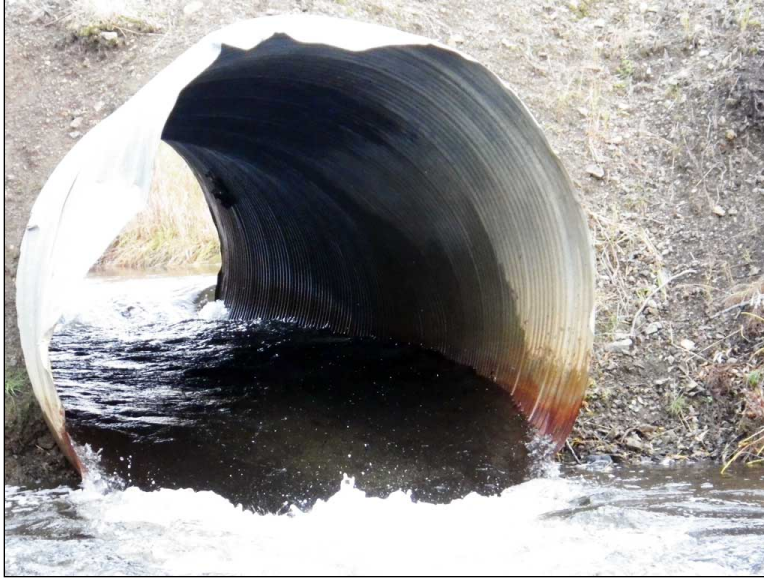
Figure 9.—Site #30303068, an undersized culvert on an unnamed Snake River tributary, Dillingham.

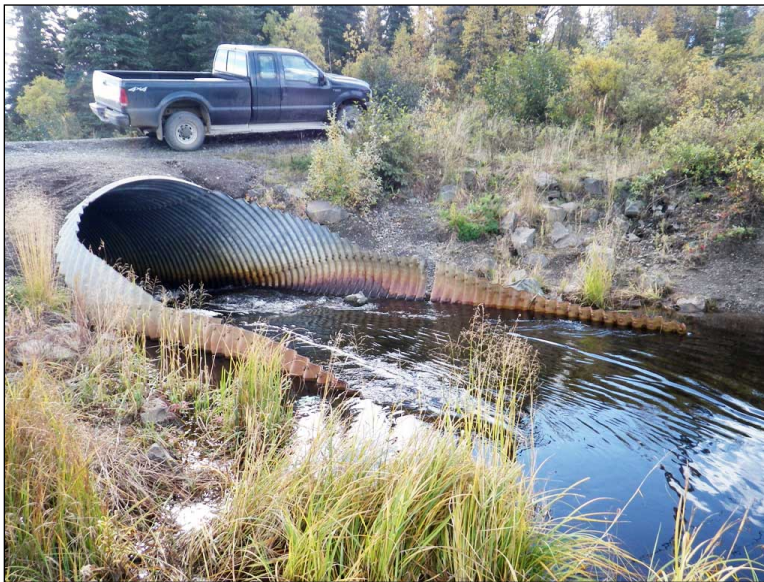
Site #30303073 is Squaw Creek at Lupine Drive. Squaw Creek is catalogued to support Chinook, coho, pink, chum and Sockeye salmon. This culvert was installed in 1999 as part of a United State Fish and Wildlife Service (USFWS) funded fish passage project but has been damaged by frost heave. It is almost certainly a total barrier to juvenile fish and is a partial barrier to adult fish.

Figure 10.—Site #30303073 Squaw Creek at Lupine Road, Dillingham showing frost heave that has raised the inlet of the culvert several feet causing ponding upstream and a fish passage barrier inside the culvert.

| Site ID | Creek Name | Road Name | Rating | Stream Width | Construction Year | Stream Gradient | Condition Rating | Site Observations |
|---|---|---|---|---|---|---|---|---|
| 30303073 | Squaw Creek | Lupine Drive | Red | 11.1 | 1999 | | 1 | Culvert gradient gray, Inlet perch, Mechanical damage or joints parting, Improper bedding, Damage associated with ice problems. |

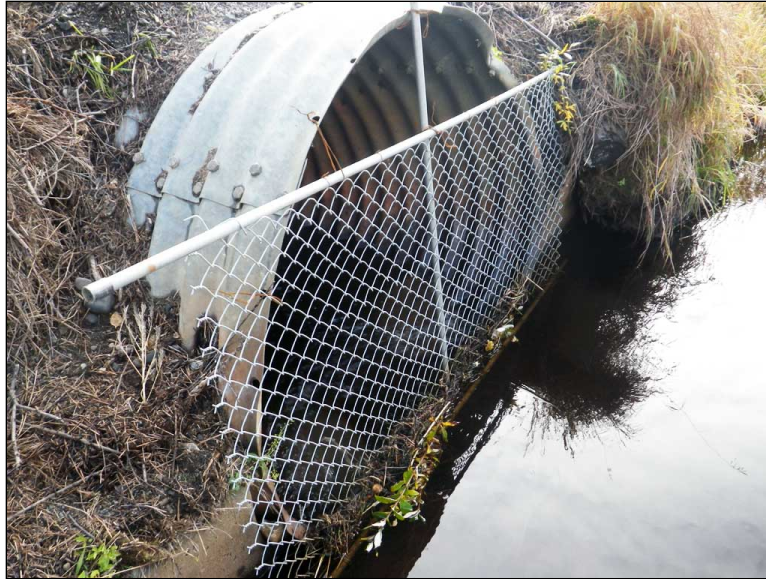
Site #30303078 is the South Fork of Squaw Creek at Aleknagik Lake Road. At the time of survey this culvert was blocked by a chain-link fence, presumably to prevent beavers blocking the culvert.

Figure 11.—Site #30303078 showing a chainlink fence preventing fish passage on the South Fork of Squaw Creek, Dillingham.

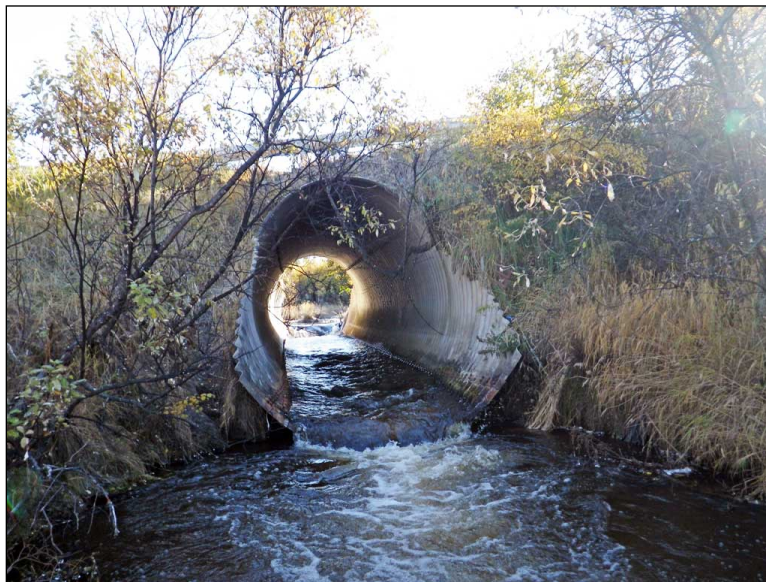
Figure 12.—Site #30203269 Eskimo Creek and the Alaska Peninsula Highway, King Salmon.

A single high-priority project was identified in King Salmon. Site #30203269 is Eskimo Creek at the Alaska Peninsula Highway. This pipe is undersized and perched. This was the sole barrier on a stream of any significant size located in the King Salmon-Nakenk area. There are believed to be culverts on military land, but crews were not able to access them for assessment.
