**Fishery Data Series No. 18-28**

# **Fish Passage Assessment and Culvert Inventory on the King Cove and Cold Bay Road Systems**

December 2018

Alaska Department of Fish and Game

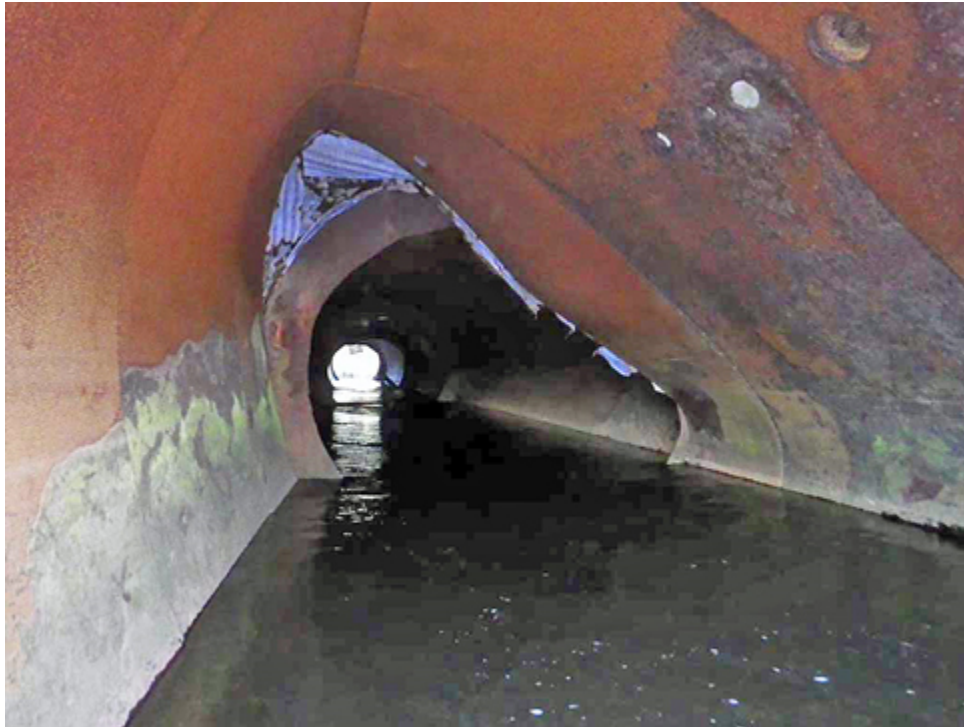
Assessments showed that 1 culvert met the project's standards for being embedded (ADF&G Fish Passage Matrix, Figure 3). Additionally, 1 site was found to be backwatered, 3 were found to potentially have tidal influence, and 2 culverts (sites 30103336 and 30103337) were found to have structures that could be considered baffling. Sites 30103336 and 30103337 are constructed out of old 8 foot diameter fuel tanks laid end to end with the inlet and outlet opens cut to create a large lip at the openings (Tables 13-16, Figure 7).

Figure 7.—Site 30103336, internal view of culvert looking upstream from outlet and showing the internal connection between tank sections and the created baffling.

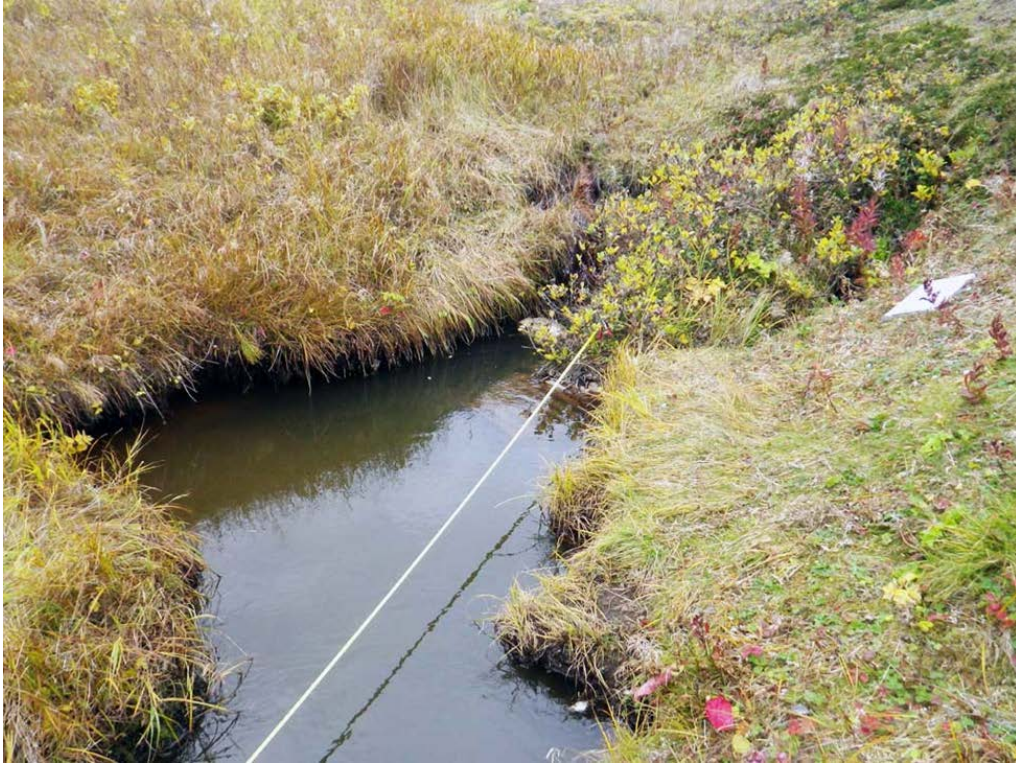
At the time of assessment, the inlet was bent downward and partially separated. Water was being funneled around the invert, which was submerged, and entering the culvert at the point of separation (Figures 10 and 11). Above the culvert is 3 miles of AWC-documented stream habitat and over 62 acres of lake habitat. The assessment crew also observed adult sockeye and coho salmon, juvenile coho salmon, and threespine stickleback below the culvert, but no fish were observed or captured above. Damage to the inlet appears to be blocking any upstream movement.

Figure 10.—Site 30103341, unnamed tributary to Trout Creek on the airport runway light access road, damaged inlet.

It is recommended that this culvert be replaced with a stream simulation culvert to restore unimpeded access to upstream spawning areas and allow juvenile salmonids and resident fish seasonal movement.

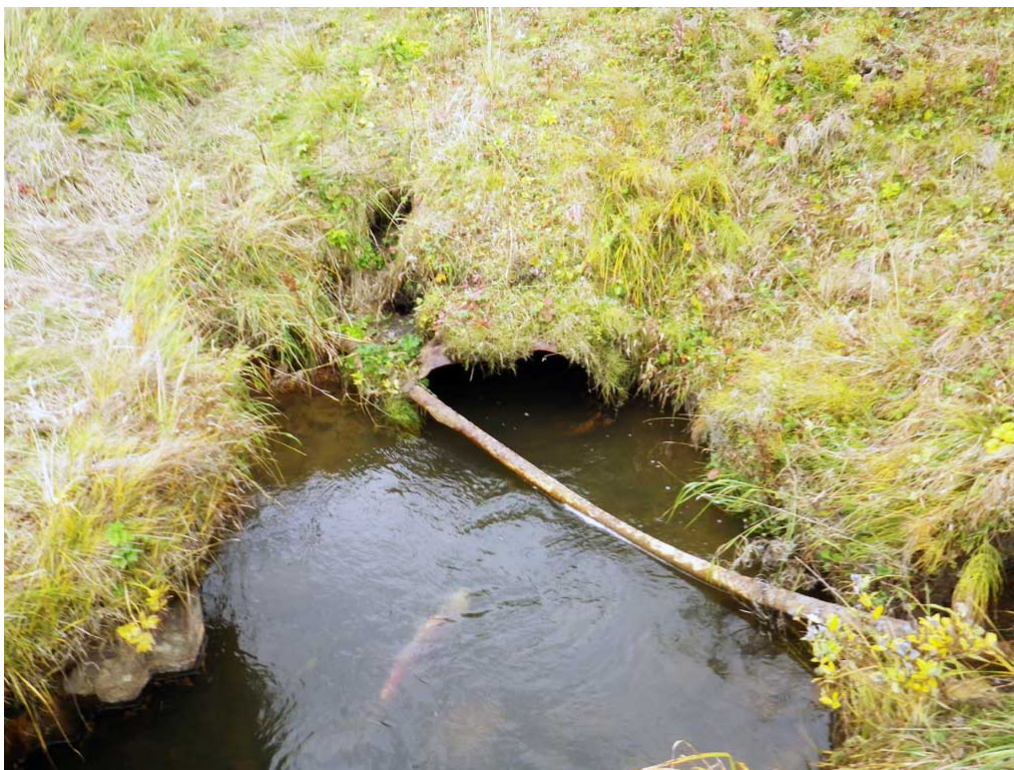
Figure 11.—Site 30103341, unnamed tributary to Trout Creek on the airport runway light access road, outlet. *Note:* Adult sockeye salmon below outlet.

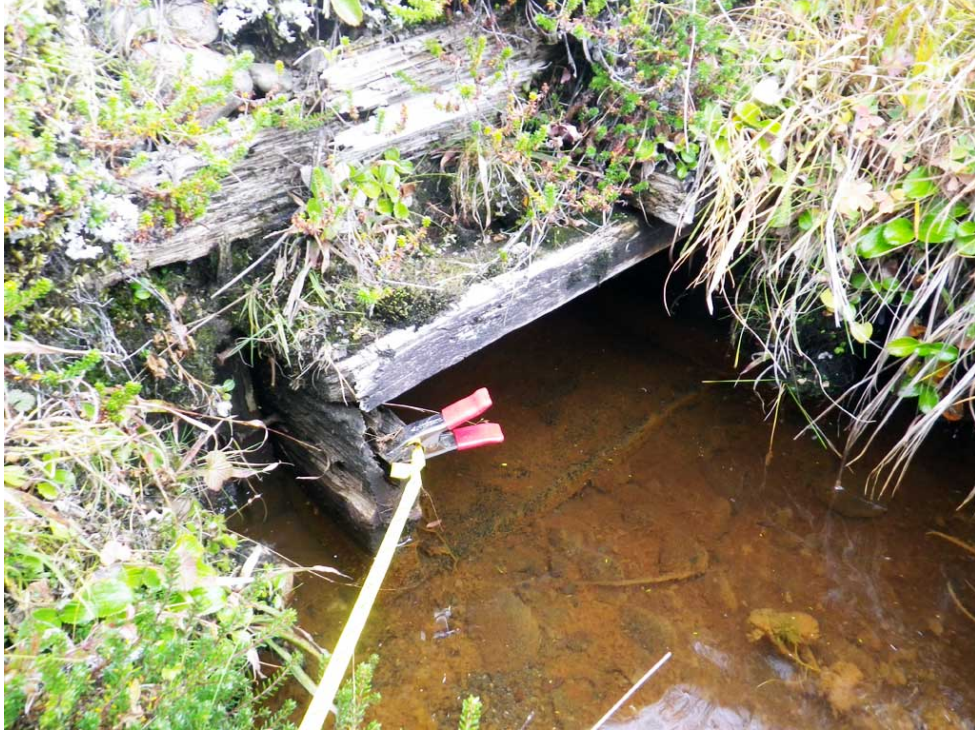
The creek is small, averaging 1.2 feet wide at OHW, but it had excellent habitat consisting of undercut banks, small pools, and riffles. Satellite imagery shows that this creek extends about another 0.3 miles upstream and drains multiple kettle ponds. During the assessment one juvenile coho salmon was caught upstream, nine juvenile coho salmon were caught downstream, and small unidentified fish were observed in the upstream kettle ponds. At the time of assessment this creek was not included in the AWC but was nominated and accepted in 2015 (ADF&G 2015).

Figure 12.—Site 30103339, inlet.

It is recommended that this crossing be either removed and the road decommissioned or replaced with a stream simulation culvert.

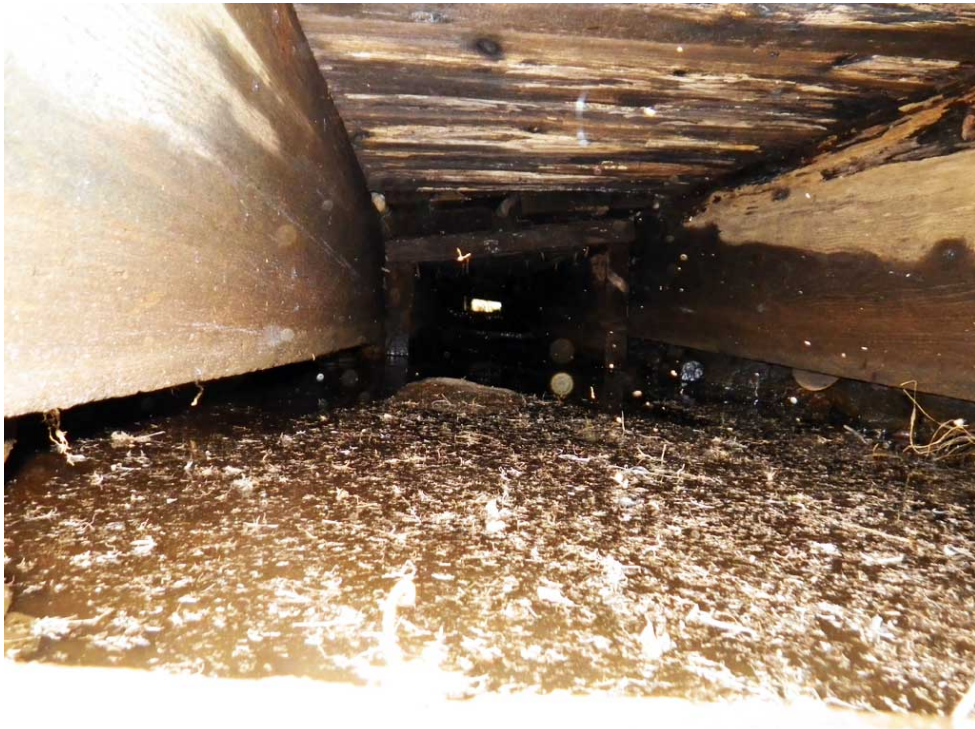
Figure 13.—Site 30103339, looking upstream inside the culvert from outlet.

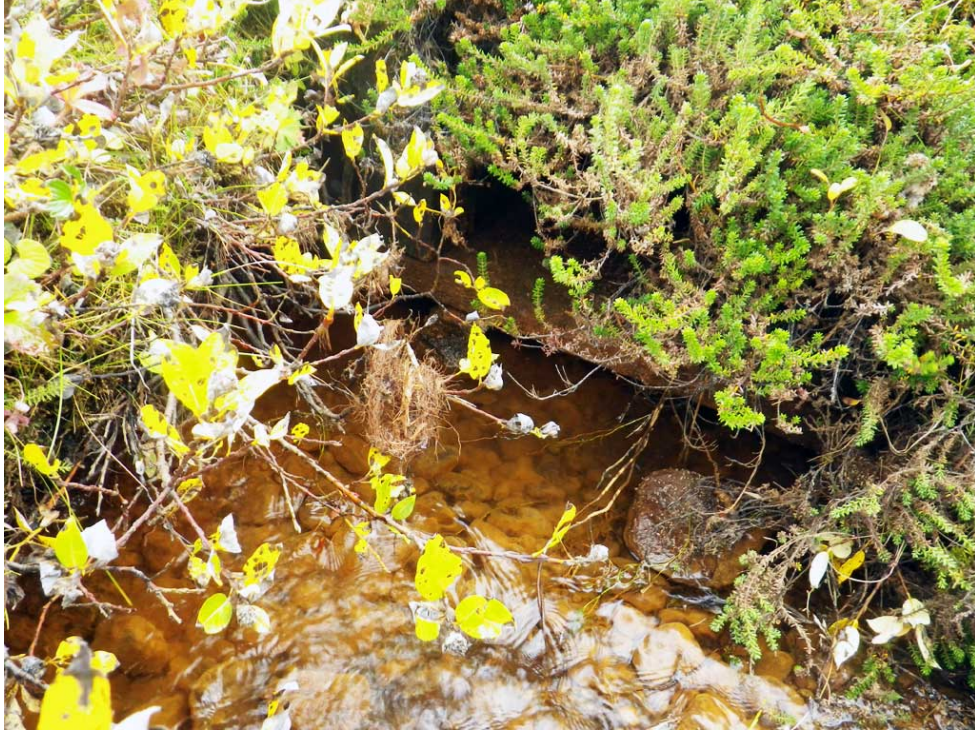
Figure 14.–Site 30103339, outlet.

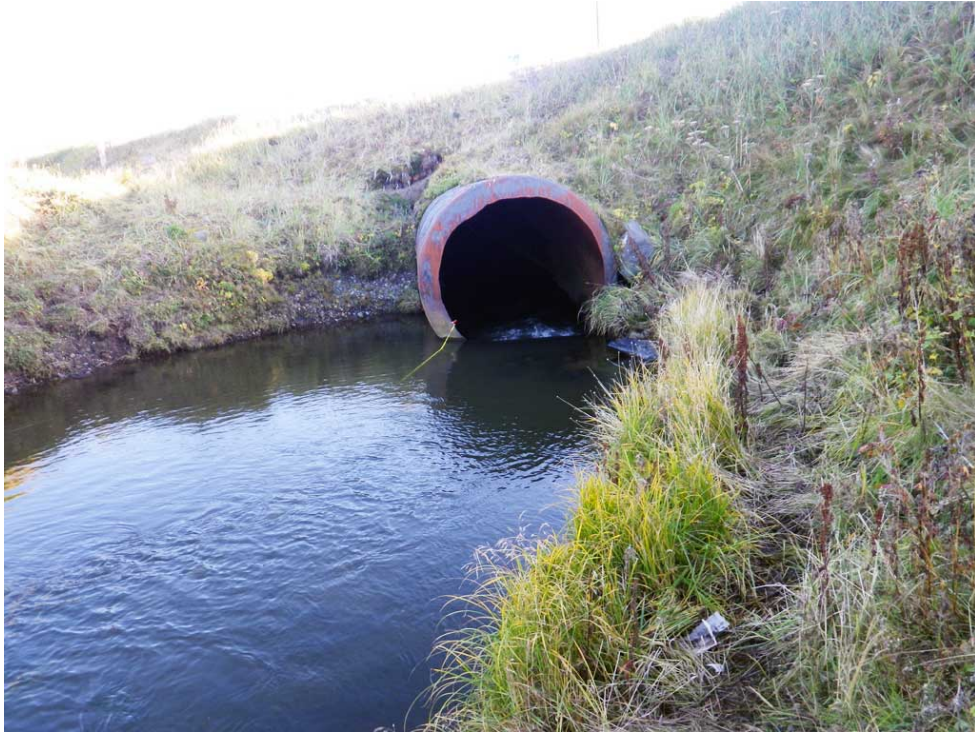
This site is located on Grant Point Road on the north side of Cold Bay. This site consists of five 8 to 9-foot diameter fuel tanks that were installed in the 1980's to replace a failing bridge (M. Miller, ADF&G, Sport Fish Biologist, Anchorage, personal communication) (Figure 9). The tank ends had been cut out and the tanks placed end to end. The way the openings were cut left about a 1 to 2-foot-high lip between sections that act like baffles. The cut-out pieces from the tanks were used as wing walls for the outlet. Overall length of the culvert is 156 feet. Upstream OHW measurements averaged 23.3 feet, and the pipes constrict the stream with a ratio of 0.37. There is a noticeable hydraulic inlet perch. This creek has been cataloged as supporting sockeye, coho, chum, and pink salmon runs and resident three spine stickleback and Dolly Varden char (Figures 15-18). This culvert shares its outlet pool with site 30103337 (Stream No. #283-34-10300-2008) with the outlet located downstream about 20 feet.

Figure 15.—Site 30103336, inlet.

It is recommended that this site be replaced along with site 30103337 with a bridge or large stream simulation culvert.

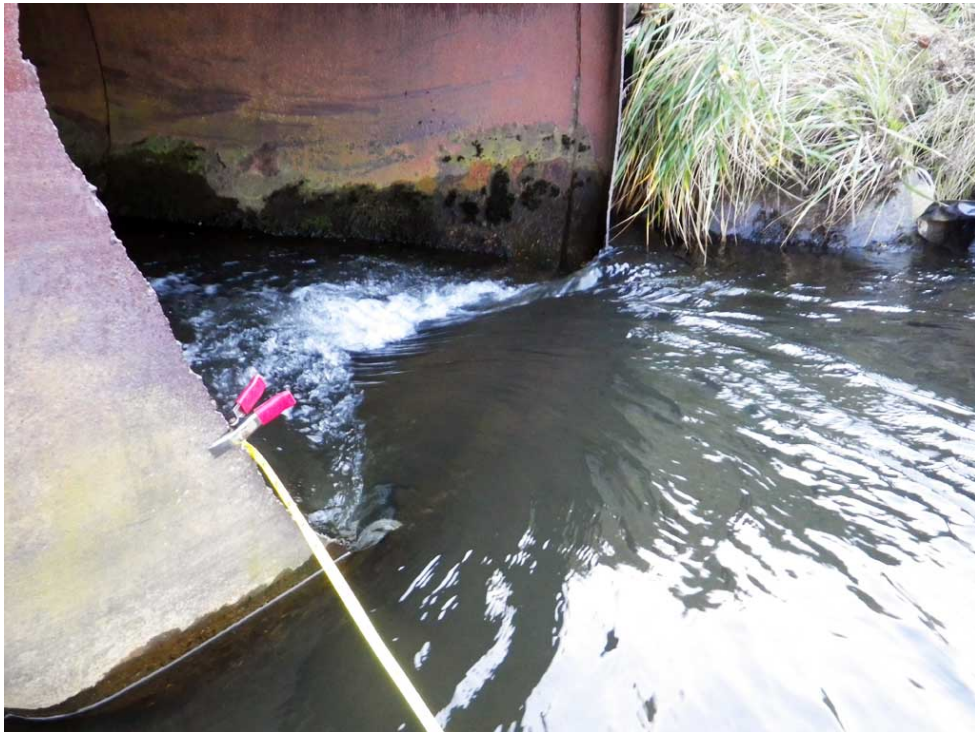
Figure 16.—Site 30103336, stream constriction at inlet creating a hydraulic jump, inlet.

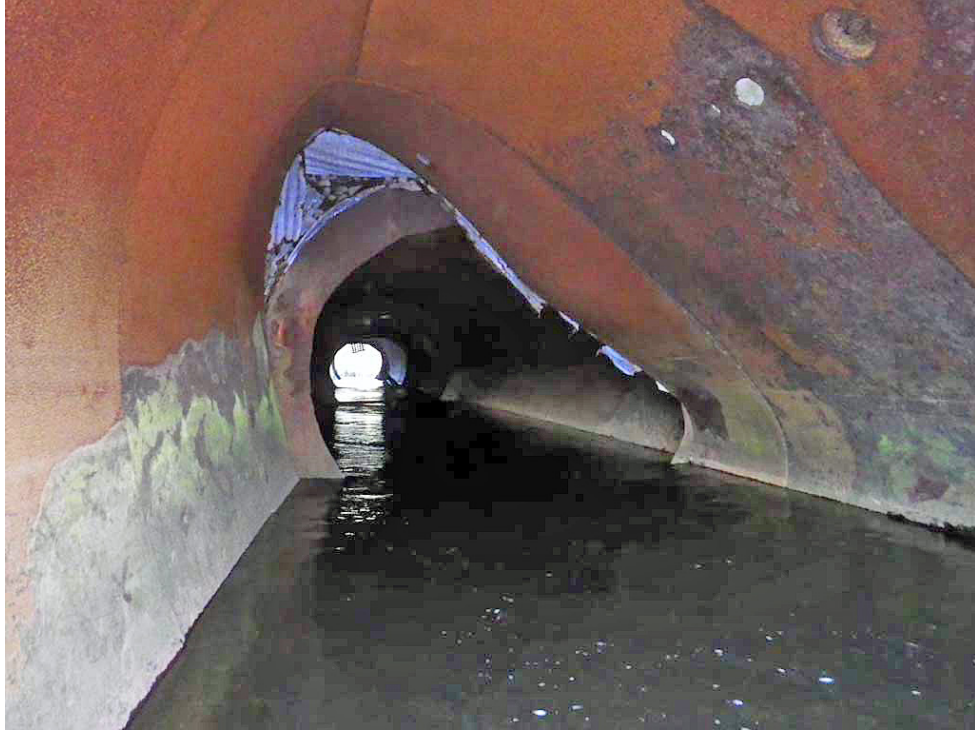
Figure 17.—Site 30103336 inside culvert looking upstream from outlet showing internal structural problems and internal baffles from tank lips.

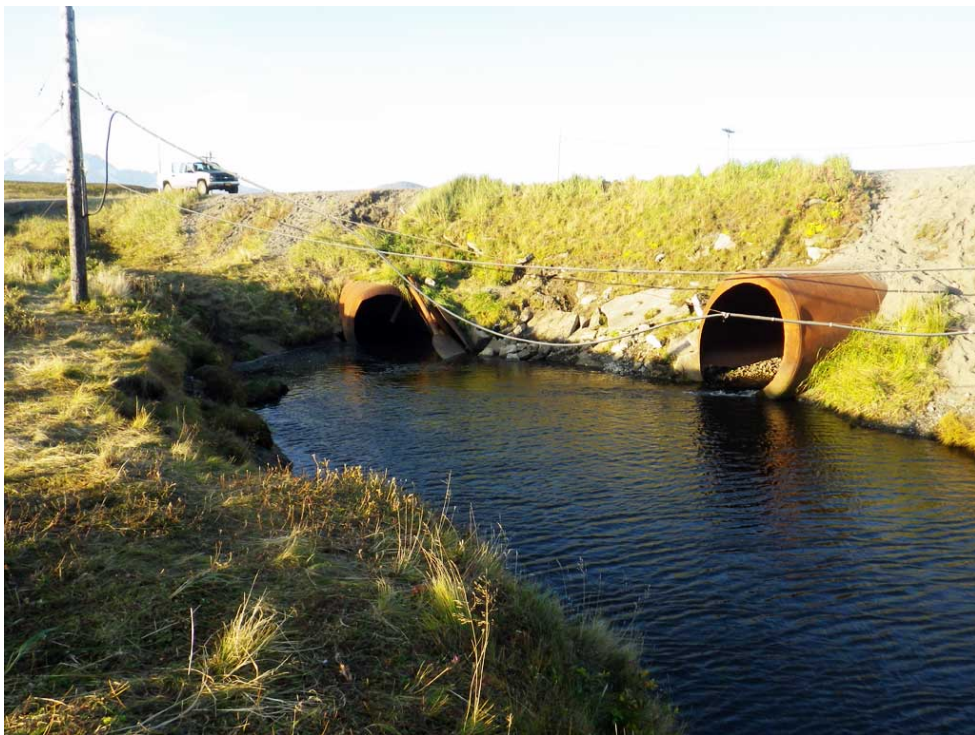
Figure 18.—Outlets of site 30103336 (left) and 30103337 (right)

It is recommended that this site be replaced in conjunction with site 30103336 with a bridge or stream simulation culvert.

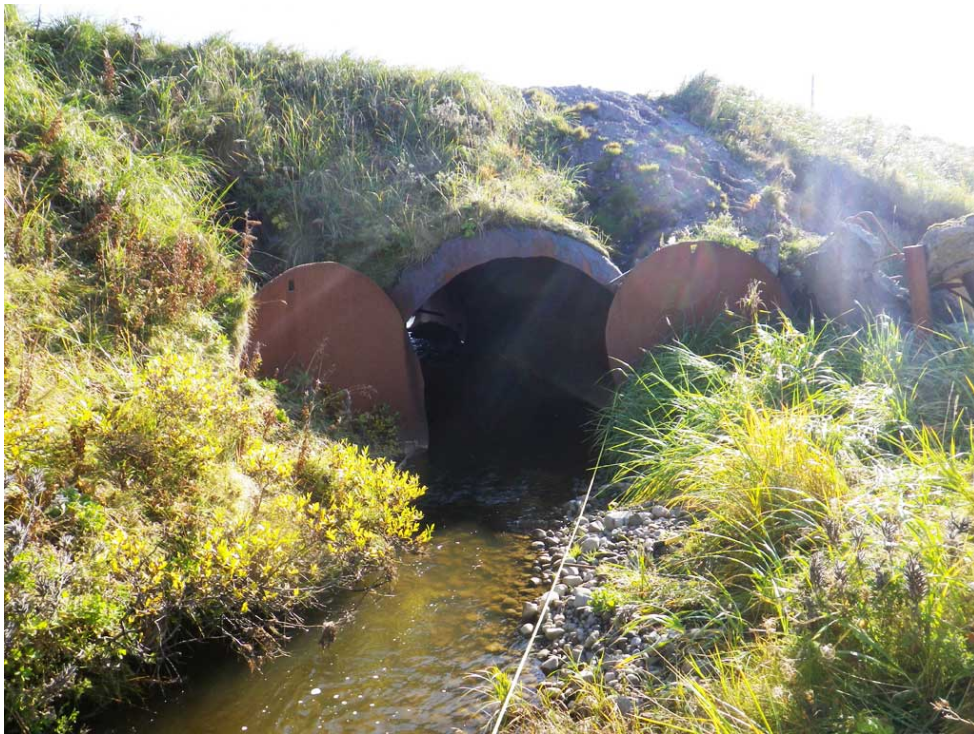
This site is about 0.40 miles downstream from site 30103341 and converges with Trout Creek (AWC #293-34-10300) directly downstream of the culvert outlet (Figure 9). It was constructed of old fuel tanks in the same manner as Site 30103336. The culvert is 78 feet long and about 8 feet in diameter. It is perched at the outlet (Figures 19–21). This stream is considerably smaller than Trout Creek with an average OHW of 8.23 feet. We caught 1 juvenile coho salmon and 1 juvenile Dolly Varden char upstream, as well as threespine sticklebacks up- and downstream. There were also adult coho salmon observed milling below the culvert.

Figure 19.—Site 30103337, inlet with metal wingwalls.

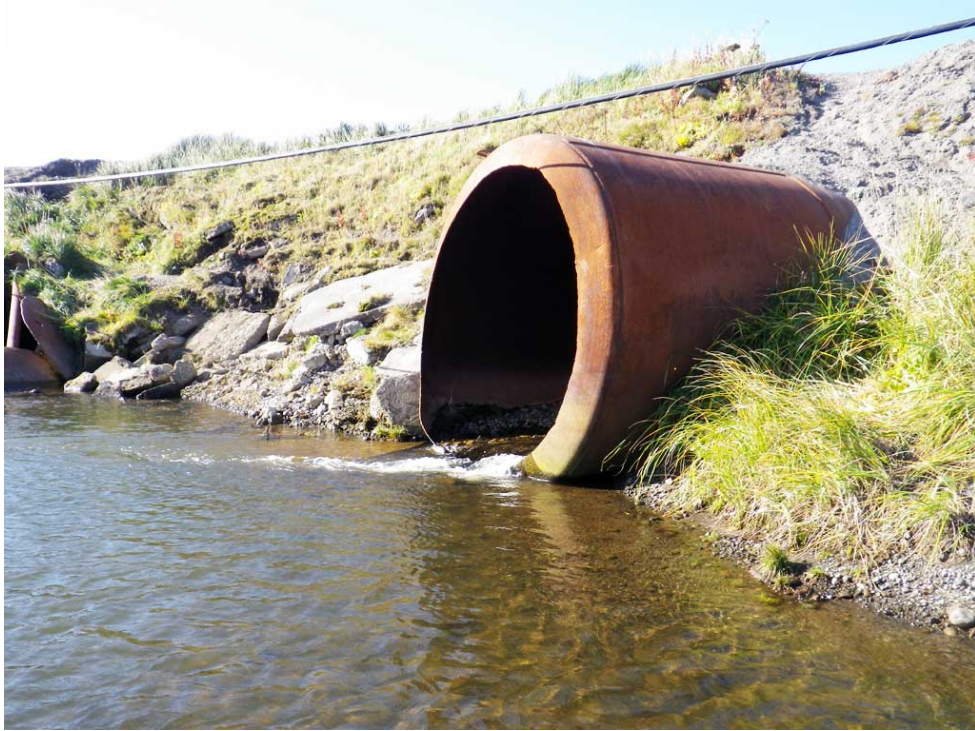
Figure 20.—Site 30103337, outlet showing outfall.

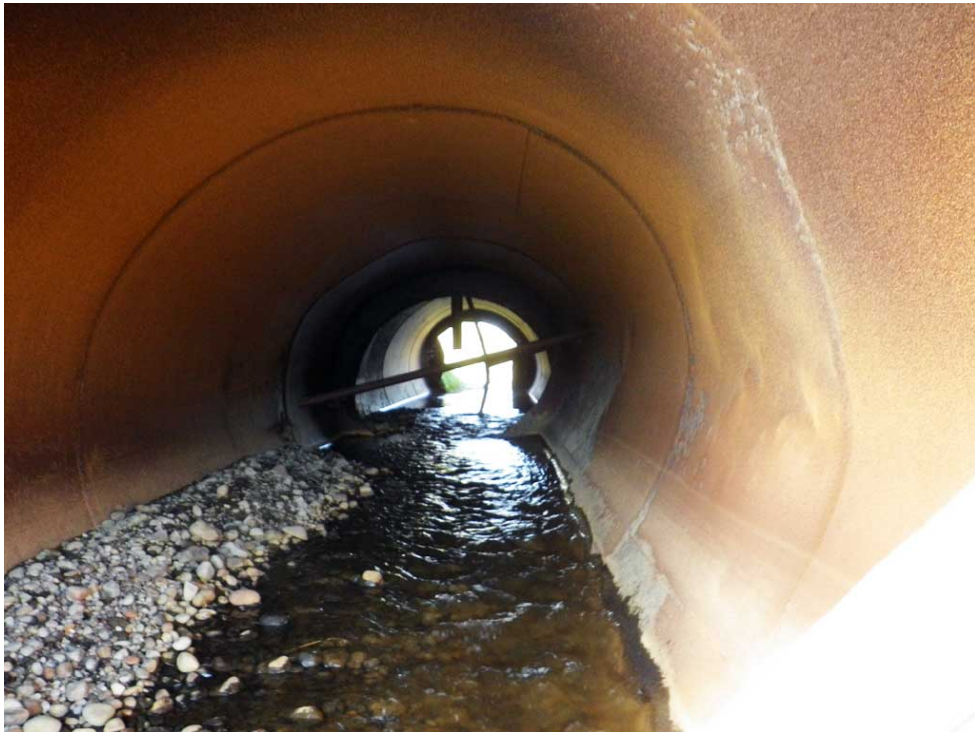
Figure 21.—Site 30103337, looking upstream inside culvert from outlet.

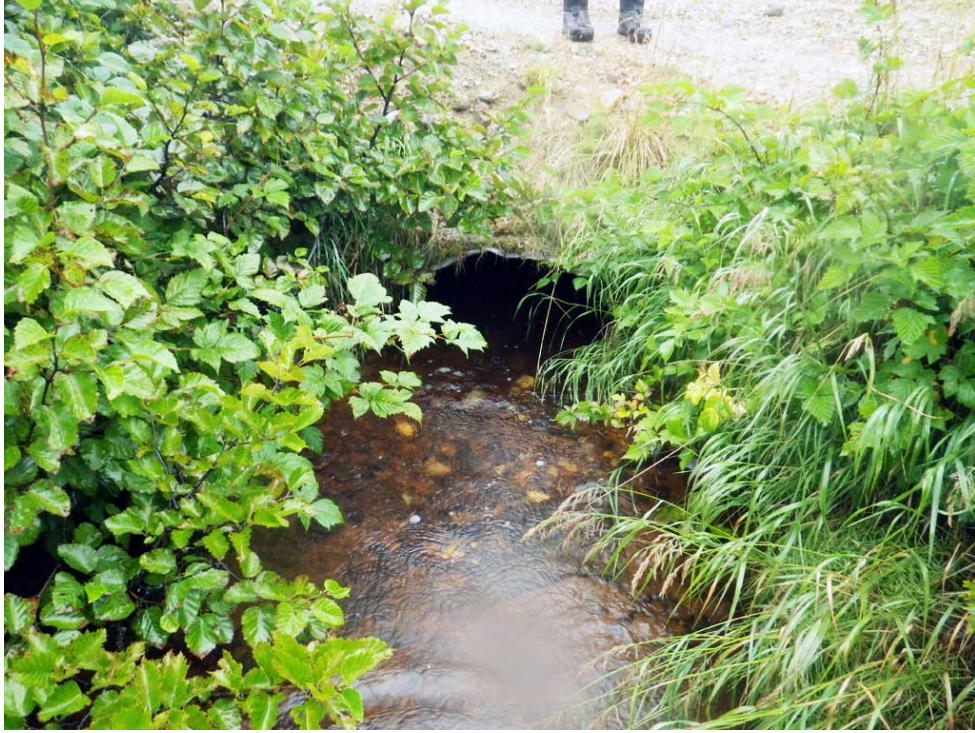
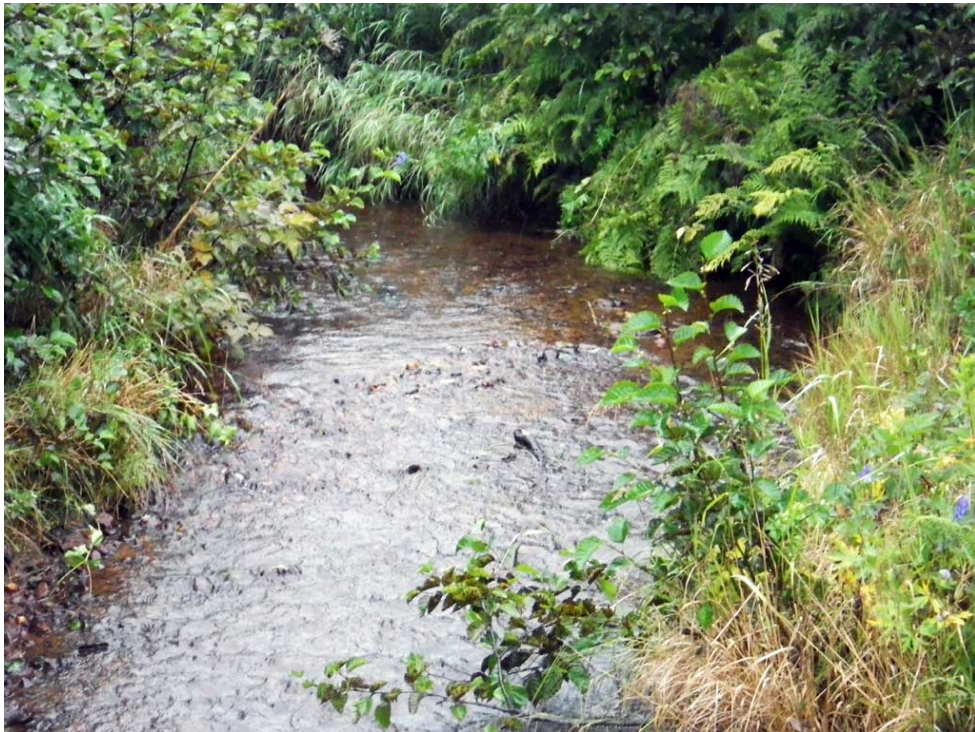
This site is about 500 feet upstream from site 30103441 (Figure 22). This creek has been cataloged for pink, coho, and chum salmon and Dolly Varden char. Cataloged anadromy extends 500 feet upstream beyond the crossing and satellite imagery shows an additional half mile of potential habitat upstream above the end of anadromy. Assessment crews noted that the culvert was undersized for the creek but were unable to access the inlet or upstream habitat because of the airport security fence. Adult pink salmon were observed above and below the culvert. The project recommends replacement with a stream simulation type culvert (Figures 23 and 24).

Figure 23.—Site 30103444, outlet.

Figure 24.—Site 30103444, upstream channel with adult pinks.

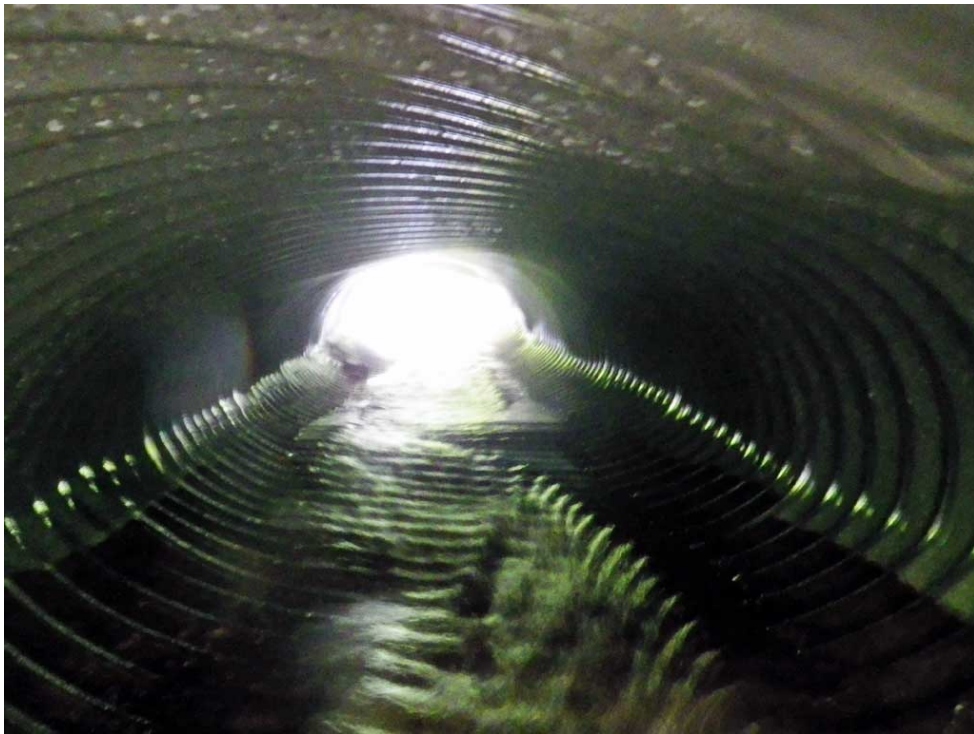
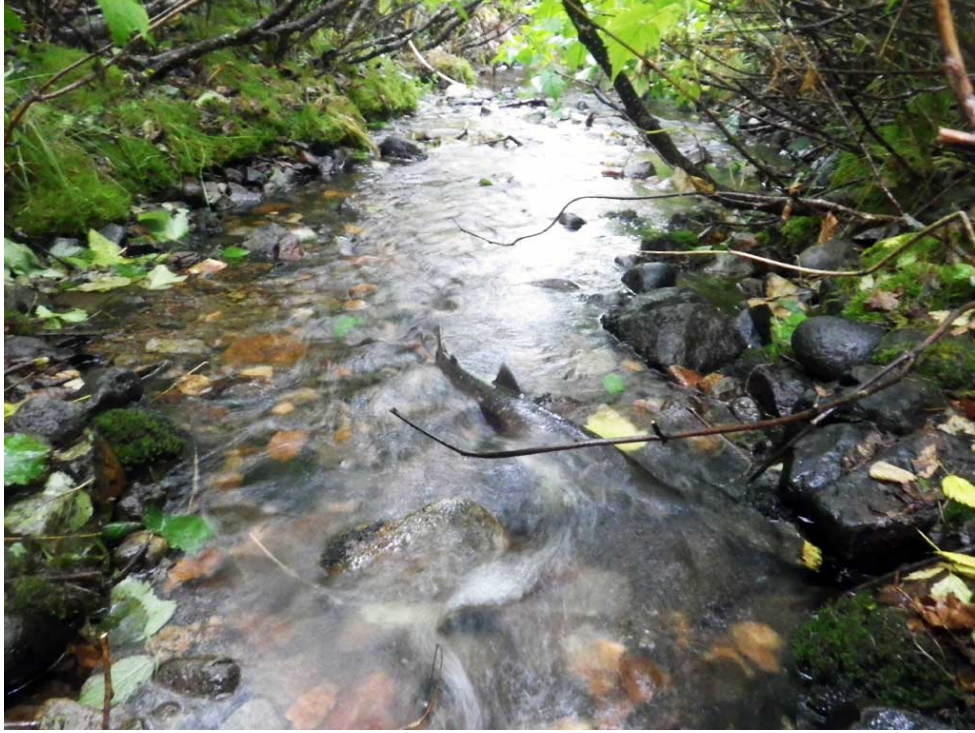
This site is about 550 feet upstream from site 30103442. The stream is documented for pink salmon and is a tributary to a known coho and chum salmon stream about 1000 feet downstream (Figure 22). The assessment crew was unable to access the culvert inlet or upstream habitat due to a security fence but noted that the culvert appeared to be a potential gradient barrier and that it had inadequate water depth for adult passage. Adult pink salmon were observed downstream of the culvert. The stream is cataloged for pink salmon for a few hundred feet above the crossing, but satellite imagery shows about a half mile of estimated upstream habitat. The project recommends replacement with a stream simulation type culvert (Figures 25 and 26).

Figure 25.—Site 30103443, looking upstream inside culvert from outlet.

Figure 26.–Site 30103443, downstream habitat with adult pink salmon.

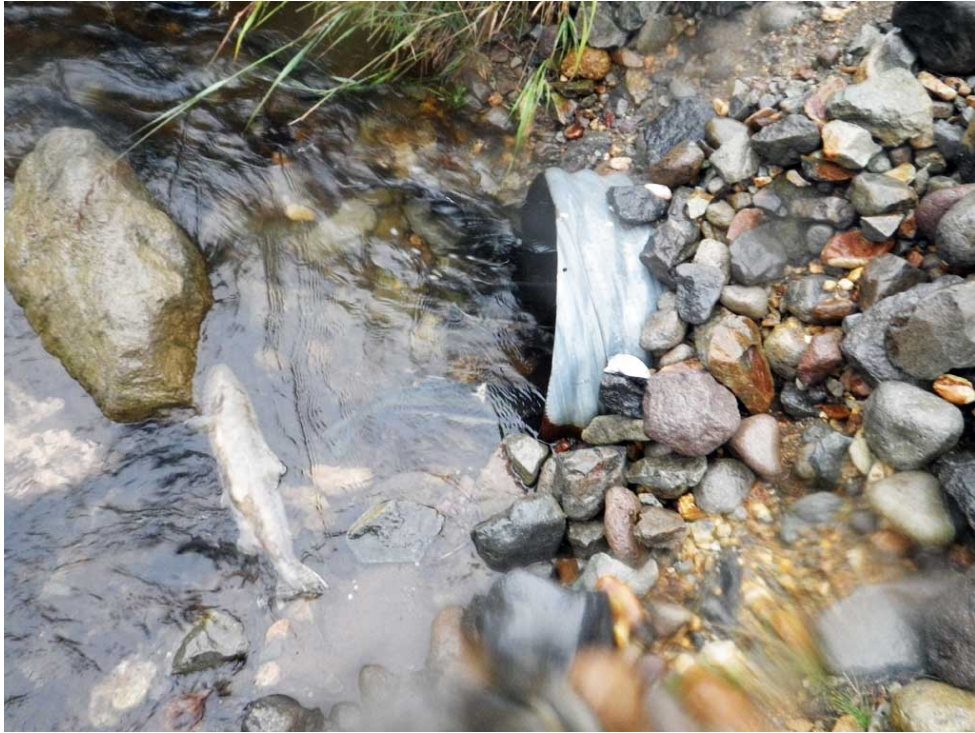
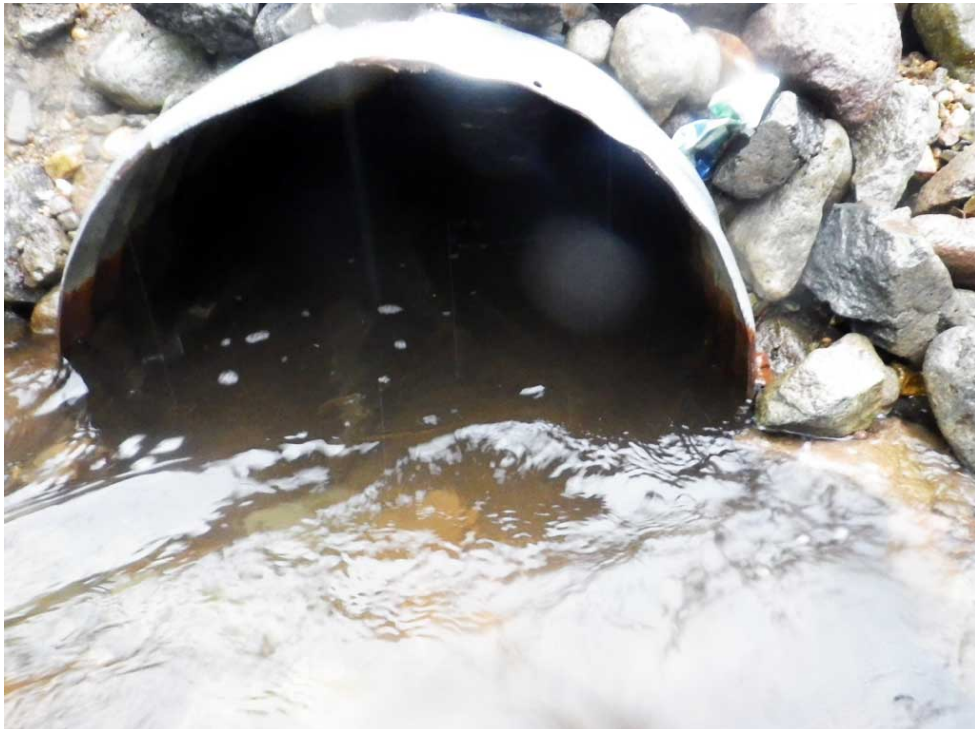
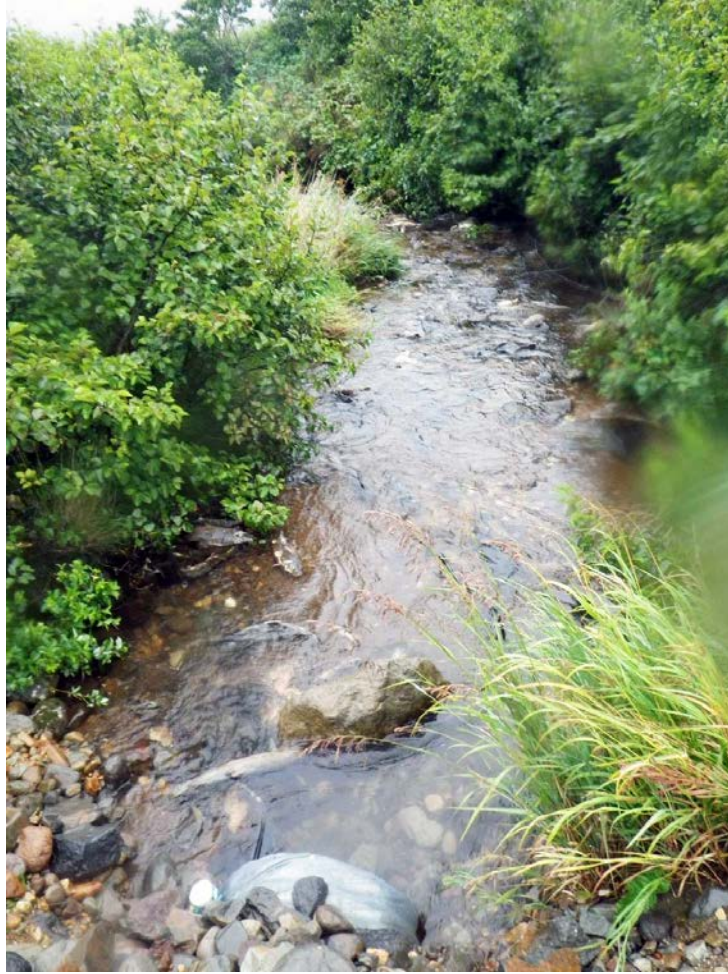
This site is about 400 feet upstream from site 30103442 and merges with a small tributary (AWC #283-42-10500-2001-3025-4020-5013) about 300 feet downstream (Figure 22). Stream is documented for pink salmon another 200 feet above site and the assessment crew encountered many spawning pink salmon during assessment. Satellite imagery shows an estimated 0.88 miles of potential habitat upstream above the current uppermost point of anadromy, and it has been documented for coho and chum salmon downstream. The airport security fence prevented the assessment crew from assessing culvert inlet and upstream habitat. The culvert is undersized, and the site is severely constricted. The project recommends replacement with a stream simulation type culvert (Figures 27–29).

Figure 27.—Site 30103445, culvert outlet side view with spawned-out pink salmon.

Figure 28.—Site 30103445, culvert outlet from directly downstream.

Figure 29.—Site 30103445, above culvert outlet looking downstream.

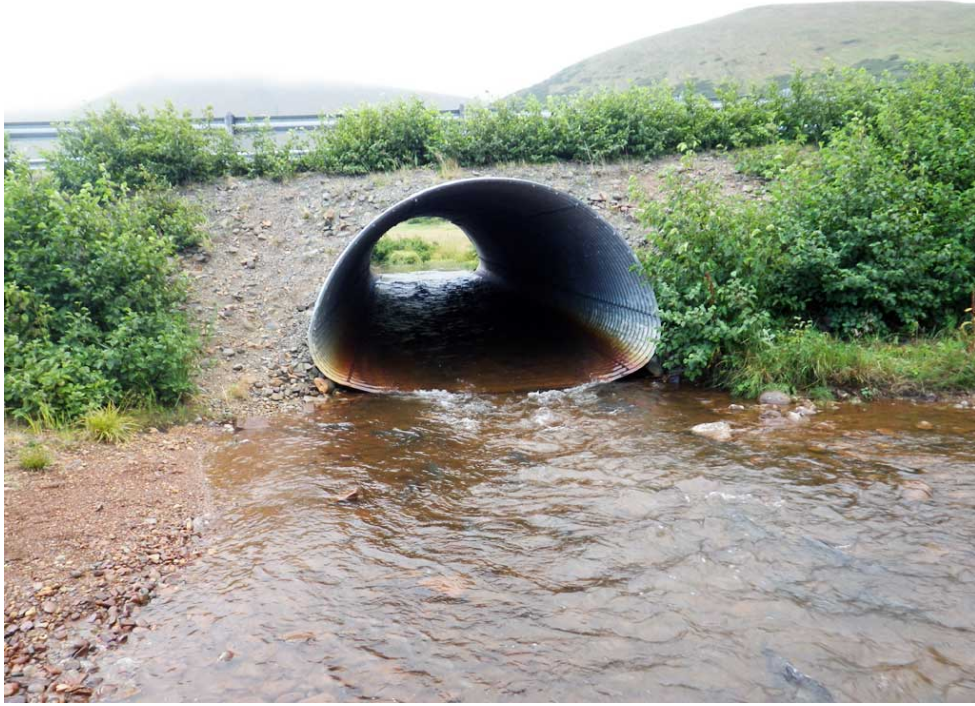
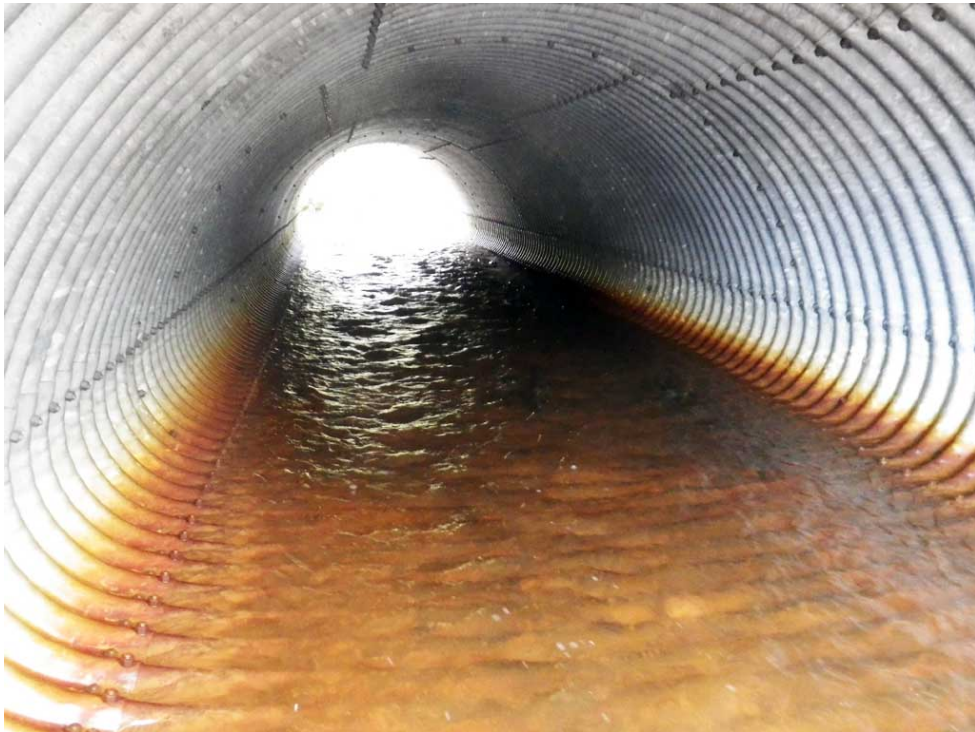
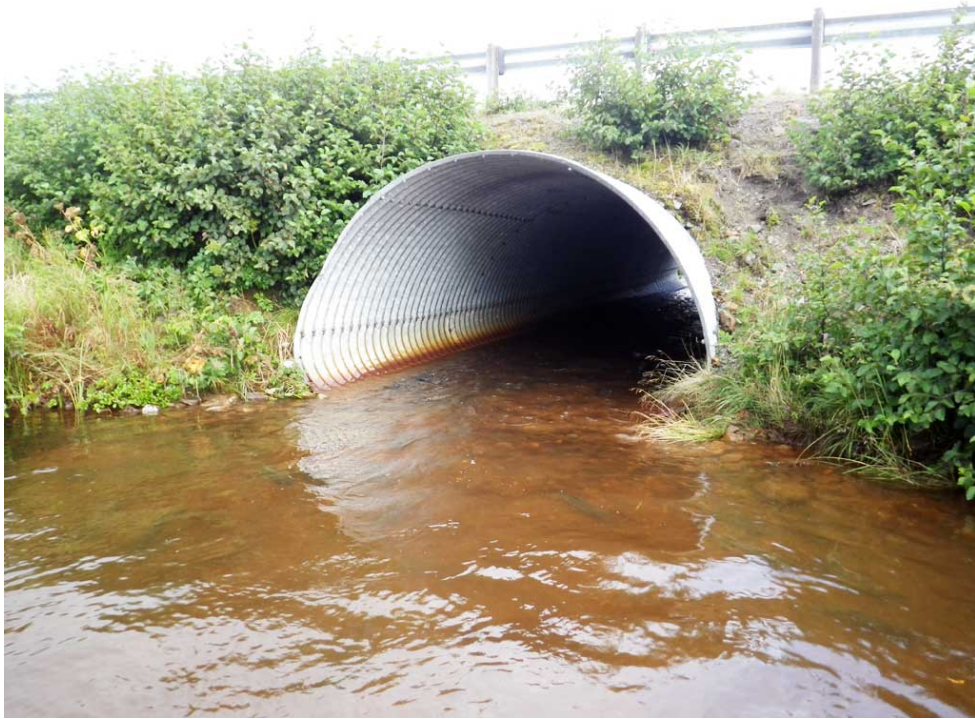
Site is located on Airport Road about 4 miles north of the city center and a quarter mile from the airport (Figure 22). A large number of adult spawning pink and chum salmon were observed to move through or attempt to move through this culvert at the time of survey.

The stream is cataloged for pink salmon 0.33 miles above culvert and was nominated for chum by project staff. Satellite imagery shows approximately 0.9 miles of stream habitat above the crossing. The culvert was somewhat undersized, had an outfall of 0.19 inches at time of assessment, and was observed to be partially impassable to adult fish after a rain event due to high water velocities. Additionally, low water levels may not allow for adequate water depth through culvert for fish passage. The project recommends replacing with a stream simulation type culvert in the long term; in the short term, a correctly installed grade control structure installed downstream may backwater the inlet and improve passage (Figures 30–33).

Figure 30.—Site 30103446, culvert outlet showing outfall.

Figure 31.—Site 30103446, interior of culvert showing water level and rust line.

Figure 32.–Site 30103446, culvert inlet.

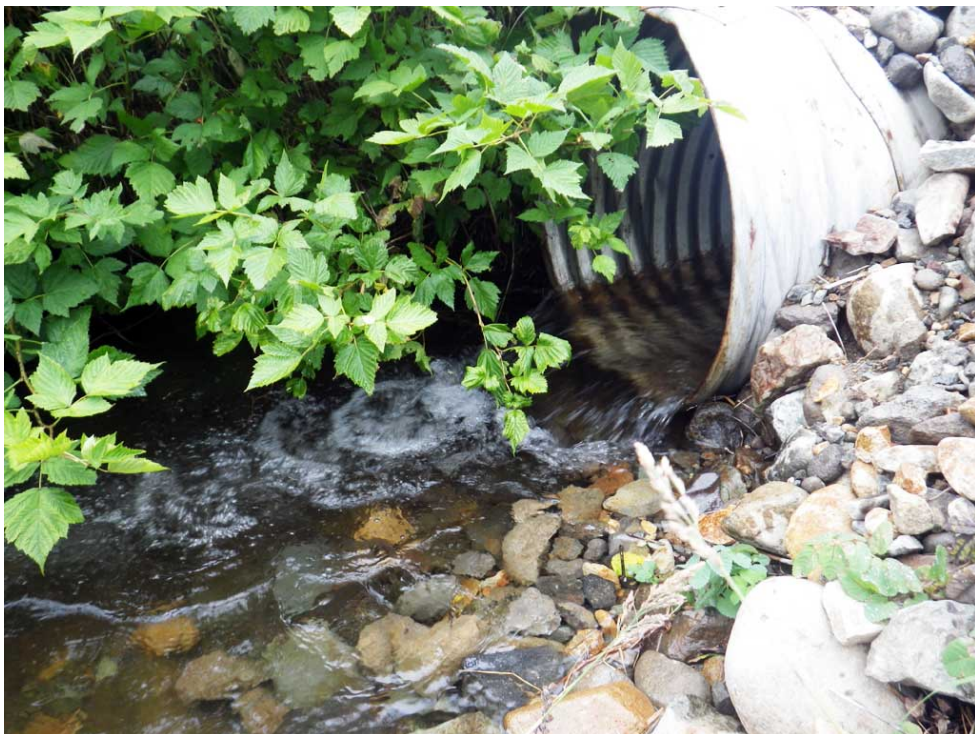
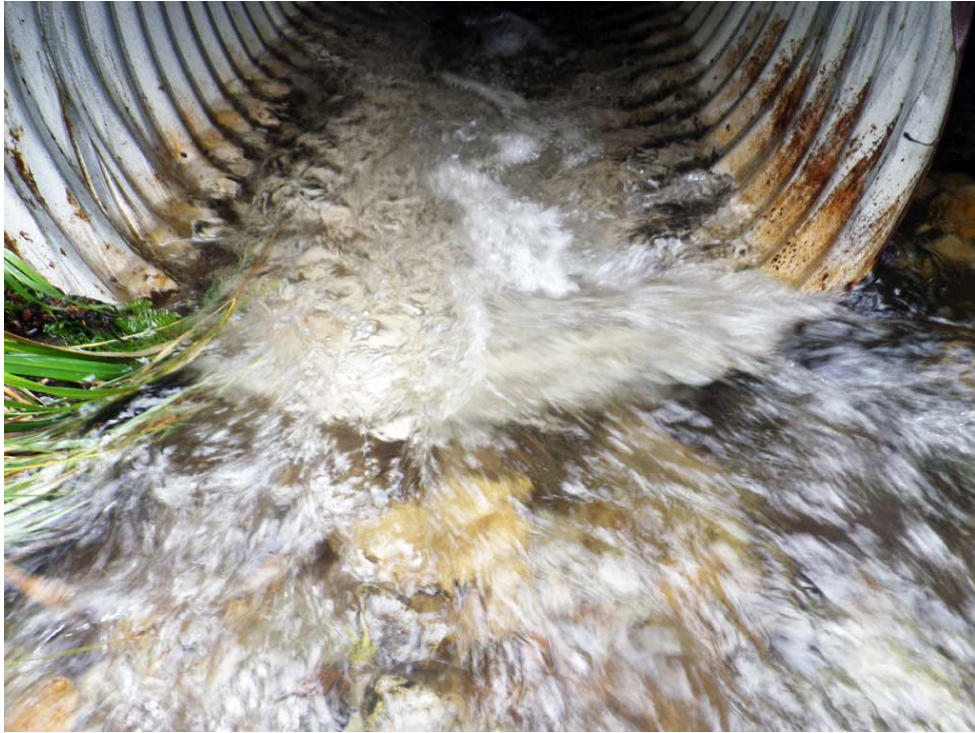
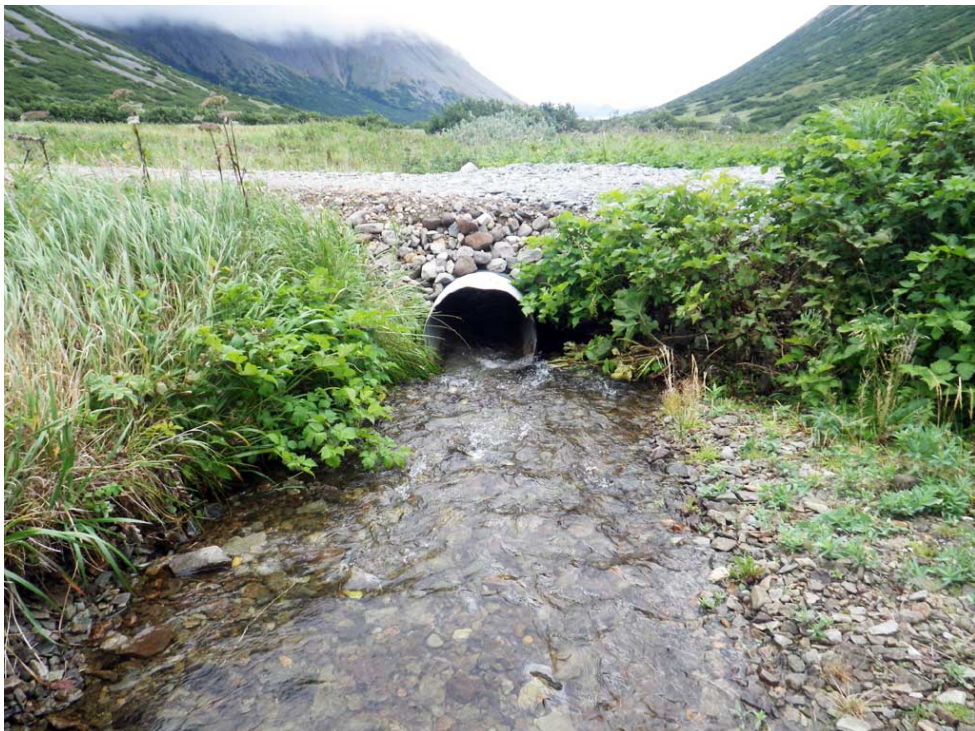
Site is on the shooting range off Airport Road about 3 miles from King Cove (Figure 33). The stream is cataloged in the AWC for chum and pink salmon about 0.3 miles downstream of this culvert. Assessment crews observed fish at the site, most likely Dolly Varden char. Satellite imagery shows about another half mile of potential habitat upstream. Recommend replacement with a stream simulation culvert (Figures 34-36).

Figure 34.—Site 30103448, culvert outlet showing outfall.

Figure 35.—Site 30103448, inlet perch.

Figure 36.—Site 30103448, constricted culvert inlet.
