**Fishery Data Series No. 18-28**

# **Fish Passage Assessment and Culvert Inventory on the King Cove and Cold Bay Road Systems**

December 2018

Alaska Department of Fish and Game

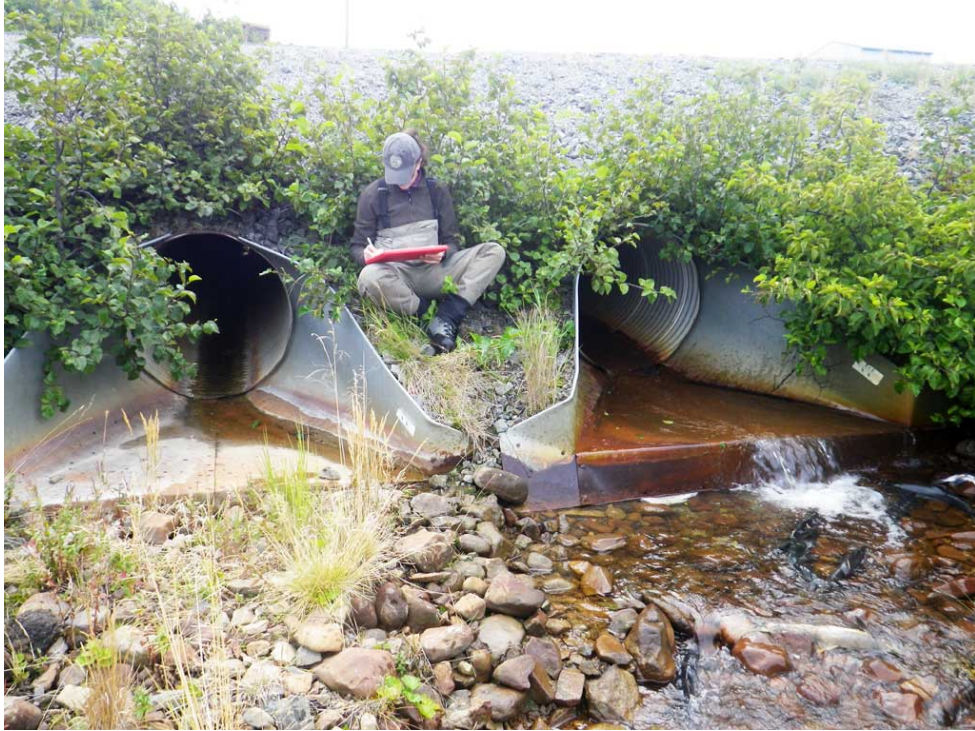
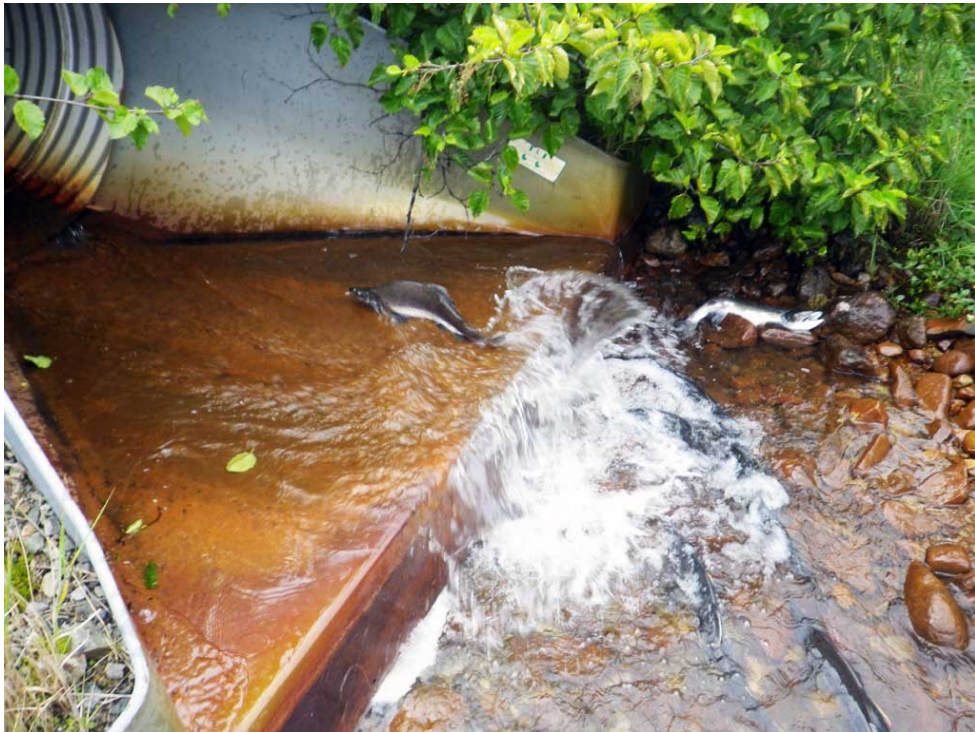
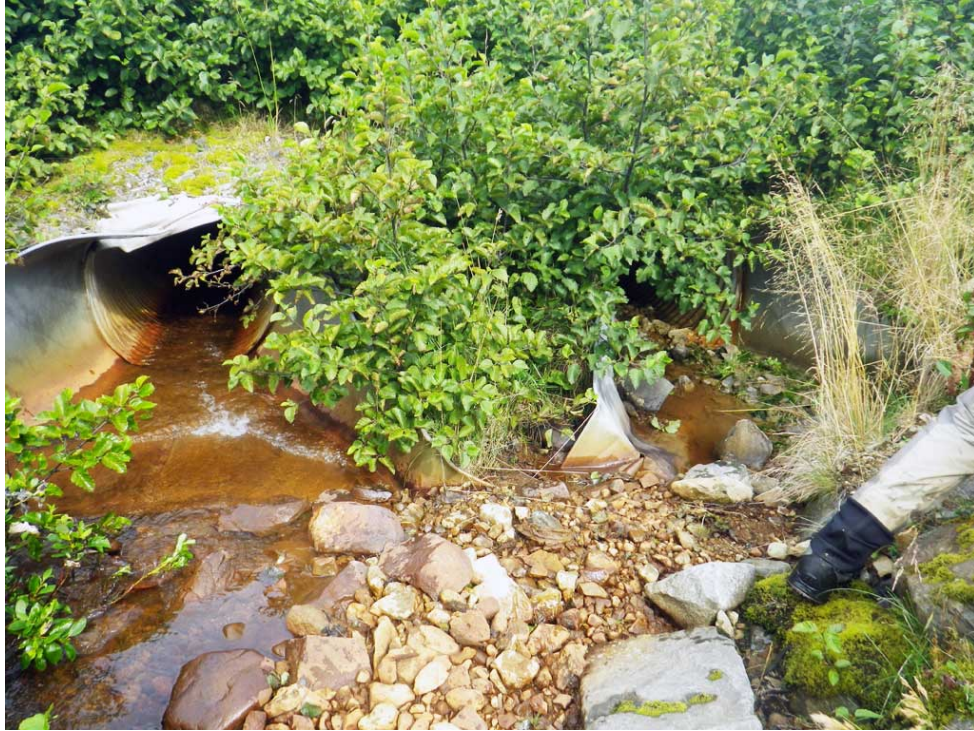
Site is about 1000 feet upstream from the confluence with Ram Creek (AWC # 283-33-10500) and about 950 feet downstream of site 30103460 (Figure 37). The assessment crew observed adult pink salmon and Dolly Varden char up- and downstream from this site. Site consists of 2 culverts, with one capturing all the flow at the time of survey. Culvert has a Red outfall and adult fish were observed leaping to pass through the crossing and stacking up below the culvert. Recommend replacing culverts with a stream simulation culvert (Figures 38–40).

Figure 38.—Site 30103461, outlets showing outfall.

Figure 39.—Site 30103461, outlet of C1 showing outfall and adult pink salmon attempting to transit.

Figure 40.–Site 30103461 culvert inlets.

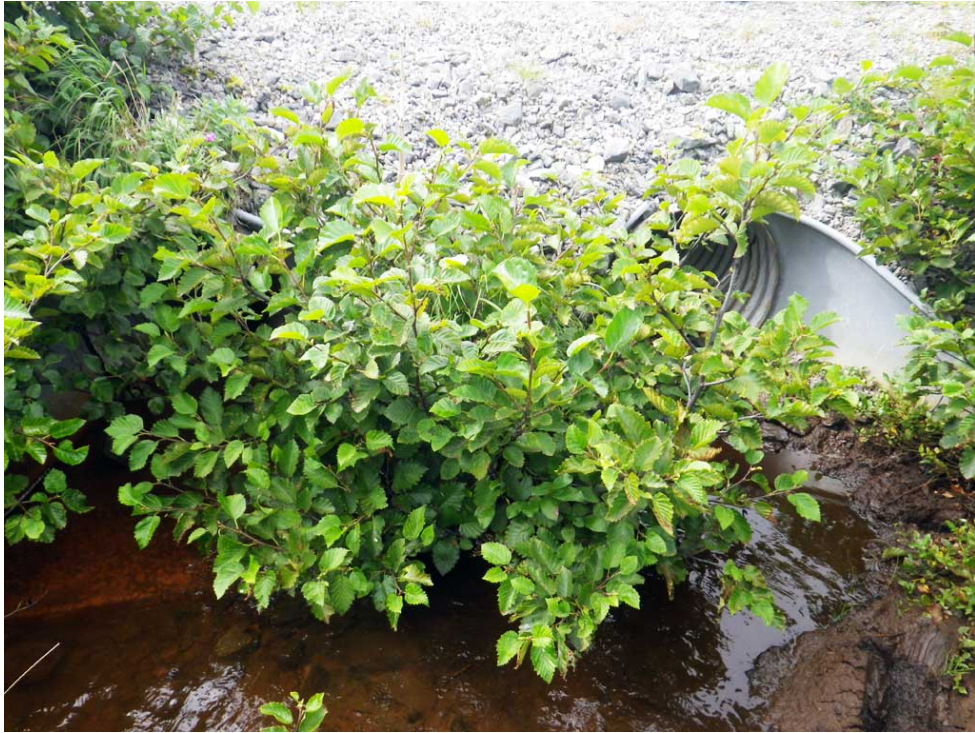
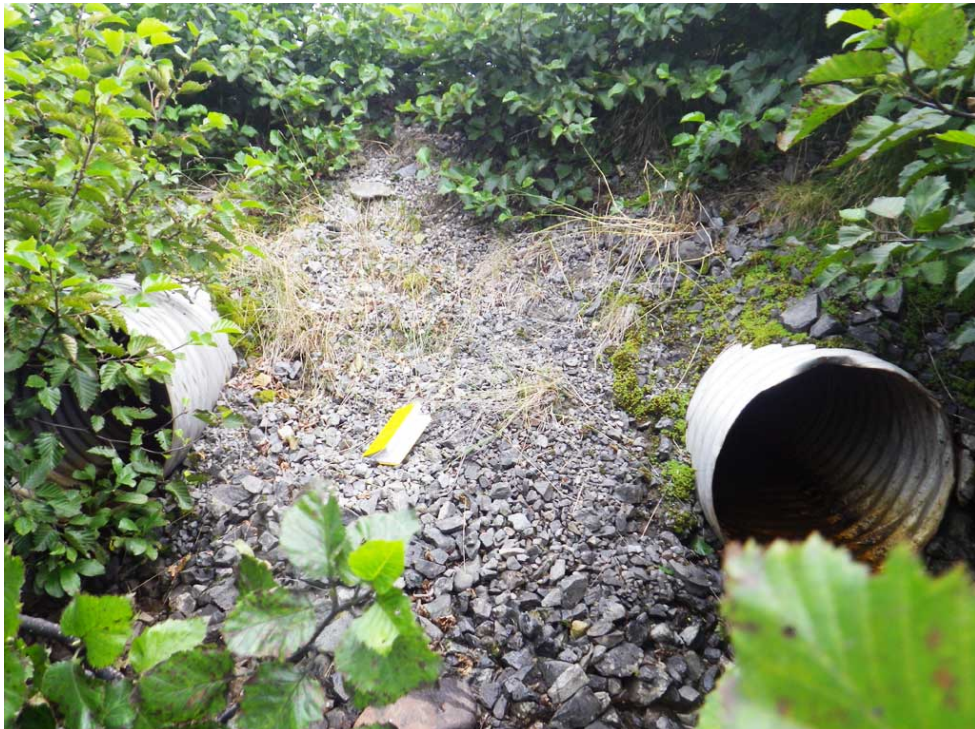
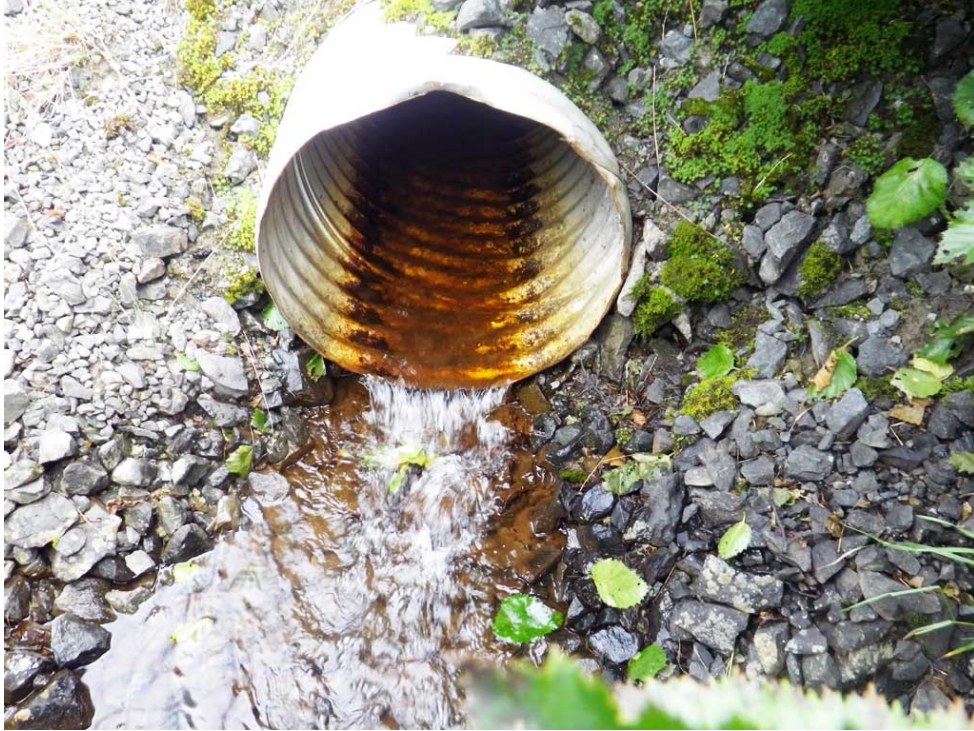
Site is about a quarter mile upstream from site 30103461 and a half mile from the confluence with Ram Creek (Figure 37). Site consists of two culverts with flared inlets. Almost all flow is being directed into the C1 culvert, or the first culvert starting from the left streambank looking downstream. Both culverts have Gray outfall and Red gradients, and the site also has a Gray constriction ratio. The assessment crew observed Dolly Varden char above culvert, adult pink salmon above and below the culvert, and adult pink salmon over 400 feet upstream of the crossing. The project recommends replacing these culverts with a stream simulation culvert (Figures 41–43).

Figure 41.—Site 30103460, culvert inlets, C1 (left hand side) taking almost all flow.

Figure 42.—Site 30103460, culvert outlets.

Figure 43.–Site 30103460, outlet of C1 showing outfall.

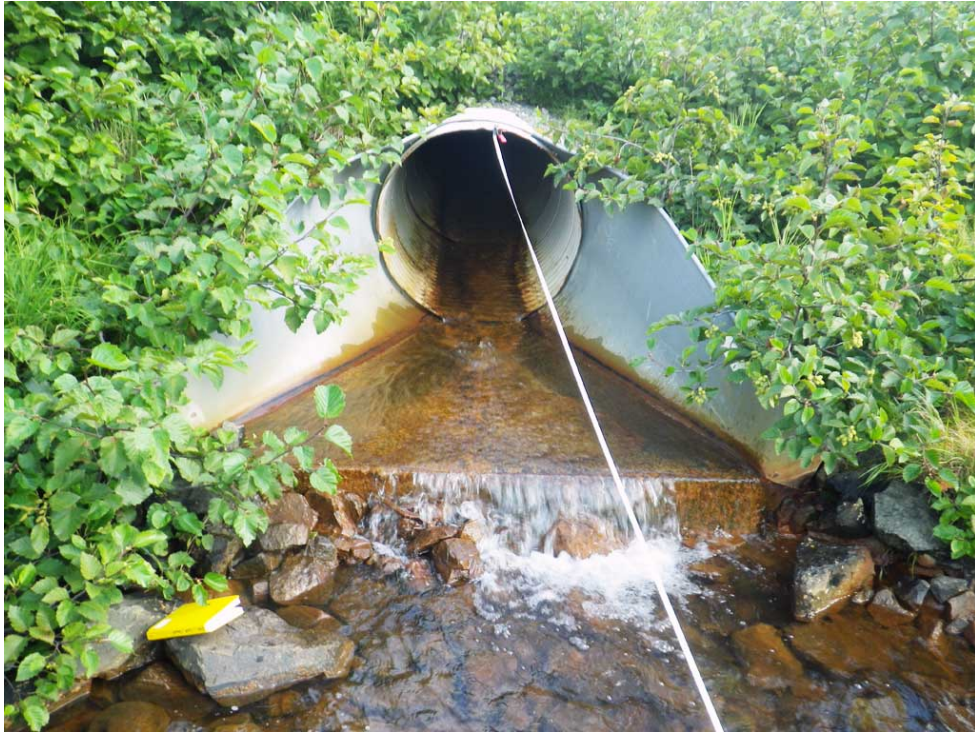
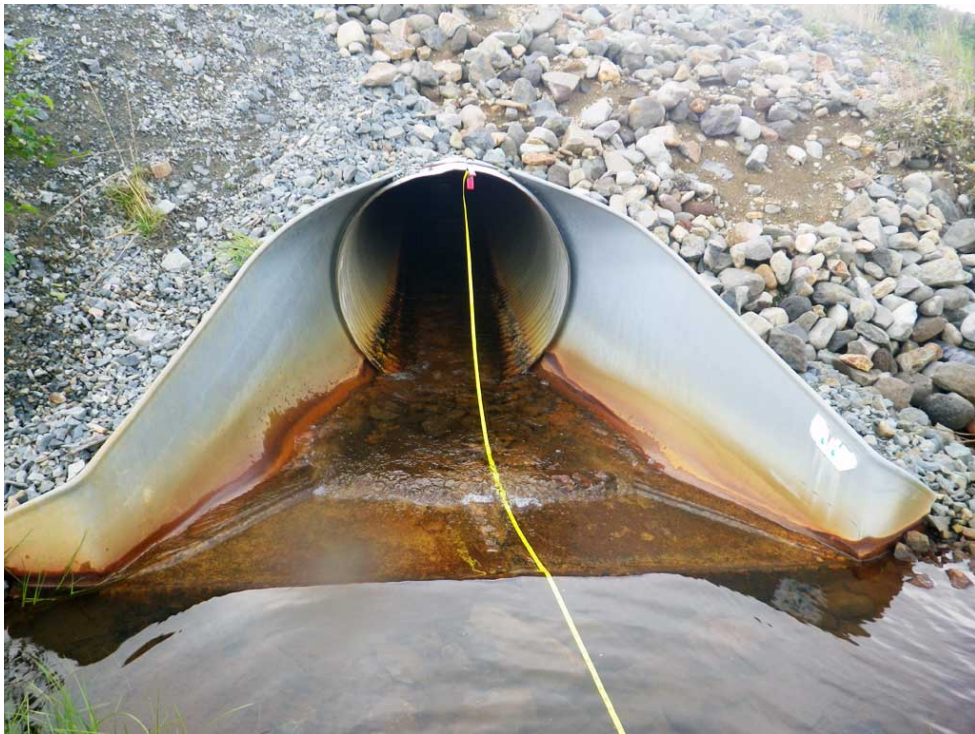
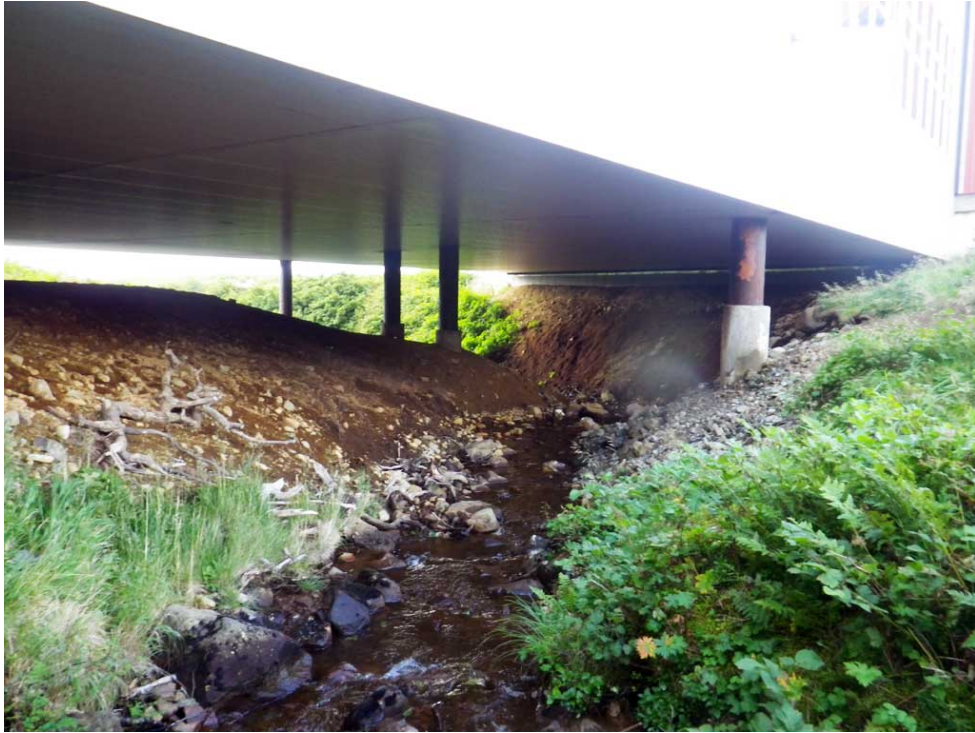
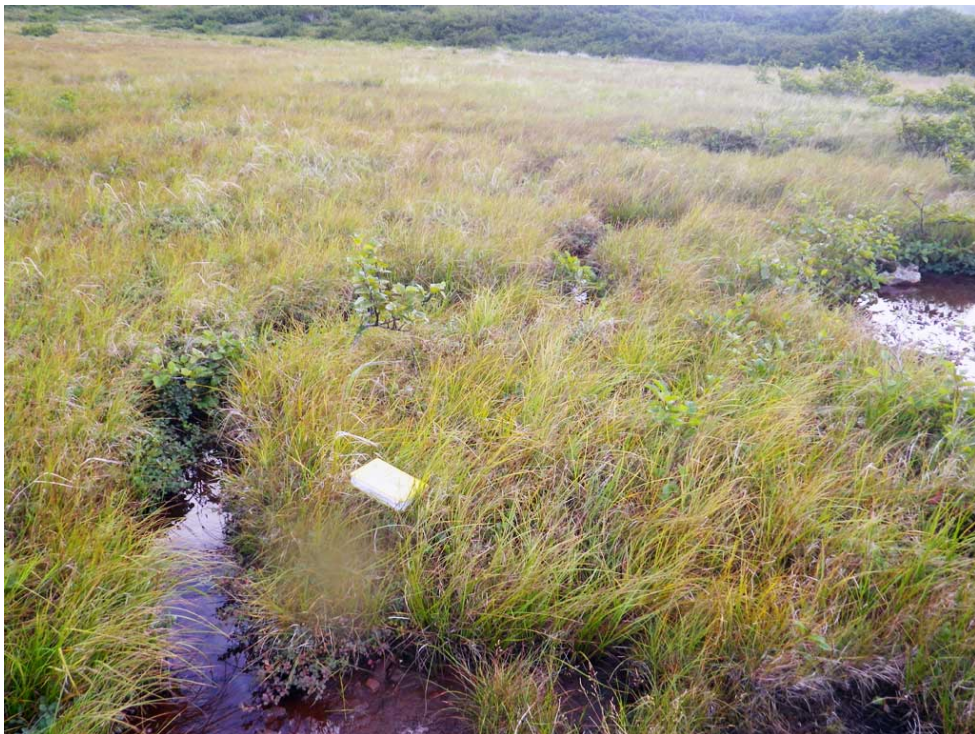
This site is about 700 feet upstream from the confluence with Ram Creek (AWC#283-33-10500) (Figure 37). The creek is documented for pink salmon up to the road crossing. The culvert has a Red outfall and gradient and a Gray constriction ratio. The assessment crew observed fish upstream and downstream of site, likely Dolly Varden char. Creek flows under the new King Cove school about 300 feet downstream of the culvert. The project recommends replacement with a stream simulation culvert (Figures 44–47).

Figure 44.–Site 30103459, flared outlet showing Red outfall.

Figure 45.–Site 30103459, culvert inlet, showing inlet perch.

Figure 46.–Site 30103459, 300 feet downstream of culvert showing creek flowing under new King Cove school.

Figure 47.–Site 3013459, habitat 400 feet upstream from culvert.
