# **Fish Passage Assessment and Prioritization of Culverts in Gustavus, Haines, Juneau, Skagway, and Sitka, 2011–2012**

May 2020

Alaska Department of Fish and Game

***FISHERY DATA SERIES NO. 20-12***

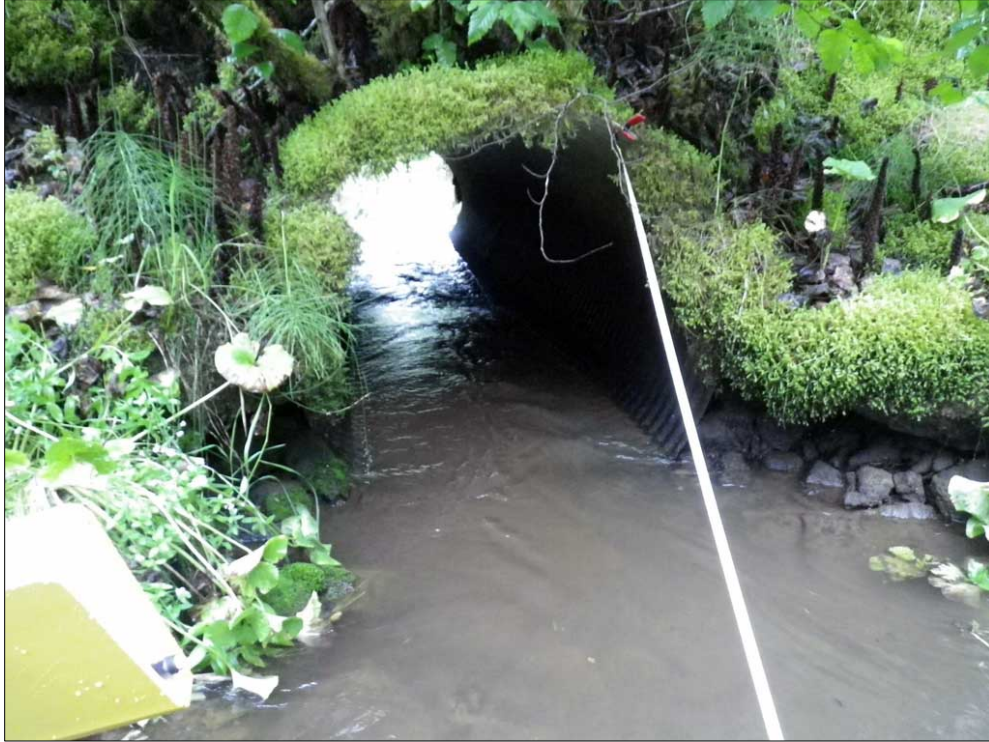
Figure 19.—Site #10302255 in Gustavus showing an undersized culvert with a constriction ratio of 0.40 on a private driveway off Mountain View Road.

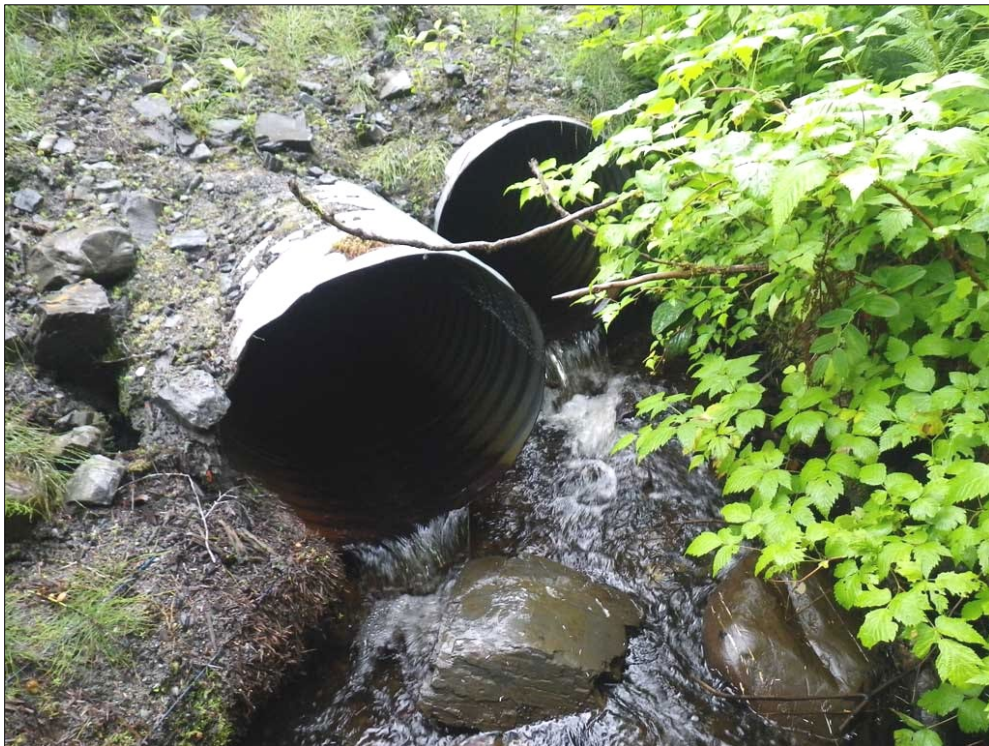
Figure 20.—Site #10302241 in Gustavus showing the Red outfall heights of both culvert outlets. This site also had a Gray constriction ratio of 0.56.

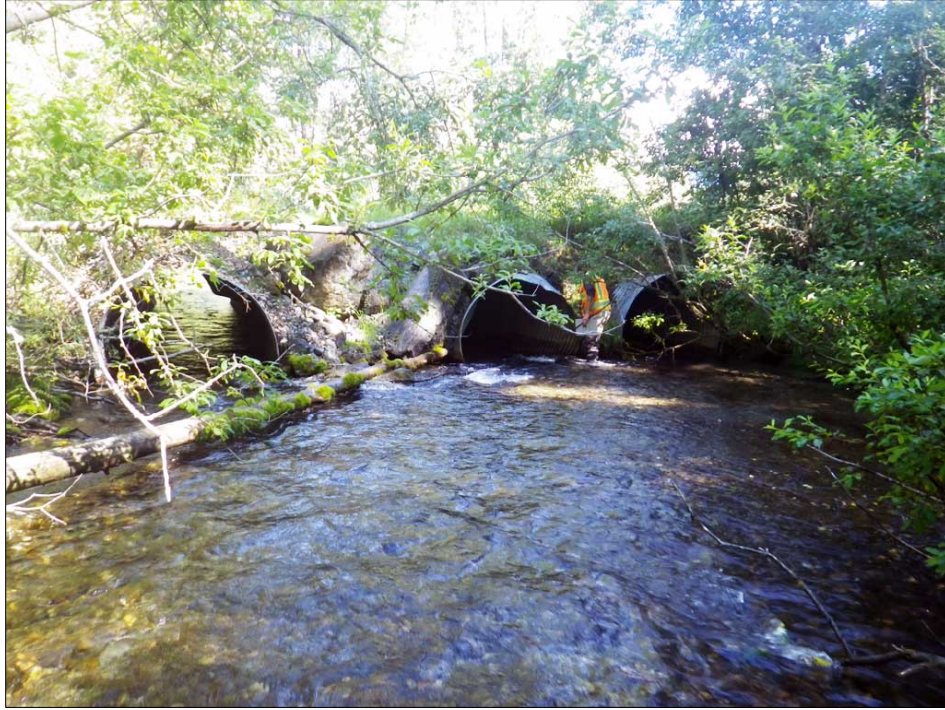
Figure 21.—Site #10302838 on the Porcupine Road north of Haines. The crossing has a Red constriction ratio of 0.40.

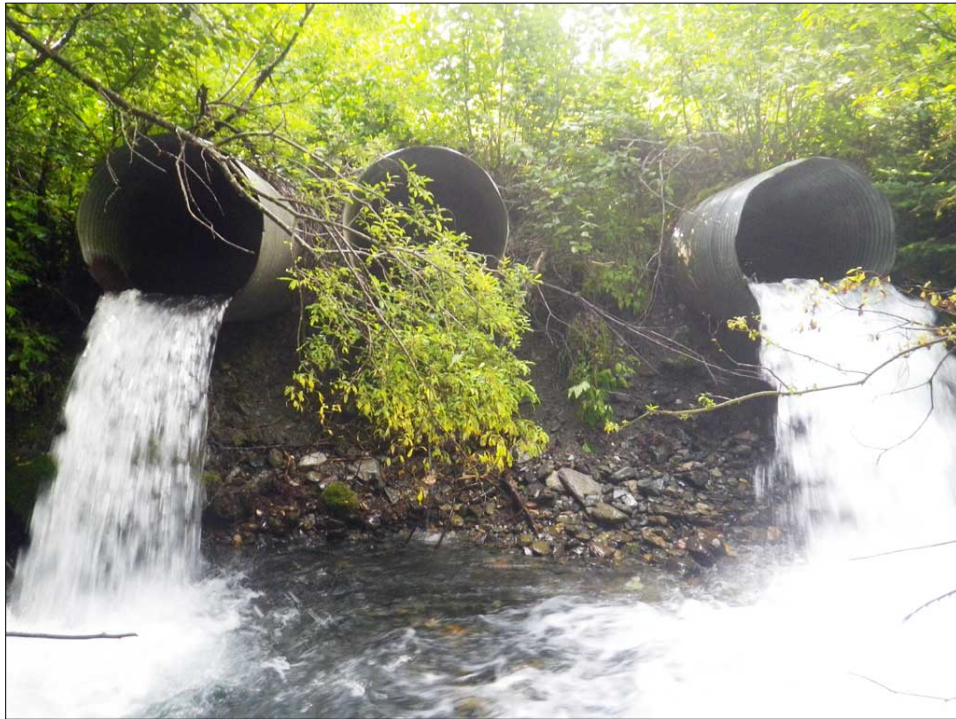
Figure 22.—Site #103022829 culverts on Kelsall Road north of Haines. All culverts perched over 5 feet, with Red gradients and Red constriction. Below this site, the stream is cataloged for coho rearing and pink spawning.

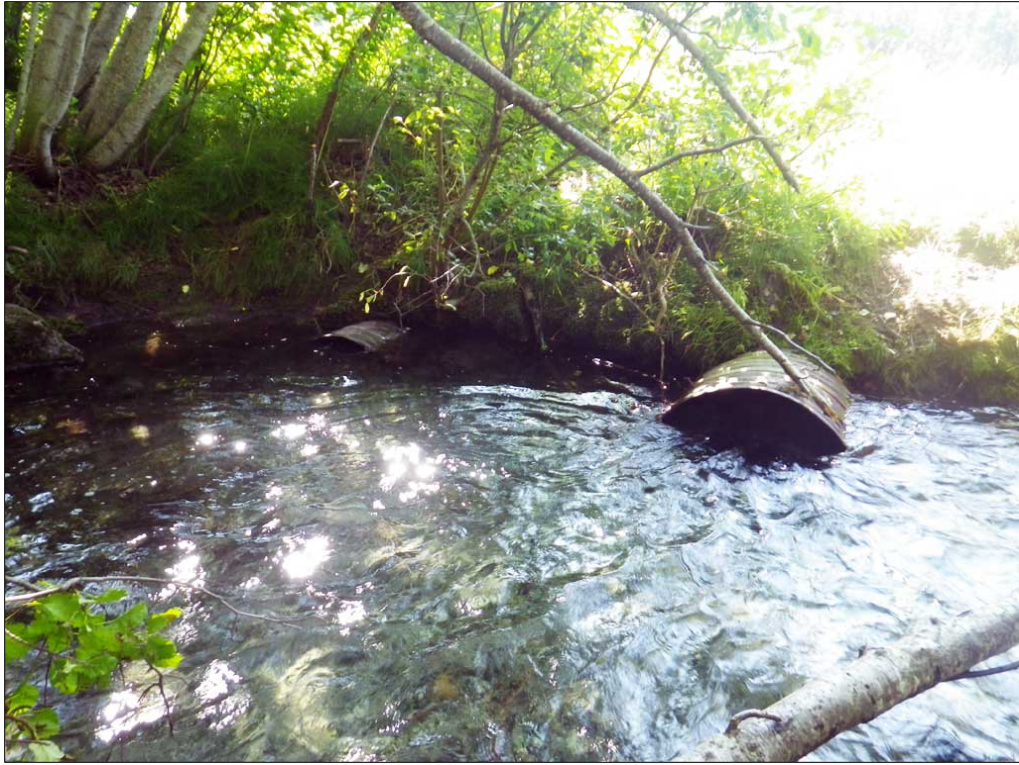
Figure 23.—Site #10302913 undersized culverts on Ten Mile Creek off the Haines Highway.

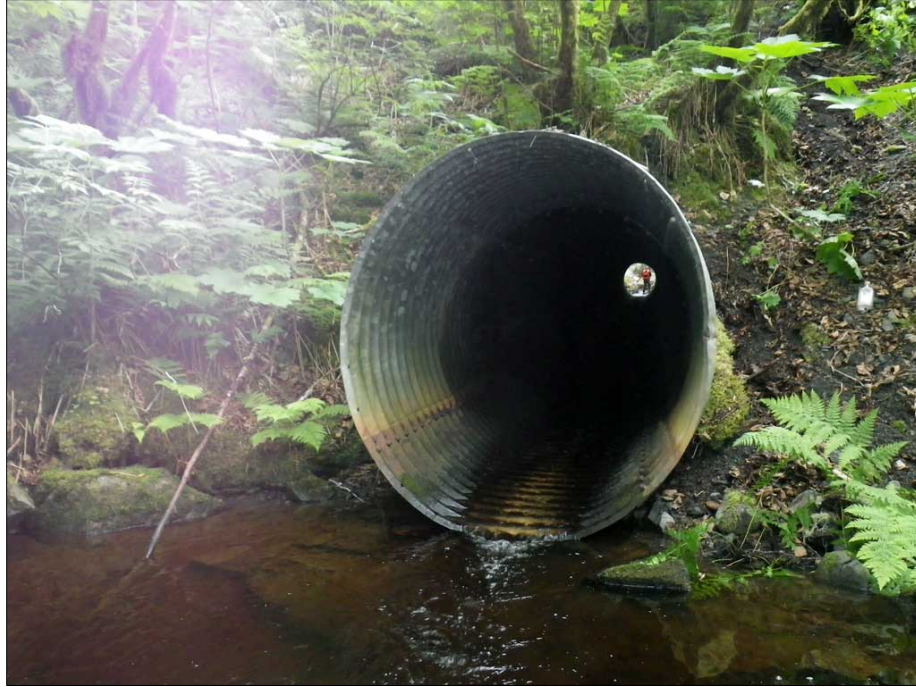
Figure 24.—Site #10302170 culvert on Johnson Creek on the North Douglas Highway. Culvert is Red for gradient and constriction and has a Gray outfall height. Stream is cataloged for coho and pink salmon, Dolly Varden, and cutthroat trout.

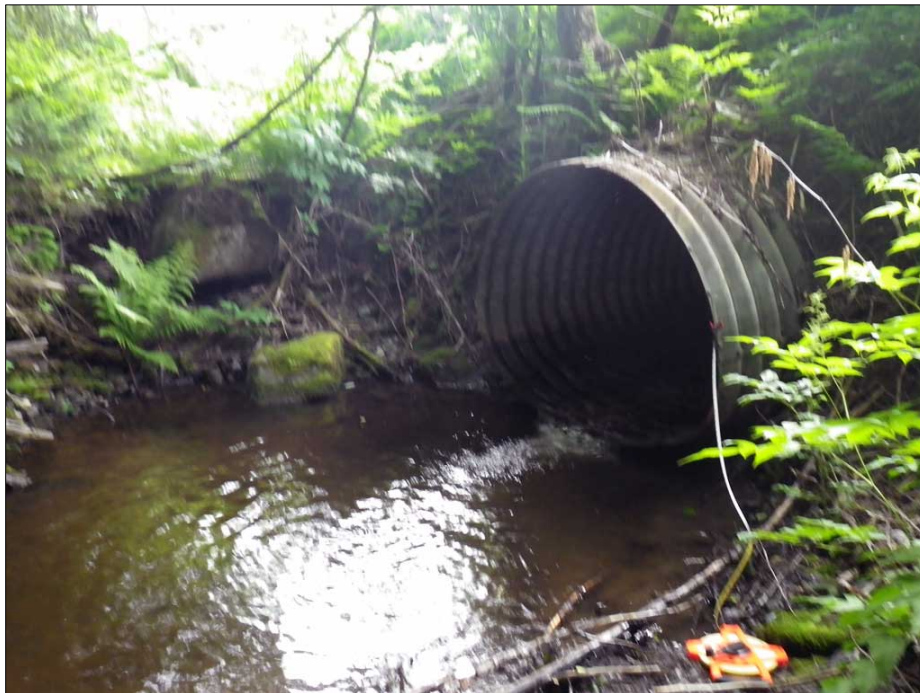
Figure 25.—Site #10302165 culvert on Hendrickson Creek on the North Douglas Highway. Culvert is a gradient barrier and has a Gray constriction ration and outfall height. Creek is cataloged for coho and pink salmon, Dolly Varden, and cutthroat trout.

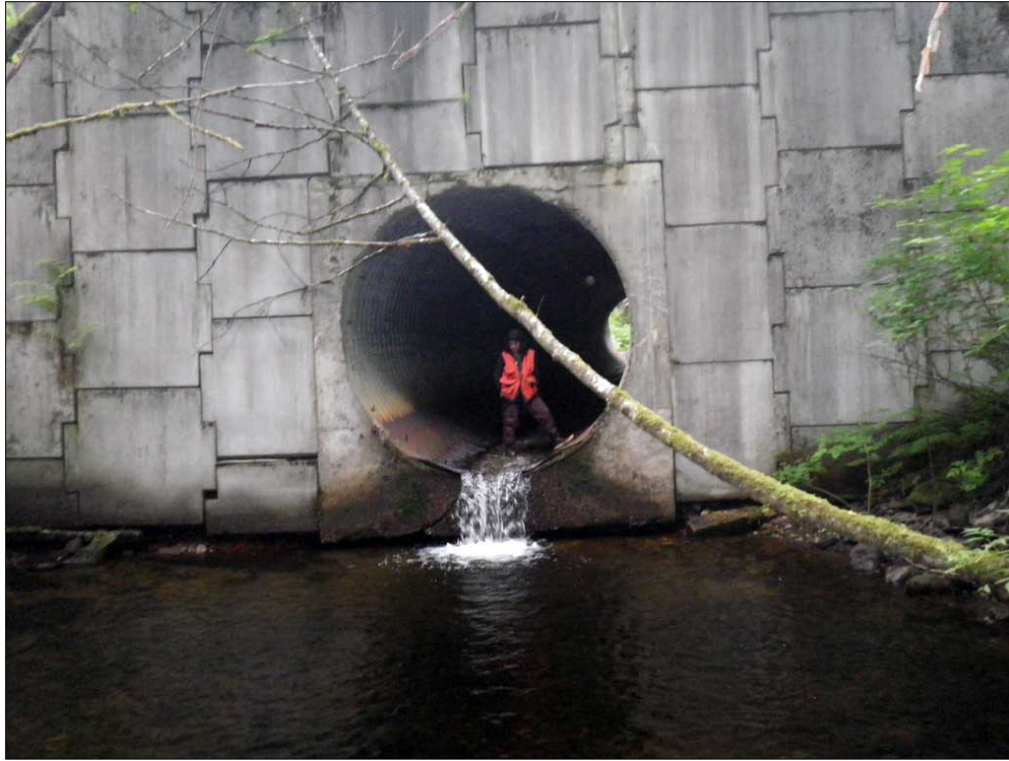
Figure 26.—Site #10302212 on Waydelich Creek off the Glacier Highway in Juneau. Site has a Red outfall, 2.63 ft, and a Red gradient, 2.63%, as well as, a Gray constriction ratio. Stream is cataloged for pink and chum salmon below crossing.

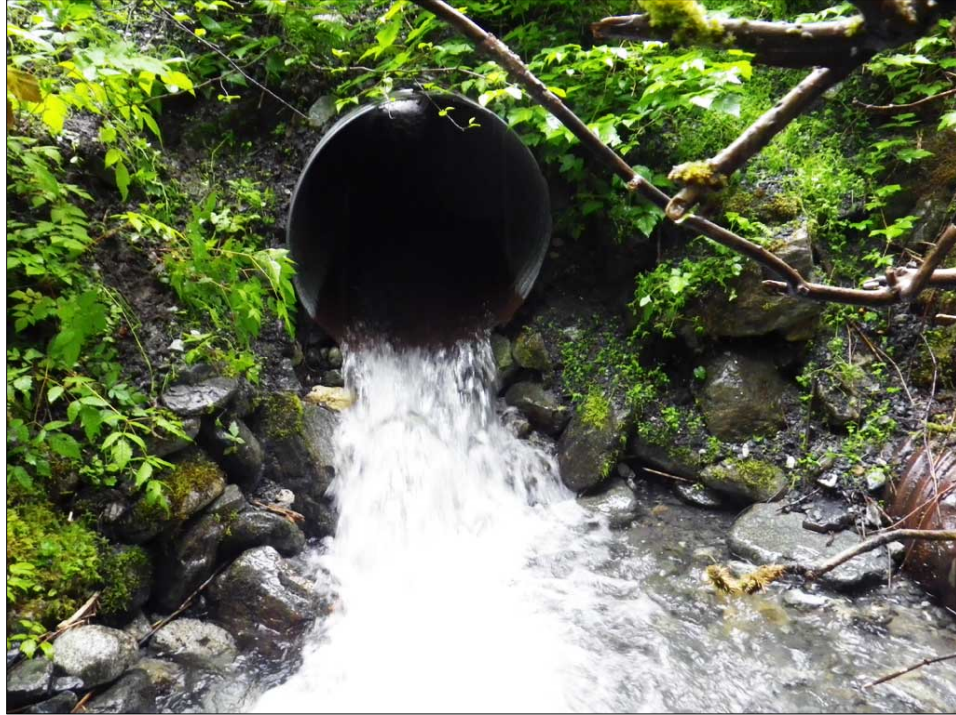
Figure 27.—Site #10302984 on Sawmill Creek Road in Sitka showing a Red outfall.

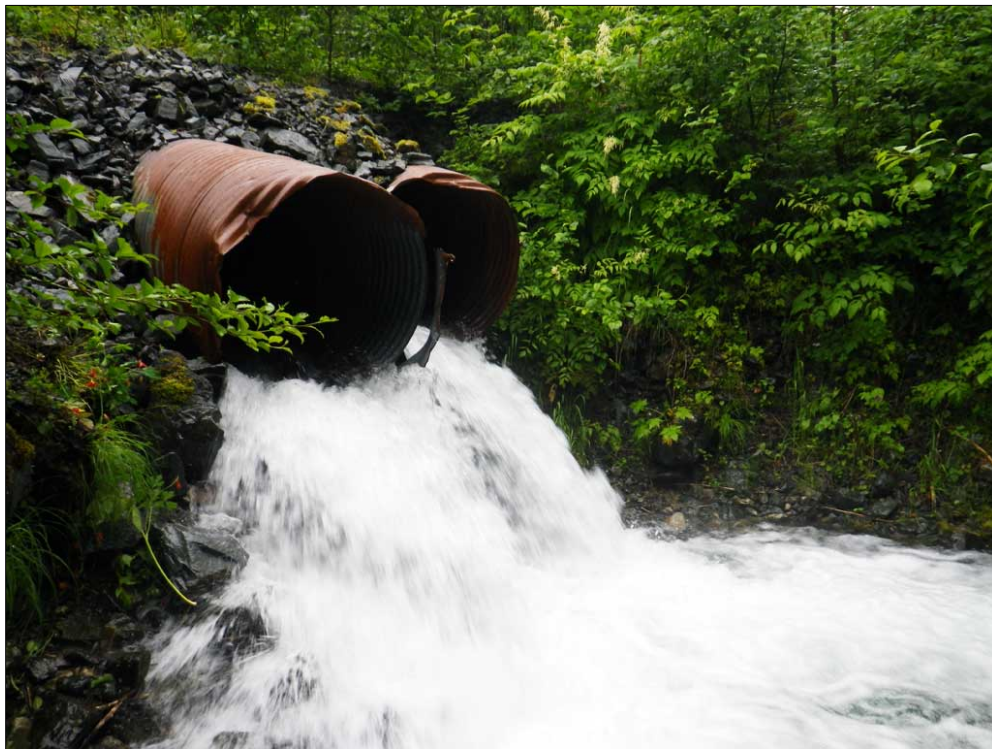
Figure 28.—Site #1030286 on Sawmill Creek Road in Sitka showing a Red outfall.

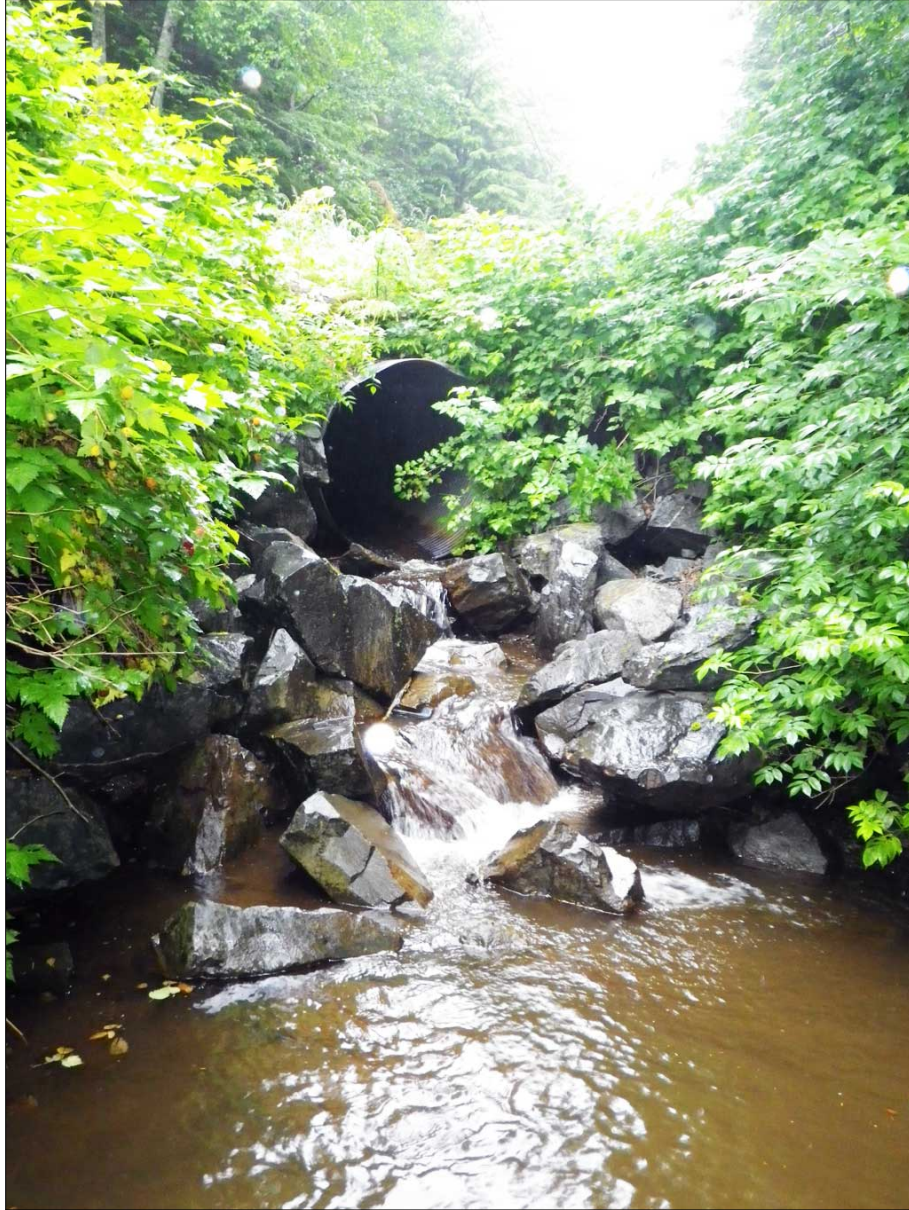
Figure 29.—Site #10303040 on Blueberry Road in Sitka, showing a Red outfall over riprap.

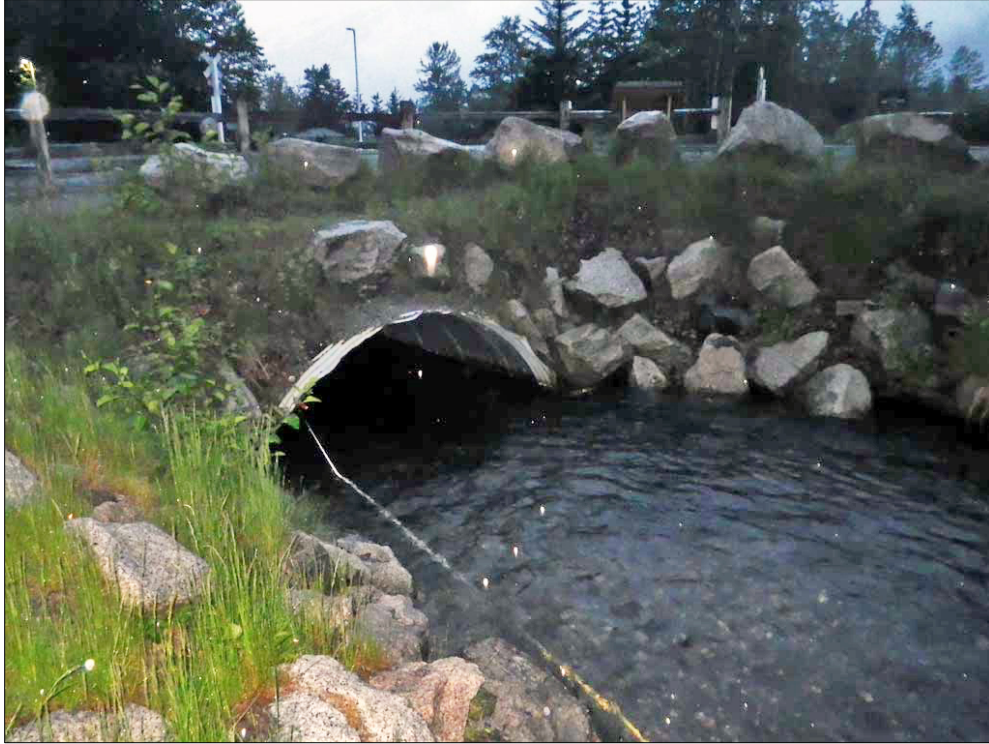
Figure 30.—Site #10302949 with an undersized culvert on Pullen Creek crossing the White Pass and Yukon Route railroad in Skagway.

On most road networks in northern Southeast Alaska, we observed a relatively small number of culverts with high prioritization scores, and we recommend those are the first structures considered for replacement when funds are available (Figures 19–31). Where there are many culverts with similar scores, replacement of many structures may be required to see a large improvement in fish passage throughout the watershed or region, and it is recommended that a comprehensive plan for improvement is developed locally to consider issues such as barriers per watershed, road ownership, scheduled road maintenance, seasonal traffic loads, and cost. An example of this includes the results for Pullen Creek in Skagway (Tables 29 and 30; Figures 30 and 31).

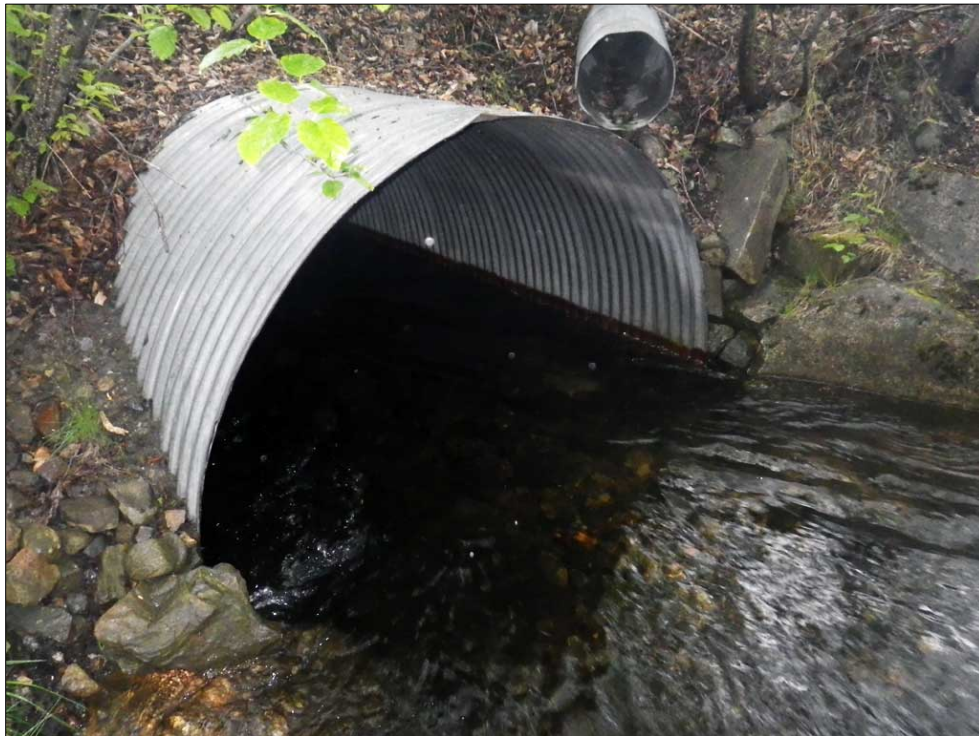
Figure 31.—Site #1030251 with an undersized culvert on Pullen Creek running under Broadway Street.
