Fishery Data Series No. 21-01

**Fish Passage Assessment, Inventory, and
Prioritization of Culverts on the Ketchikan,
Petersburg, and Wrangell Road Systems, 2013–2016**

June 2021

Alaska Department of Fish and Game

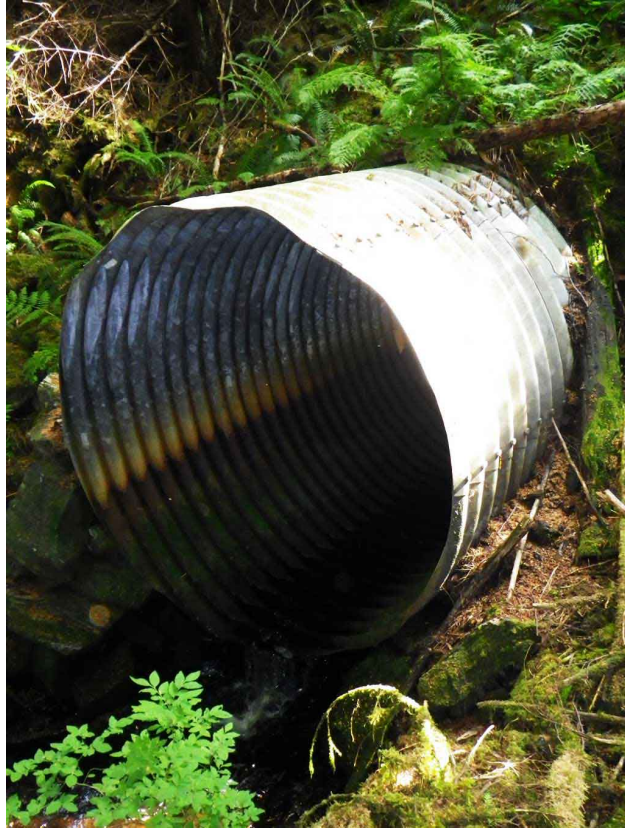
Figure 12.—Site 10103229, North Tongass Highway, Trollers Creek (AWC# 101-90-10705), Ketchikan, culvert outlet.

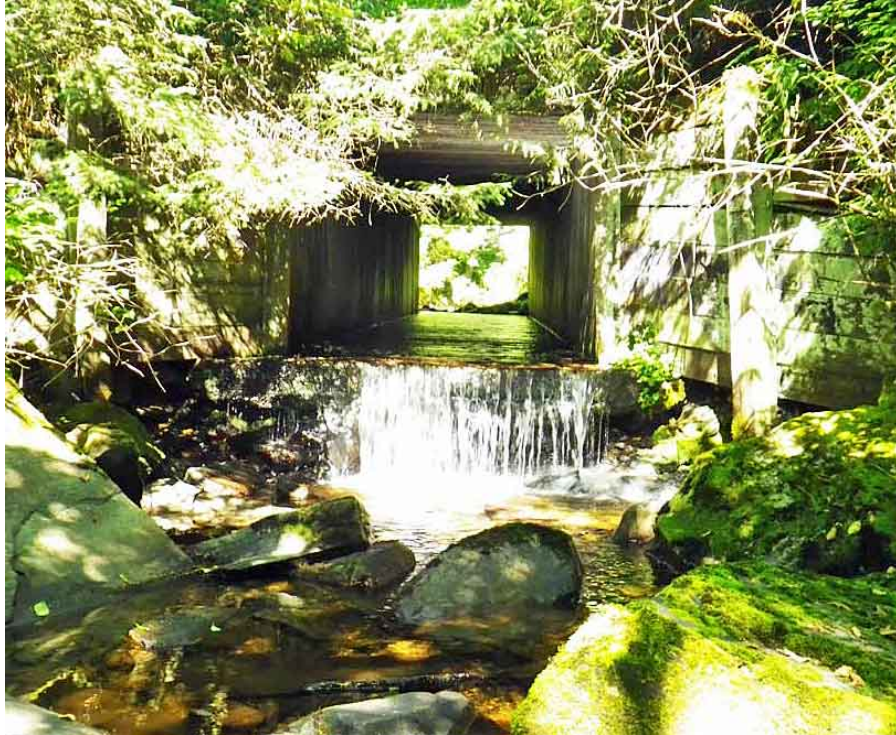
Figure 14.—Site 10103208, South Tongass Highway, unnamed creek (AWC# 101-47-10300), Ketchikan, culvert outlet.

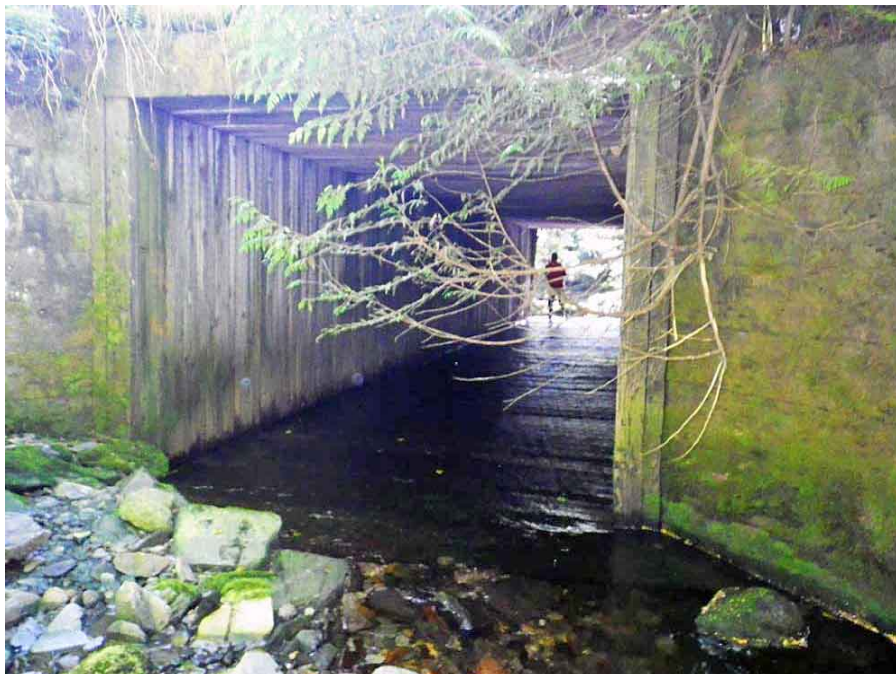
Figure 15.—Site 10103208, South Tongass Highway, unnamed creek (AWC# 101-47-10300), Ketchikan, culvert inlet.

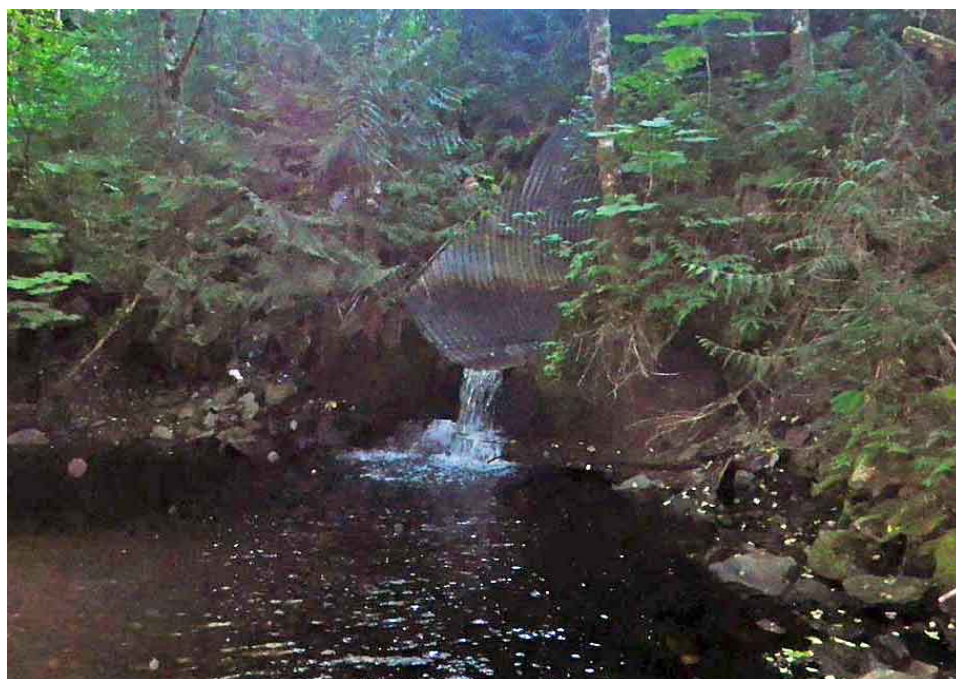
Figure 17.—Site 10103174, Ward Lake Road, unnamed creek, Ketchikan, culvert outlet.

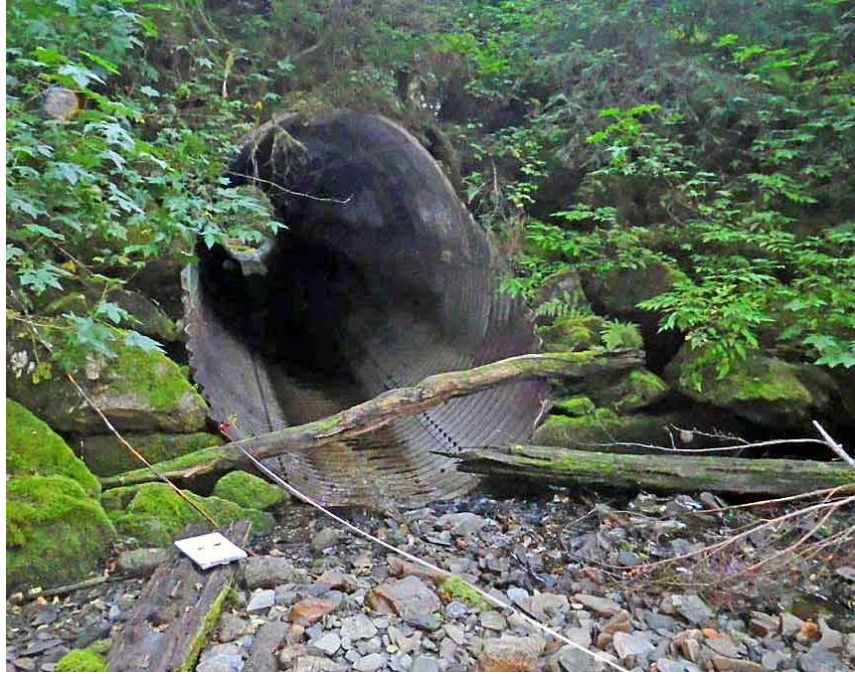
Figure 18.—Site 10103174, Ward Lake Road, unnamed creek, Ketchikan, culvert inlet.

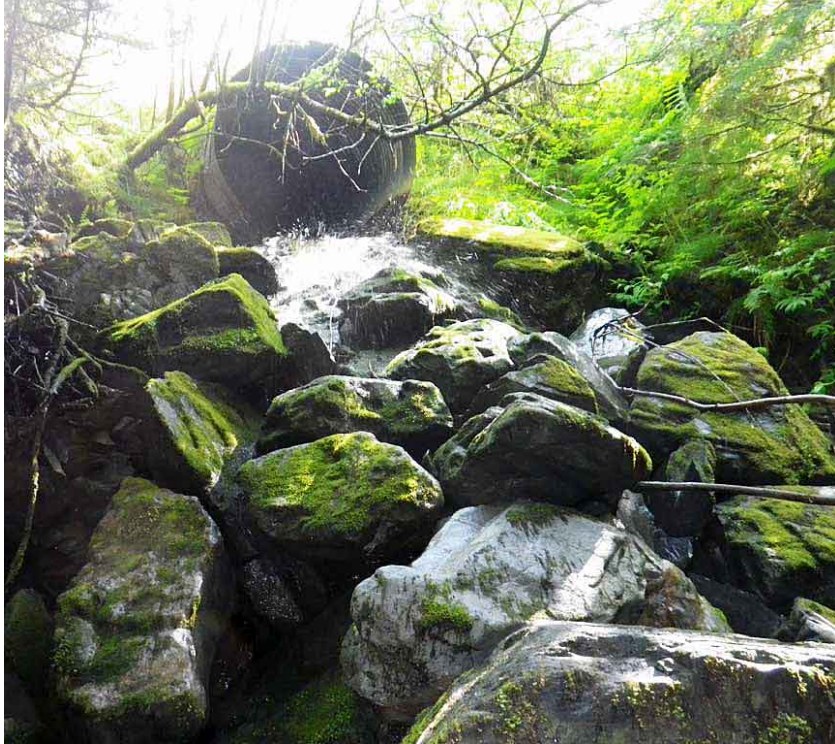
Figure 20.—Site 10203301, Mitkof Highway, Letti Creek (AWC# 106-44-10070), Petersburg, outlet showing outfall onto riprap barrier.

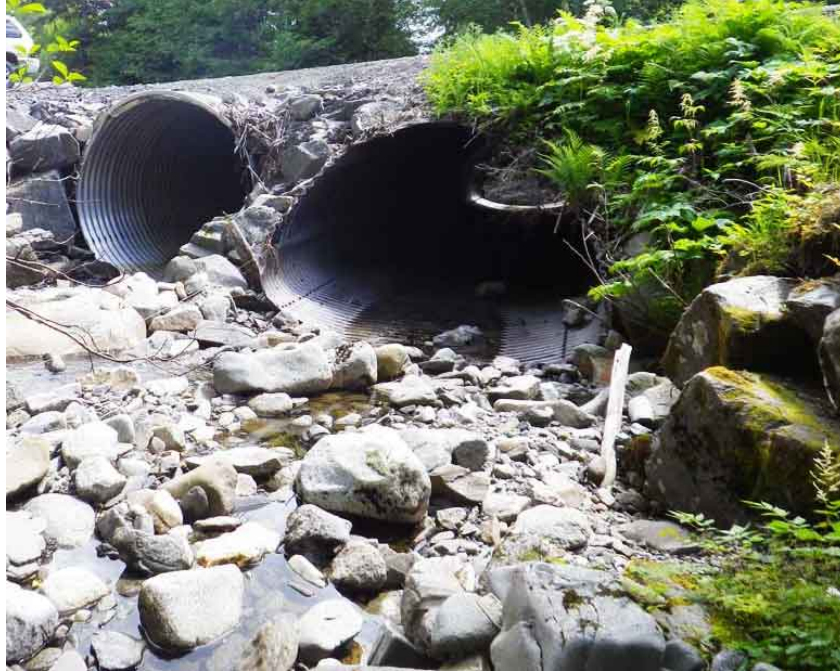
Figure 22.—Site 10203133, Mitkof Highway, unnamed creek (AWC Stream #108-40-10600), Petersburg, culvert inlets.

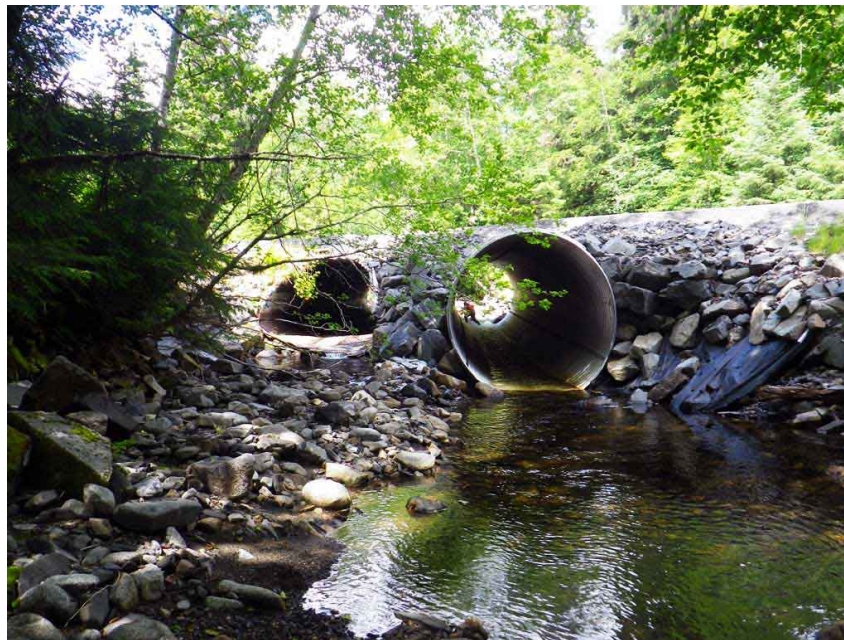
Figure 23.—Site 10203133, Mitkof Highway, unnamed creek (AWC Stream #108-40-10600), Petersburg, culvert outlets.

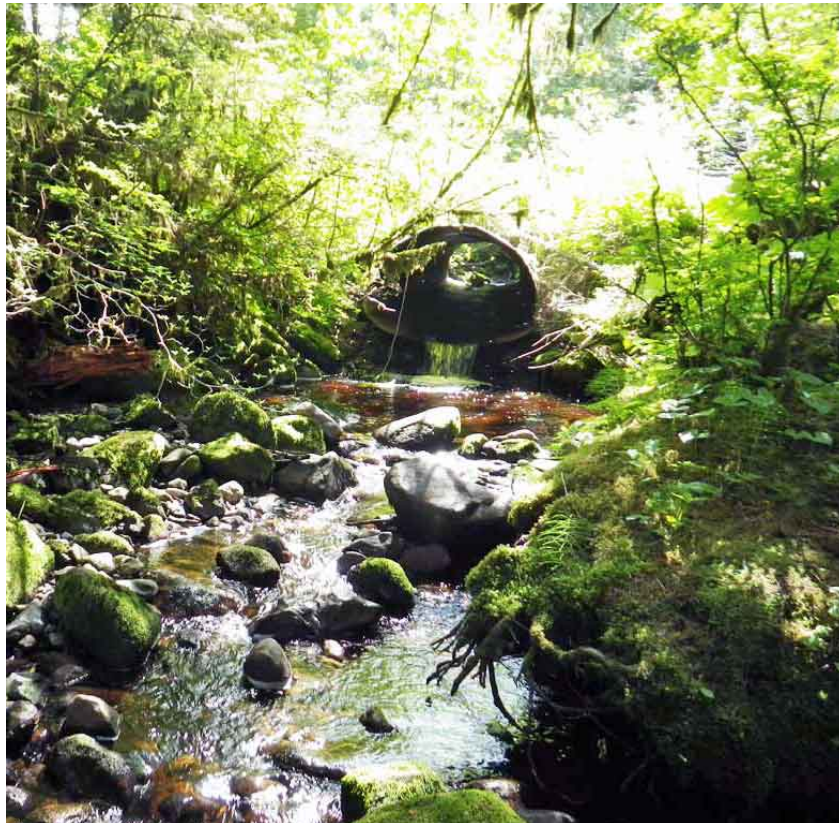
Figure 25.–Site 10203171, Sandy Beach Road, unnamed creek (AWC Stream #108-60-10051), Petersburg, culvert outlet.

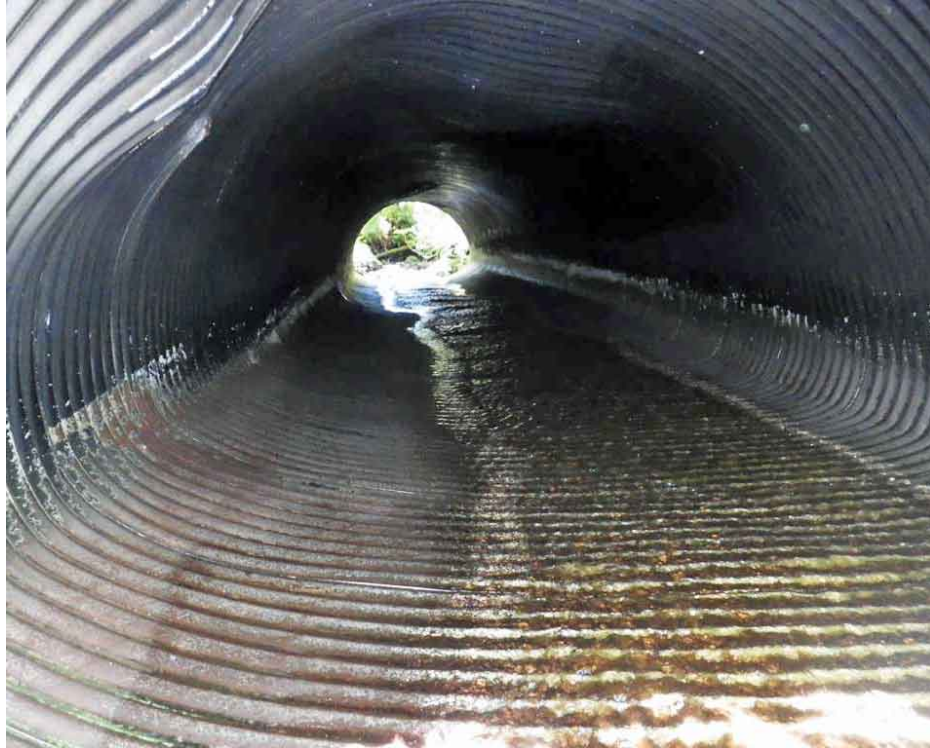
Figure 26.–Site 10203171, Sandy Beach Road, unnamed creek (AWC Stream #108-60-10051), Petersburg, culvert interior.

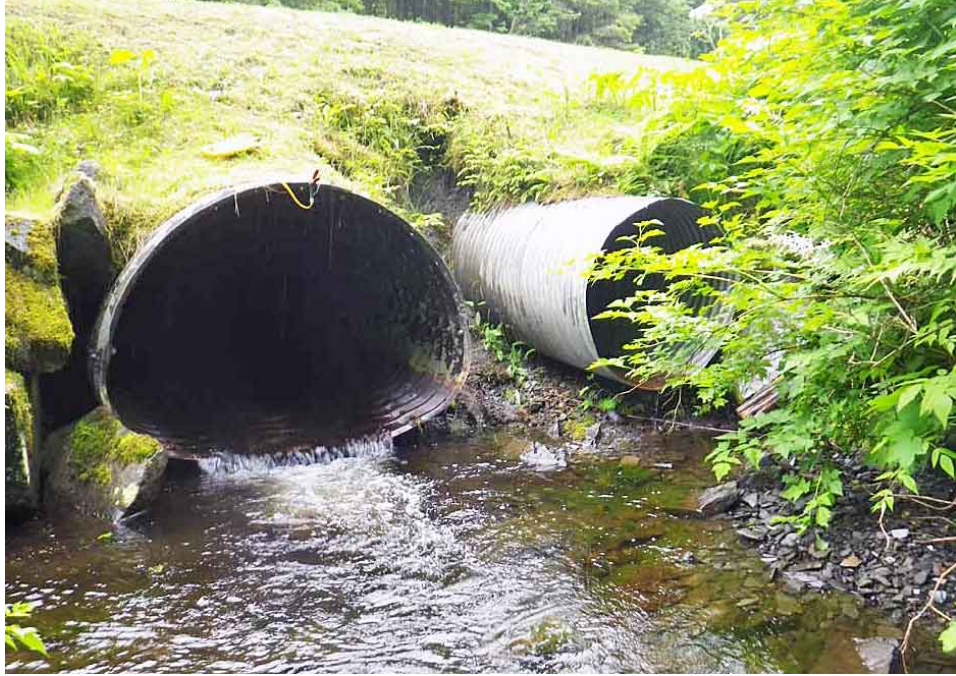
Figure 28.—Site 10203312, Zimovia Highway, Playground Creek (AWC# 108-40-10282), Wrangell, culvert outlets.

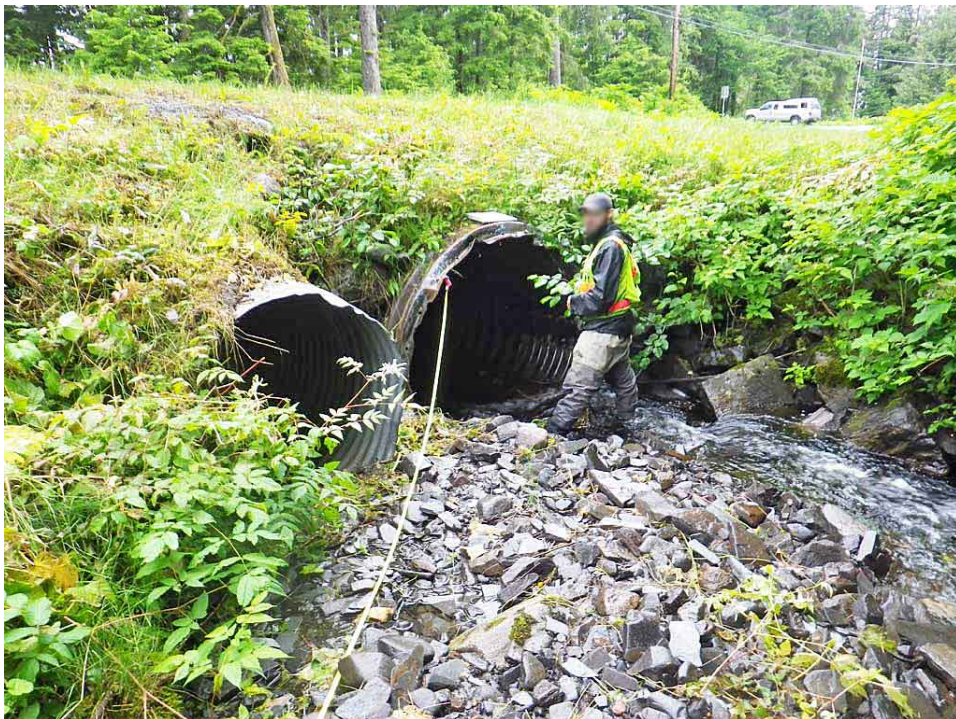
Figure 29.—Site 10203312, Zimovia Highway, Playground Creek (AWC# 108-40-10282), Wrangell, culvert inlets.

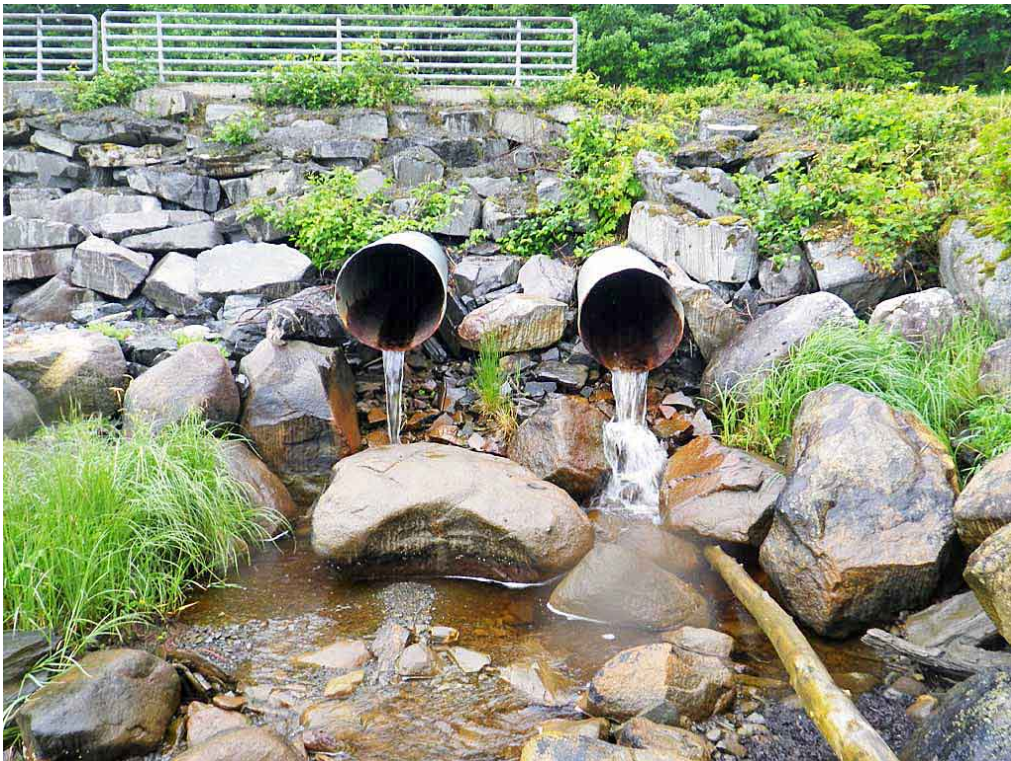
Figure 31.—Site 10203315, Zimovia Highway, unnamed creek (AWC# 108-40-10290), Wrangell, culvert outlets.

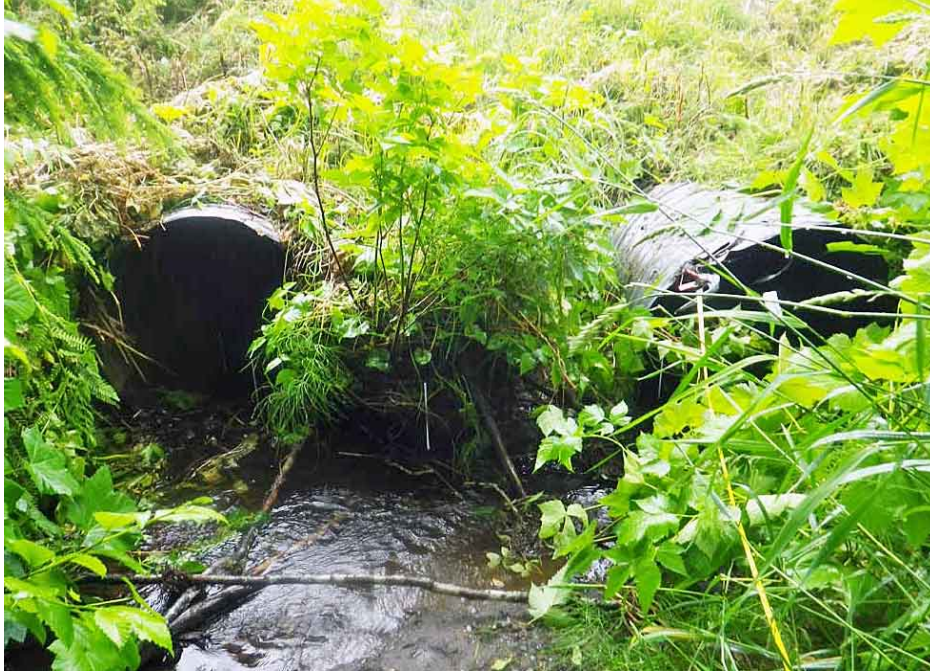
Figure 32.—Site 10203315, Zimovia Highway, unnamed creek (AWC# 108-40-10290), Wrangell, culvert inlets.

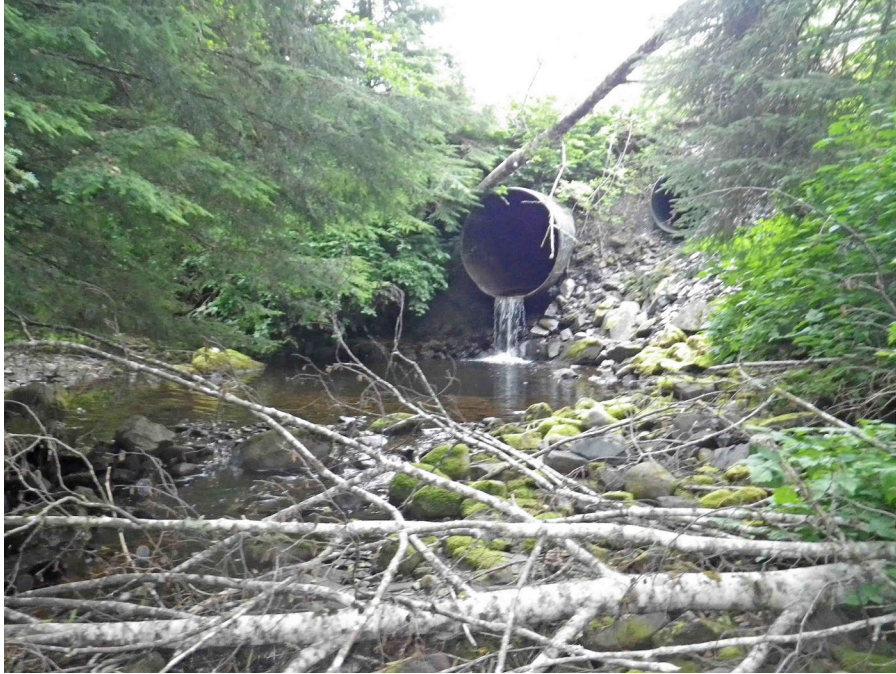
Figure 34.—Site 10203506, Zimovia Highway, unnamed stream, Wrangell, culvert outlet.

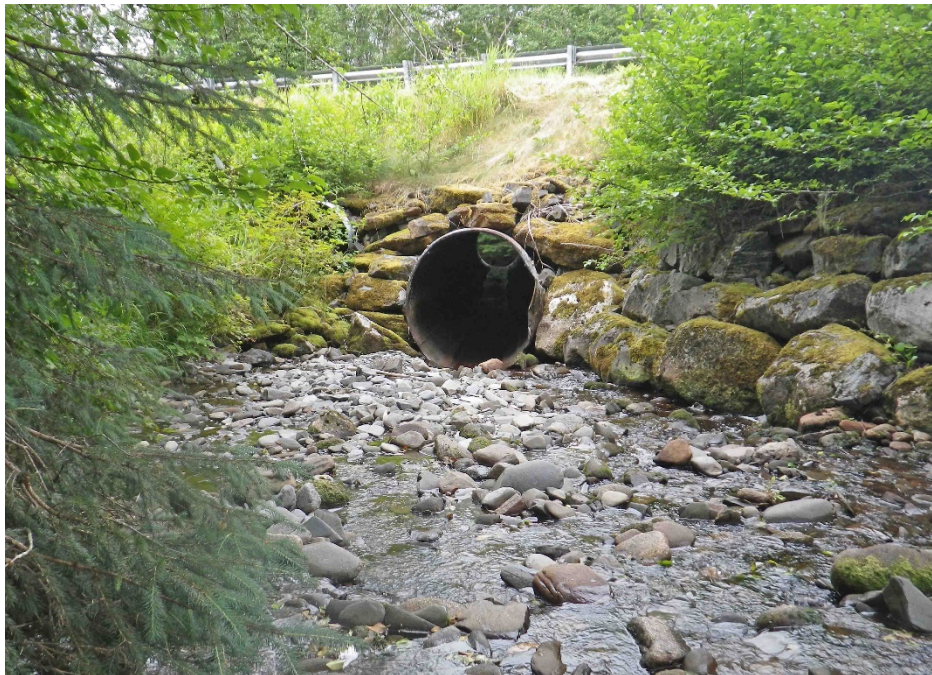
Figure 35.—Site 10203506, Zimovia Highway, unnamed stream, Wrangell, culvert inlet.
