PB90-916405  
NTSB/MAR-90/04

# NATIONAL TRANSPORTATION SAFETY BOARD

## MARINE ACCIDENT REPORT

GROUNDING OF  
THE U.S. TANKSHIP EXXON VALDEZ  
ON BLIGH REEF, PRINCE WILLIAM SOUND  
NEAR VALDEZ, ALASKA  
MARCH 24, 1989

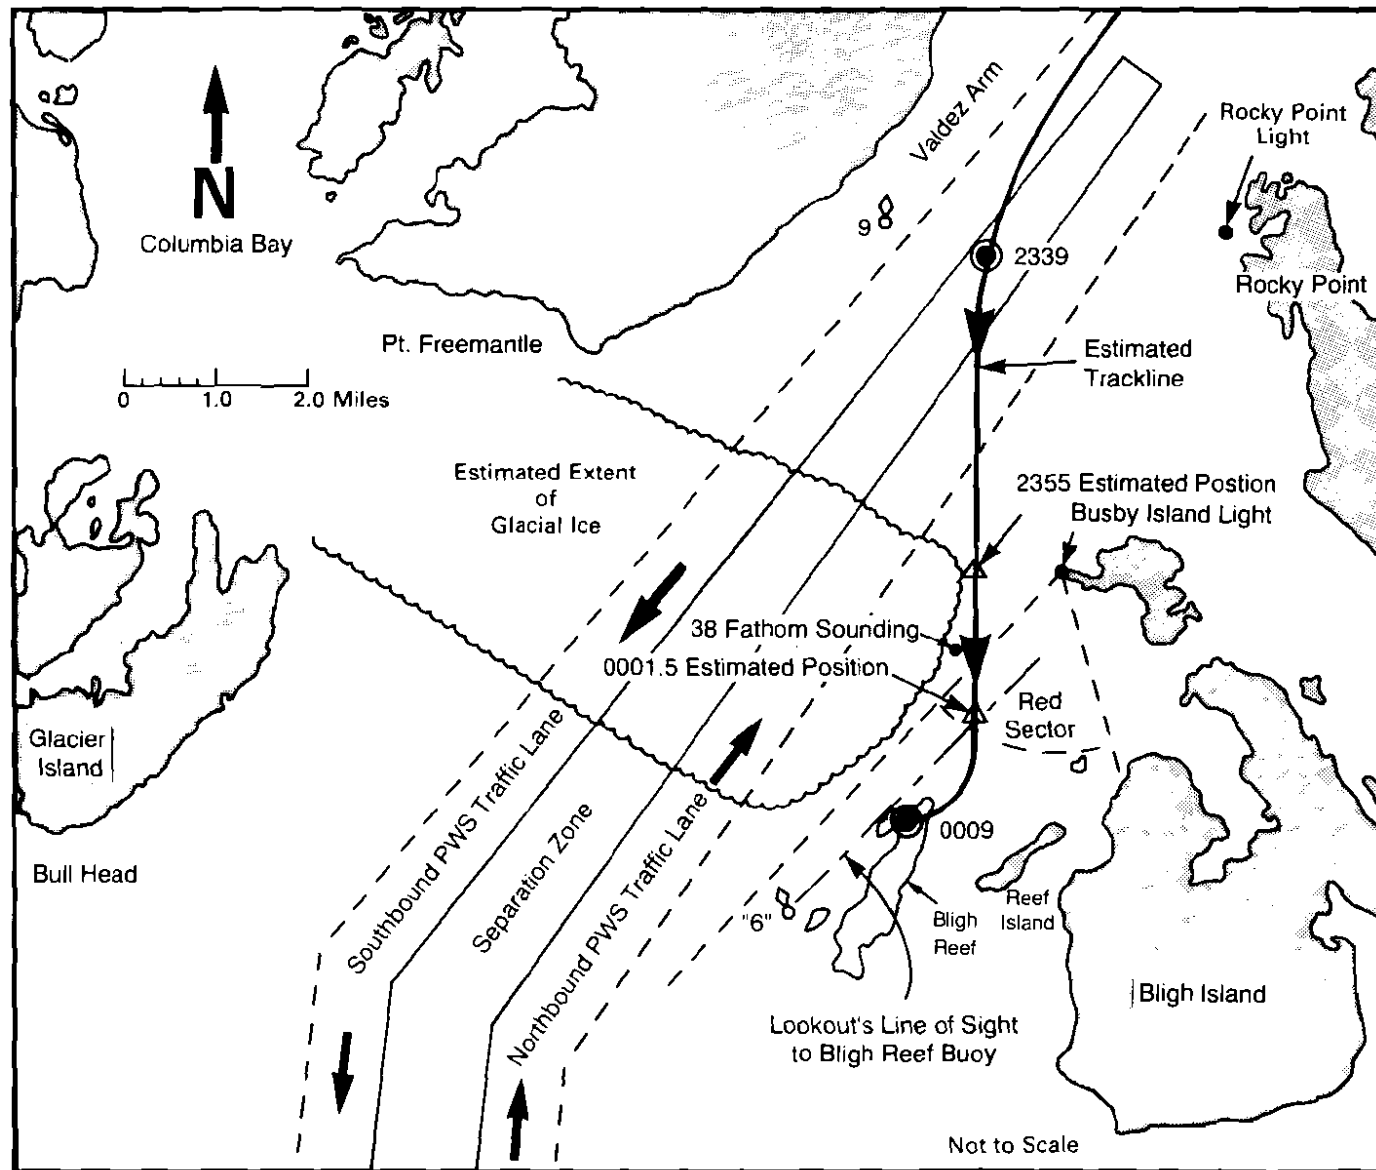
Figure 3.--Trackline of EXXON VALDEZ.

Light and Buoy No. 9 and a radar range to the land adjacent to Buoy No. 9. The third mate stated that the vessel was turning while he was taking the bearings. When plotted, his fix showed that the vessel's 2339 position was in the middle of the separation zone and approximately 2 miles west of Rocky Point Light. By about 2343, according to the course recorder, the vessel was steady on a course of 180°.

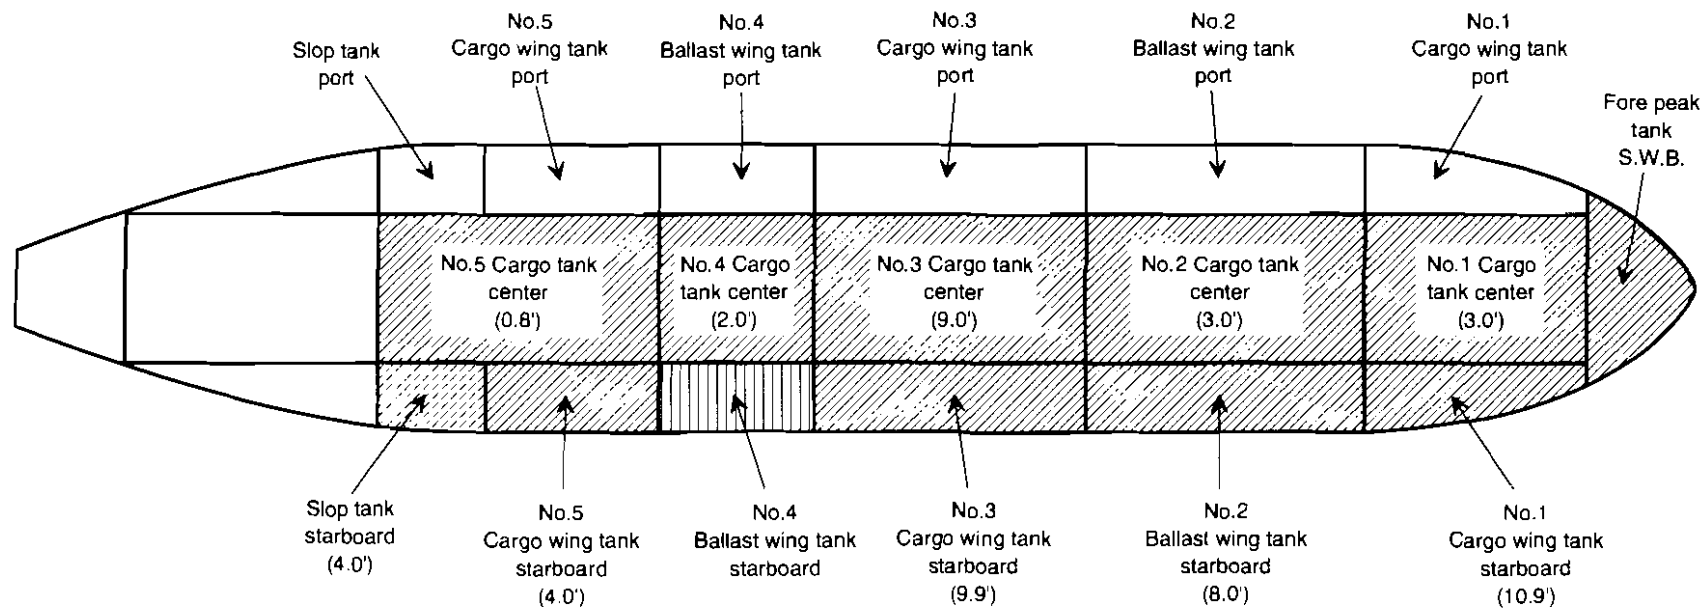
Figure 8.--Plan view showing damaged tanks.

An inspection of the vessel in drydock at the National Steel and Shipbuilding Company shipyard in San Diego was conducted on August 29, 30, and 31 and September 1, 1989. The inspection revealed that the forepeak tank was severely holed and that center cargo tanks Nos. 1, 2, 3, and 4 were ripped open over almost their entire lengths. Although holed, center cargo tank No. 5 sustained the least damage. Starboard cargo tanks Nos. 1, 3, and 5 also were severely holed, as was starboard ballast tank No. 2. Starboard ballast tank No. 4 sustained minor damage, resulting in a small opening at

the bottom of the forward bulkhead near the turn of the bilge caused by a separation of the bulkhead from the bottom plating. The void (double bottom) below the starboard slop tank was also ripped open. (See figure 8.)

The Safety Board found that the maximum vertical damage was 10.9 feet above the bottom of the vessel at two locations in the after half of starboard cargo tank No. 1. The most forward of the two locations was between frames Nos. 10 and 11, where a large boulder had lodged in the ship's hull structure, causing a longitudinal to break loose at frame No. 11 and curve upward to a height of 10.9 feet. The highest point of the boulder was about 8 feet. Upward bending and breaking of longitudinals near the after end of the tank between frames Nos. 12 and 13 resulted in the second 10.9 feet of vertical damage. In starboard ballast tank No. 2, frames Nos. 15 and 17 near the middle of the tank sustained deformation up to about 15 feet. There were two locations in the forward part of starboard cargo tank No. 3, between frames Nos. 23 and 24 and Nos. 24 and 25, where the vertical damage reached 9.9 feet. The maximum vertical damage in center cargo tank No. 3 was 9 feet in the forward part of the tank between frames Nos. 23 and 24 and Nos. 24 and 25. The vertical damage in the other cargo tanks ranged from less than 1 foot to 8 feet in a few locations.

The center vertical keel had broken loose from the after bulkhead of center cargo tank No. 2 from the tank bottom to a height of about 9 feet, and a small crack in the weld extended to a height of about 11 feet. On the other side of this bulkhead, which was the forward bulkhead of center cargo tank No. 3, the center vertical keel had broken loose from the bulkhead from the tank bottom to a height of about 9 feet.

There was no damage to the port tanks and except for the after part of the void under the starboard slop tank, which is outboard of the pumproom, all damage occurred forward of the pumproom.

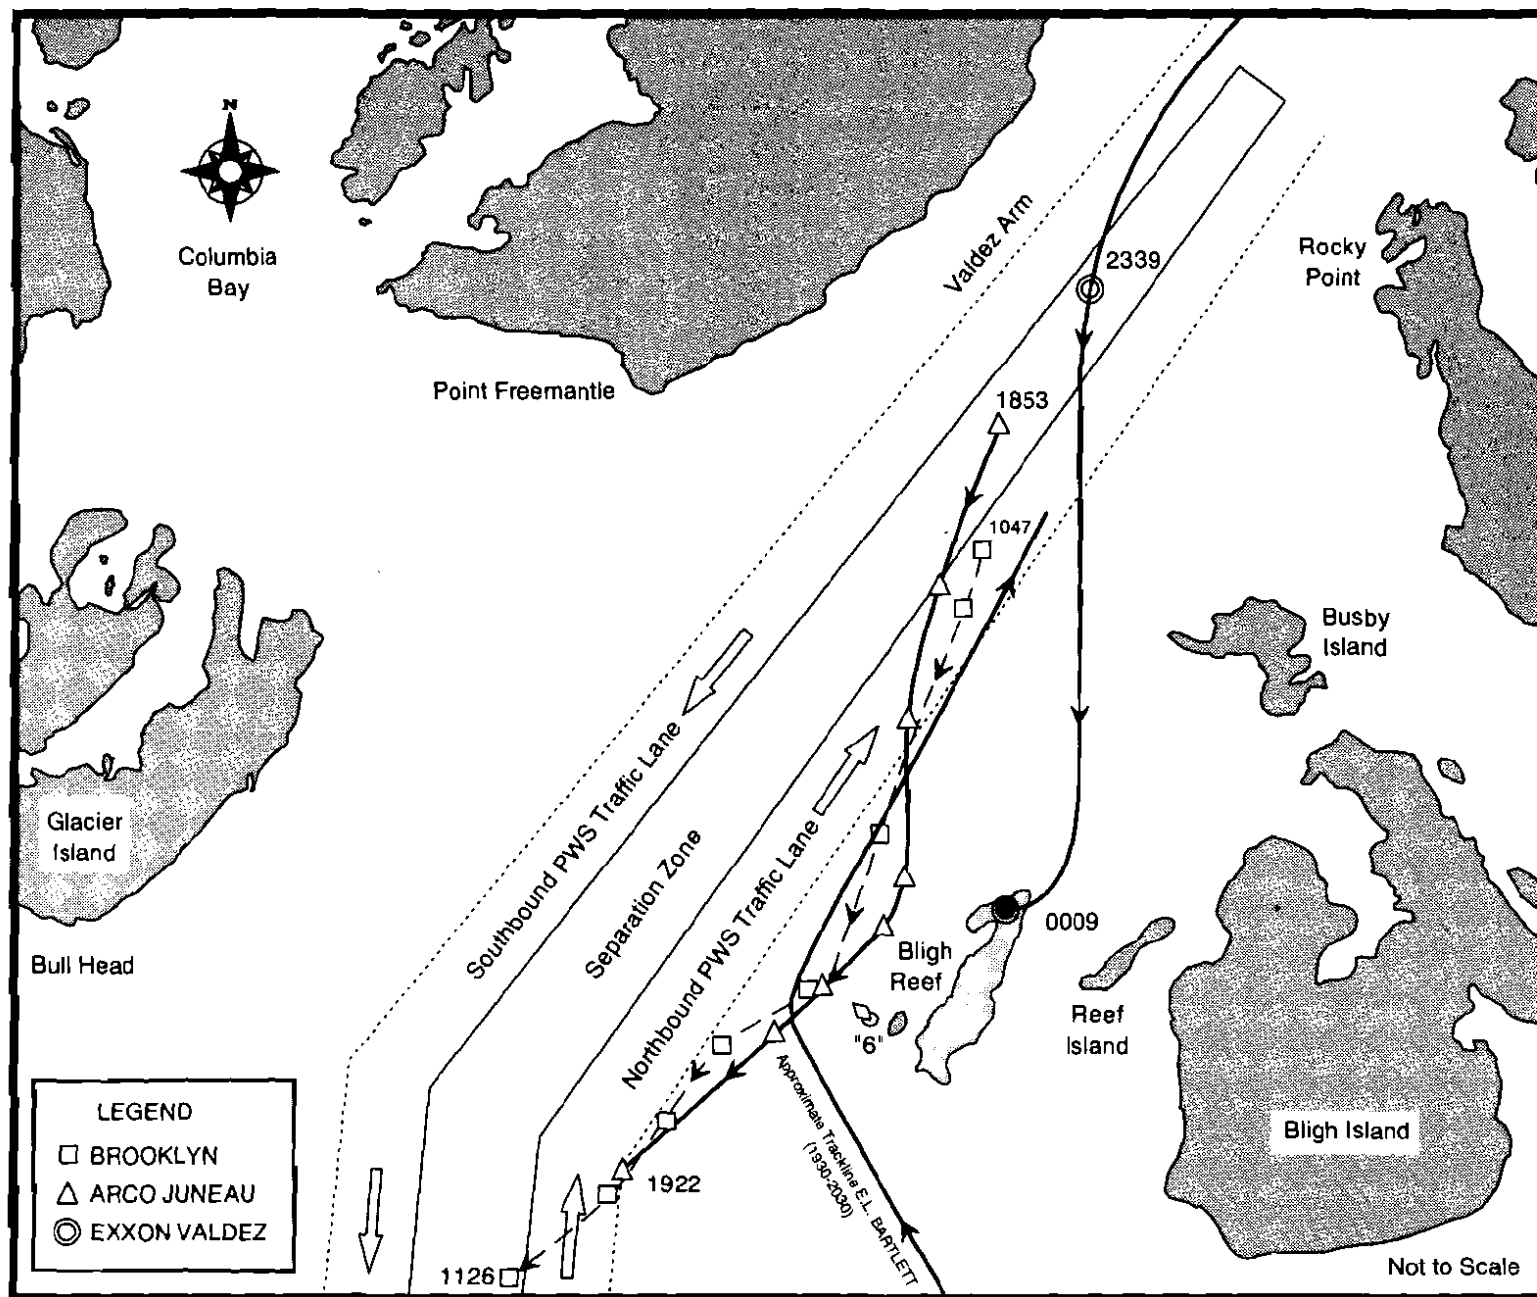
Figure 9.--Vessels departing the TSS.

(about 2,400 feet) west of Bligh Reef buoy before returning to the TSS about 1922.
