***Denali Mine On Valdez  
Creek, South Central Alaska:  
A Cultural Resources Evaluation***

by Beth E. Walton  
Cheryl A. McCaffrey

Bureau of Land Management  
Alaska

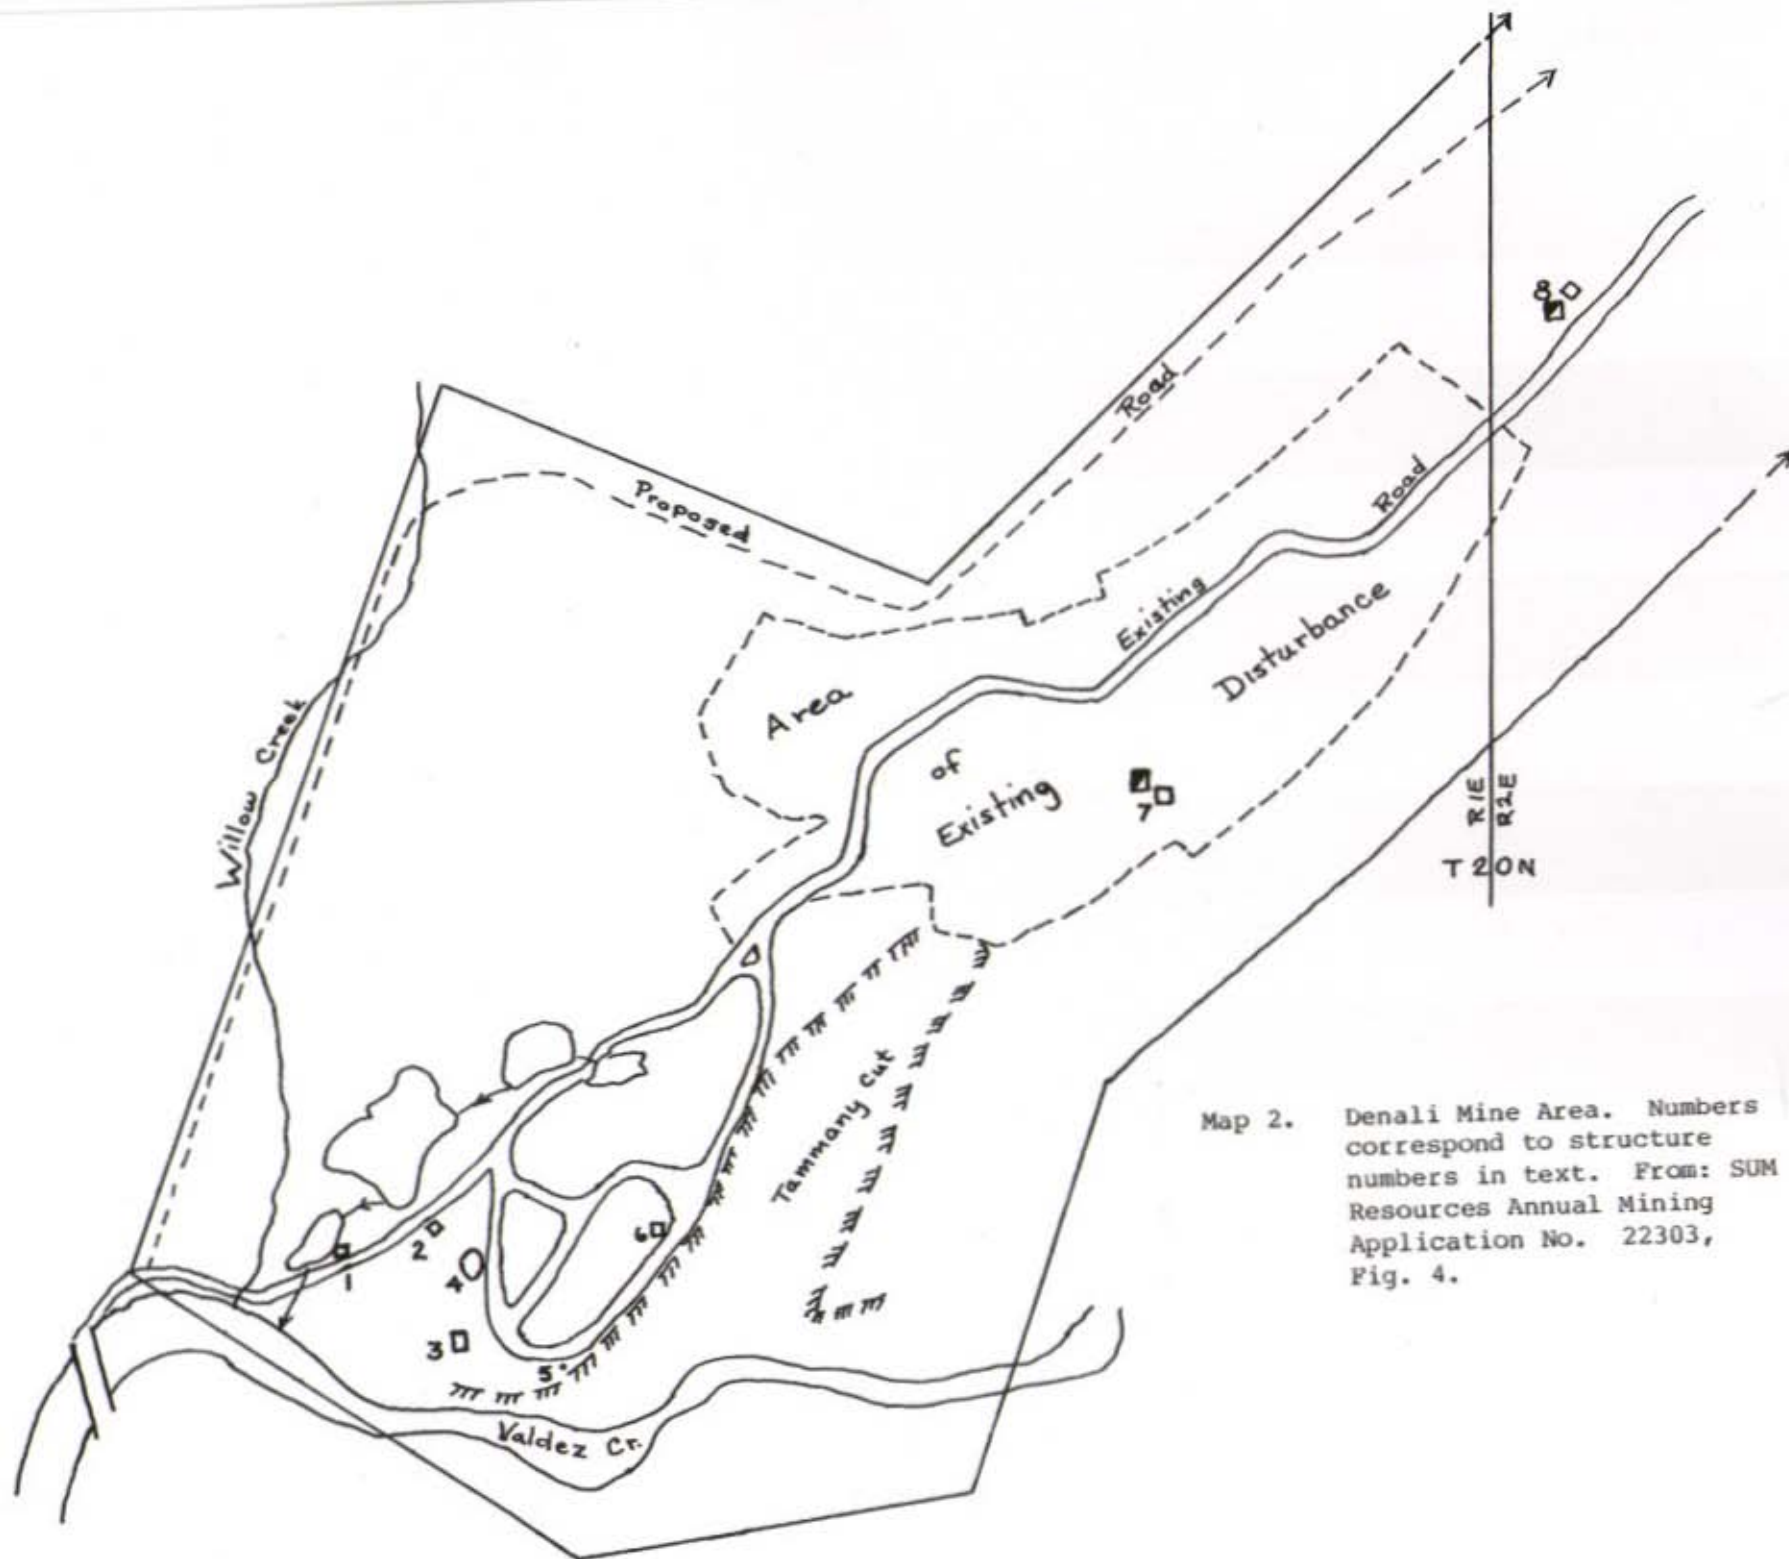
As shown on Map 2 and numbered as below, the remains consist of:

- 1 Cabin ruin: logs, trash, broken bottles, broken china and a wood stove. The structure is completely destroyed.
- 2 Dog kennels: four simple sloped roof structures remain. All are in poor (unusable) condition.
- 3 Graves: white picket fences about 8' long, 5' wide and 4' high surround each of two graves. Both graves are in good condition. Fences are made of 4x4 corners and 2x4 rails with 4x1/4 pickets. The east grave is identified by a horizontal, bronze(?) plaque (approximately 12" x 8") that reads

The west grave is marked by a smooth round-top wooden slab headstone. No lettering or paint is visible. The area enclosed by the fence and the size of the headstone are typical of an adult burial (graves and headstones for children are usually smaller than for adults). This is probably the grave of Joe Polken, ". . .killed in a hydraulic accident in 1922, . . .and the third for a Coffield child (1964-65)." (Dessauer and Harvey 1980, 94). No trace was found of this third grave. Both graves are in good condition.

- 4 Sled dump: The remains of sleds used to haul in supplies are primarily of running gear; no beds were observed. Tundra vegetation has obscured many pieces. There are likely more than ten and fewer than thirty pieces.
- 5 Three-hole Privy: This 9' x 6' shiplap plank structure is still in occasional use. The roof is gabled and there are 1 x 8" cornercaps. The interior has two partitions for semiprivacy of multiple occupants.
- 6 Superintendent's house: The roof and east wall of this three-room log cabin have fallen in. Dessauer and Harvey (1980: 89, 98-99) noted that this structure was partially collapsed in 1977. Observations in 1984 are at variance with the details given in their 1980 report, particularly in the floor plan (compare Fig. 1, p. 4 with Dessauer and Harvey, Fig. 5).

- 7 Shack at Shaft No 1: This single room structure is 14' x 10'. The entry is in the west side of the south wall as is one 3/3 casement window. The exterior saltbox shape is modified to a gabled ceiling on the interior. The exterior planks were covered by tar paper and battened. The roof is corrugated tin. The three board door is locked with a new looking padlock.

- 8 Shack at Shaft No 3: This board and batten one room structure measures 10'x10'. The entry is in the middle of the south wall. There is a 2/2 sliding casement window slightly south of center in the west wall. The interior has a table on the west wall and an open overhead rack in the northeast corner.

Based on the plan of operation and discussion with the mine operator, the operations will not disturb the graves, kennels, sled dump, superintendent's house, or privy. The cabin ruin between the access road and proposed settling pond #4 may be disturbed or may sluff down; since this structure is ruined, further disturbance is inconsequential. The shack at Shaft No. 1 may be disturbed in overburden removal. The shack at Shaft No. 3 is not in this year's plan area but may be disturbed in a future year. Although in good condition, these structures lack association with to the historic (1903-1930) period or with known persons and their disturbance would be inconsequential. Measurements taken in this survey will serve to document their structural characteristics.

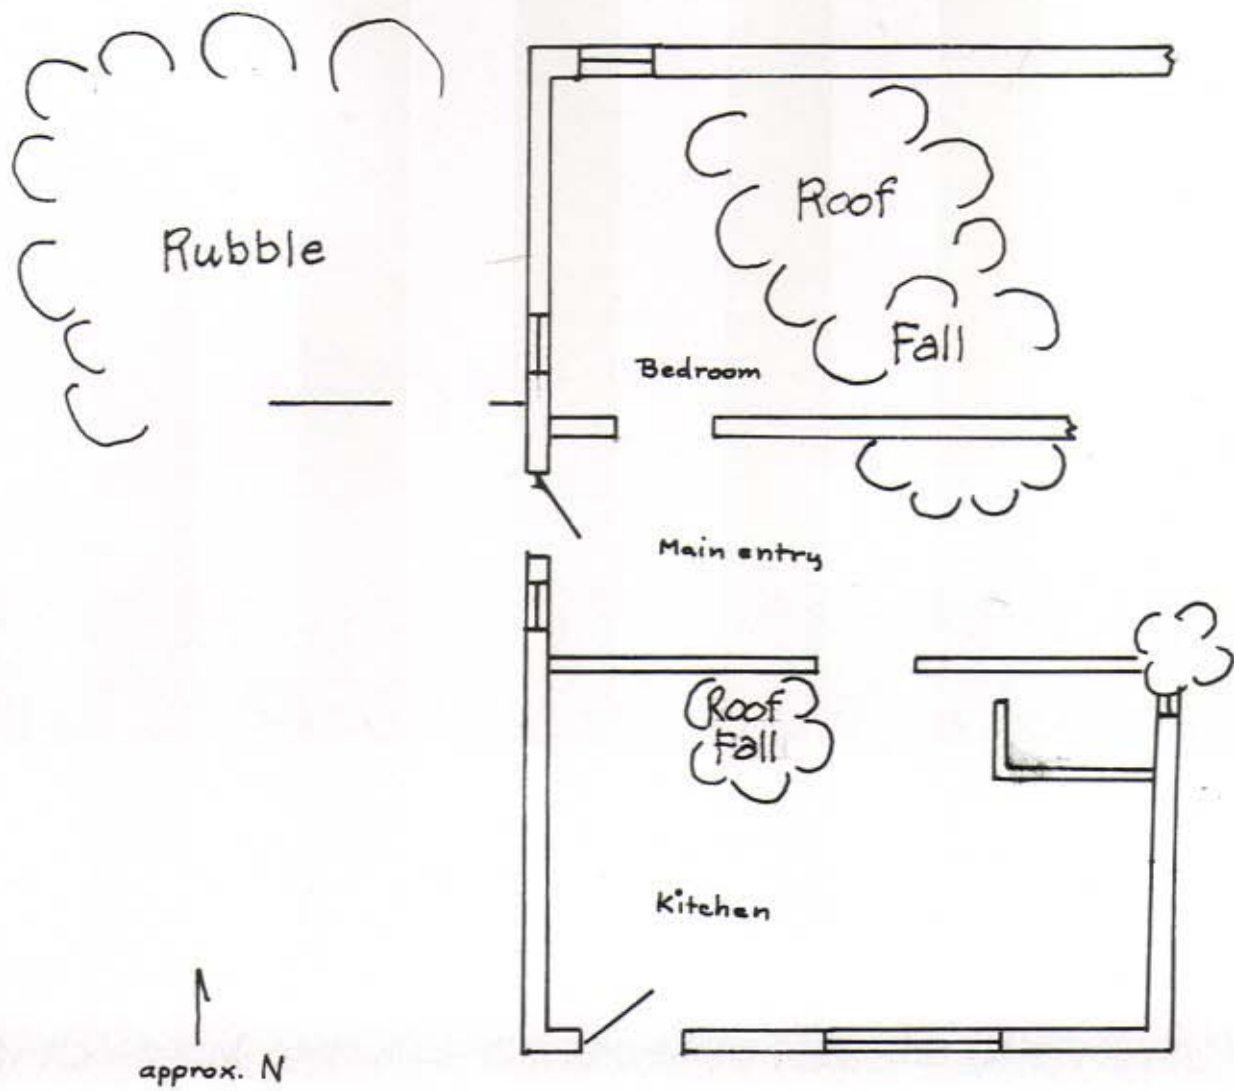
Fig. 1. Superintendent's House

Exterior: walls are log (approximately 8" diameter) chinked with sphagnum and burlap. Sawdust was used as insulation in the ceiling. On the east side, vertical bark slabs close the space between the bottom log and the present ground surface.

Interior: Exterior logs were smoothed on the interior side. The interior floor space (Fig. 1) was divided into three rooms and a small walk-in pantry. Walls and ceiling were covered with canvas tarps. This, in turn, was overlain with patterned oilcloth on some ceilings and, at least in the main entry area, a wainscot of brown burlap. Windows and doorways had cornice treatments (Fig. 2).

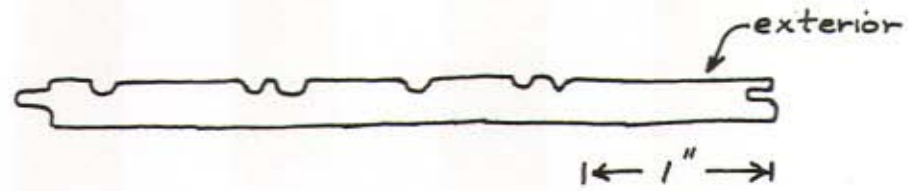
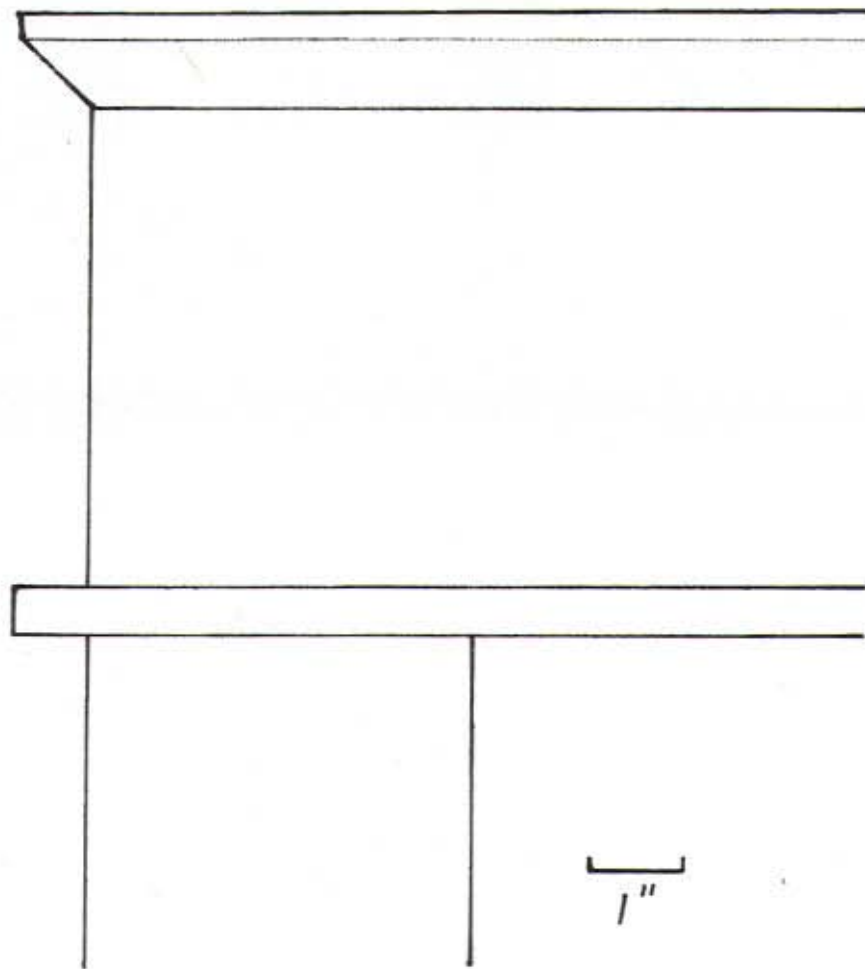
Fig 2 Details Superintendent's house

The main entry, a four horizontal over two vertical panel door, is nearly centered in the west wall of the structure. A second (kitchen) entry is in the south wall. This door is Z-braced, patterned tongue-and-groove (Fig. 2). There is one long 4/4 fixed window in the south wall. In the west, there is a 2/2 window beside the main entry door and a 2/2 window near the south corner of the bedroom. The standing remnant of the east wall has a small 2/2 window. The north wall has a 2/2 window near the west corner. All these windows are double hung. All remaining exterior frames are simple 1x6 casement painted a deep amber yellow.

X-Section of typical plank, south entry door

Cornice treatment for windows and doors (interior)
