ROAD CONDITION SURVEY FOR THE FOREST ROAD SYSTEM IN THE KENAI PENINSULA BOROUGH

PREPARED FOR: The Alaska Sustainable Salmon Fund (AKSSF)

DATE OF REPORT: March 1, 2015

PREPARED BY: Joel Nudelman, Forest Practices/Resource Forester, Alaska Department of Natural Resources Division of Forestry, Juneau, AK (907) 465-5406

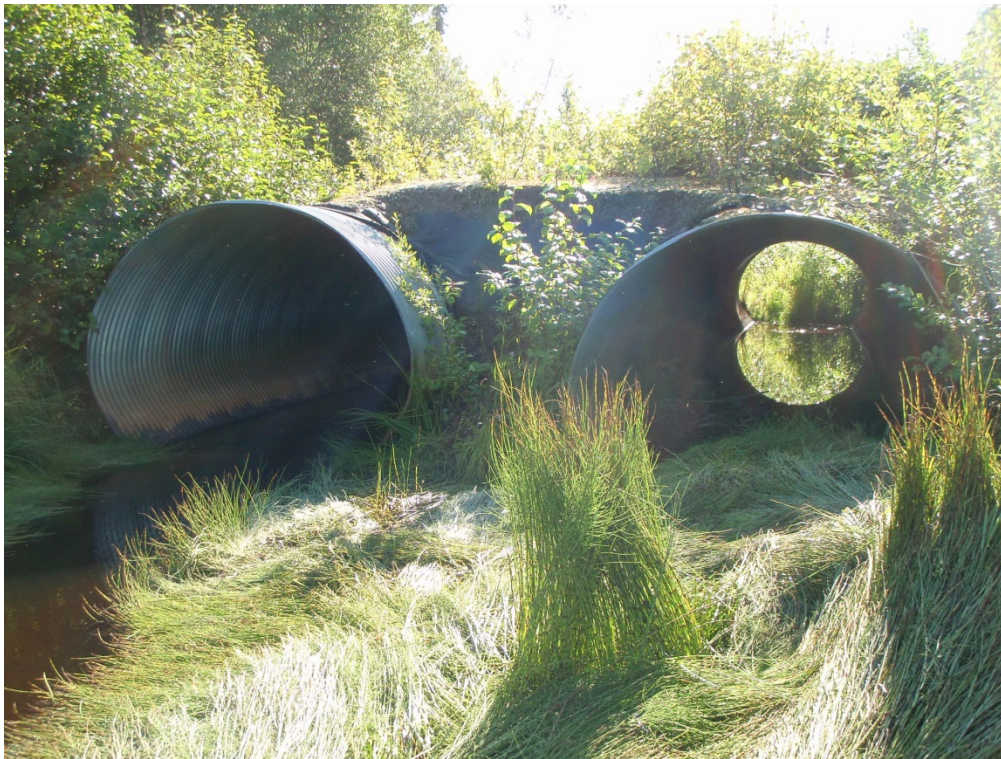
Most road surfaces were in excellent shape, with regular maintenance taking place. Much of the road system had an adequate number of drainage structures and water moved quickly off the roads after rain events. Some of the lower ratings were related to culvert sizing, where pipes were narrower than bed width. Also, the BMP related to a culvert's ability to withstand a 25 year storm event caused some lower ratings. Additionally some lower ratings were noted on the BMP related to perched culverts on fish bearing waters. The BMP's for culvert perch was discussed in the fish culvert section. The remaining BMP scores showed full implementation or close to full implementation (ratings of 3 or 4). The overall BMP rating average for MHT ownership was 3.46 (out of 4). The average on Municipal roads, which belong to the SOA at the time of construction, was 2.5. The Native corporation road system had an average rating of 3.22 while the SOA's was 3.14.

Figure 13. Twin culverts with a rating of 4, Tyonek.
