# SVALBARD AIRPORT GEOTECHNICAL STUDY: ENGINEERING METHODOLOGY AND RESULTS

Truls Mølmann<sup>1</sup>, Bjarne Bergheim<sup>2</sup>, Mark Valeriote<sup>3</sup>

## Abstract

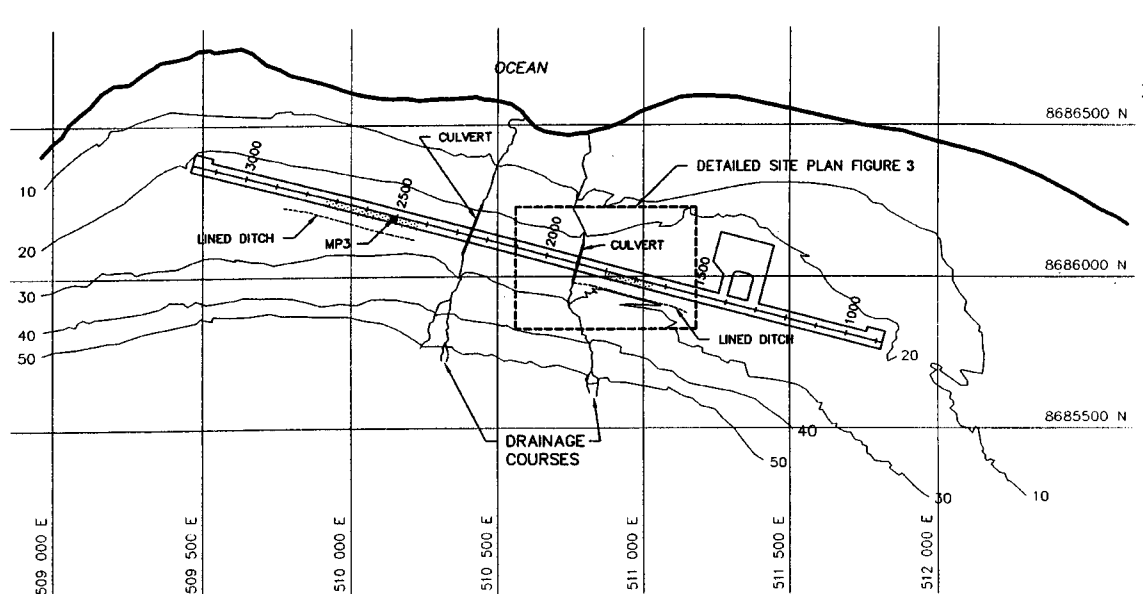
Figure 2. Svalbard Airport Site Plan.

Svalbard Airport is located a short distance northwest of Longyearbyen. The paved runway lies on a relatively flat coastal plain in an east-west direction (Figure 2). Isfjorden (ocean) is located immediately north of the runway, while south of the runway, steeply sloping foothills rise to an upland plateau known as Platåberget. These hills provide a source of surface and groundwater flow towards the runway. This water is channeled into two major drainage courses that cross beneath the runway through corrugated steel culverts. Cut-off ditches have been constructed on the uphill side of the runway to intercept runoff from the slope.

problem areas in 1989: Stations 1700 and 2500 (Figure 2). Other mitigation measures used by Luftfartsverket include the construction of cut-off ditches on the uphill side of the runway.

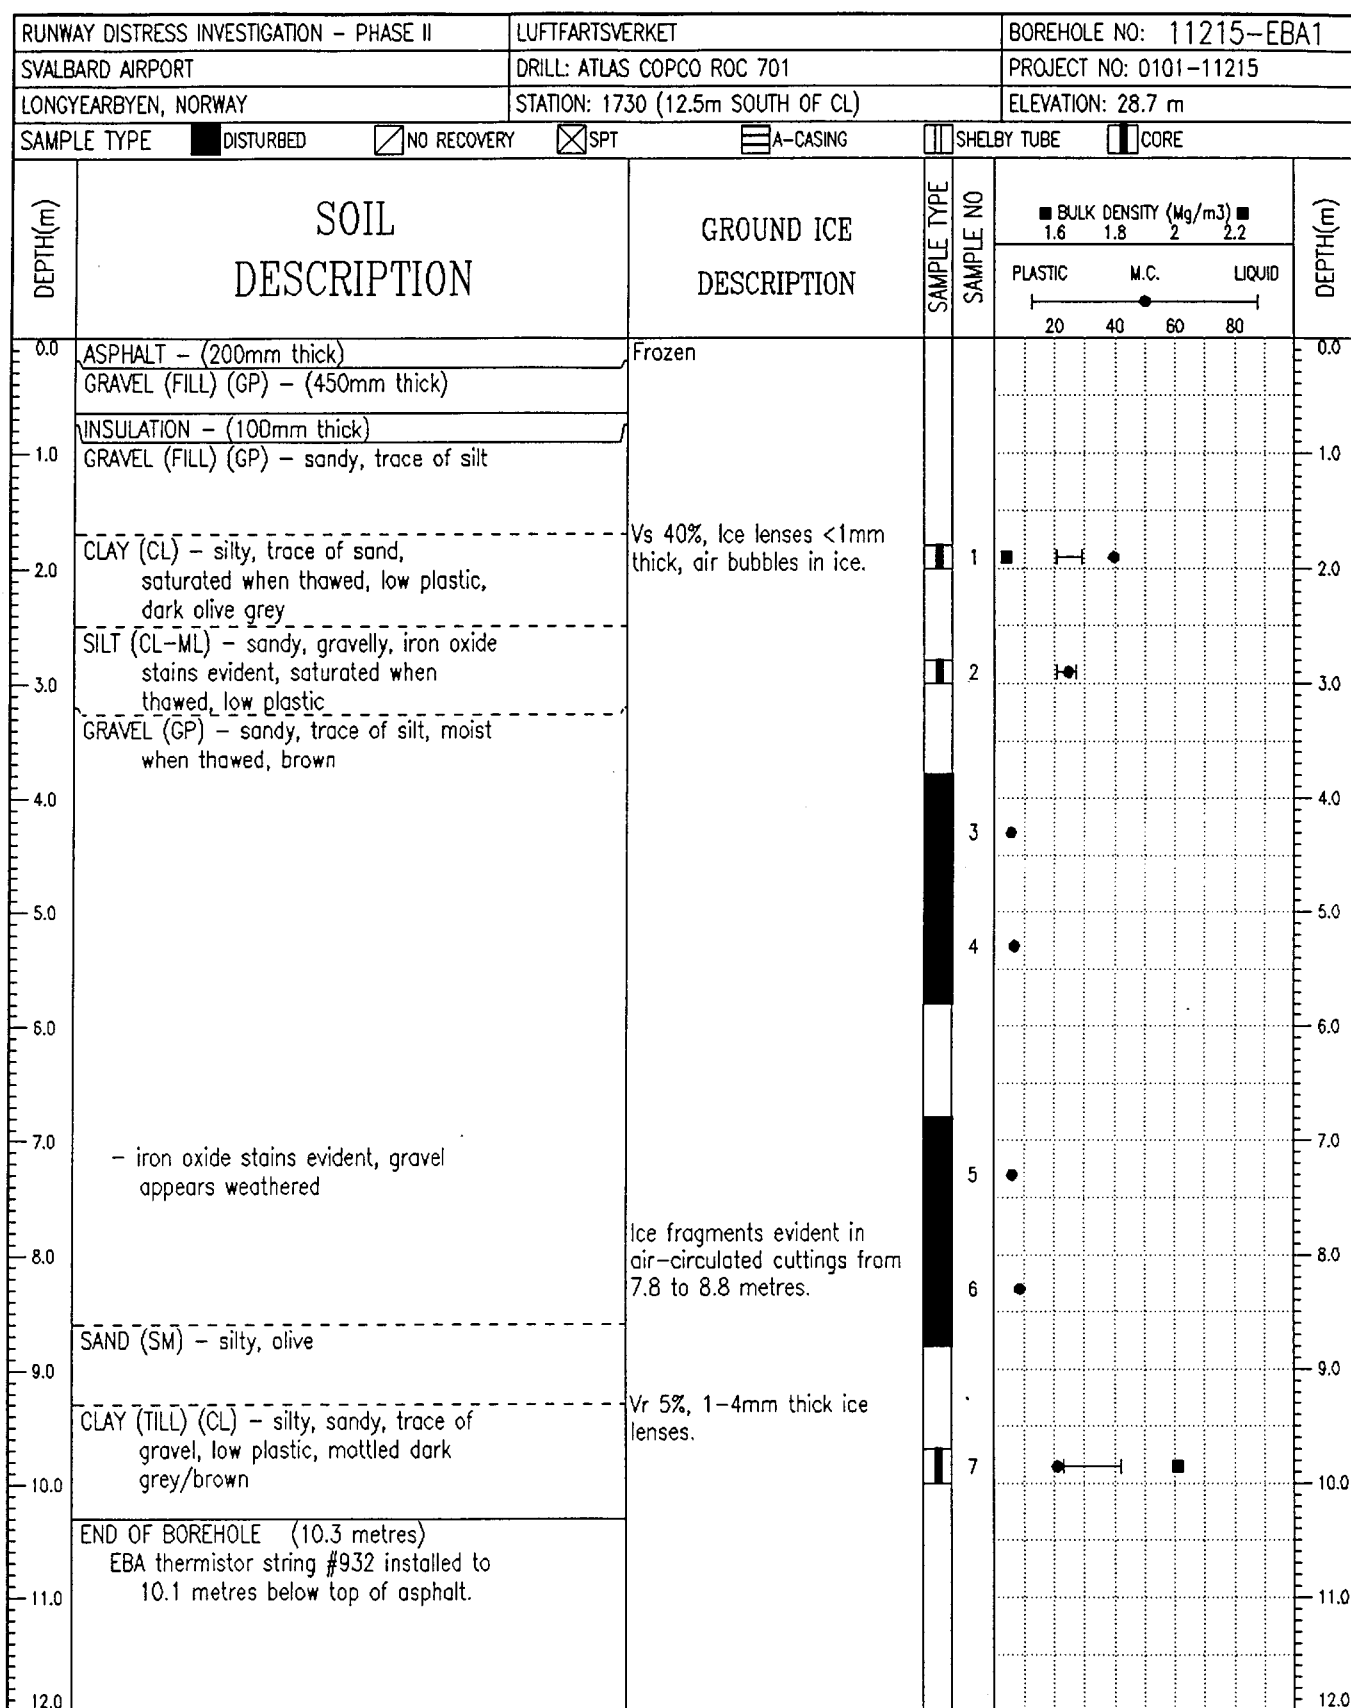
Figure 4. Borehole Log EBA1.

The soil condition below the runway surface are known to be highly variable. Borehole logs for EBA1 and EBA2 are shown in Figures 4 and 5.

Both EBA1 and EBA2 were characterized by asphalt that varied from 220 mm to about 350 mm in thickness. This is significantly greater than the initial construction thickness of 60 mm and is a result of the numerous asphalt overlays that have taken place over the years.

A 1.7 m layer of granular fill was observed underneath the paved runway in Borehole EBA1. Extruded polystyrene insulation (100 mm thick) was encountered at 0.65 m below the asphalt surface. The granular fill overlays a 0.7 m layer of ice-rich silty clay, which in turn overlays a 0.7 m layer of silt. The silt is underlain by gravel.

Ice lenses typified the clay stratum observed below the gravel fill. Ground ice is present in the form of thin stratified, segregated ice lenses. As much as 40% of the core volume recorded is present as ground ice. The clay is considered silty and of low plasticity (CL).

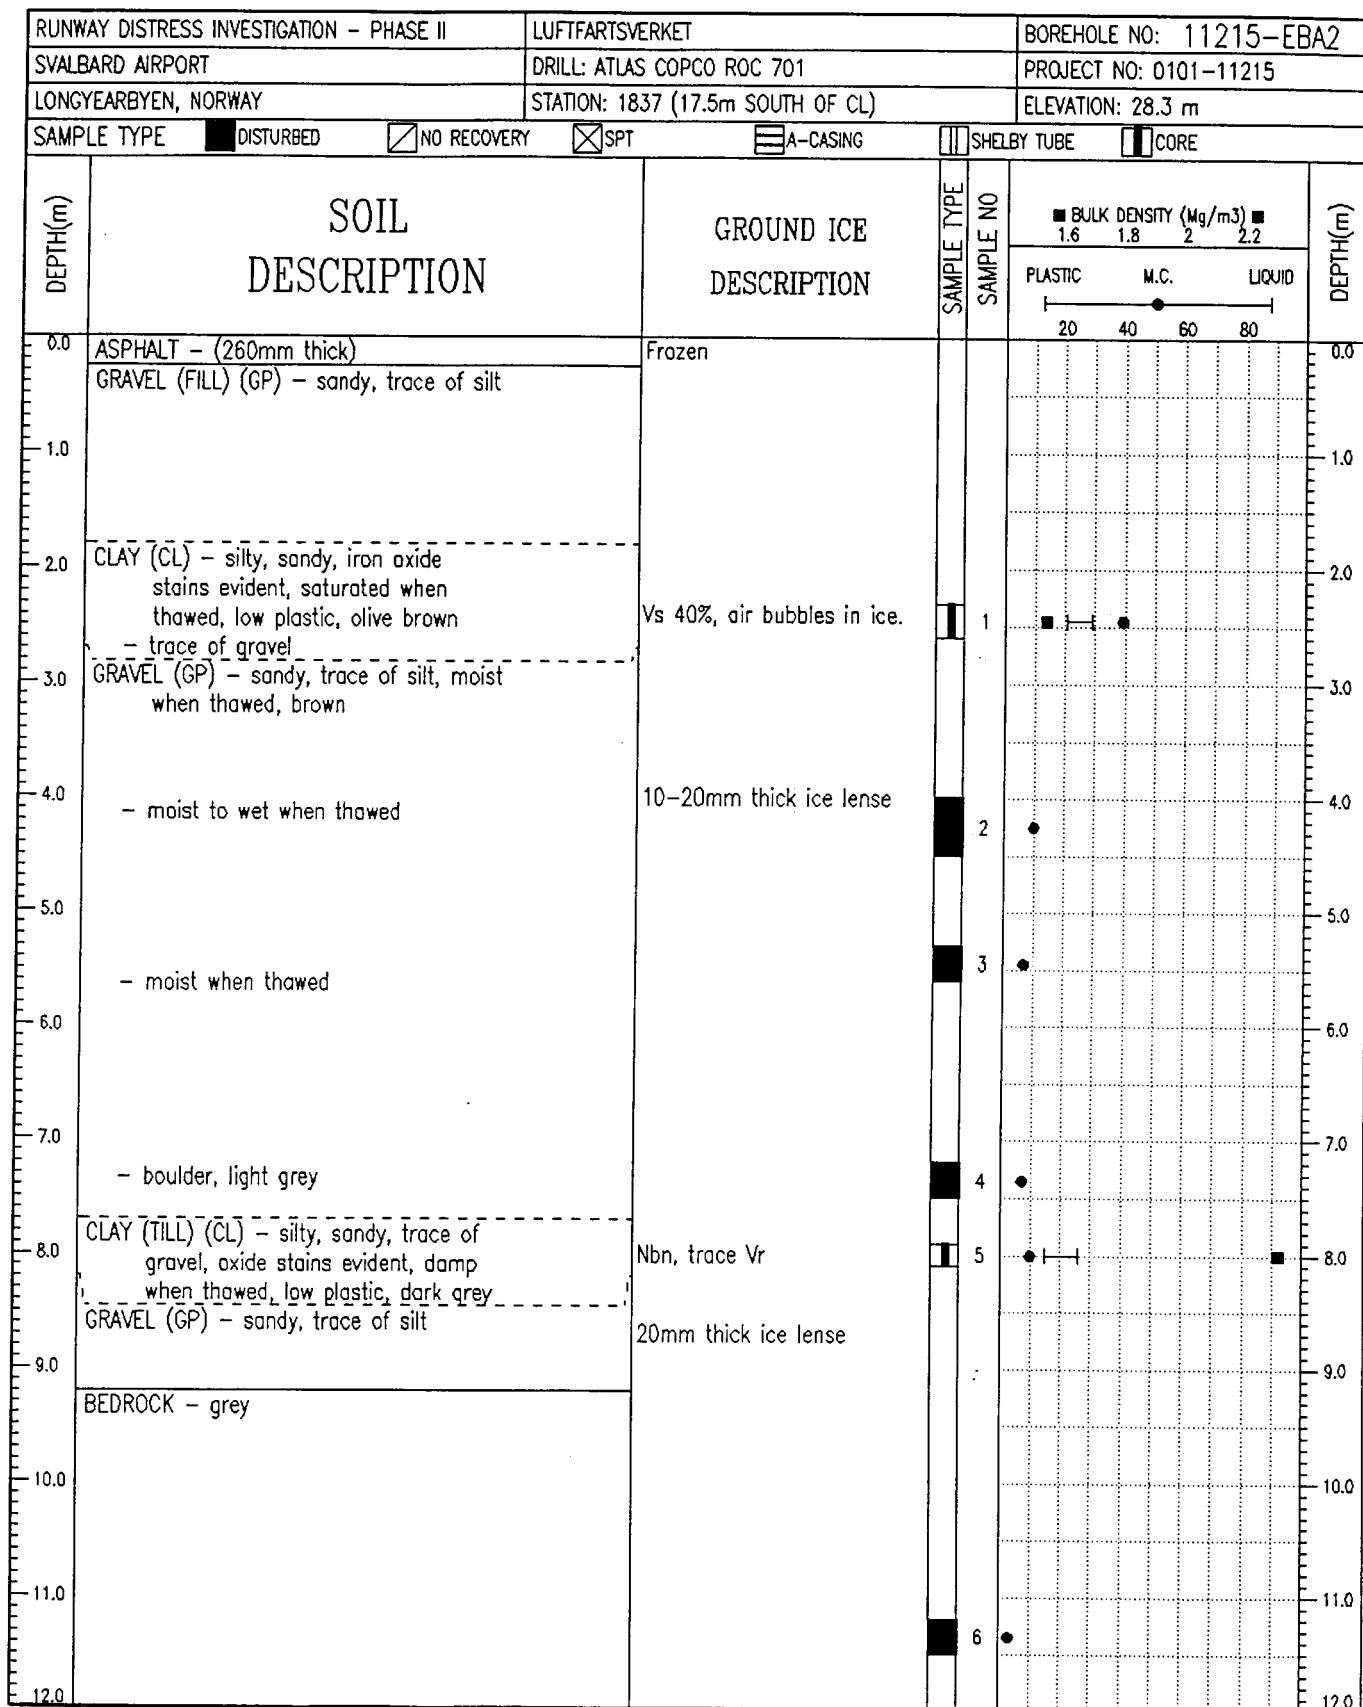
Figure 5. Borehole Log EBA2.

The conditions for Borehole EBA2 were quite similar to that of EBA1. In the case of EBA2, granular material was observed to 1.8 m below the asphalt. The gravel is followed by 0.9 m of ice-rich silty clay, which is underlain by gravel.

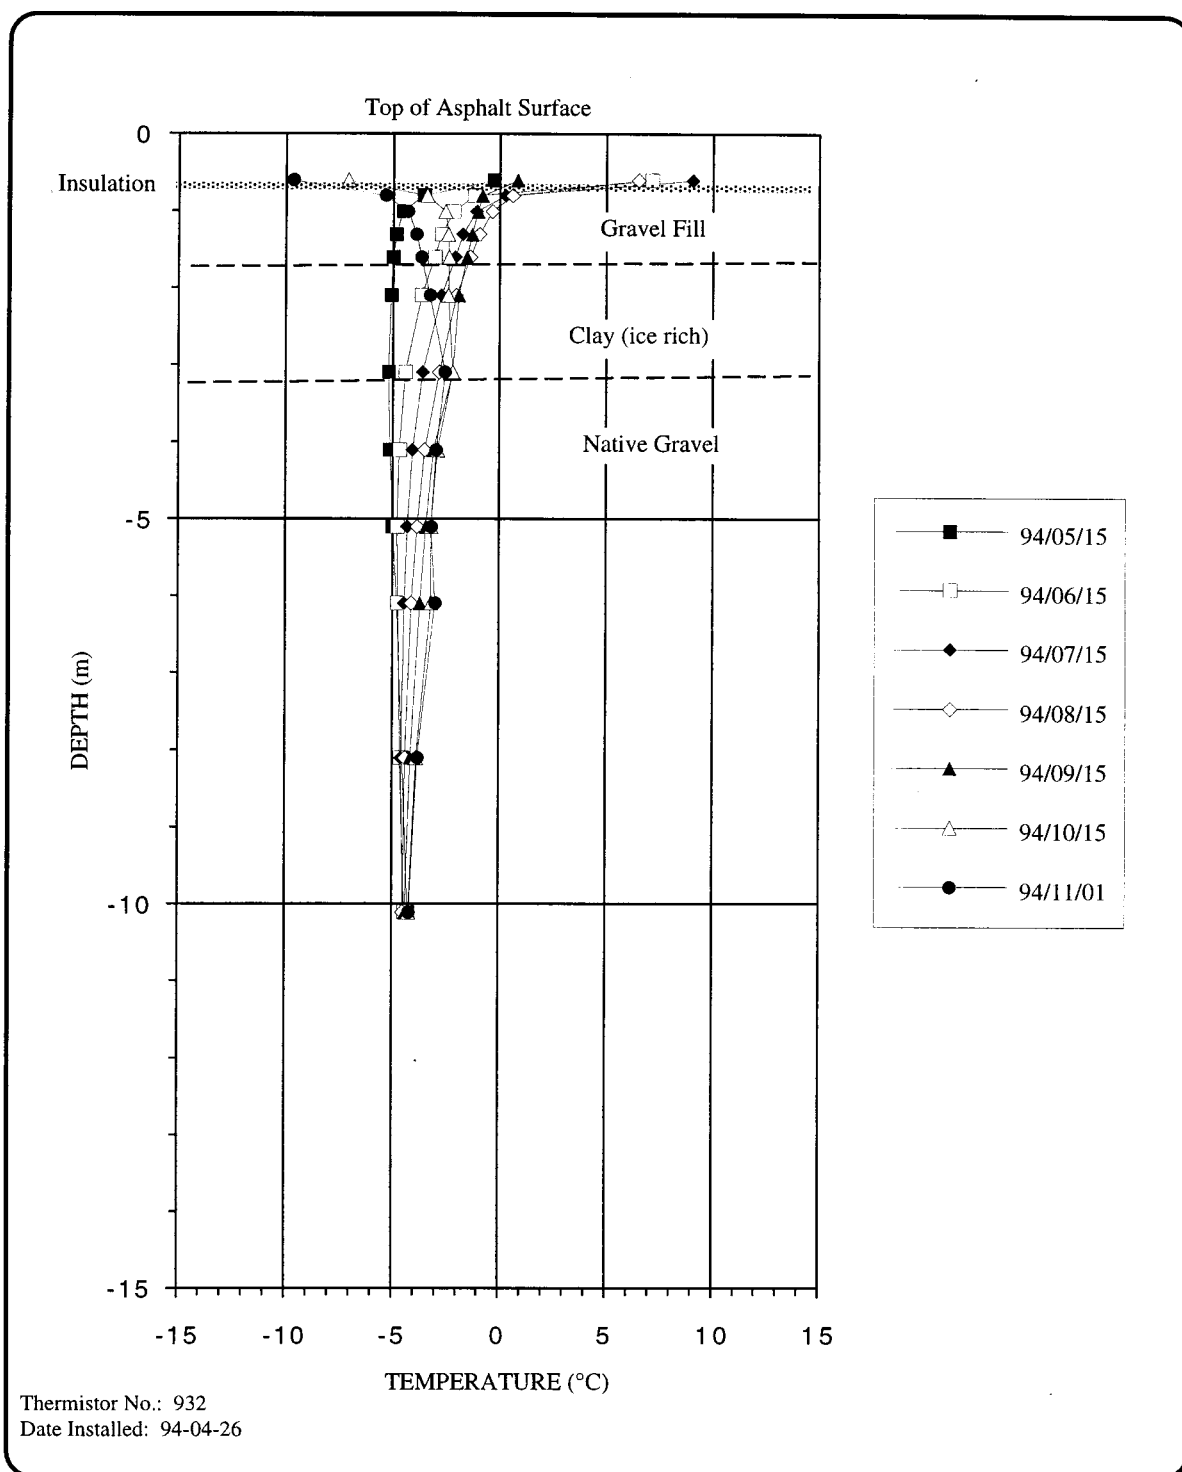
Figure 6. Ground Temperature Profile (EBA1).

Ground temperature data have been downloaded every 3 to 5 months since the dataloggers were installed on April 28, 1994. Ground temperature profiles for EBA1 and EBA2, as used in the analysis conducted in 1994, are shown in Figures 6 and 7.

The presence of the insulation in the vicinity of EBA1 results in a quite different temperature profile in comparison to EBA2. The maximum annual thaw front in the insulated area extends to just below the insulation and therefore does not reach the ice-rich silty clay located at 1.8 m depth. The insulation installed is performing well. This is readily apparent when comparing the settlement that has occurred in the insulated and non-insulated areas.

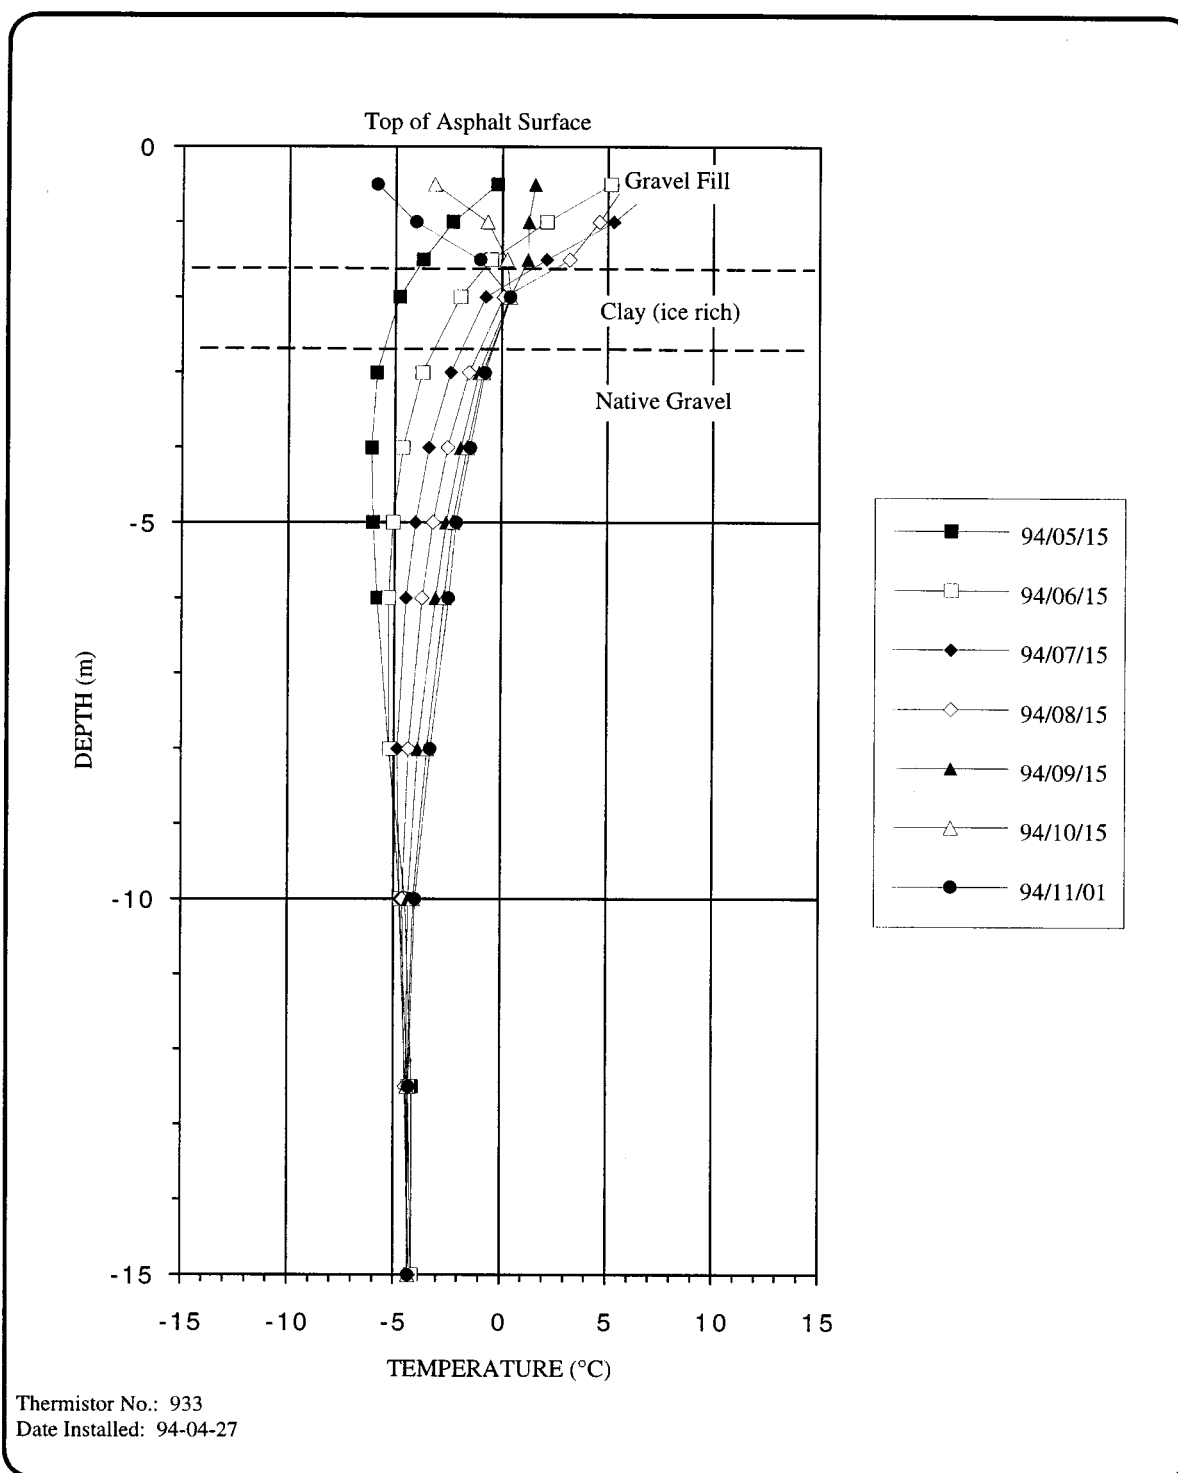
Figure 7. Ground Temperature Profile (EBA2).

The seasonal thaw front in the non-insulated area extends to 2.5 m, well beyond the surface of the ice-rich soils found at 1.8 m depth. The site investigation and temperature measurements obtained show that runway settlement is due to thawing of the ice-rich soils.

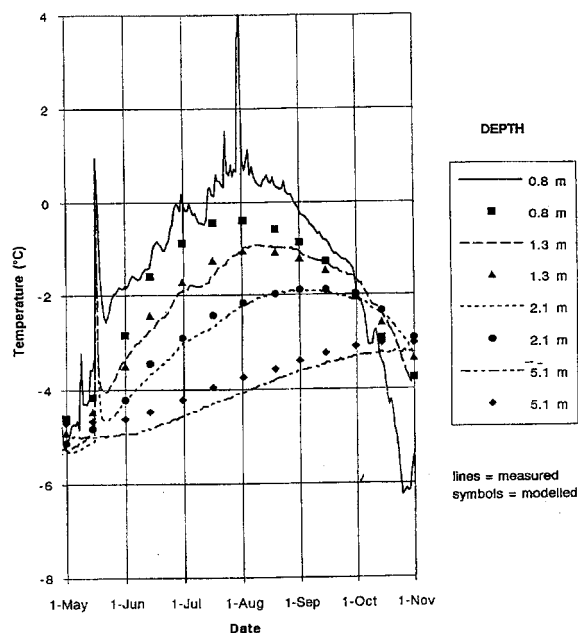
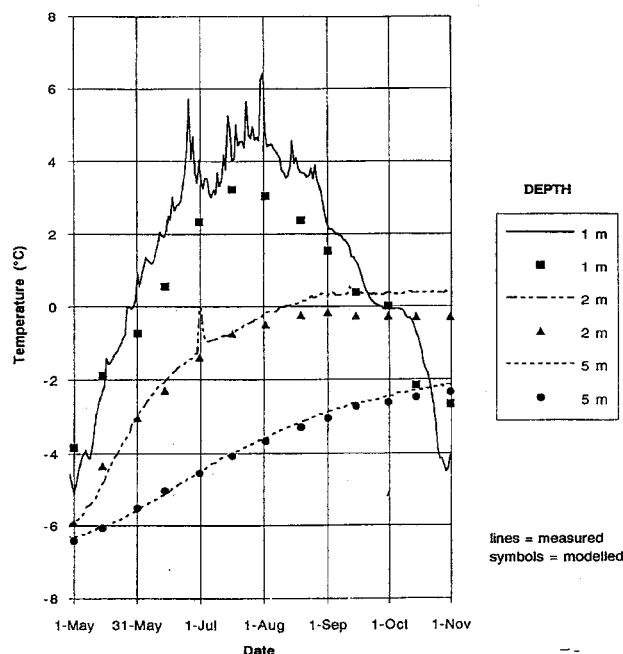
Figures 8 and 9 illustrate that the predicted ground temperatures are within 0.5°C of the measured values. Thaw depths predicted by the model are 0.2 m and 0.4 m less than the measured depths at EBA1 and EBA2, respectively. The lesser predicted thaw depths than those measured can be partially explained by the fact that the finite element program does not model the progressive thaw-settlement and consolidation of the soil which results in a downward movement of the upper soil surface on which the boundary conditions are applied. In addition the resulting change of the thermal properties as the soil consolidates are not taken into account by the thermal model.

The agreement between the predicted and measured ground temperatures indicate to the authors that the conductive heat transfer model was appropriate to explain the observed behaviour, and that water flow beneath the runway did not provide a significant contribution to the thawing process.
