A RECONNAISSANCE OF TRACTOR TRAILS AND RELATED PHENOMENA ON THE NORTH SLOPE OF ALASKA

JEROME R. HOK

1969

U.S. DEPARTMENT OF THE INTERIOR
BUREAU OF LAND MANAGEMENT

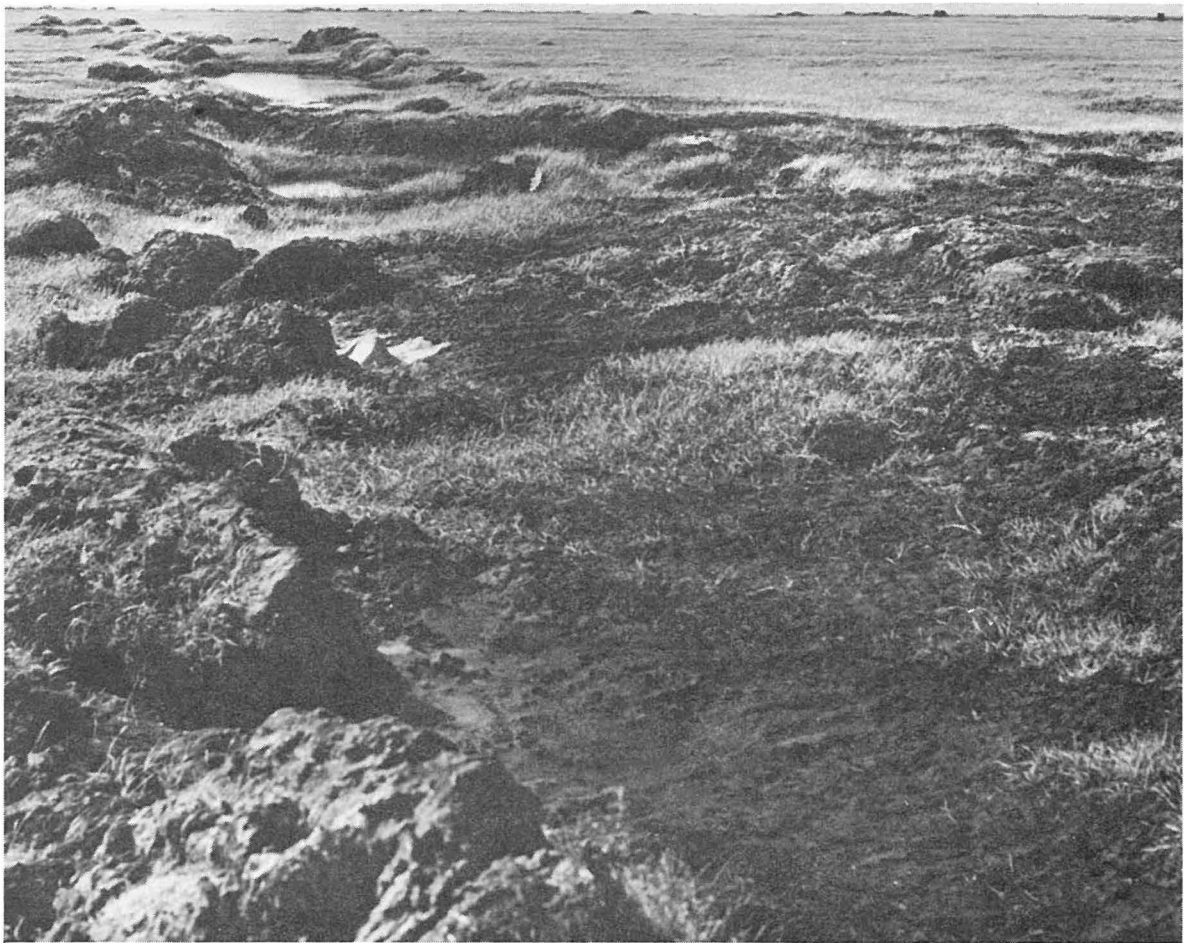
Photo 1: A bladed summer trail with distinct berm of sod and vegetation (Cape Simpson).

the trail were formed by two conspicuous berms consisting of a peeled-back layer of sod and old vegetation (photo 1), the trail was usually considered to have been made by down-blading to frozen ground during the summer. On the other hand, if no appreciable berm was present, or if an existing berm contained little or no sod and peat (photo 2), it was usually assumed that the disturbance was made during the winter when the active layer was frozen.

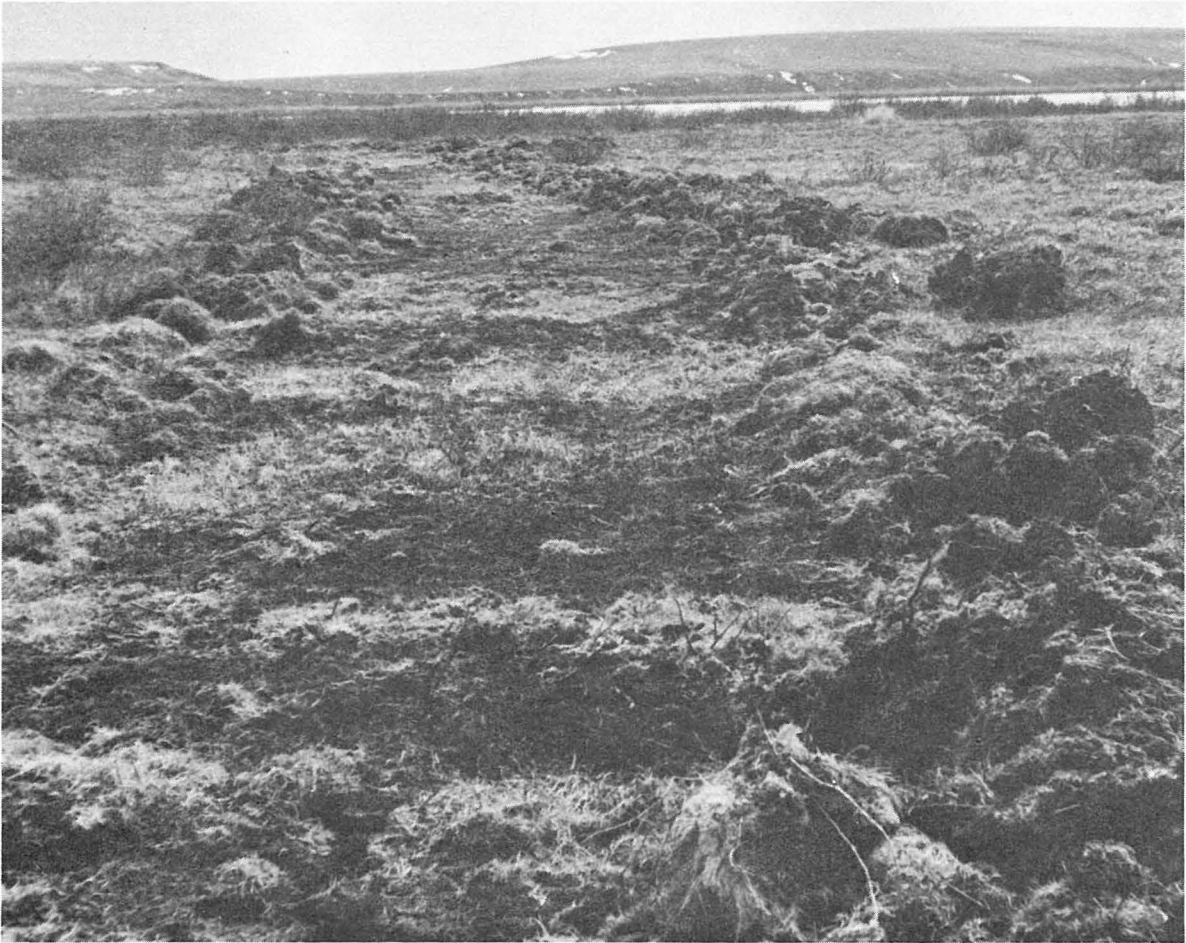
Photo 2: A recent winter trail with berm of vegetation only and little surface disturbance (Umiat).

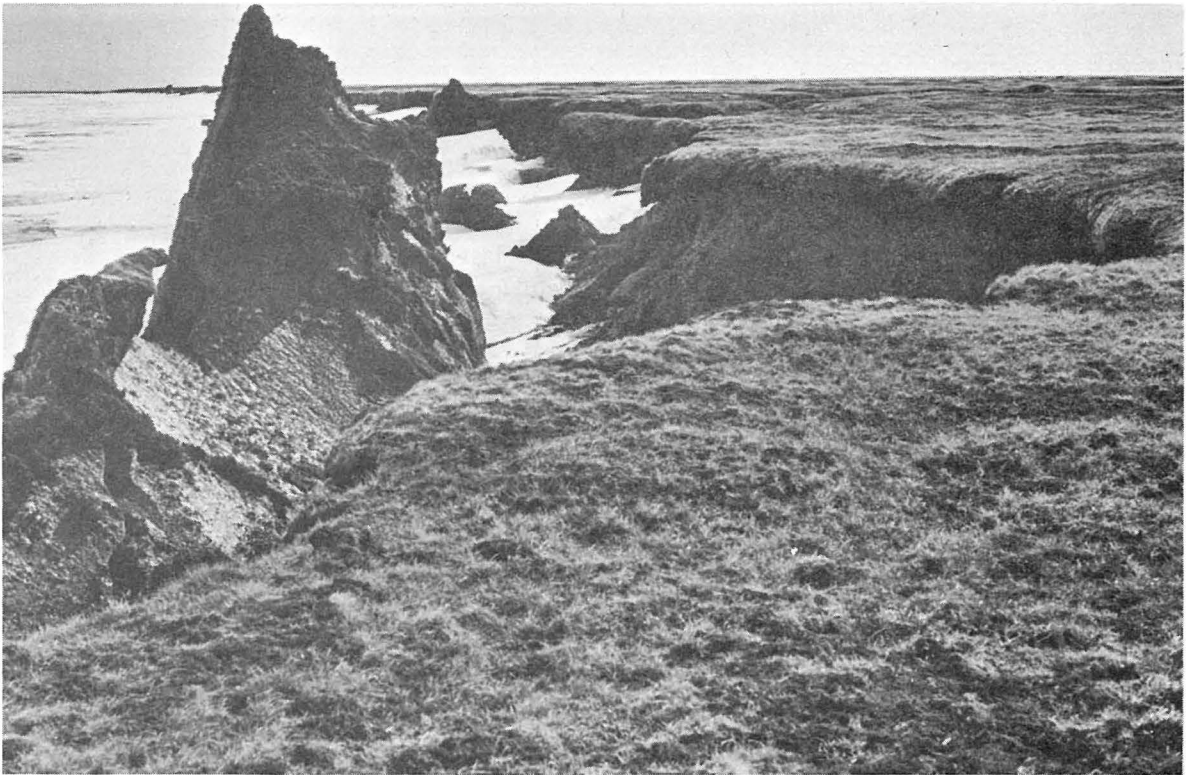
Photo 3: Ice cliffs on naturally unstable coastline of the Beaufort Sea (Cape Simpson).

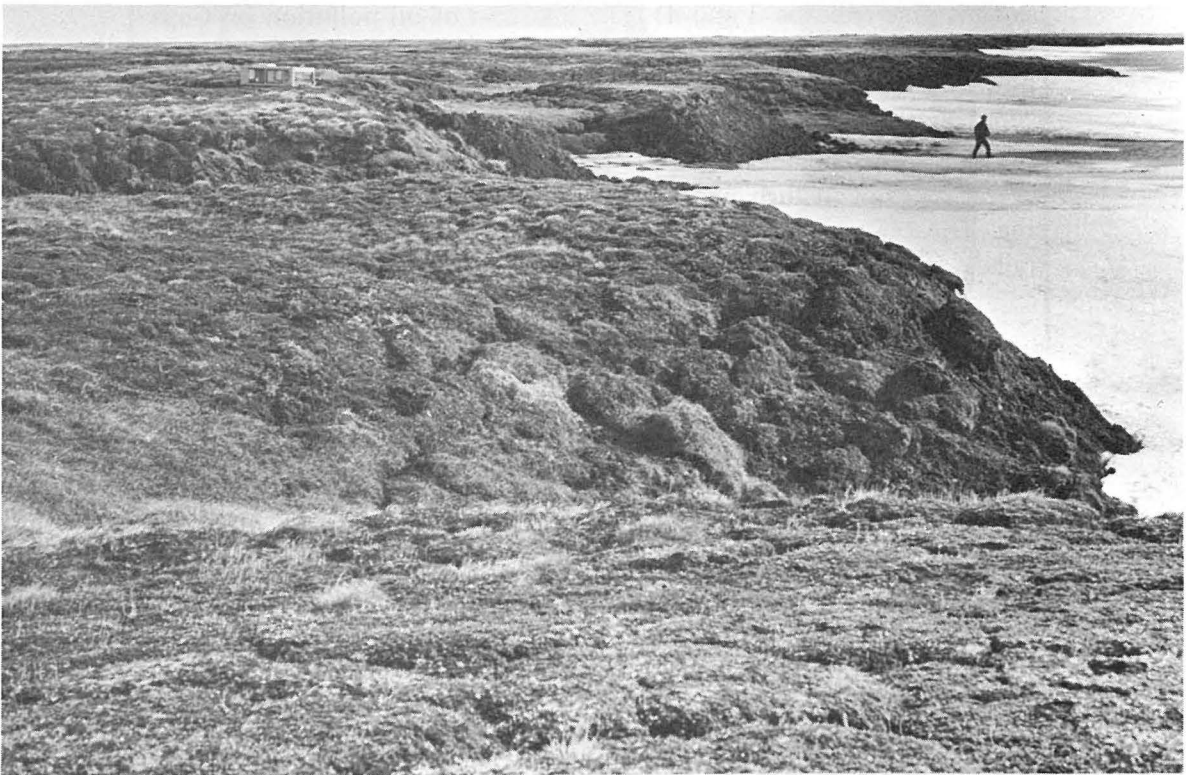
Photo 4: Slumping lake margin (natural) near Sinclair Lake (Cape Simpson).

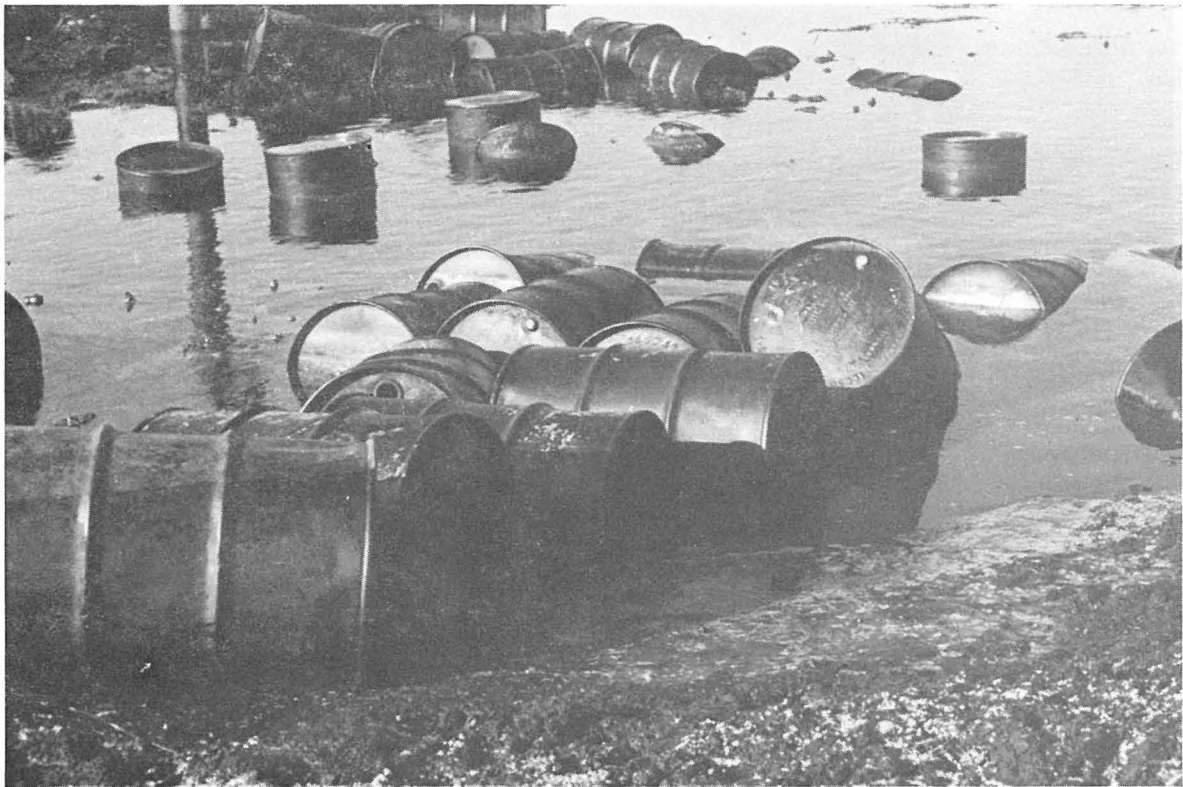
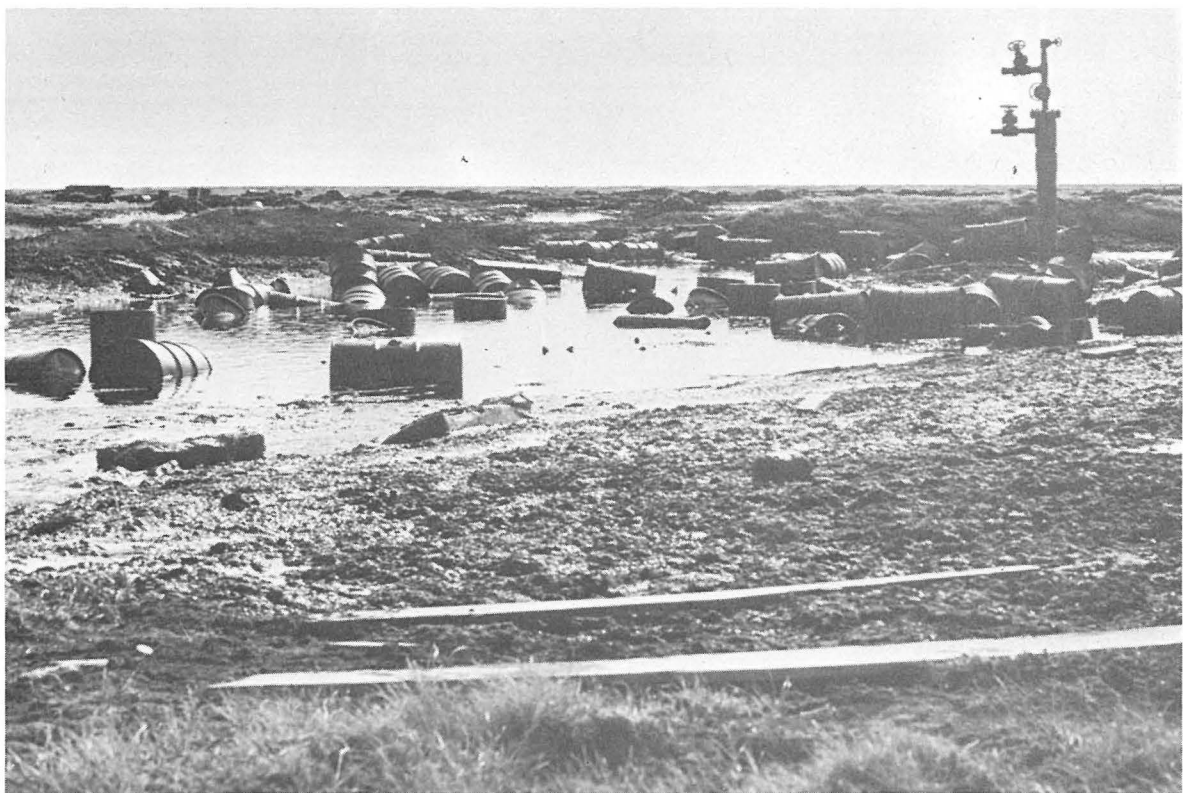
Photos 5 & 6: A man-made oil seep at Cape Simpson.

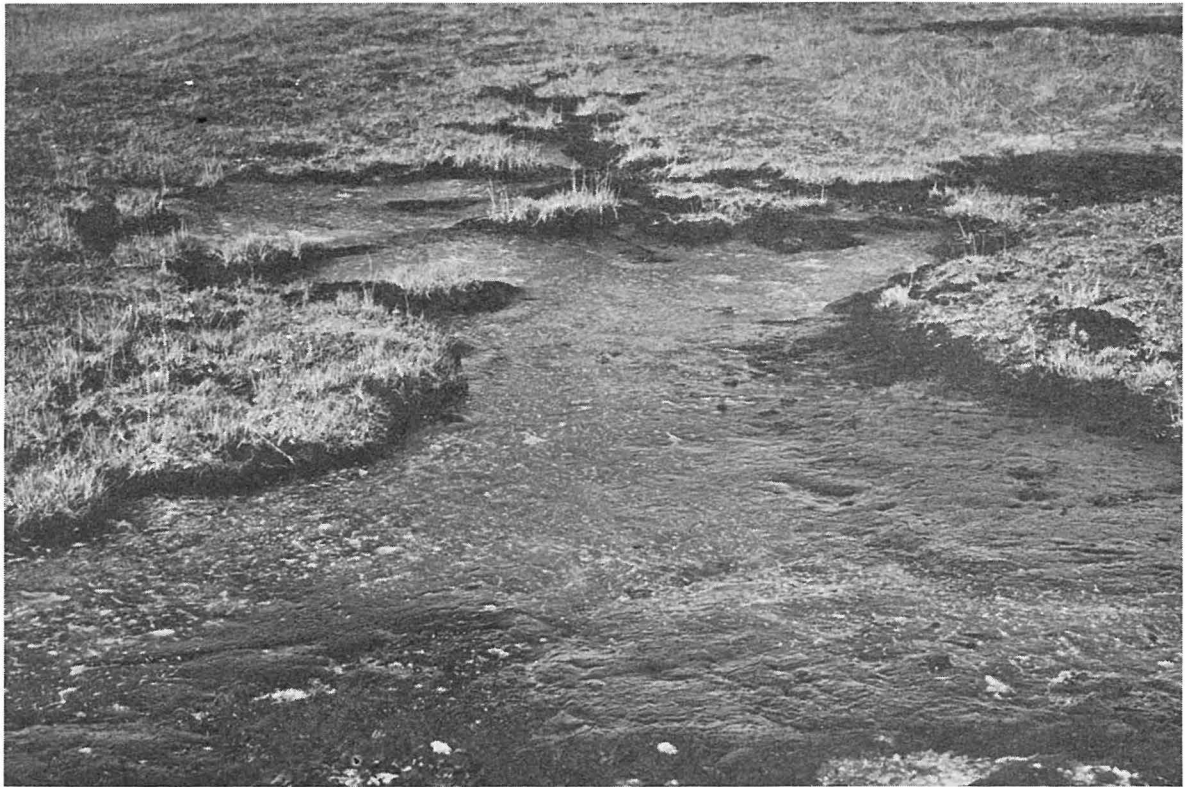
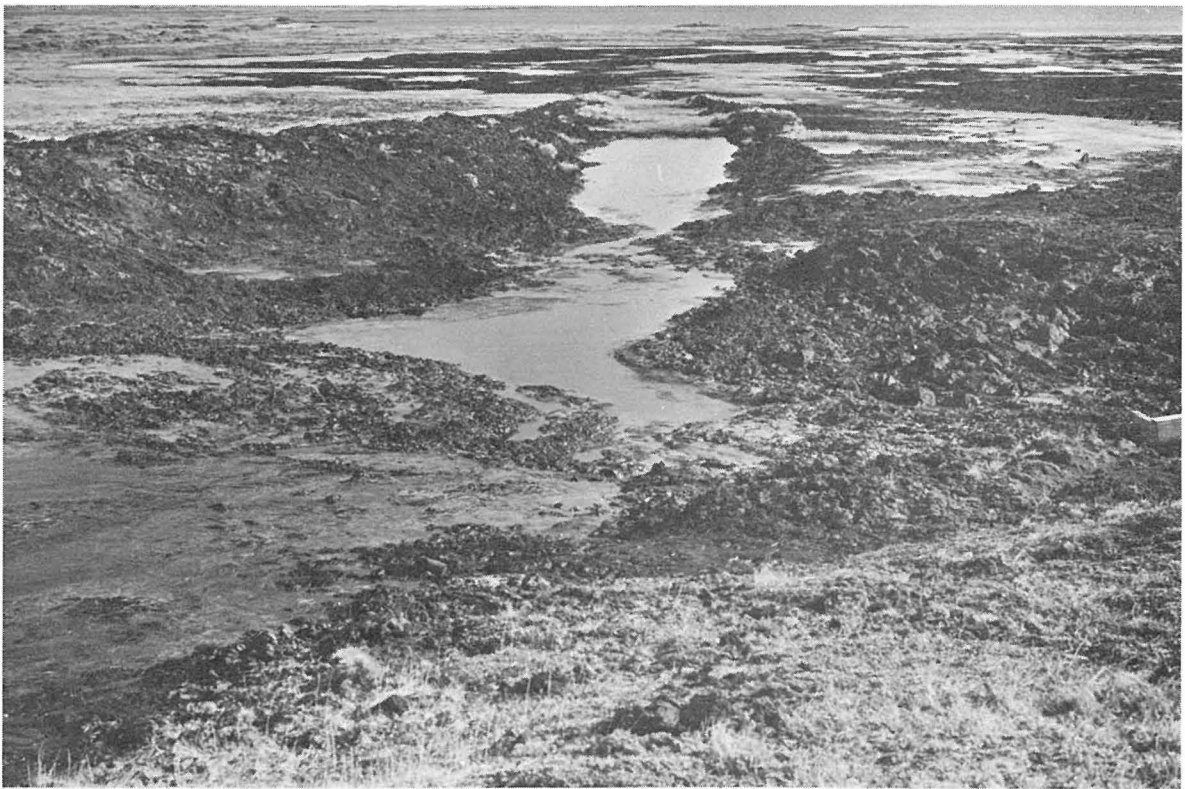
In addition to surface disturbances resulting from human activity, the Cape Simpson region also has distinct elements of natural instability. Two notable examples of this are parts of the coastline and some lake margins (photos 3 and 4). The question of oil pollution on Cape Simpson, associated with the early naval exploration of the area (photos 5 and 6), is complicated by the presence of near-by natural oil seeps (photos 7 and 7A).

Photos 7 & 7A: A natural oil seep at Cape Simpson.

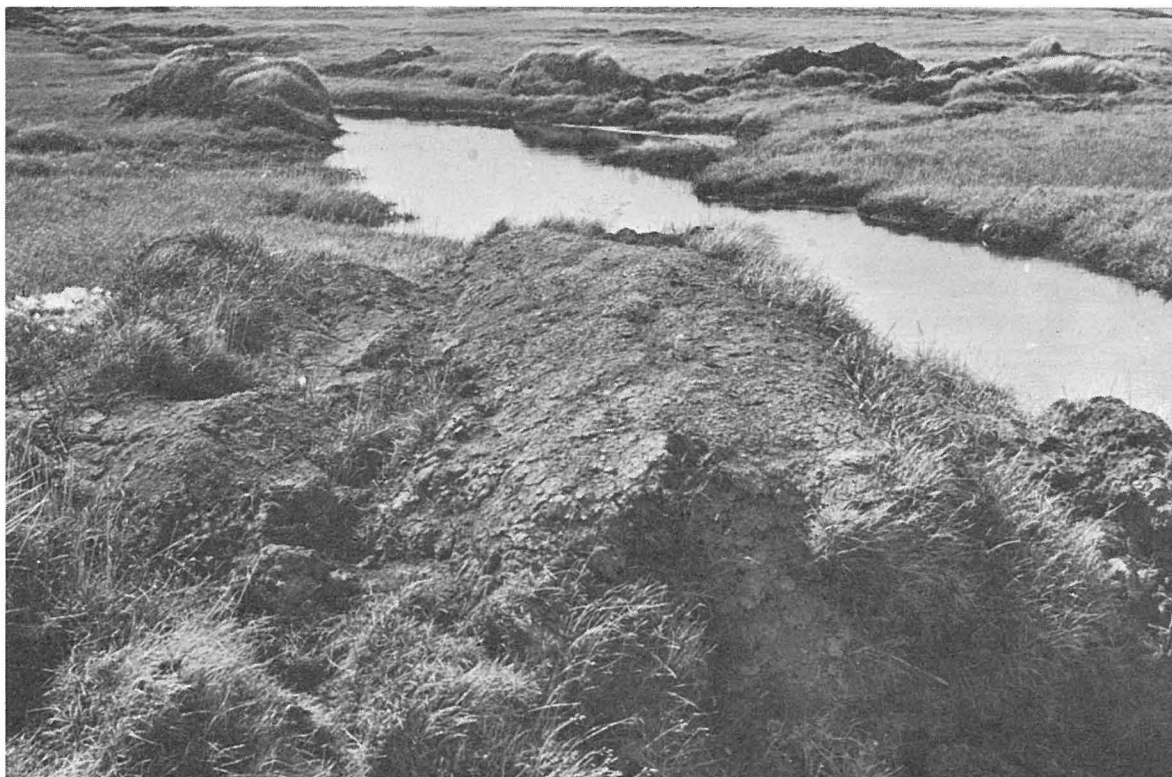
Photos 8 and 9 illustrate typical extremes in water saturation of bladed flatland trails: dry bed and submerged bed, respectively. In the dry bed trail, the return of ground cover is complete and appears quite similar to that of surrounding areas. In the submerged bed trails, however, no rooted plants have returned.

Photo 8: A dry bed summer bladed trail. 16-20 years old.

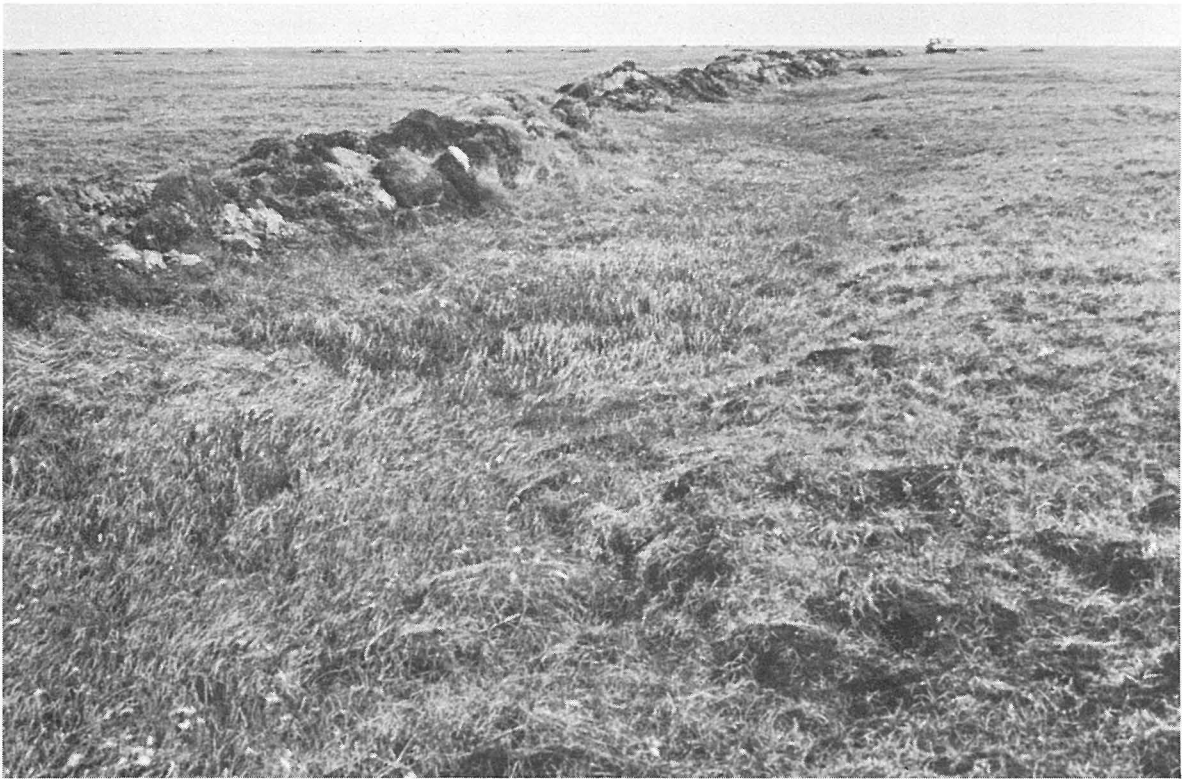
Photo 9: A submerged bed summer bladed trail. 7-14 years old.

All of the trails except the one shown in photo 9 were created during exploration of Pet. No. 4 and illustrate the conditions which have resulted after the passage of 16 to 20 years' time. Examples of more recent bladed trails are found in photos 11, 12, and 13, all of which were taken within the area indicated in green on map 2. In each case, vegetative cover is far from complete. This condition is probably due, in part, to the comparative youth of the trail. Ground cover where these newer trails are located is also less continuous in its undisturbed state than the ground cover around the older trails described earlier.

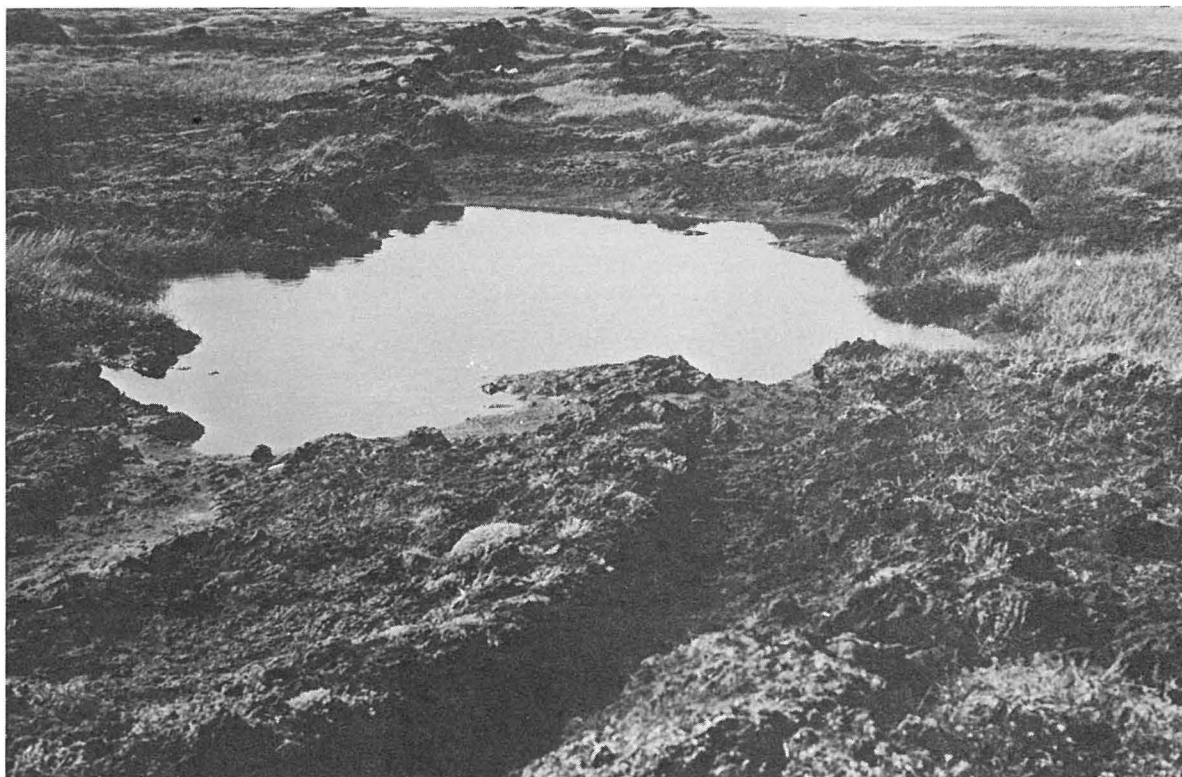
Photo 10 illustrates a 16 to 20 year old trail which is intermediate between the extremely wet and dry trails. In this case the new vegetation in the trail bed is typical of a wet meadow with the rooting portions of the plants submerged in free water. The areas immediately adjacent to the trail are dry underfoot and support a more varied assemblage of plants.

Photo 10: Bladed summer trail wet sedge meadow vegetation in bed; adjacent areas dry. 16-20 years old.

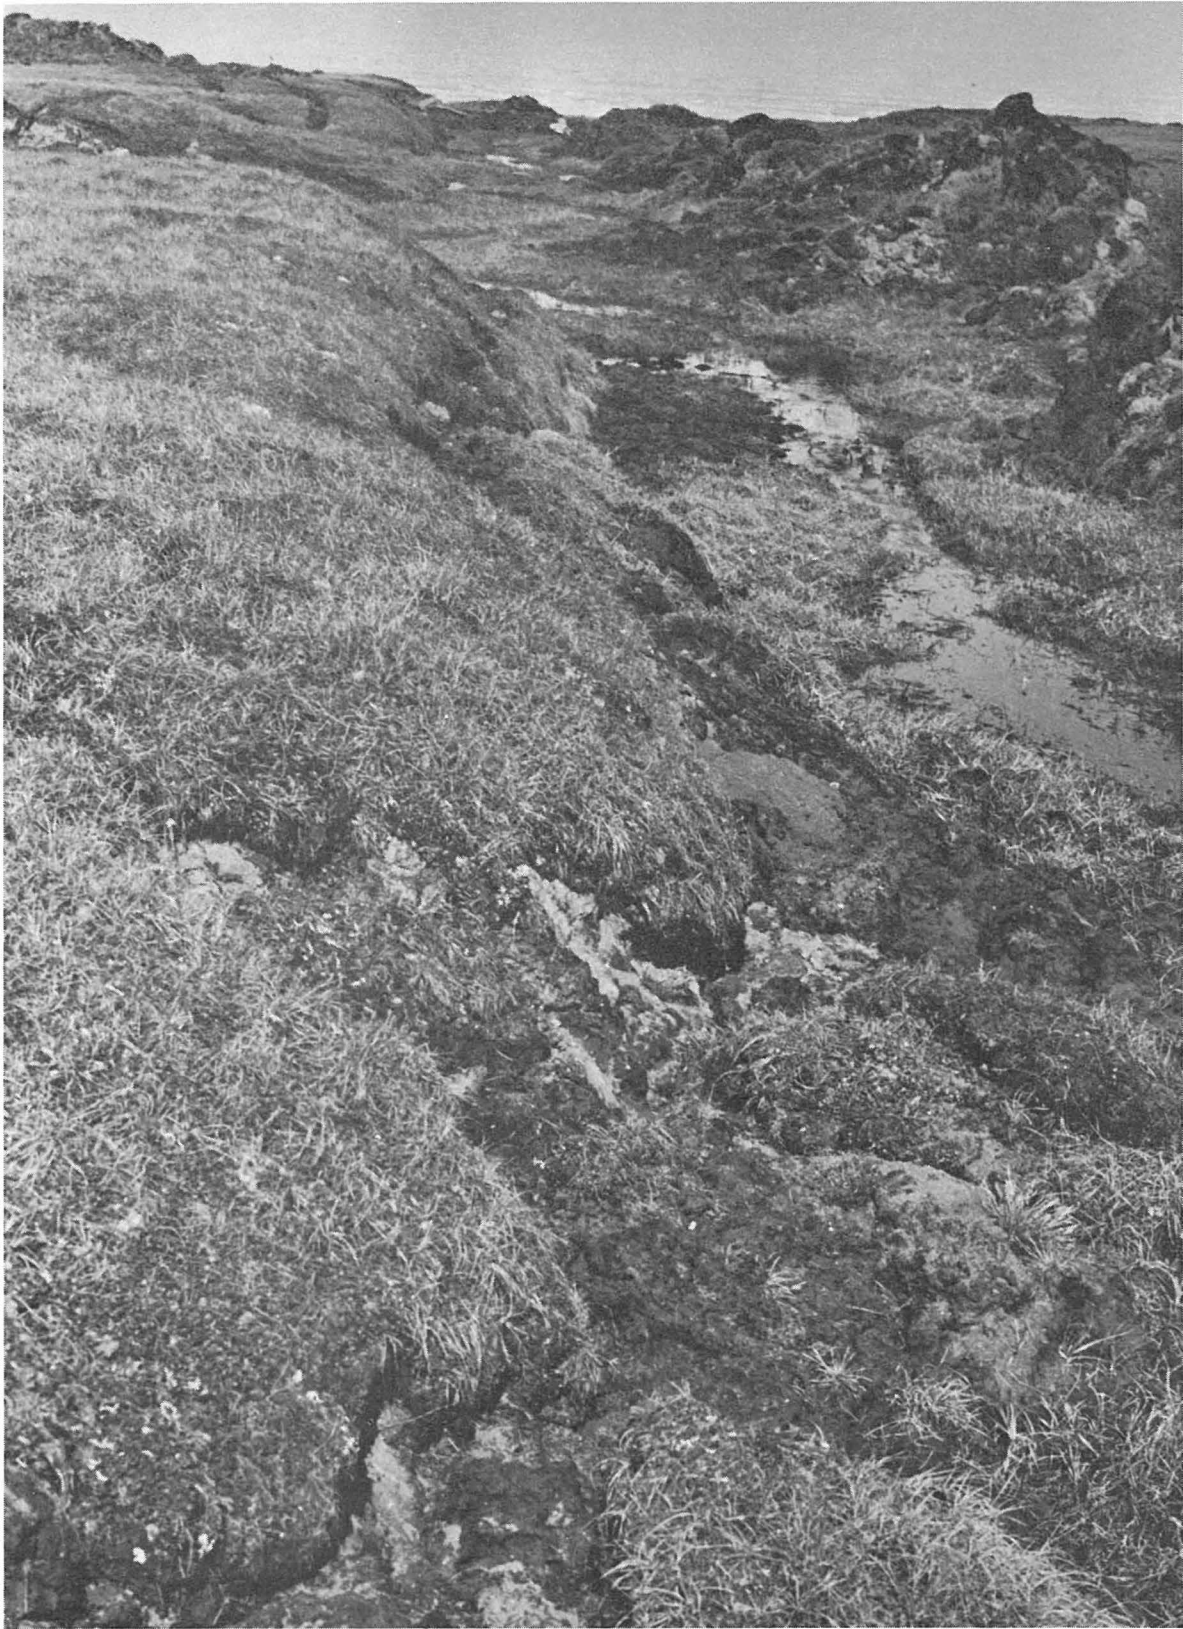
The first trail collects water at the base of a low hill as it slopes gently down to the Beaufort Sea. The bed of this trail is completely revegetated with semi-aquatic plants and seems quite stable. However, the banks of the trail have remained active, and are still slumping into the channel (presumably as support is lost as permafrost thaws along the exposed bank). Photos 14 and 15 show the inclined position of this trail. Photo 16 illustrates the track left by a single blade-up, tractor pass along the bank of the main trail at a point seen at top center on photo 15.

Photo 14: Bladed summer trail on gentle, wet slope. Sides are continuing to slump. 16-20 years old.

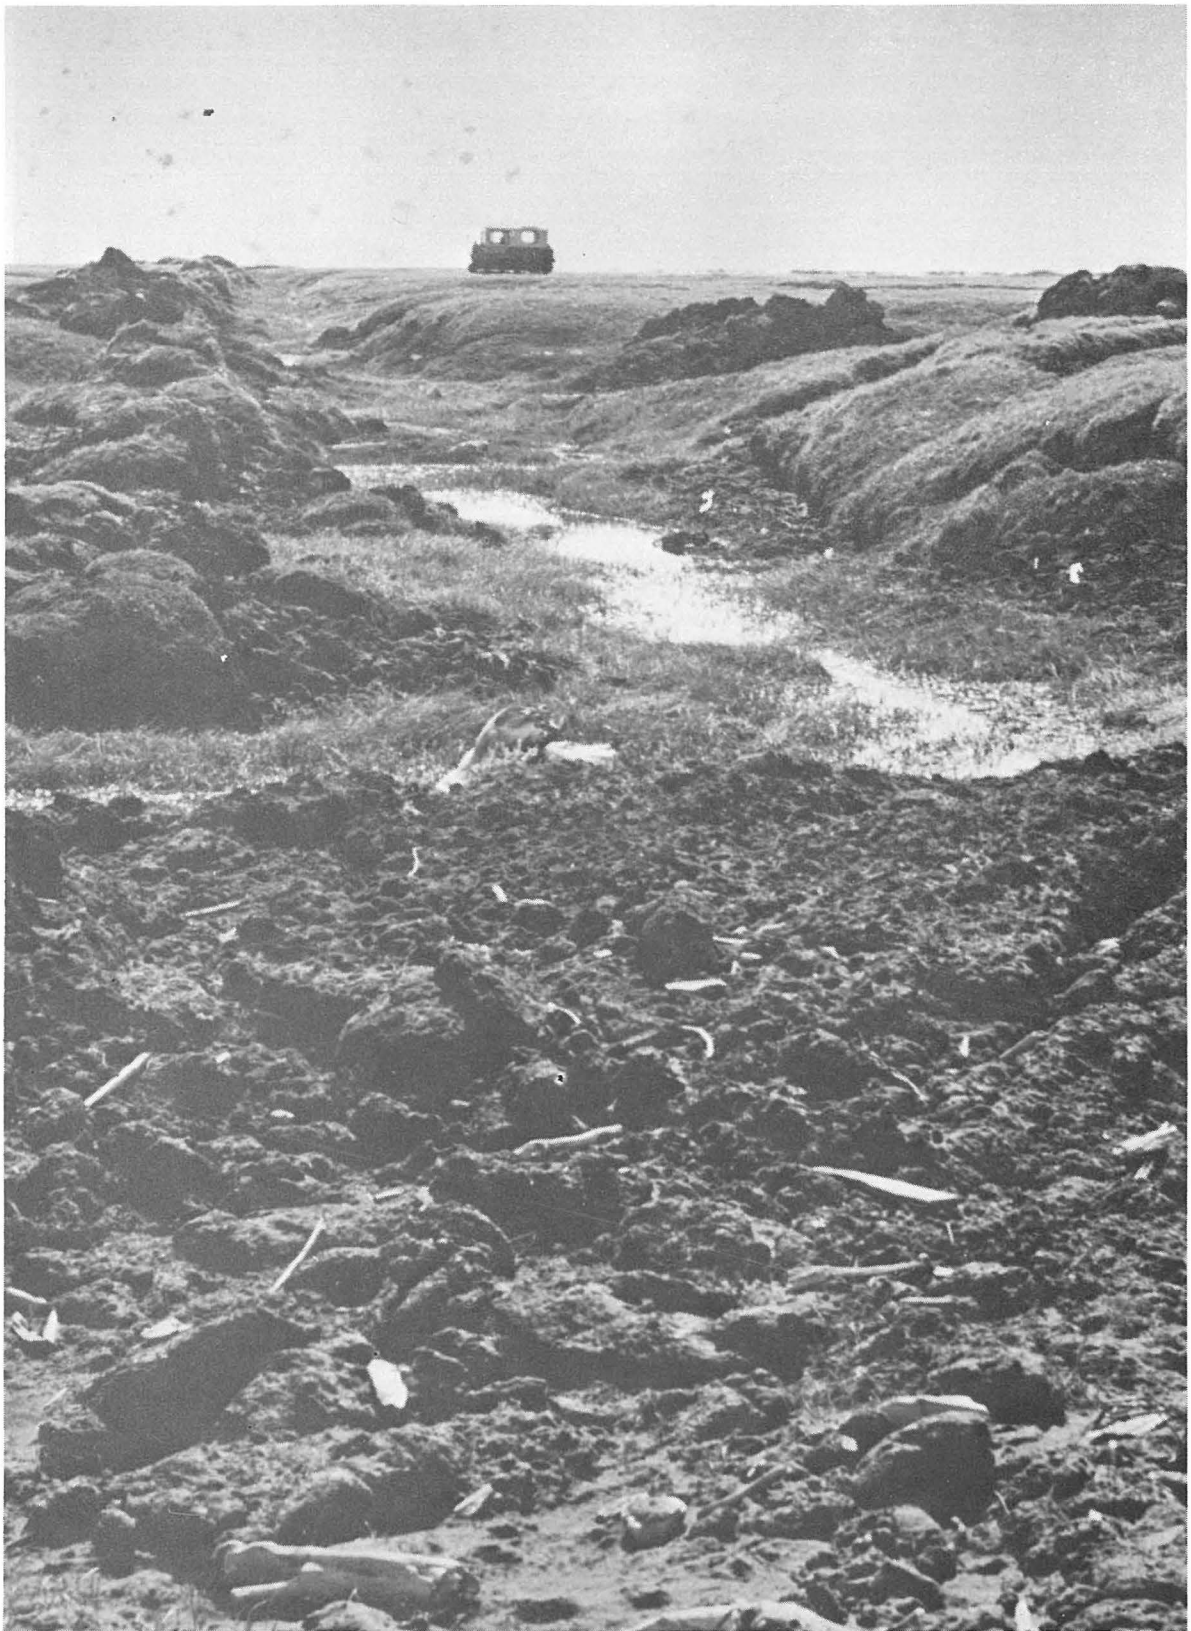
Photo 15: The same trail as shown in photo 14 seen looking uphill.

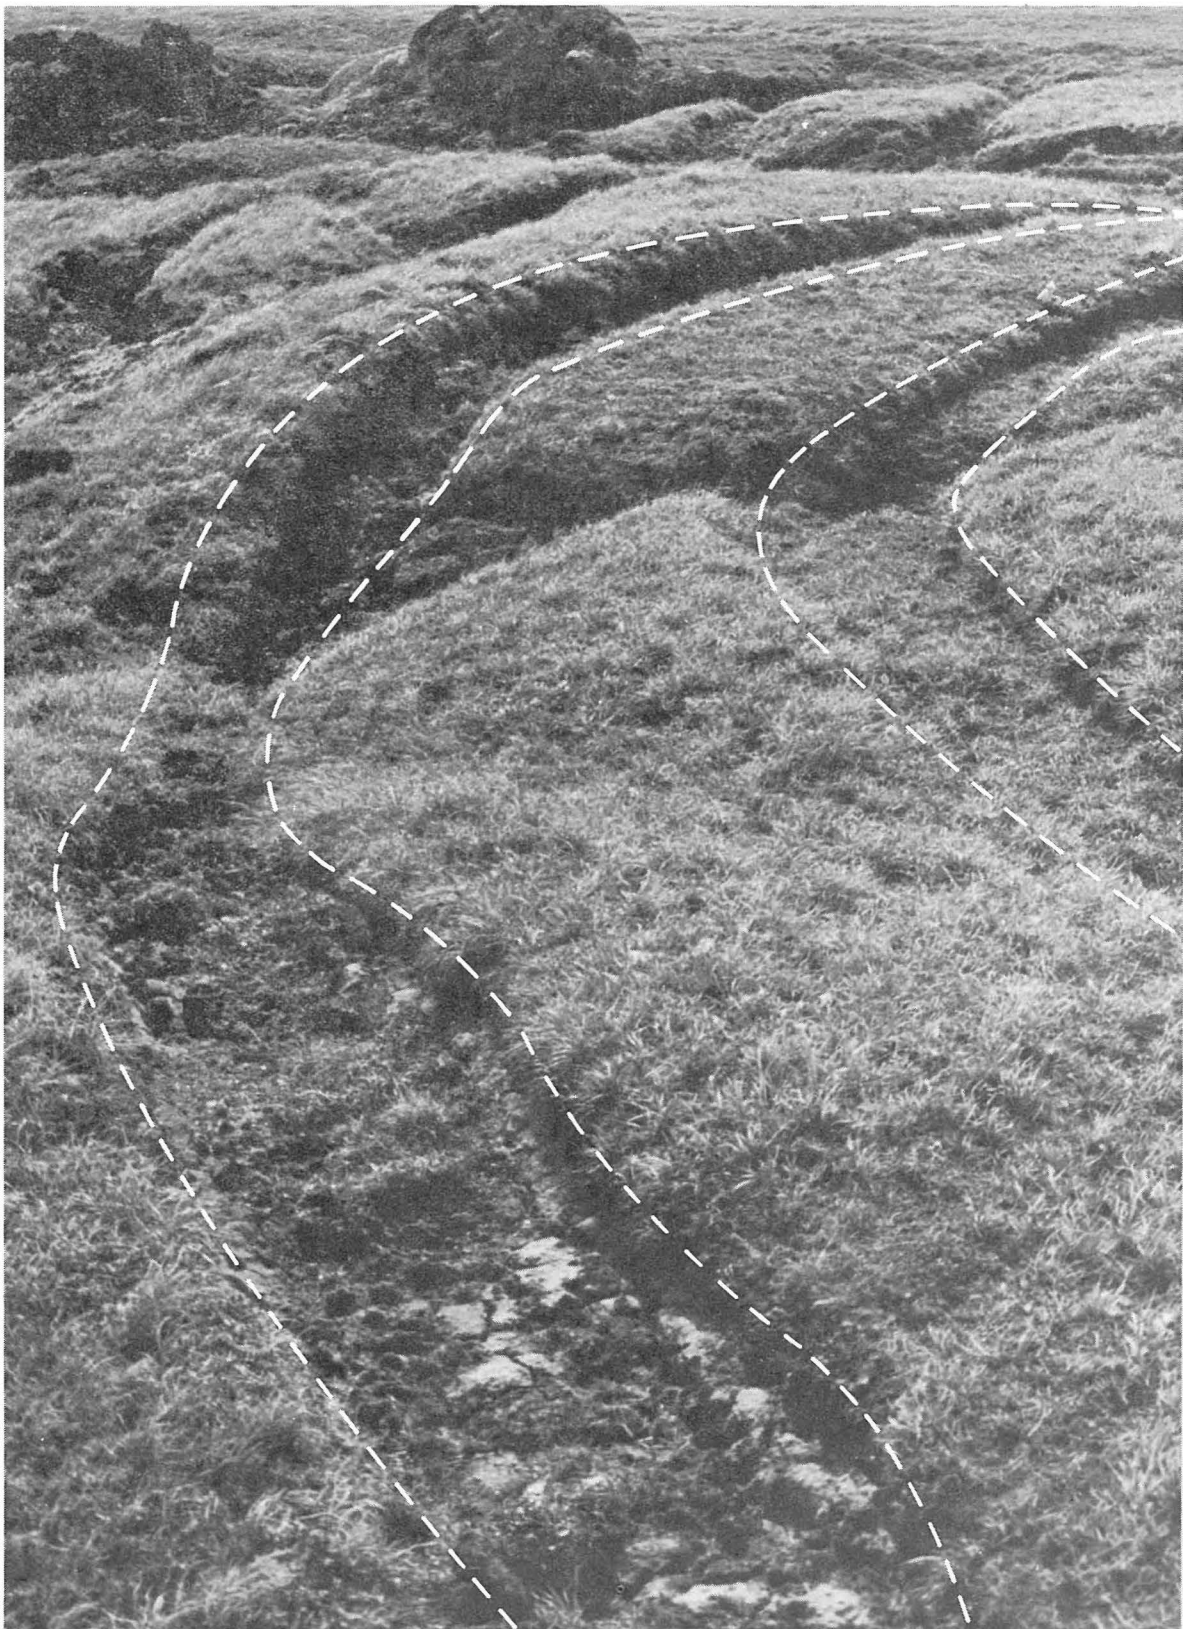
Photo 16: The mark left by the tracks of a heavy tractor on the bank of the trail as shown in photos 14 and 15.

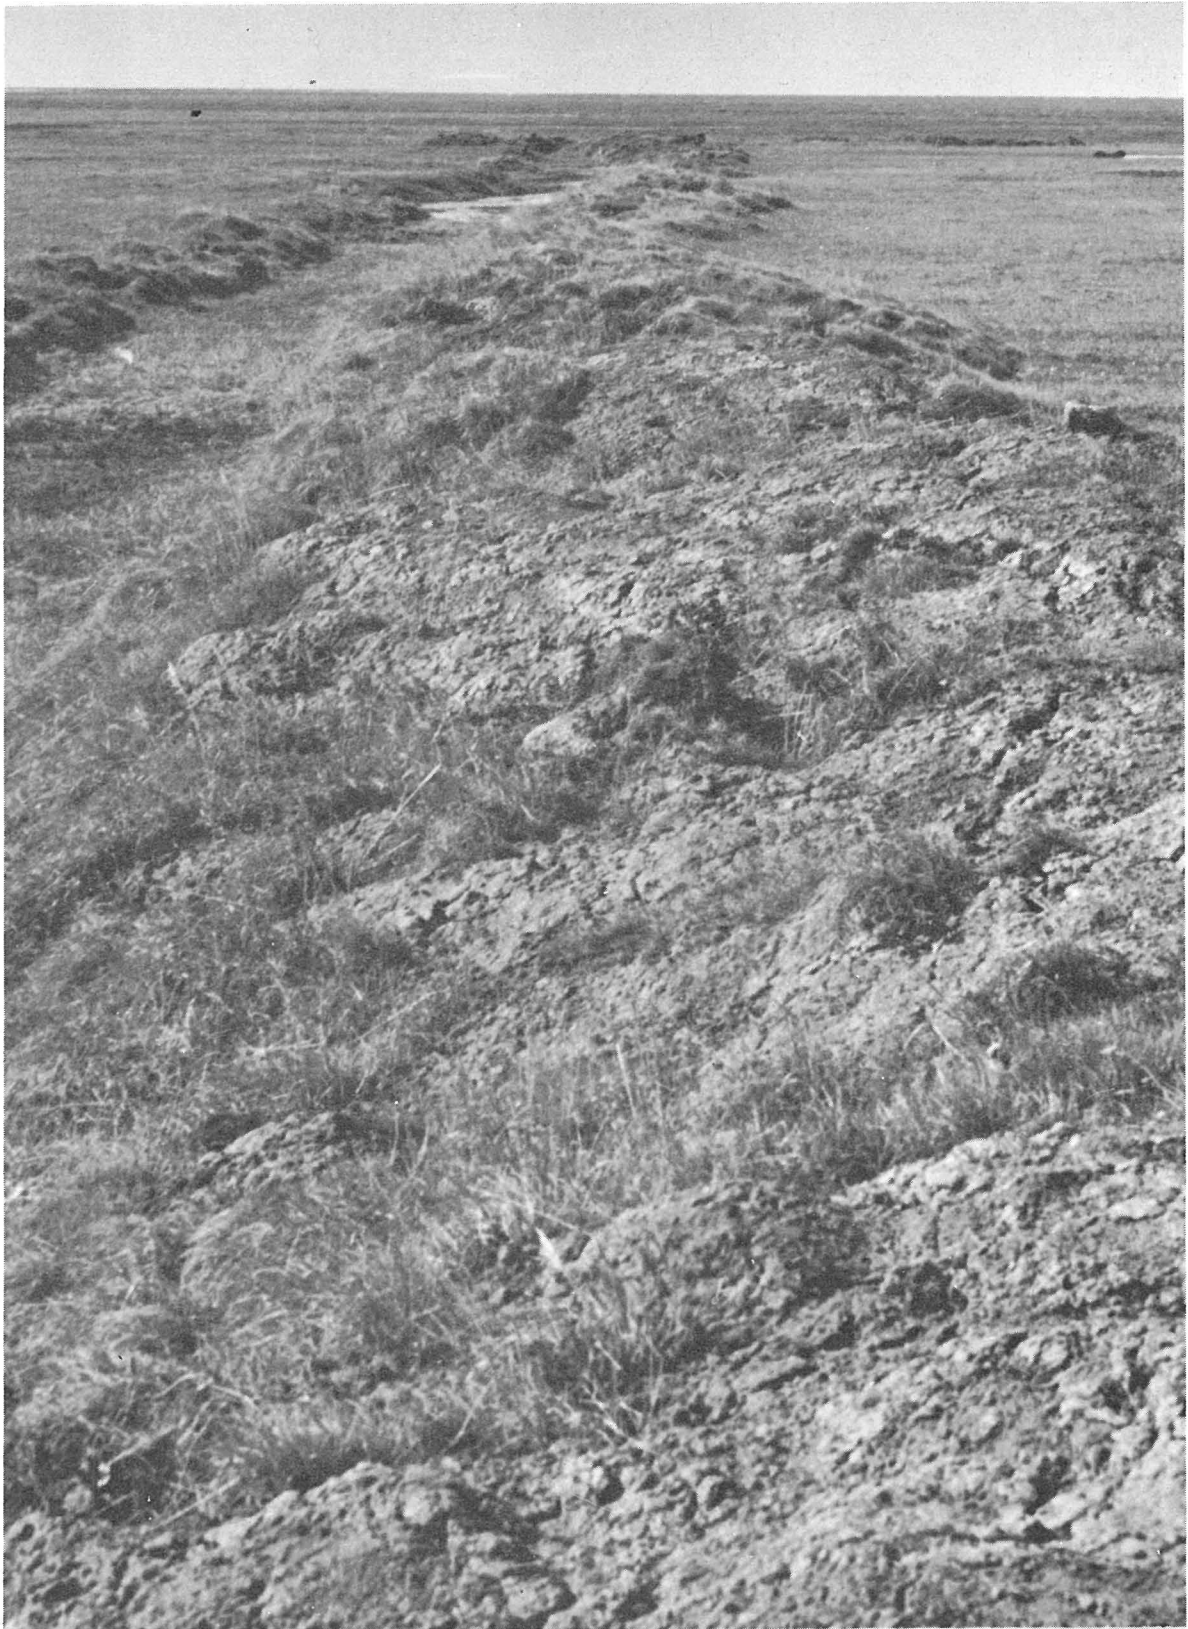
Photo 17: A bladed summer trail on a gentle, dry slope. 16-20 years old.

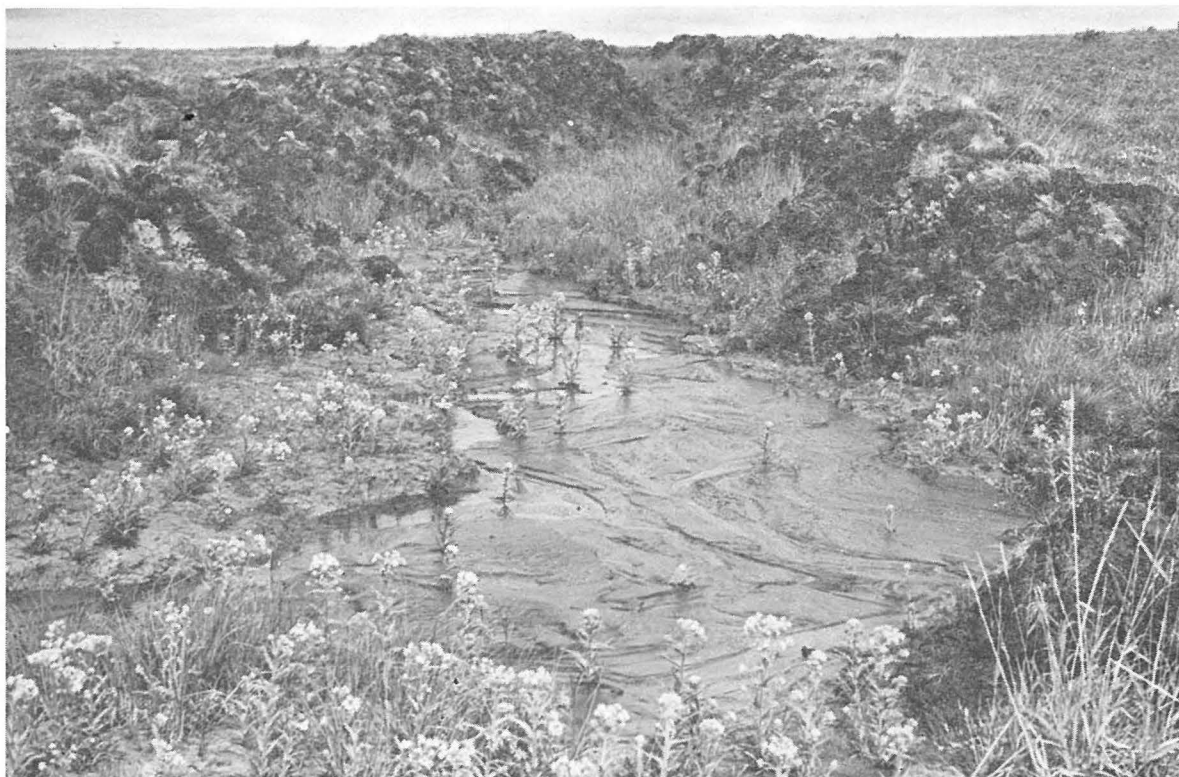
The sloping portion of the trail, although 7-10 years old, has not yet begun to approach a stable condition. This is indicated by the slumping surface cover (photo 33), the deep, unvegetated water channel (photo 32) and the accumulating outwash (photo 30). A yellow flowering plant *Senecio congestus*, is particularly prominent as a colonizer of silty mud outwashes in active eroding areas (photo 31). This plant is not found in the immediate area other than in this active outwash habitat.

Photo 30: Silt outwash from eroding trail at base of slope. 7-10 years old.

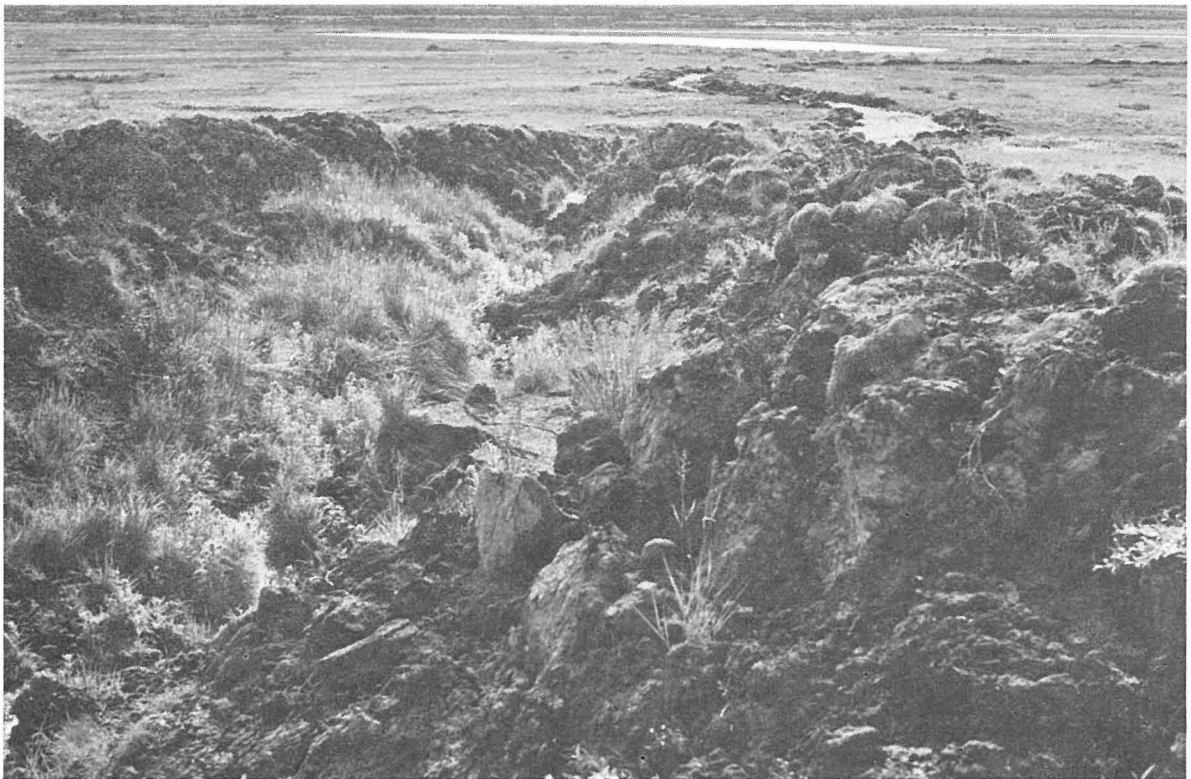
Photo 32: View downslope at the point of deepest erosion. Banks are far from stable.

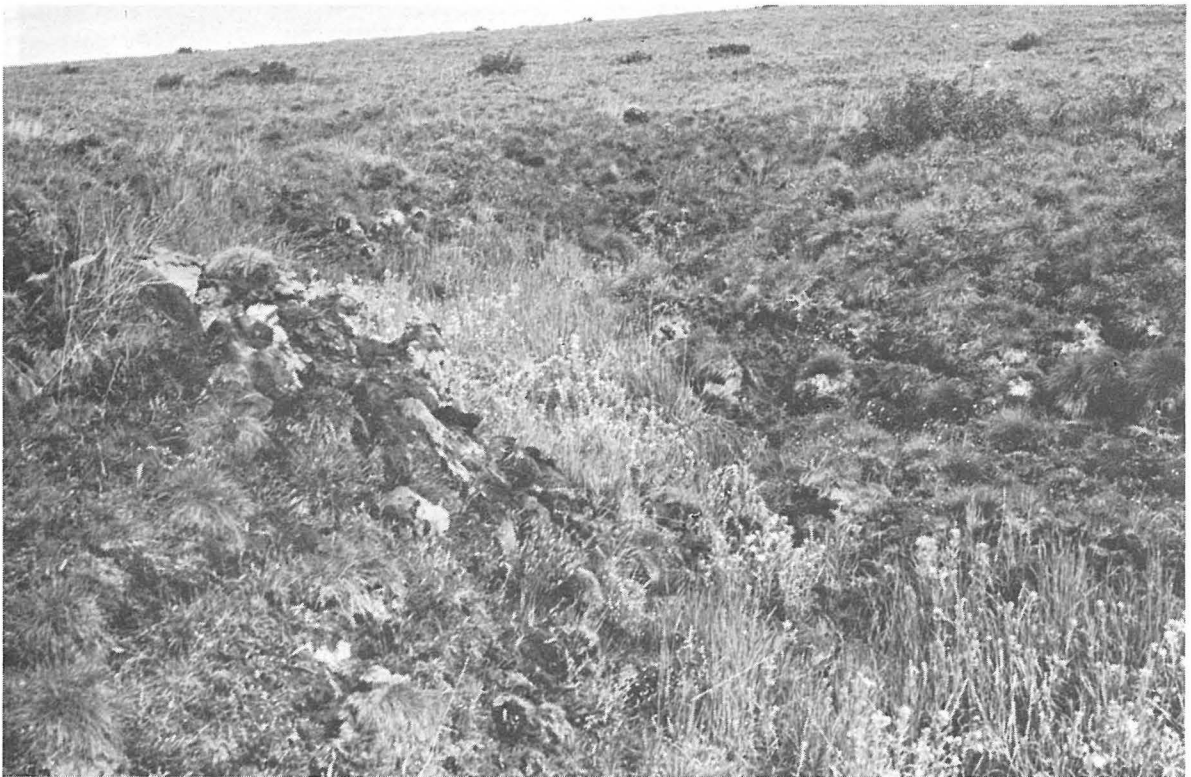
Photo 33: Dish-like head of eroding portion of trail. 7-10 years since disturbance.
