A RECONNAISSANCE OF TRACTOR TRAILS AND RELATED PHENOMENA ON THE NORTH SLOPE OF ALASKA

JEROME R. HOK

1969

U.S. DEPARTMENT OF THE INTERIOR
BUREAU OF LAND MANAGEMENT

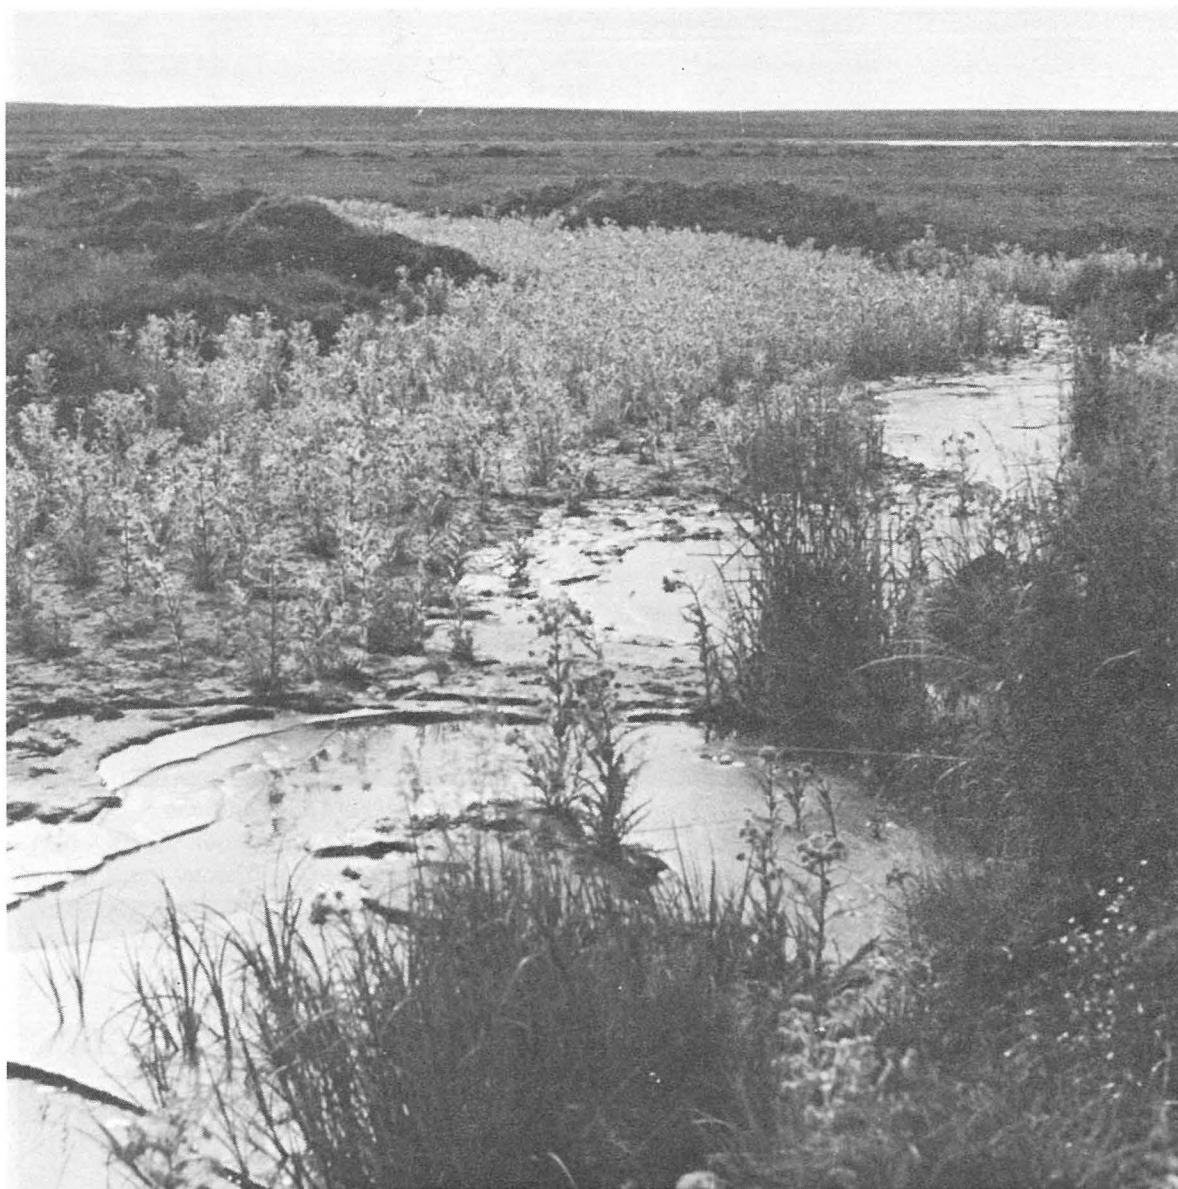
Photo 34: Outwash from eroding trail.

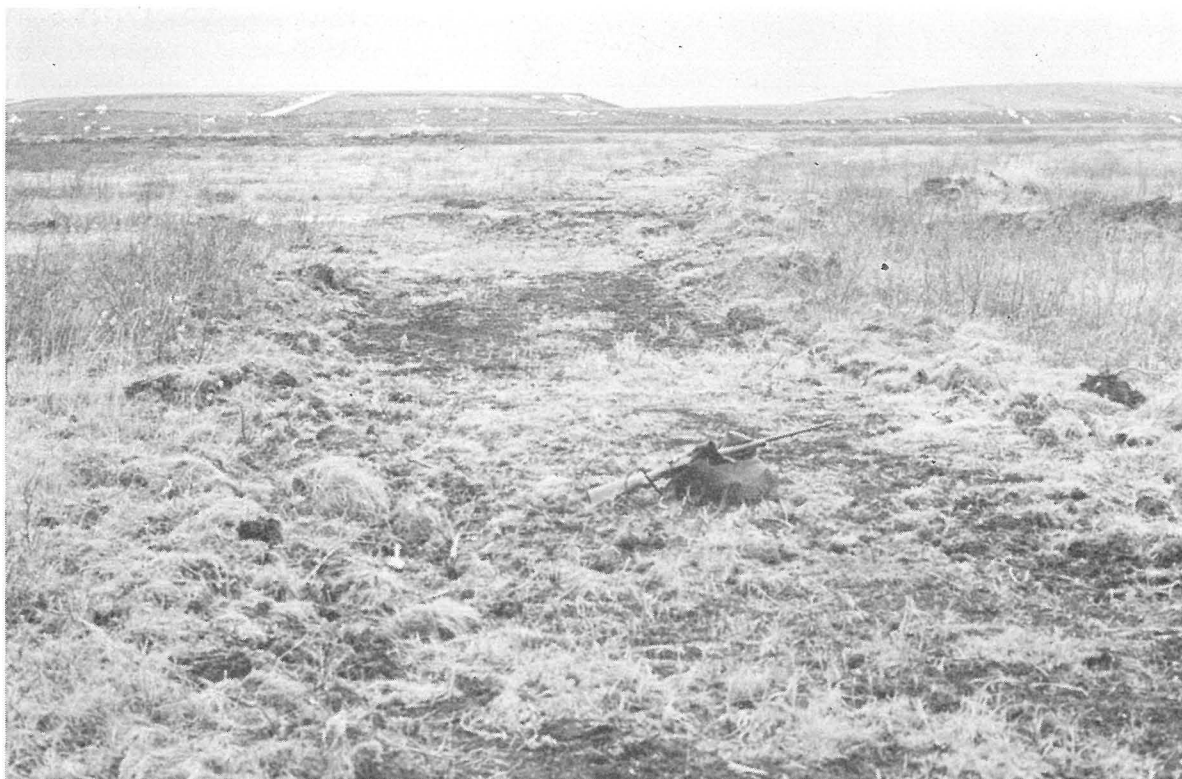
A winter haul road used during the winter of 1968-1969 is located near these older trails. Photos 41 and 42 were taken of this trail on June 11th, 1969. Photos 43 and 44 were taken from nearly the same spot several weeks later on July 7th. The small berm which consists almost entirely of vegetation (little or no peat included) is a typical feature of winter haul trails. It can be seen that a good deal of vegetation, particularly shrubs, was removed from the trail bed. Some areas were bladed completely bare. The condition of this trail, if it is not used again, will be interesting to follow and study in future years.

Photo 41: A winter haul trail seen on June 11th after use the previous winter. Looking south.

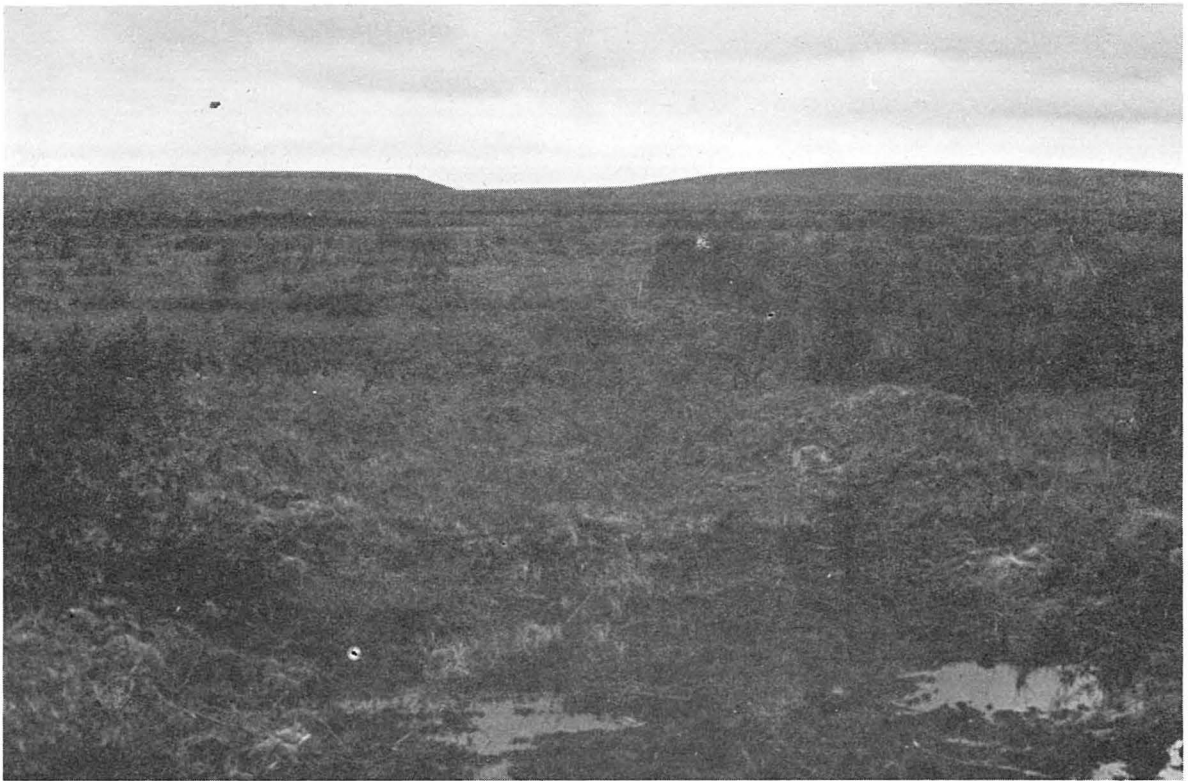
Photo 43: Same trail seen in photos 41 & 42 rephotographed on July 25th. Looking south.

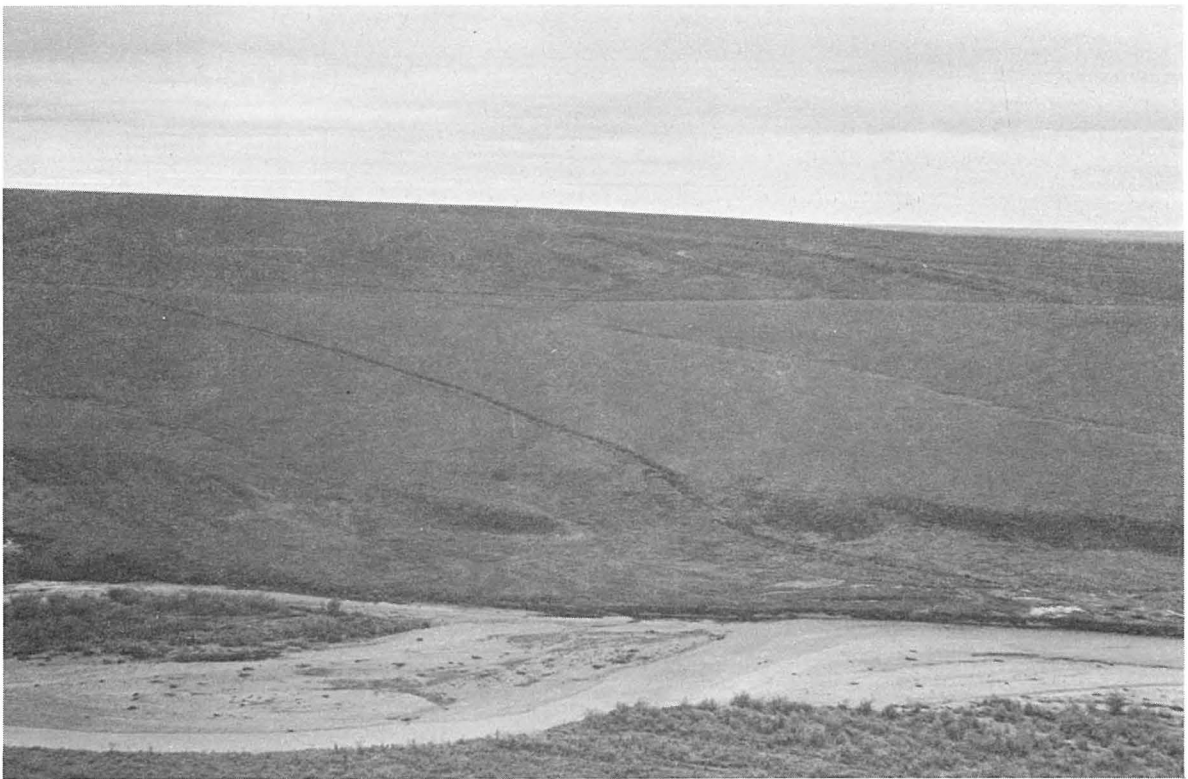
Photo 59: Bladed summer trail as it descends ice-rich, tussock covered slope. (Age unknown)

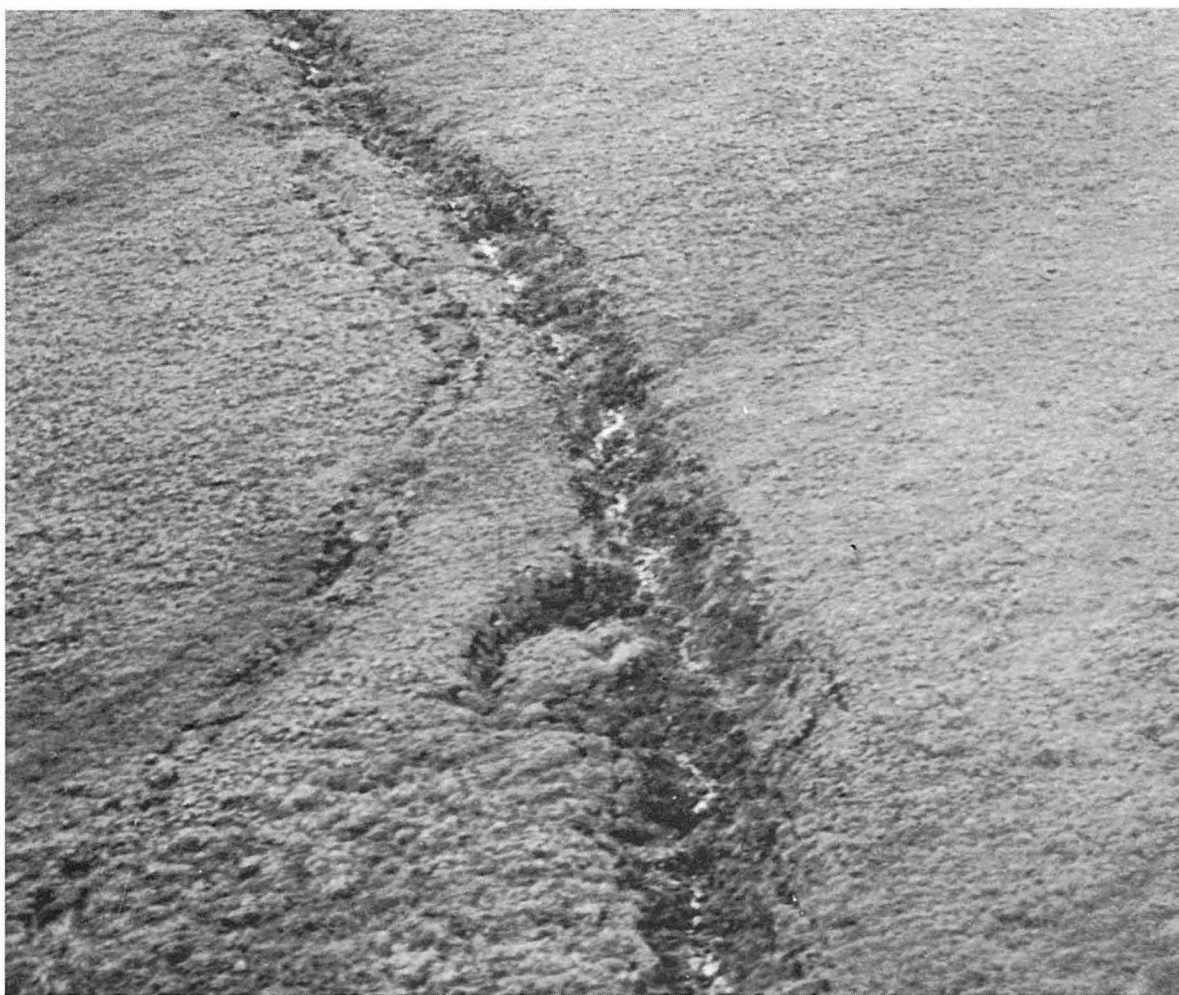
Photo 68: An aerial view of the most active (and steepest) section of the trail.

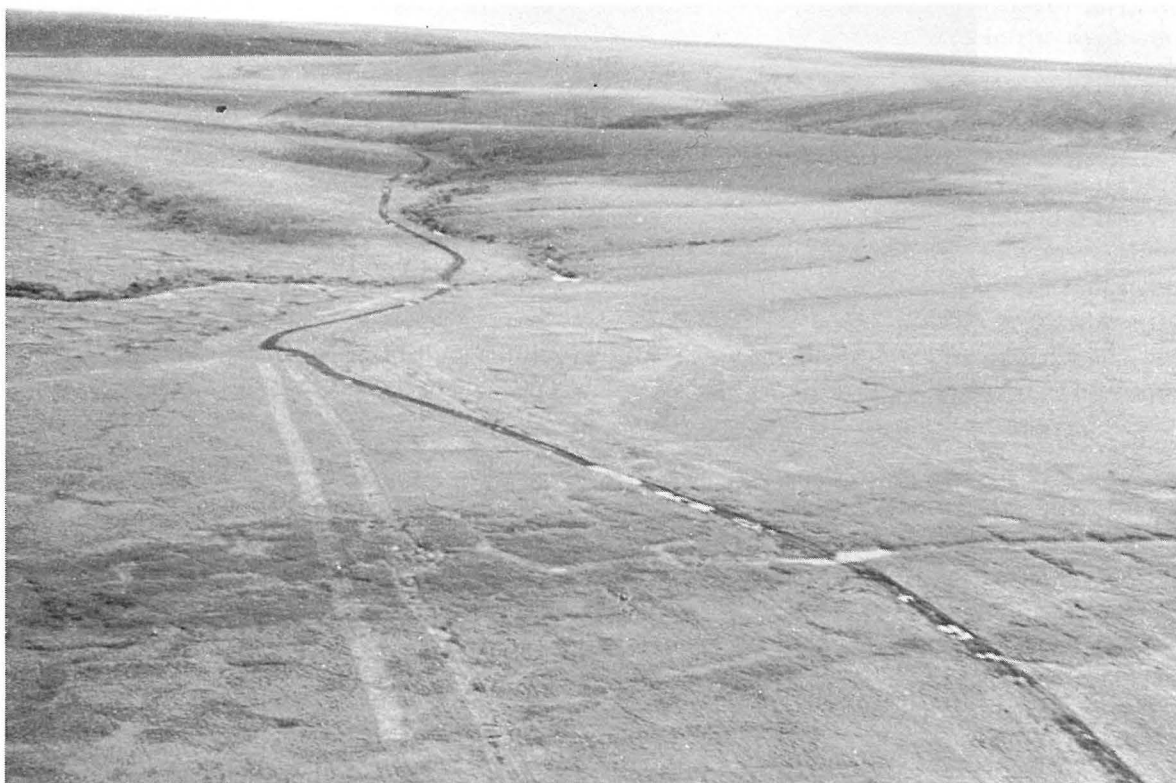
It is interesting to note in photos 70 and 71 (bladed winter trail) that the areas immediately adjacent to the actual road-bed, presumably where snow was heaped and packed while keeping the road open, have the same appearance as the packed-snow trail beds in photos 72 and 73. The cause of this phenomenon is probably a combination of mechanical pressure and shortened growing season (due to late melting of the packed areas). (Wiggins & Thomas -- 1962: 28-29)

Photos 70 & 71: Bladed winter trail. Winter 1968-69.

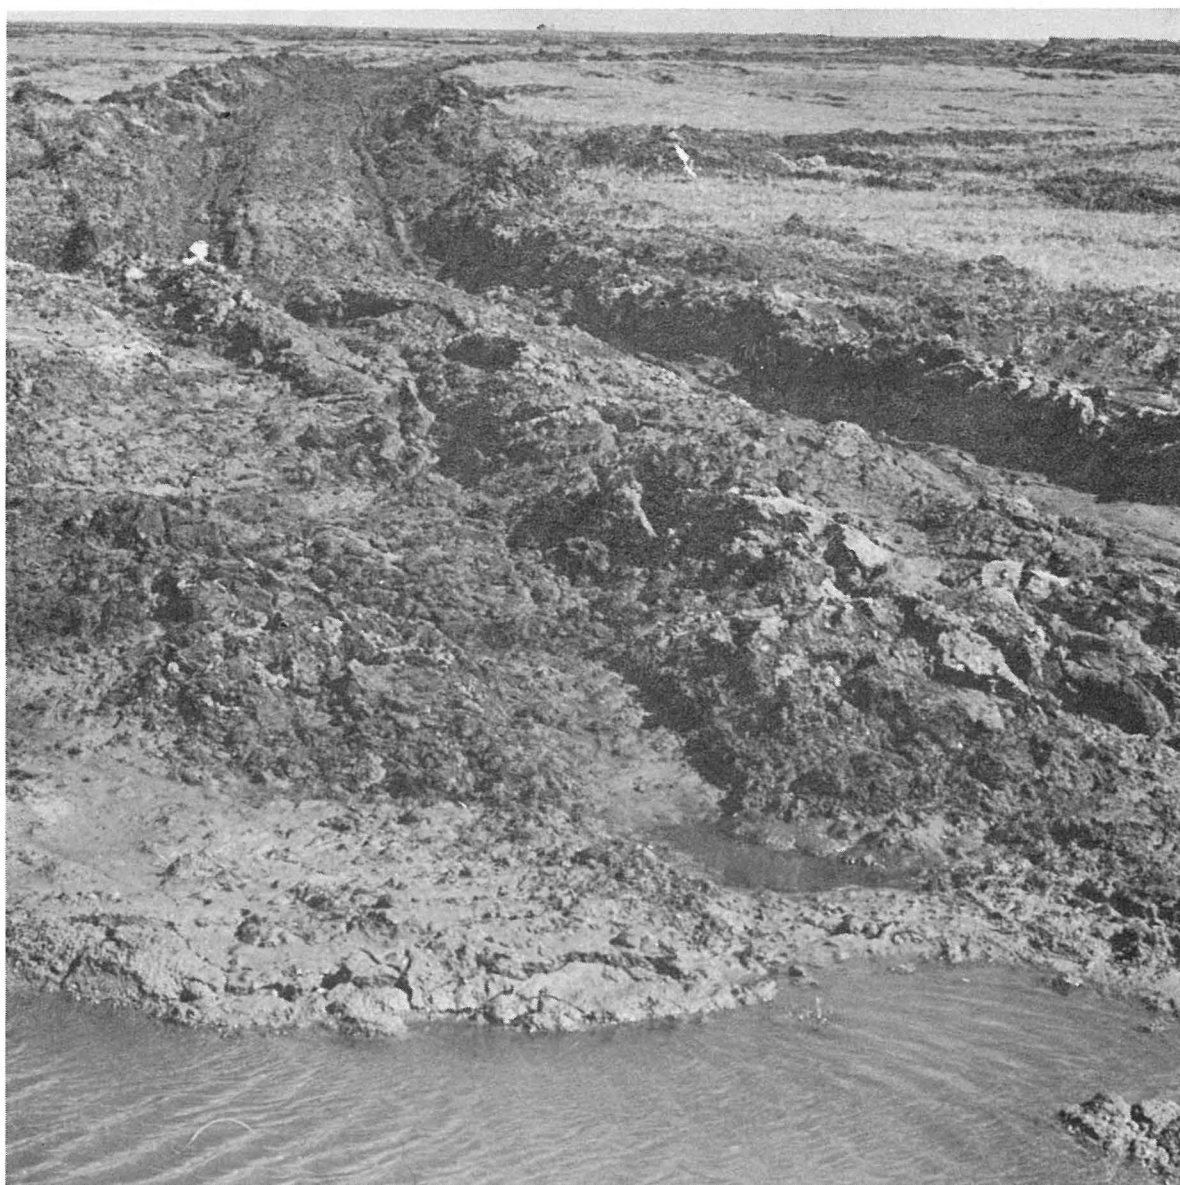
An unusually detailed description of the changes which occurred in an abandoned summer "cat" trail during a summer three years after repeated travel, is given by Hopkins (1949: 122-124): "During 1945, a gentle hill slope had been crossed repeatedly by a caterpillar tractor. When first examined in 1948, the route of the tractor was marked by lone, swampy furrows indented 3-12 inches in the tundra. Later in the summer a series of sinkholes, 3-5 feet deep, connected by subterranean watercourses, was discovered beneath the tracks in areas where the tractor had traveled directly upslope. Still later, the roofs of the connecting caverns had collapsed, and the course of the tractor was marked by narrow gullies 3-4 feet deep." The condition described by Hopkins is probably similar to that seen in photo 75, taken at Barrow.

Photo 75: Result of repeated "cat" travel over thawed ground at Barrow.

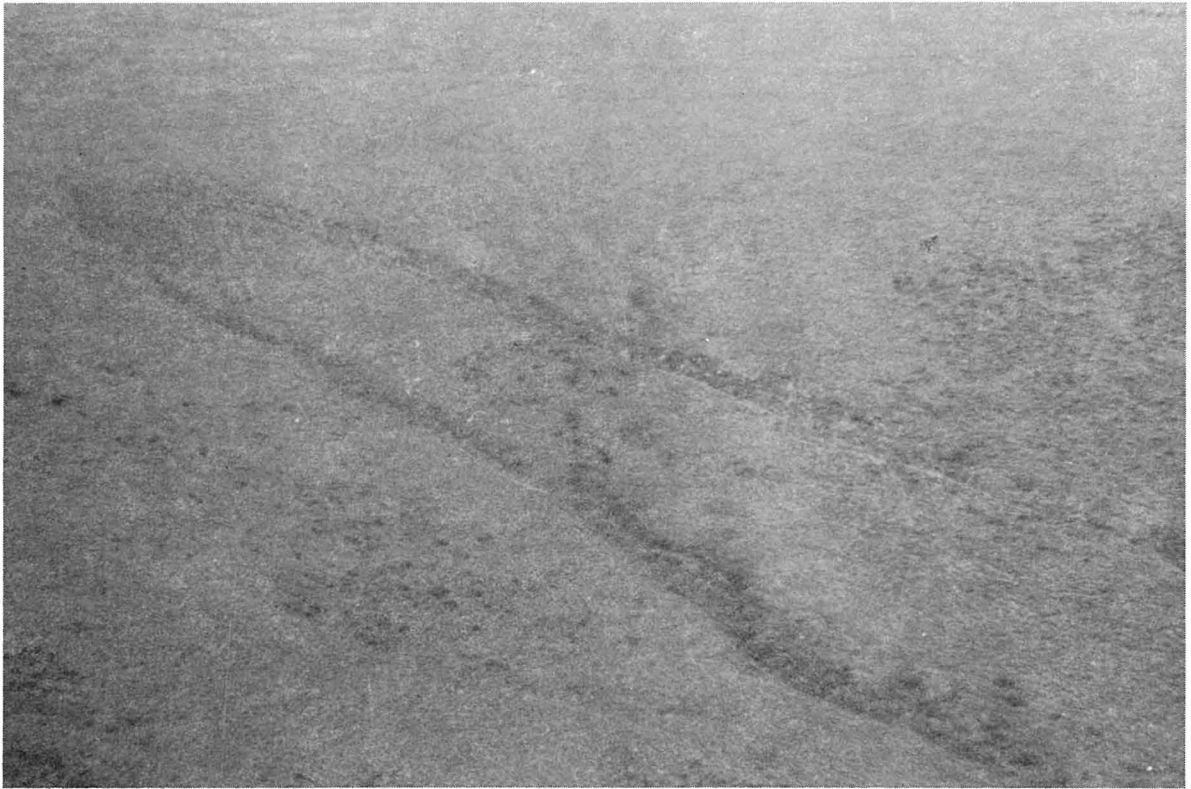
A more difficult question is: how to repair or minimize damage once a disturbance has been created? Unfortunately, where restabilization would be most valuable (on ice-rich slopes), the only impression gained was that the task was generally beyond the powers of vegetation, as indicated by continued rapid erosion even after the passage of many years (see photos 30, 32, and 33, Gubik section). In most of these cases some mechanical means will probably be necessary to permit vegetation to gain a foothold. Exceptions do exist, however. Photos 76 and 77 show a trail on ice-rich slopes along the Chandler River that have eroded and finally stabilized in a condition markedly similar to that of the natural drainages near it.

Photos 76 & 77: An eroded summer trail now stabilized. Natural gully at left of trail.
