REPORT  
ON  
EROSION OF WILDFIRE AREAS IN ALASKA

James L. Hagihara  
Soil Scientist

Glenn H. Lipscomb  
Hydrologist

Date 6/26/68

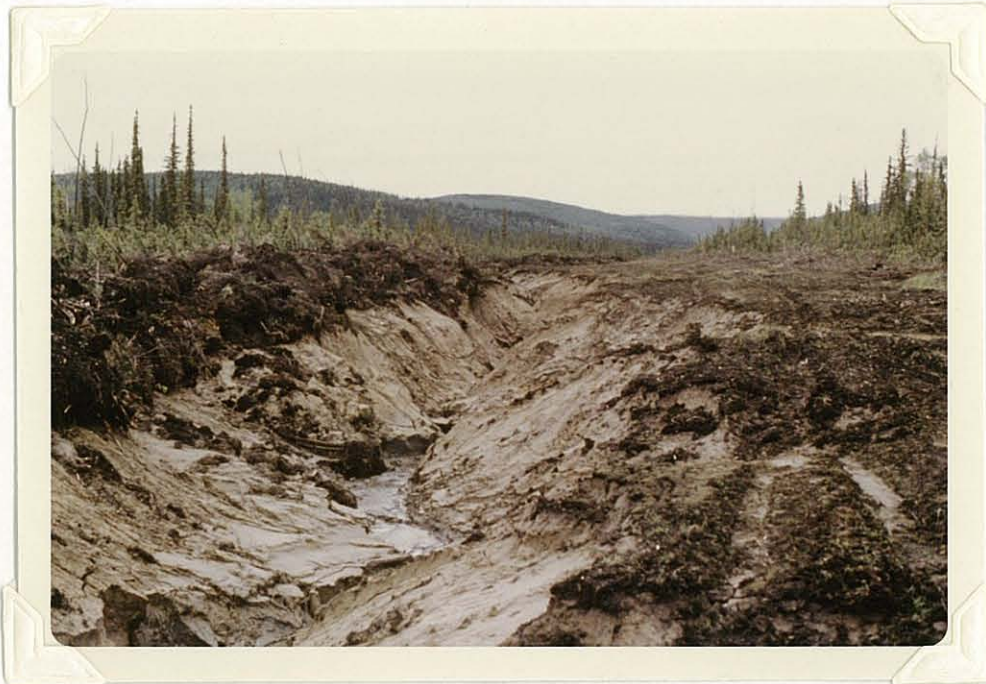
After viewing some of the eroded fire lines on the Goldstream and Y-34 burns, it is quite clear that some areas in Alaska belong in the fragile or "frail" category. Removal of the vegetation and organic accumulation in areas underlain with shallow permafrost and with deep loess soils can result in severe soil erosion. (See Photo No. 1) Melt from permafrost and thick ice lenses together with runoff from rainfall provide

2. Dozer constructed fire lines over permafrost areas (drainage bottoms, north slopes, etc.) appear to thaw rapidly after removal of the insulating ground cover, and new drainages or channels are created as the melt water from frost and ice lenses erode away the noncohesive loess. (Photos No. 5 and 6 show similar adjacent areas -- No. 5 contains no fire line while No. 6 contains a gullied fire line). In some areas fire line debris acted as a training dike confining water flow to the cleared line resulting in additional erosion. (Note left center of Photo No. 1).

Photo No. 1 - Dozer-constructed fire line on Goldstream Fire showing debris berm in left center, gully in center, and unvegetated cleared line to right.

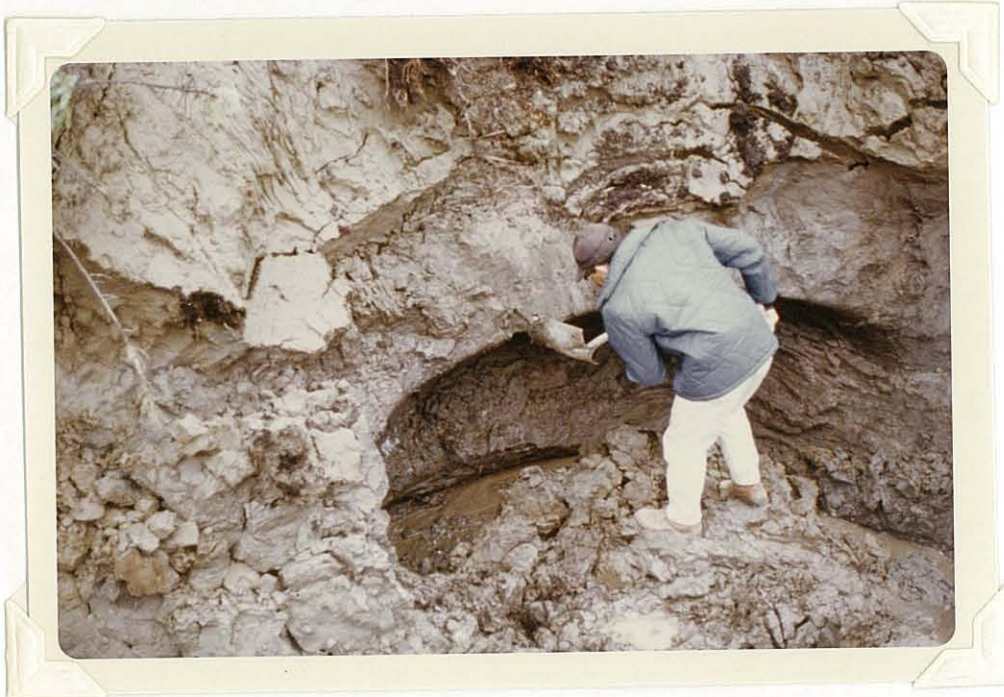
the eroding forces. (See Photos No. 2 and 3). Such areas are generally located on north slopes and in drainage bottoms and are characterized by spare stands of stunted black spruce. On the other hand, well drained soils generally found on south slopes, along ridge tops and on points do not appear to be a problem. Field investigation revealed very little erosion where fire lines were constructed on these areas.

Photo No. 2 - Deep gully (approx. 10') on Goldstream Fire showing melting ice lenses and permafrost.

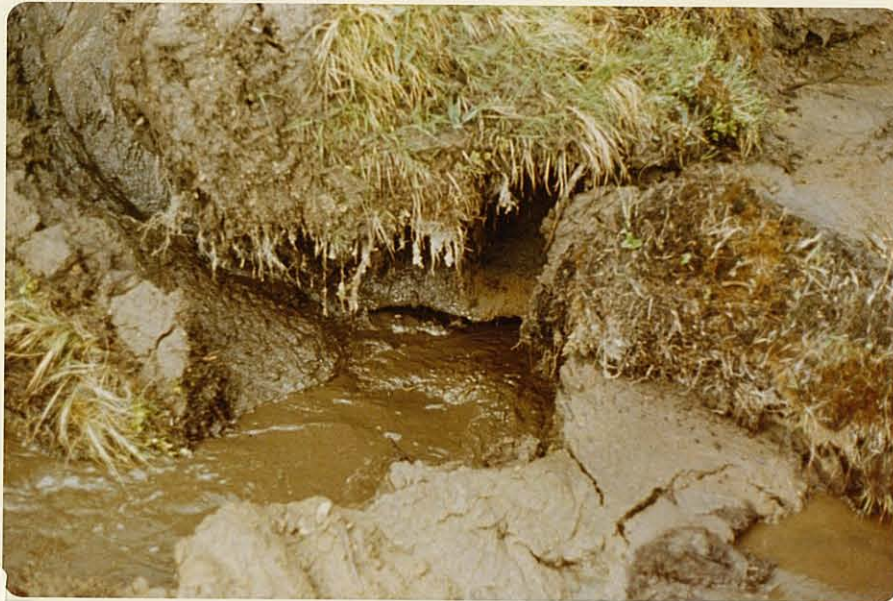
Photo No. 3 - Active gully on Y-34 Fire area showing melting ice lenses and sediment laden water. Note that water is emerging from a tunnel formed in melting ice lenses.

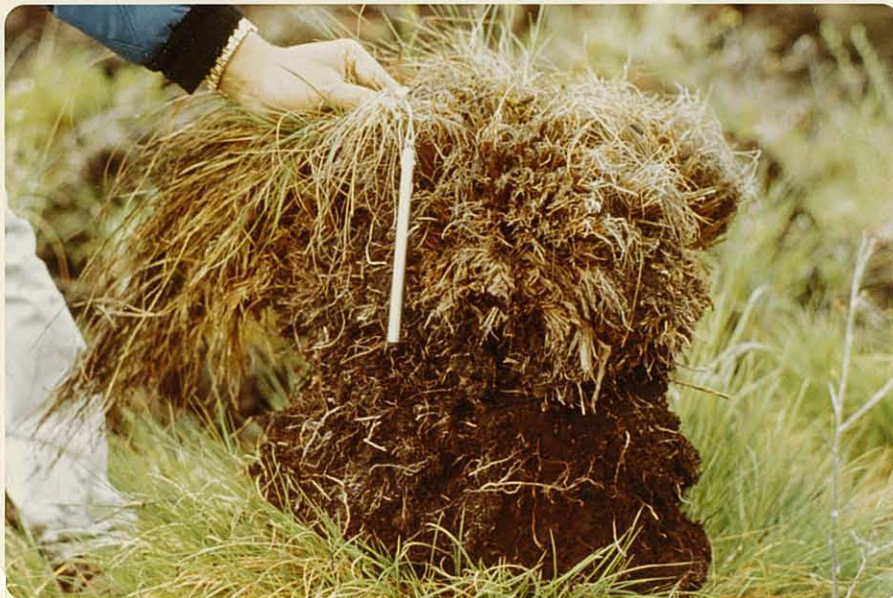
c. The Goldstream Soil is found on the bottoms of upland valleys, low terraces and alluvial fans. The vegetation consists of black spruce, low shrubs, mosses, and sedge tussocks that are about 12 to 18 inches high and about 12 inches in diameter. (Photo #4 depicts these tussocks). Elevations range from 600 to 1200 feet and the average frost free season is 108 days.

Photo No. 4 - Sedge tussock commonly found on the Goldstream soils -- Y-34 Fire area.

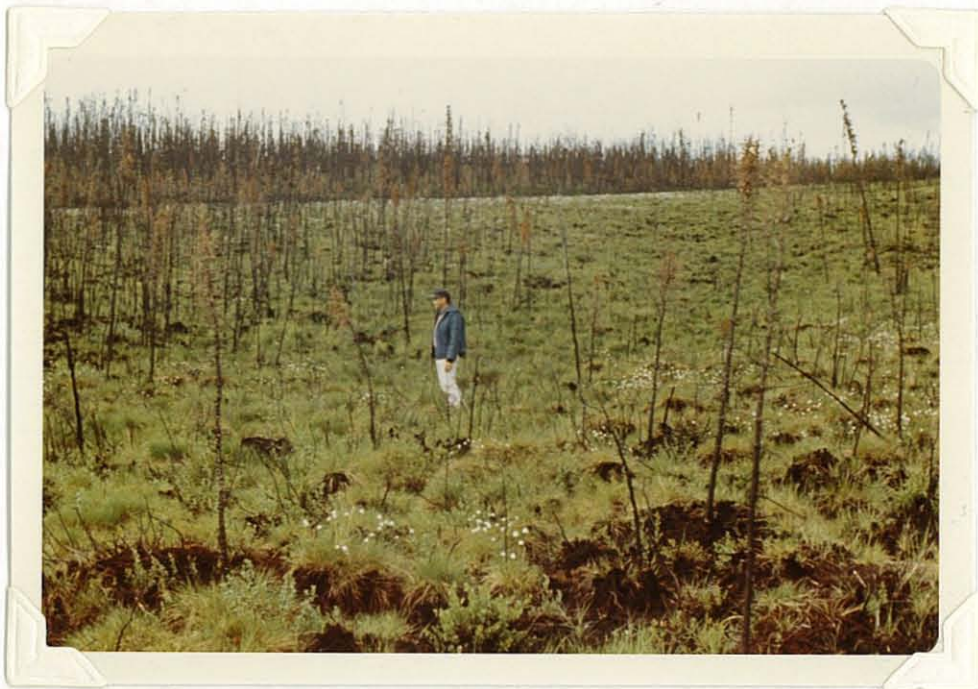
5. Most of the 1966 burns (excluding dozer fire lines) are well covered by grasses (calamagrostis). (See Photo No. 5).

Photo No. 5 - Looking upstream at a small drainage in Y-34 Fire area. Note the reproduction of grasses and sedges. Photo taken at junction with drainage shown in Photo No. 6.

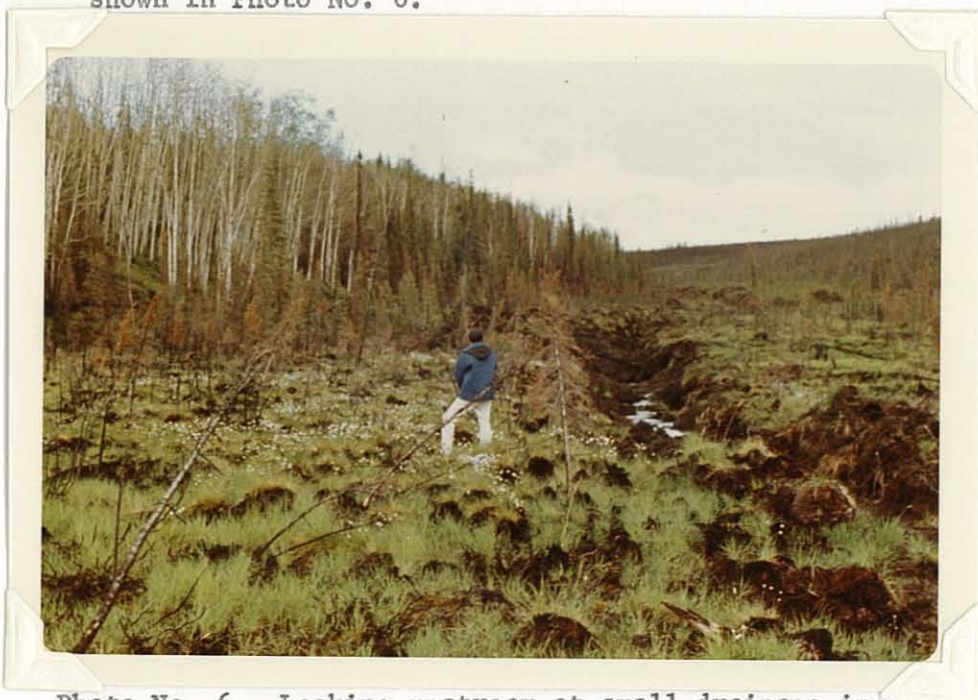
Photo No. 6 - Looking upstream at small drainage in Y-34 Fire area where fire line was constructed. Photo No. 5 was taken from same point but to the left up adjacent drainage.

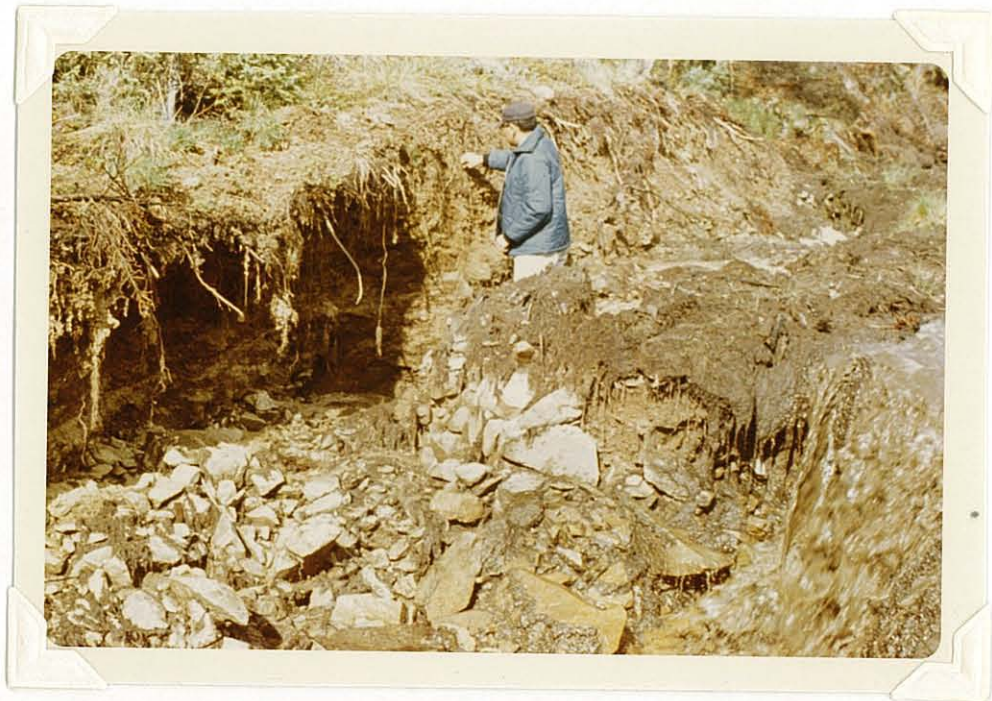
3. Fire lines constructed by dozers on south slopes, ridges, points, and other well drained, warmer sites have very little erosion even on steep slopes. (Photo No. 7 shows a well drained soil on south slope - however, cleared line in drainage bottom has eroded to bedrock).

Photo No. 7 - Shows a well drained soil on south slope -- Y-34 Fire area. Fire line constructed in drainage bottom adjacent to slope has eroded down to bedrock.
