SUSITNA-WATANA HYDROELECTRIC PROJECT
 LINEAMENT GROUP 20
 MAP DATA

FIGURE
 A20.1

79_218900_Alaska_Railbelt/2189_Lineament Report October 2013, modified 10.18.13

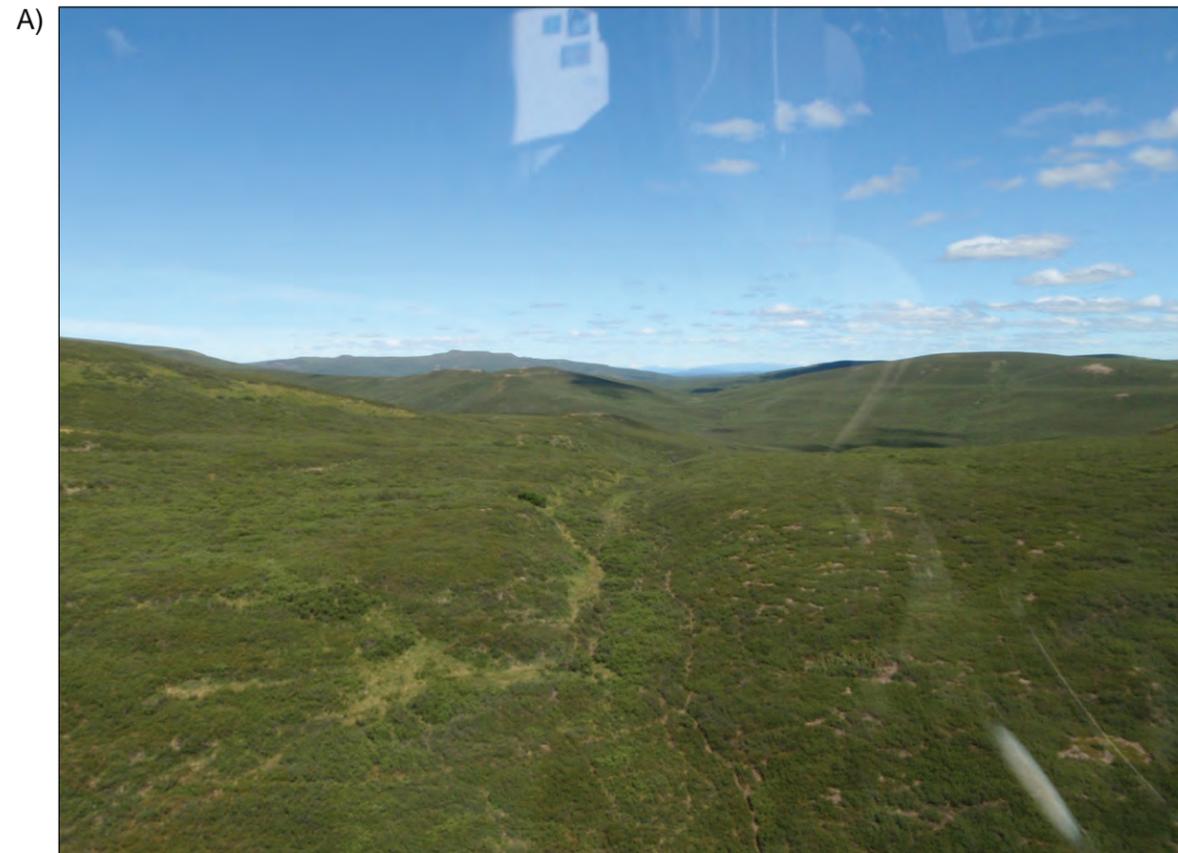
Photograph looking northeast from location A.

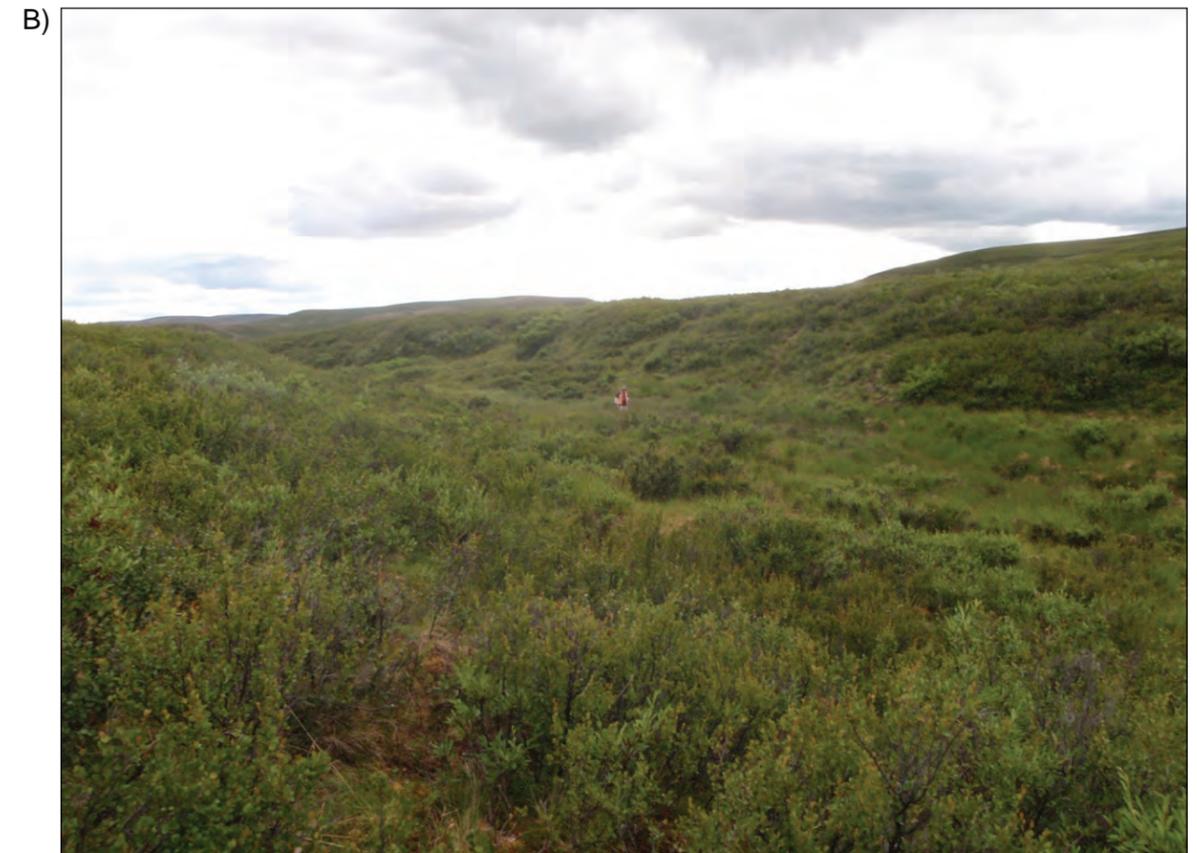
Photograph looking west-southwest from location B. Geologist standing in 3- to 6-m deep and ~30-m-wide swale. Swale only exists in saddle; it does not continue down either side of saddle.

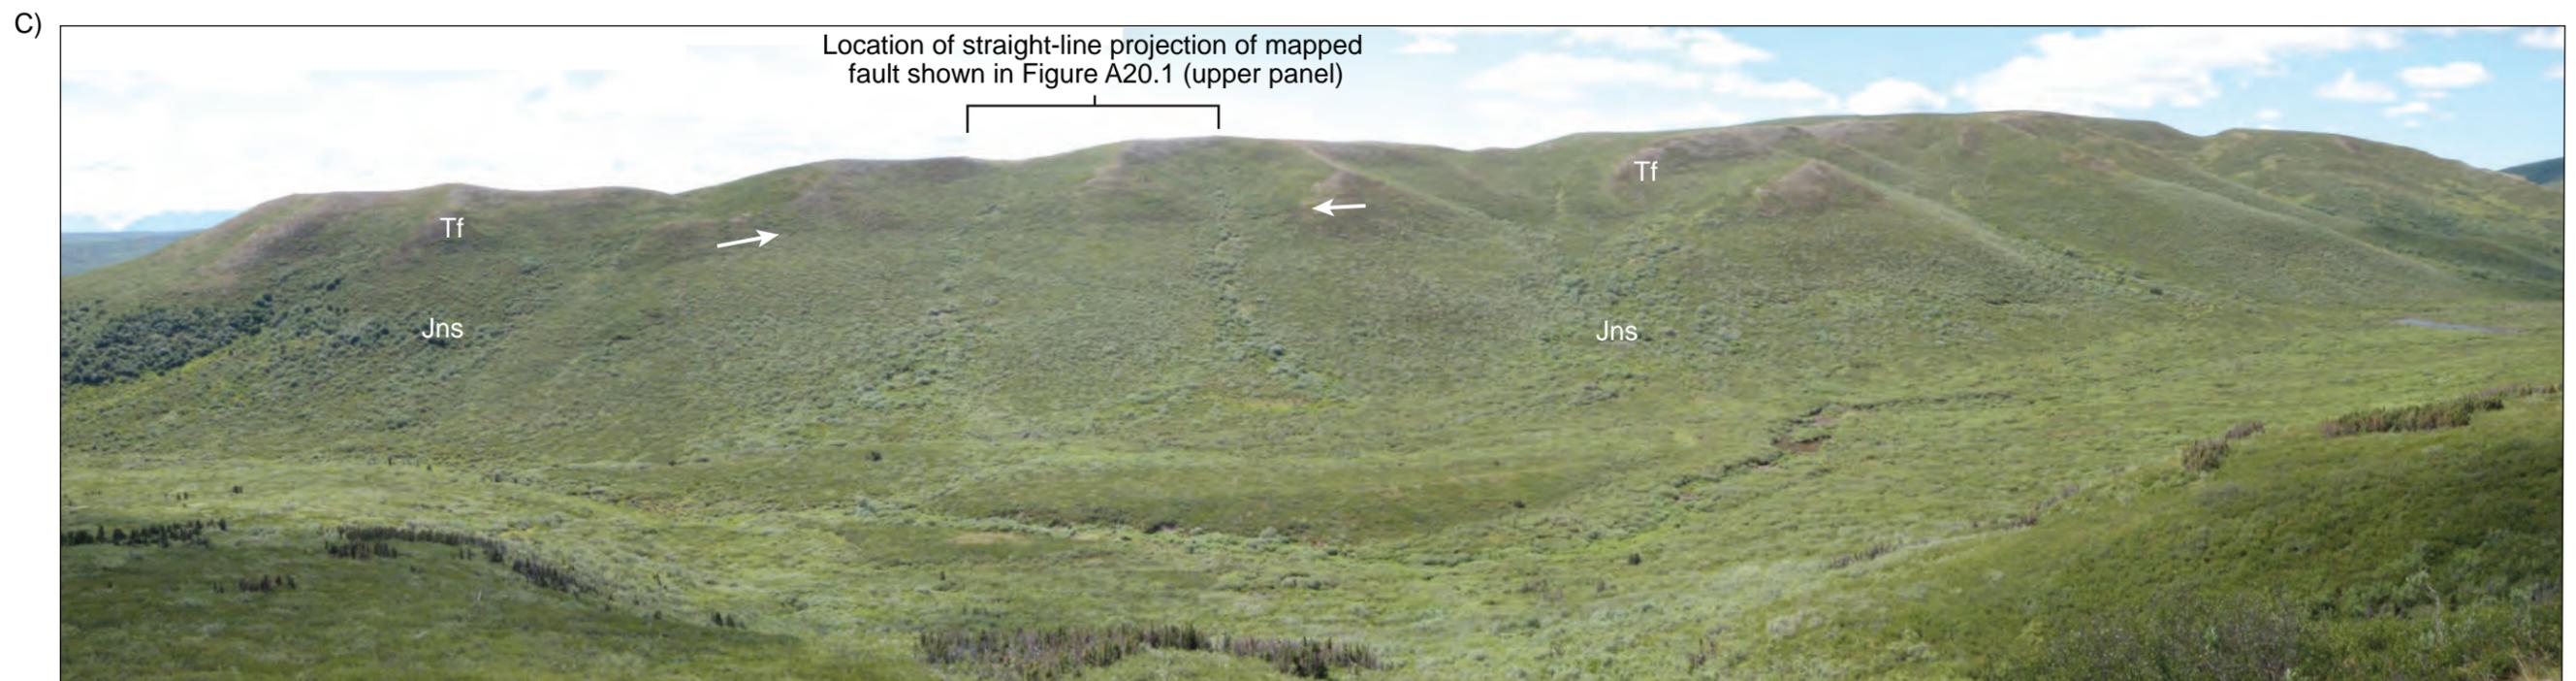
Photograph looking southwest from location C. Basal contact shown by arrows. Note that base of contact is not apparently deformed along projection of fault and that no expression of faulting in valley bottom is apparent.

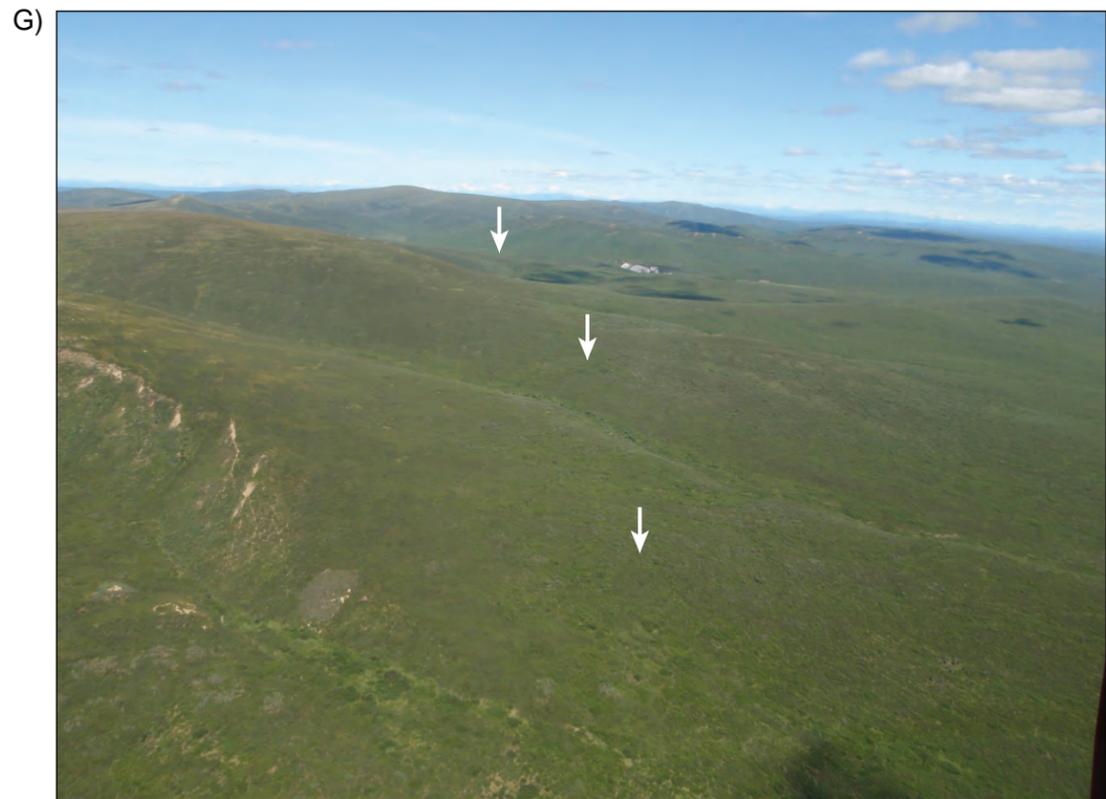
Photograph looking north from location G along mapped fault of Grantz (1960). Arrows point to approximate location of mapped fault. Note absence of apparent geomorphic expression fault.

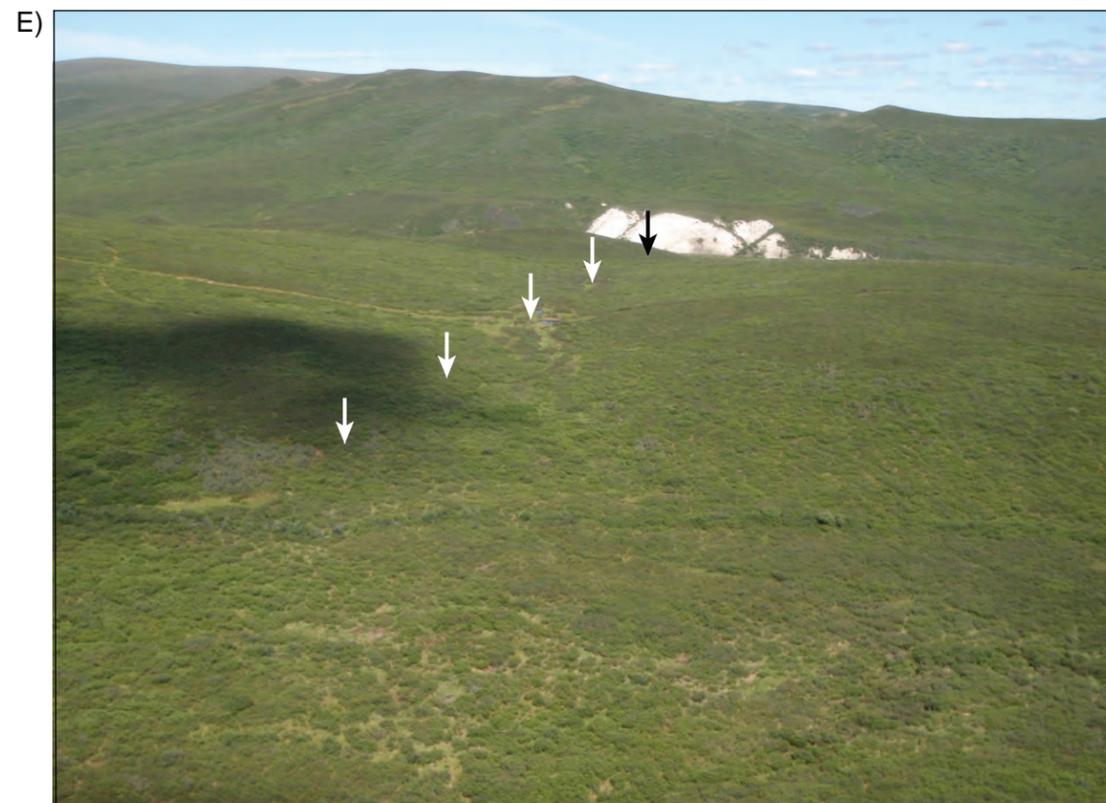
Arrows show location of FCL mapped lineament (shallow U-shaped swale). Note no apparent deformation of white-bedded sediments (glacial lake sediments) along projection of lineament.

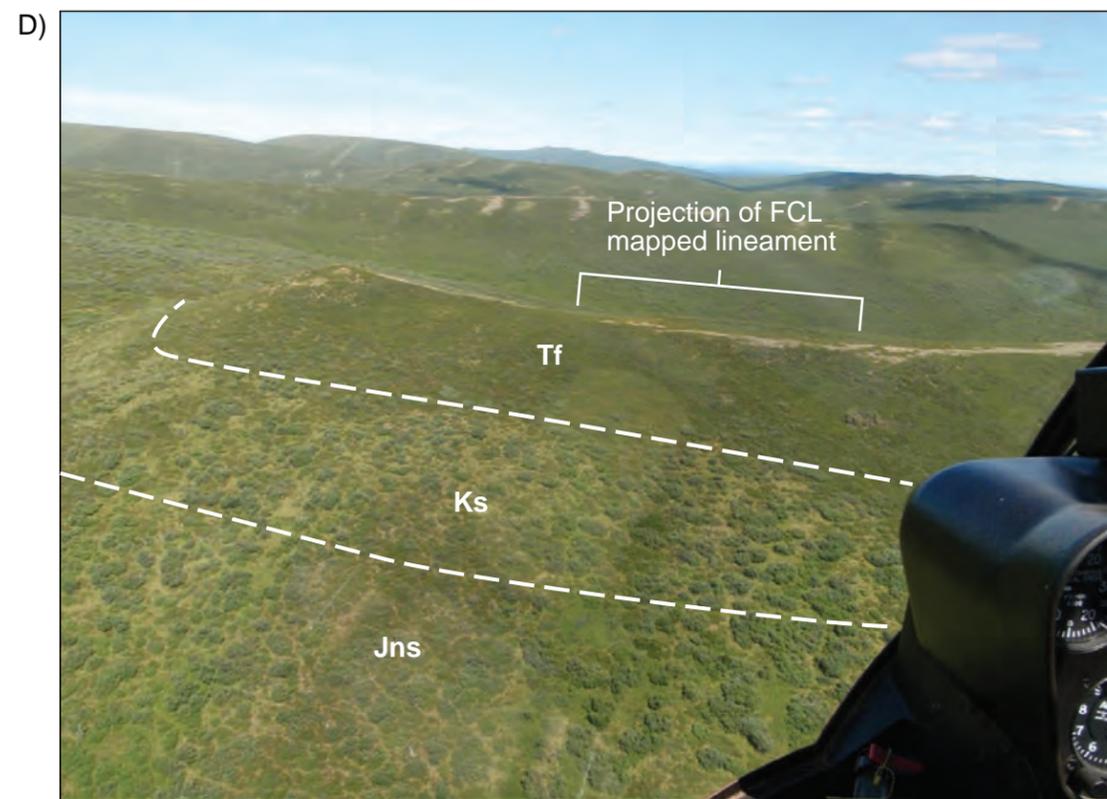
Photograph looking northeast from location D. Note absence of deformation in ridge line of Tf.

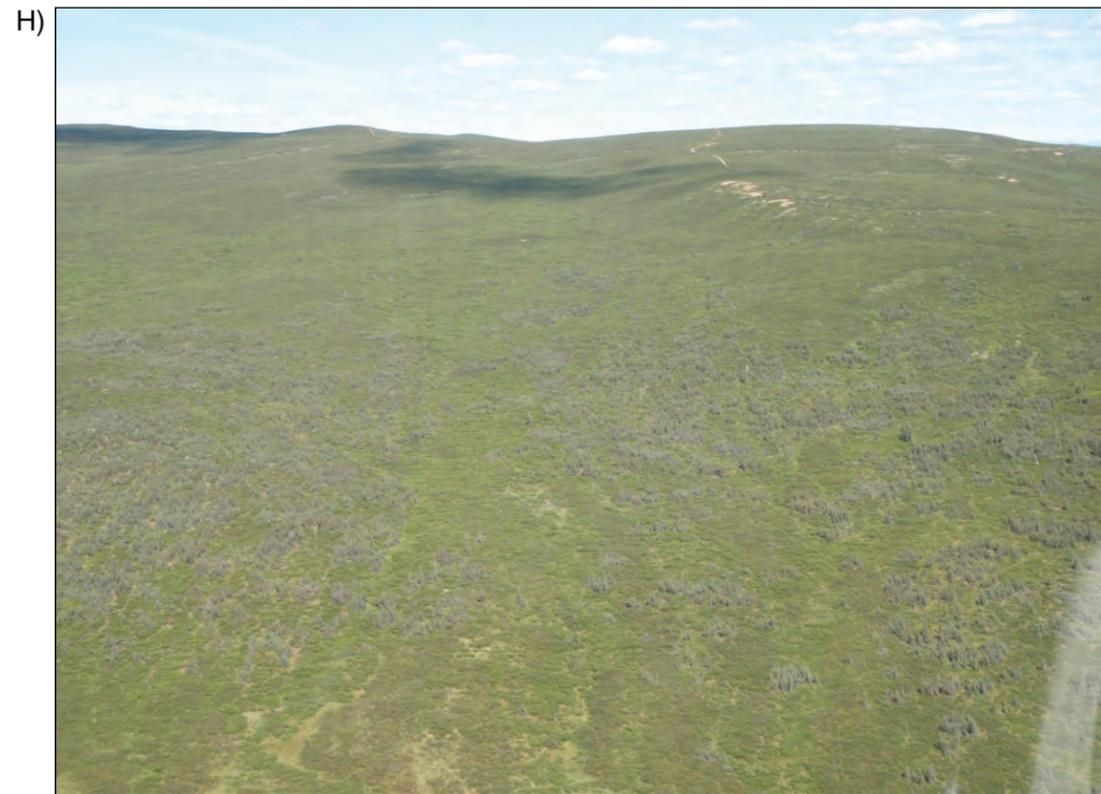
Photograph looking north-northeast from location H along queried mapped fault of Grantz (1960) that lies outside of lineament group. Note absence of fault expression.

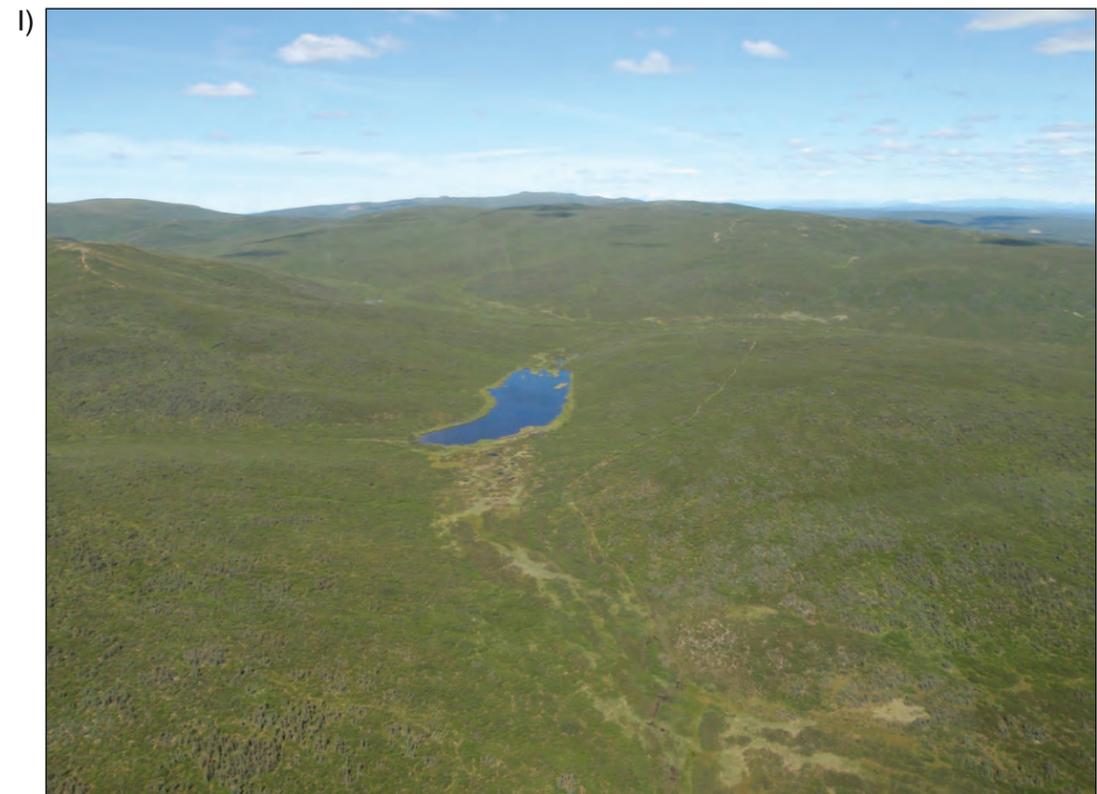
Photograph looking north-northeast from location I along queried mapped fault of Grantz (1960) that lies outside of lineament group. Note absence of fault expression.

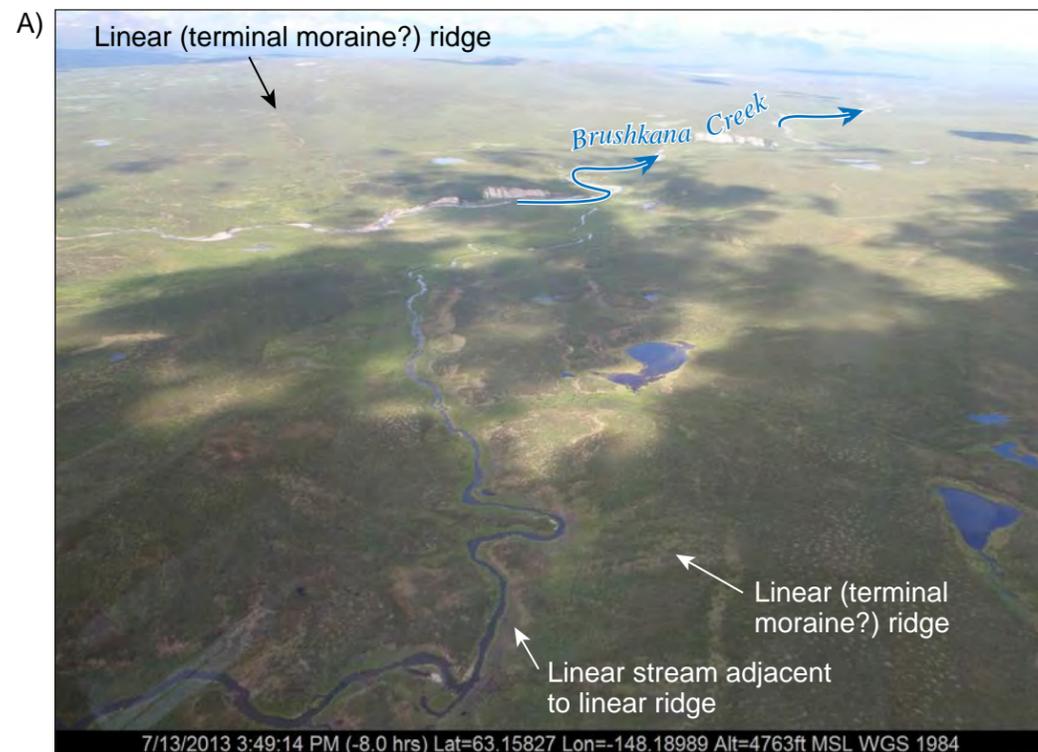
View looking north across Brushkana Creek along north-trending linear ridge and roughly linear stream. Arrows point along alignment of ridges interpreted to be terminal moraine from northeasterly flowing ice.

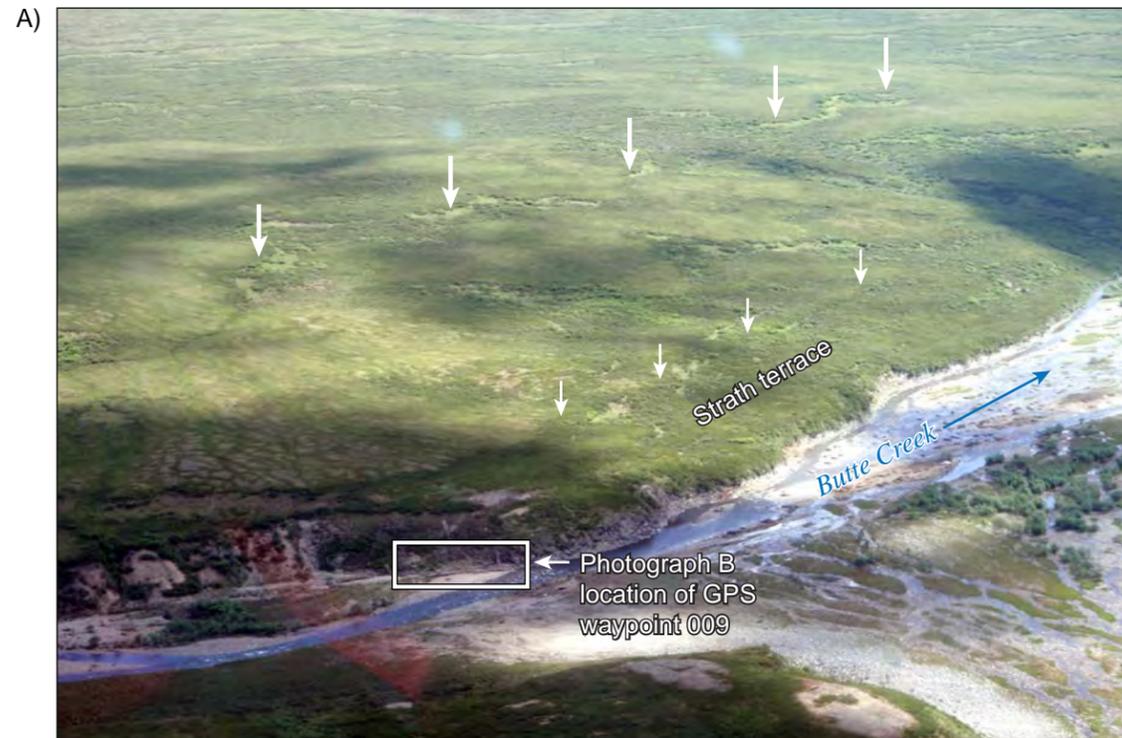
Photograph looking east from location A. Large arrows point to downhill facing slope break visible in INSAR and mapped by Fugro (2013). Field reconnaissance revealed smaller lineament (not visible in INSAR data) lies along the small arrows and projects toward the vertically-dipping bedrock exposed in the creek bank shown in Photograph B.

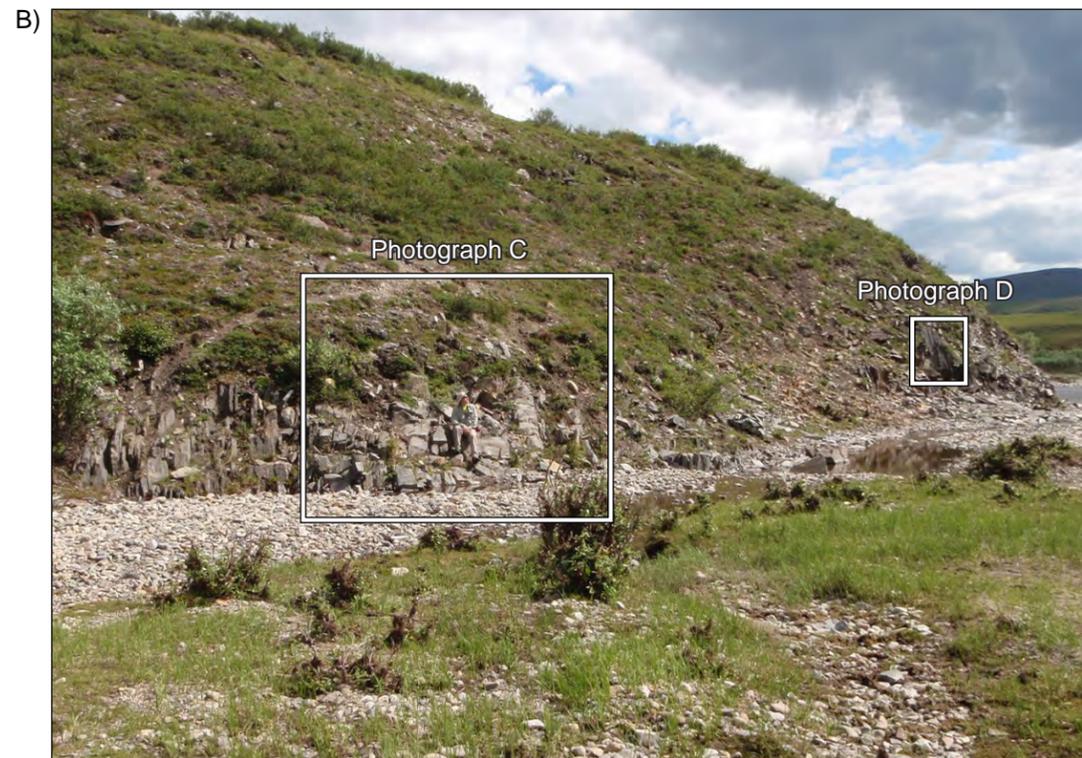
Overview of east-southeast striking, vertically-dipping phyllite exposures located at GPS waypoint 009.

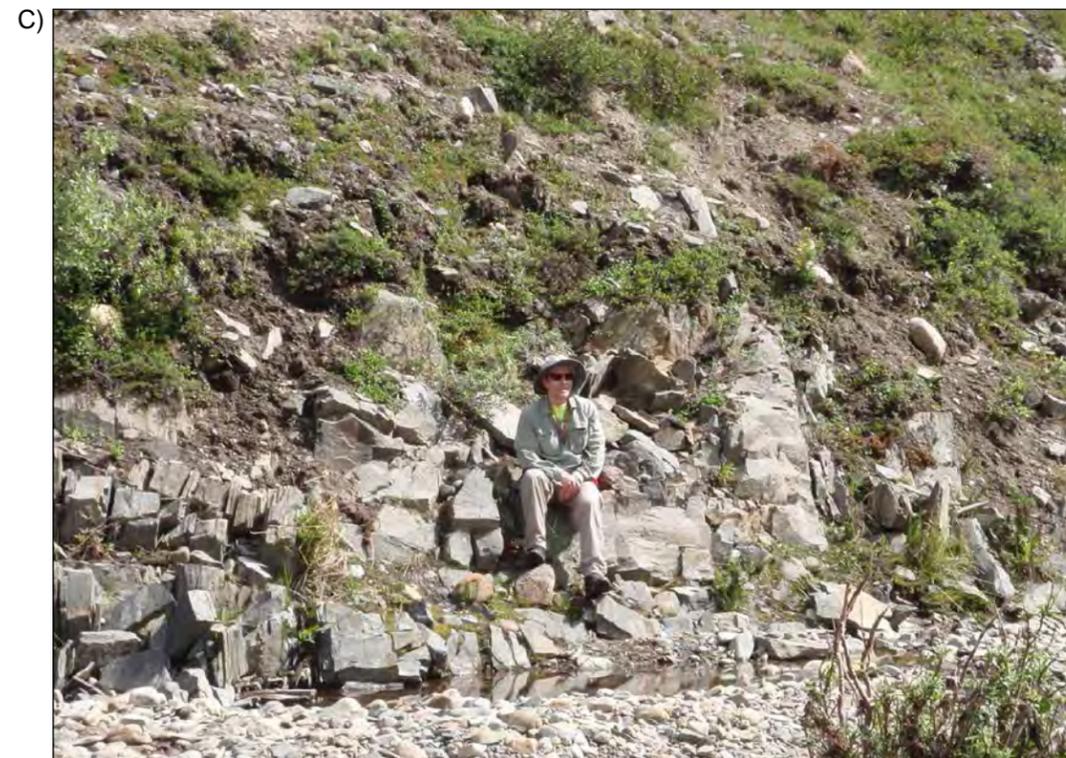
Detail of phyllite exposure showing ~3-meter-wide resistant bed of metamorphosed fine to medium sand. Thick, resistant beds, such as this, are interpreted to create the lineament shown by small arrows in Photograph A above. Geologist for scale.

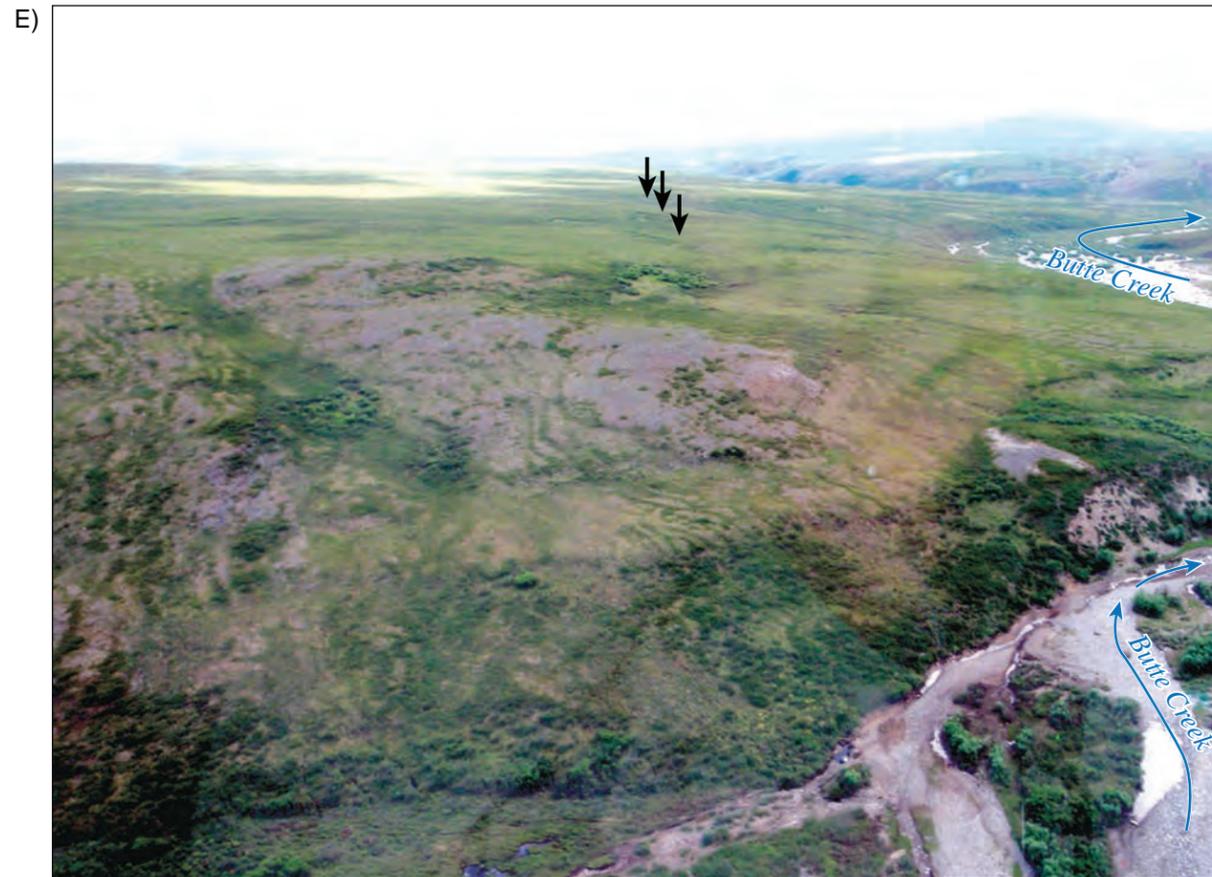
Photograph taken from location E looking east-southeast along trend of FCL mapped lineament (shown by arrows). Note absence of any apparent deformation in surficial deposits or in terrace riser on left bank of Butte Creek.

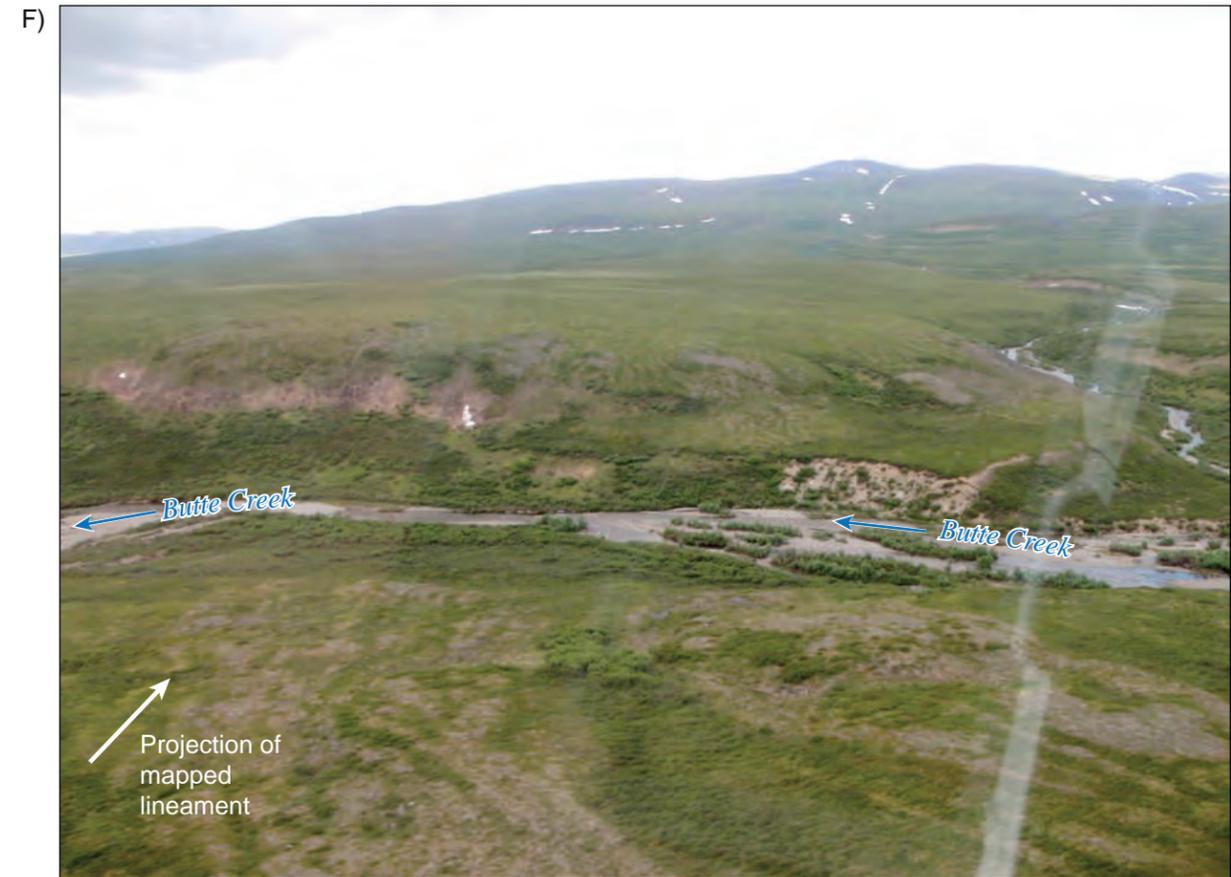
Photograph taken from location F looking west along trend of FCL mapped lineament to west of Butte Creek. Note no apparent deformation in right bank of stream or any expression of faulting in broad, flat terrace surface mapped as Qdt3 by Smith et al. (1988).

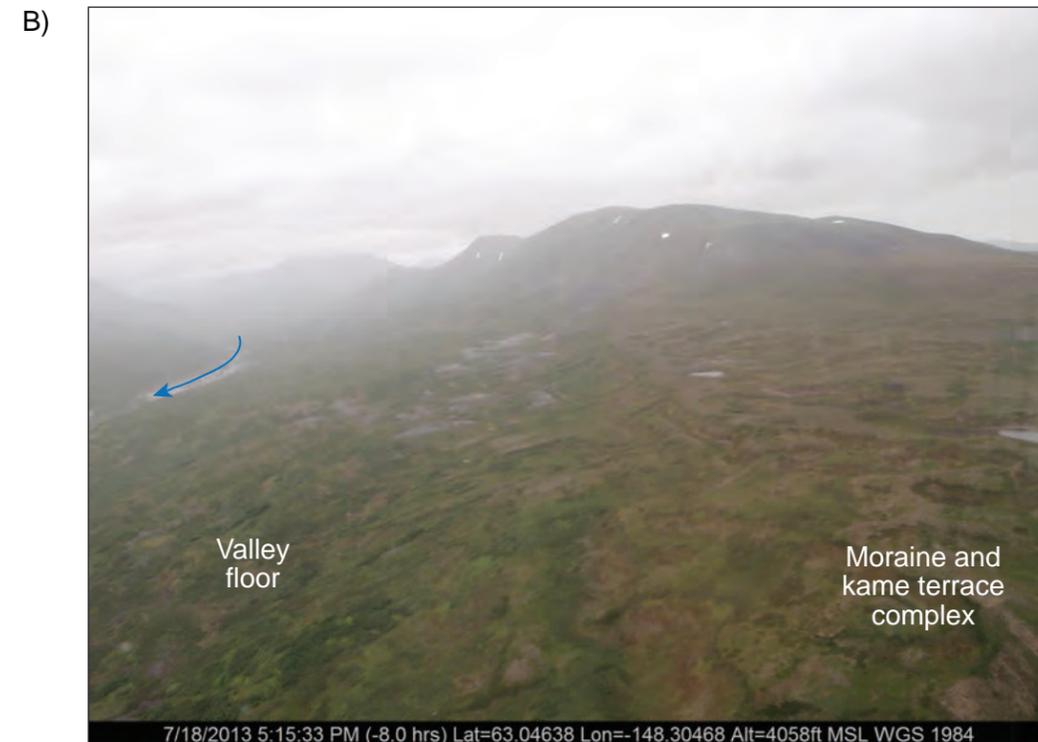
View looking north-northwest up-valley along the margin of the left-lateral moraine and kame terrace complex. No lineaments were observed cutting these deposits.

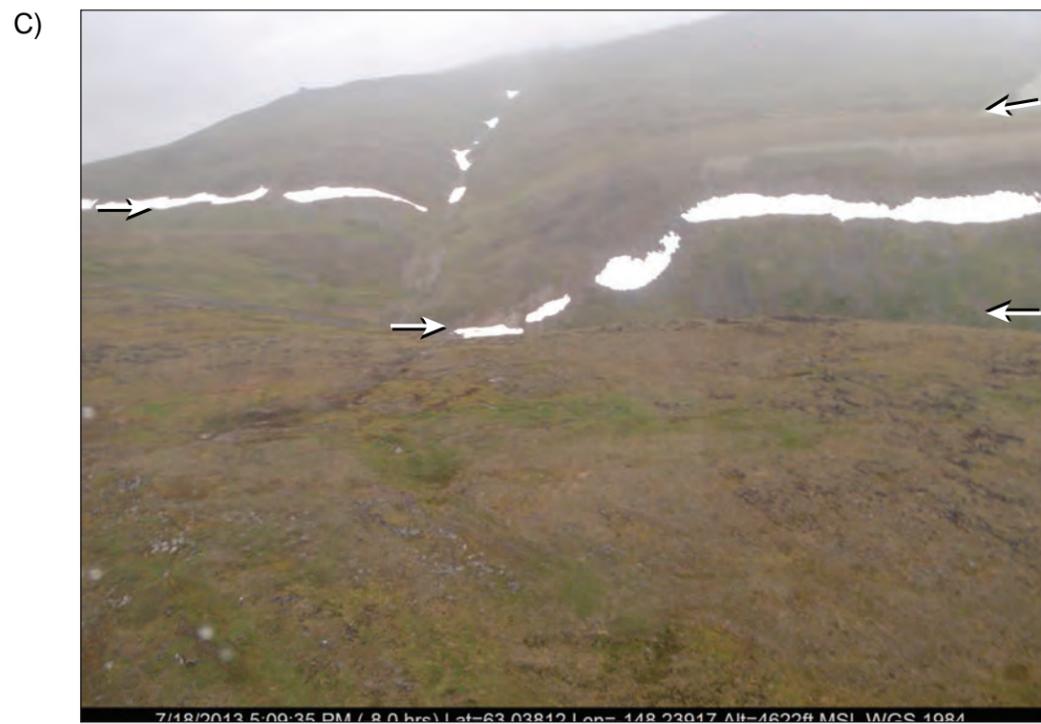
View looking north at deep drainages whose margins coincide with nivation terraces and hollows. The large size of these drainages is inconsistent with the weakly expressed lineaments located east of Deadman Creek. Such deeply incised drainages are interpreted to be a result of sub-ice erosion.

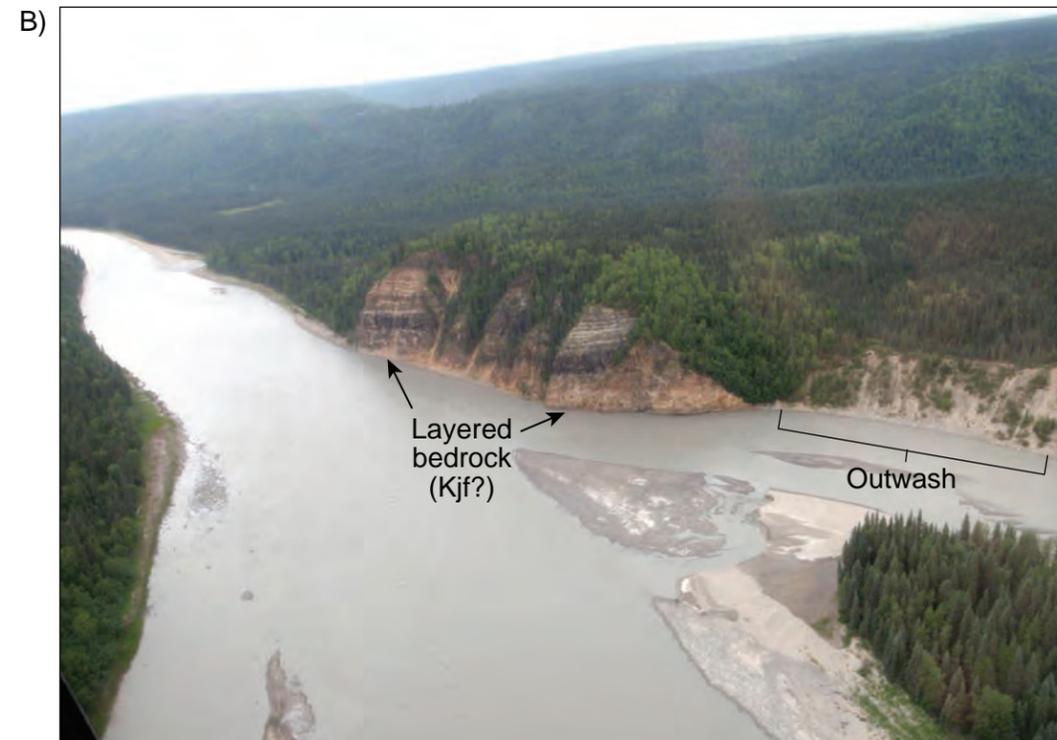
View looking northwest at layered bedrock (on left) with apparently undisrupted horizontally-bedded outwash (on right).

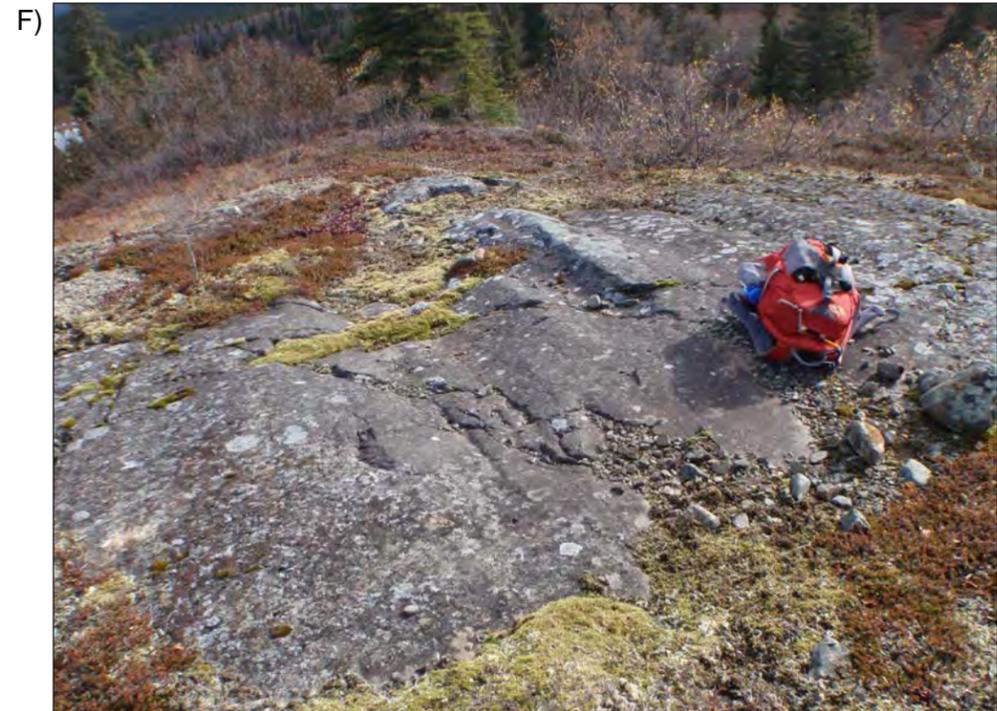
Photograph of fluted ice-scoured rock surface with cracks and joints.

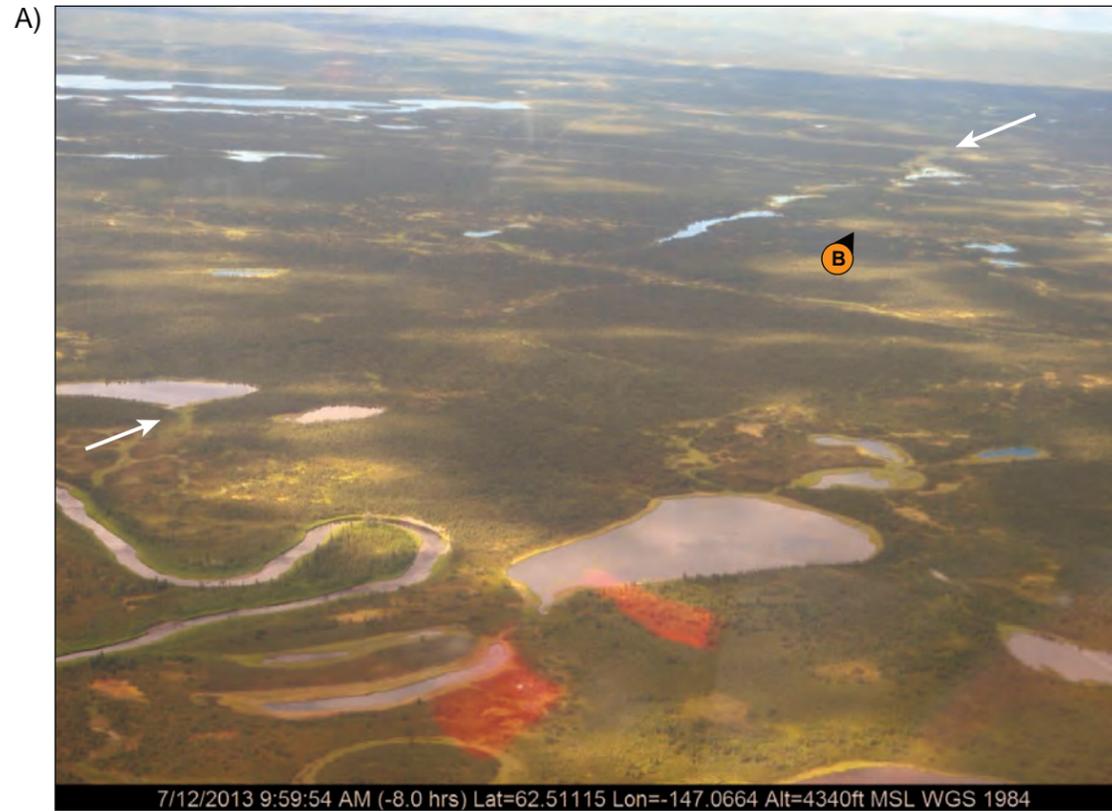
View looking west-southwest toward linear alignment of lakes. Arrows point along lineament. Note kettle lake terrain in the foreground.

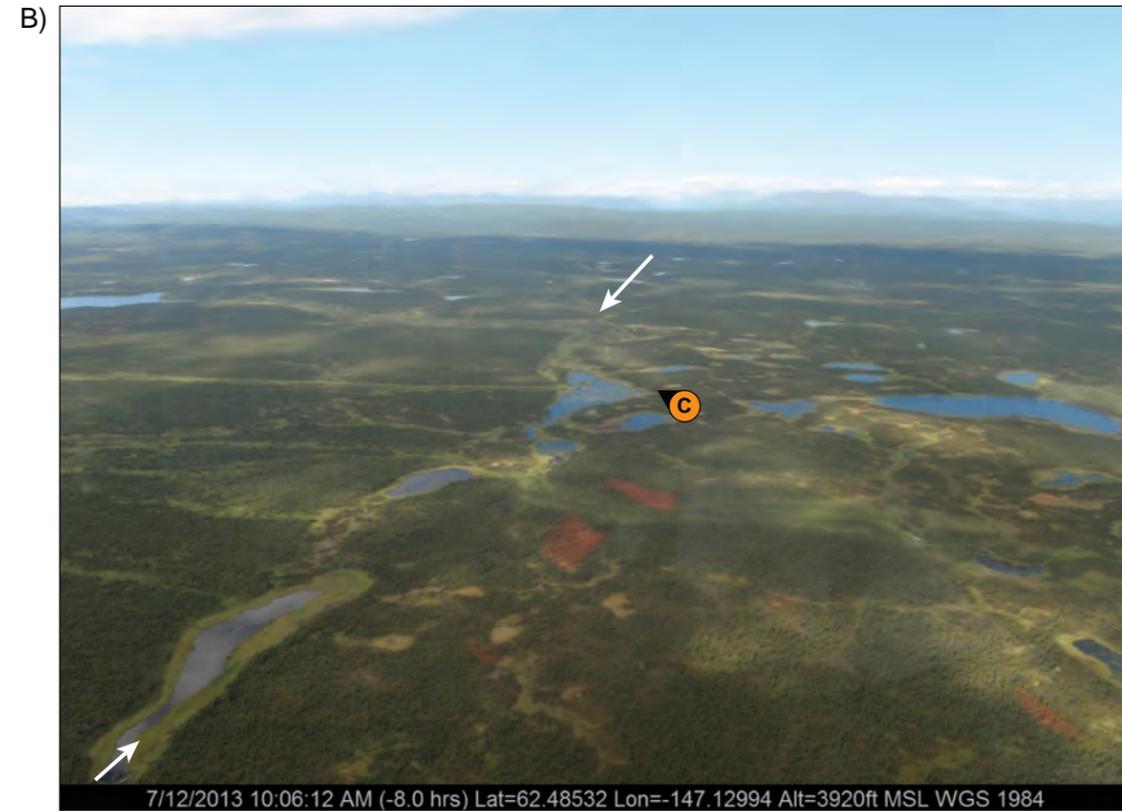
Close up view looking west-southwest along linear alignment of lakes in Photograph A. Arrows point along lineament.

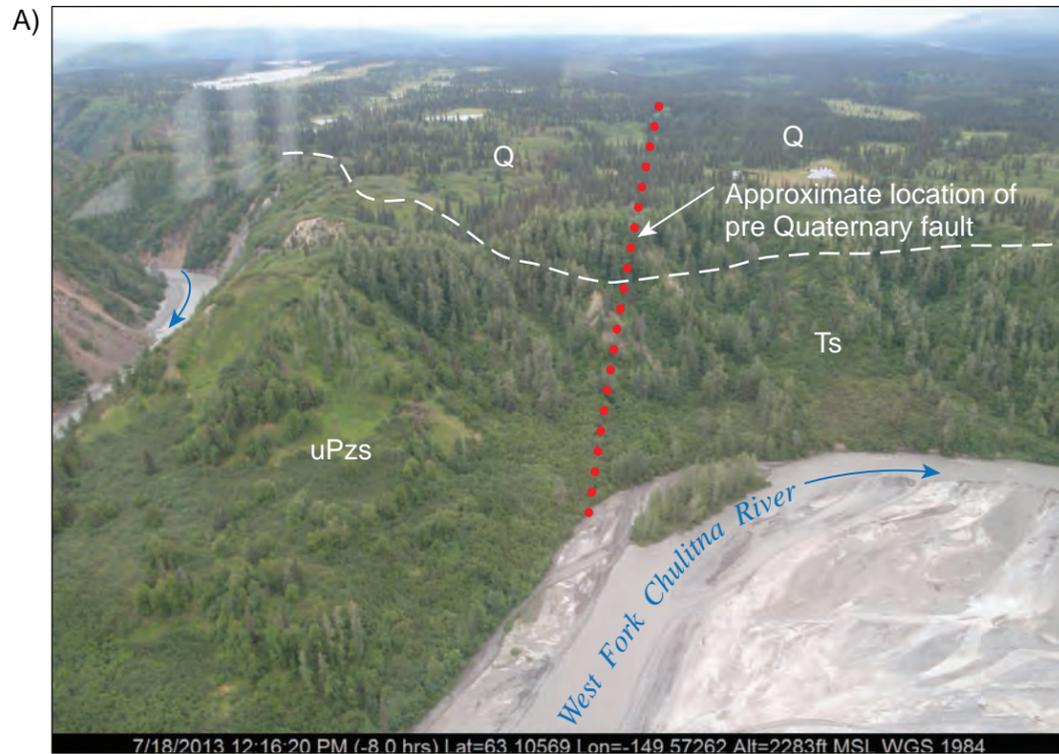
View looking north at location where mapped fault would traverse across Quaternary sediments.

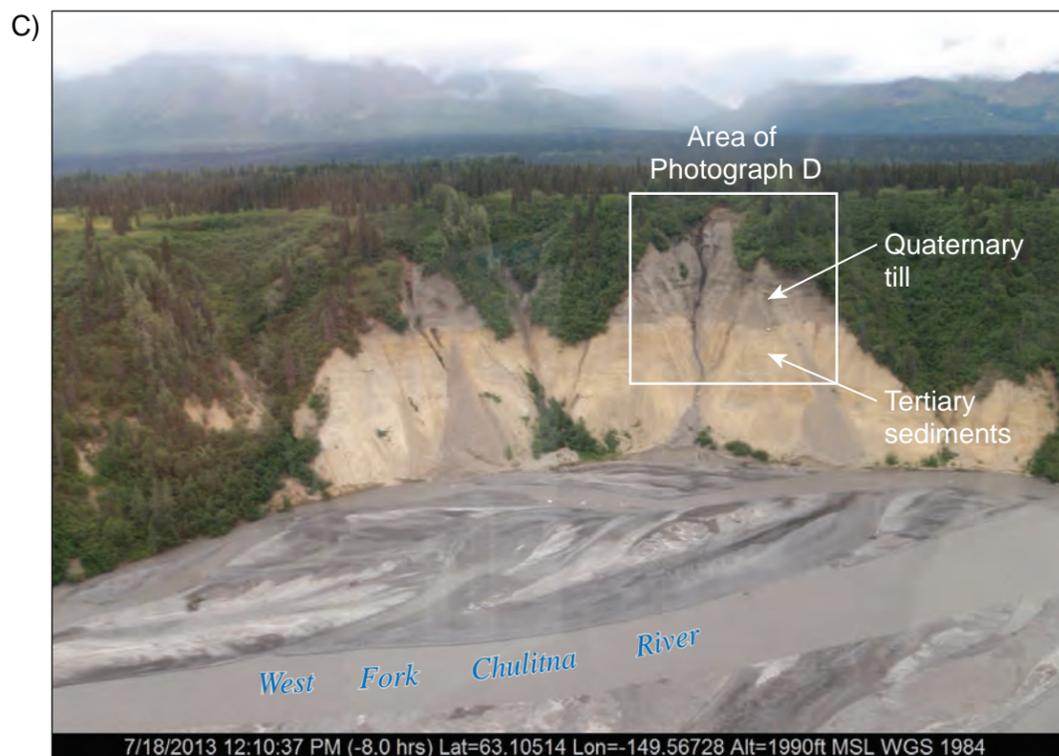
View looking west at exposure along east bank of the West Fork Chulitna River demonstrating Quaternary till overlying Tertiary fluvial sediments.

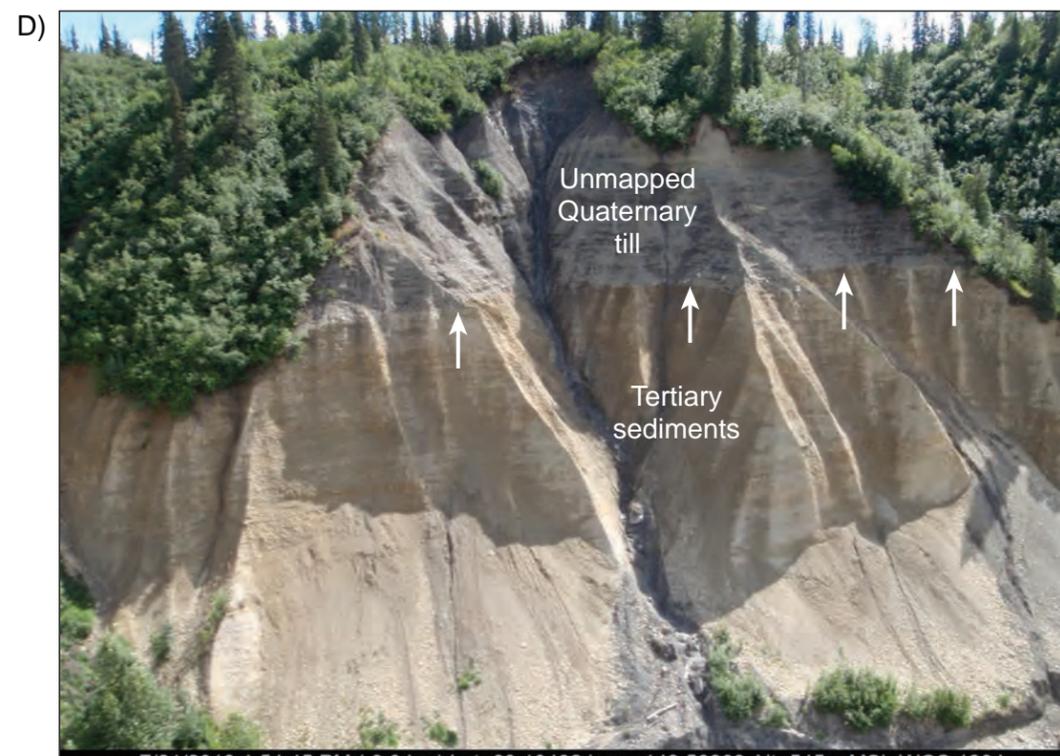
Close up view of exposure shown in Photograph C. Basal contact between overlying till and underlying fluvial deposits appears to be sub-horizontal.

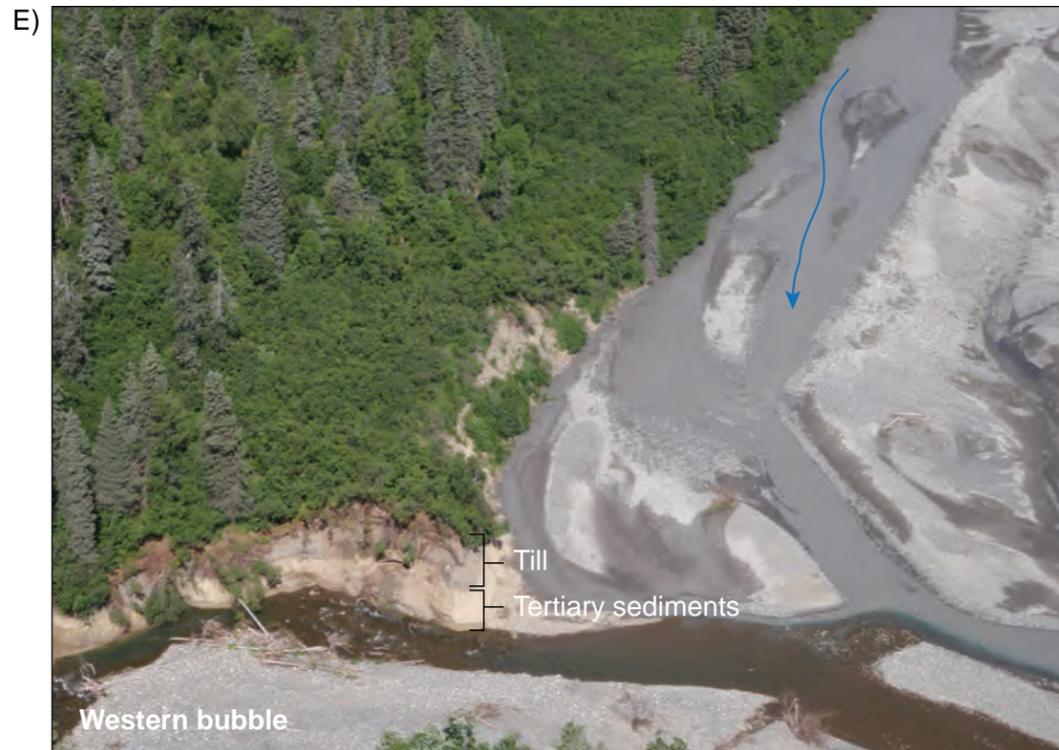
View looking northeast at subhorizontal contact between till and Tertiary sediments.
