SUSITNA-WATANA HYDROELECTRIC PROJECT
 LINEAMENT GROUP 20
 MAP DATA

FIGURE
 A20.1

79_218900_Alaska_Railbelt/2189_Lineament Report October 2013, modified 10.18.13

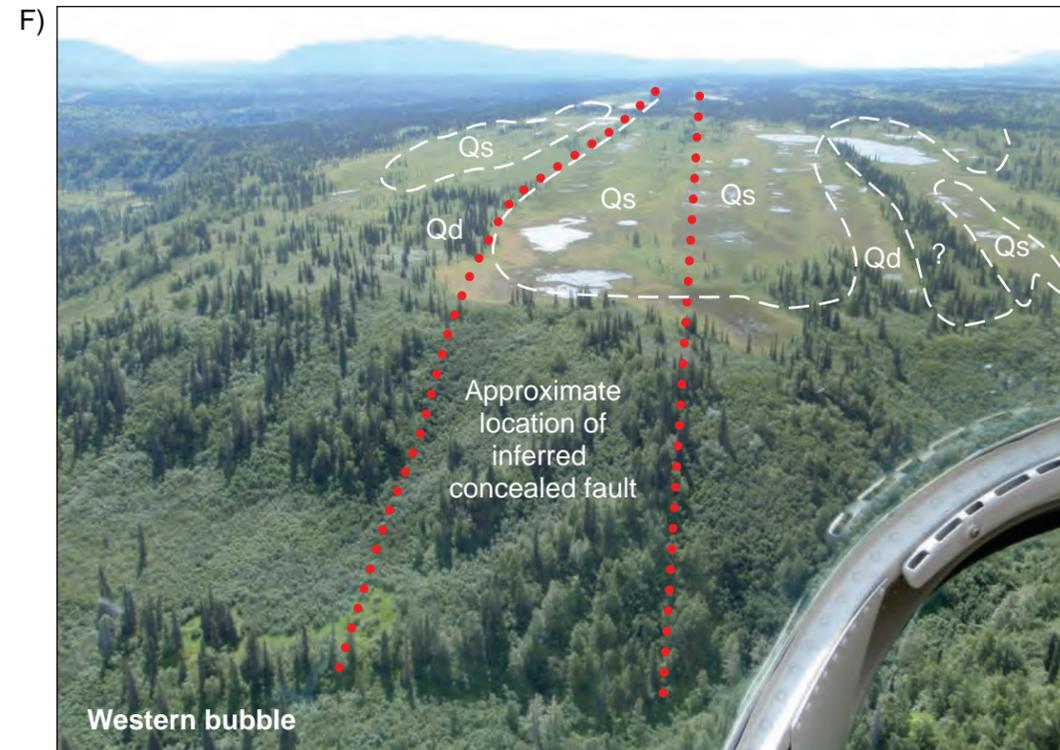
View looking south along Quaternary surface directly south of river valley. Marshy Quaternary sediments show no evidence of deformation or offset.

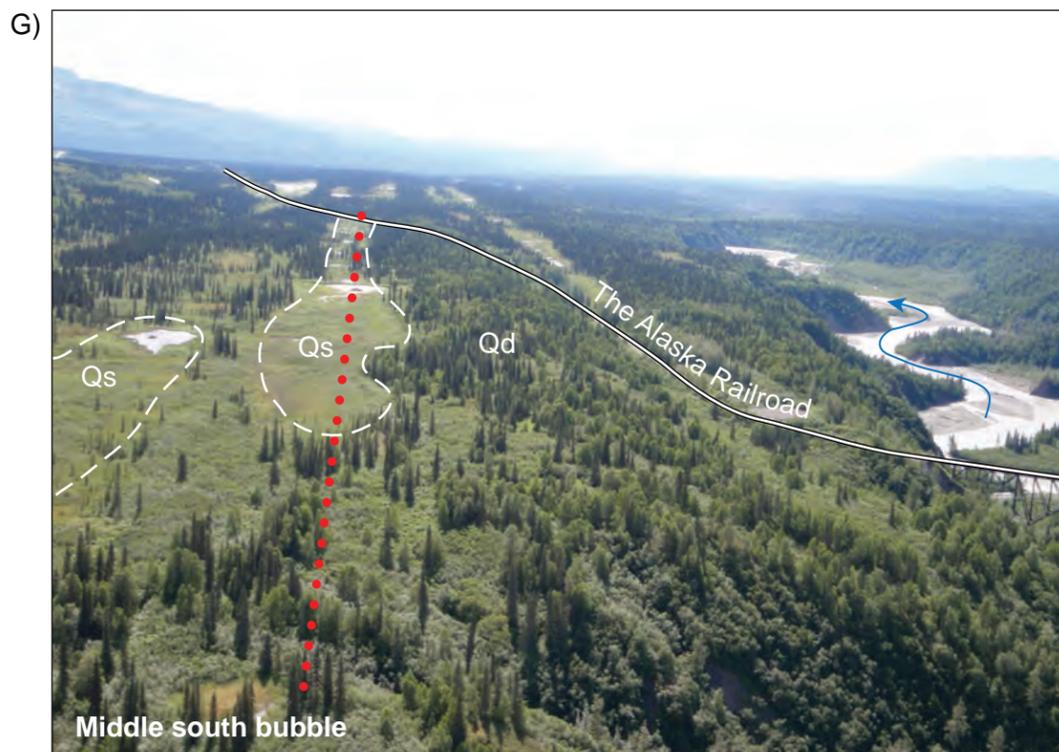
View looking south at location where inferred fault would traverse east of railroad tracks. Fault is mapped as juxtaposing Triassic and Cretaceous rocks outcropping in creek behind photograph. No evidence of faulting in Quaternary deposits.

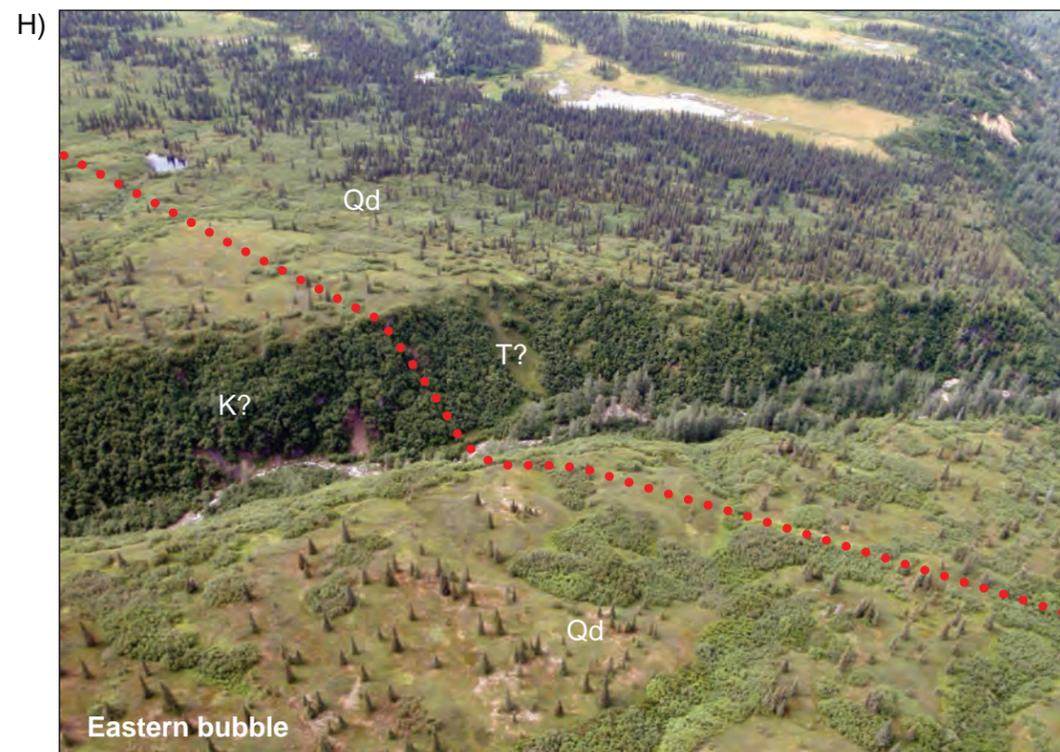
View looking west at creek exposure along projection of mapped fault that depicts Cretaceous/Tertiary juxtaposition. Undisturbed surfaces support absence of Quaternary faulting.

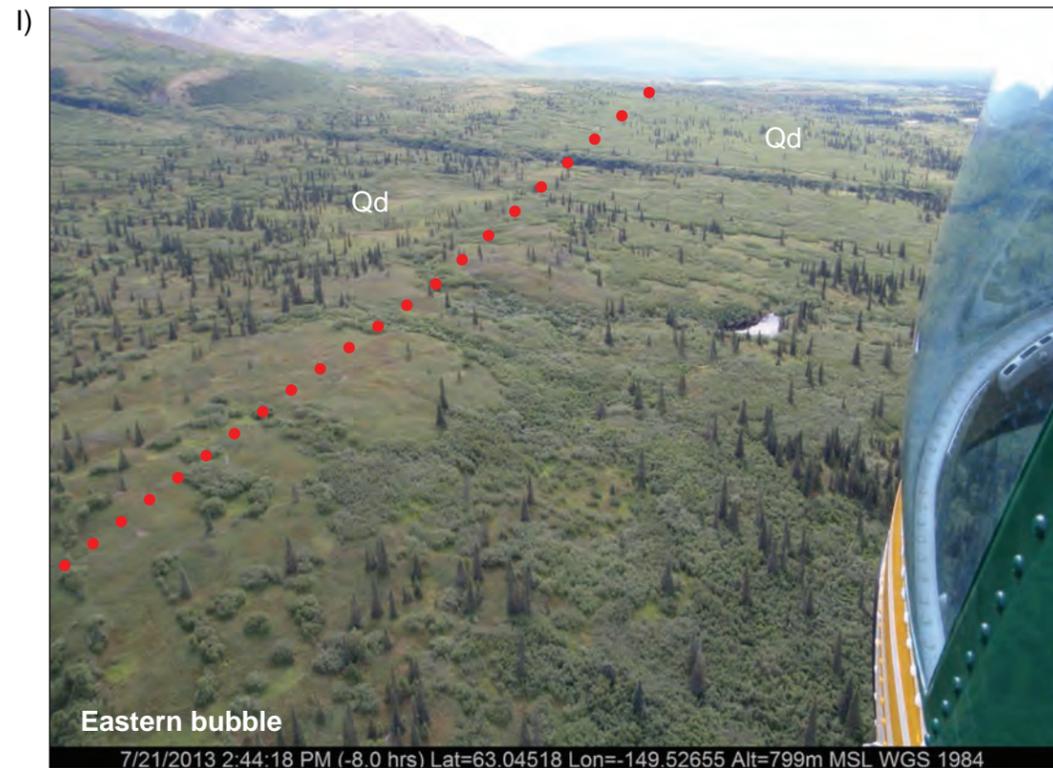
View looking west at creek exposure shown in Photograph H, Figure A-BP.2, showing morphology of Quaternary deposits along strike.

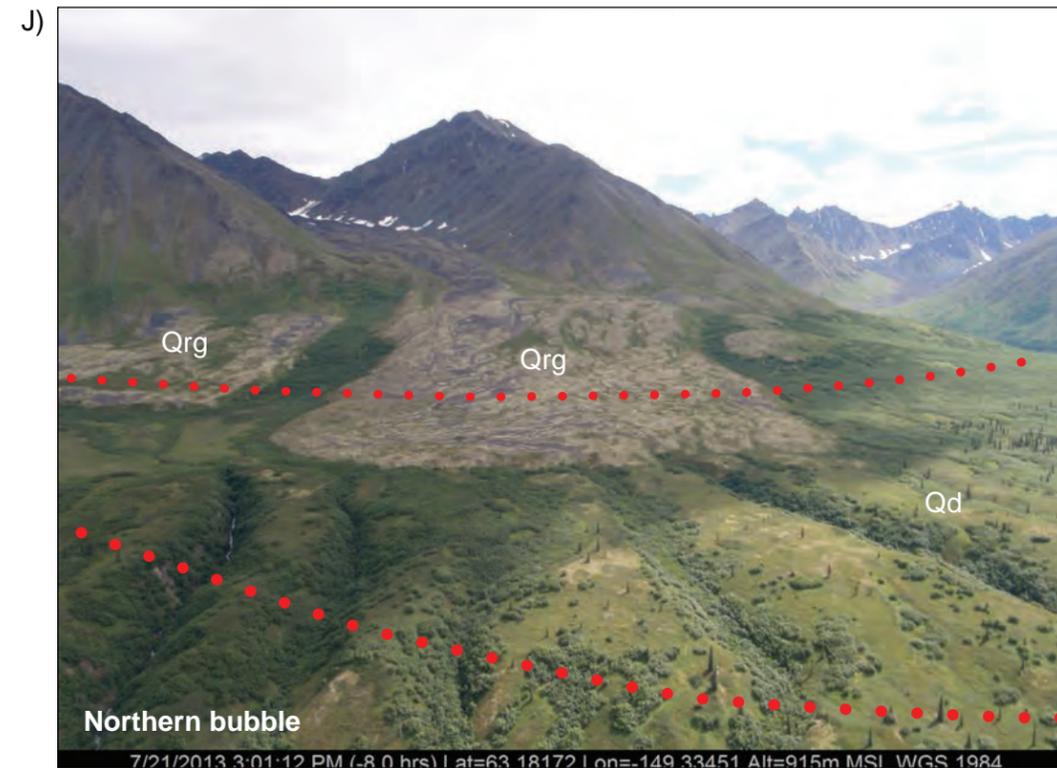
View looking east at uninterrupted interfluvial surfaces in dissected Quaternary glacial drift along with the mapped fault projects. Undisturbed surfaces support absence of Quaternary faulting.

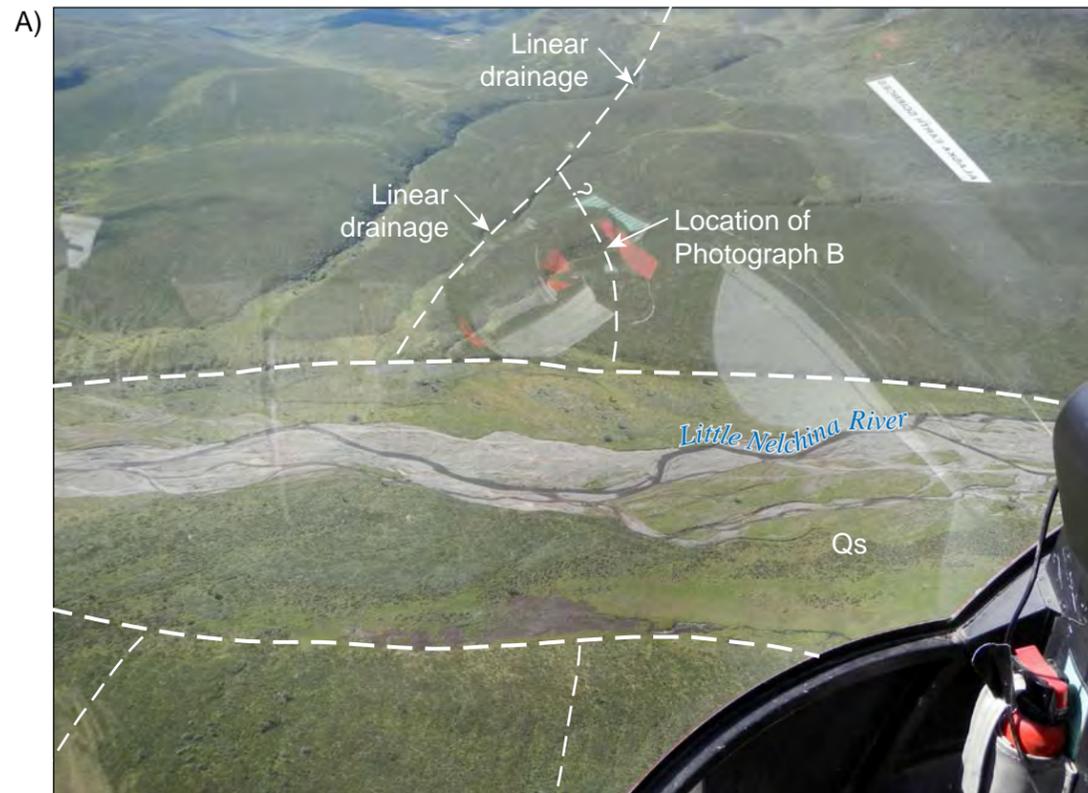
View looking southwest from location A, nearly along-strike with Csejtey et al. (1978) mapped faults. Note clear expression of linear features on bedrock landscape and absence of linear expression in Quaternary deposits.

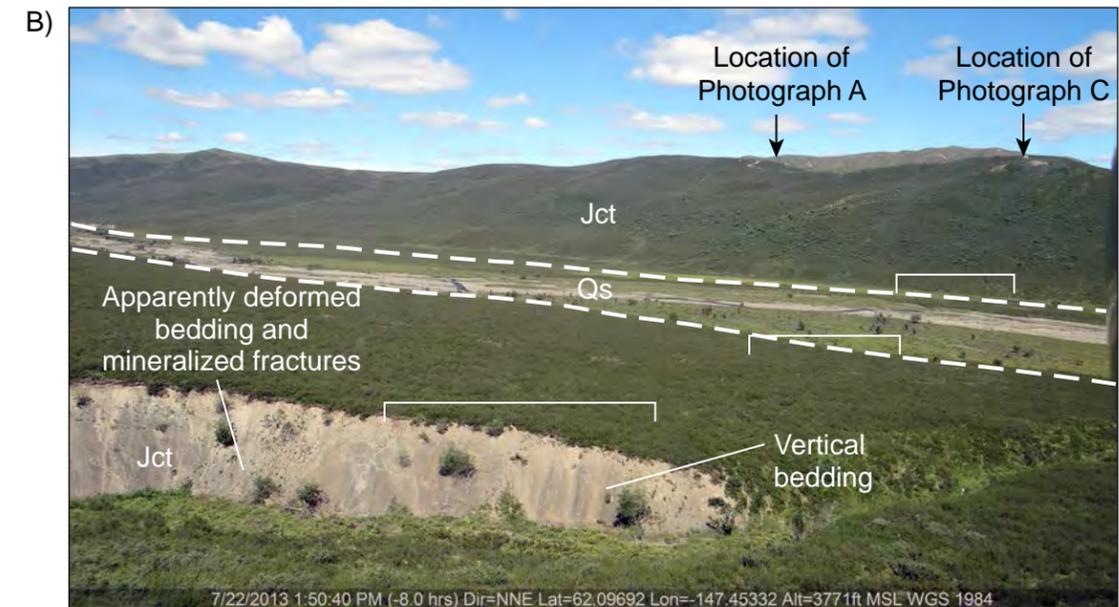
View looking northeast from location B nearly along-strike with Csejtey et al. (1978) mapped fault. The mapped fault segment projects through the vertical beds observed in the outcrop towards photograph location C. Note apparent undeformed hillslope and Quaternary deposits over projected trace of fault.

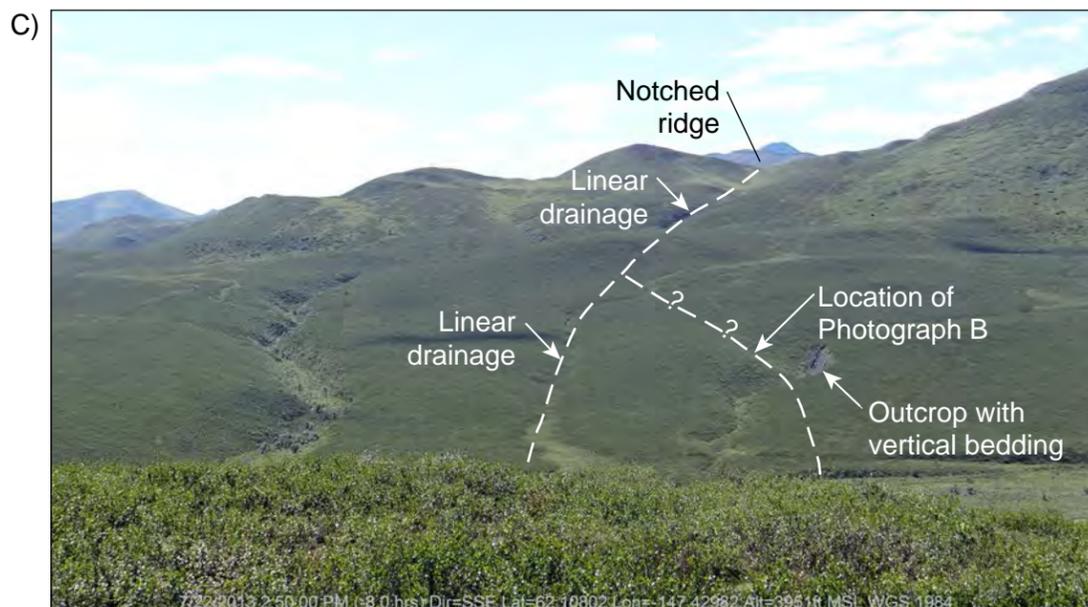
View looking southwest from location C. Note alignment of features over mapped trace of fault.

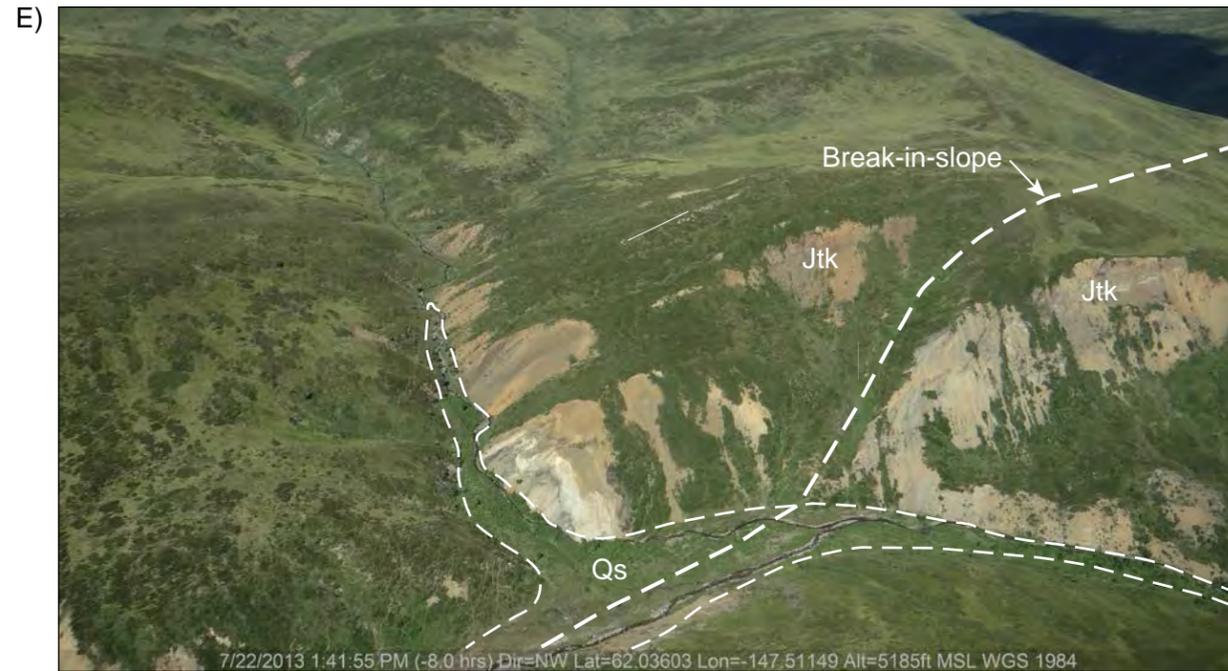
View looking northwest from location E at faulted Jurassic units. The fault occupies the linear valley then climbs the hill-slope where it correlates with a clear break-in-slope on the ridge crest.

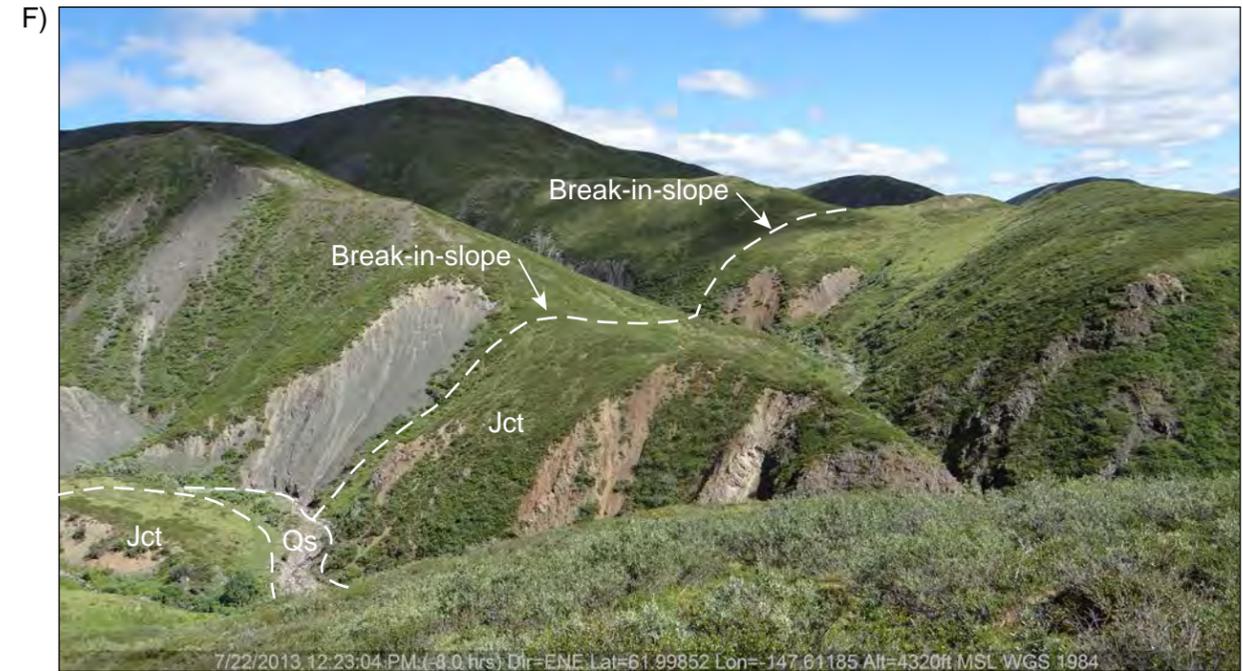
View looking north-northeast from location F. The fault juxtaposes Cretaceous against Jurassic bedrock and coincides with a break-in-slope on each ridge crest.

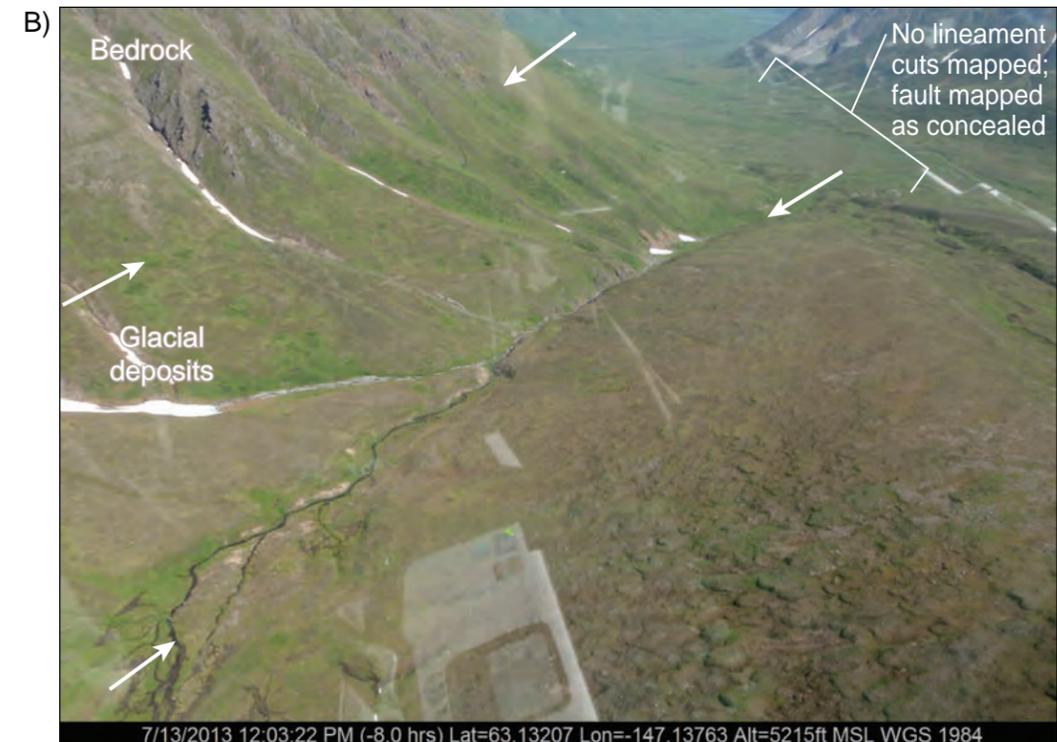
View looking northeast along linear drainage mapped as a lineament by FCL that coincides with a mapped fault. Another FCL-mapped lineament lies at the subtle break-in-slope and may correspond to the ice limit elevation.

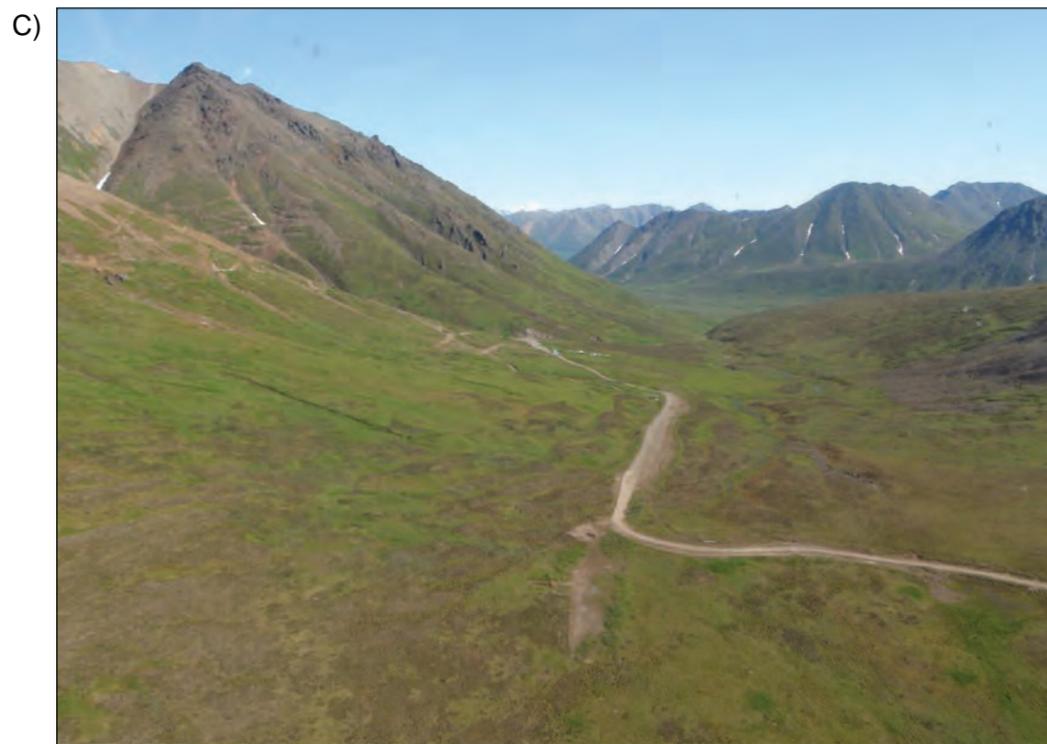
View looking northeast through the broad saddle at the head of the linear drainage shown in Photograph B. Note the absence of any tectonic geomorphic features.

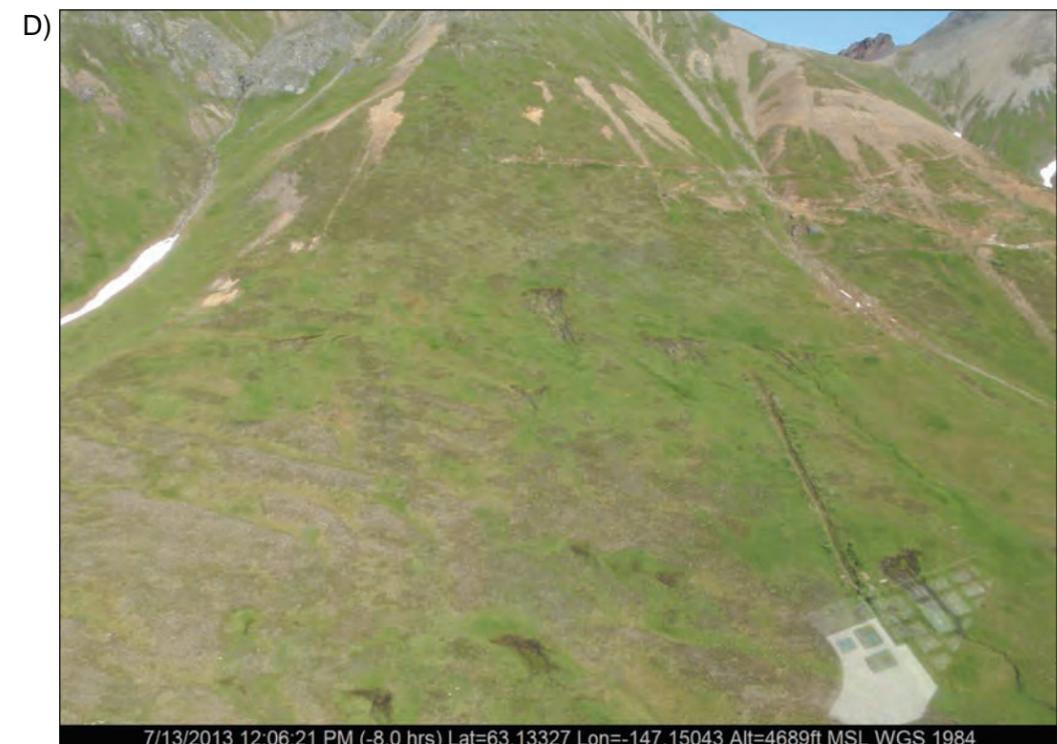
View looking northwest at location of FCL-mapped lineaments and mining roads partly shown in Photograph C. Note that FCL-mapped lineaments on the sidehill are not readily apparent and correspond to subtle break-in-slope like that shown in Photograph B.

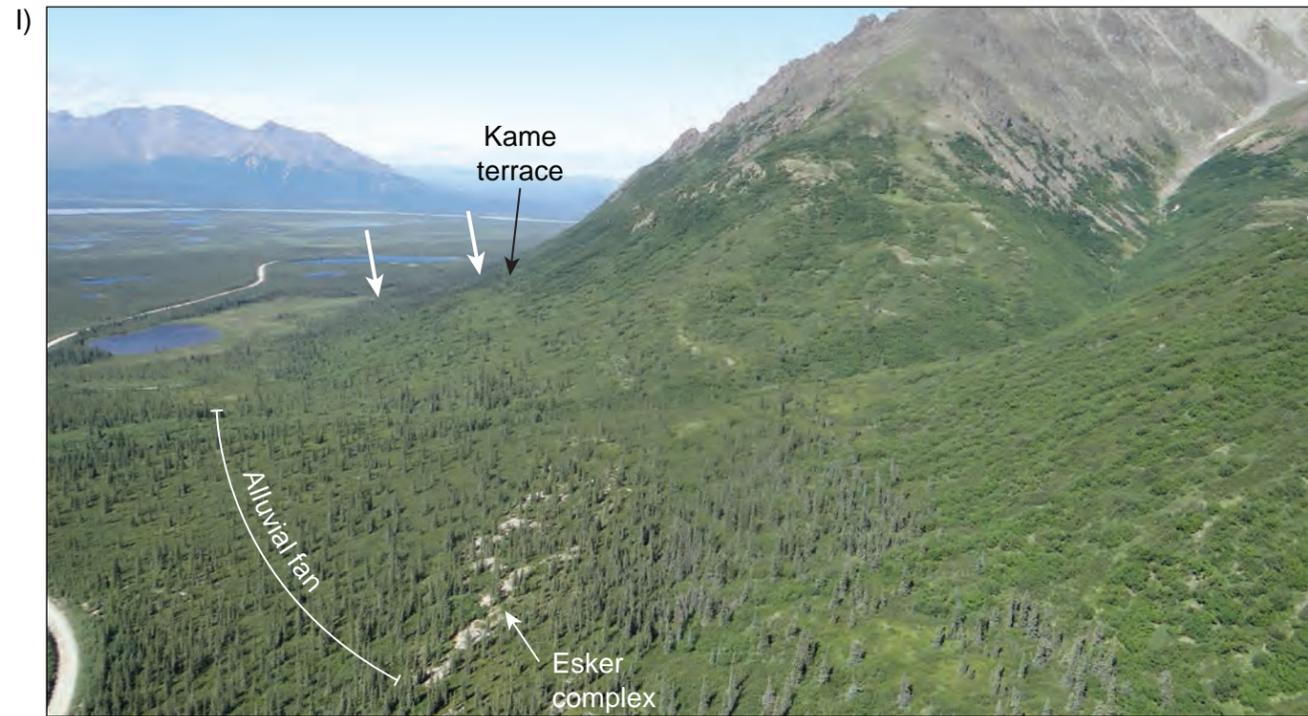
I) Overview looking west along mapped FCL-mapped lineaments that coincide with left-lateral moraines and kame terraces. The lineaments are interrupted by an alluvial fan and esker complex. Large arrows point along the mapped lineaments.

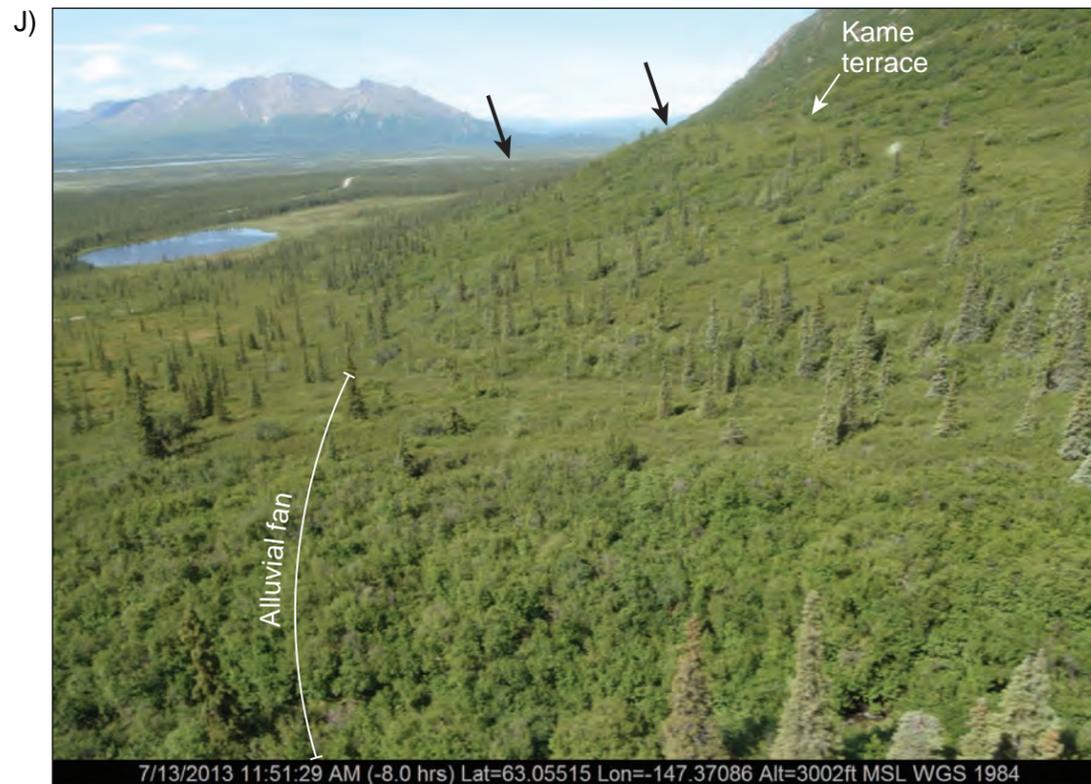
J) Close-up view looking west along FCL-mapped lineaments.

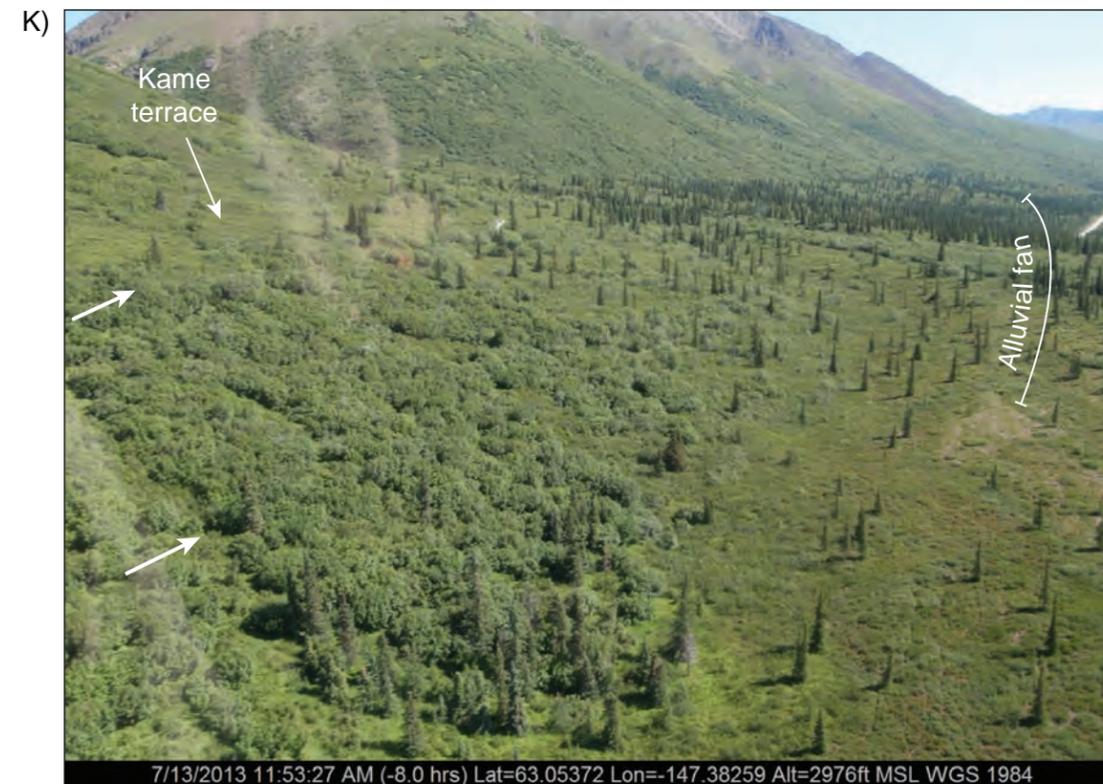
K) Close-up view looking east along FCL-mapped lineaments.
