SUSTINA-WATANA HYDROELECTRIC PROJECT  
Broad Pass Area

**Appendix B:  
Strip Maps and Photographic Documentation  
of Lineament Data for Lineaments Mapped by Reger et al. (1990)**

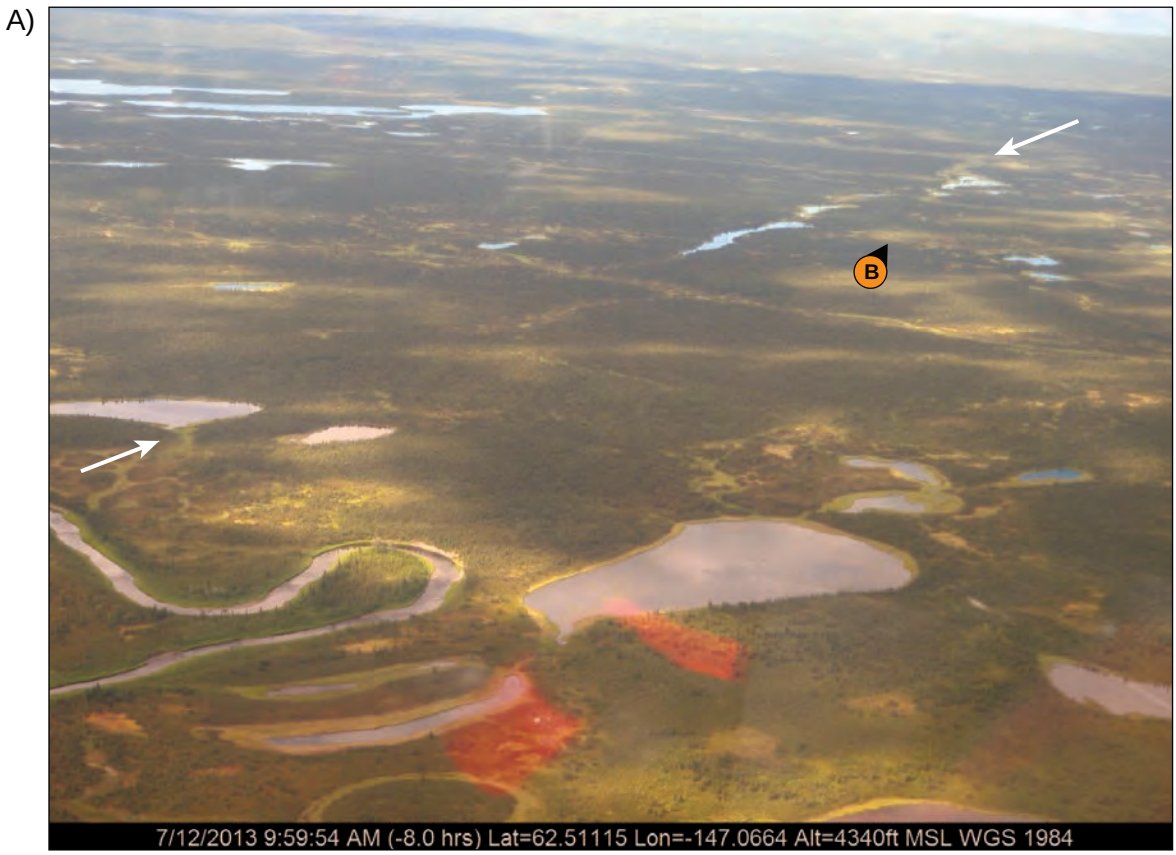
View looking west-southwest toward linear alignment of lakes. Arrows point along lineament. Note kettle lake terrain in the foreground.

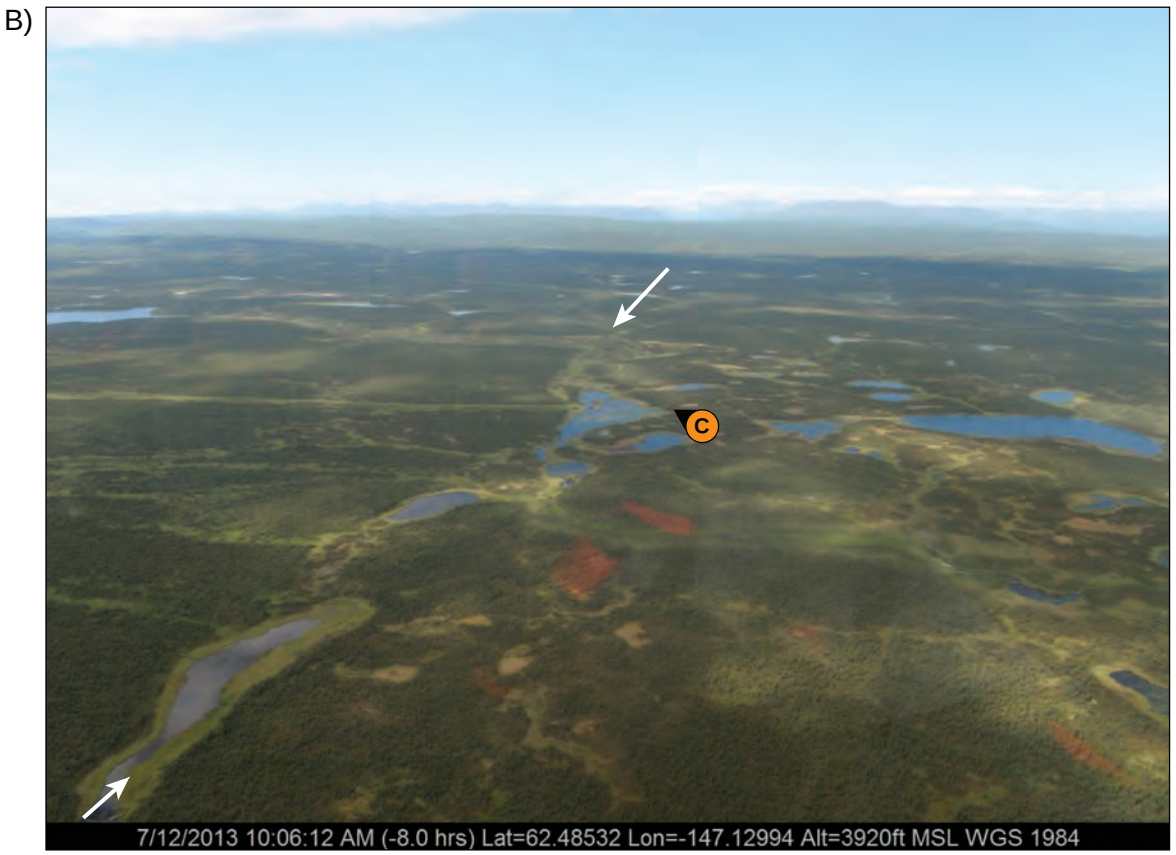
Close up view looking west-southwest along linear alignment of lakes in Photograph A. Arrows point along lineament.

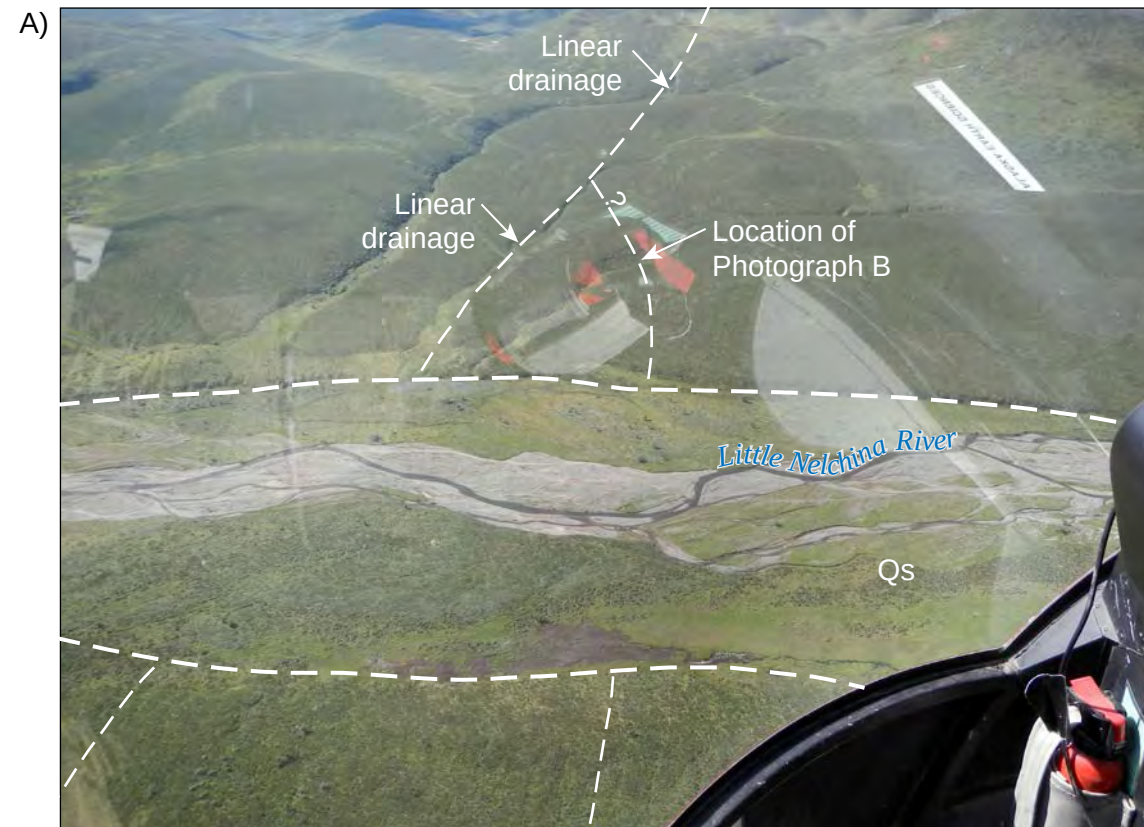
View looking southwest from location A, nearly along-strike with Csejtey et al. (1978) mapped faults. Note clear expression of linear features on bedrock landscape and absence of linear expression in Quaternary deposits.

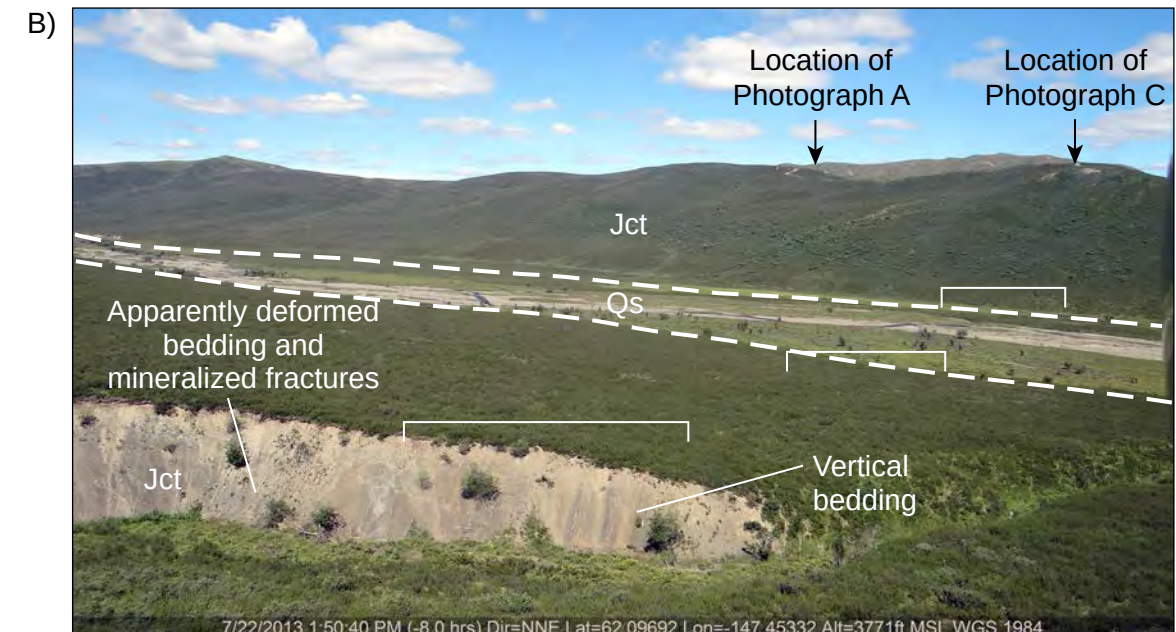
View looking northeast from location B nearly along-strike with Csejtey et al. (1978) mapped fault. The mapped fault segment projects through the vertical beds observed in the outcrop towards photograph location C. Note apparent undeformed hillslope and Quaternary deposits over projected trace of fault.

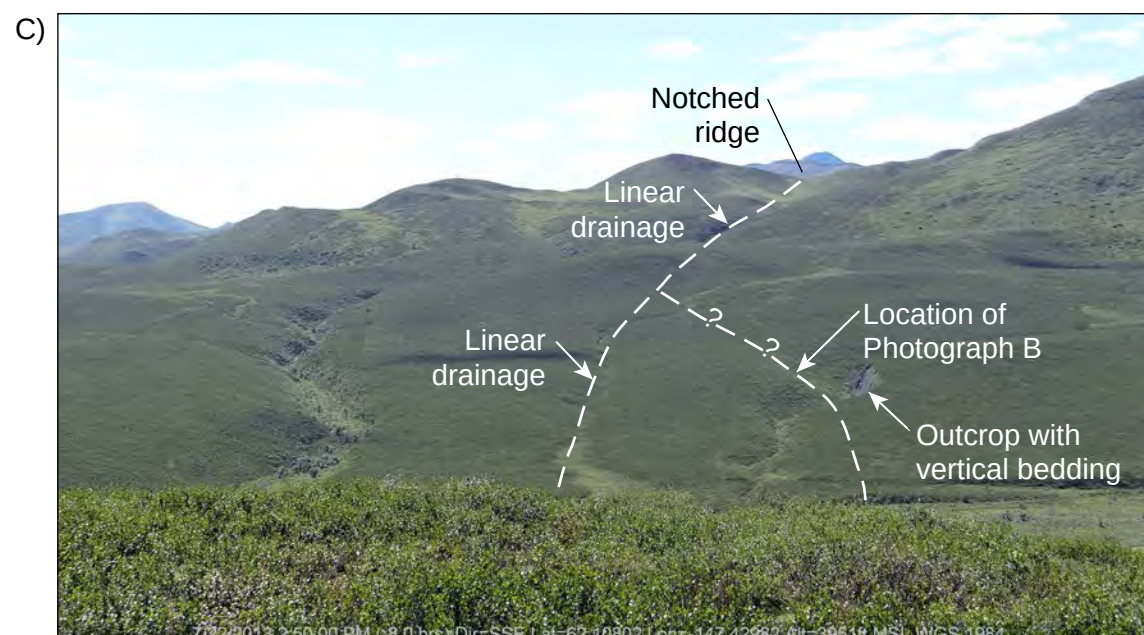
View looking southwest from location C. Note alignment of features over mapped trace of fault.

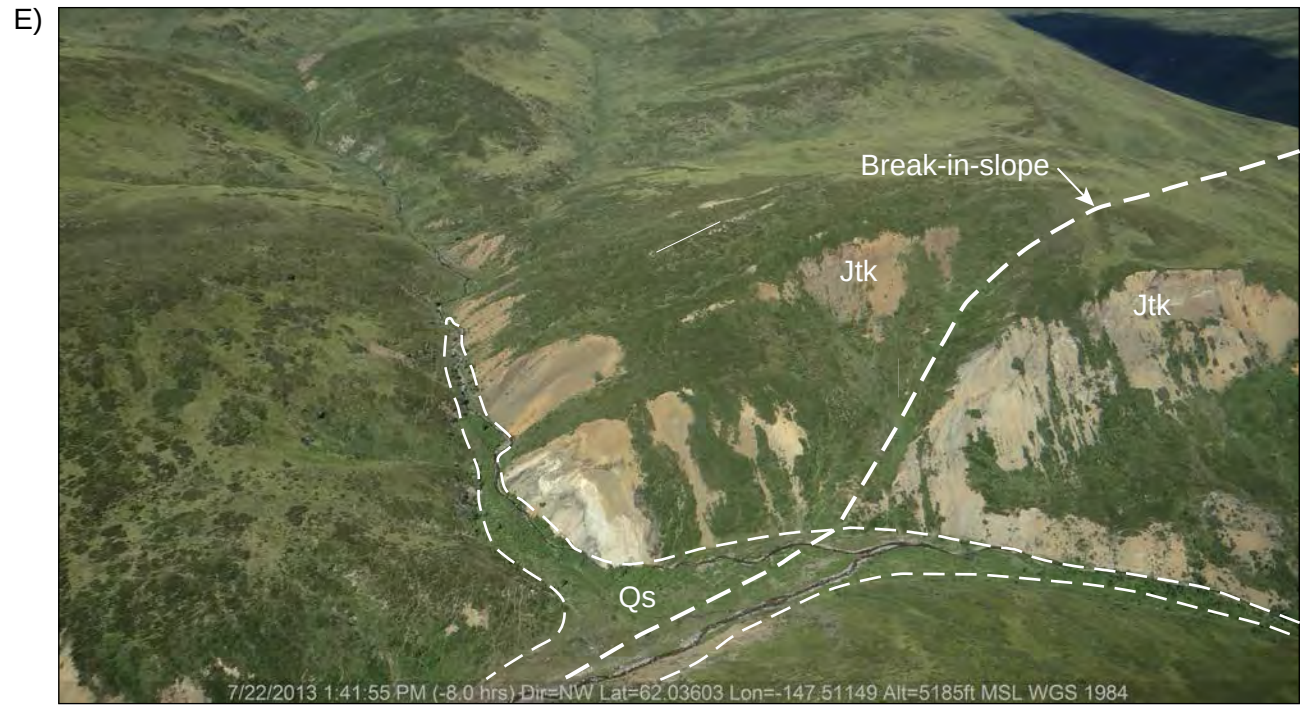
View looking northwest from location E at faulted Jurassic units. The fault occupies the linear valley then climbs the hill-slope where it correlates with a clear break-in-slope on the ridge crest.

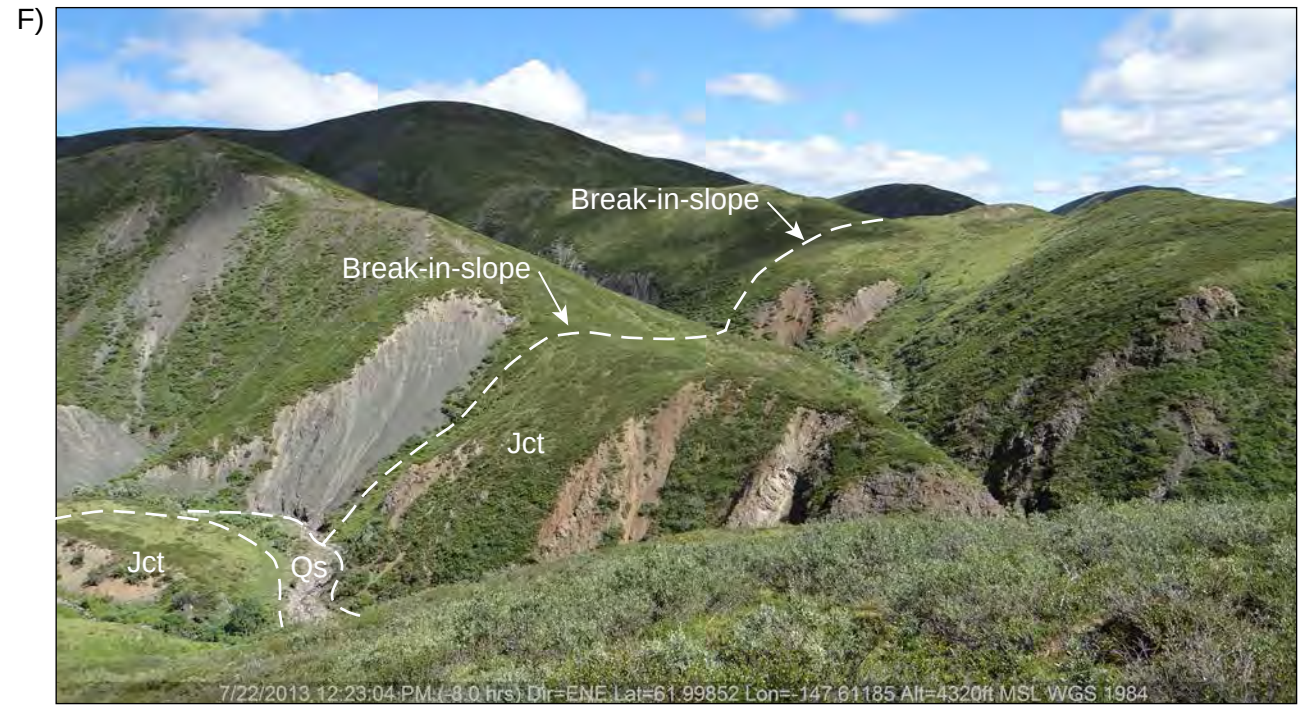
View looking north-northeast from location F. The fault juxtaposes Cretaceous against Jurassic bedrock and coincides with a break-in-slope on each ridge crest.

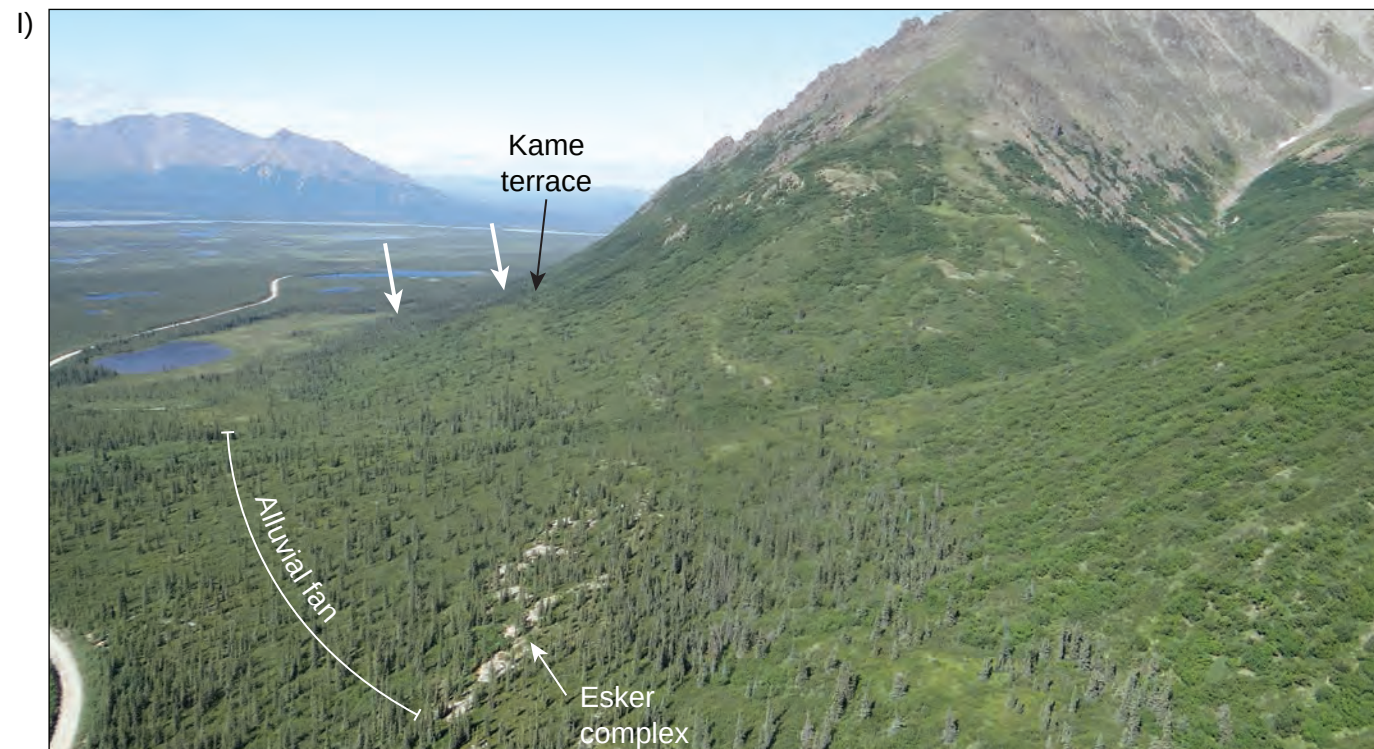
Overview looking west along mapped FCL-mapped lineaments that coincide with left-lateral moraines and kame terraces. The lineaments are interrupted by an alluvial fan and esker complex. Large arrows point along the mapped lineaments.

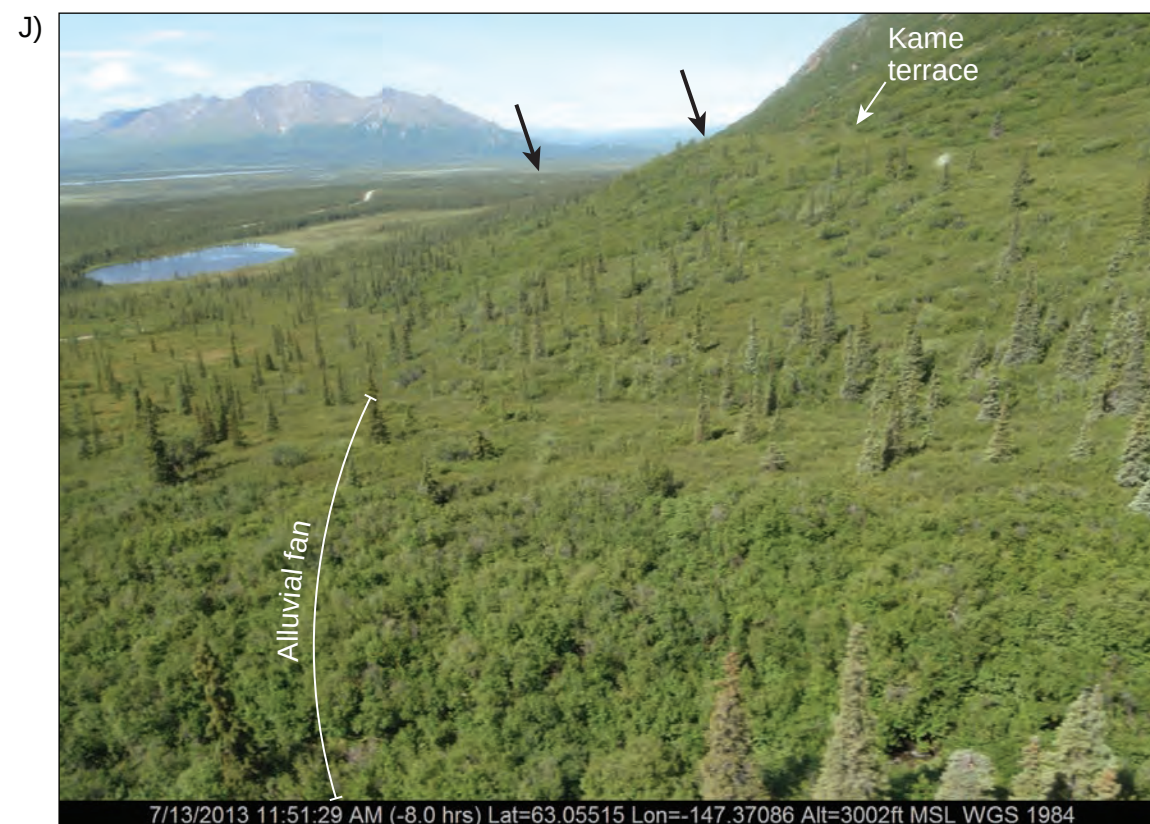
Close-up view looking west along FCL-mapped lineaments.

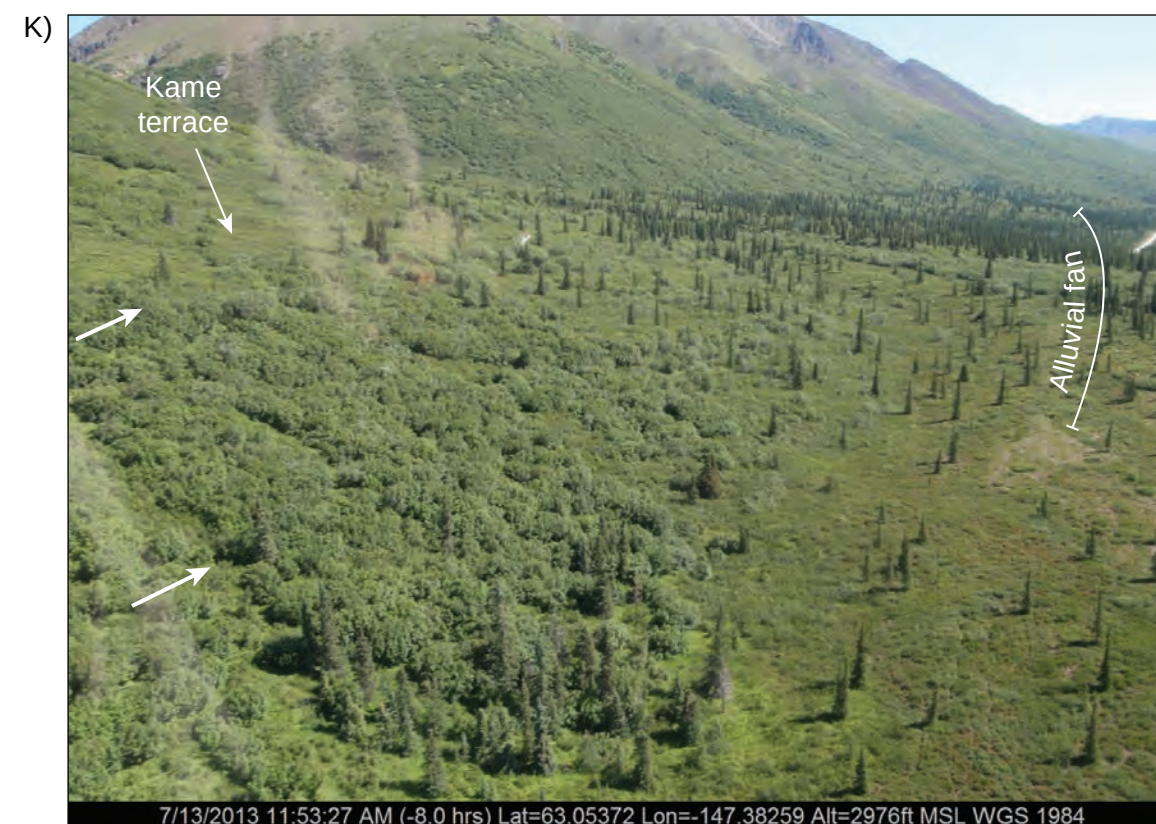
Close-up view looking east along FCL-mapped lineaments.

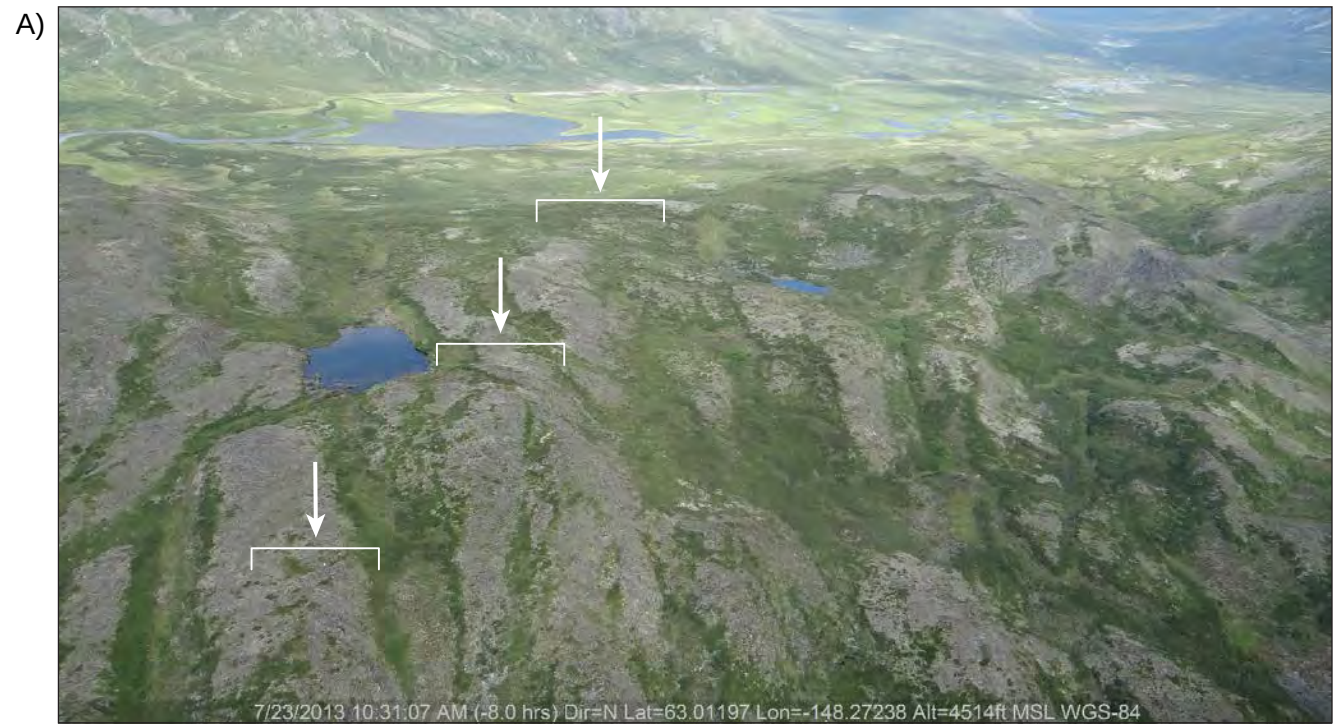
View looking northwest from location A. Arrows and brackets show projected trace of lineament. Note absence of continuous lineament across projected trace.

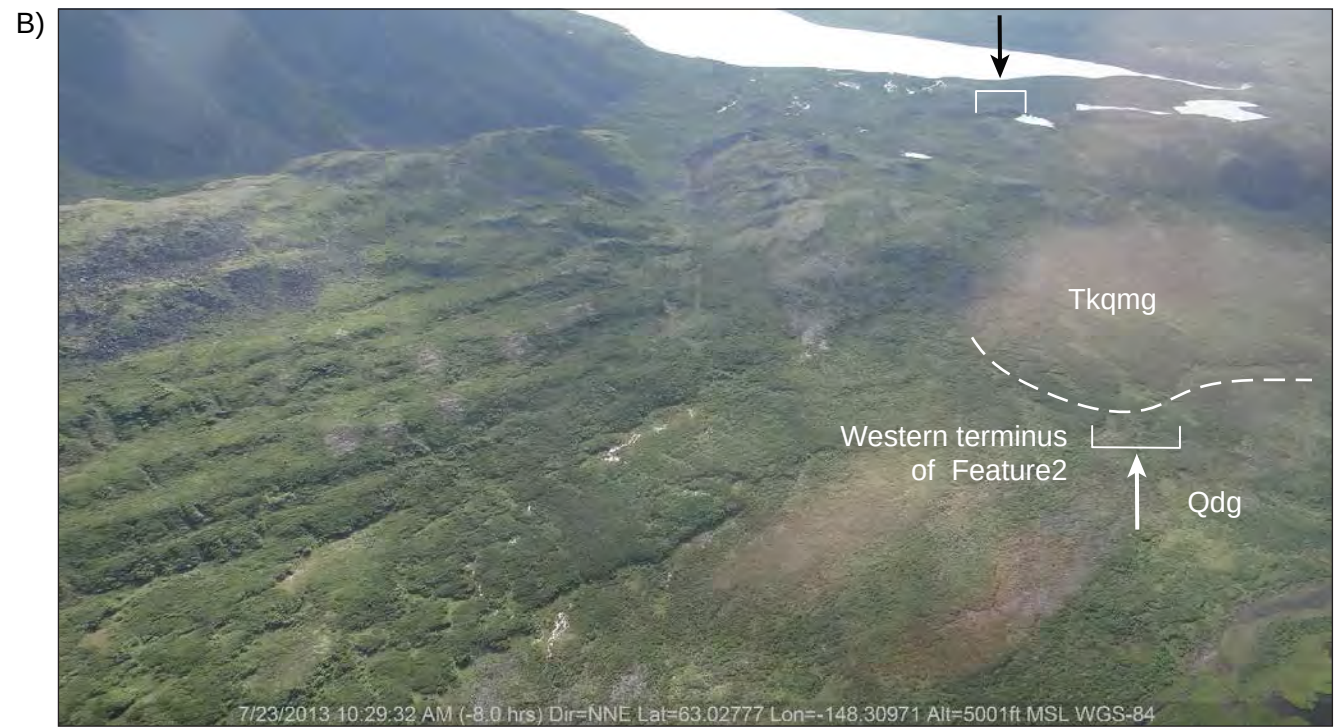
View looking southeast from location B. Arrows and brackets show projected trace of lineament. Note lack of deformation or lineament trace in foreground within Quaternary deposits.

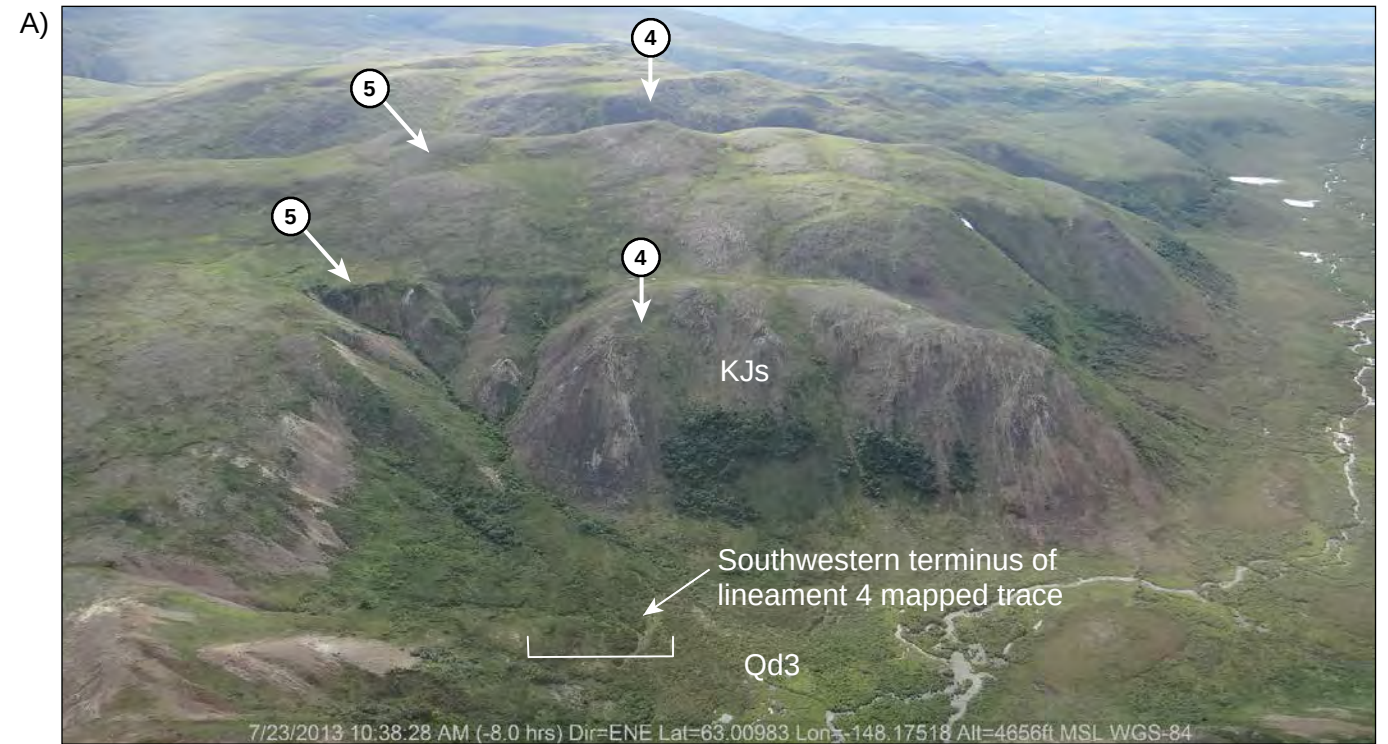
View looking southeast from location A. Arrows show the projected traces of Features 4 and 5. Note absence of lineament or deformation in Quaternary deposits in foreground.

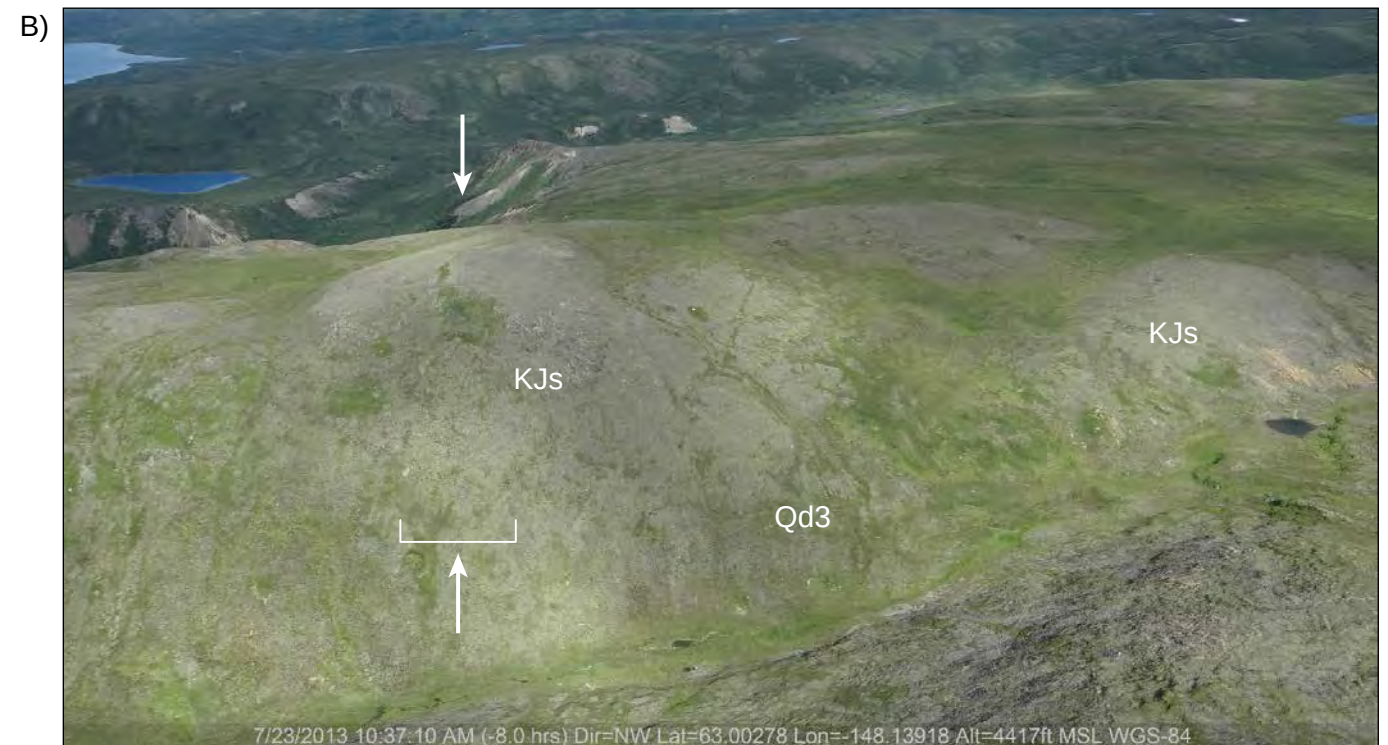
View looking northwest from location B. Arrows show the projected trace of Feature 5. Note absence of discernable lineament along mapped trace.

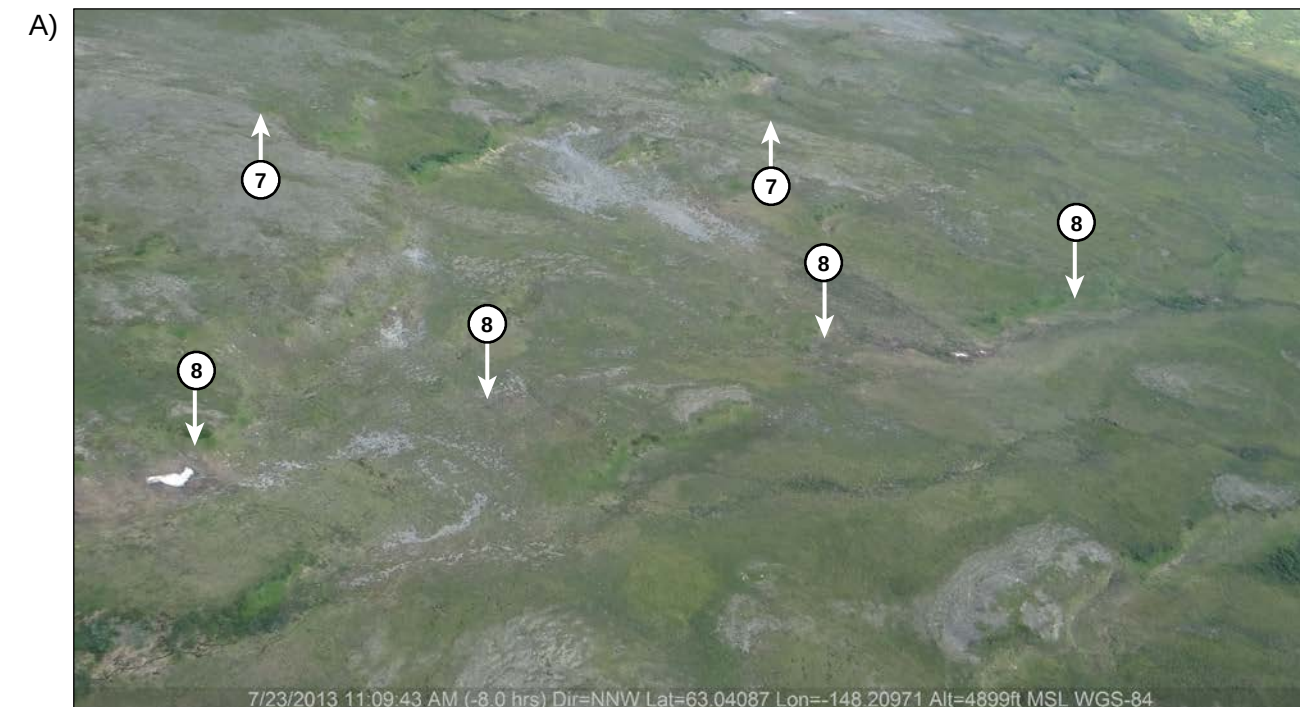
View looking northeast at lineaments 7 and 8 from photograph location A.

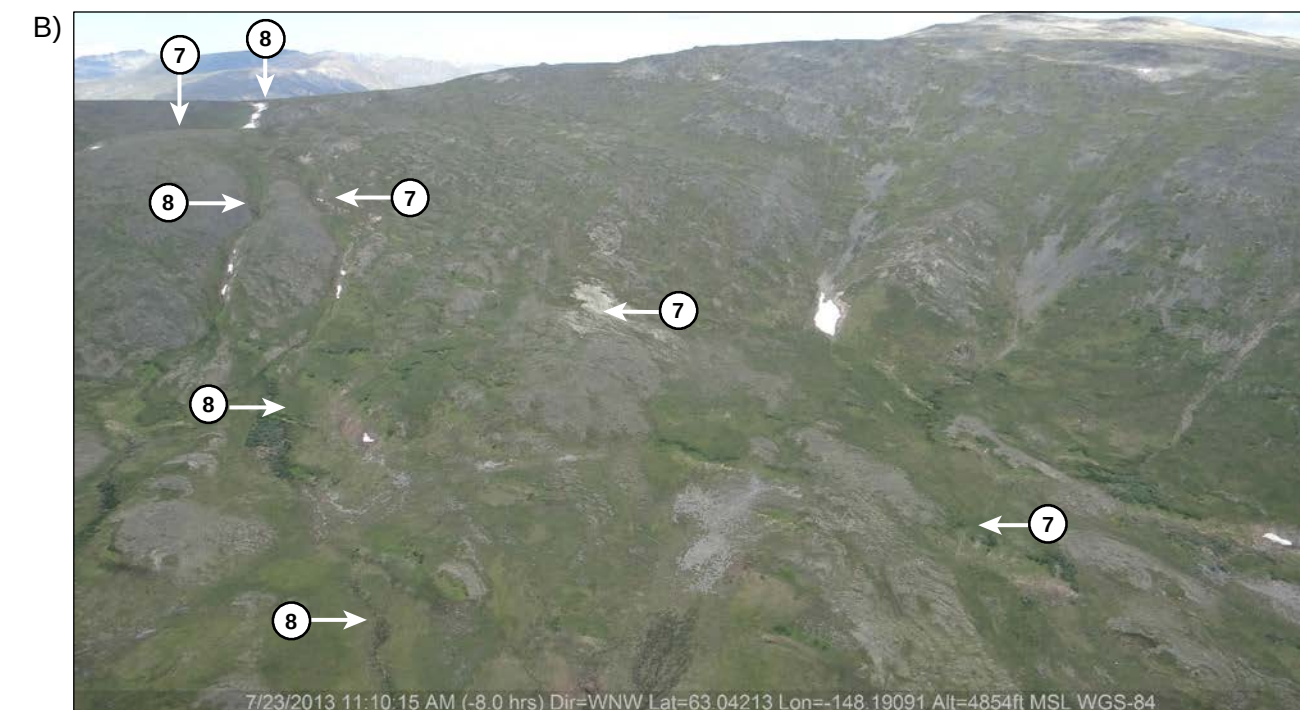
View looking west at lineaments 7 and 8 from photograph location B. Note that lineament 7 is a linear series of unrelated features.

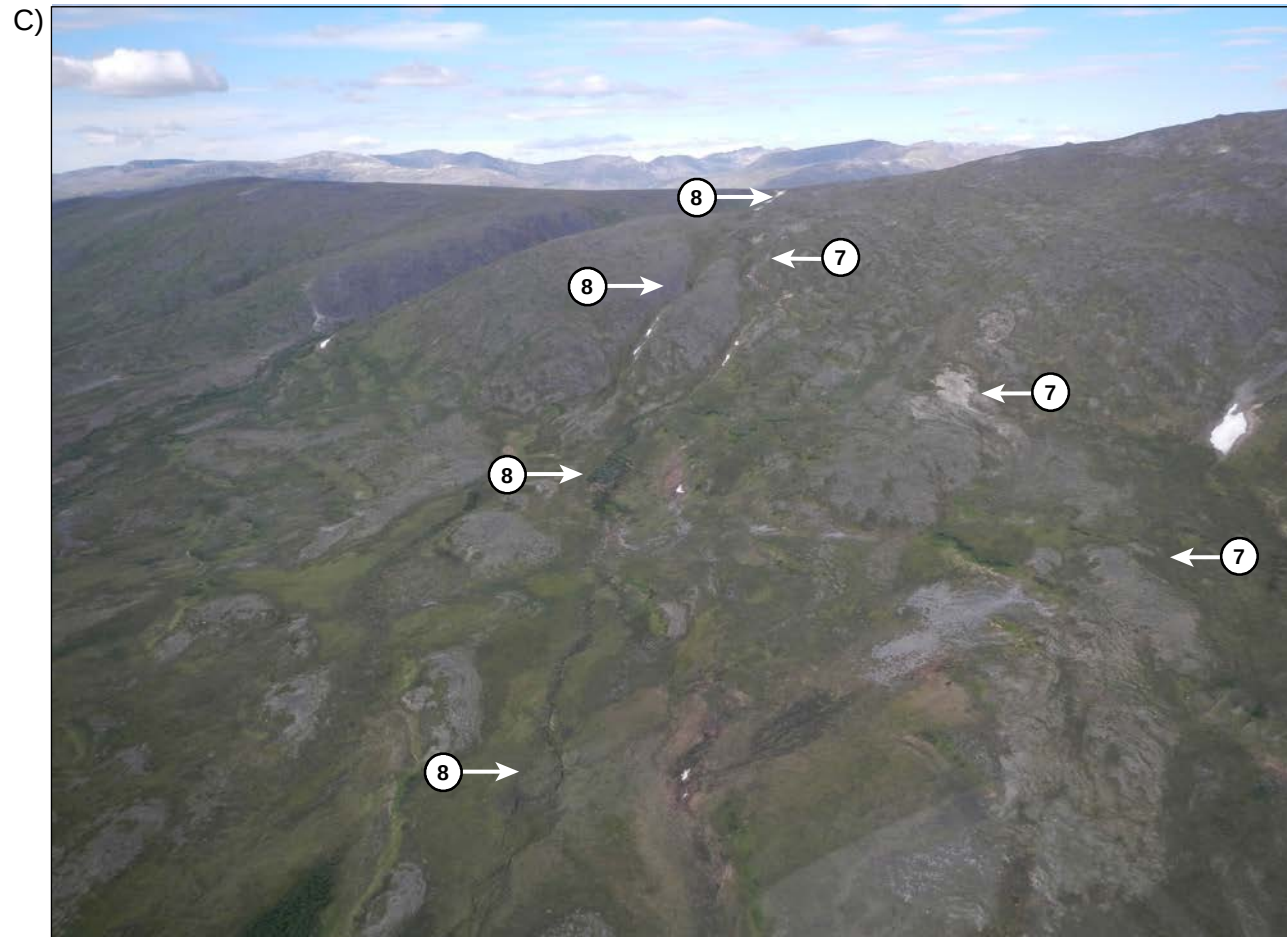
View looking southwest at lineaments 7 and 8 from photograph location C.

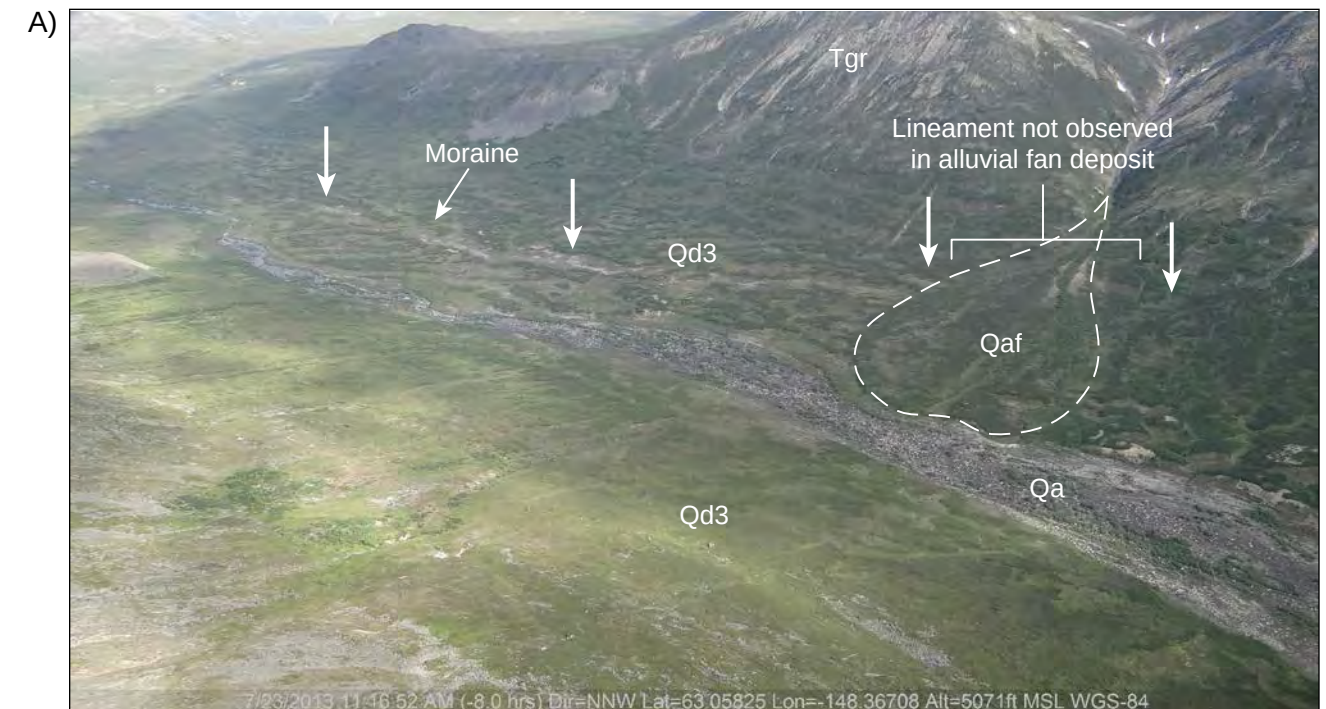
View looking north from location A. Arrows show projected trace of Feature 9 lineament. Note lineament is overprinted with Quaternary alluvial fan deposit.

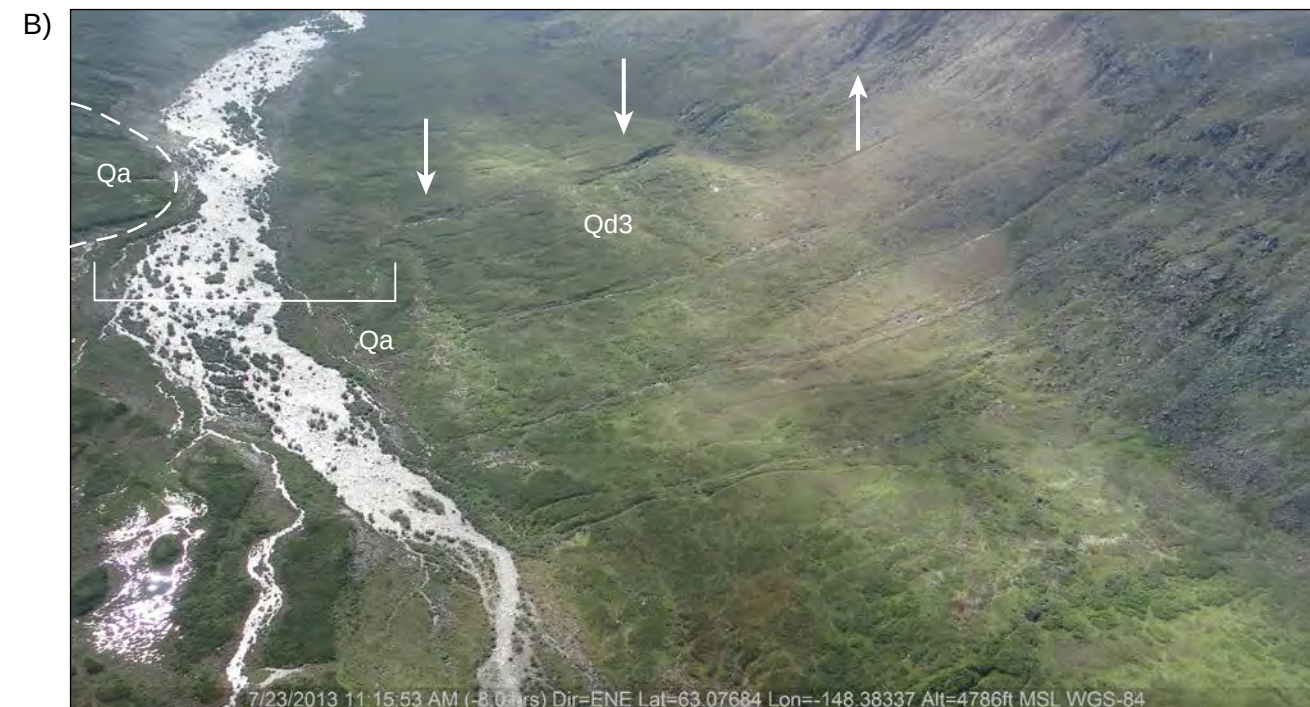
View looking south from photograph location B. Arrows show the projected trace of lineament. In Qd3 (till) the lineament is coincident with linear drainage in till deposit. Note absence of lineament in Qa deposit.

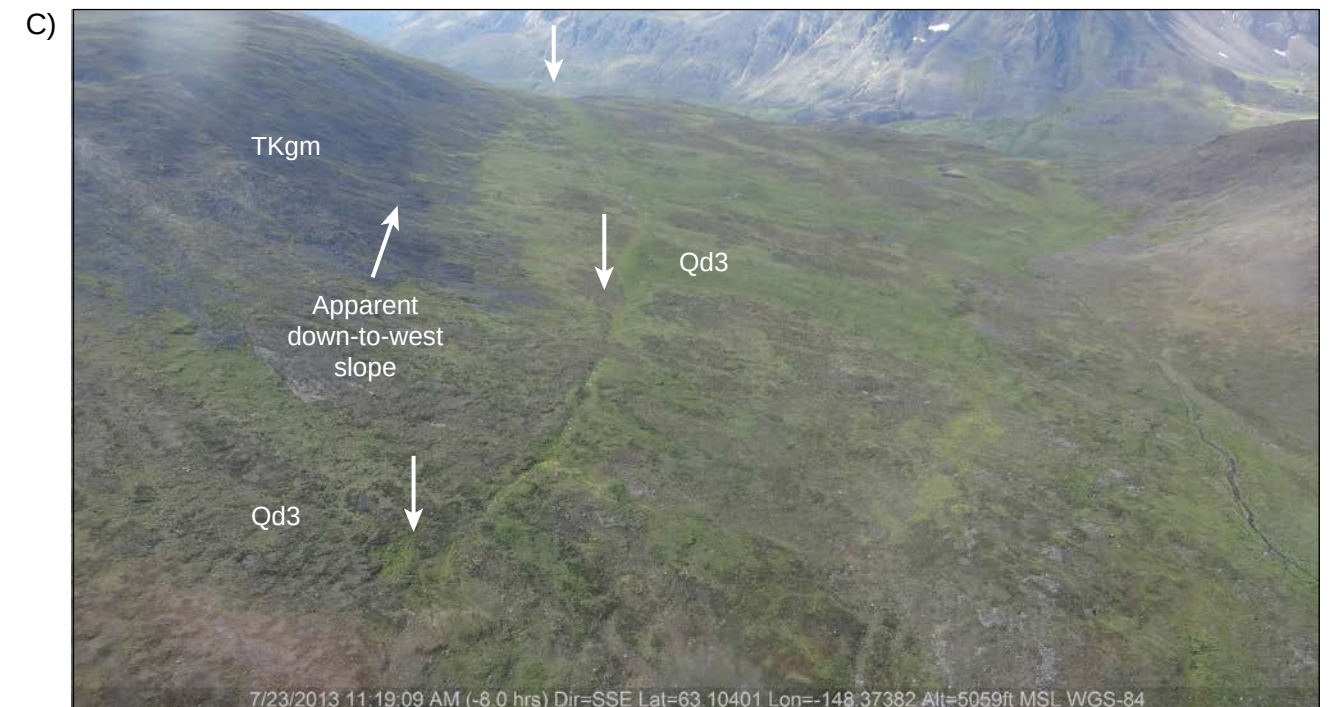
View looking south from photograph location C. Arrows show the projected trace of lineament. Note lineament is coincident with a linear drainage in this view.

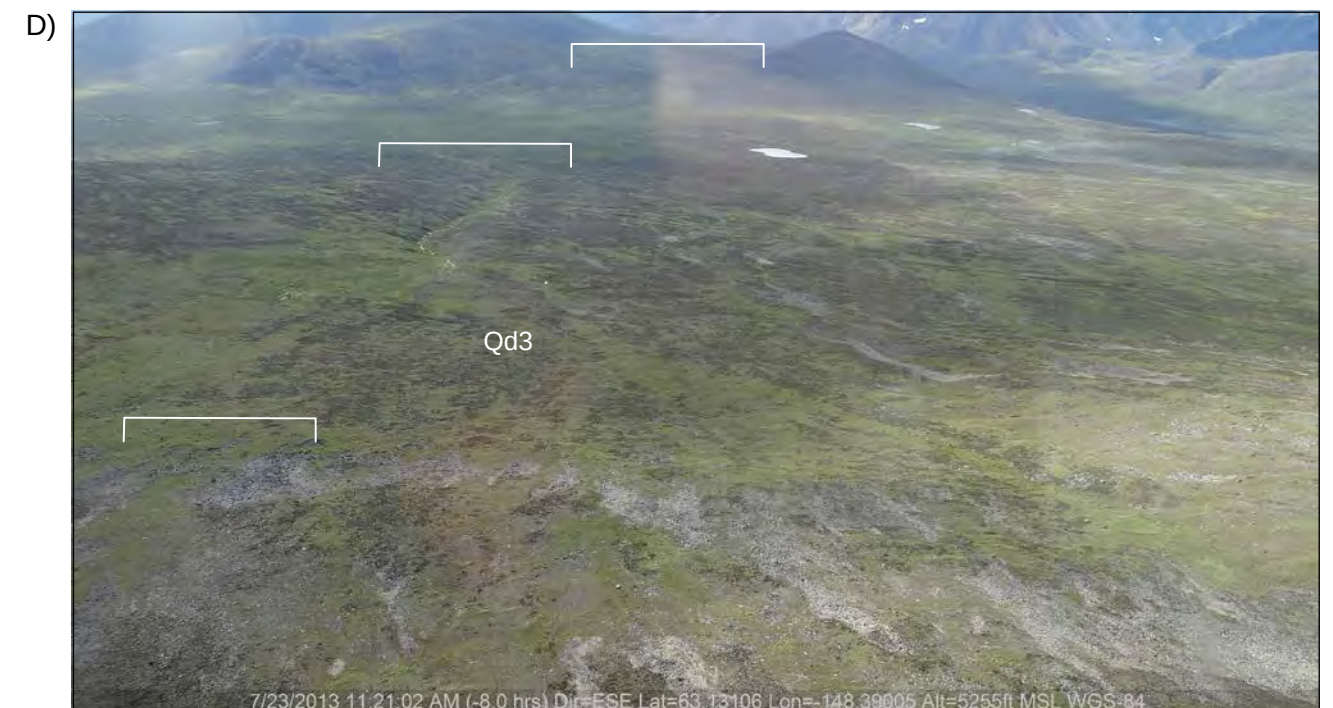
View looking south from location C. Brackets show the projected trace of lineament.

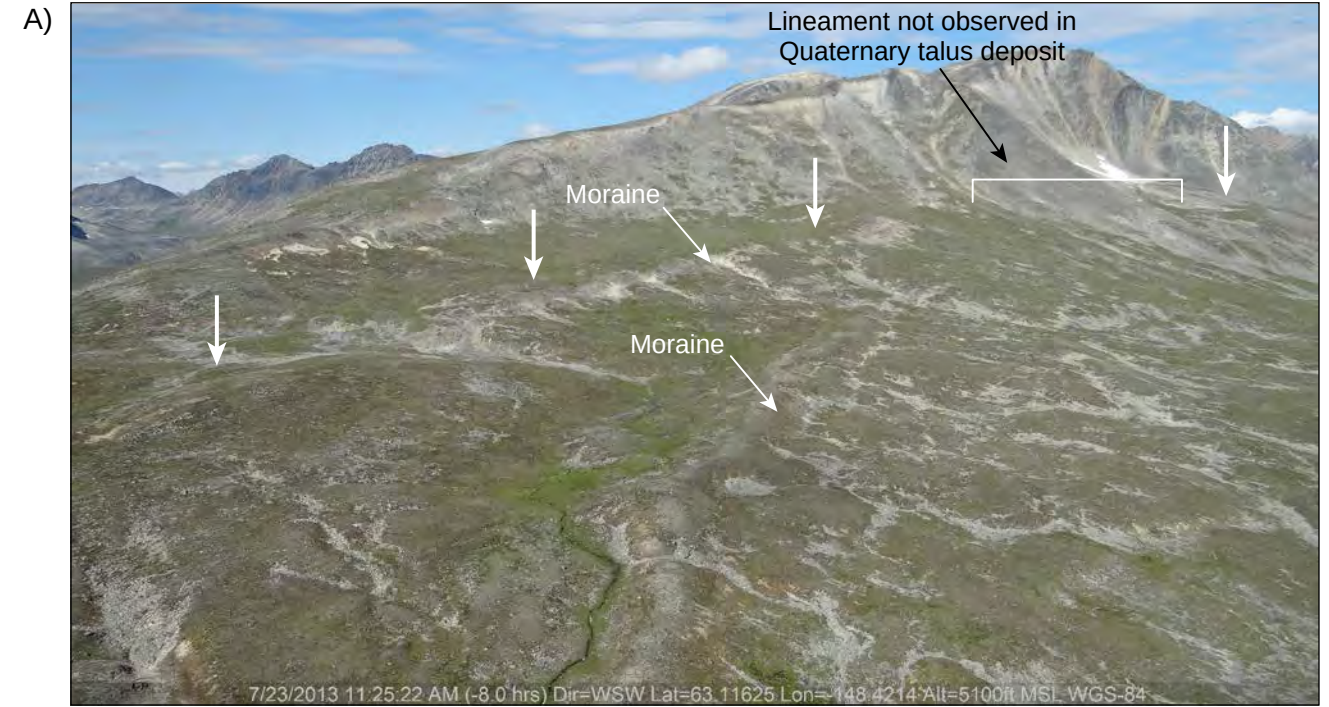
View looking west from location A. Arrows and brackets show projected trace of Feature 11 lineament. Note the mapped lineament correlates with a moraine crest.

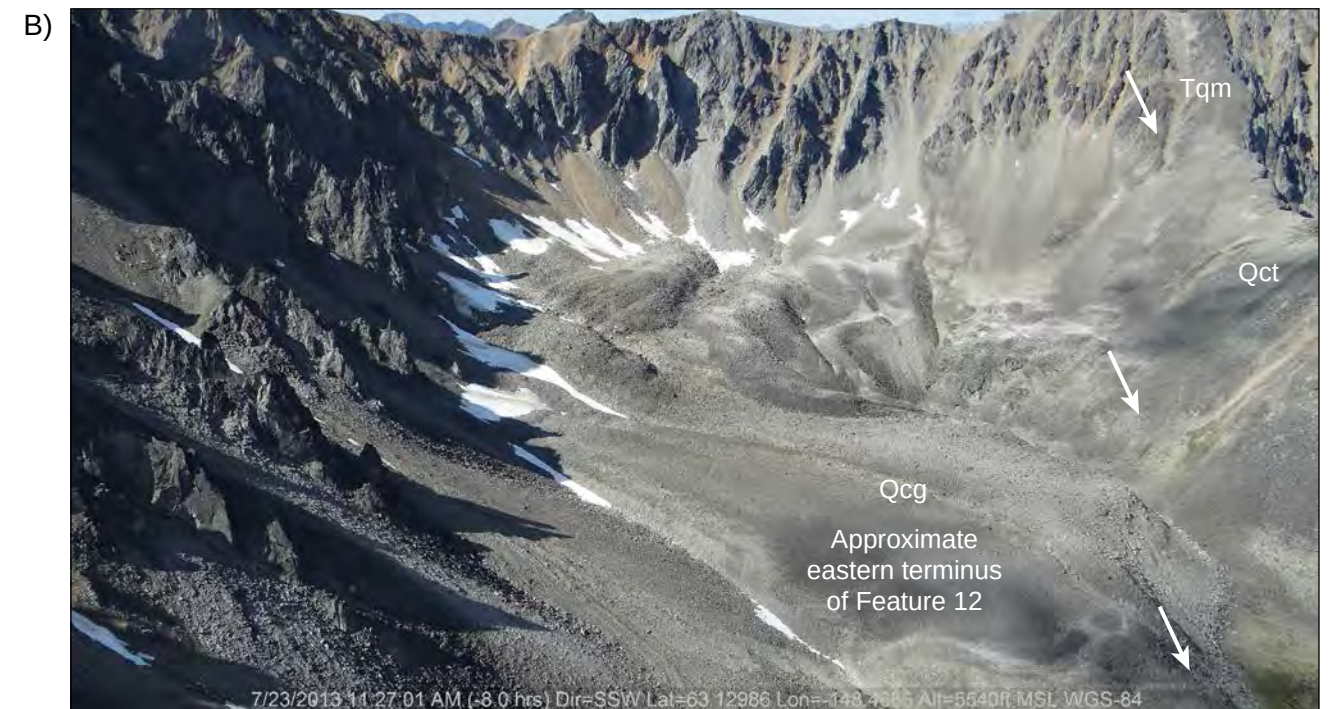
View looking west from location A. Brackets show projected trace of Feature 12 lineament. Note the trace of the lineament is a collection of unrelated features rather than a through-going feature.
