SUSTINA-WATANA HYDROELECTRIC PROJECT  
Broad Pass Area

**Appendix B:  
Strip Maps and Photographic Documentation  
of Lineament Data for Lineaments Mapped by Reger et al. (1990)**

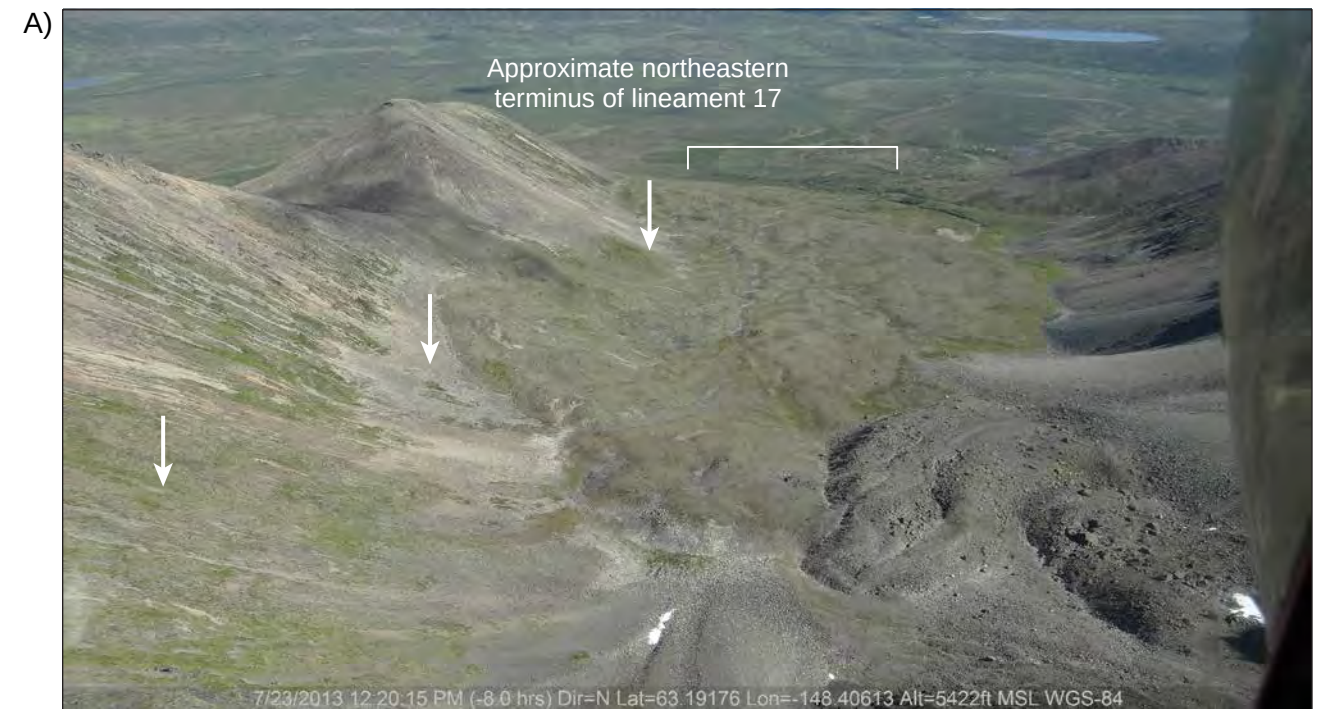
View looking northeast from location A. Arrows and brackets show projected trace of lineament 17.

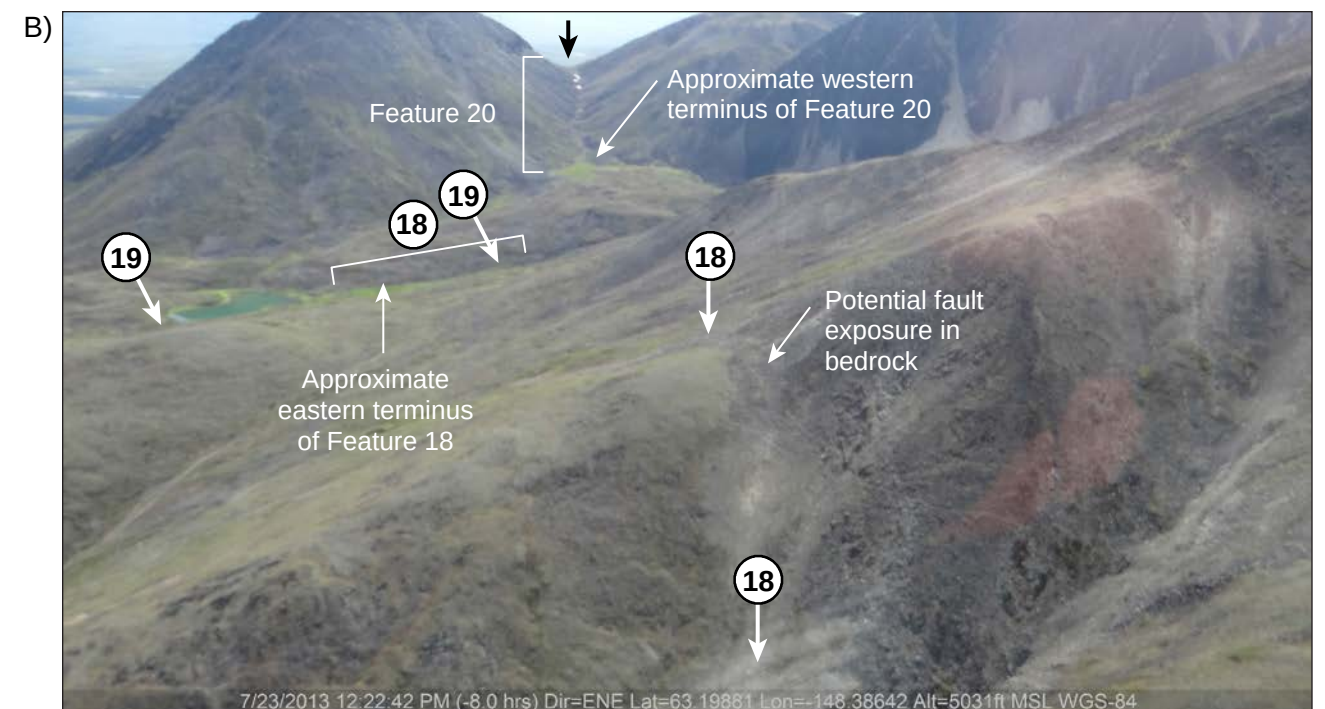
View looking southeast from photograph location B. Arrows and brackets indicated the projected trace of lineaments 18, 19, and 20.

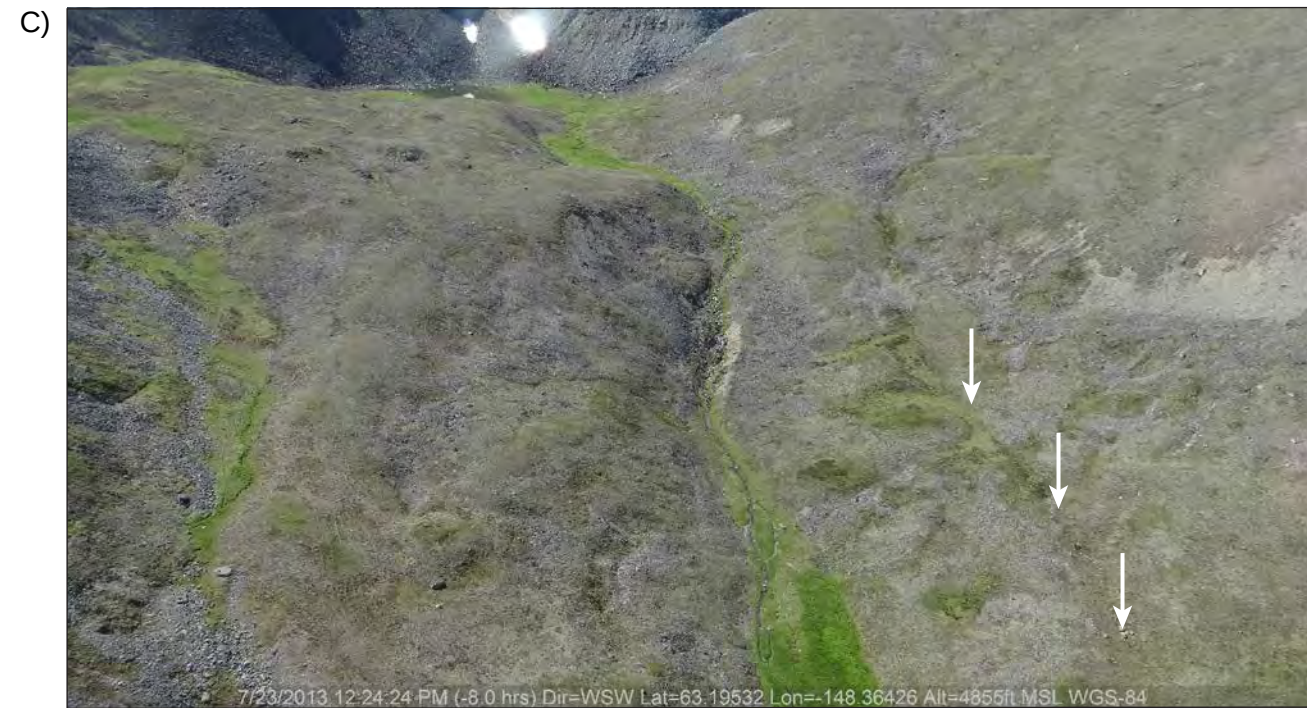
View looking southwest from photograph location C. The arrows indicate the projected path of Feature 19 lineament.

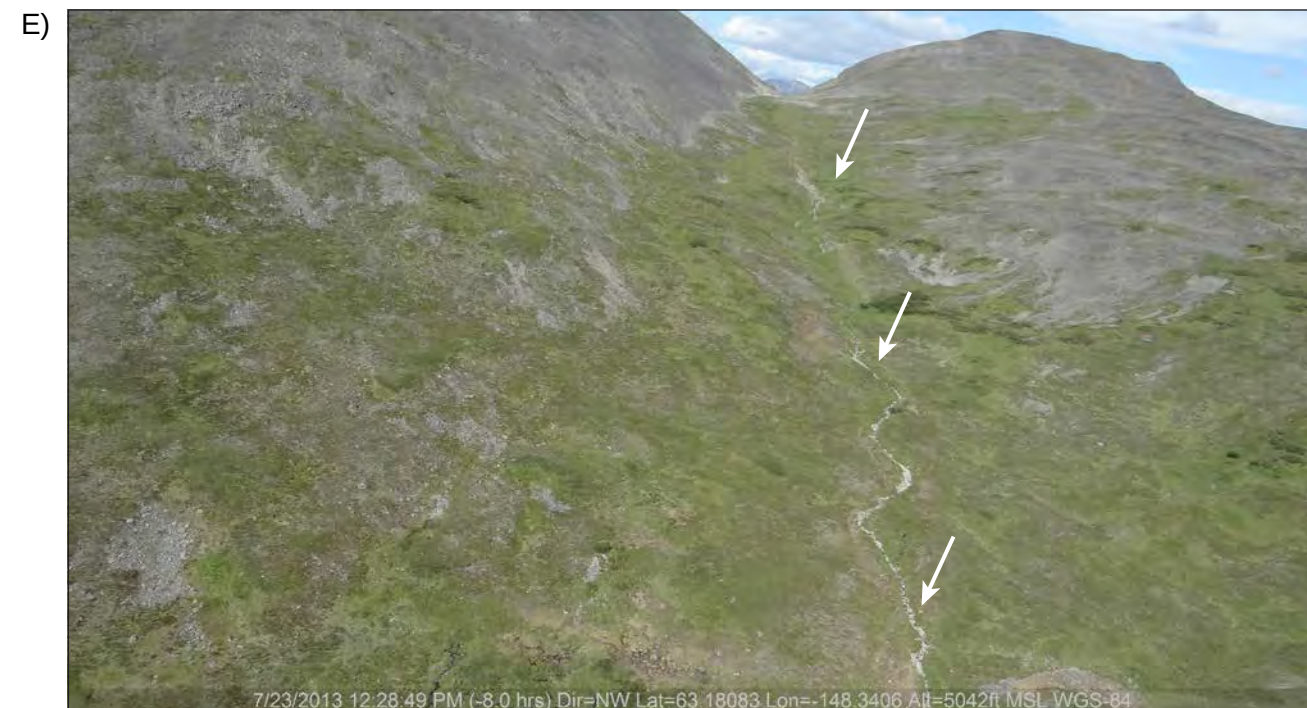
View looking northwest from photograph location E. Arrows show the mapped trace of Feature 20 lineament. Note mapped trace of Feature 20 is coincident with linear drainage.

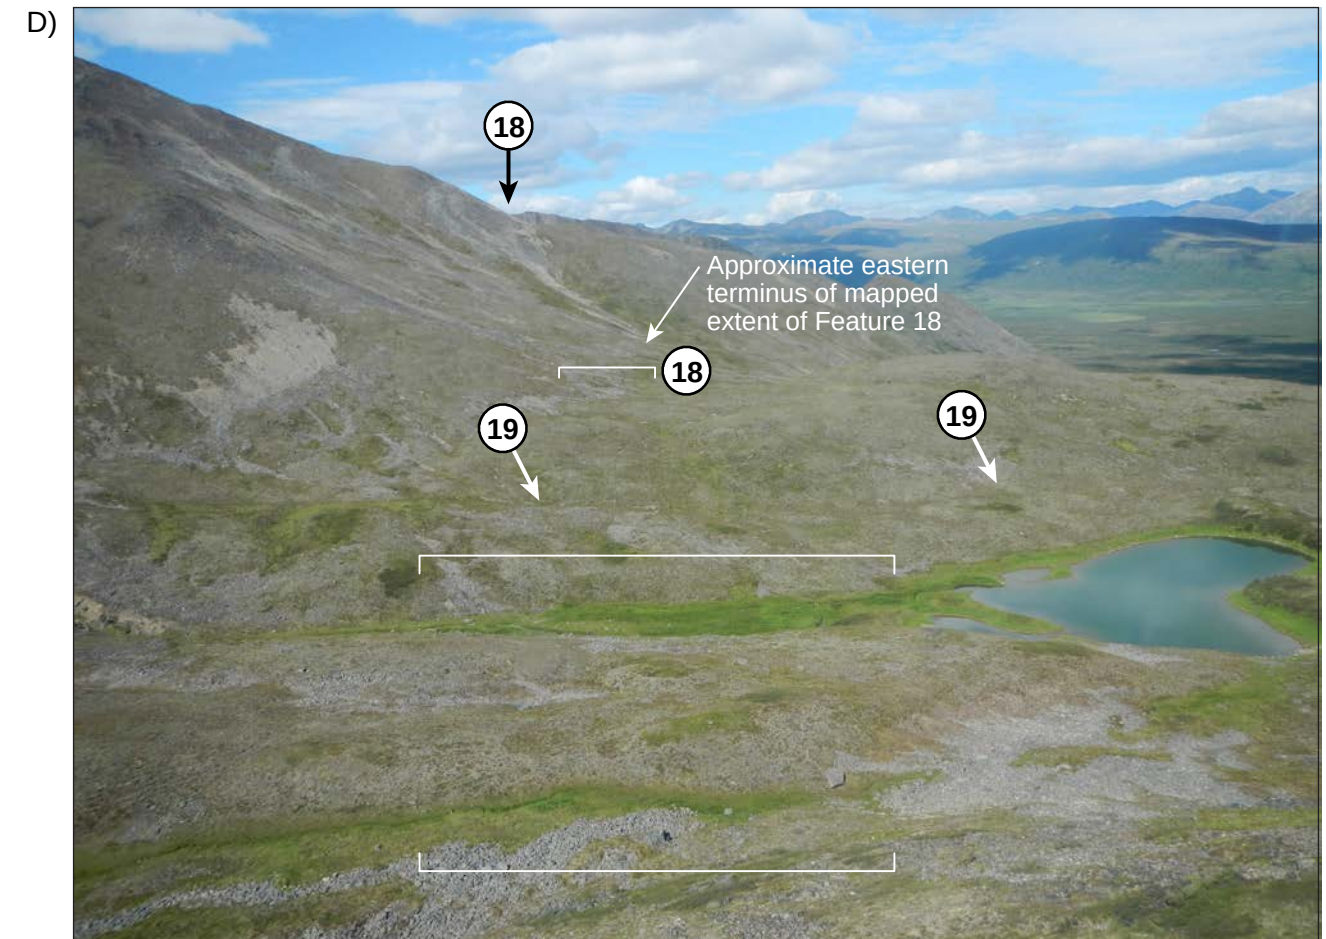
View looking northwest from photograph location D. Arrows show the mapped trace of Features 18 and 19. Note absence of lineaments or apparent deformation in Quaternary deposits between brackets in lower middle portion of photograph.

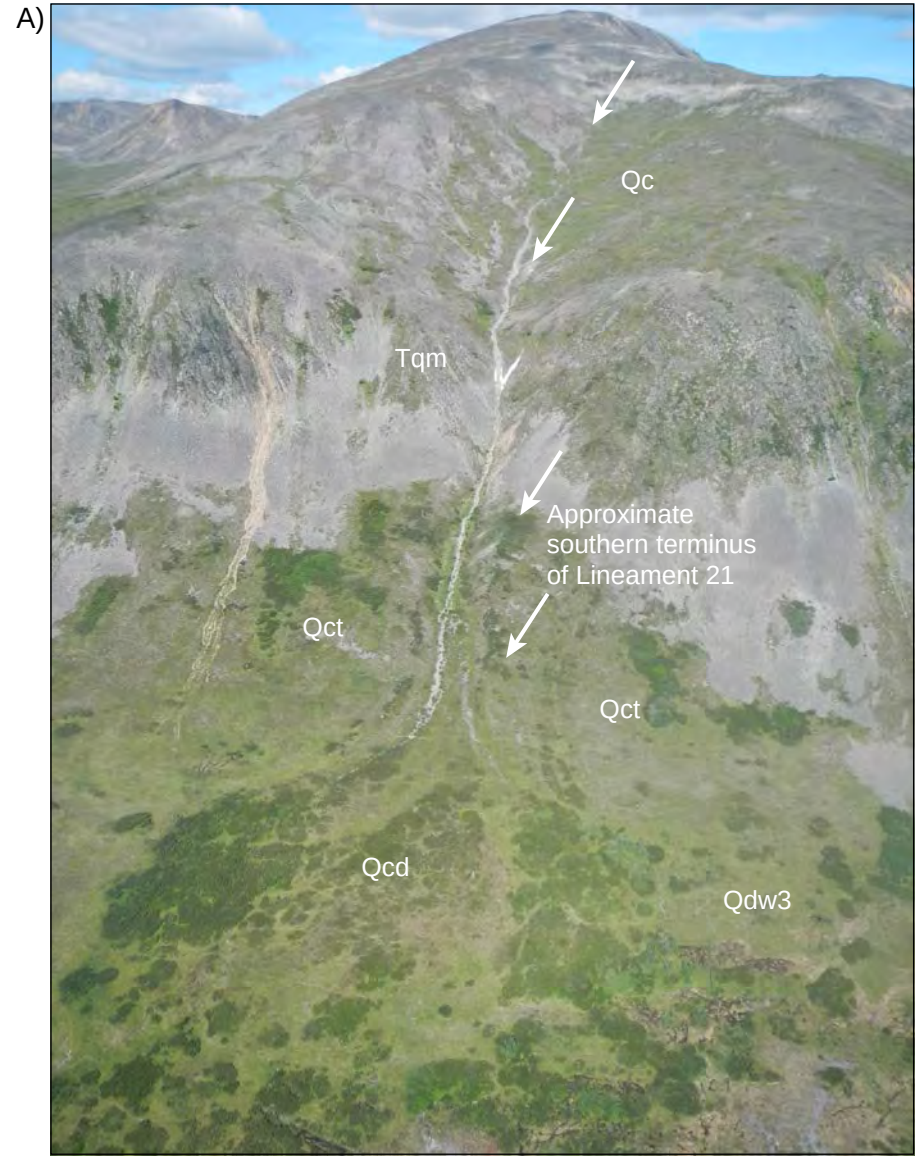
View looking northwest from photograph location A. Arrows indicate the projected path of Feature 21 lineament.

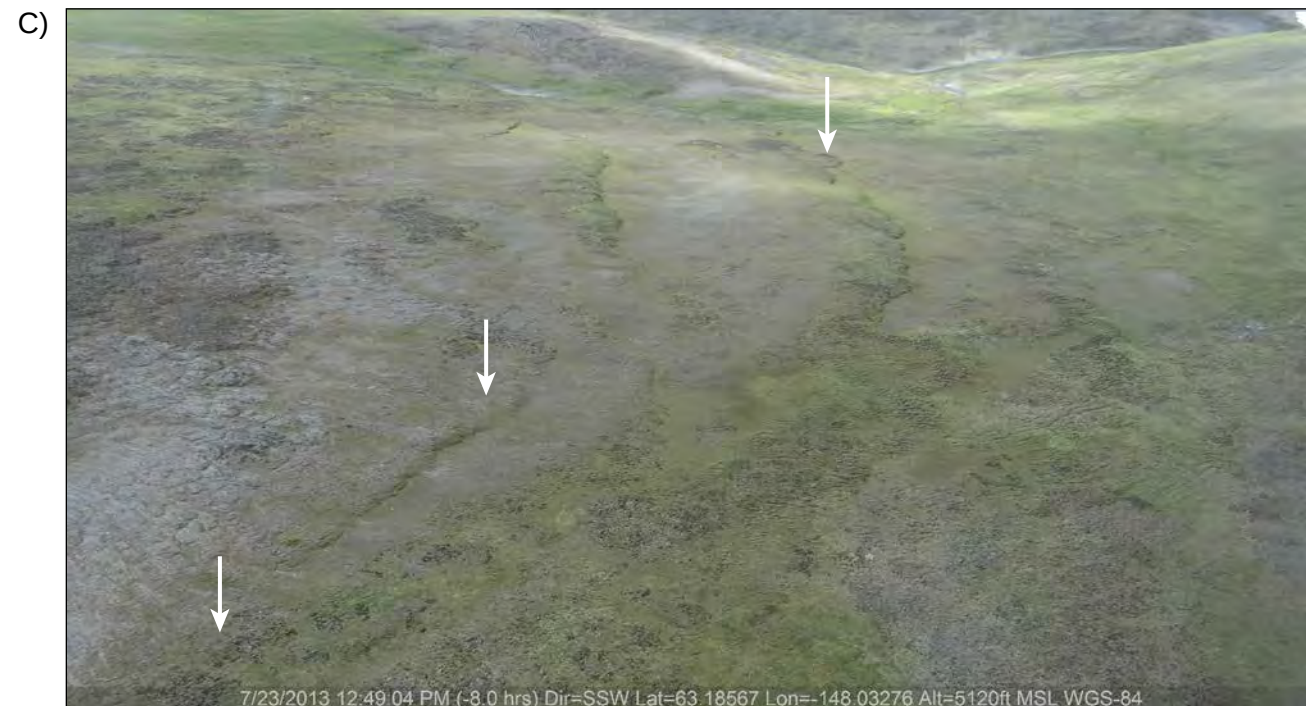
View looking west from photograph location C. Arrows show the projected trace of the Feature 22 lineament. Note linear expression is coincident with solifluction lobes and not continuous.

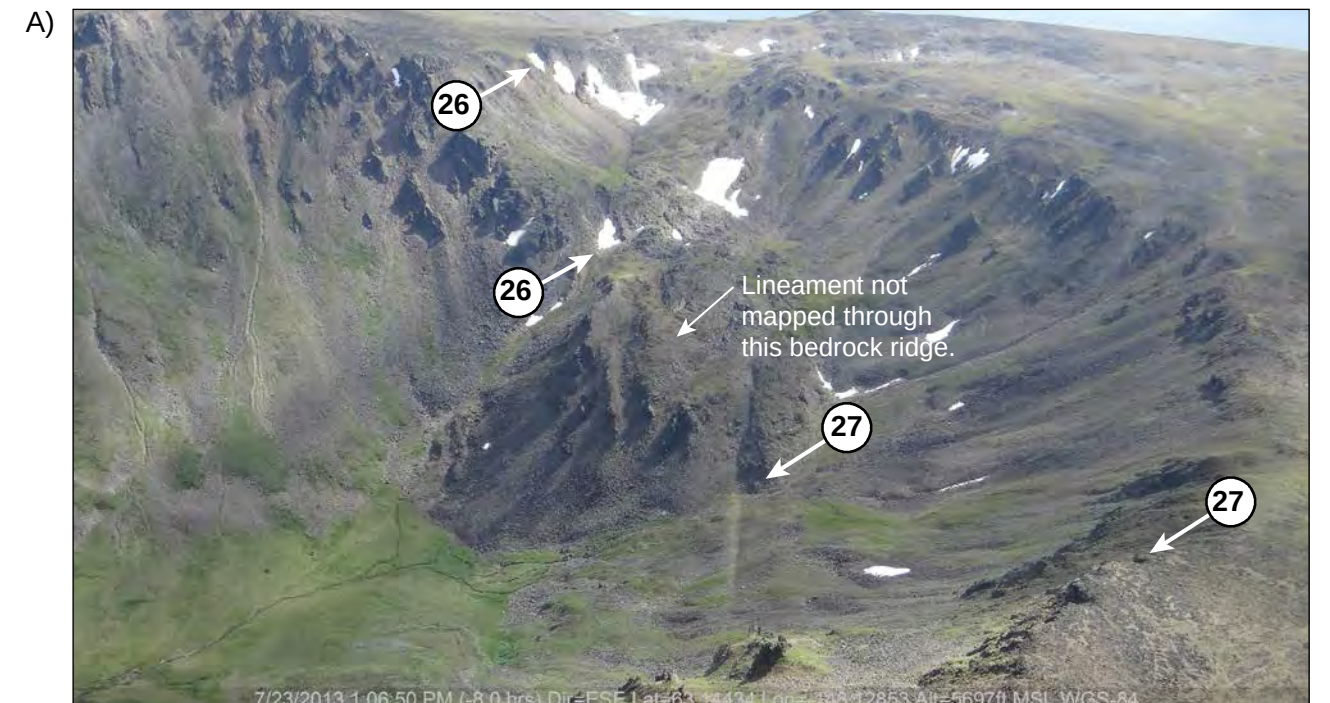
View looking west from photograph location A. Arrows show the projected trace of Features 26 and 27. Note the absence of a continuous and clear lineament along projected traces.

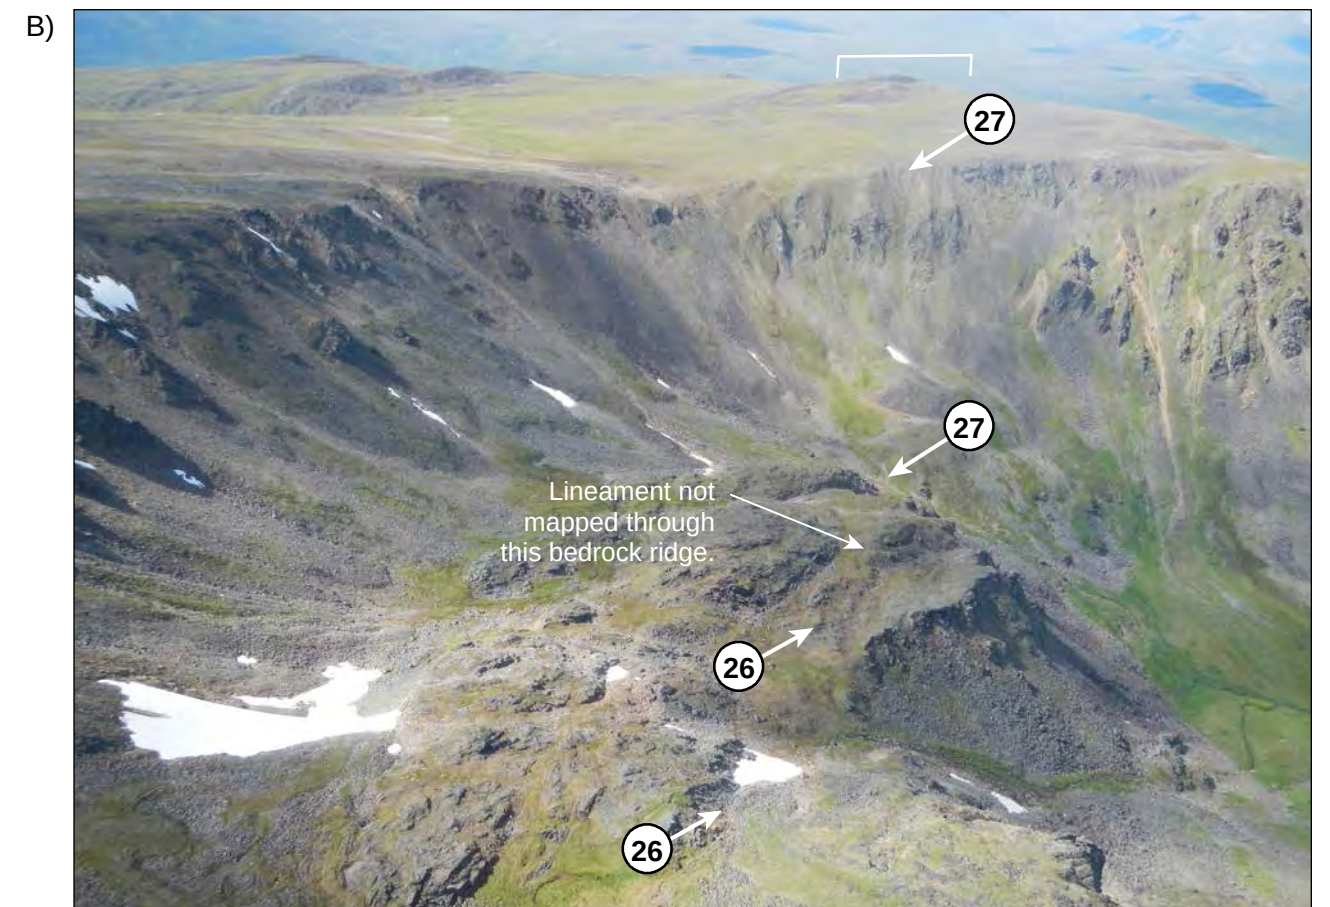
View looking east from photograph location B. Arrows and brackets indicate the projected path of Feature 26 and 27 lineaments. Note the absence of a continuous and clear lineament along projected traces.

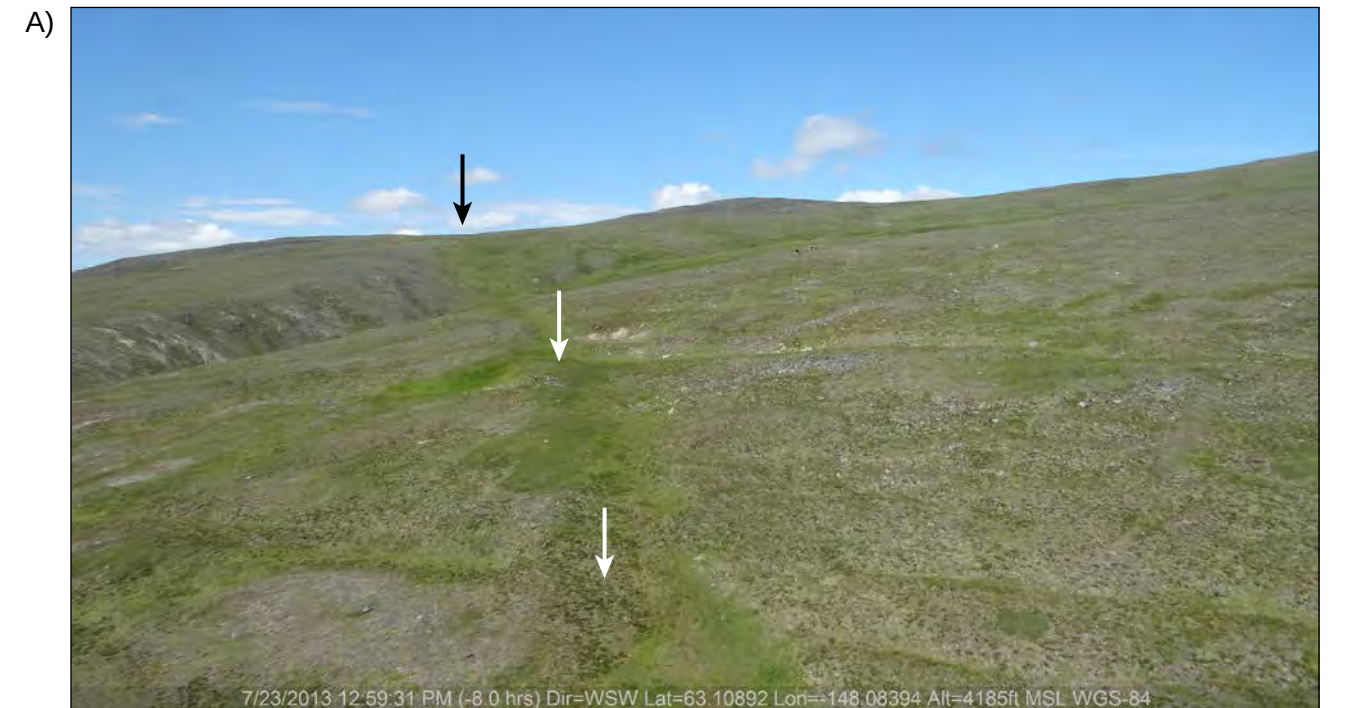
View looking west-northwest from photograph location A. Arrows show mapped trace of Feature 28. Note lineament corresponds to subtle linear trough and linear vegetation trend.

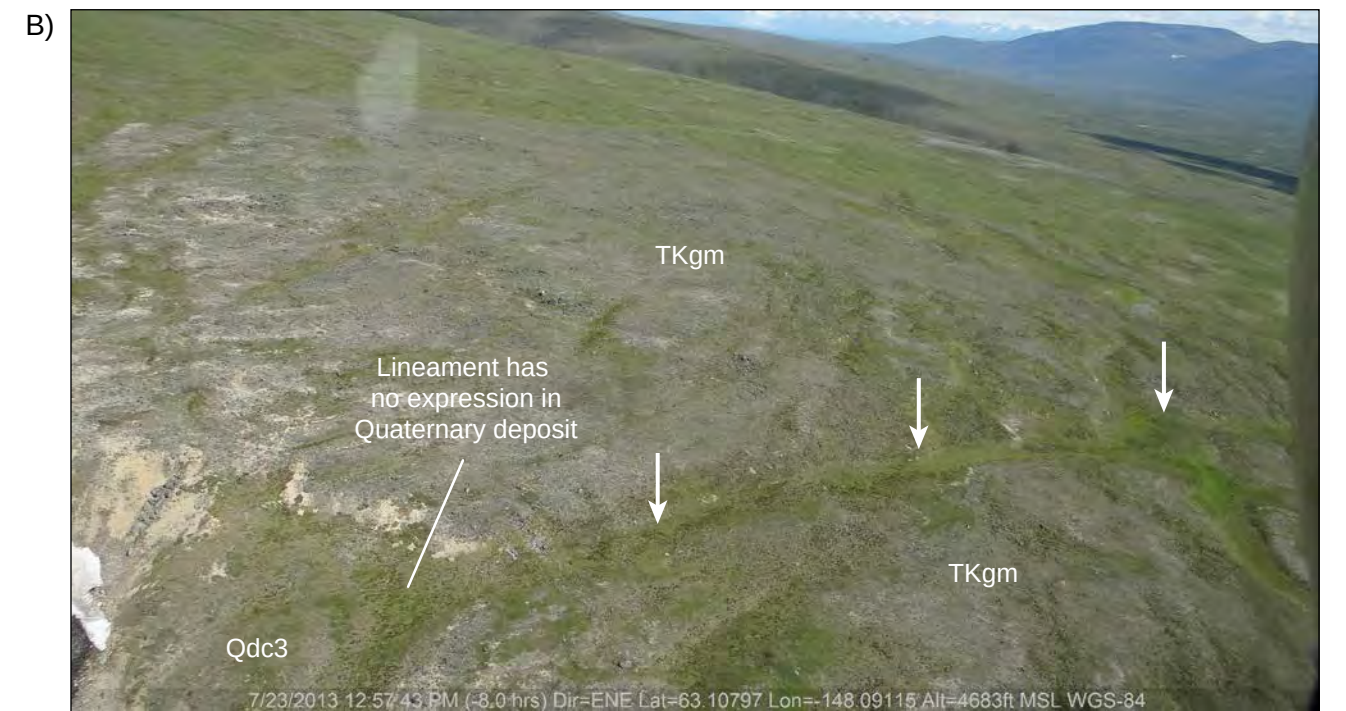
View looking east from photograph location B. Arrows indicate the mapped trace of Feature 28. Note absence of linear expression in Quaternary deposits.
