**REPEAT PHOTOGRAPHY OF  
BADAMI PIPELINE RIVER CROSSINGS:  
1999 PROGRESS REPORT**

**To:**  
**BP EXPLORATION (ALASKA), INC.**  
**ANCHORAGE, ALASKA**

**FROM:**  
**JAY D. MCKENDRICK**  
**LAZY MOUNTAIN RESEARCH**  
**PALMER, ALASKA**

**12 JANUARY 2000**

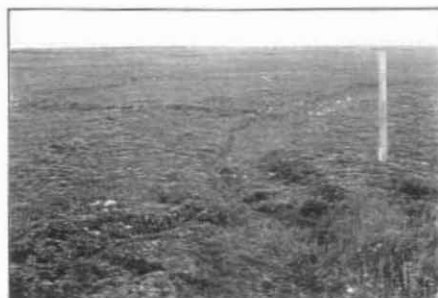
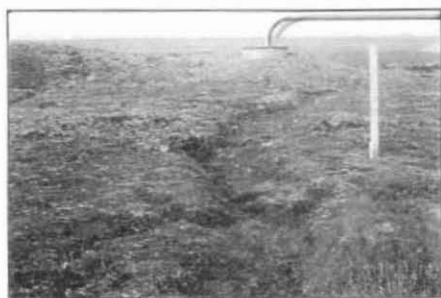
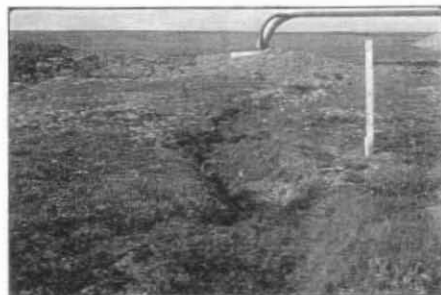
Figure 1 shows the riser pipe at the east end of the Shaviovik River crossing. The soils at this site are well-drained, and polygon troughs are well-developed, indicating subsurface ice masses. Vegetation at this location is a mixture of grasses, sedges and forbs. Legumes and other showy flowering forbs are common, which is typical for well-drained habitats along rivers in this region. Through 1999, there was no evidence that construction activities caused thermokarst adjacent to the pipeline. However, the cover photo on this report (taken in August 1999) shows marked settling of that backfilled trench. Settling was not apparent in 1998 and must have occurred after our inspection. Since it is likely more settling will occur, delaying revegetation activities until the backfill becomes stabilized is probably the best action at this time.

*Figure 1. Northward view from photopoint (N70°08'41.7"; W147°15'13.1") south of Badami pipeline at the east end of the Shaviovik river crossing. Upper, middle, and lower views were taken, respectively, on 15 August 1997 (pre-construction), 14 August 1998 (6 months following construction), and 27 August 1999 (18 months after construction). The photo sequence shows no significant changes in either the adjacent landscape soil and vegetation as a result of pipeline construction and operation. This is helpful information, because there were indications suggesting the site might have been prone to thermokarst.*

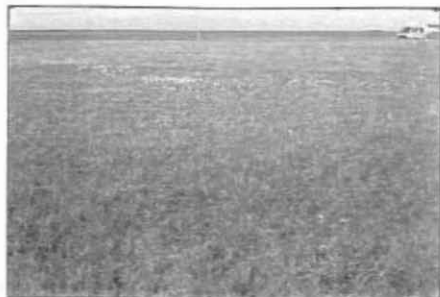
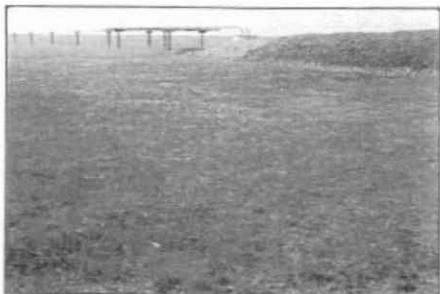
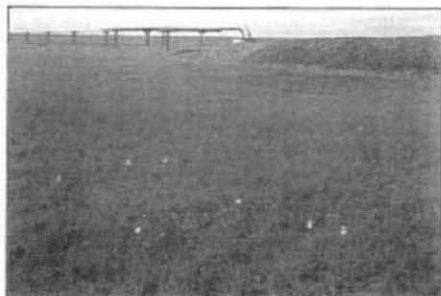
The west end of the Shaviovik river crossing is moist sedge meadow, formed in the flood plain of an old river meander. The habitat is more moist than habitat on the east side of the river, and polygon troughs are less prominent, suggesting the surface is geomorphically younger than on the east. Figure 2 photo sequence shows the pre-construction and post-construction view of portions of the elevated and buried pipeline and the riser pipe between the two. Following construction there was a little soil left on the surface next to the backfilled trench. Vegetation was not affected by that soil, and shoots produced in 1998 and 1999 emerged through the thin layer of soil. There is no evidence of thermokarst due to excavation and backfilling the trench. It is instructive to observe there was little settling of the backfilled trench at this end of the river crossing, in contrast to that on the east end (cover photo). That indicates less ground ice on the west side of the river and is consistent with observations of poorly developed polygon troughs on the west side of the river.

*Figure 2. Northwest view from photopoint (N70° 08' 44.6"; W147° 15' 32.6") on south side of Badami pipeline at the west end of the Shaviovik river crossing. The upper, middle and lower photos were taken, respectively, 15 August 1997 (pre-construction), 14 August 1998 (6 months post-construction), and 27 August 1999 (18 months post-construction). The sequence shows no significant alterations in either the terrain or vegetation beyond that disturbed during trenching and backfilling.*

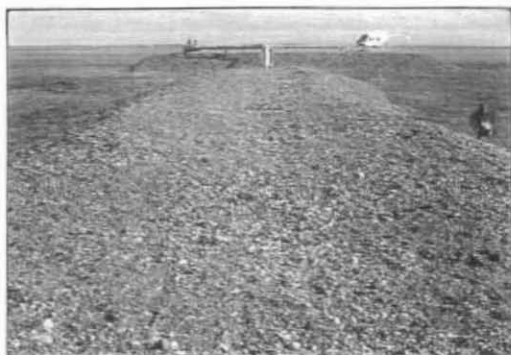
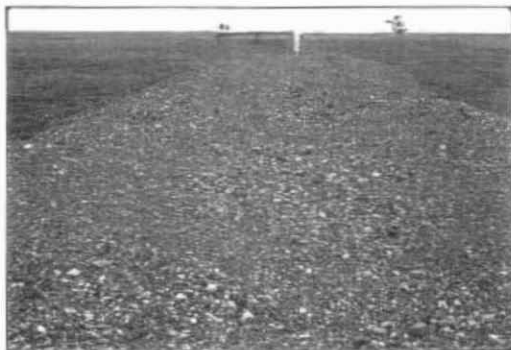
On the east side of the river, the landscape is a large gravel deposit that is geologically too young to have acquired a significant covering of silt. There is little accumulation of peat on the surface, which would improve the soil's water and nutrient supplying capacity for vegetation. As a result the vegetation is sparse and consists primarily of gravel colonizing plant species. Nitrogen fixing legumes and other forbs are common. However, wetland species which dominate most of the route and which are found at other river crossings were absent. It is likely there are no large accumulations of ice masses in the subsurface on the east end of this river crossing. Consequently, relatively little settling of this backfilled trench is expected. Figure 3 shows a sequence from 1998 and 1999 images of the gravel backfilled trench on the east end of the Kadleroshilik crossing, and there is little evidence of significant settling having occurred by August 1999, in contrast to backfill settling observed at the east end of the Shavirov crossing.

*Figure 3. West to east view of backfilled trench at the east end (N70° 10' 39"; W147° 38' 13") of the Badami Pipeline crossing of the Kadleroshilik River. Upper photo was taken 14 August 1998, and the lower was taken 27 August 1999. This gravel fill was seeded with a mixture of indigenous plant species and fertilized with 300 lb/a (10-20-20) fertilizer on 31 July 1999 (McKendrick, 2000).*

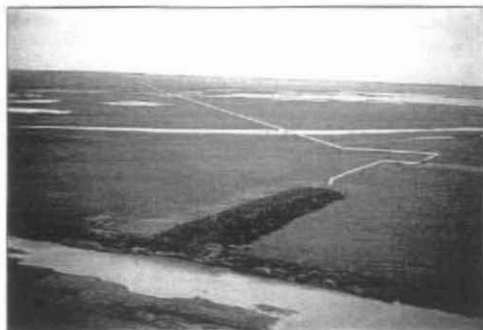
Figure 4 shows an aerial oblique of the west end of the Kadleroshilik river crossing. The landscape is geomorphologically older than on the east side of the river. There is a moderately thick accumulation of peat overlying silt atop a fluvial gravel deposit. Large low centered polygons are present, indicating presence of some subsurface ice masses in the vicinity. There was adequate peat and silt to cap the gravel backfill over the buried pipeline on this side of the river.

*Figure 4. Low angle aerial oblique view westward of west end of Badami Pipeline crossing of the Kadleroshilik River (27 August 1999). Peat and silt overburden used to cap the backfilled trench for the buried section of the pipeline appears dark, in contrast to the light-colored gravel fill around the riser pipe and for the helipad and check valve. Vegetation is moist rhizomatous sedge/Dryas meadow. In the distance, an old river terrace is apparent. Gravel fill at this location was seeded and fertilized 31 July 1999 (McKendrick, 2000).*

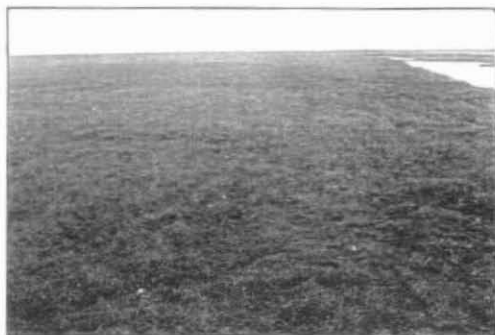
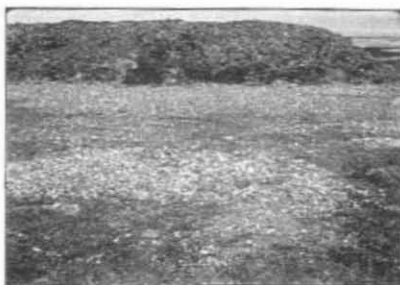
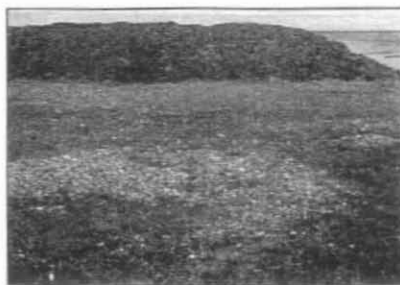
Figure 5 shows a sequence before and after construction at the west end of the Kadleroshilik River crossing. There was a thin scattering of gravel on a small area of the tundra surface beyond the boundaries of the trench. This appeared to have affected few plants. Vegetation was emerging through the gravel in 1998 and 1999, and in time it is expected the gravel will become less and less obvious. There has been no apparent settling of the backfill over the buried pipeline trench at this site, since construction. It is expected that eventually the gravel will be obscured by plant cover and accumulated litter.

Figure 5. Northward view from south of the buried Badami Pipeline at the west bank of the Kadleroshilik River ( $N70^{\circ} 10' 42.9''$ ;  $W147^{\circ} 38' 29.8''$ ). This photo sequence consists of a pre-construction view (15 August 1997, on previous page), and two post construction views, (14 August 1998 and 27 August 1999, above left and right), respectively. The thin scattering of gravel deposited next to the pipeline during construction was less apparent 18 months after construction (1999), indicating vegetation was covering the stones.

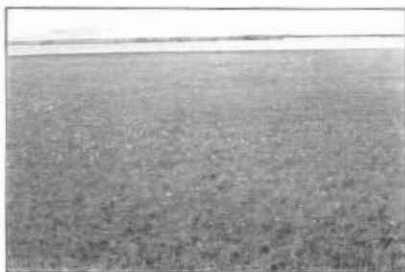
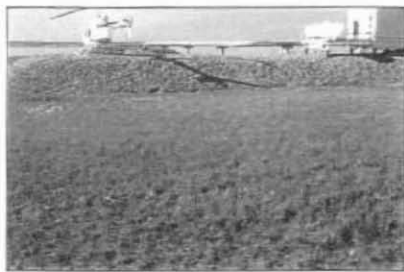
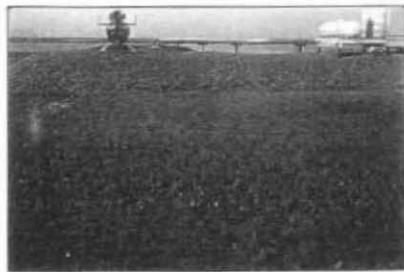
The photo sequence acquired on the east side of this river crossing indicate no damages to soil and vegetation beyond the boundaries of construction (Figure 6). If any gravel was spilled outside the helipad border, it was not apparent. The absence of polygon troughs indicates there are few ice lenses at this east end of the pipeline river crossing. Thermokarst is not anticipated at this location.

Figure 6. Photo sequence is a westward view of the Badami Pipeline crossing on the east side of the east channel of the Sagavanirktok River ( $N70^{\circ}13'28.9''$ ;  $W147^{\circ}56'42.3''$ ). The helipad and gravel fill for a check valve station were constructed on the area included in this view. Upper, left lower and right lower photos were taken, respectively, on 15 August 1997 (pre-construction), 14 August 1998 (post-construction), and 27 August 1999.

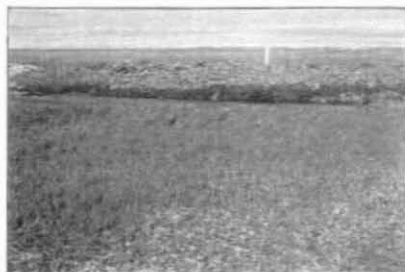
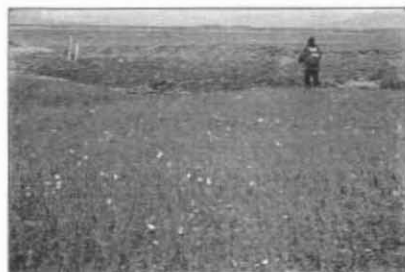
Figure 7 is a photo sequence that captured the development of the erosion at the west end of the Sagavanirktok crossing. Examining the 1997 photo shows a strand of red grass (*Arctophila fulva*) in the midst of a dark green wet sedge meadow. This indicated the presence of a waterway which drained the pond up slope. Within that waterway, ponding against the backfill and marked subsidence in the backfilled trench was evident in the 1998 photo. In the 1999 photo, much of the backfill has been removed. Signs of the potential problem were present prior to construction, but they were not adequately recognized. Perhaps experiences gained here will be helpful in siting future pipeline projects in the region. The photo sequences in Figures 8, 9 and 10 also show the backfilled trench before and after erosion occurred. Figure 11 is a view of the gully from the river toward the riser pipe.

Figure 7. A photo sequence of the Badami Pipeline crossing on the west side of the east channel of the Sagavanirktok River ( $N70^{\circ} 13' 34.4''$ ;  $W147^{\circ} 58' 19.5''$ ). Upper, lower left and lower right photos were obtained, respectively, on 15 August 1997 (pre-construction), 14 August 1998 (post-construction), and 27 August 1999. View is northward across the area transected by the buried pipeline.

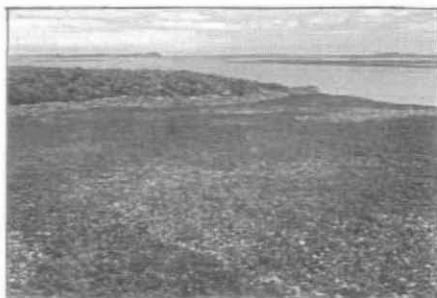
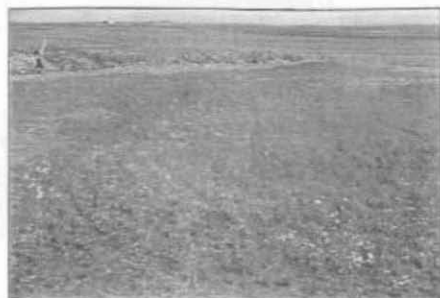
Figure 8. Northeastward from photopoint #2 at the west end of the Sagavanirktok river crossing. Left image shows backfill over the buried pipeline 14 August 1998, and the right view shows the same area on 27 August 1999 after water removed most of the backfill.

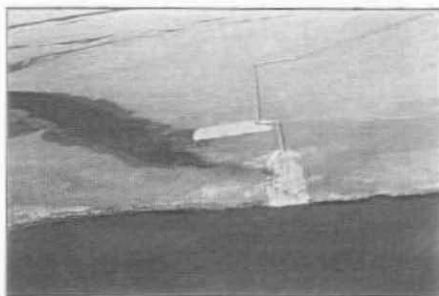
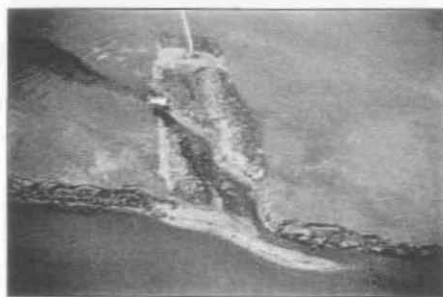
On the west bank, stream erosion was particularly noticeable between 1997 and 1999. This erosion was unrelated to the cutting away of backfill over the buried pipeline, discussed later, and it is evident in Figure 9. In flat terrain, such as this river delta, channel erosion normally occurs predominantly on one side of a river channel at a time, and as the stream meanders, cutting and filling occur on opposite sides of the channel. Cutting simultaneously on both sides at this location suggests increased water flow. Perhaps increased flow has been induced by changes in the main channel upstream, which recently forced more water toward the east side of this braided river. Periodic fluctuation in river flow is consistent with the varied deposits of sand and peat in this area.

Figure 9. Aerial oblique views of Badami Pipeline on the west side of the Sagavanirktok crossing 22 July 1998 (upper) and 27 August 1999 (lower). Two sets of crawler tracks are prominent in the tundra to the left of the backfilled trench. A single faint set of tracks can be seen to the right of the pipeline above the helipad (upper photo). These marks are believed to have resulted from heavy equipment moving across the tundra during construction without protection from the ice pad. They may not cause thermokarst and will probably become vegetated naturally in time. Those in the margins of the *Arctophila fulva* bed are apt to persist as depressions in the soil for an indefinite period. Vegetation cover will obscure them more quickly in the wet habitats than on the dry sites. This type of tundra marking is relatively uncommon for the Badami Pipeline, and is pointed out here, because it appeared so obviously in these photos. Also important to note is the marked erosion and calving of the river bank that occurred between the 1998 and 1999 photos.

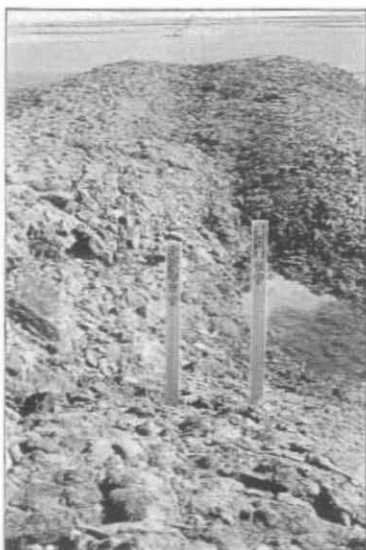
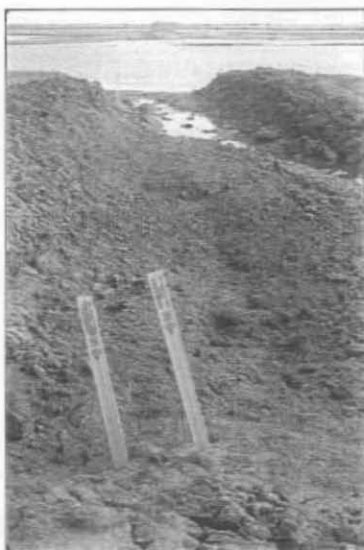
Unlike the other river crossings, the west end of the Sagavanirktok crossing developed an erosion problem. The pipeline was constructed through a naturally-occurring drainage. Once subsidence in the backfill over the buried pipe began, water soon filled the depression and softened the soil. At breakup, the

head of water cut through the backfill, washing much of it into the river and formed a channel (gully) through the pipeline trench. Headward erosion of this channel was controlled by the natural vegetation of rhizomatous sedges up slope from the pipeline trench. Gully depth within the pipeline trench was controlled

by the water elevation in the river. Hence, deeper erosion within the pipeline trench is unlikely, without major lowering of the sea level. That and the depth to which the pipeline was buried prevented any damage to the pipeline integrity from this erosion process. The major environmental consequence presented by all this is increasing the risk for draining the water body up slope (see upper photo Figure 9). That pond was formed in the depression of an abandoned river channel. It is considered by wildlife biologists as valuable habitat for waterfowl, because it contains an extensive bed of *Arctophila fulva*. Based on observing stickleback fish in the shallow margins of this pond in 1998, I would expect it to also be a feeding area for loons.

*Figure 10. View eastward of backfilled trench over buried pipeline on the west side of the Sagavanirktok River. Photos were obtained, respectively on 14 August 1998 (left) and 27 August 1999 (right). Water was impounded in a subsidence over the pipeline in 1998, and had cut through the backfill during spring breakup in 1999. The east end of the river crossing can be seen in the distance.*

The west end of the Sagavanirktok crossing is a separate matter. Presumably some type of repairs for erosion control will be installed at that site, and depending upon the nature of those features, assisted revegetation may be needed to stabilize the soil.

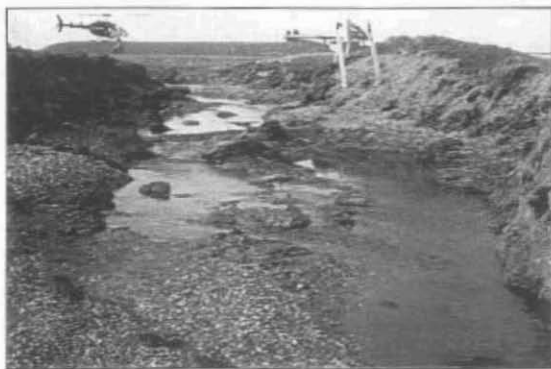
*Figure 11. View westward up the gully cut through the backfill over the buried pipeline at the west end of the Sagavanirktok crossing for the Badami Pipeline (27 August 1999).*

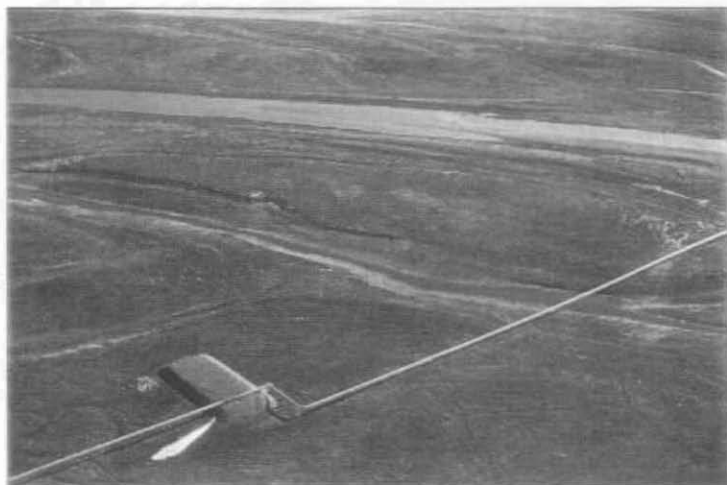
*Back cover: Southwest to northeast aerial oblique view of check valve and helipad for Badami Pipeline just west of Shavirovik River crossing. Construction is 16 months old in this 23 June 1999 view, and few marks appear in the tundra from construction. Exceptions are vehicle tracks beyond protection of the ice pad used for building the pipeline.*
