Source Water Assessment

A Hydrogeologic Susceptibility and
Vulnerability Assessment for
LDS Steese Chapel Drinking Water
System,

Fairbanks area, Alaska

PWSID 312253

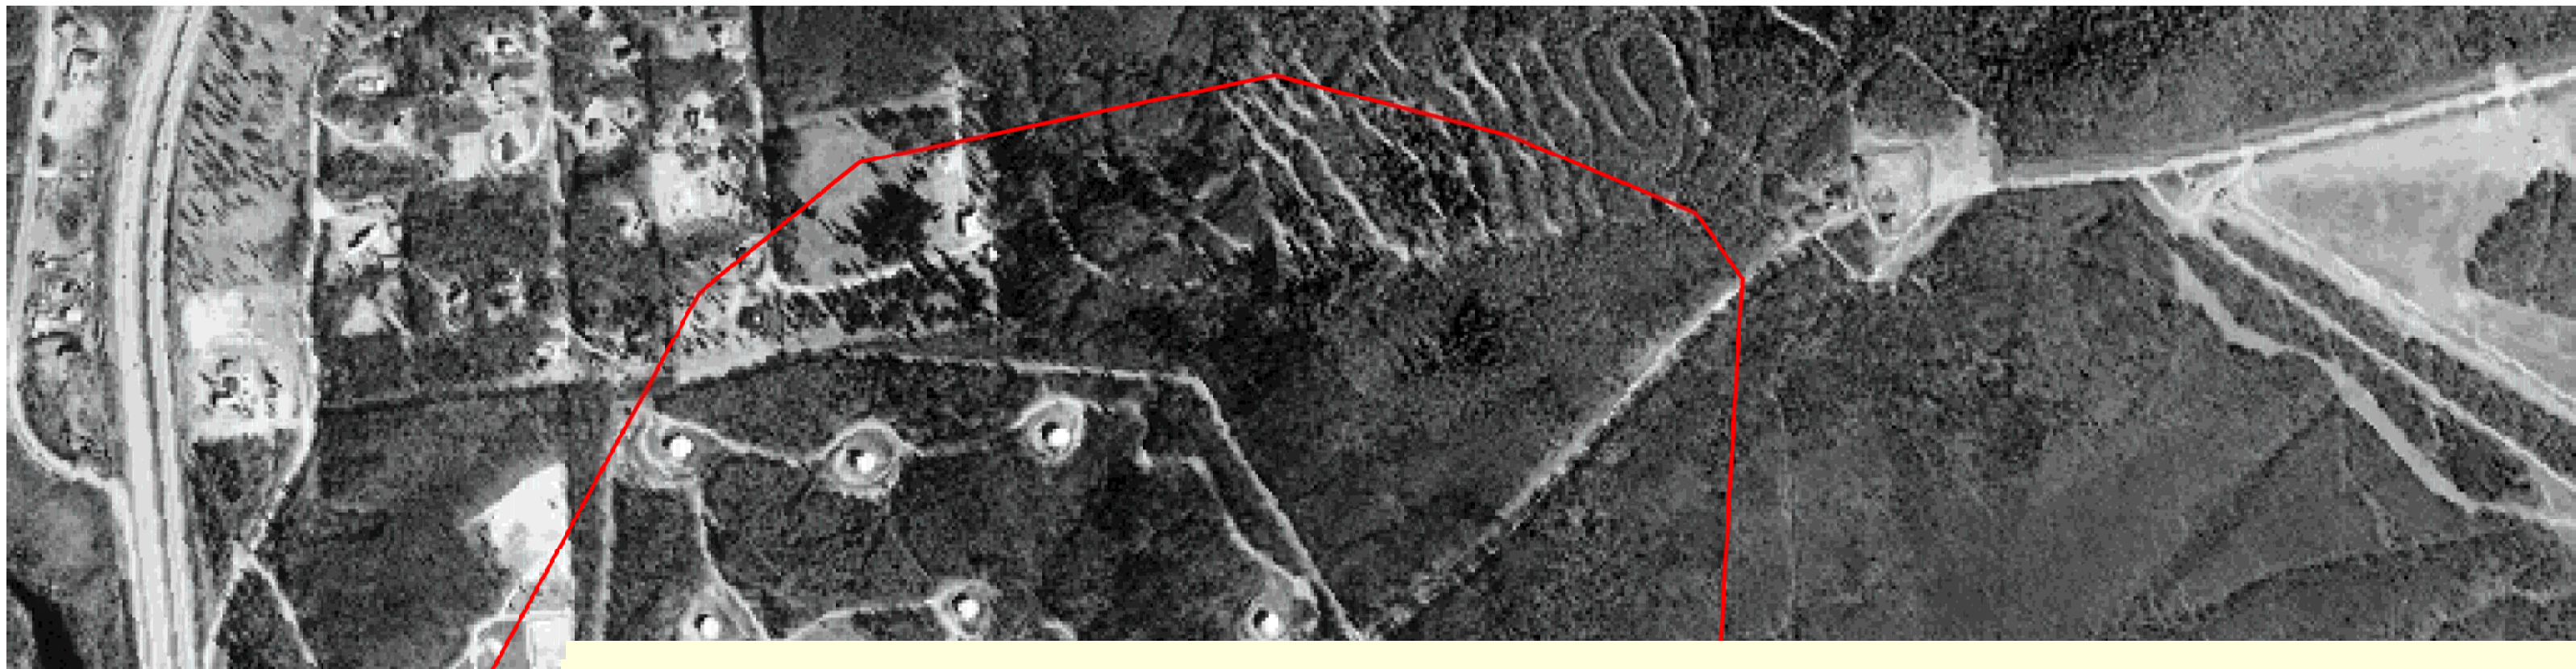
LDS Steese Chapel Drinking Water Protection Area and Potential and Existing Contaminant Sources (Map 2)

The ADEC-recognized contaminated sites in Zone A of the protection area are located on Birch Hill at the tank farm and its associated pipelines (RecKey 199231X927401, 199231X127402, and 199231X127403). Fuel contamination has been found in the soil and the groundwater on the hill and in the area downgradient of the tank farm. Free product has been identified in the bedrock of Birch Hill. It is

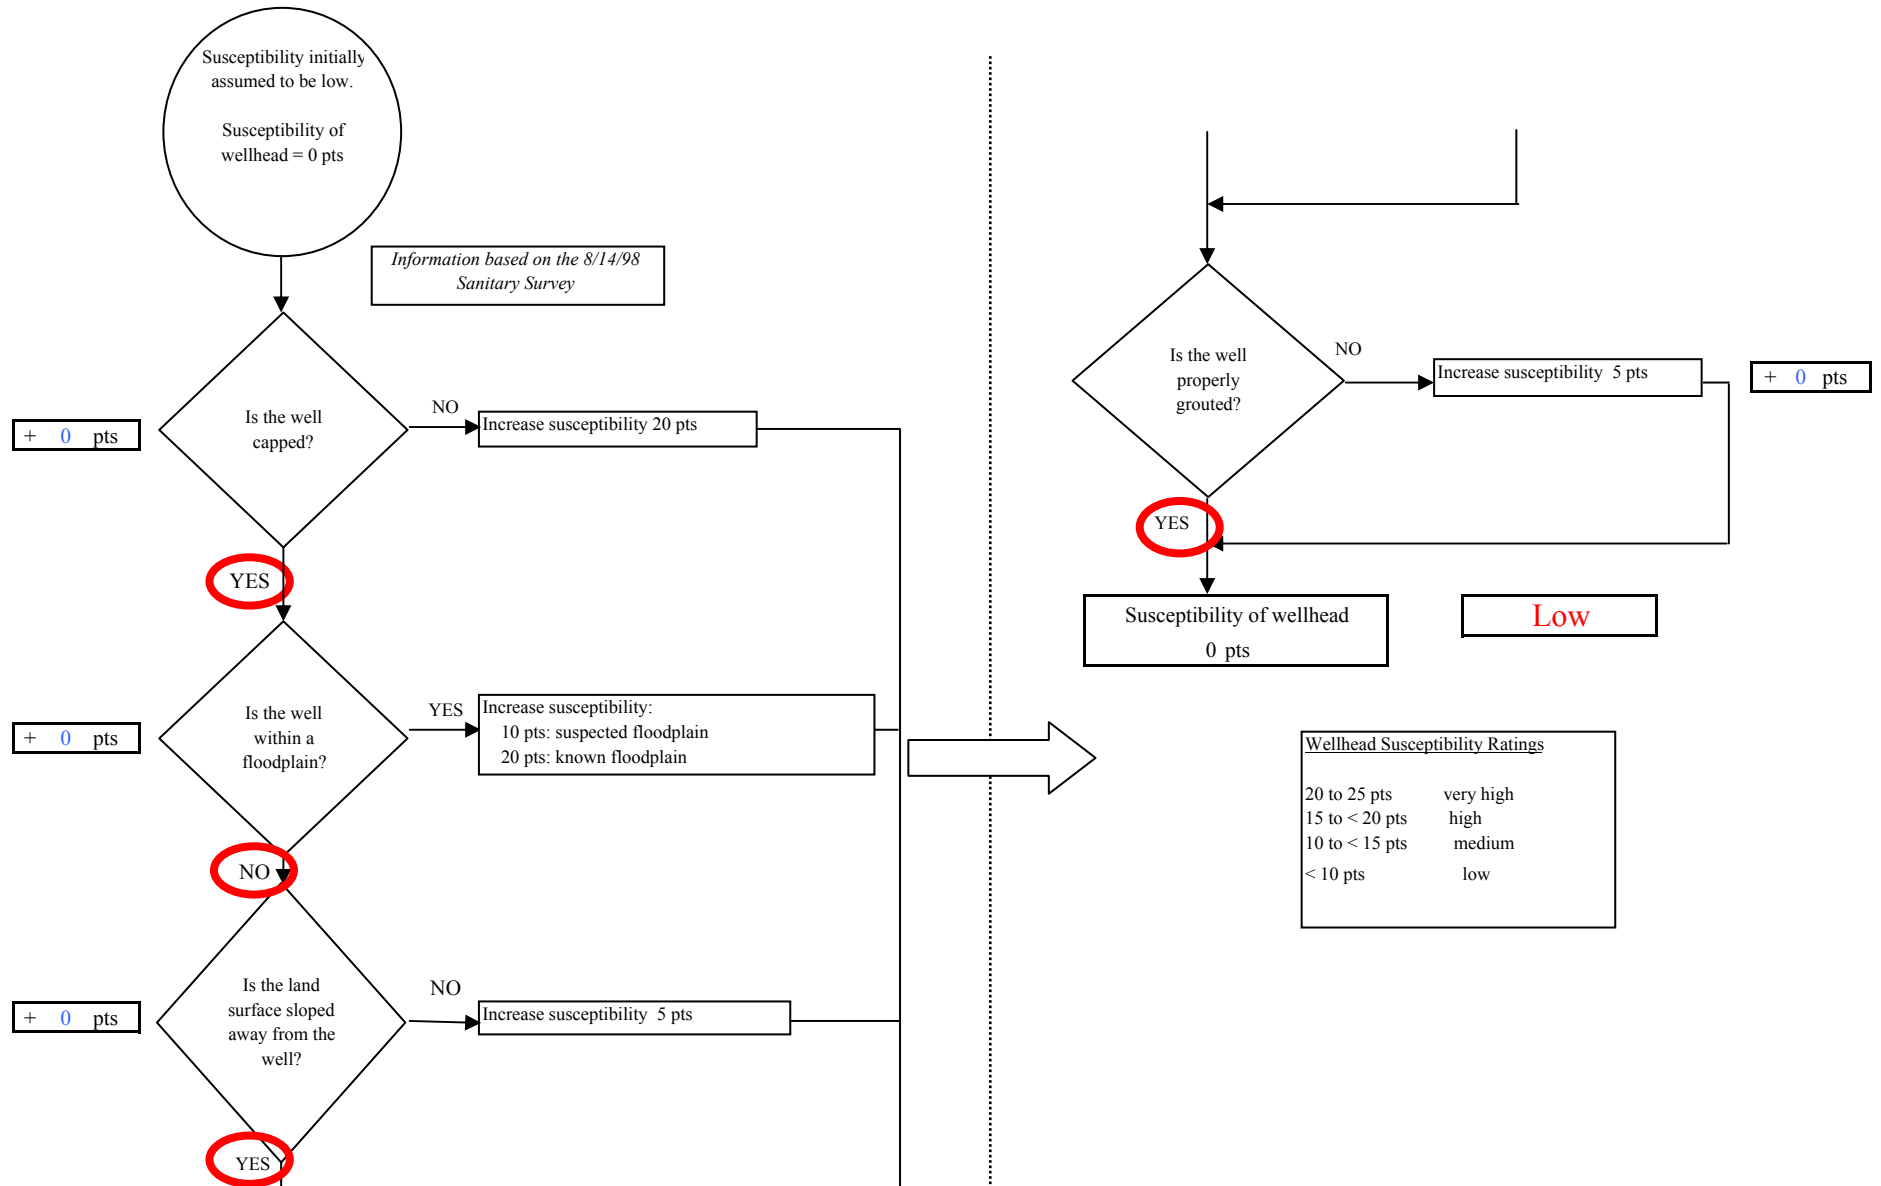
Chart 1. Susceptibility of the wellhead - LDS/Steese Chapel

The wellhead for the LDS Steese Chapel received a Low Susceptibility rating. The 8/14/98 Sanitary Survey indicated the well is capped with a sanitary seal, the well site is adequately drained, and the well is grouted. A sanitary seal prevents potential contaminant from entering the well while grouting helps to prevent potential contaminants from traveling down the outside of the well casing.

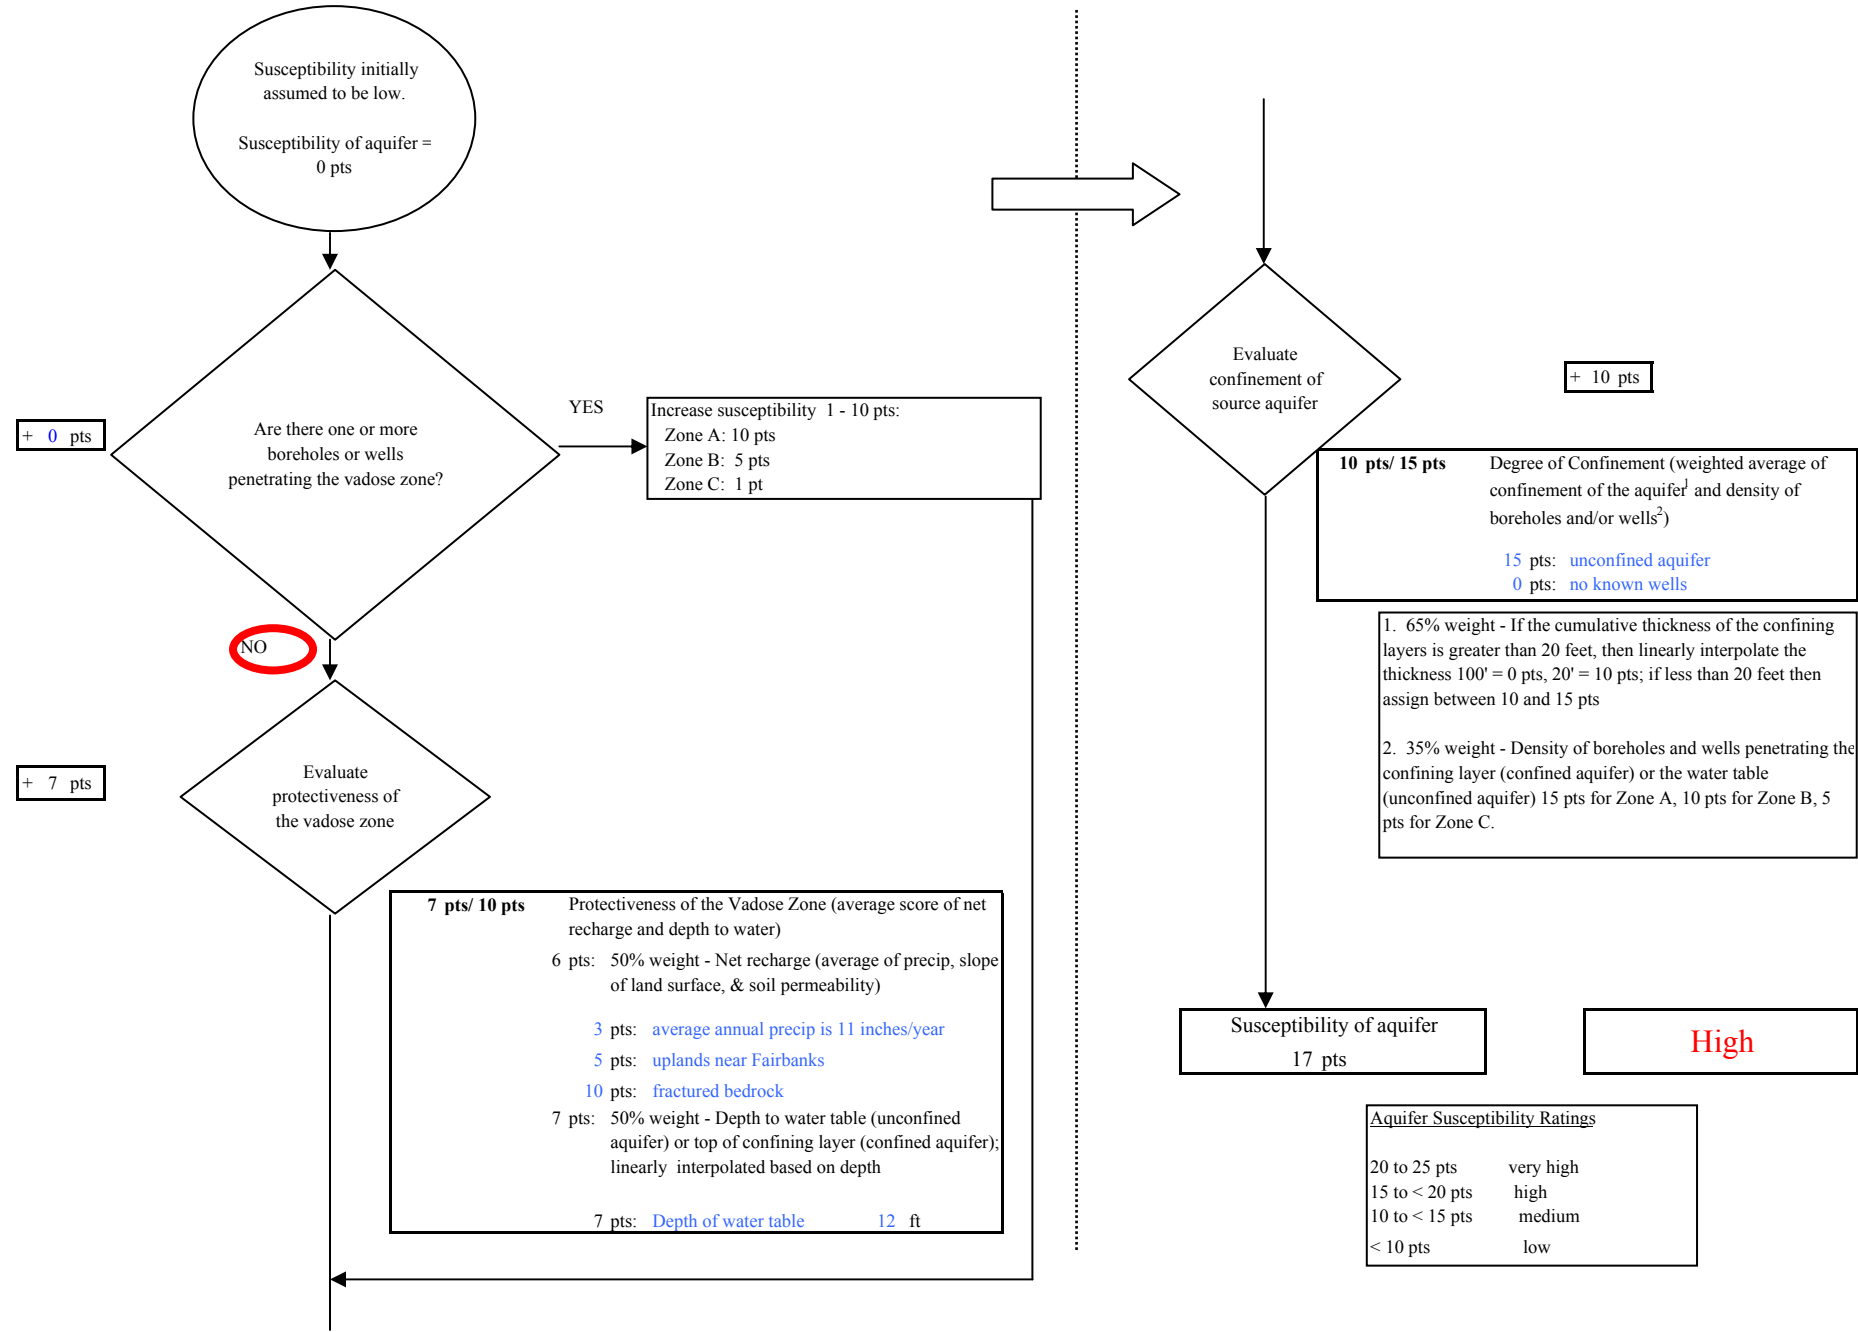
Chart 2. Susceptibility of the aquifer - LDS/Steese Chapel

The aquifer in the area the LDS Steese Chapel well is completed in received a High Susceptibility rating. The fractured bedrock can allow contaminants to travel at a fast rate downward from the surface with the precipitation and surface water runoff. Table 2 summarizes the Susceptibility scores and ratings for LDS Steese Chapel.

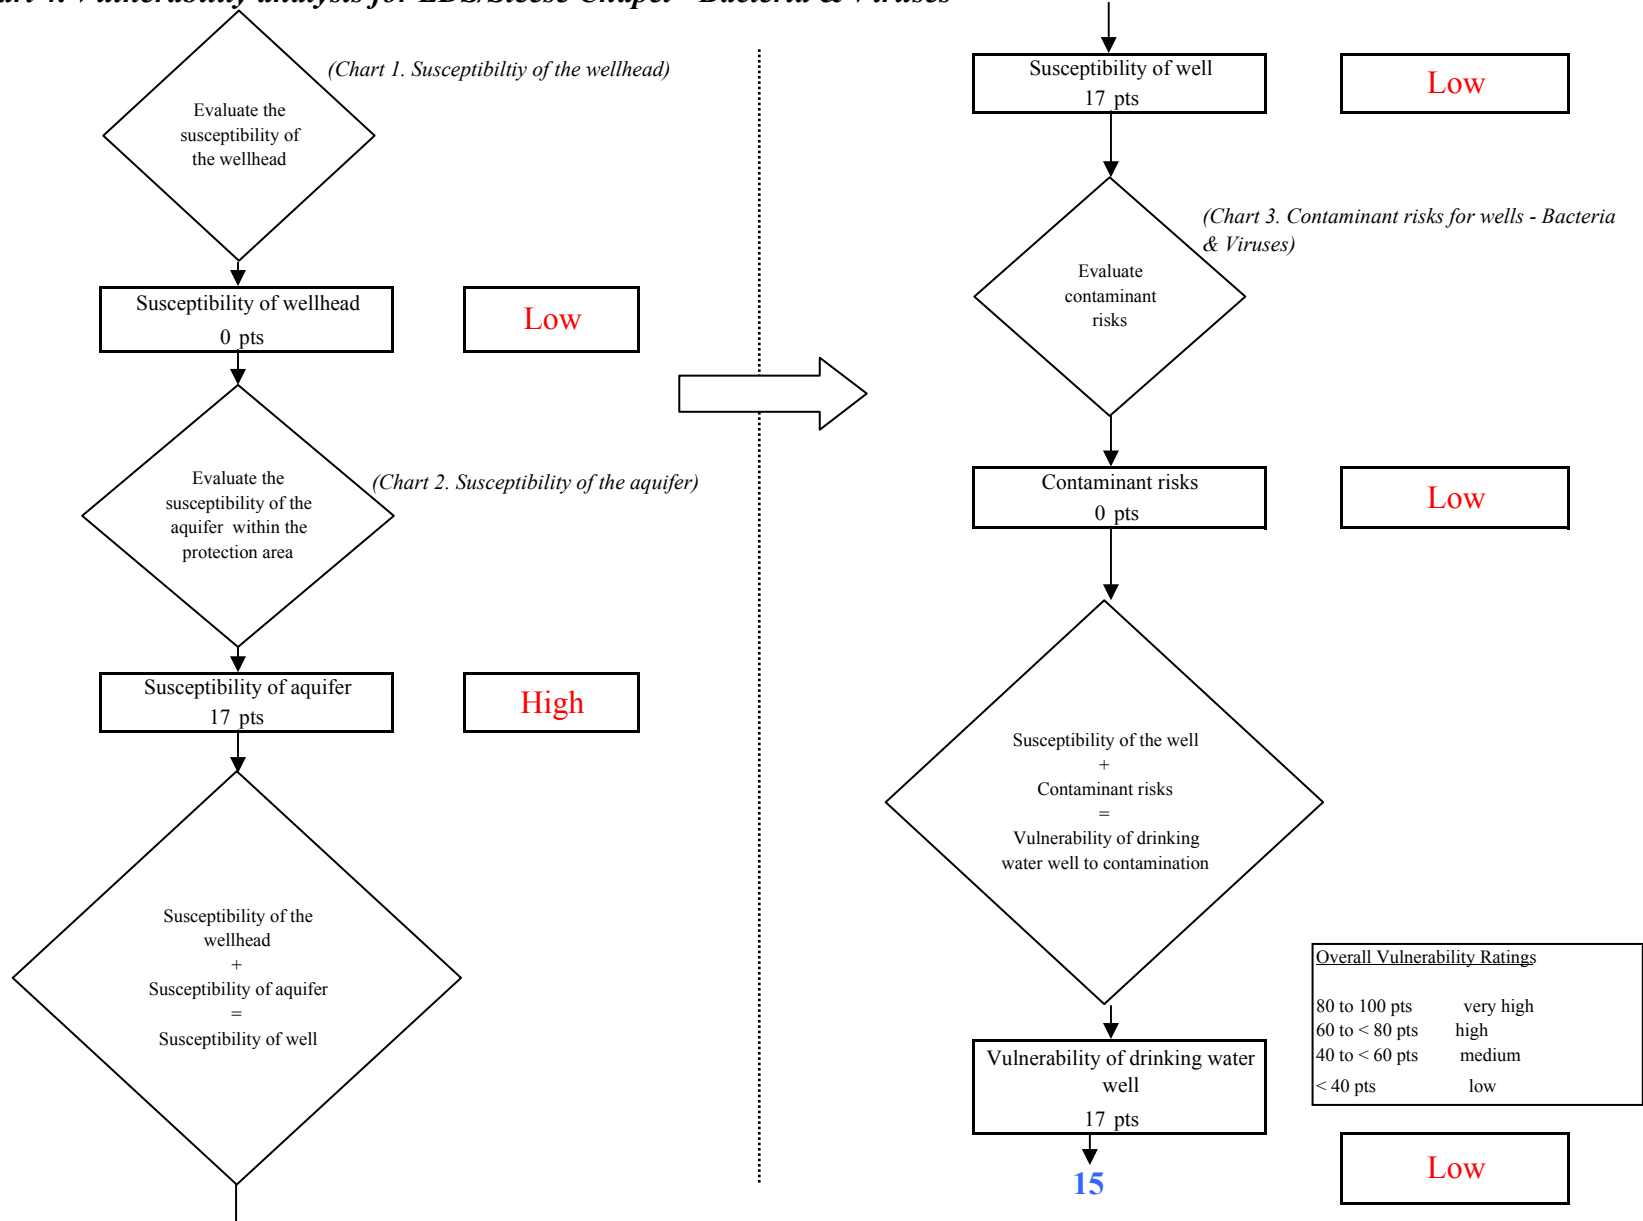
Chart 4. Vulnerability analysis for LDS/Steese Chapel - Bacteria & Viruses

After combining the contaminant risk for bacteria and viruses with the natural susceptibility of the well, the overall vulnerability of the well to contamination is low.

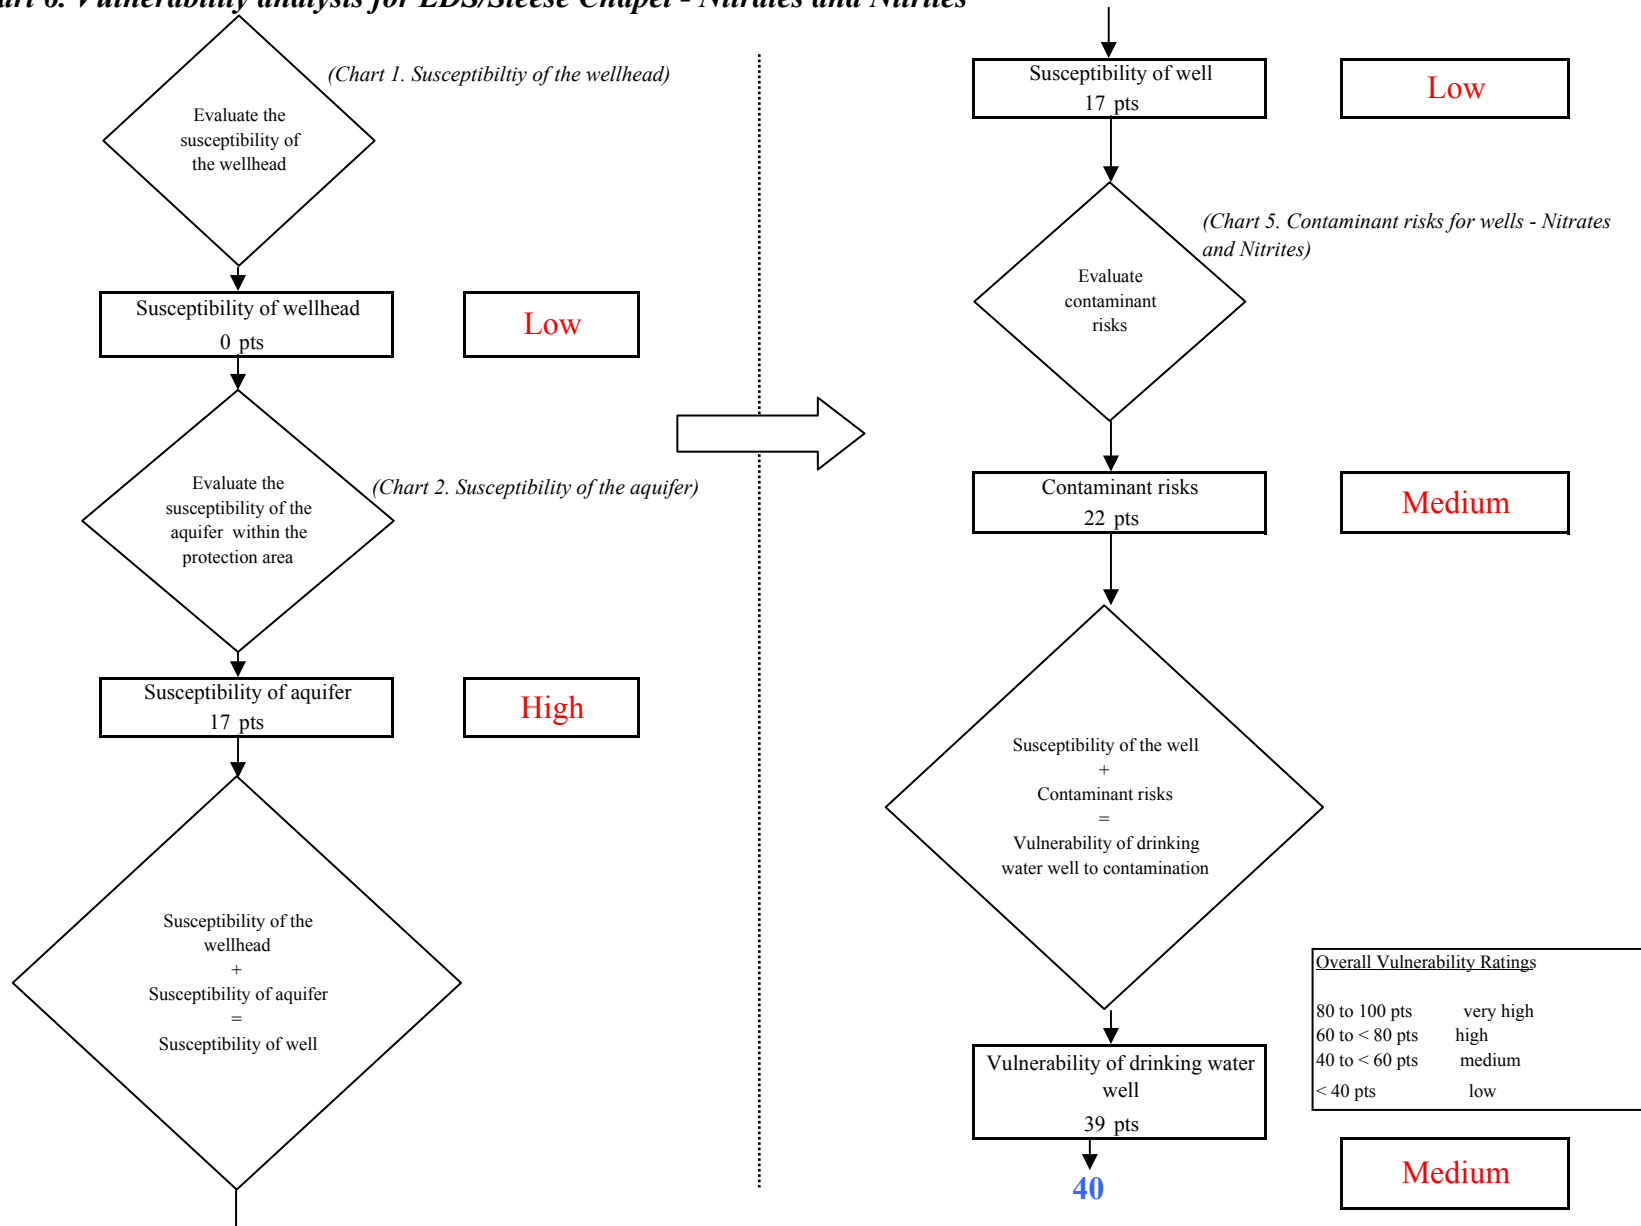
Chart 6. Vulnerability analysis for LDS/Steese Chapel - Nitrates and Nitrites

After combining the contaminant risk for nitrates and nitrites with the natural susceptibility of the well, the overall vulnerability of the well to contamination is medium.

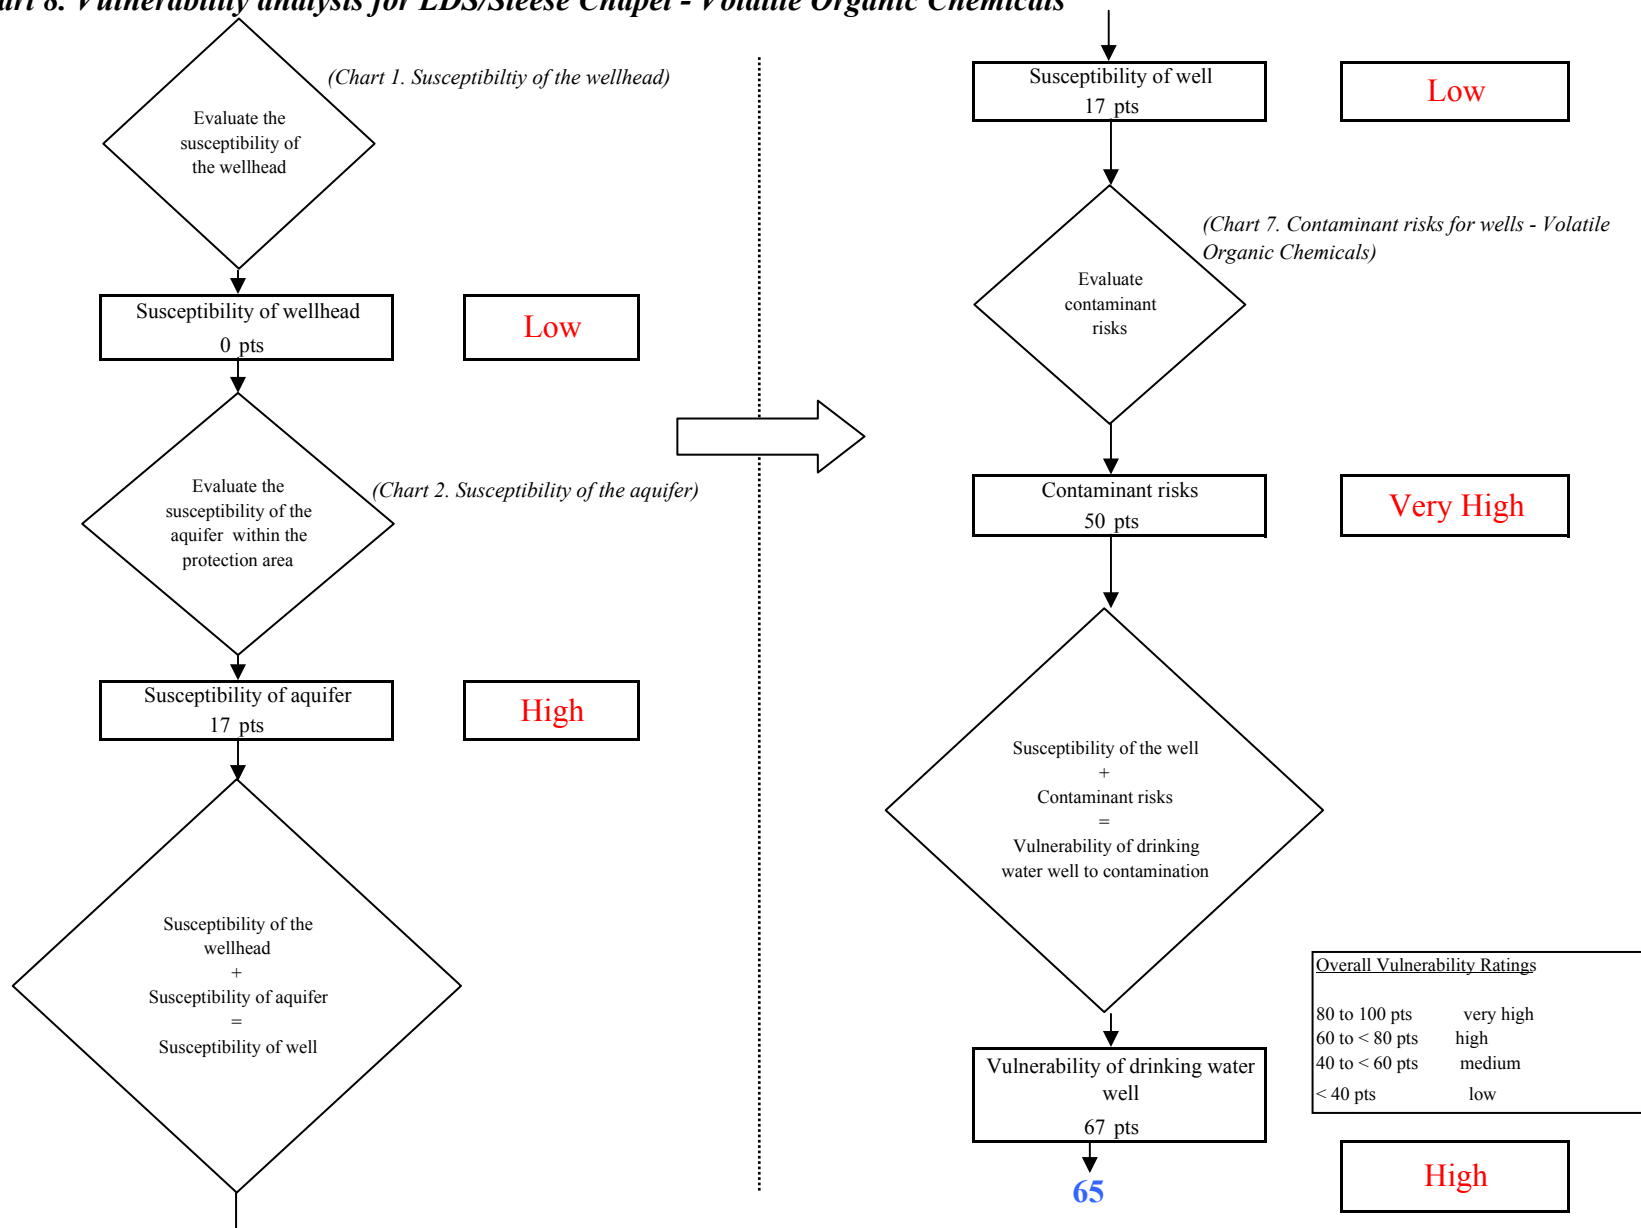
Chart 8. Vulnerability analysis for LDS/Steese Chapel - Volatile Organic Chemicals

Volatile Organic Chemicals are routinely sampled for but have not been detected in significant quantities (1,2-Dichloroethane is routinely detected but in concentrations well below its maximum contaminant level) in the LDS Steese Chapel public water system. After combining the contaminant risk for volatile organic chemicals with the natural susceptibility of the well, the overall vulnerability of the well to contamination is high.
