PRELIMINARY INTERPRETIVE REPORT 2012-2

**ACTIVE AND POTENTIALLY ACTIVE FAULTS ALONG
THE ALASKA HIGHWAY CORRIDOR, TETLIN JUNCTION
TO THE CANADA BORDER**

Rich D. Koehler and Gary A. Carver

May 2012

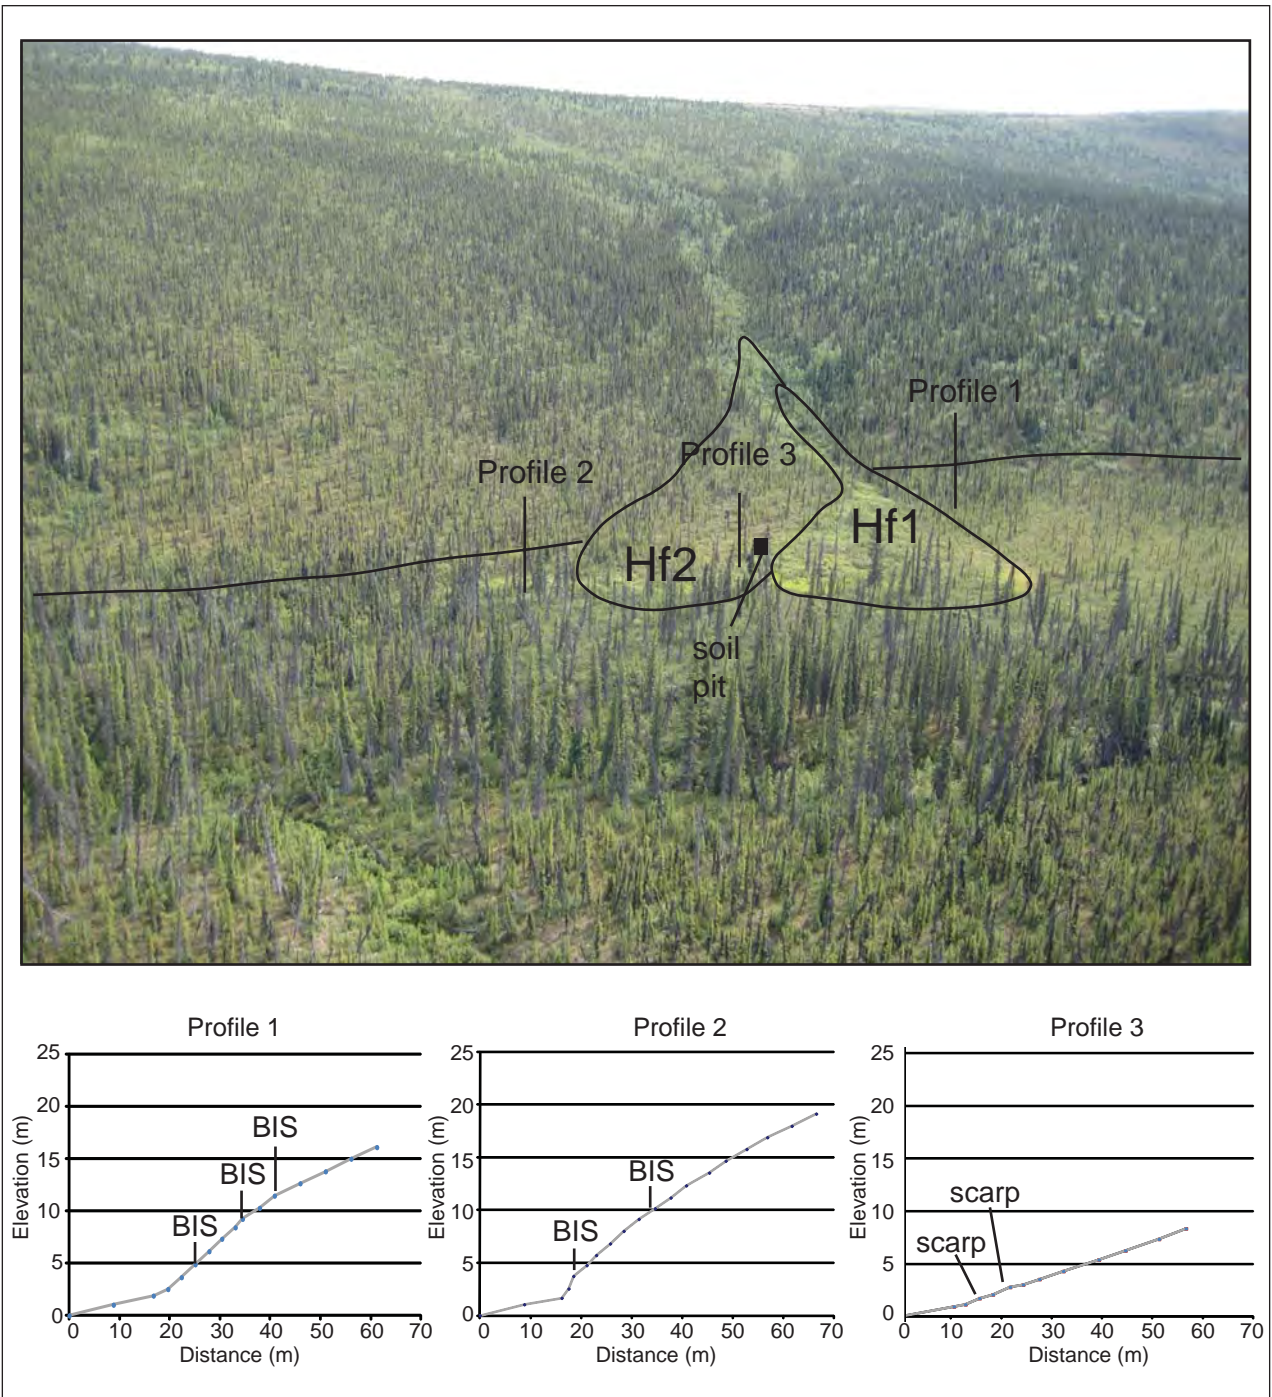
At OBS 3, a north-facing alluvial fan emanates from a broad colluvial hollow that occurs along the alignment of scarps (figs. 5 and 6). From the air, we noted the possibility of the fault extending part way across the eastern side of the fan. Subsequently, we conducted ground traverses along the fault and surveyed several topographic profiles to evaluate the recency of faulting in more detail. A semi-continuous bedrock scarp ranging from 2 to 10 m high extends along the base of the slope on either side of the fan (figs. 6 and 7). Scattered tabular boulders averaging 1–2 m in diameter are present at the base of the scarp. Profiles 1 and 2 were surveyed across the scarp west and east of the fan, respectively. These profiles show the scarp is gently sloping, but contains several subtle breaks in slope (bevels?). Profile 2 has an oversteepened base; however this feature is localized. Profile 3 was surveyed across the projection of the scarp in the older part of the alluvial fan (surface Hf2, fig. 6), where we observed two

Figure 6. Photograph of alluvial fan crossing the upland segment of the Caribou Creek fault, showing locations of profiles 1, 2, and 3 and soil pit on Hf2 surface. Location of alluvial fan shown in figure 5 as OBS3. BIS; break in slope. Coordinates for endpoints of profiles are: Profile 1, 63.4226, -142.1488 and 63.4231, -142.1490; Profile 2, 63.4247, -142.1439 and 63.4241, -142.1435; and Profile 3, 63.4240, -142.1459 and 63.4236, -142.1456.

semi-parallel breaks in slope. The profile indicates that the breaks in slope occur across two <1-m-high scarps. The scarps do not continue across the inset fan surface (surface Hf1). A soil pit excavated into the Hf2 surface adjacent to profile 3 indicates that the surface is likely Holocene in age (fig. 8). Although we cannot preclude that the scarps are tectonic in origin without subsurface observations, the lack of similar scarps along the length of the fault indicates that an alternative mechanism is responsible for their formation. Possible mechanisms include erosion by floodwaters emanating from the mouth of the canyon, fan deposition associated with draping over a preexisting bedrock scarp, or game trails, or both.

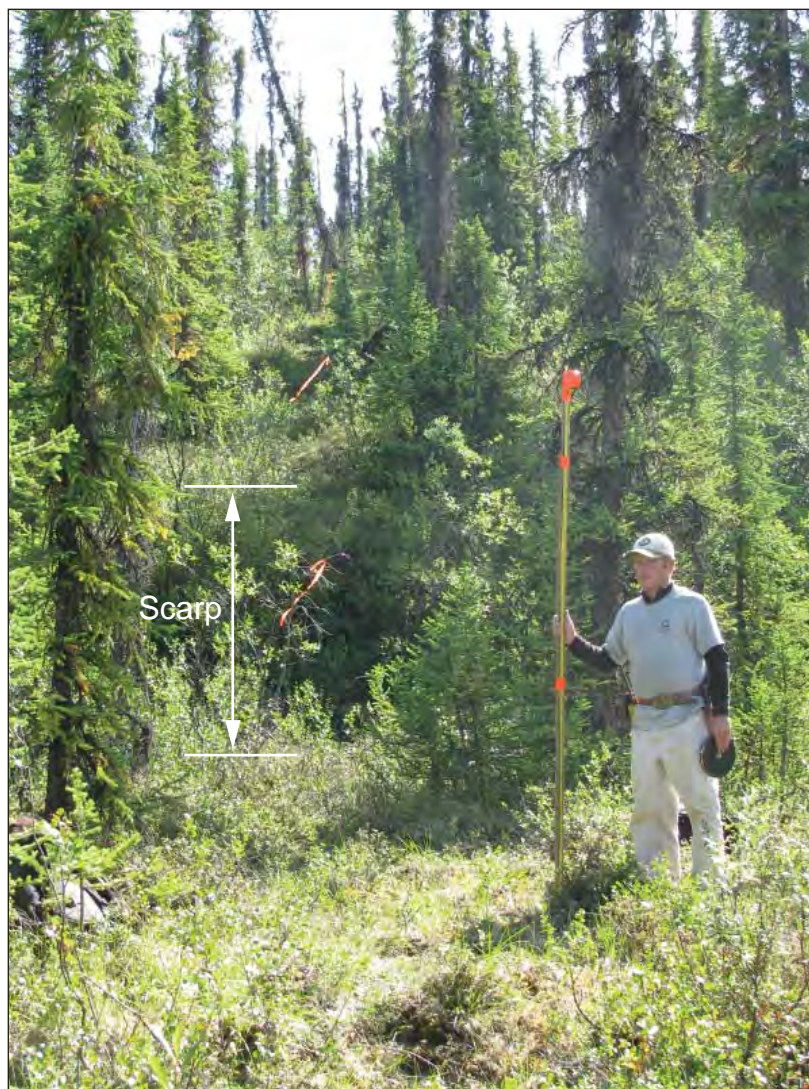
Figure 7. Photograph of scarp at Profile 2, showing oversteepened base. Geologist and 2.25 m survey rod for scale. Location of Profile 2 shown in figure 6.

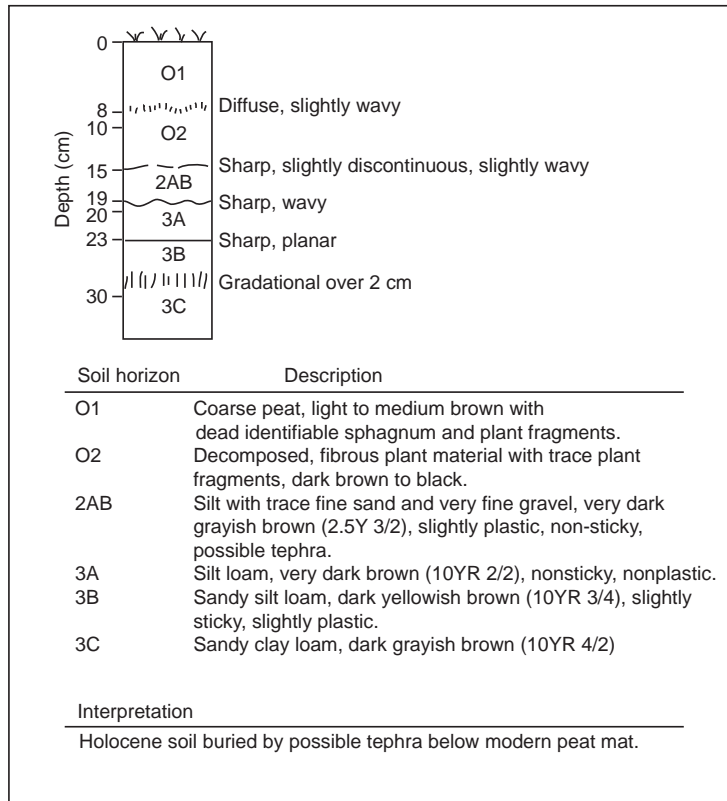
Figure 8. Soil profile and description of soil pit excavated adjacent to profile 3 on the Hf2 alluvial fan surface along the Caribou Creek fault zone. Soil pit coordinates: 63.4238, -142.1457; location shown in figure 6.

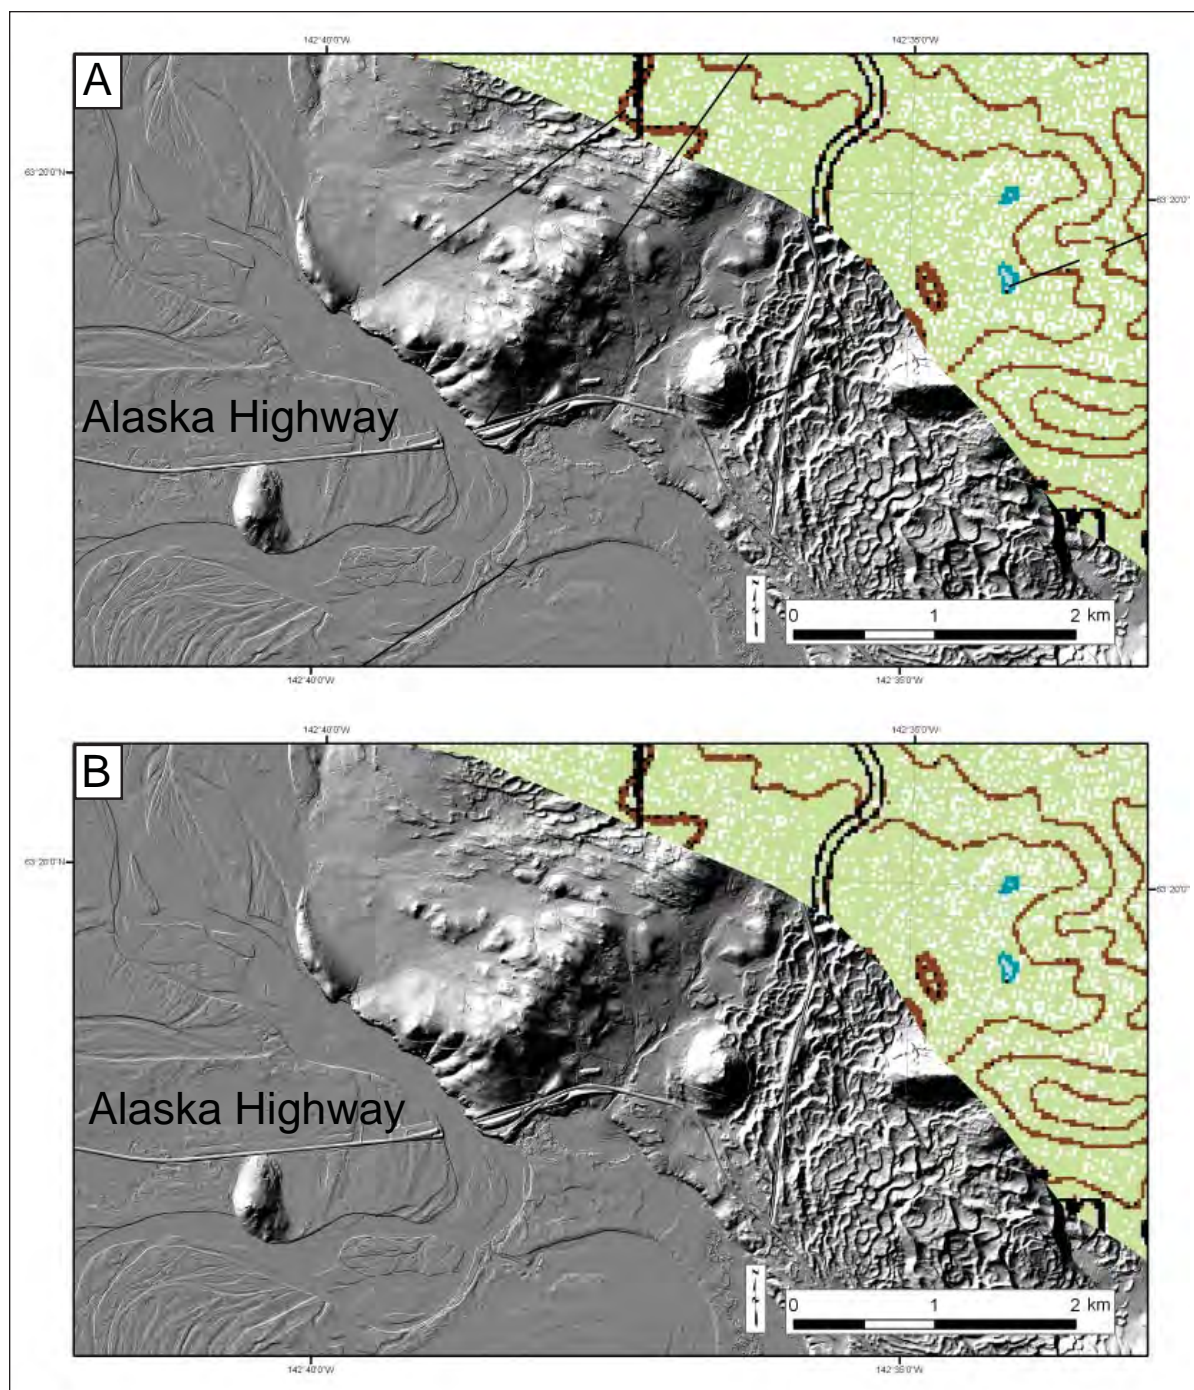
Figure 13. (A) Lidar hillshade images showing the mapped trace of the Caribou Creek fault (Woodward–Clyde Consultants, 1981). (B) Same image as A without the mapped trace, showing the lack of tectonic features in the landscape.

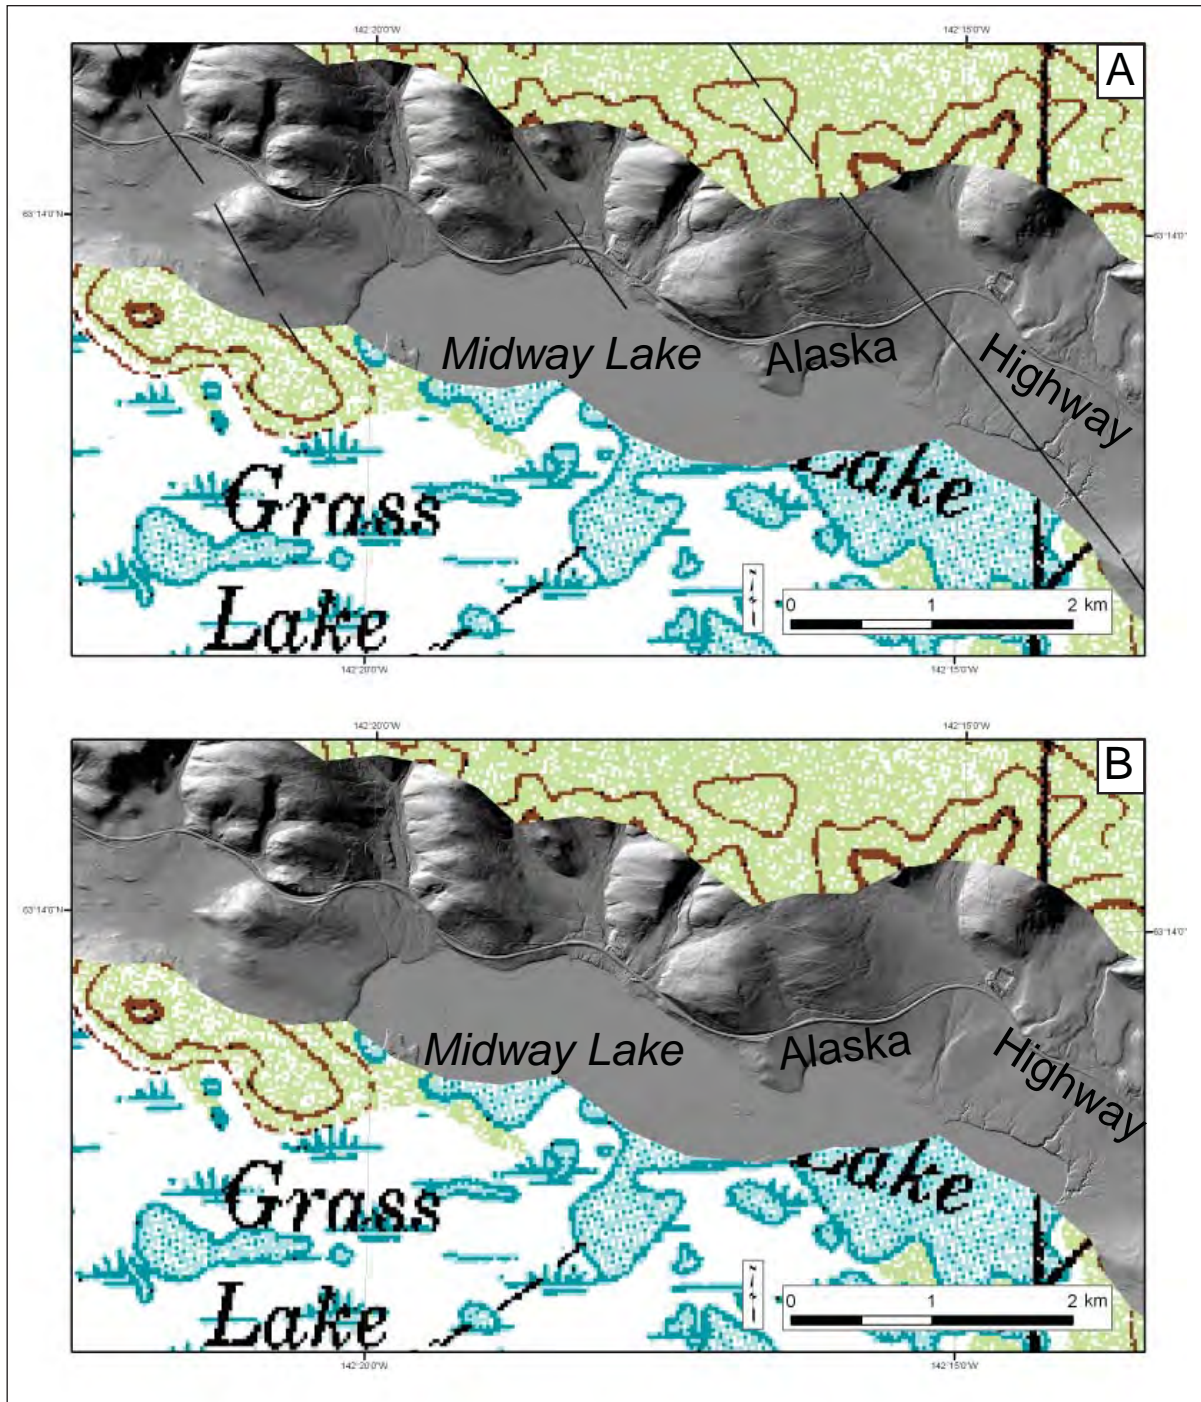
Figure 14. (A) Lidar hillshade images showing the mapped trace of the Midway Lake faults (Woodward–Clyde Consultants, 1981). (B) Same image as A without the mapped trace, showing the lack of tectonic features in the landscape.

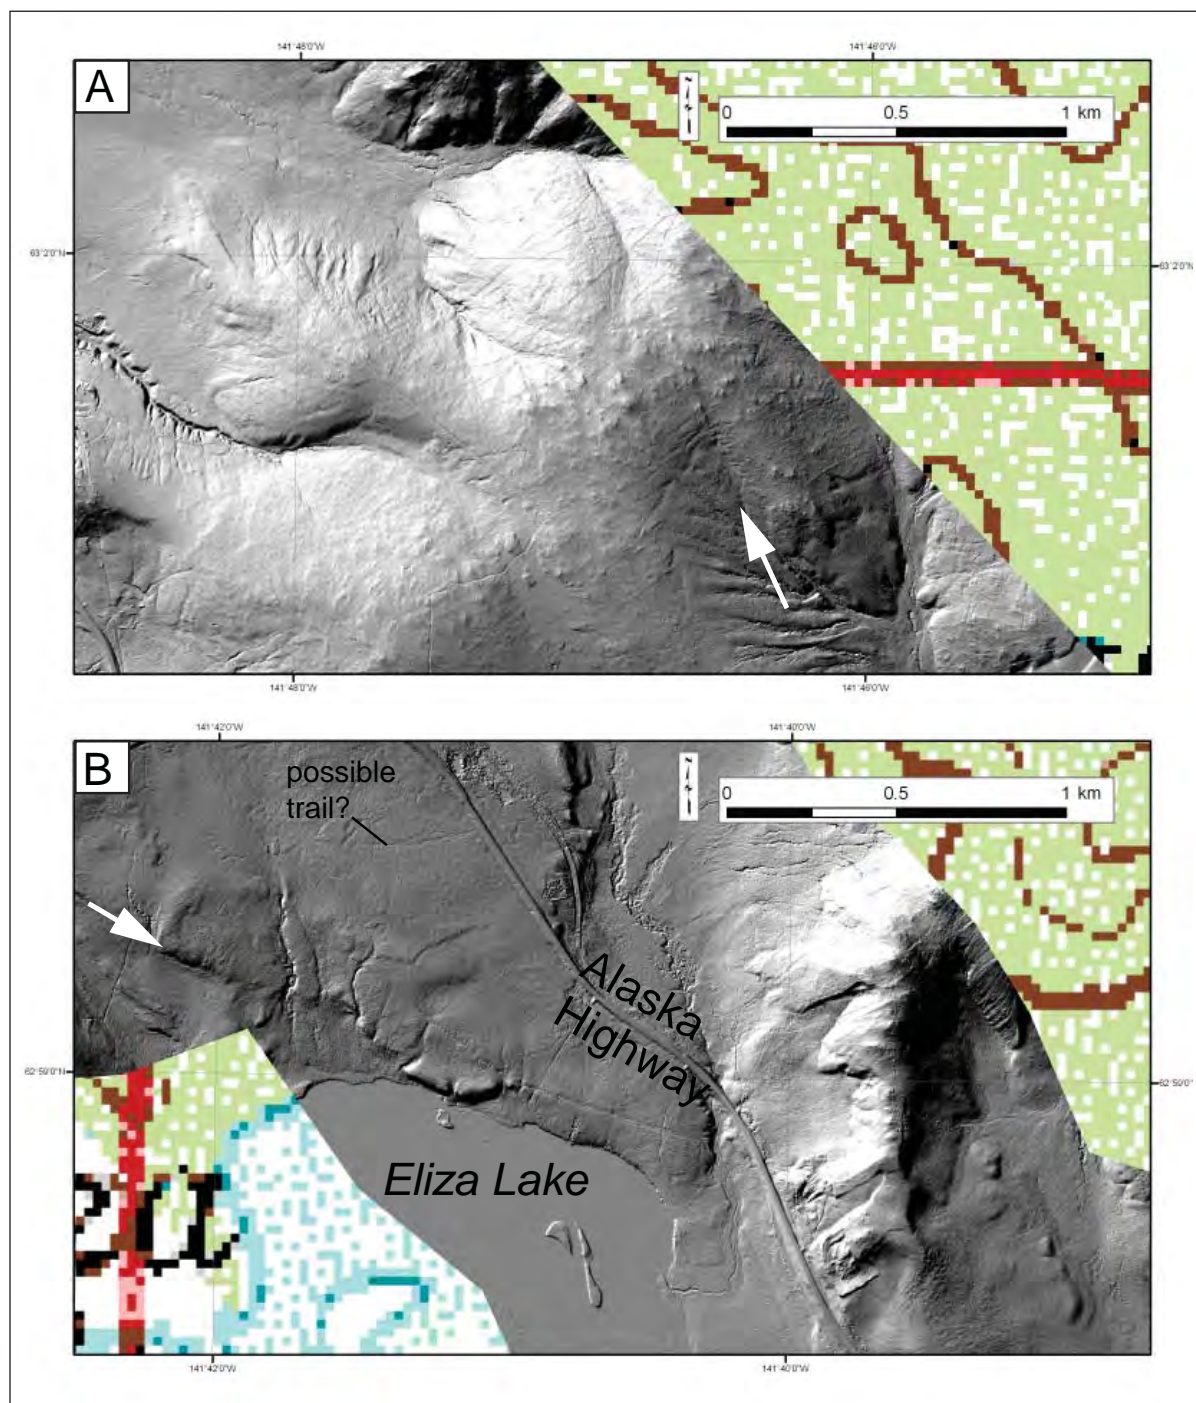
Several lineaments observed on the lidar hillshade images are of suspicious origin. A north–northwest-trending lineament was observed extending across the bedrock hills 2.2 km north of Northway Junction southeast of the Northway Junction faults (fig. 15A). This feature is approximately 1 km long and is characterized by a linear valley extending across the crest of a broad bedrock hill, and a subtle linear drainage. The feature is not expressed along the lower colluvial slopes of the hill to the southeast and does not extend across the Tanana River floodplain deposits. Several linear features extend orthogonal to the feature on the crest of the hill. Based on its short length and lack of expression in Quaternary sediments, we suspect that this feature is an inactive bedrock fault and that the orthogonal features may be joints.

Another suspicious lineament was observed approximately 5 km southeast of Northway Junction. This lineament is about 2 km long and extends northwest from the northern side of Eliza Lake (fig. 15B). The lineament is characterized by several south–southwest-facing escarpments in bedrock with a mantle of eolian deposits. The scarp appears to continue to the northwest for a short distance but is diminished in size. A small scarp that may extend across Quaternary deposits is present along the base of the bedrock escarpment near the center of the lineament. Based on the lack of continuity of this small scarp and the length of the bedrock escarpment, as well as the lack of escarpments in the Tanana River floodplain sediments southeast of Eliza Lake, we suspect that the lineament is not a youthful fault. The escarpment may be a relict bedrock escarpment that has been buried by eolian deposition. However, because the lineament was not inspected in the field we cannot preclude it is a tectonic fault. North of this escarpment, a subtle sinuous lineament was observed (fig. 15B); this feature is also discontinuous and may be a game trail or drainage channel.

Figure 15. Suspicious features identified during inspection of lidar hillshade images (not field checked). Features indicated by white arrows. (A) Lineament extending across the crest of a rounded bedrock hill 2.2 km north of Northway Junction. (B) Lineament extending parallel to the base of the hills along the northern margin of the lowlands near Eliza Lake about 5 km southeast of Northway Junction.
