PRELIMINARY HYDROLOGY REPORT
ALCAN PIPELINE ROUTE
DELTA JUNCTION TO CANADIAN BORDER

Prepared
For
Alcan Pipeline Company

By
R&M CONSULTANTS, INC.
ENGINEERS GEODETISTS PLANNERS SURVEYORS
July 15, 1976

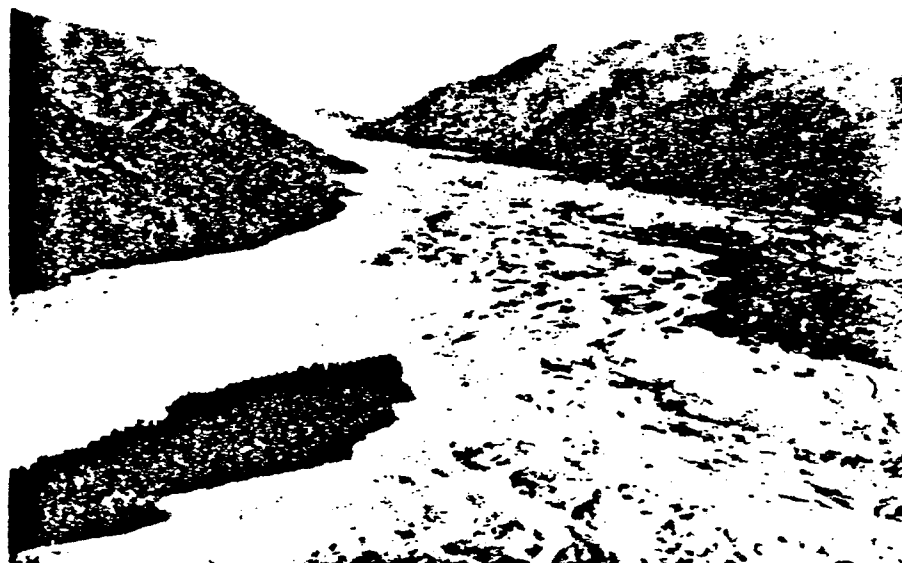
Johnson River, with a drainage area of approximately 350 square miles, drains what appears to be a glacially eroded valley (Photo 14). The braided river bed runs northward and slightly eastward from Johnson Glacier (Photo 15). The river has an active full-width sand bottom with some gravel. The banks are steep alluvial bluffs. Once out of the lowlands, mountains rise on all sides in fairly sharp relief.

Photo 14 - Johnson River (looking upstream)

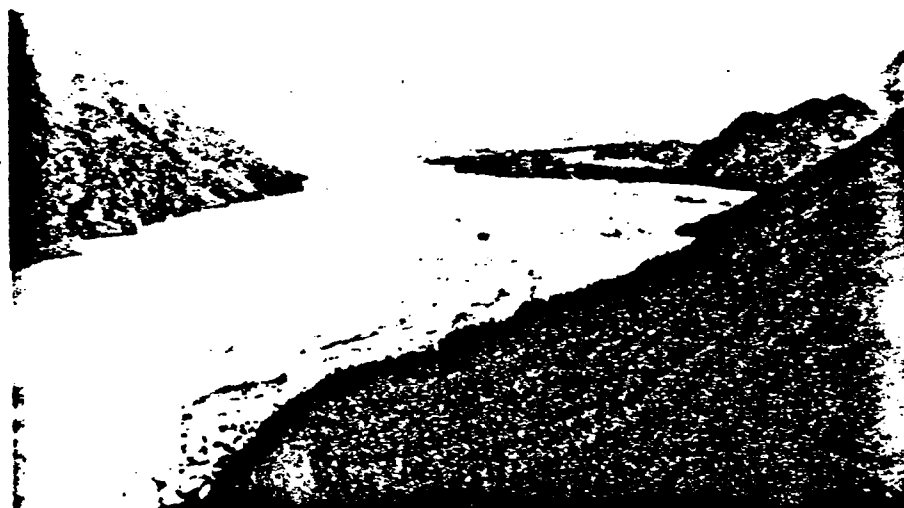
All the clouds seem to collect at the heads of drainages such as the Johnson (Photo 16). This seems to be generally true along this range of foothills. Rainfall data along the highway is not representative of the

Photo 16 - Johnson River (note clouds
at head of basin).

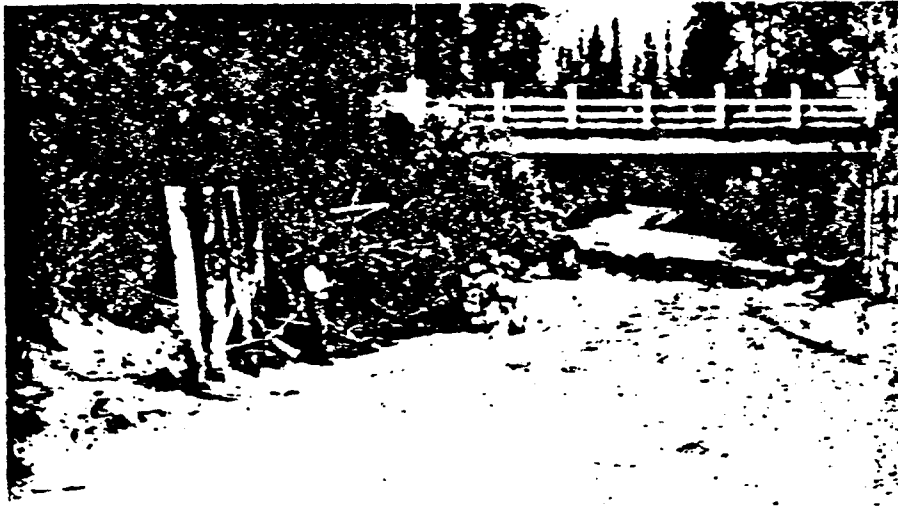
Dry Creek has a USGS crest stage gage installed at its crossing (Photo 17). This was investigated and measurements taken of a recently recorded stage. The date of the flow is unknown, but it probably occurred during spring breakup. It is likely that some ice was present in the channel during the recorded stage, but measurements indicate a flow of approximately 1000 cfs. At the time of this observation, June 22, the channel was dry but well defined, with vertical cut banks. Debris in overhanging brush at or above the top of the bank (Photo 18) indicates that this stream definitely has carried some significant flow. This data will be checked with the USGS for correlation with their records.

Photo 17 - Dry Creek

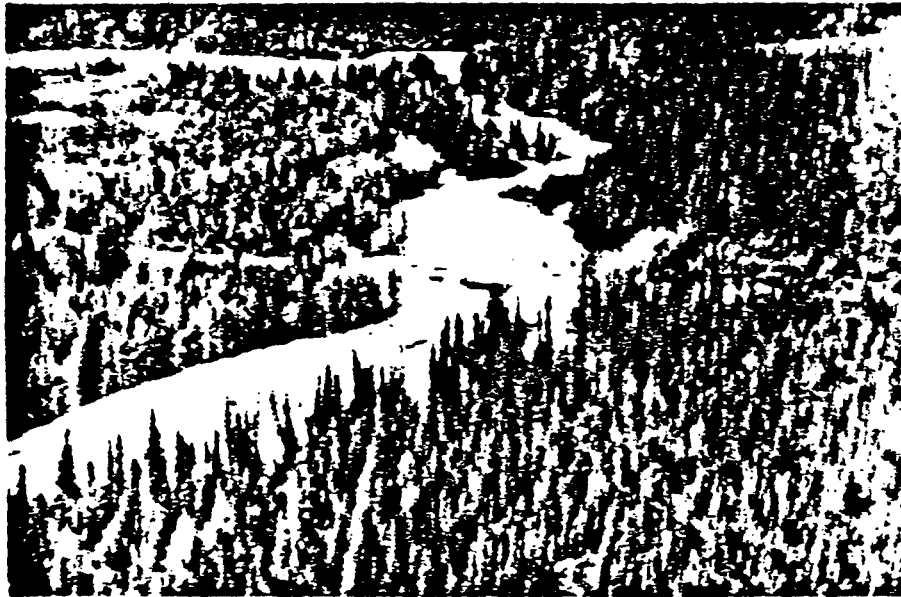
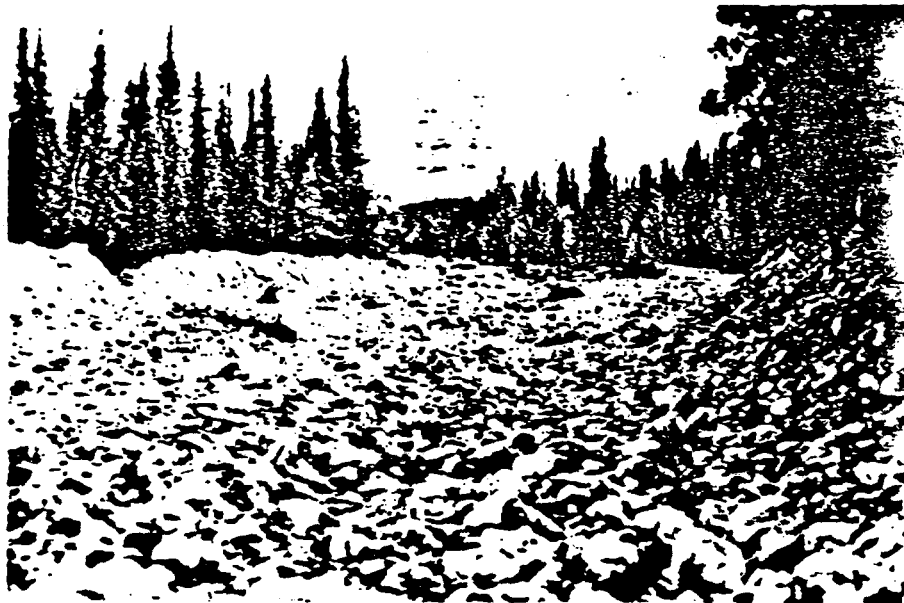
Cathedral Rapids Creeks (three streams) have steep upper reaches producing a large bed-load, with significant aggradation in the vicinity of the right-of-way (Photos 26 and 27). Several small streams in this area around Cathedral Rapids have essentially the same characteristics. Any line shift upslope in this area could very well result in serious scour potential, but where the right-of-way is located it appears that all streams are aggrading.

Photo 26 - Cathedral Rapids Creek #1
(looking downstream).

Photo 27 - Cathedral Rapids Creek #1
looking upstream from highway
bridge. Note cobbles in channel.

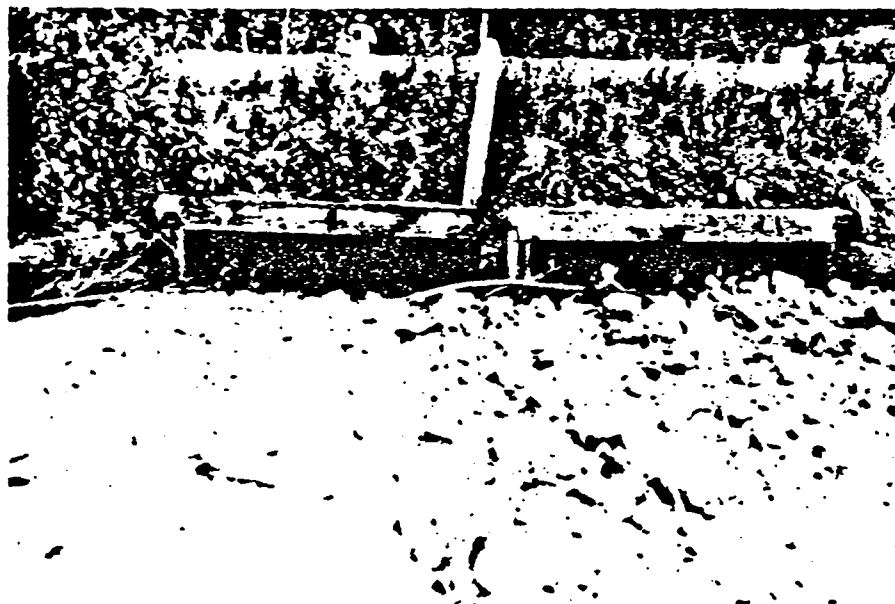
A box culvert at Highway Milepost 1341 was observed to be almost completely plugged by gravel and cobbles (Photo 29). Another 6-foot box culvert at approximately Milepost 1339 had about 2 to 3 feet of clearance remaining.

This is very typical of the maintenance problems in this area created by aggrading streams.

Photo 29 - Standard box culvert at MP 1341 near
Sheep Creek.
