Restoration Evaluation—Fish Passage

Final Report

March 2008

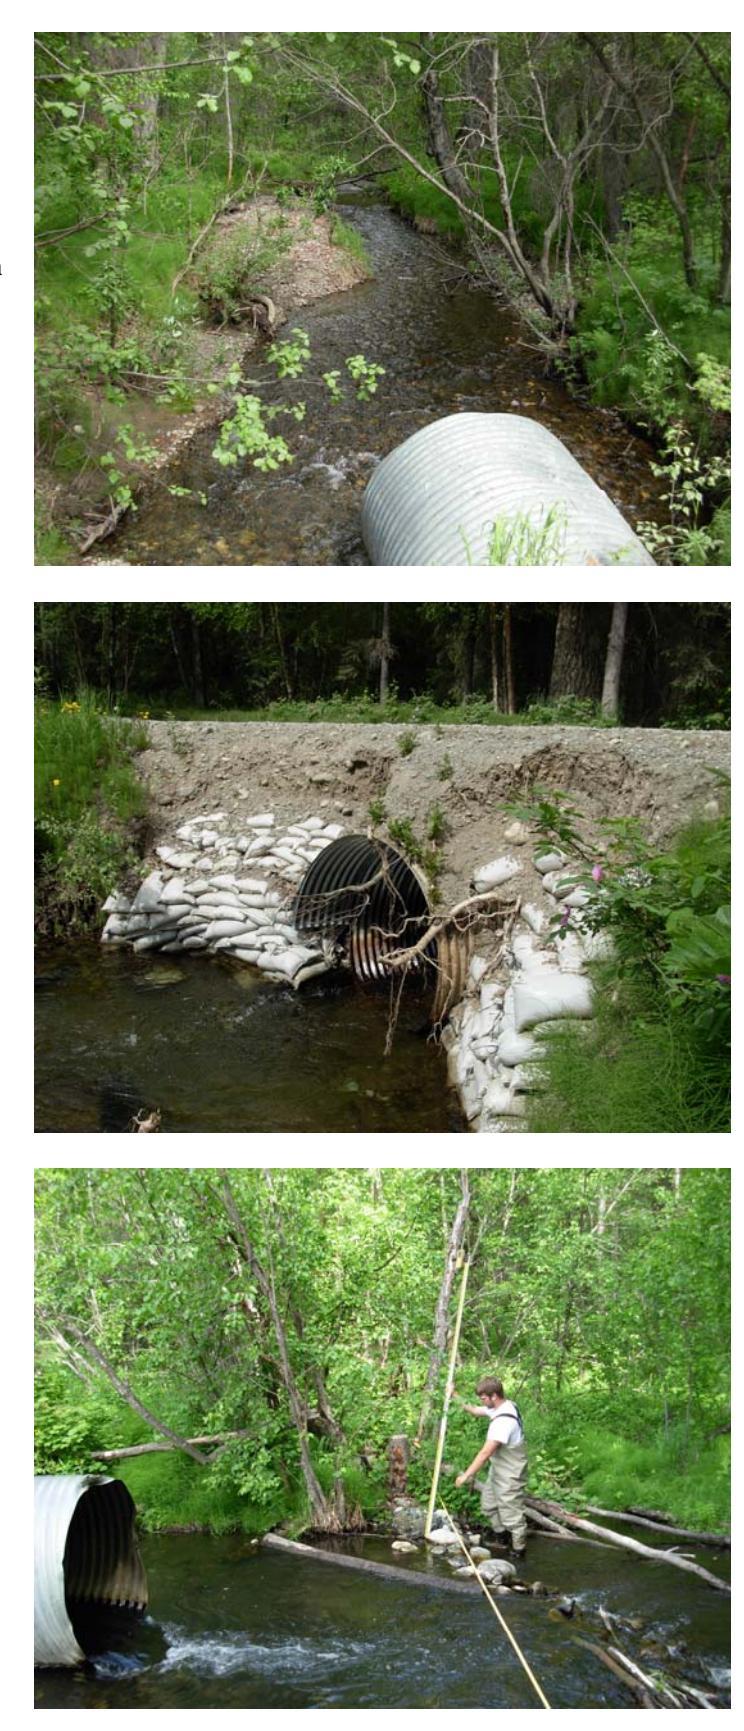
Photograph 1. Colter Creek upstream of N. Seitze Road Crossing.

Photograph 2. Colter Creek outlet.

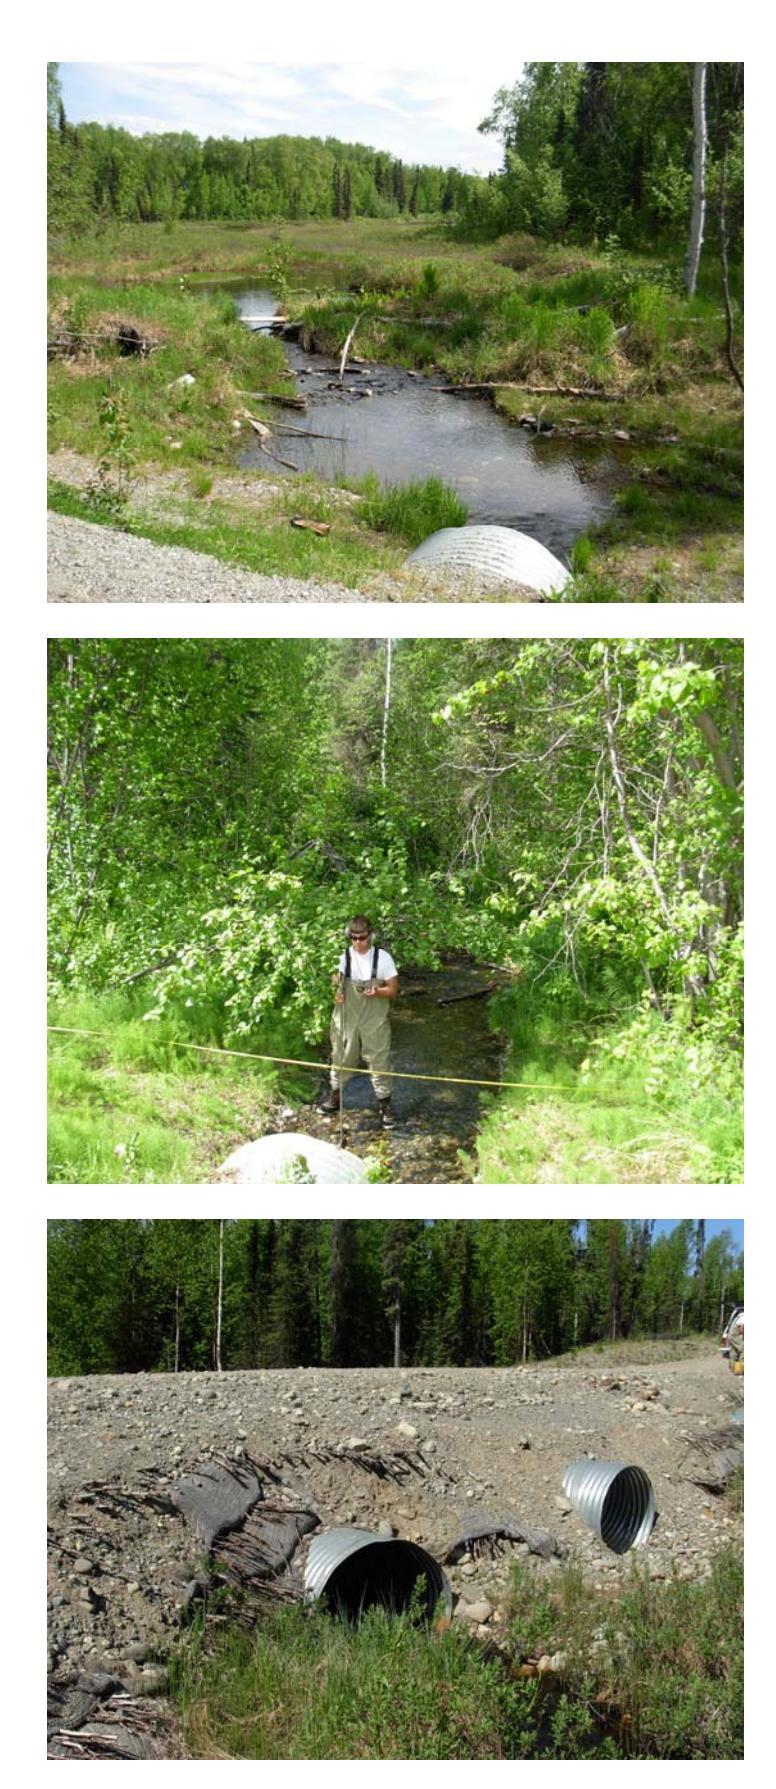
Photograph 4. Upstream of Crooked Lake Creek (upstream crossing).

Photograph 5. Outlet of Crooked Lake Creek (upstream crossing).

Photograph 6. Inlet of Lower Crooked Lake Creek culvert.

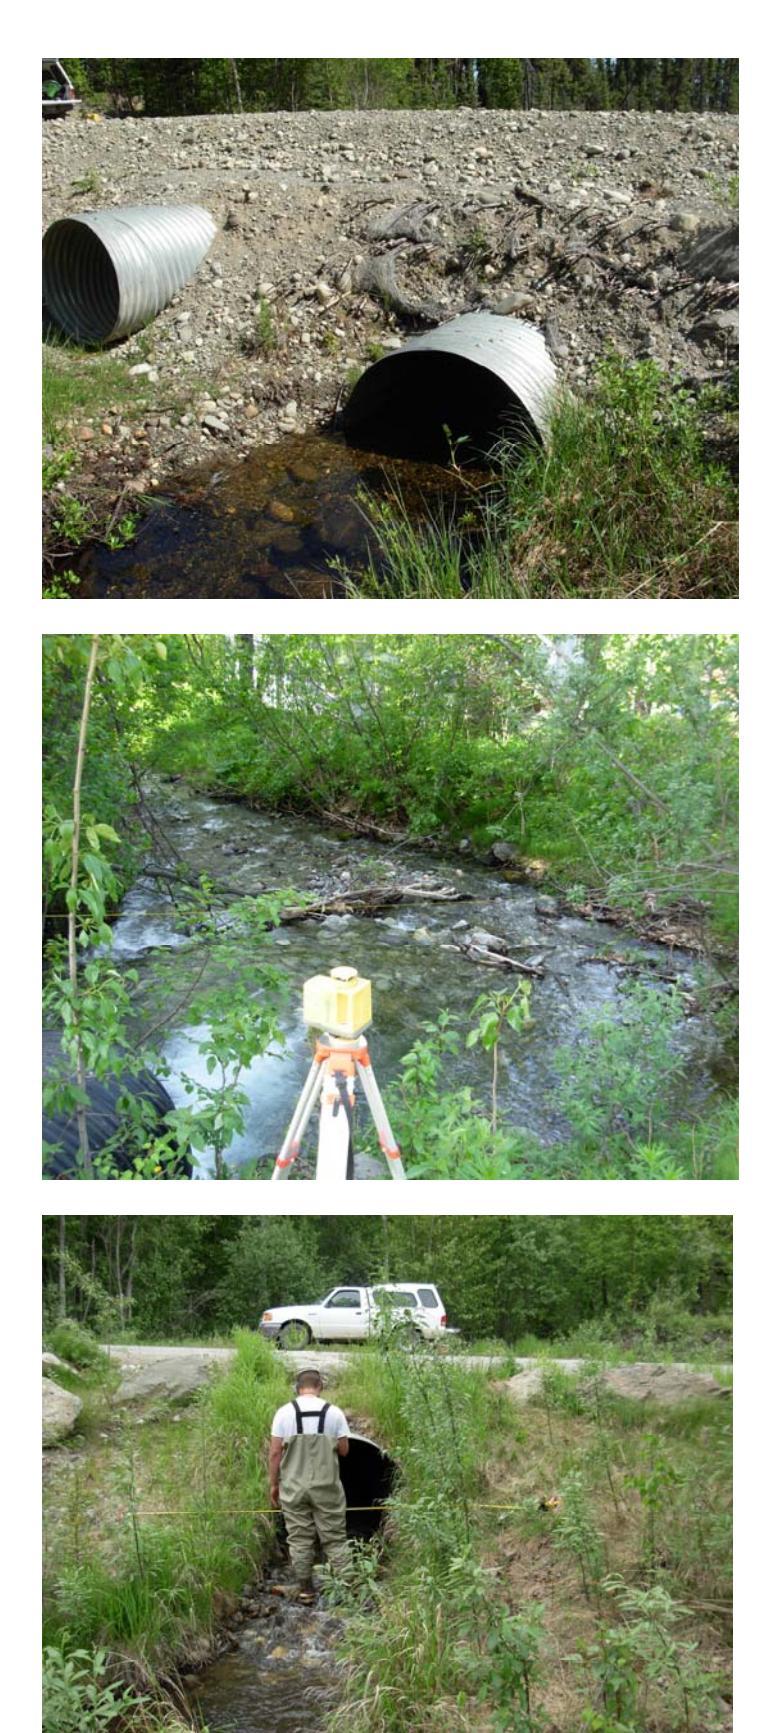
Photograph 7. Outlet of second Crooked Lake Creek culvert.

Photograph 8. Outlet of Government Creek crossing.

Photograph 9. Measuring discharge at outlet of Lucy Creek 3 crossing.

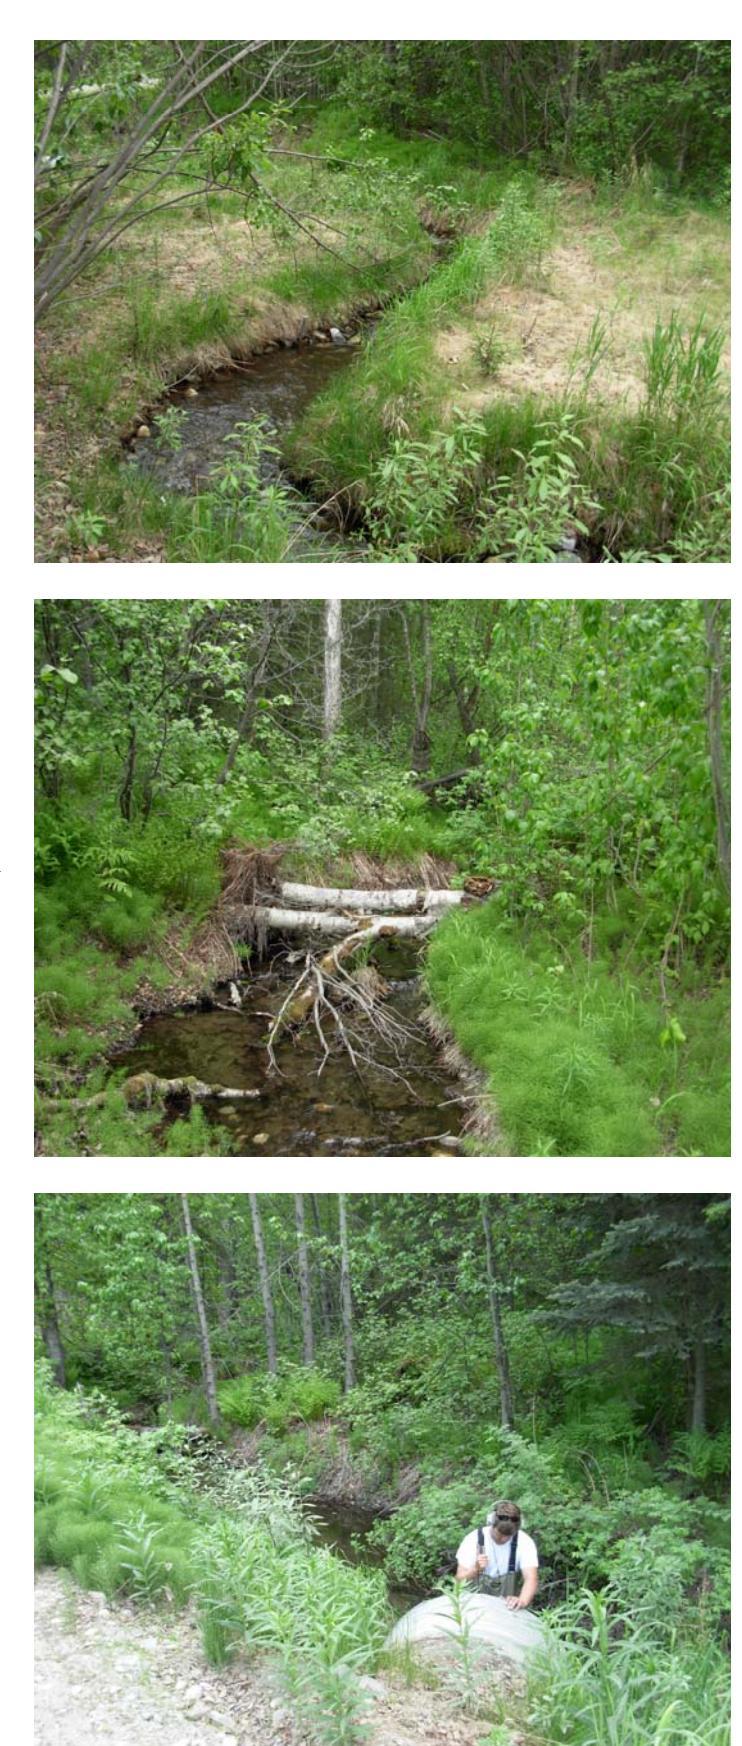
Photograph 10. Constructed Lucy Creek channel downstream from crossing number 3.

Photograph 11. Lucy Creek upstream from crossing number 3.

Photograph 12. Lucy Creek at the outlet of crossing number 2.

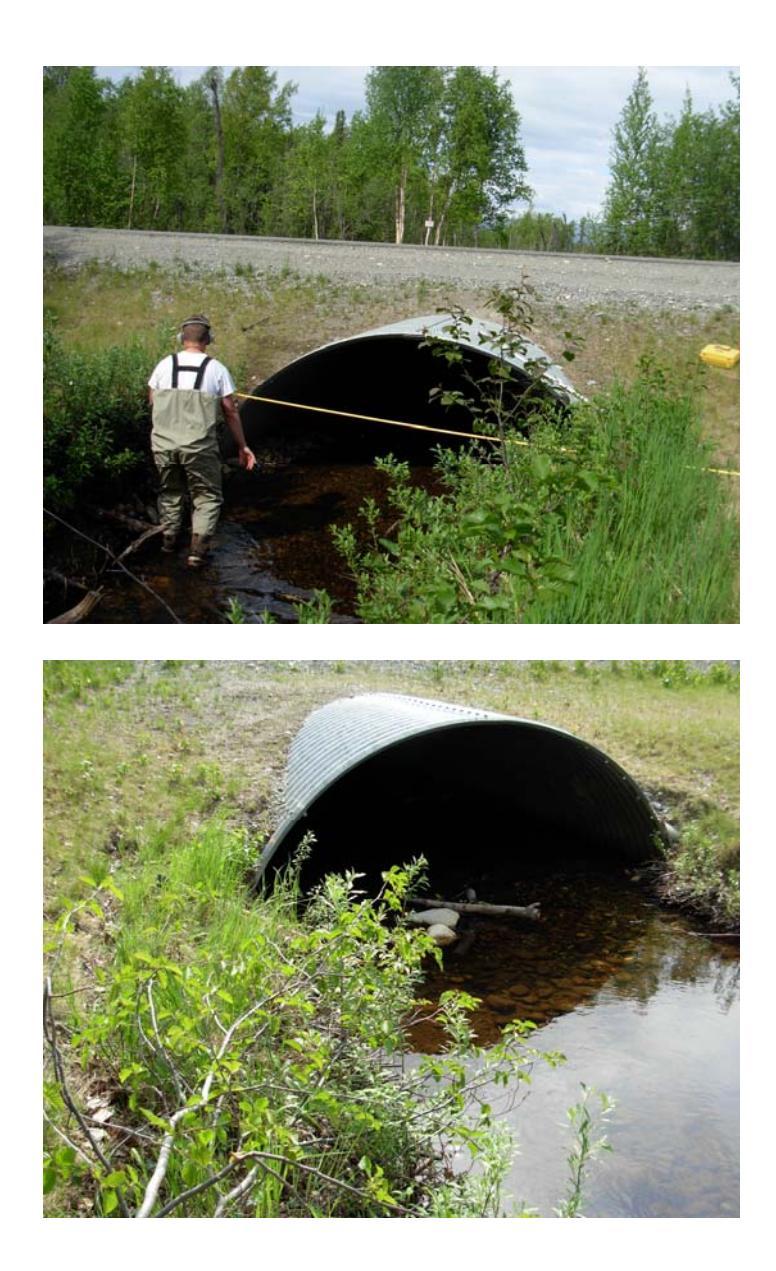
Photograph 13. Outlet of Little Meadow Creek at Meadow Lakes Loop road.

Photograph 14. Inlet of Little Meadow Creek crossing of Meadow Lakes Loop Road.
