Klawock Watershed Road Condition Survey

Jeff Nichols, Brian Frenette, and Moira Ingle

December 2002

Alaska Department of Fish and Game

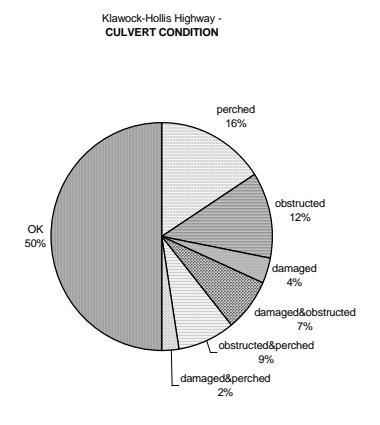
Figure 5. Condition of all culvert pipes associated with the Klawock-Hollis Highway (n=82).

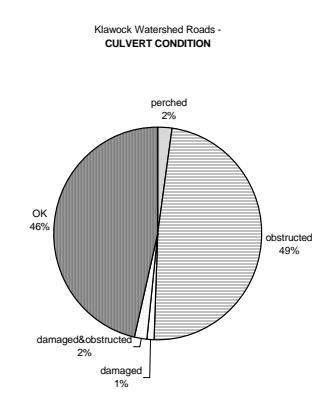
Figure 6. Condition of all culvert pipes associated with Klawock Watershed temporary roads (n=172).

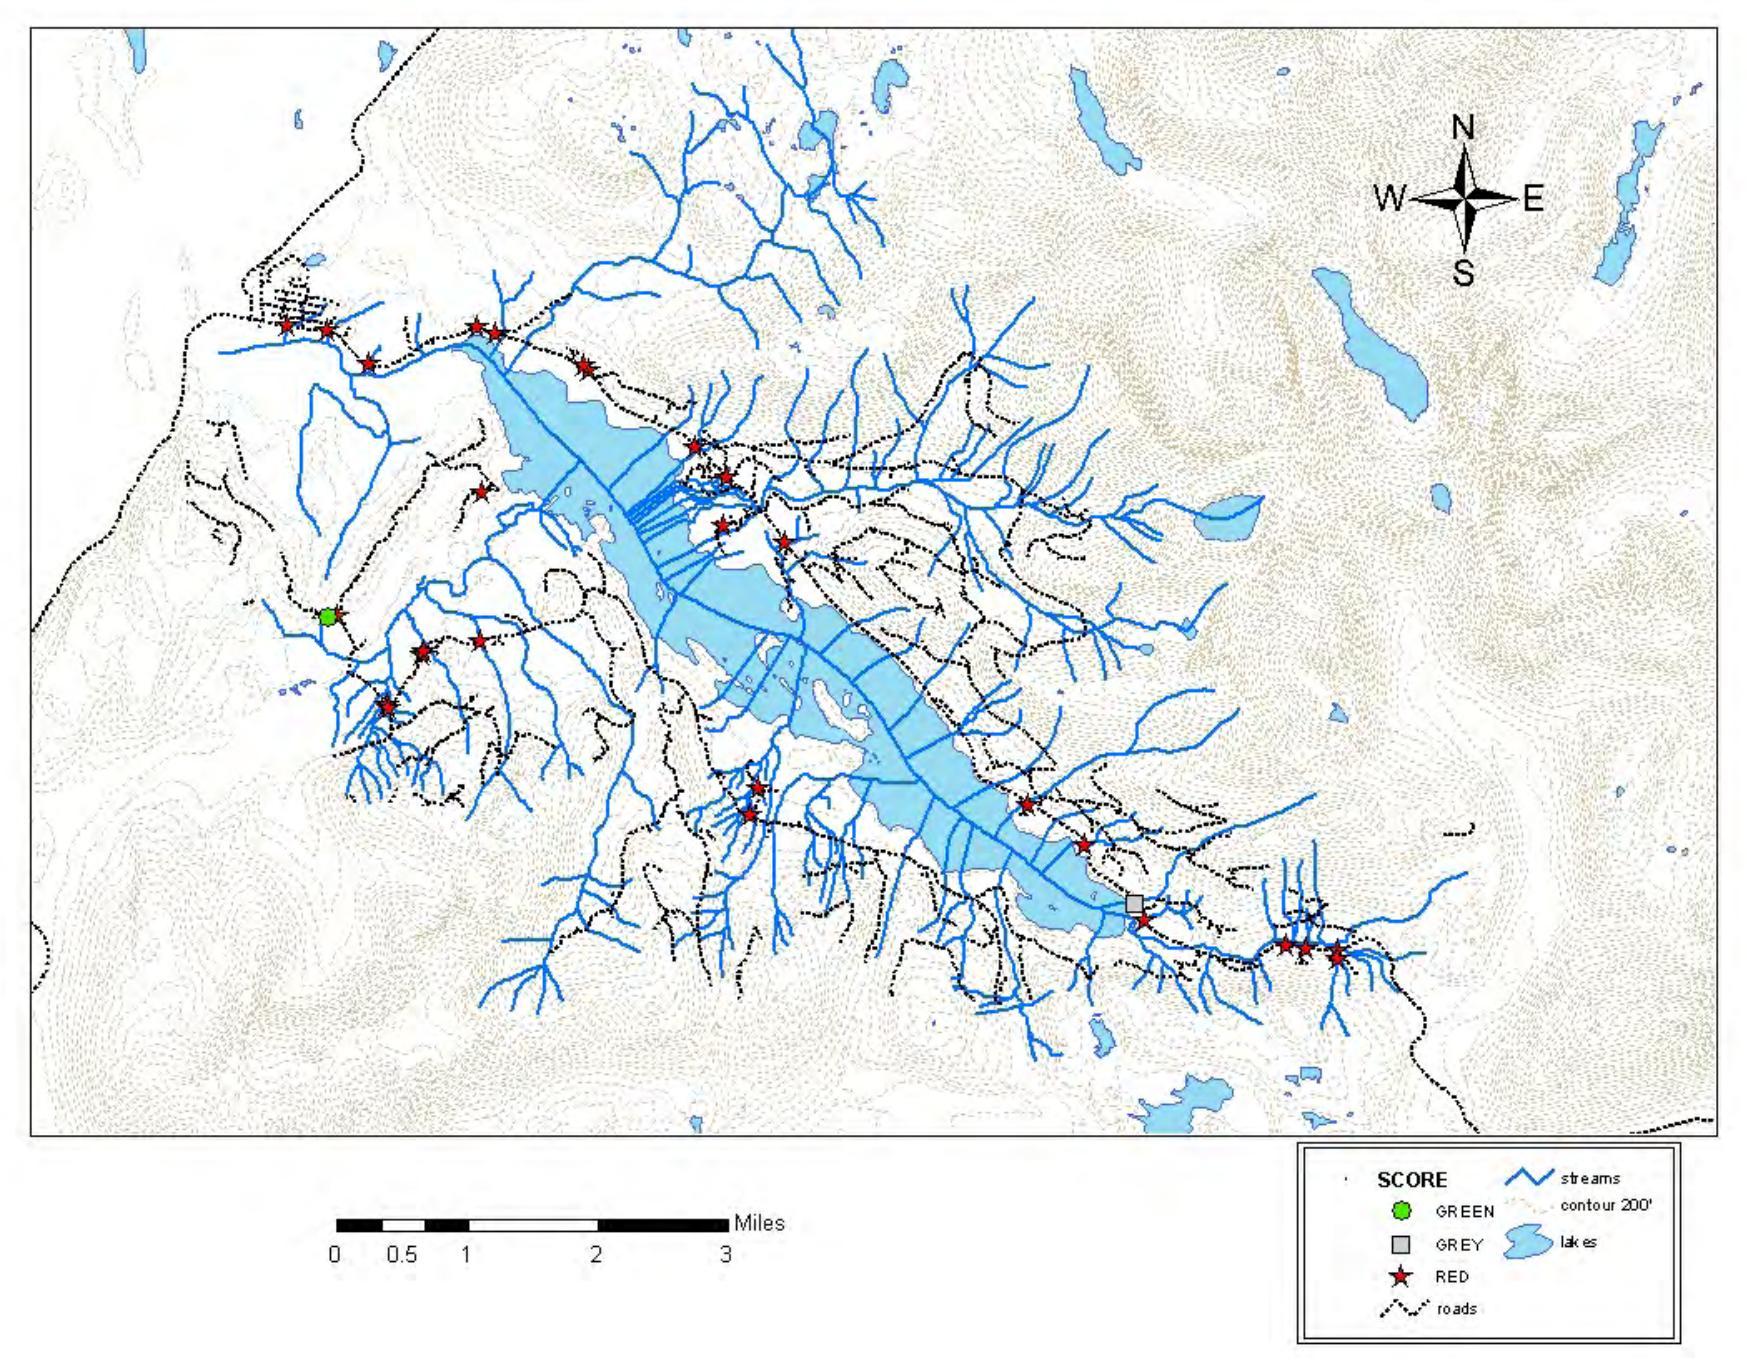
Additional measurements were collected at culvert pipes that occurred within (or potentially within) anadromous habitat, which allowed H&R staff to perform a RED-GREY-GREEN analyses. Thirty-one culvert pipes had enough information to allow this analysis, 29 of these were considered to be RED, indicating that conditions were assumed to be inadequate for fish passage (Figure 7). The full results of this evaluation are summarized in Appendix 8.

Figure 7. Location and SCORE (Red-Grey-Green analyses) of 31 selected culvert pipes occurring within anadromous habitat in the Klawock Watershed, Southeast Alaska.

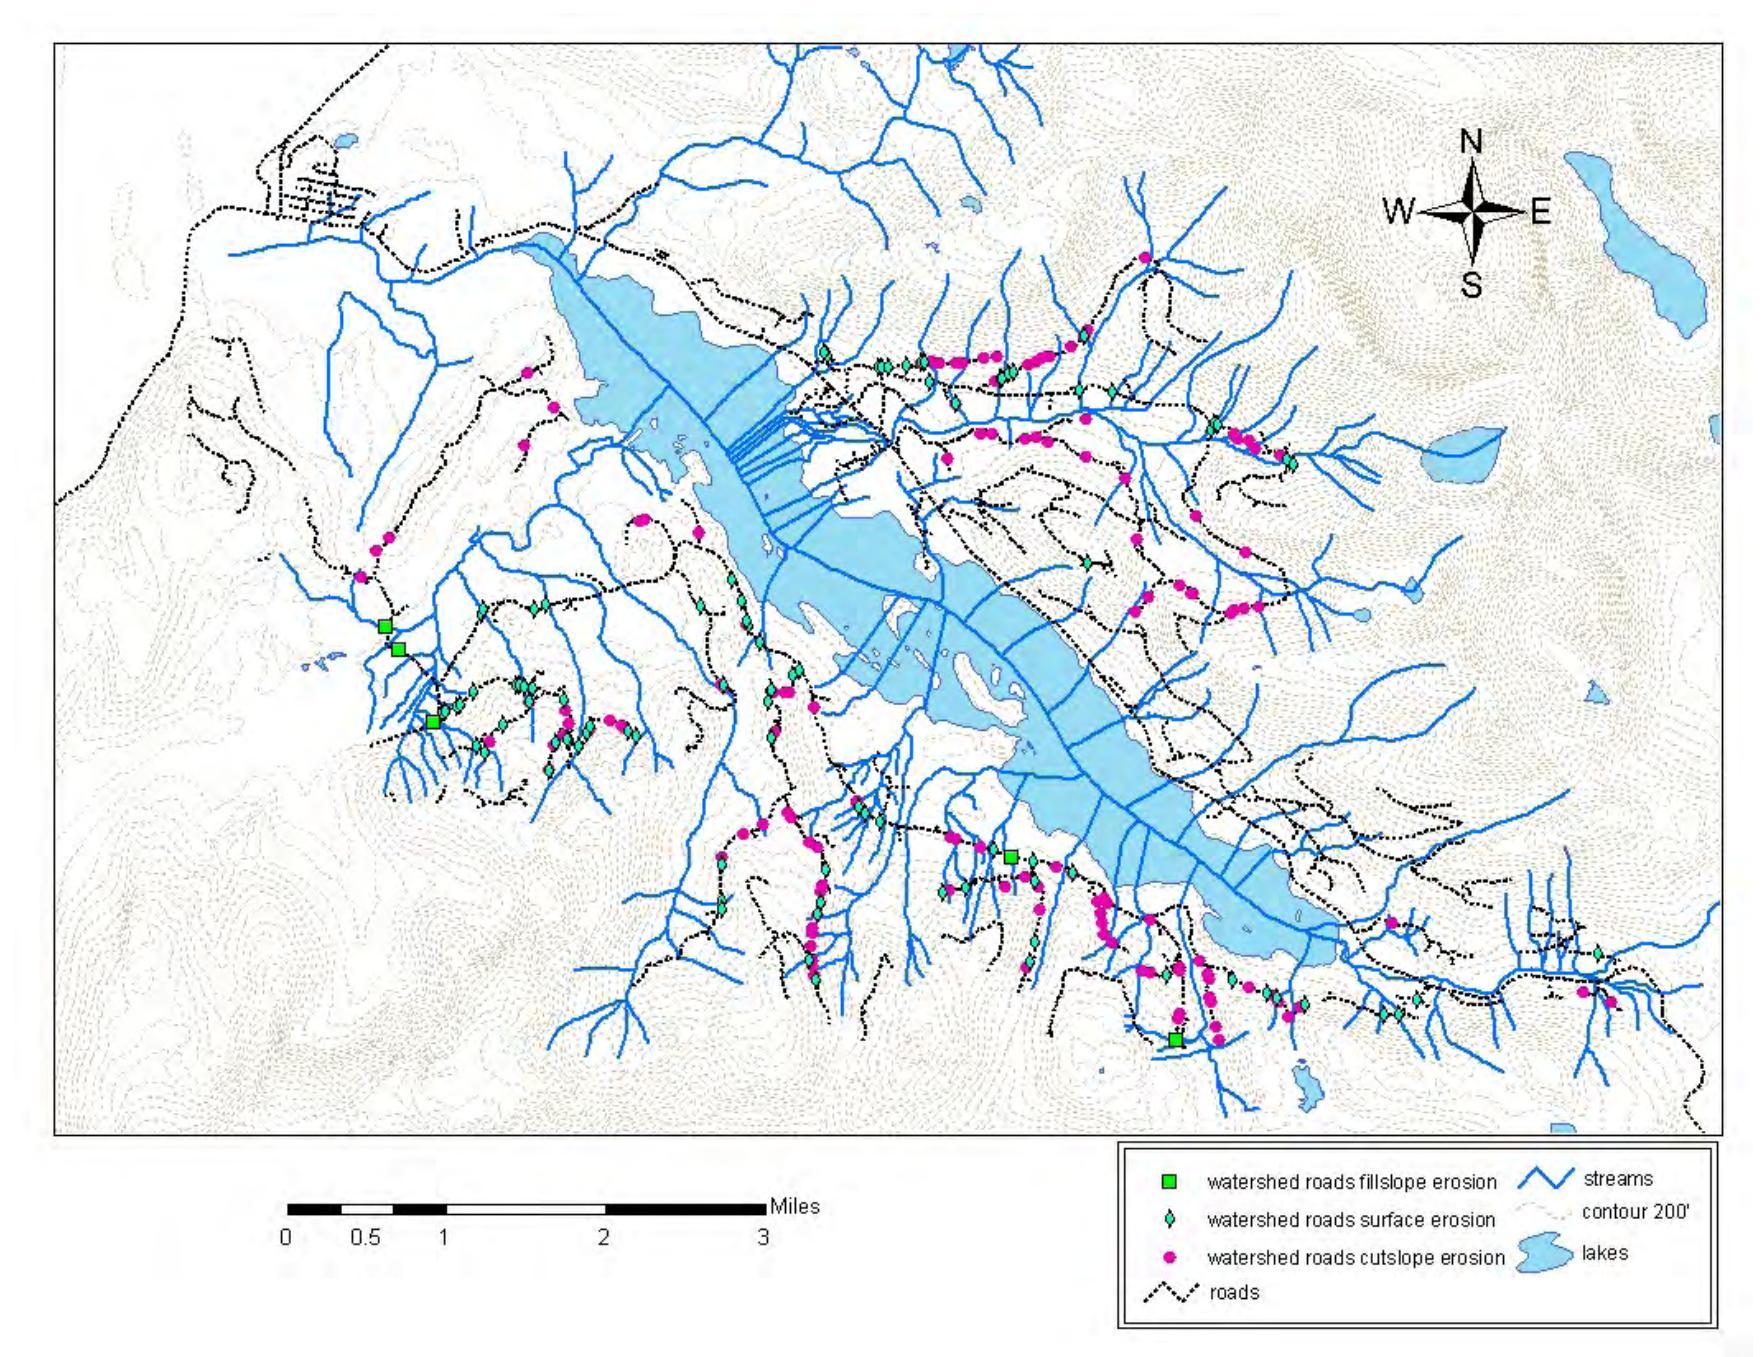
Cut-slope erosion occurred throughout the watershed and was observed at 137 locations (Figure 12). Erosion of this kind paralleled the temporary roads on the watershed and had a mean length of approximately 117 feet (S.D.= 139 ft). The width of cut-slope erosion averaged approximately 18 feet (S.D. = 20 ft). The largest single incidence of cut-slope erosion on the watershed covered an area of approximately 16,500 sq feet (length = 1,100 feet).

Surface erosion occurred on the temporary roads and was observed at 98 locations throughout the watershed (Figure 12). Surface erosion was generally the result of inadequate ditch relief, undersized or obstructed stream crossing structures, or lack of water bars. Erosion on the surface of roads averaged 73 feet long (S.D. = 59 ft) by 14 feet wide (S.D. = 12 ft). The largest single incidence of surface erosion on the watershed covered an area of approximately 1,500 sq. feet.

Several other types of erosion were observed less commonly within the Klawock Watershed and included fill-slope erosion (Figure 12), which was observed at 10 locations; ditch erosion (n = 9); fill falling through road surface (n=6); landslides across road (n=3); removed structure erosion (n = 1); and stream abutment erosion (n=1).

Figure 12. Location of major erosional features within the Klawock Watershed, Southeast Alaska.
