SUSITNA HYDROELECTRIC PROJECT

1980-81 GEOTECHNICAL REPORT

**VOLUME 1
TEXT
FINAL DRAFT**

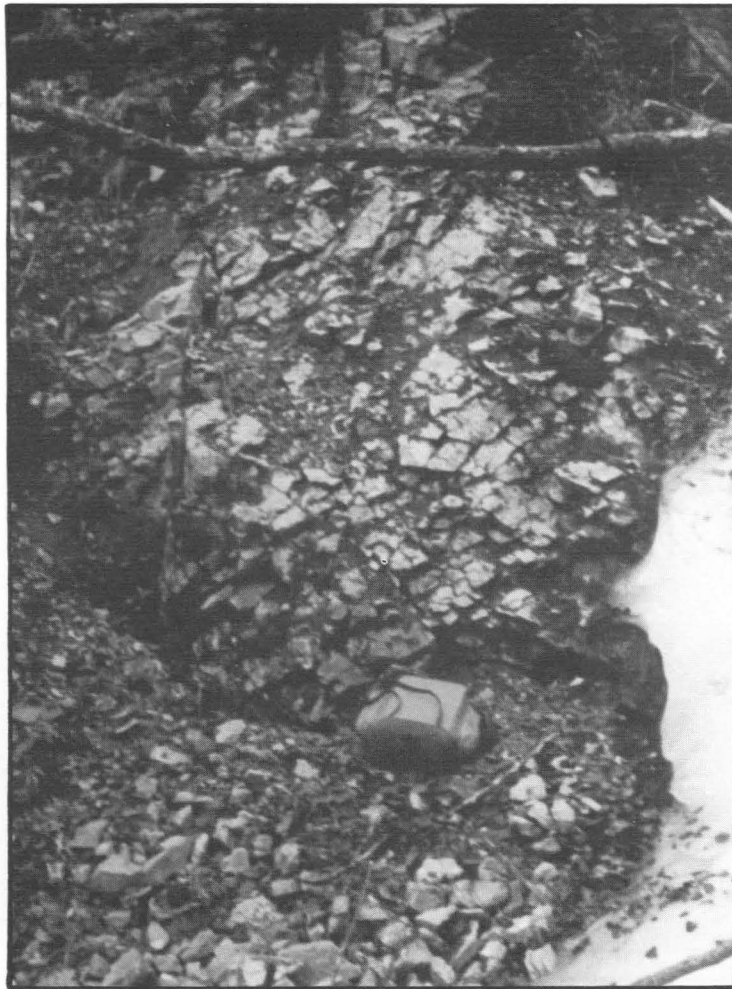
ANDESITE PORPHYRY
ABOVE DIORITE OUTCROP
APPROX. EL. 1800 FEET - SOUTH BANK

WATANA
FRACTURE ZONE IN ANDESITE PORPHYRY

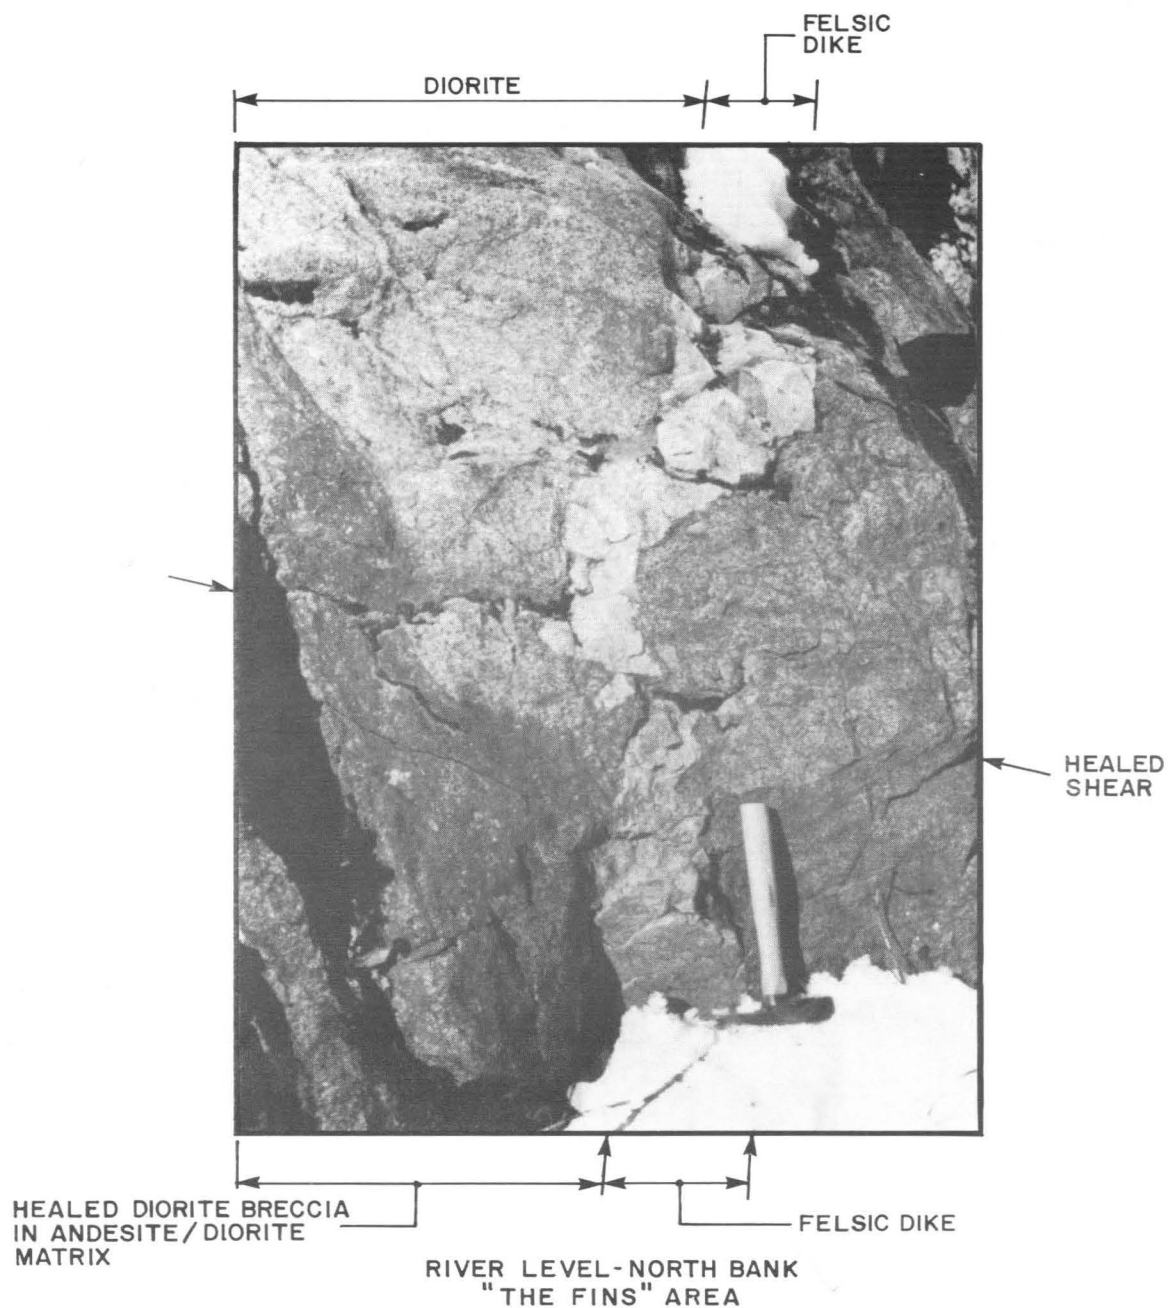
WATANA
FELSIC DIKE IN DIORITE

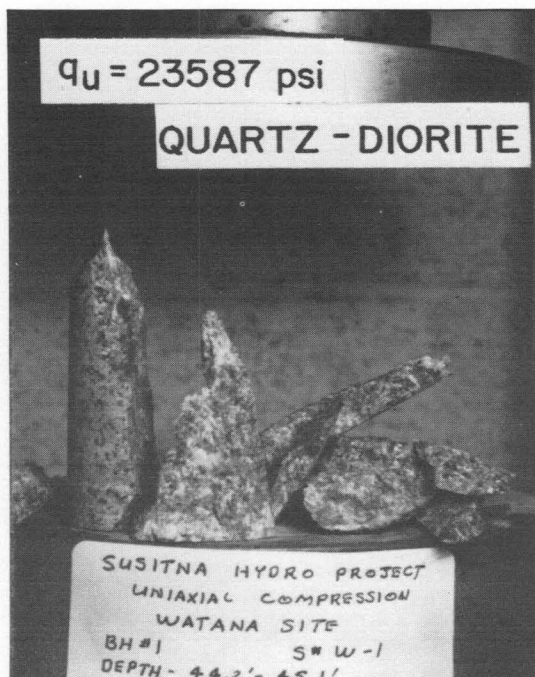
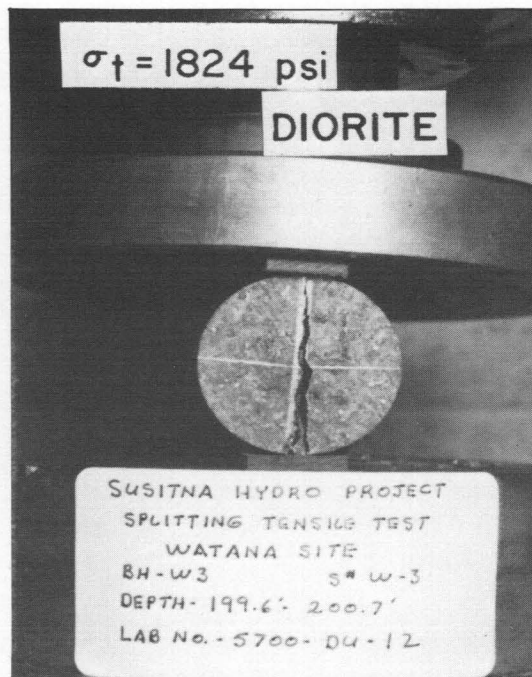
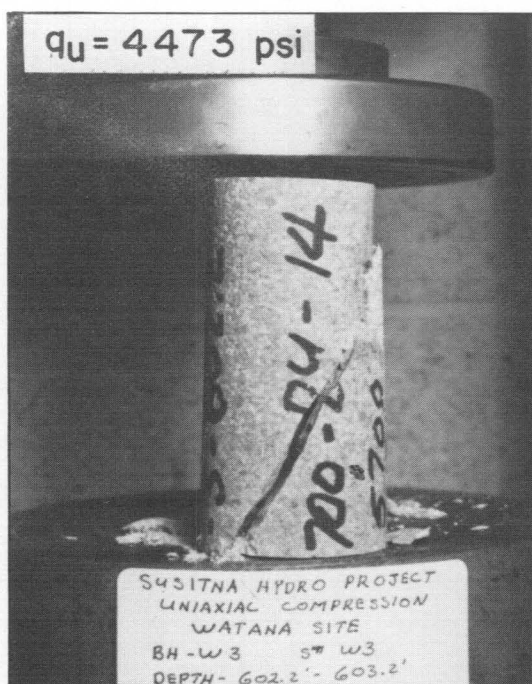
WATANA ROCK TESTS

TYPICAL COMPRESSION
TEST FAILURE

TYPICAL TENSILE
TEST FAILURE

ALTERED DIORITE -
COMPRESSION TEST

ALTERED DIORITE -
TENSILE TEST

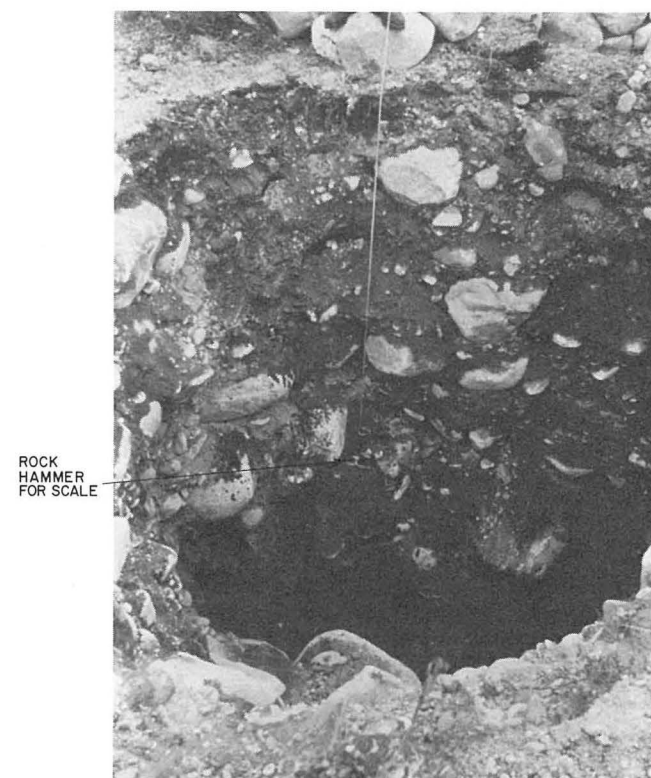
TEST PIT TP-E15
SOUTH WALL SHOWING BOULDER LAYER
OVER SANDY GRAVEL

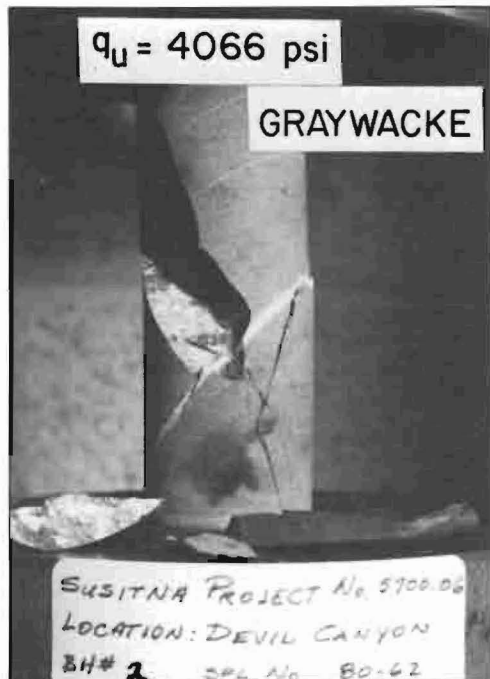
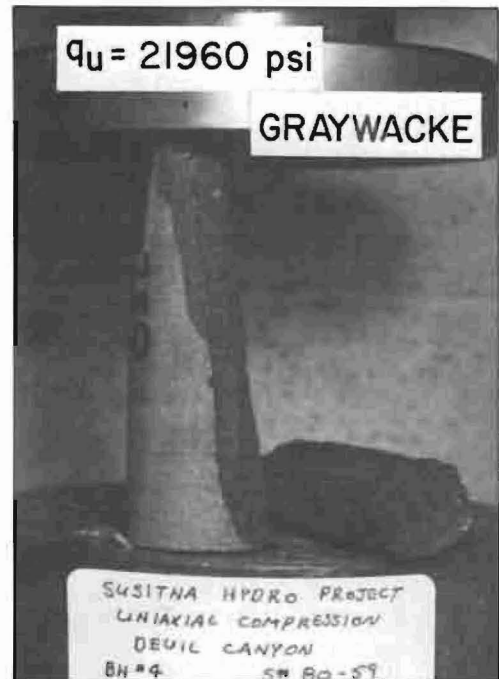
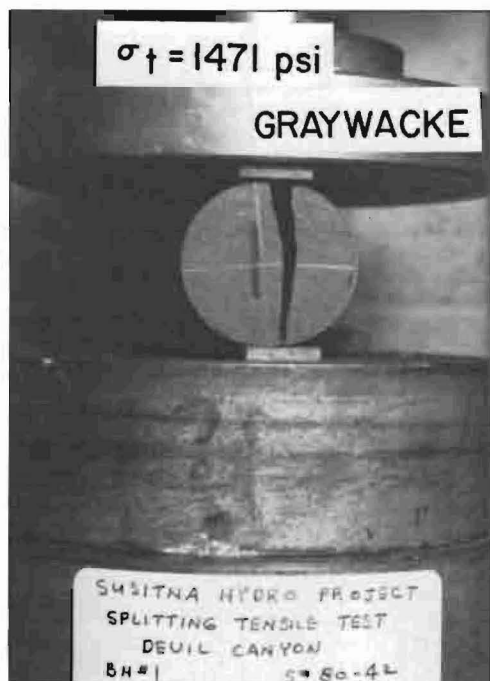
DEVIL CANYON ROCK TESTS

COMPRESSION TEST FAILURE
ALONG HEALED DISCONTINUITY

COMPRESSION TEST FAILURE
THROUGH INTACT ROCK

TYPICAL TENSILE STRENGTH TEST
