# Susitna-Watana Hydroelectric Project (FERC No. 14241)

# 2012 Susitna River Water Temperature and Meteorological Field Study

# Appendix A

# **APPENDIX A: PHOTOGRAPHS AND SITE INFORMATION**

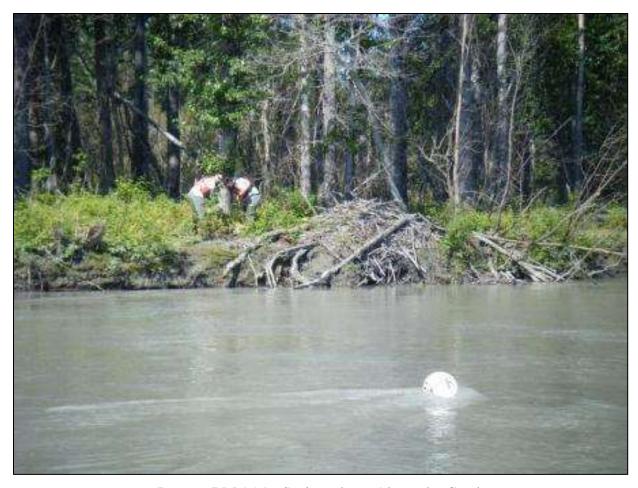
**Station Notes:** The buoy is deployed approximately 800 feet upriver of the proposed location due to an absence of anchoring trees or rocks. The system is anchored to shore with a cable, looped around a cottonwood tree and secured with cable clamps. The river gradient is quite low through this reach and eddy currents are not as obvious as locations upriver. A faint salty odor was observed emanating from the wake of the boat suggesting potential salt intrusion from Cook Inlet.

Buoy at RM 15.1 - Susitna above Alexander Creek

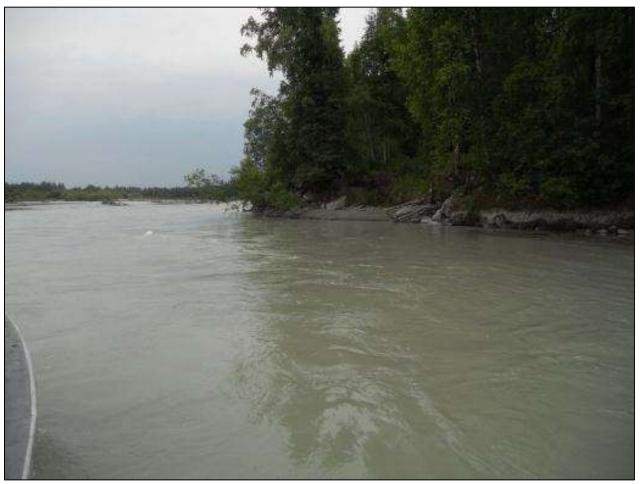
**August 28, 2012** – Buoy and anchor stuck and buoy missing. No download of buoy system. Pipe system was in good condition and thermistor was downloaded.

**September 28, 2012** – Missing buoy and cable to shore was covered with debris. Used wench to free system from debris. Data loggers were found to be in good condition and in place and were downloaded. Pipe system was found to be in good condition and was also downloaded.

October 23, 2012 – Helicopter fly by only. Cable for buoy system was visible but no buoy visible (maybe under ice). Pipe was present but bent.

Buoy System at RM 95.8- Alternative to LRX 1

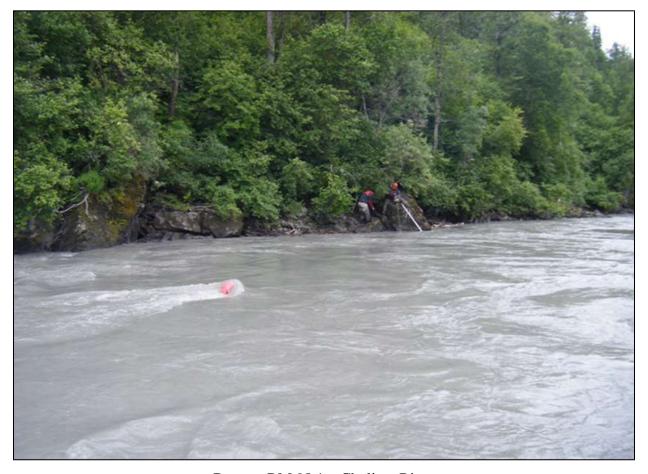
October 17, 2012 – Both systems downloaded at 13:15 ADT. Sensor 10174257 is missing and likely lost. Buoy system had moved up against shore due to flooding. Upper thermistor in pipe was out of water and incased in frozen silt. Lower thermistor was in approx. 1 foot of water. Additional 7 foot section of pipe added to pipe setup (20 inches) and cable lengthened to 18 feet). Summer buoy system was removed and replaced with single data logger winter system.

Buoy at RM 98.1 – Chulitna River

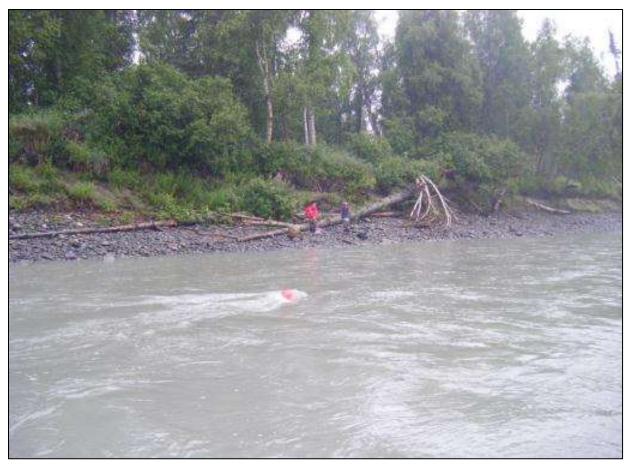
**September 27, 2012** – Buoy was missing. Replaced buoy, system was still intact and thermistor data was downloaded at 17:45 ADT.

October 23, 2012 – Buoy system intact. Downloaded at 12:30 ADT and removed summer buoy string with multiple data loggers. Replaced with winter single data logger system (data logger # 10174249). Pipe system dry and data logger cable was frozen in pipe – could not remove for download. Left pipe in place.

Buoy at RM 103.3 – Talkeetna

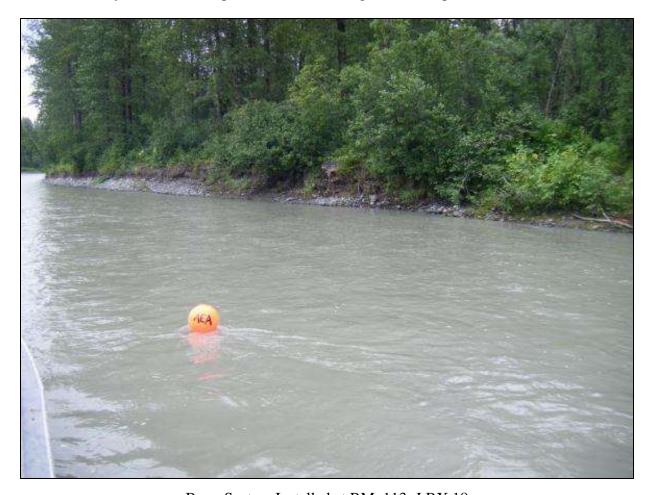
**September 27, 2012** – Buoy system came loose from anchor during flood but was found dry on bank down river and retrieved. Data logger 252 was missing remaining loggers were downloaded. System was not replaced due to lack of good anchor point.

Buoy System Installed at RM. 113- LRX 18

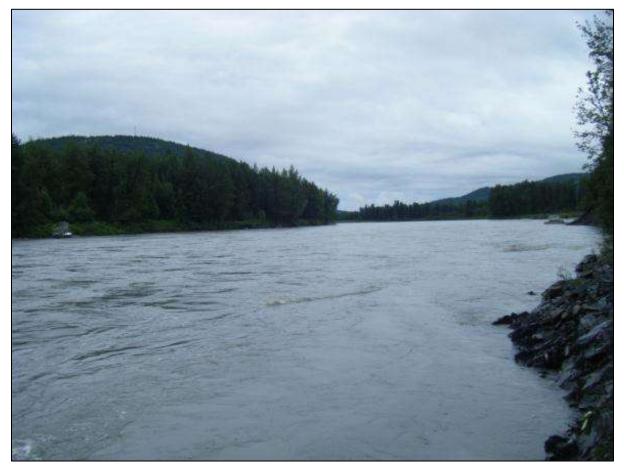
**September 27, 2012** – Buoy was missing and was replaced. System still intact, tidbits downloaded at 16:45 ADT, but missing data for 10174269. Pipe downloaded.

Buoy System Installed at RM 120.7- Up-River of Curry Fishwheel Camp

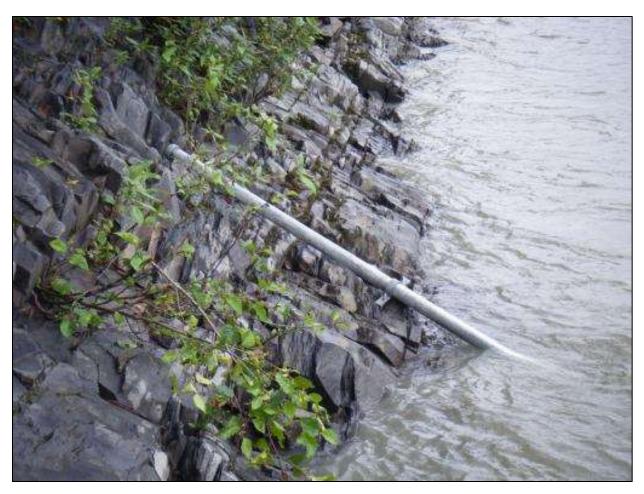
The housing pipe was fastened to shale with two pipe clamps and lag bolts slightly upstream of the buoy. The pipe houses 13 feet of cable with a thermistor attached by zip ties to a loop at the end. The thermistor was mounted to the cap at the end of the pipe in the river. The pipe was submerged 8 feet in the water at a 35° angle. The integrity of the shale is questionable; it may give way eventually.

RM 120.7 – Pipe Mounted at Curry Fishwheel Camp

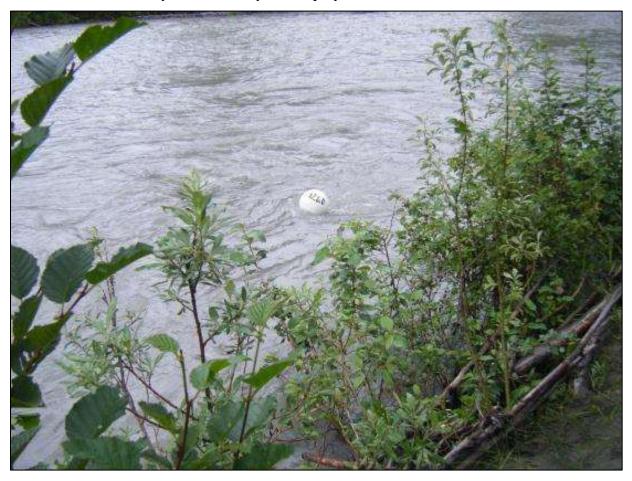
October 15, 2012 – Buoy with complete data logger string was found in downstream slough. System was retrieved and downloaded at 13:45 ADT.

October 23, 2012 – Helicopter flyby. The side channel where system was deployed was observed to be almost dry. No winter system deployed.

Buoy at RM 126.0 - Slough 8A

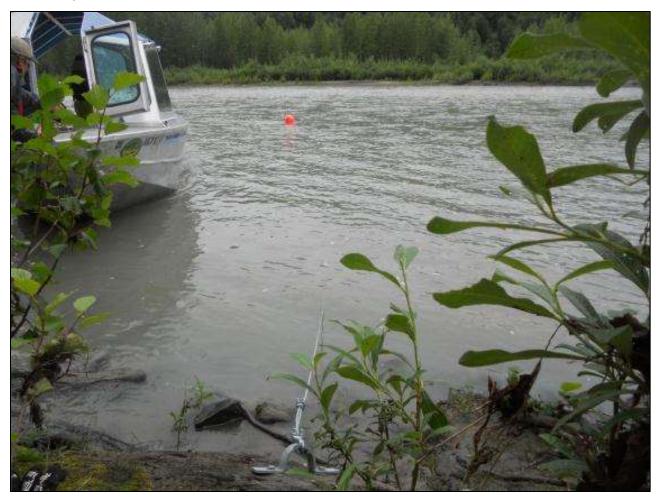
**August 27, 2012** – Downloaded system at 16:00 ADT. Buoy was missing.

**September 27, 2012** – Replaced buoy and downloaded data loggers at 16:20 ADT.

Buoy Install at RM 126- LRX 129

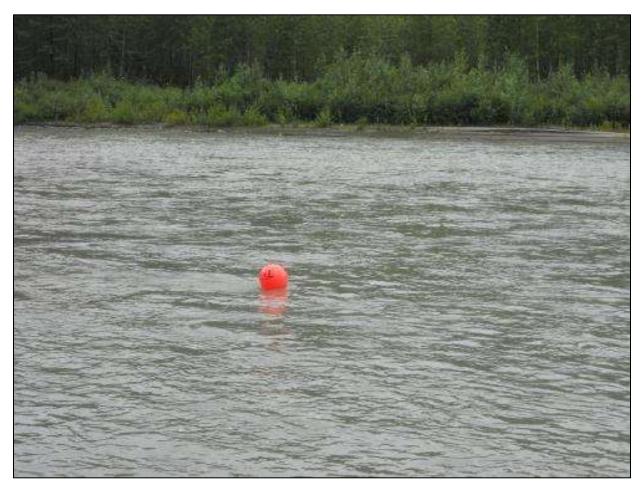
October 23, 20912 – Buoy system intact, buoy froze in ice but data loggers in 1 foot of flowing water. System downloaded at 10:15 ADT and removed. No winter system deployed – too shallow.

Buoy at RM 129.2 - Slough 9

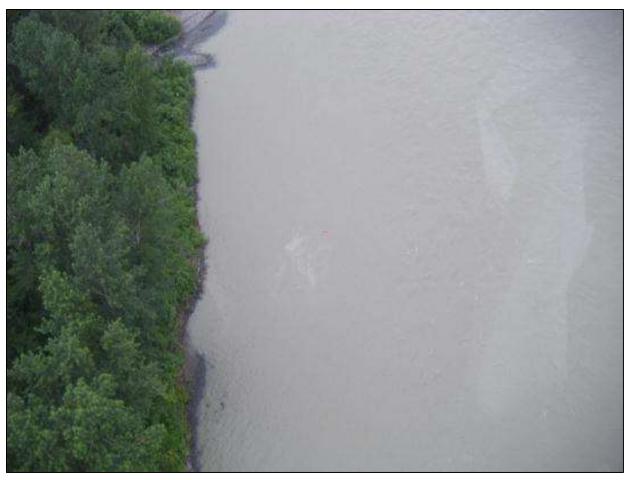
October 22, 2012 – Buoy and shore cable iced in but data loggers were ice free in approx. 2.5 feet of flowing water. Able to free system of debris and downloaded top two tidbits at 15:45 ADT. Removed buoy and redeployed.

Buoy at RM 130.8- LRX 35

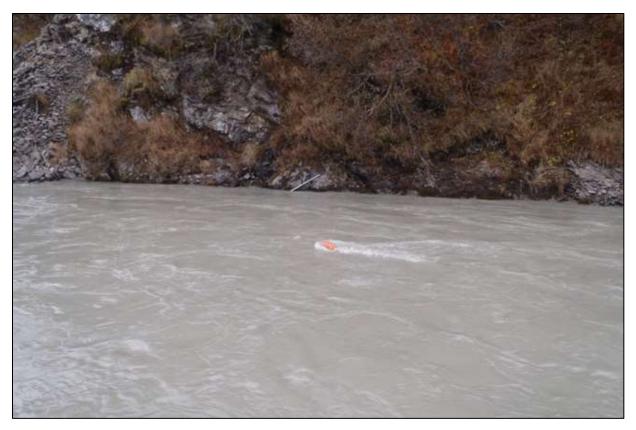
**September 27, 2012** – Buoy was missing but replaced. One data logger was missing (10174227) and not replaced. Both systems downloaded at 14:28 ADT.

October 23, 2012 – Pipe was high and dry and tidbit cable was frozen in pipe and could not be removed, no download. Buoy system intact. Downloaded at 13:45 ADT and removed initial buoy string with multiple data loggers. Replaced with winter, single data logger system (data logger #10174227).

Buoy and Pipe Systems at RM 138.7 - Susitna above Indian Creek

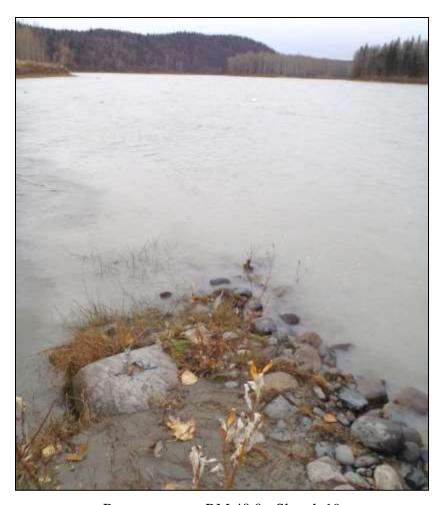
**August 27, 2012** – Buoy was missing but found downstream and reattached. System downloaded 14:10 ADT and re-deployed.

October 22, 2012 – System intact but dry and incased in ice. System was downloaded at 12:00 ADT and removed from the river. No winter system deployed due to shallow water conditions.

Buoy system at RM 40.0 - Slough 19

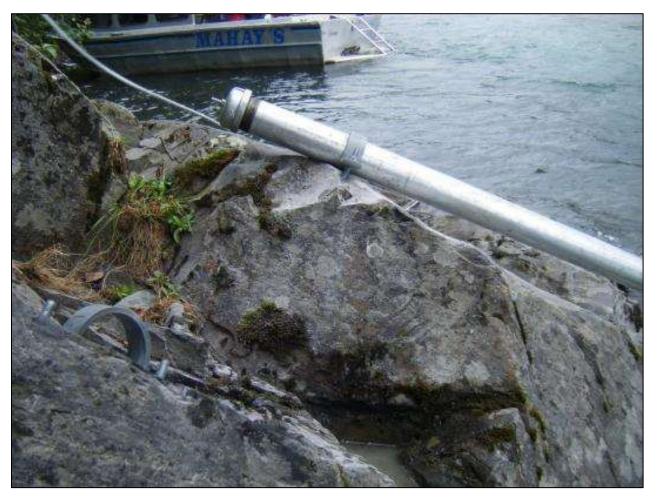
October 22, 2012 – Internal cable is frozen in and cannot be removed for download. Leave system in place until spring.

Pipe System at RM 148.0 – Susitna below Portage Creek

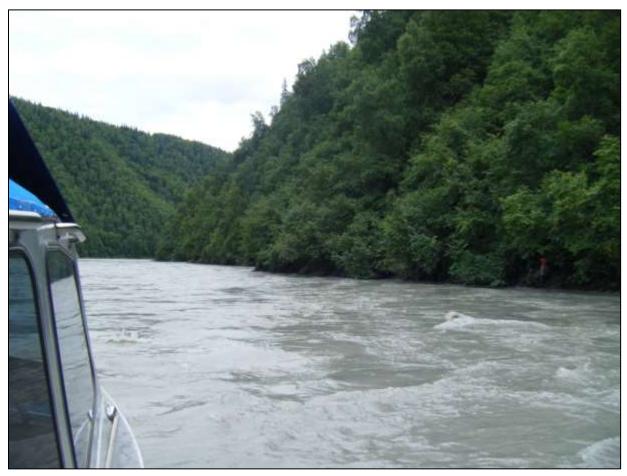
**August 28, 2012** – Buoy missing and replaced. System downloaded. At 12:21 ADT and redeployed.

Buoy Installation at RM 148.8- Above Portage Creek
