79_218900_Alaska_Railbel/2189_Lineament Report October 2013, modified 10.18.13

SUSITNA-WATANA HYDROELECTRIC PROJECT
 LINEAMENT GROUP 9
 MAP DATA

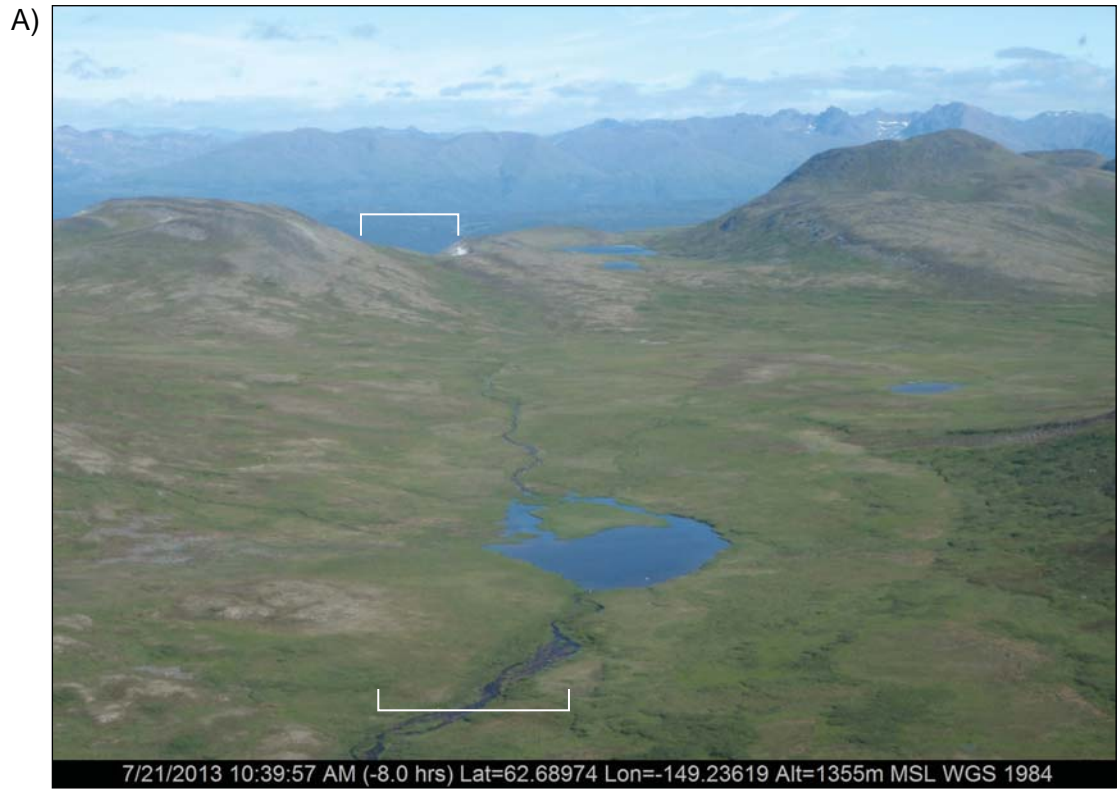
View looking north at middle portion of lineament group 8 along mapped inferred fault. Brackets show position of fault but note that no geomorphic expression of faulting is readily apparent.

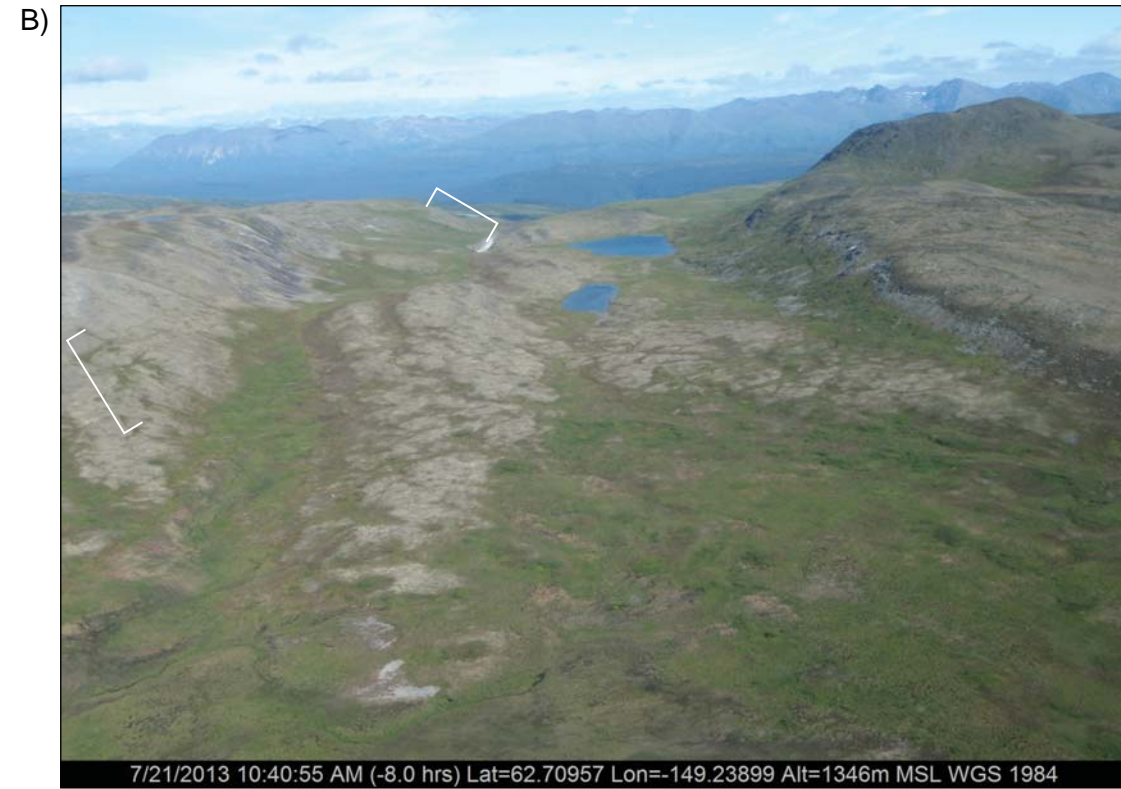
Close up view of saddle area shown in Photograph A. Brackets, again, show position of fault but note that no geomorphic expression of faulting is readily apparent.

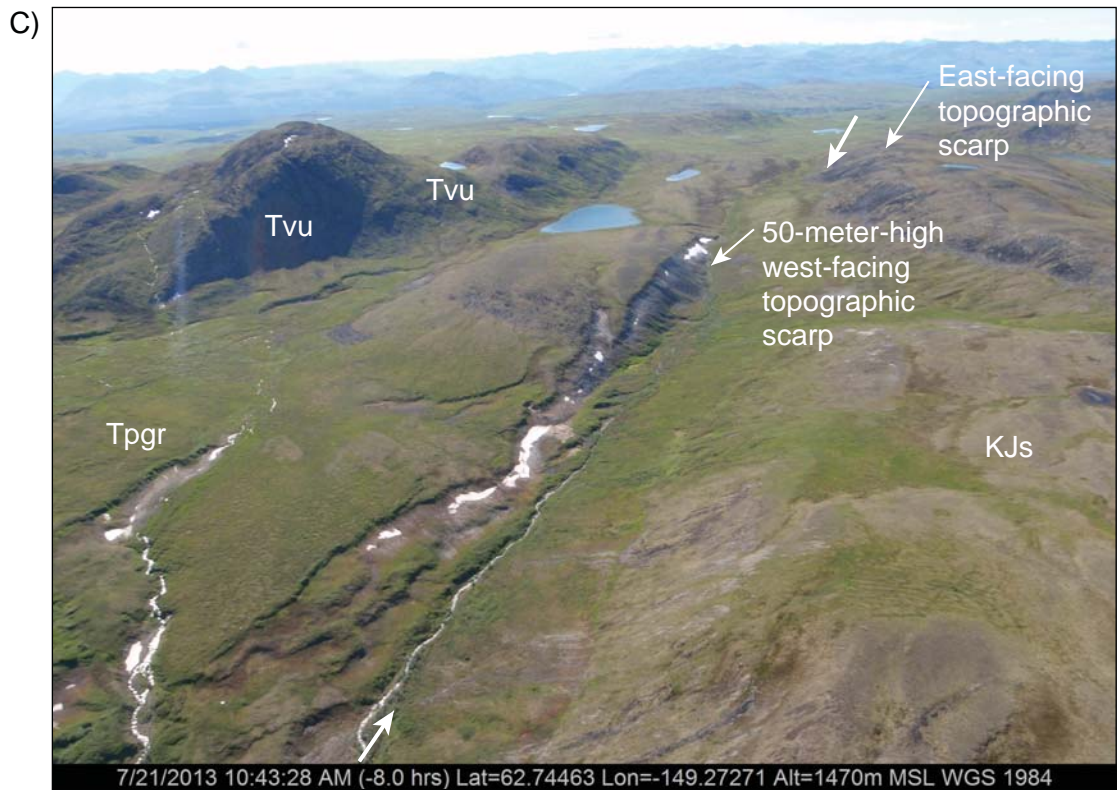
View looking south opposite that shown in Photograph B above. Mapped fault runs between large arrows. Note presence of many solifluction scarps in the landscape.

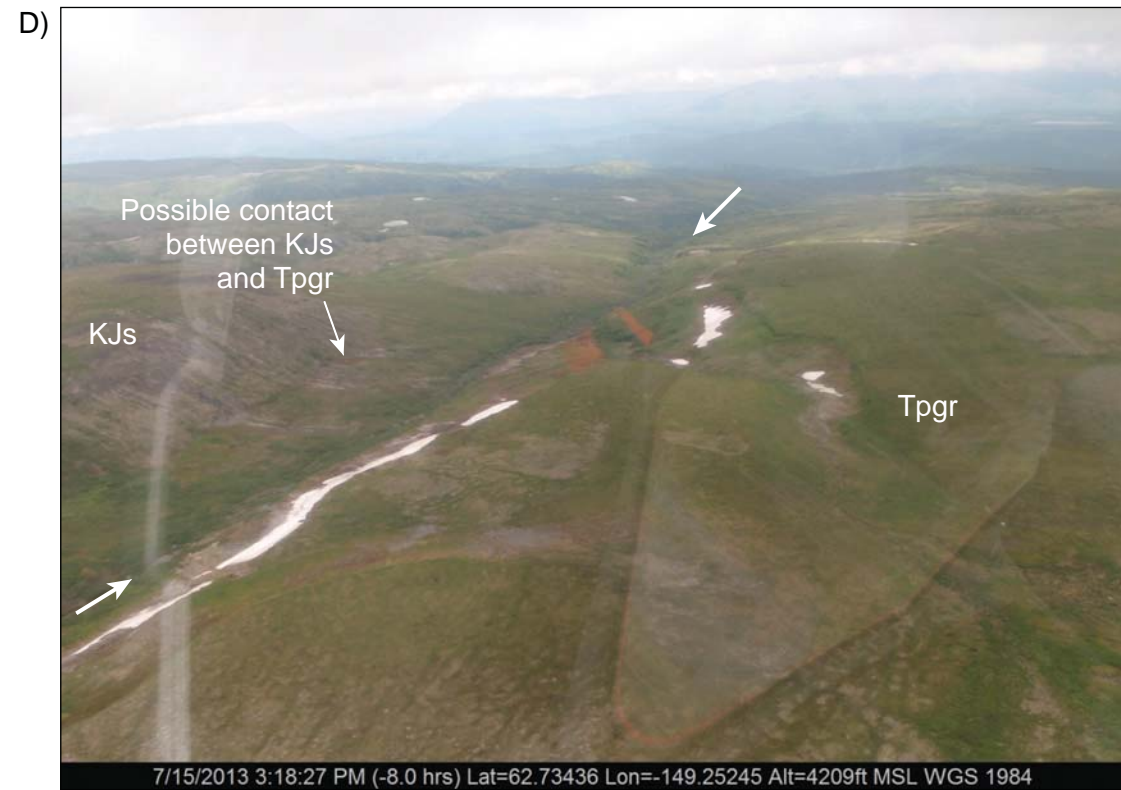
View looking north down the prominent, deeply incised linear drainage. Mapped fault runs between large arrows.

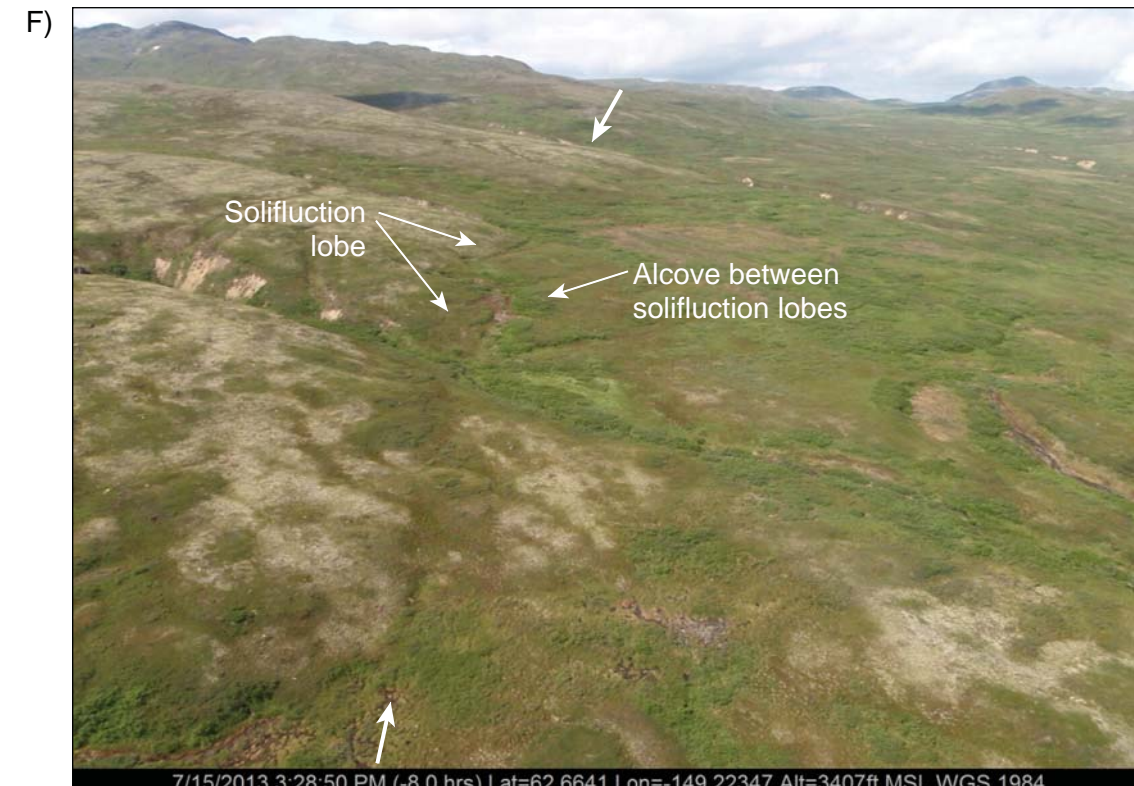
View looking north along 1- to 2-m-high east-facing scarps along southern portion of lineament group 8. Large arrows point along mapped lineament. Note the presence of solifluction lobes with an alcove or recession in between them that create an irregular and curving topographic scarp.

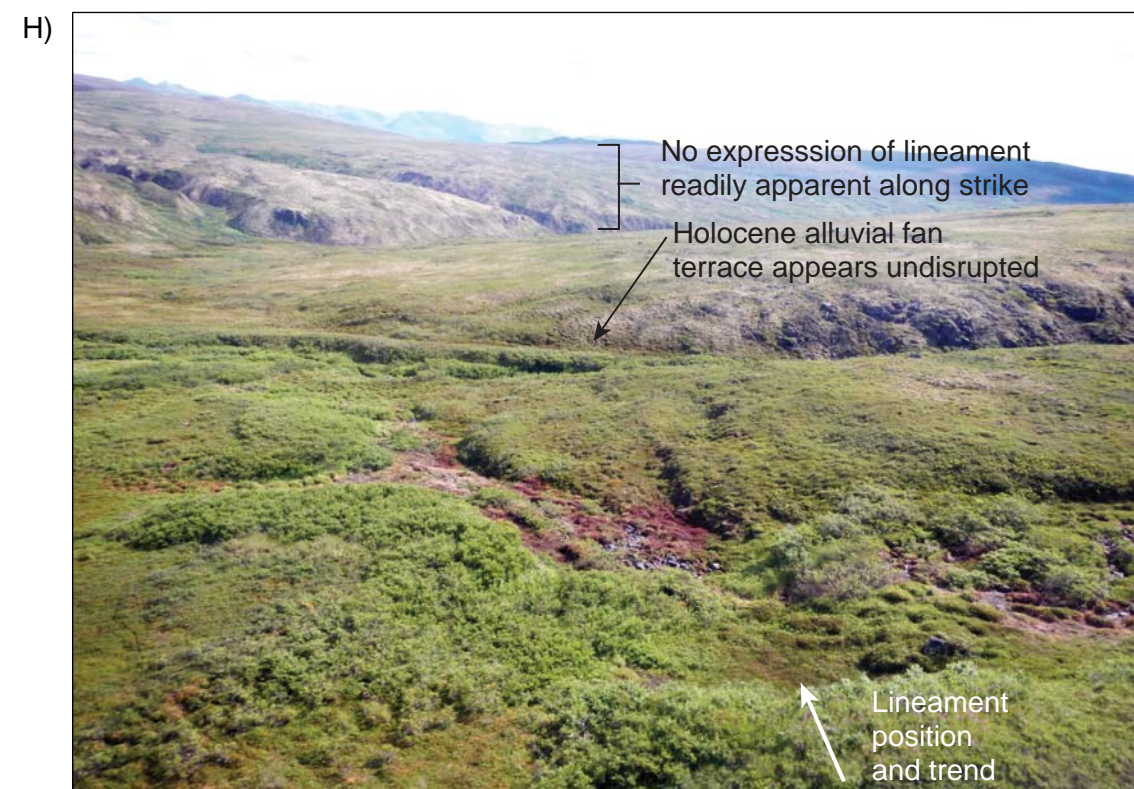
View looking south opposite that shown in Photograph F above. Large arrow points along lineament position and trend.

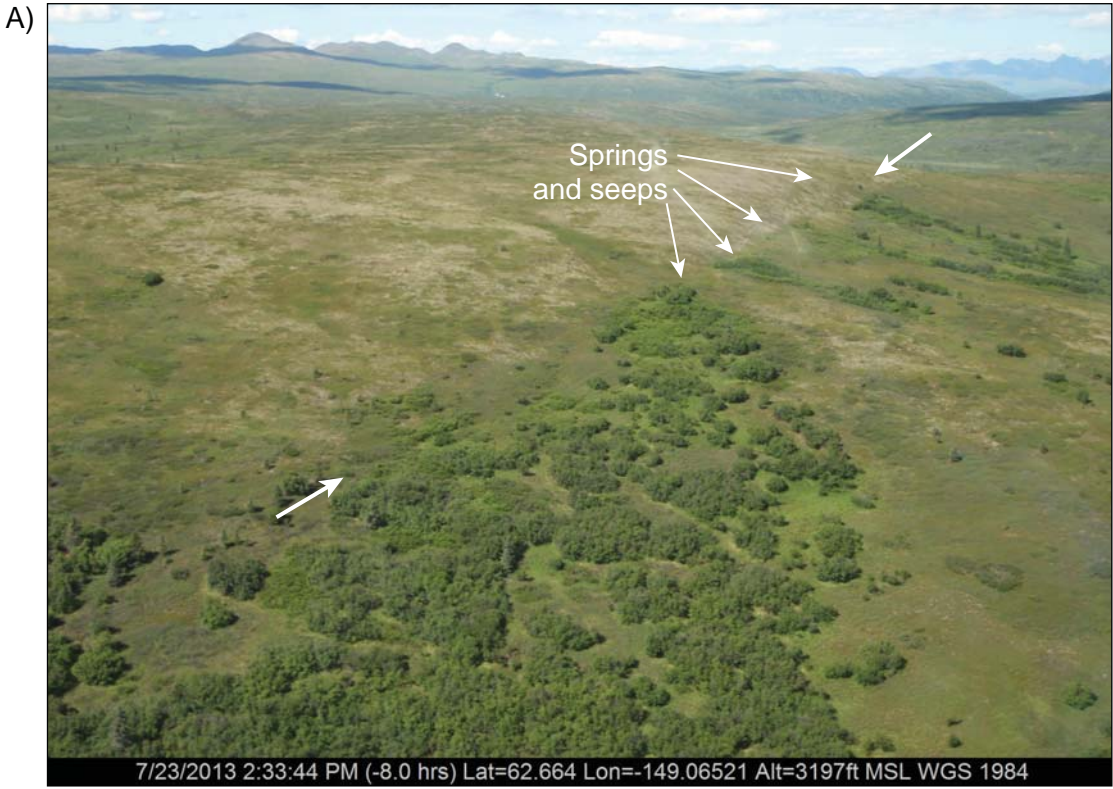
The first in a sequence of 5 photographs looking northwest taken along a series of north-trending, east-facing aligned slope breaks in the southernmost portion of lineament group 8. Large arrows point along lineament.

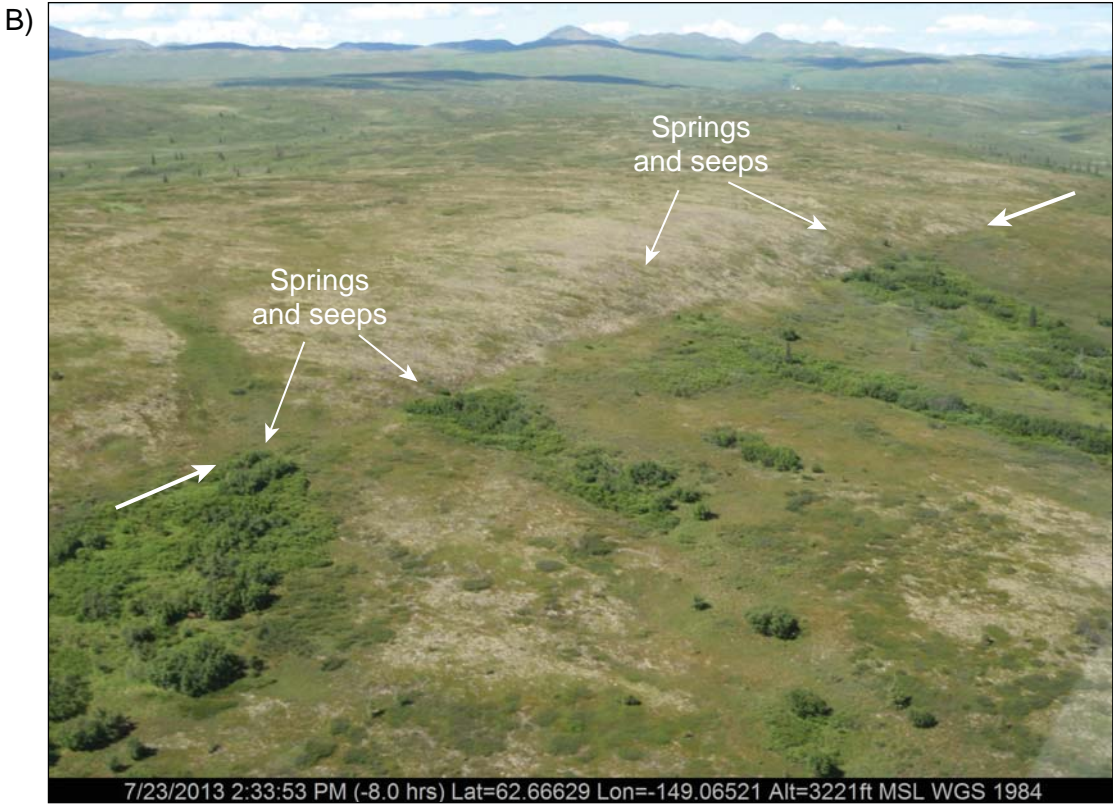
Photograph 2 of 5 looking northwest. Large arrows point along lineament.

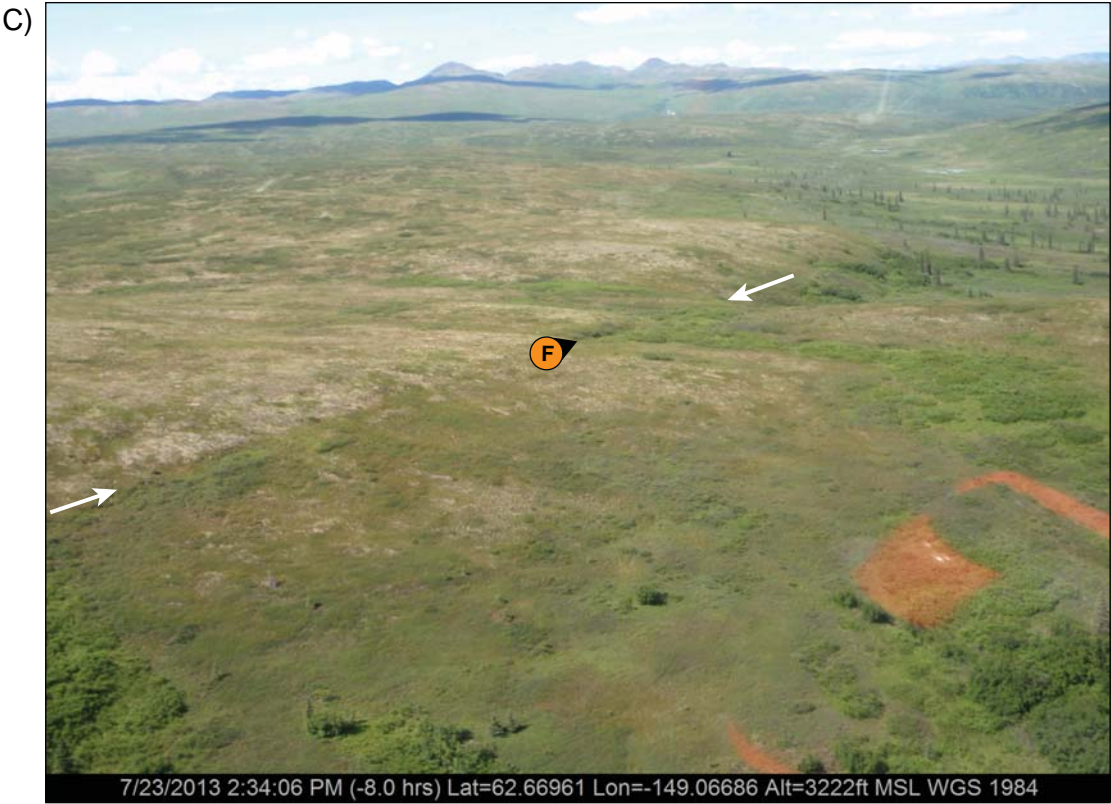
Photograph 3 of 5 looking northwest. Large arrows point along lineament.

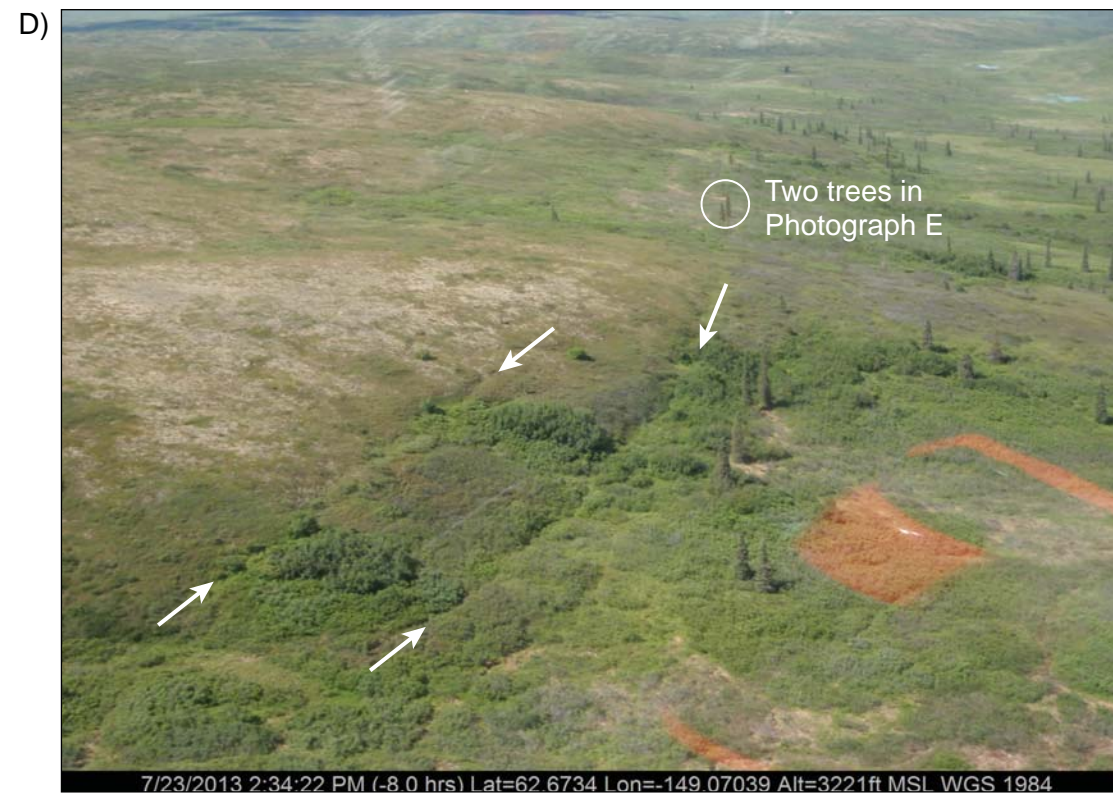
Photograph 4 of 5 with view looking northwest. Large arrows point along lineaments.

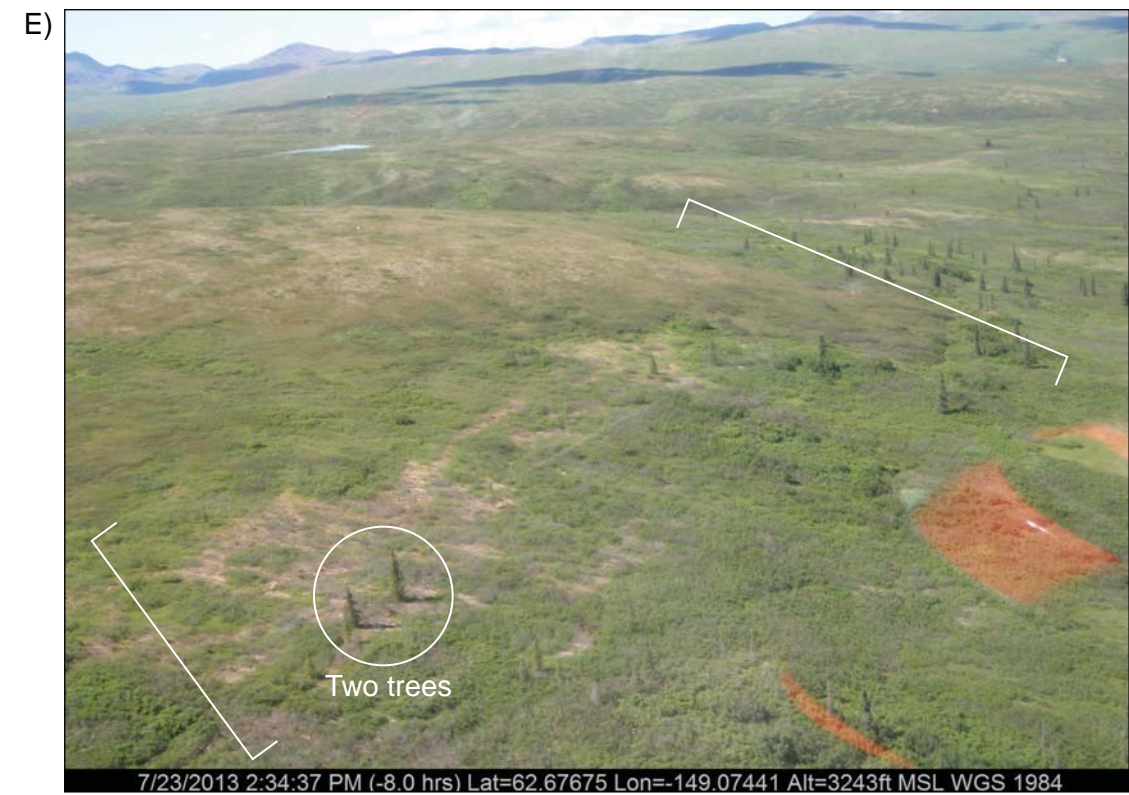
Photograph 5 of 5 with view looking northwest. Note that lineament expression has died out and brackets bound the location of its projection.

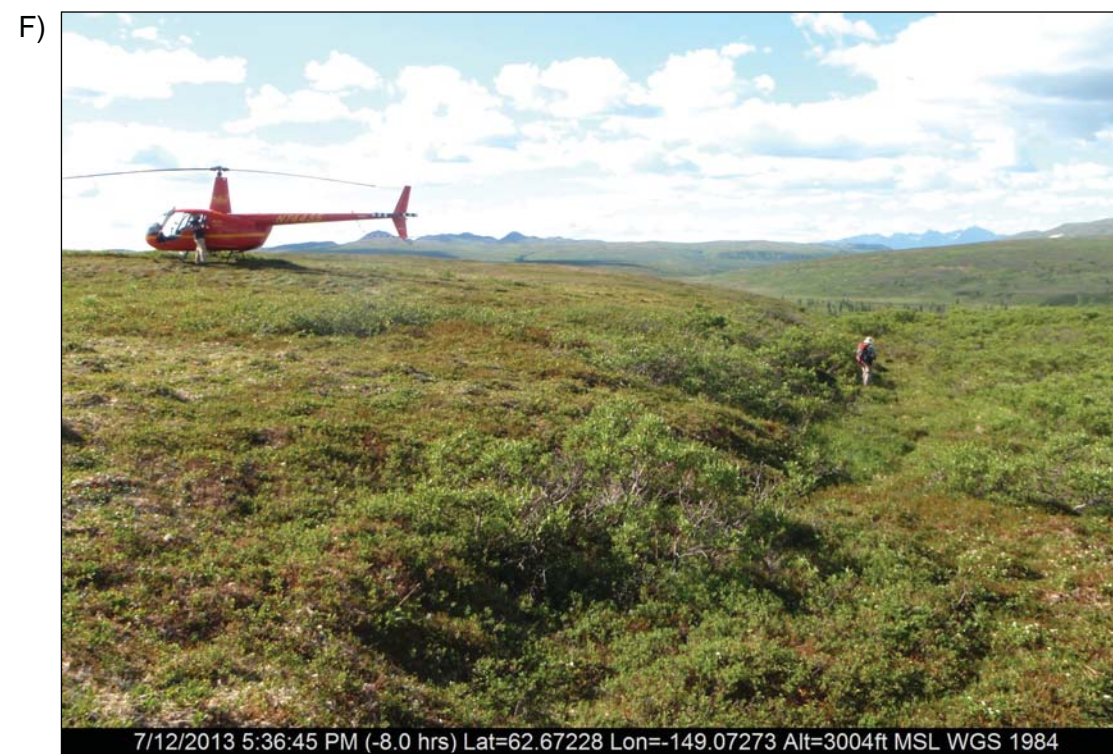
View looking north from location F. Geologist at base of east-facing break-in-slope is 170 cm tall.

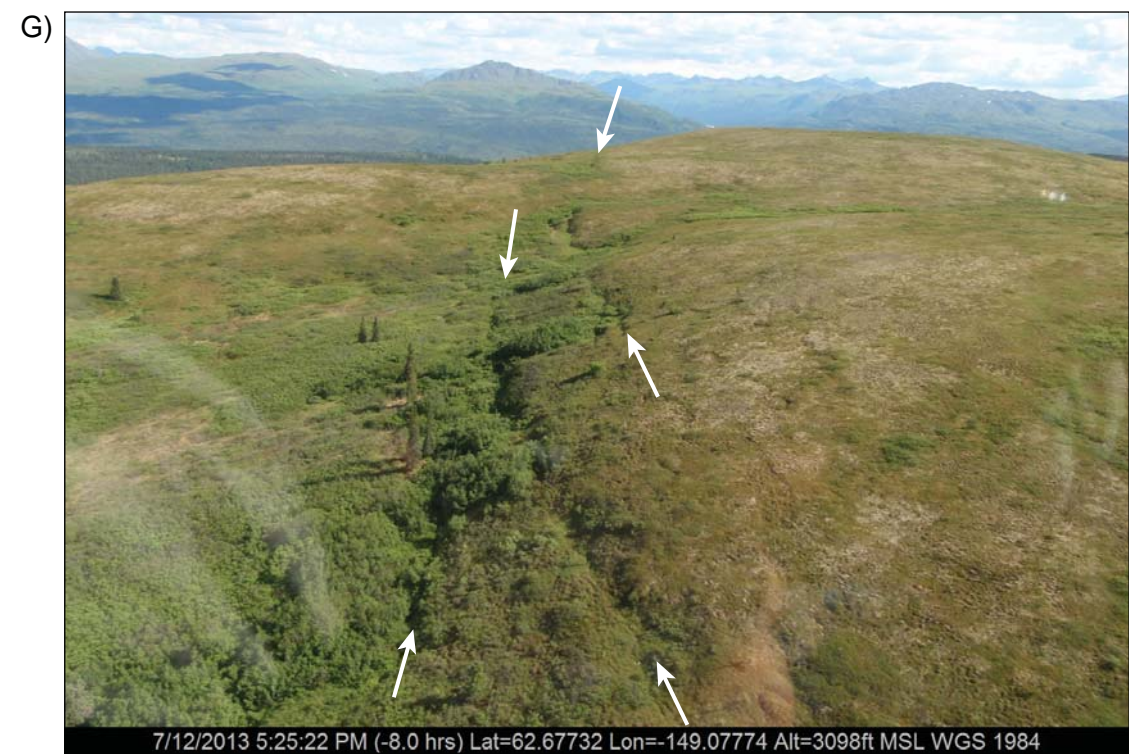
View looking almost 180 degrees from that shown in Photograph D. Large arrows point along lineaments.

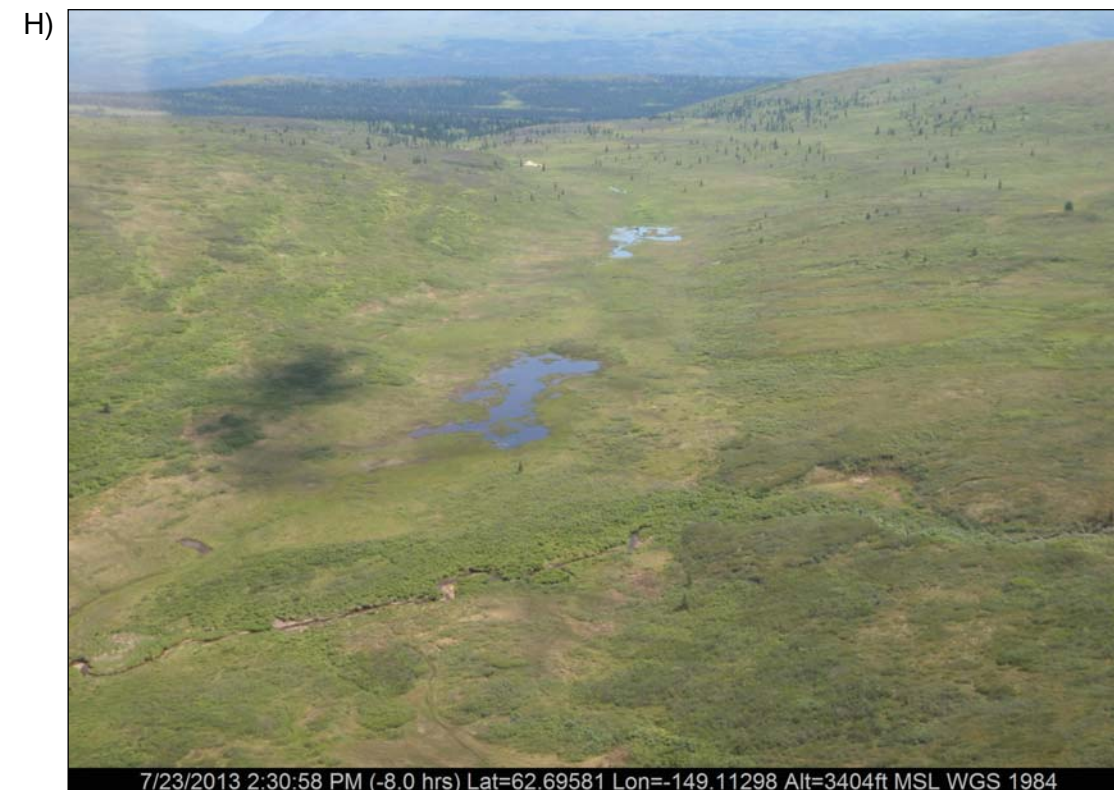
View looking south from location I across area within WCC's segment 3. Note the lack of expression of any lineaments in the broad depression.

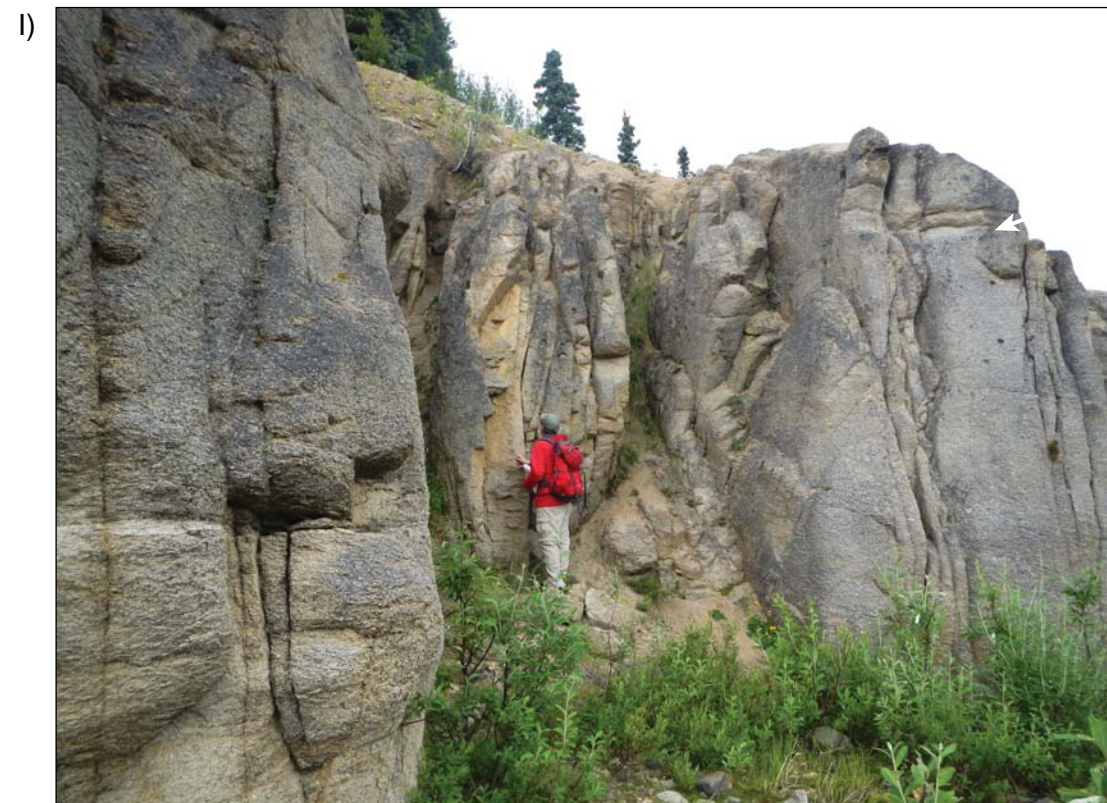
Exposures of widespread granodiorite in unnamed creek near GPS waypoint 176 in terrain mapped as flysch (map unit KJs) by Wilson et al. (2009). The geologist is approximately 175 cm tall.

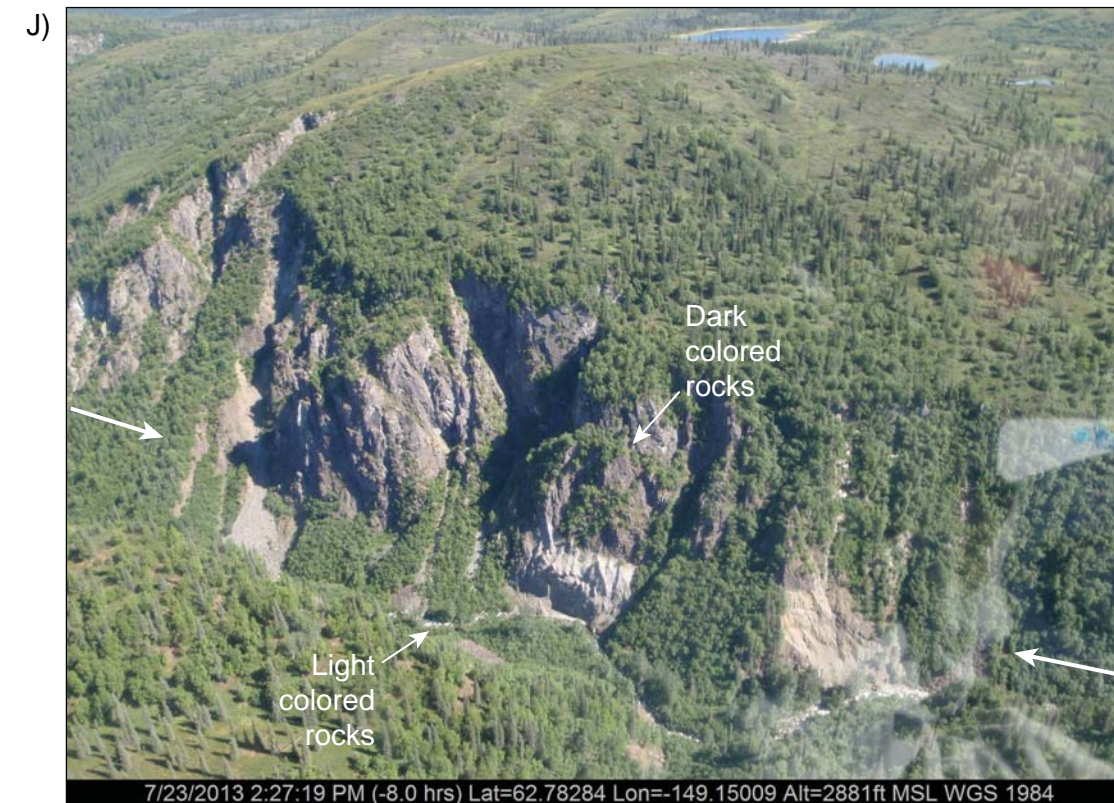
View looking northeast at right wall of linear v-shaped canyon. Large arrows point along apparent bedrock type contrast.

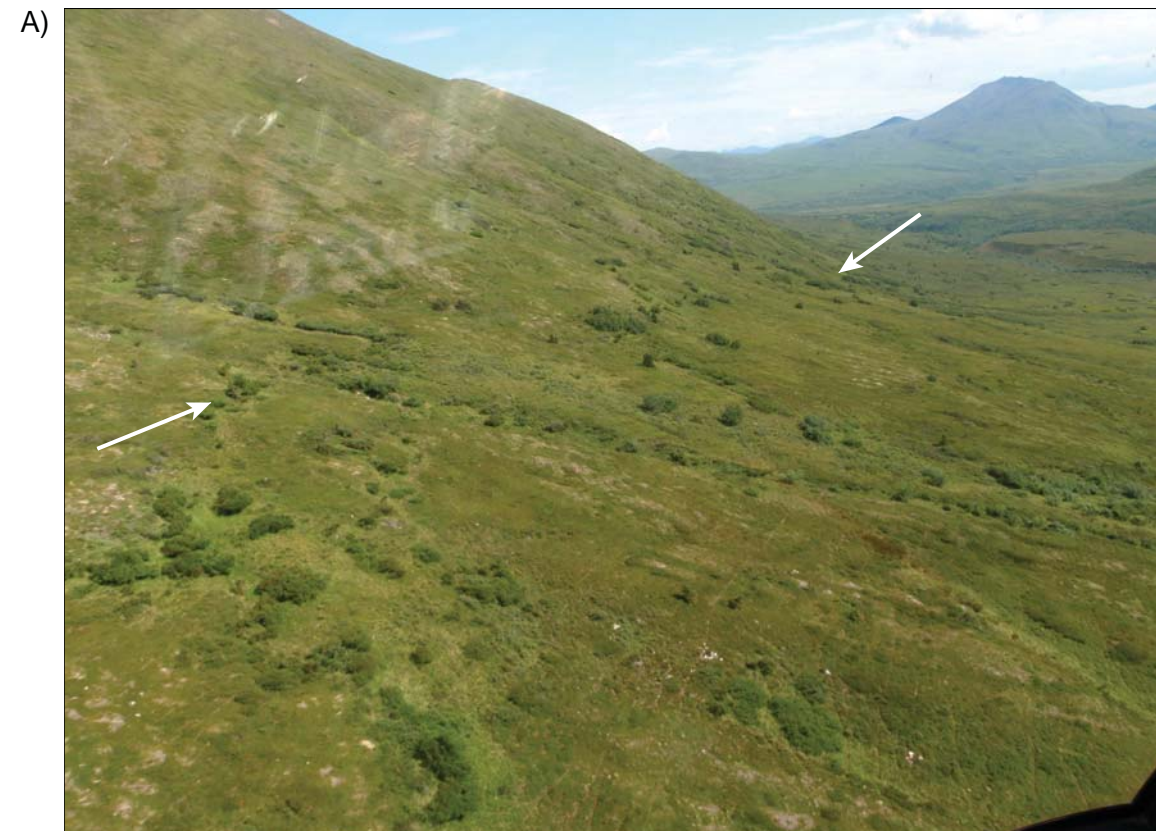
View looking northeasterly along lineaments. Arrows point along trend and position of lineaments.

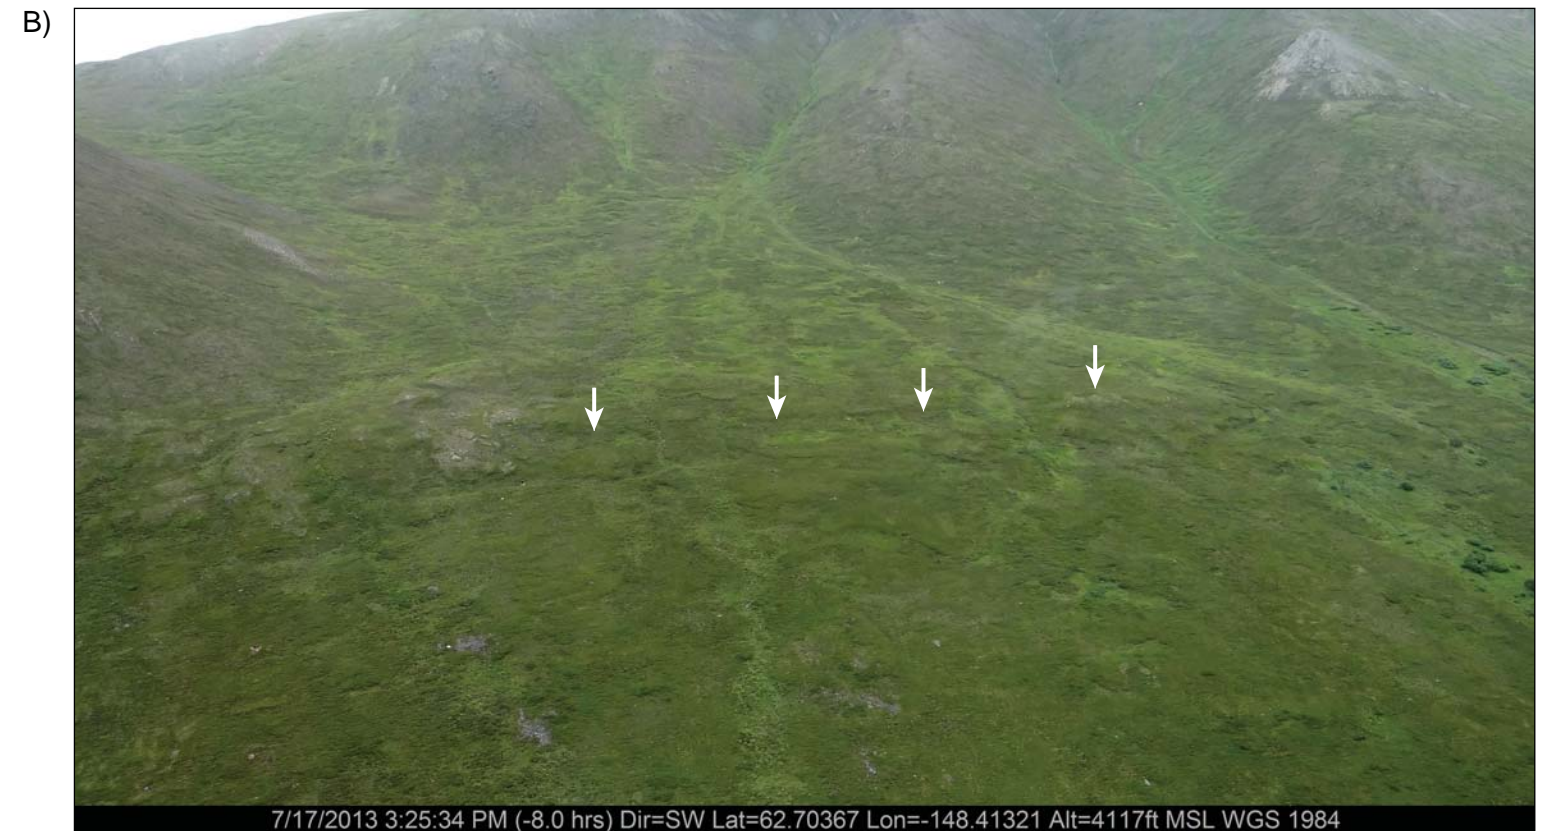
View of lineaments expressed in Quaternary sediment.

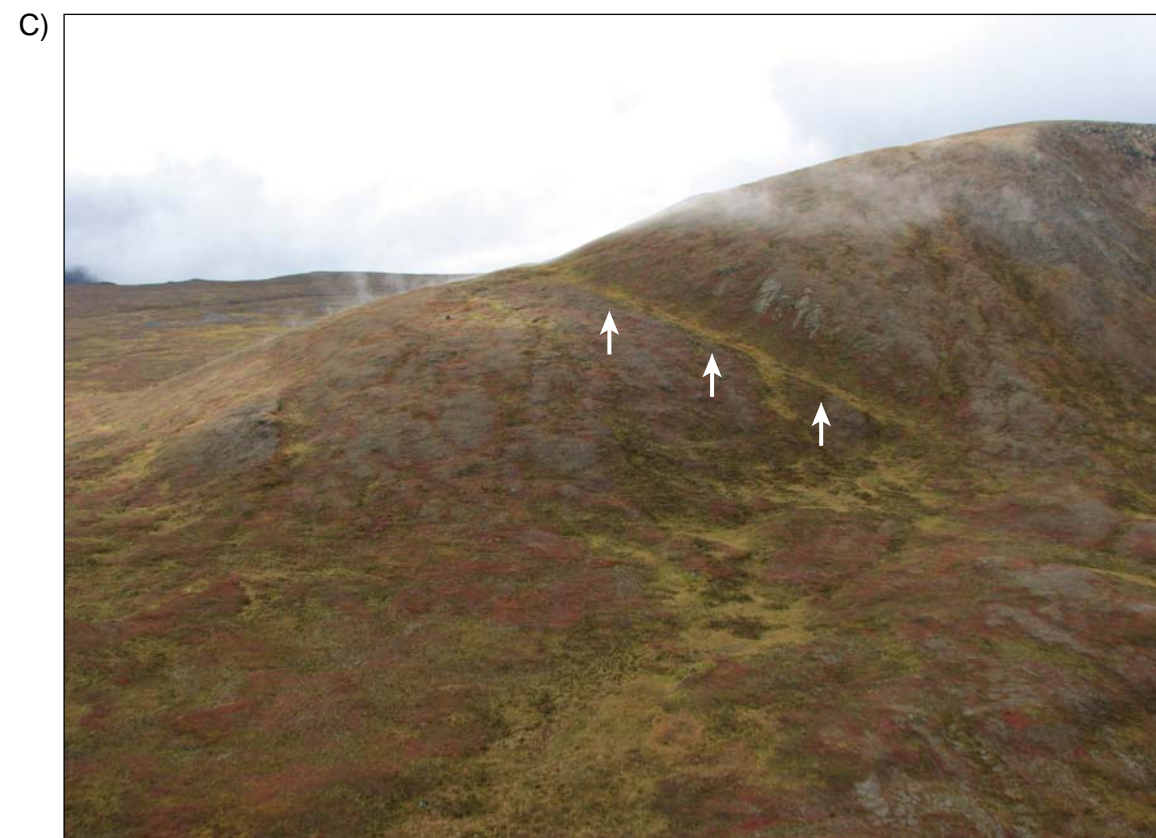
View looking at notch in bedrock with expression of apparent northwesterly dip.

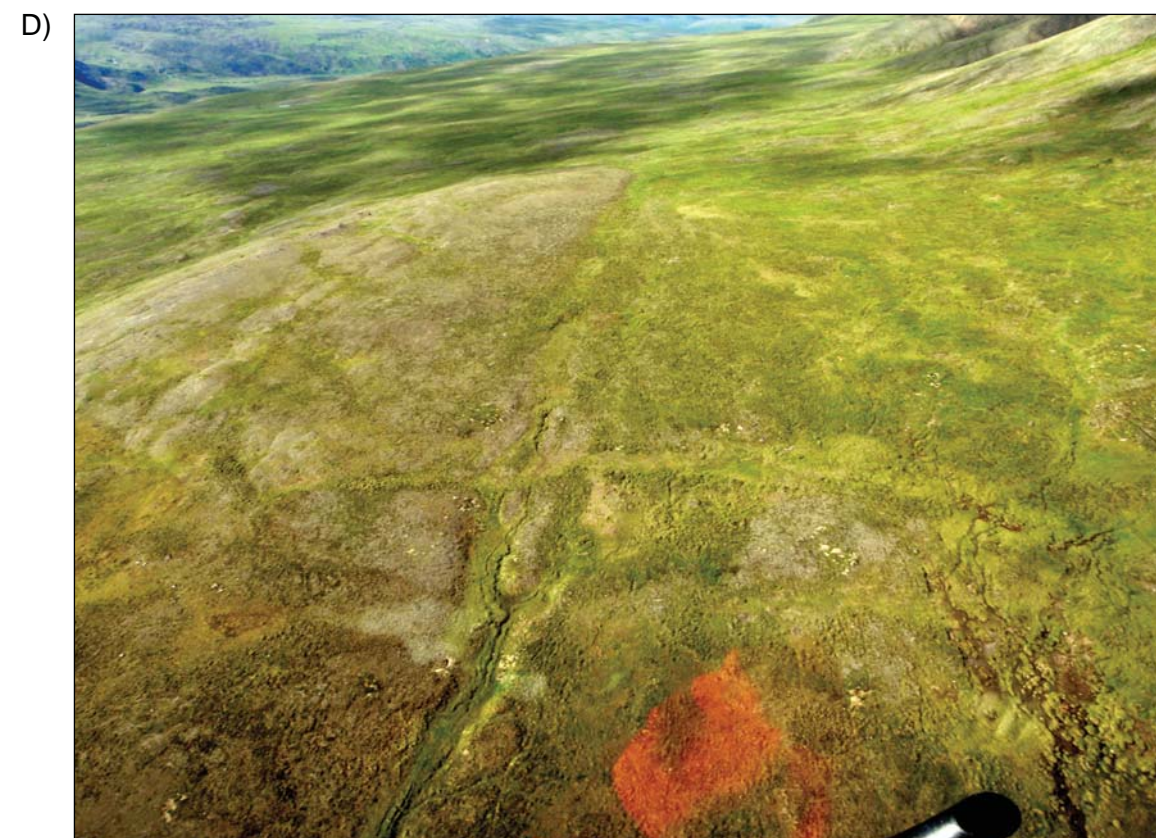
View looking southwesterly along glacially scoured surface.

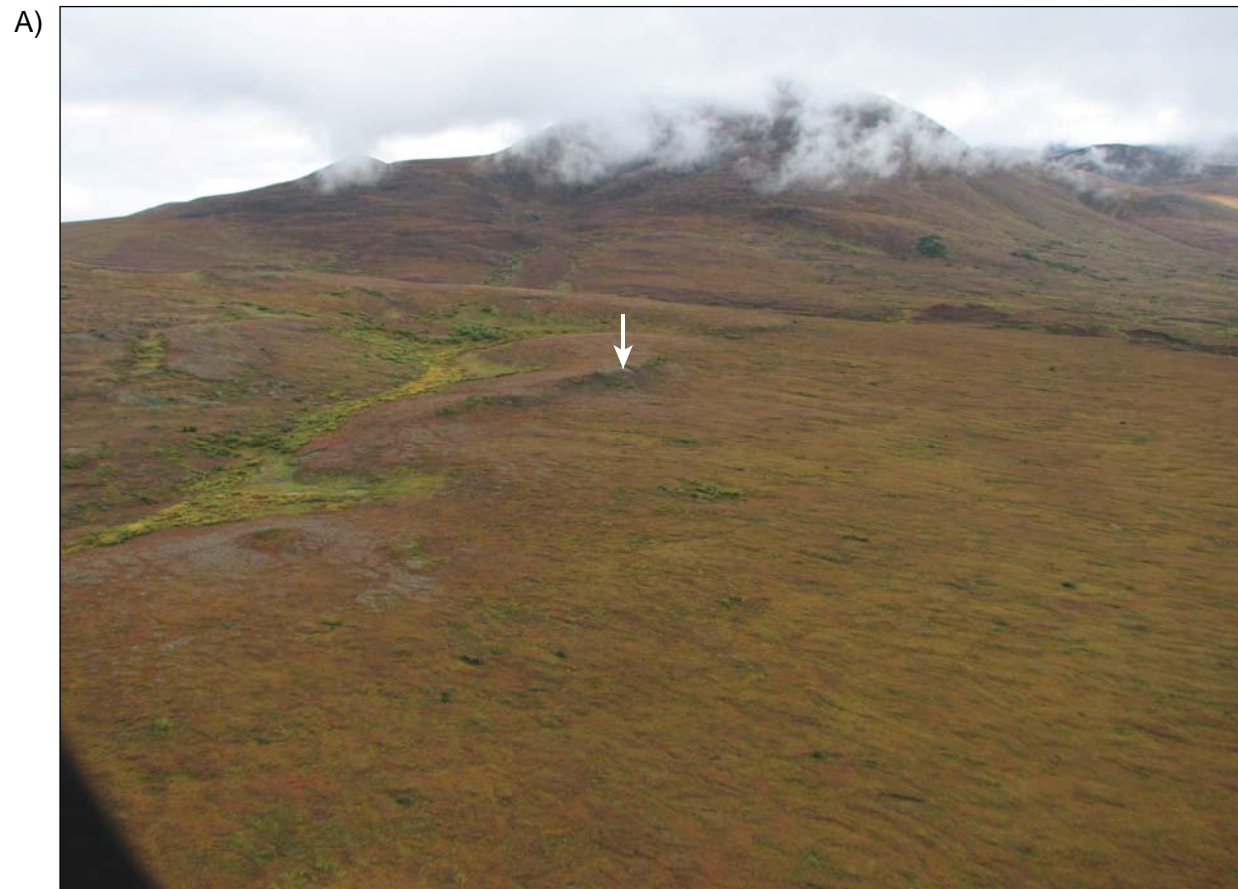
View looking northeast at erosional break-in-slope mapped as an individual lineament. Feature is absent in the background along projection of strike.

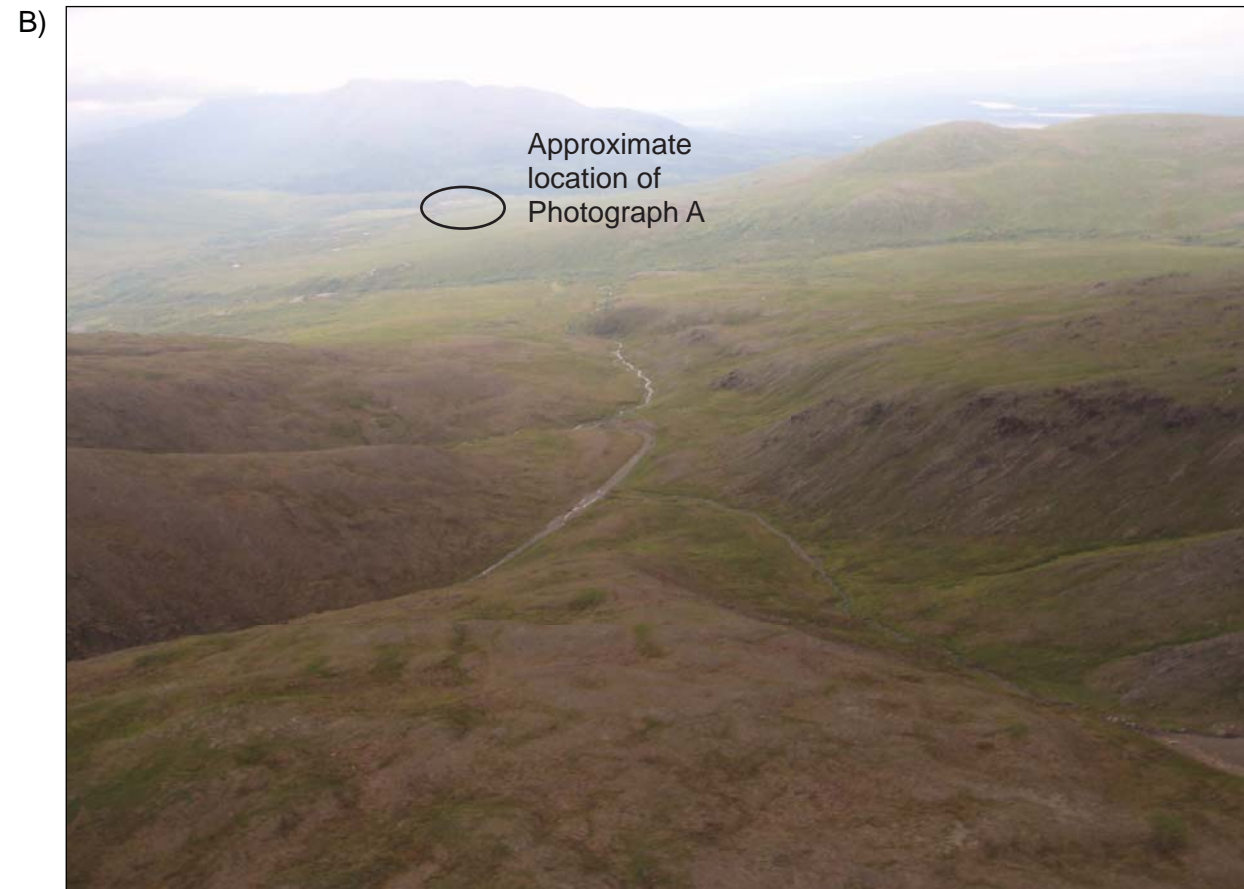
View looking southwest down-valley along lineament geomorphically expressed as linear valley. Very little alluvium has accumulated in the drainage, and glacially sculpted bedrock is shallow.

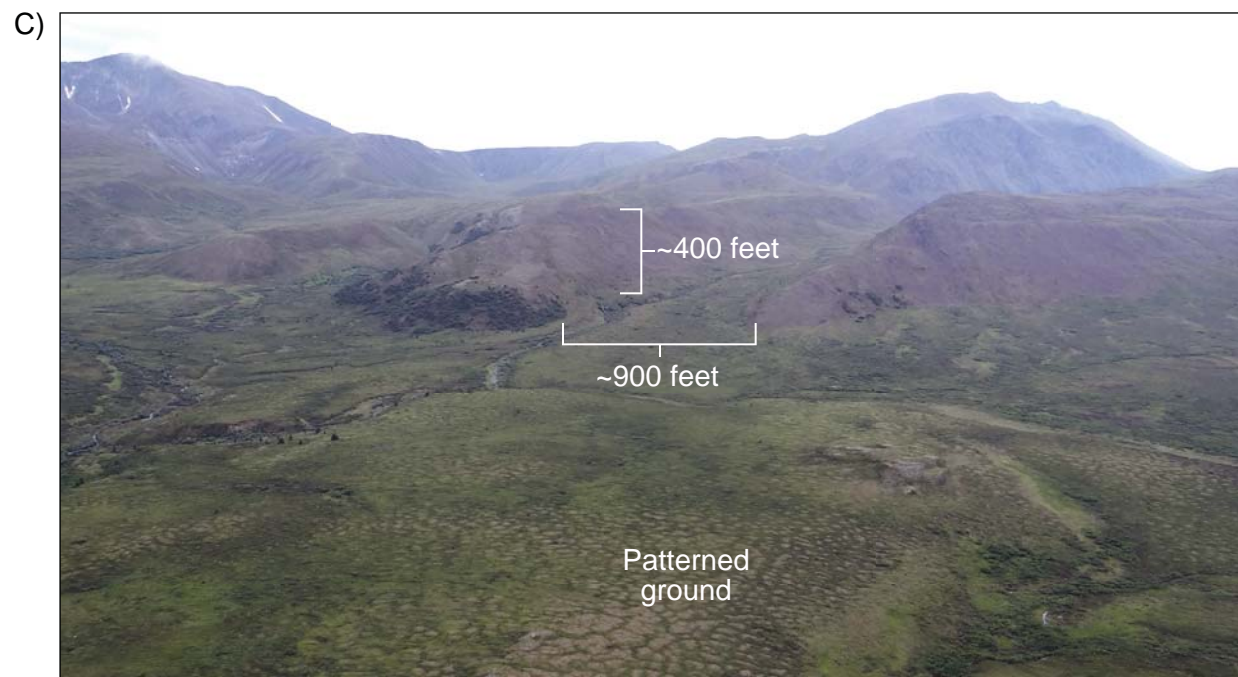
View southerly up-valley into glacial valley along lineaments geomorphically expressed as linear valley and drainage. Underfit creek in deep linear valley suggests landform created by sub-ice channel meltwater.

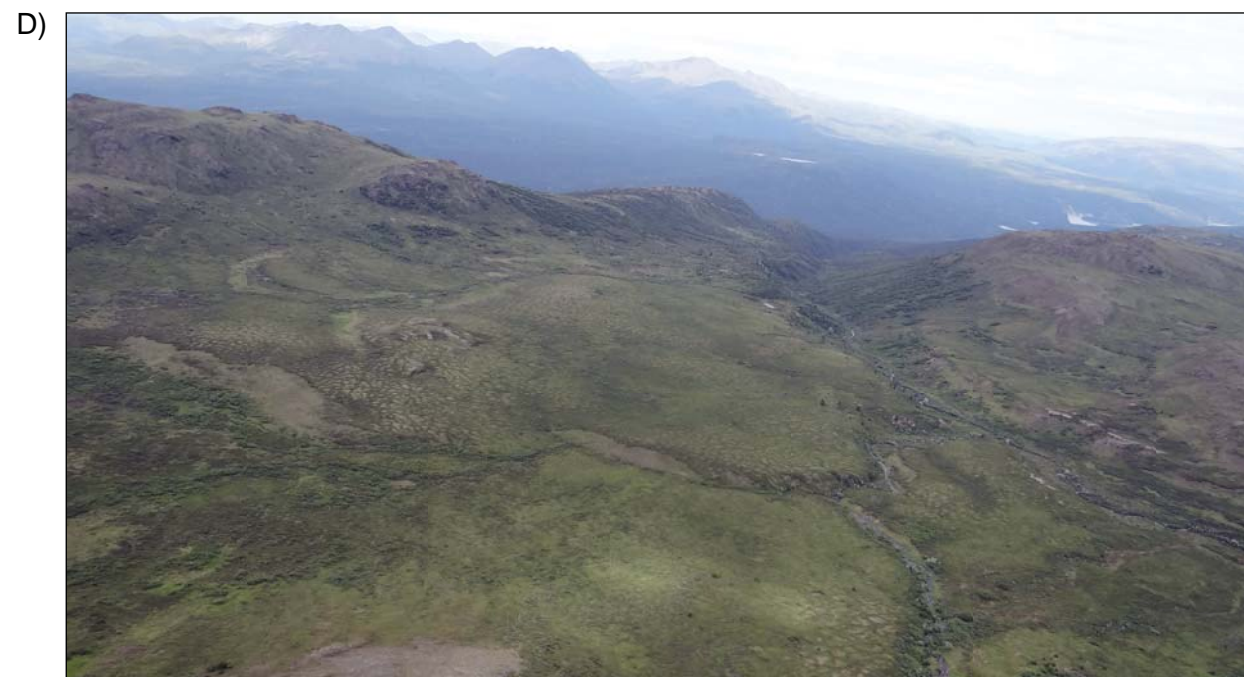
View northerly down-valley along lineaments geomorphically expressed as linear drainage. Thin cover of unconsolidated surficial sediment mantles the Paleozoic rocks.
