79_218900_Alaska_Railbel/2189_Lineament Report October 2013, modified 10.18.13

SUSITNA-WATANA HYDROELECTRIC PROJECT
 LINEAMENT GROUP 9
 MAP DATA

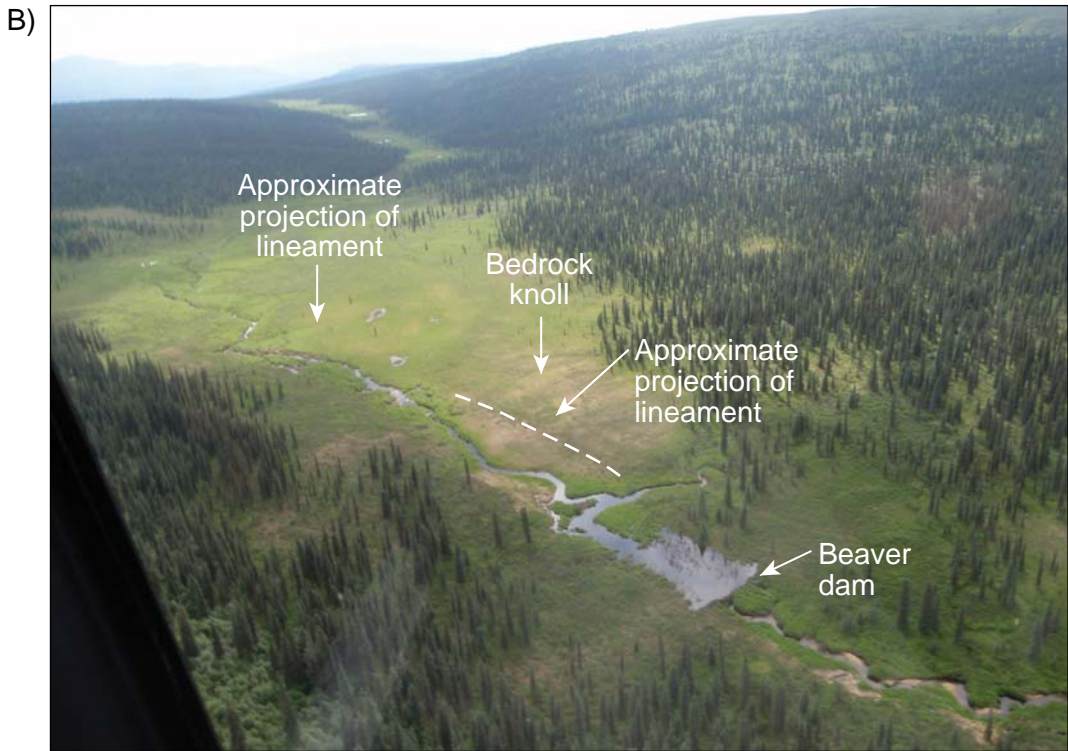
View looking north-northeast at creek in boggy (Holocene) drainage. Lineament is expressed as a depositional contact along the shallow bedrock knoll.

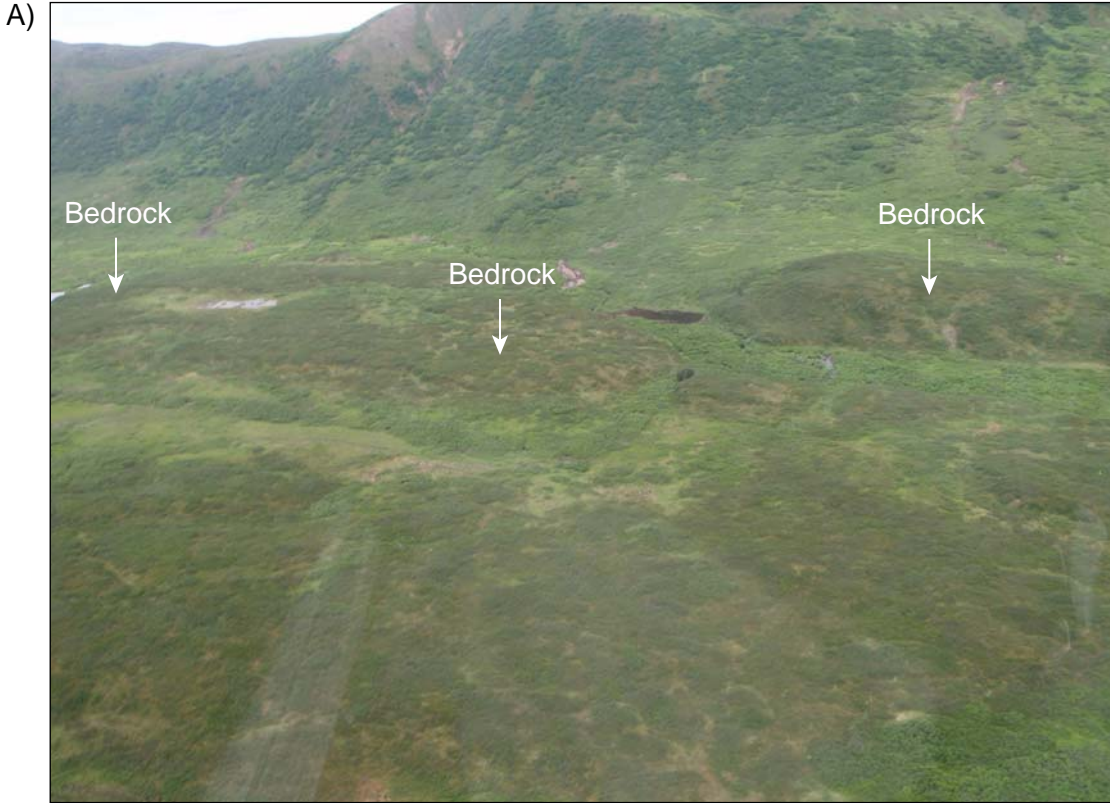
View looking westerly at break-in-slope at base of hillside and undulating glacially-eroded bedrock knobs in foreground.

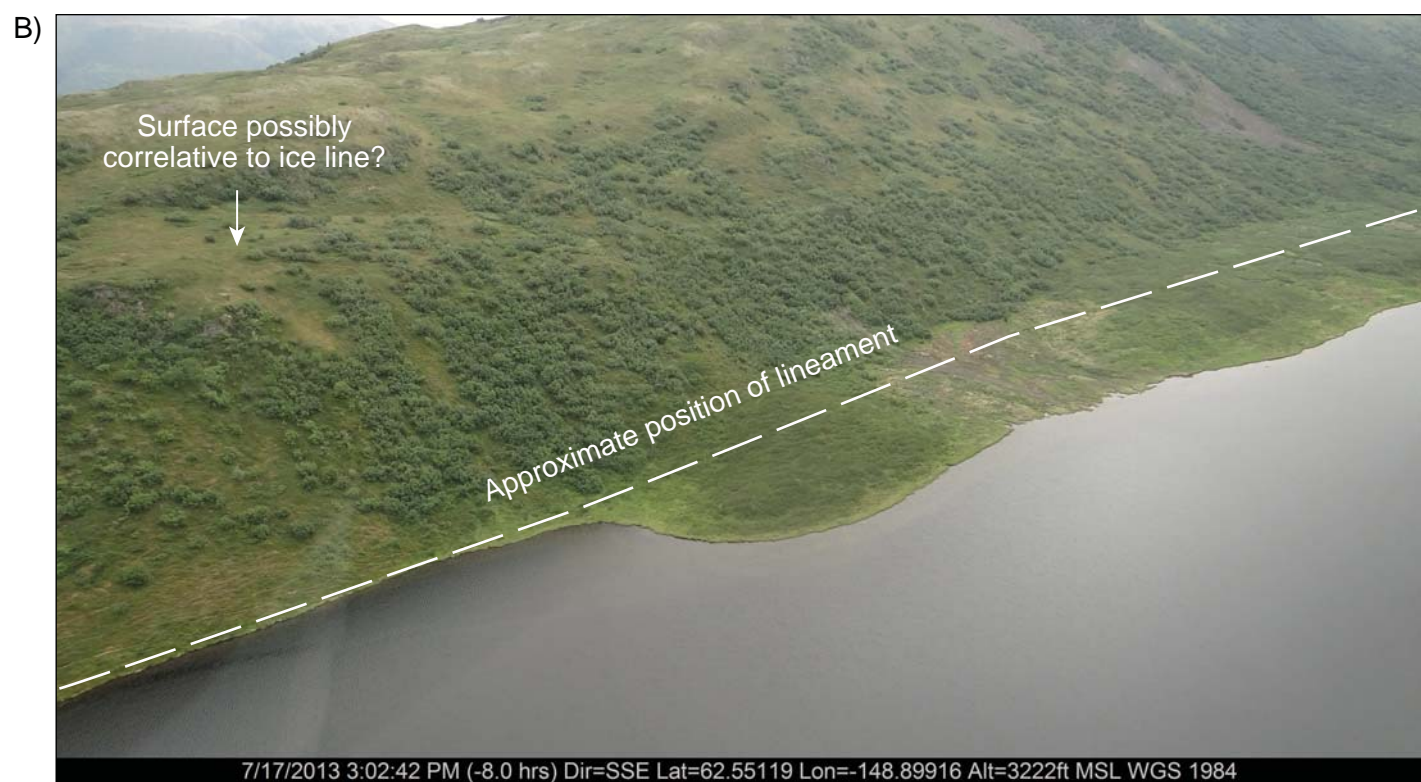
View looking south southwest at lake margin of glacial valley. Lineament was mapped at base of slope, and is not expressed as a scarp-type feature. Apparent colluvium along projection of lineament does not appear offset.

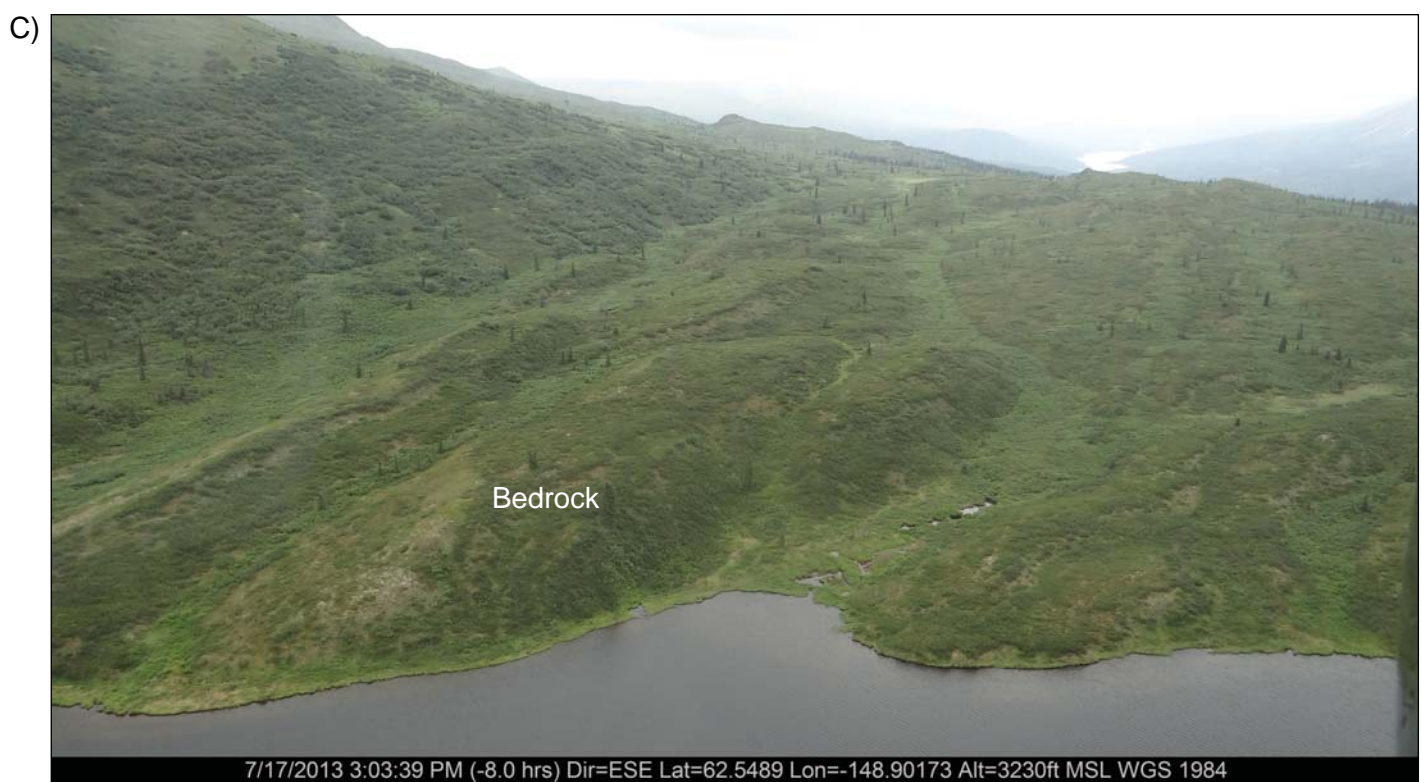
View looking south southeast along glacially-sculpted terrain along which Csejtey (1974) has inferred a fault within the glacial sediment that mantles the bedrock knolls (Figure A17b.1).

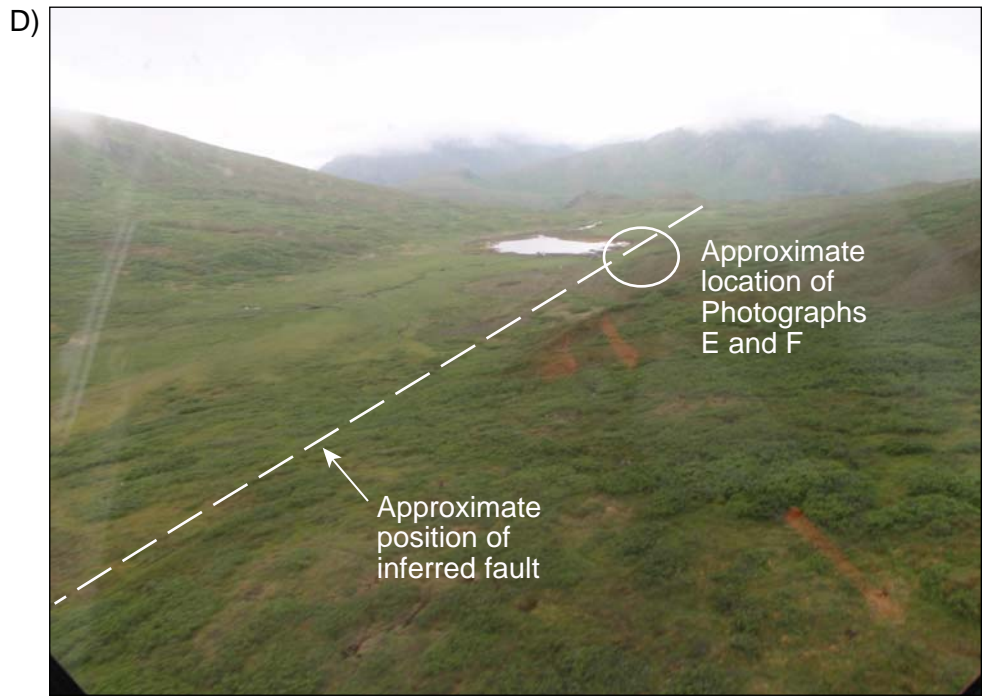
View looking south along southern extent of group 17b, along which an inferred bedrock fault is mapped by Wilson (2009). Photographs B and C are adjacent to lake.

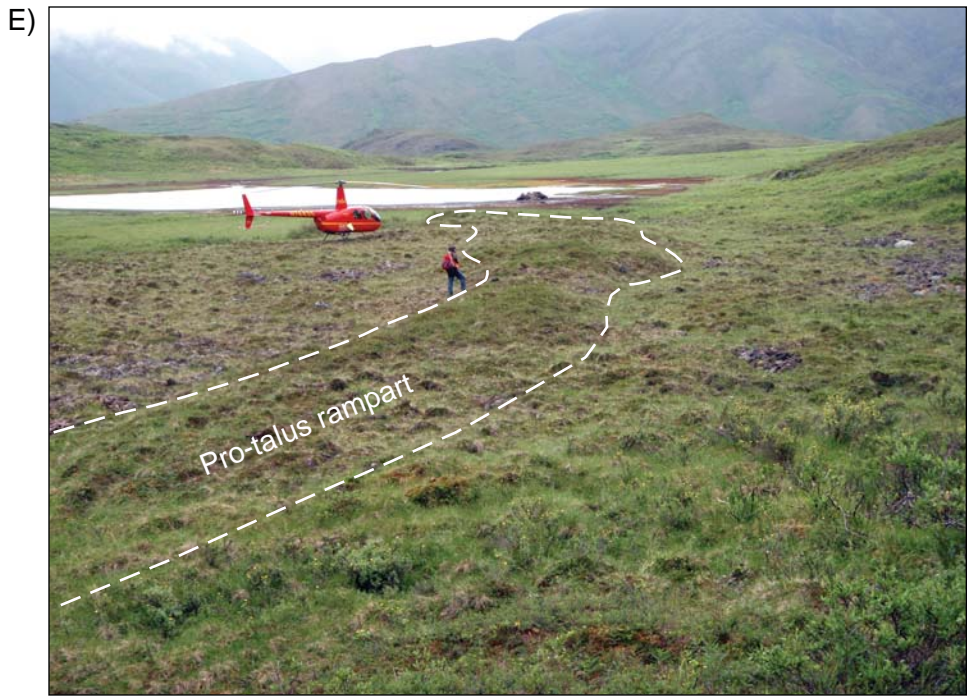
View looking south at pro-talus rampart and GPS waypoint 15. Note lateral distance between base of slope to crest of rampart. Geologist for scale is about 180 cm tall.

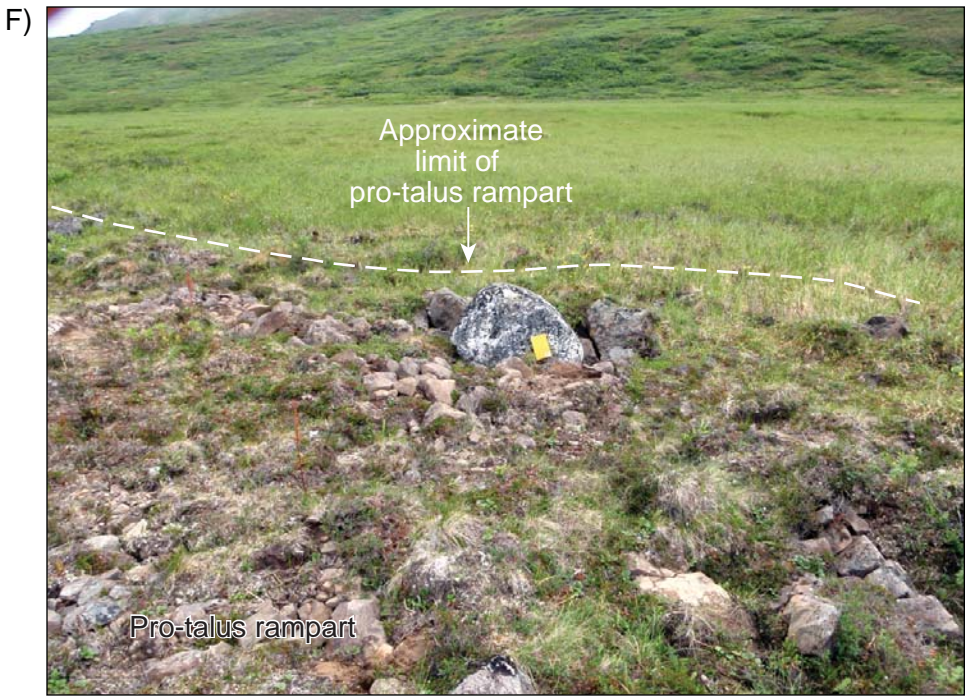
Pro-talus rampart constructed from blocky, frost-shattered volcanic rocks. Photograph is centered on more sub-rounded glacial erratic (granitic) that is not similar to any of the local hillside lithologies. Field notebook is 19 cm tall.
