Figures

SUSITNA-WATANA HYDROELECTRIC PROJECT

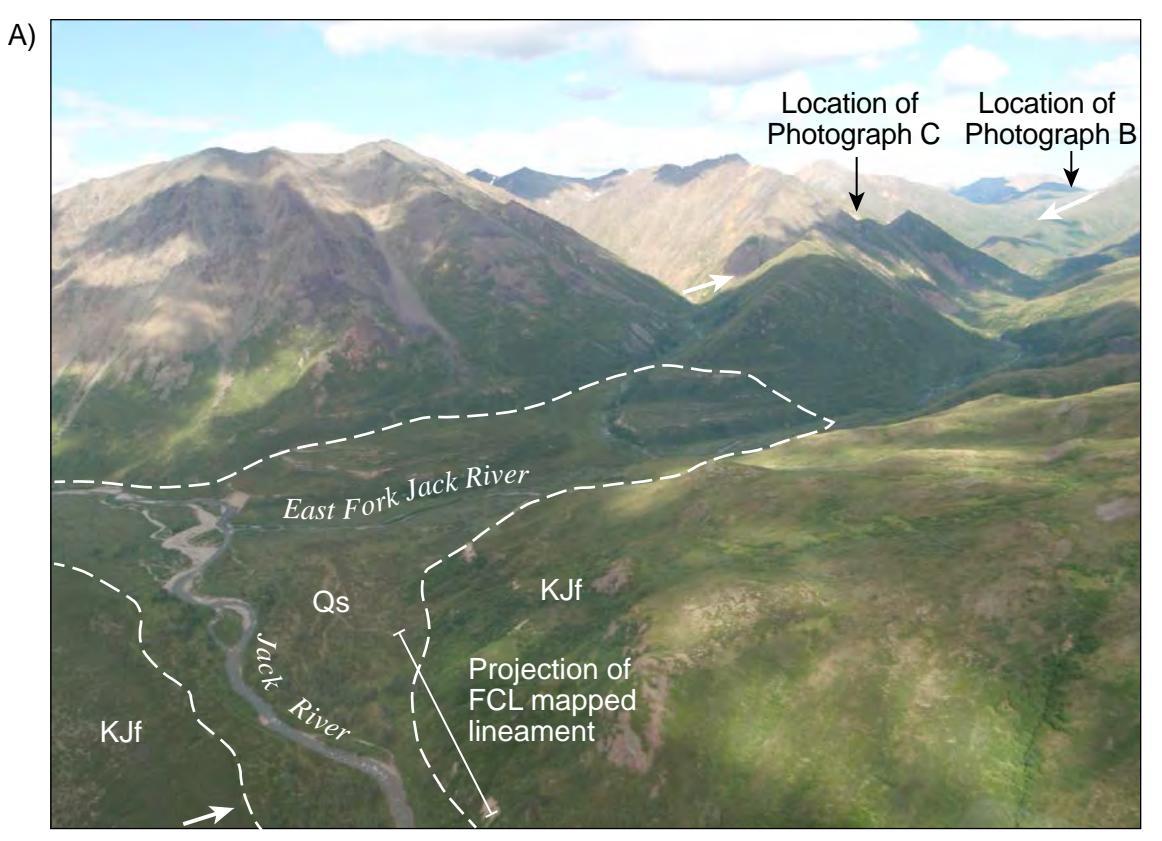
View looking northeast from location A towards the confluence of the Jack River and the East Fork Jack River. Arrows point along the alignment of mapped lineaments. Note absence of linear expression in Quaternary deposits.

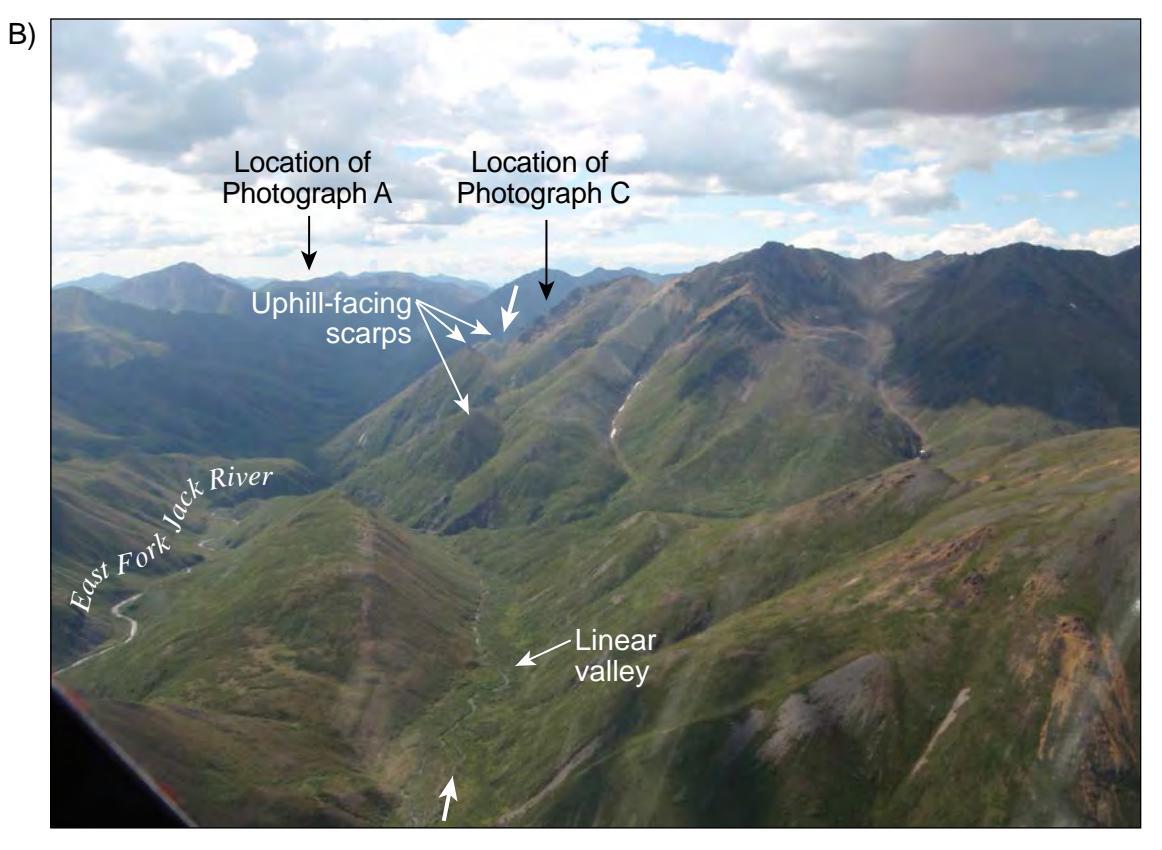
View looking southwest from location B along alignment of linear features. Arrows indicate the alignment of the mapped lineaments.

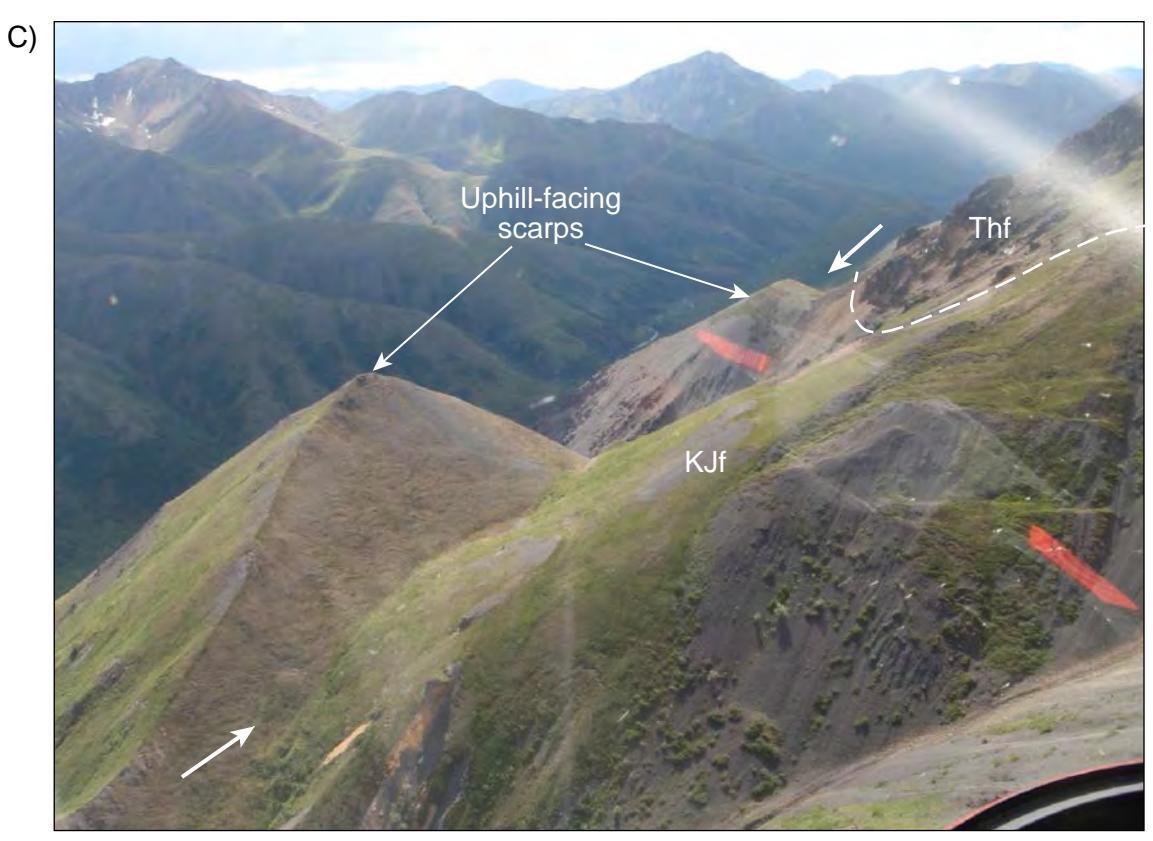
View looking southwest from location C at a detailed view of aligned uphill-facing scarps. Note Thf contact is up-slope from the scarp in the distance.

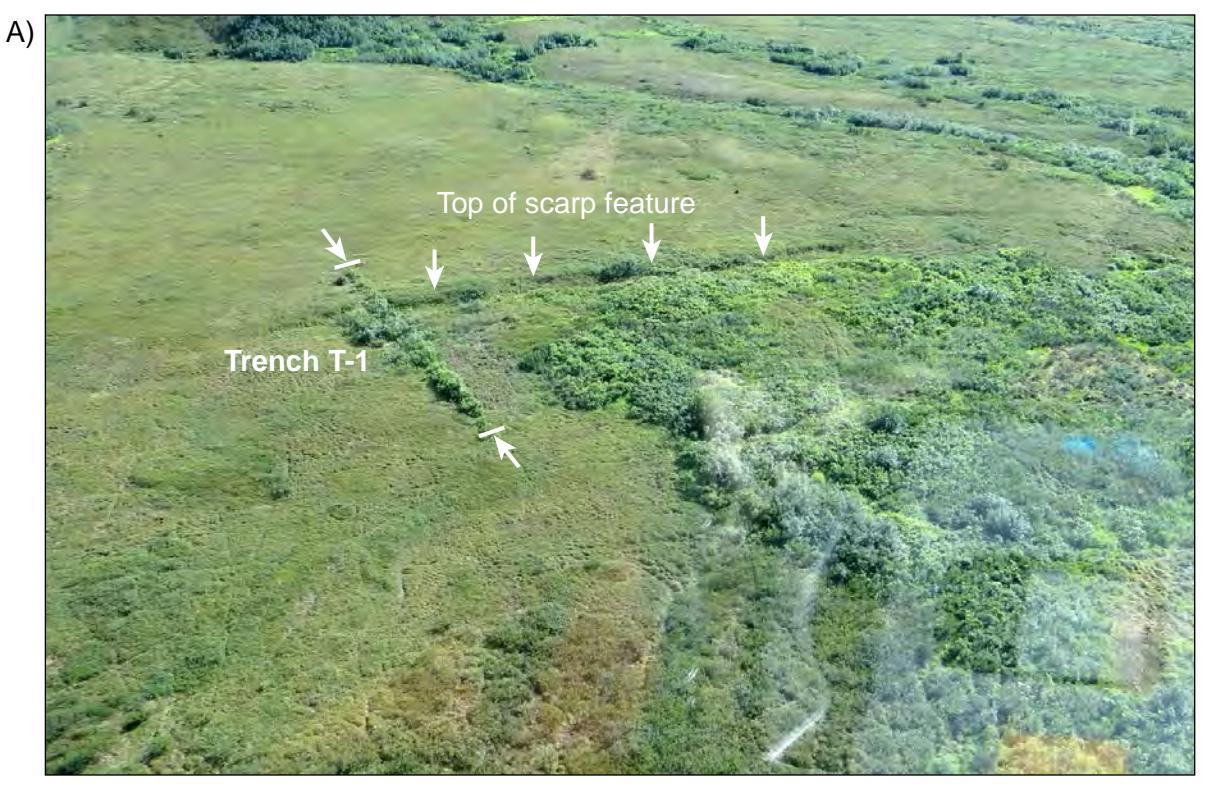
View of WCC T-1 location (marked by tree line), looking slightly east of south.

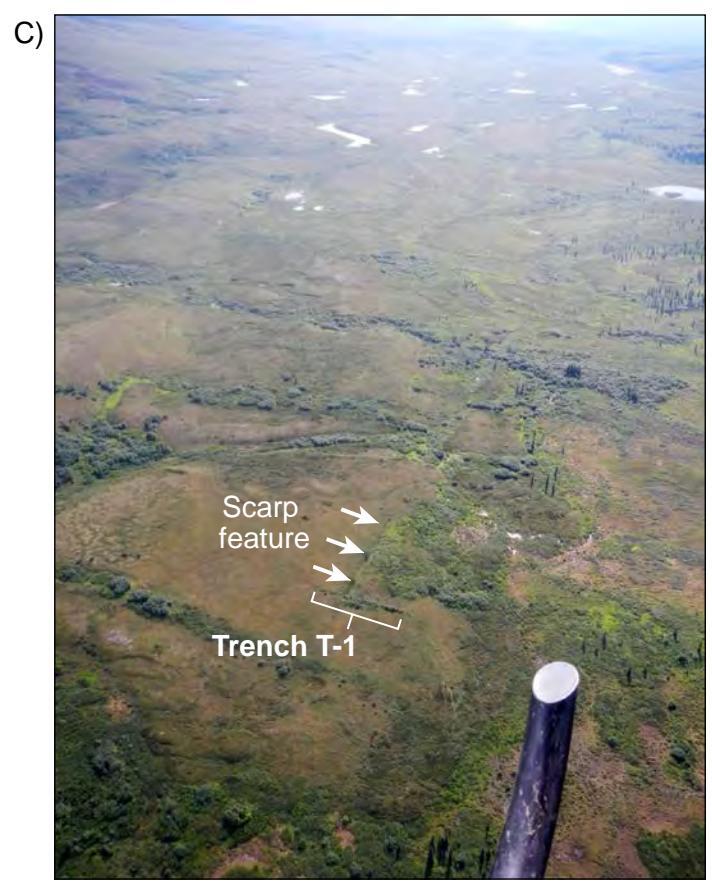
View of WCC T-1 looking southwest. Note how the expression of the scarp feature dies out along the projected trend of the feature.

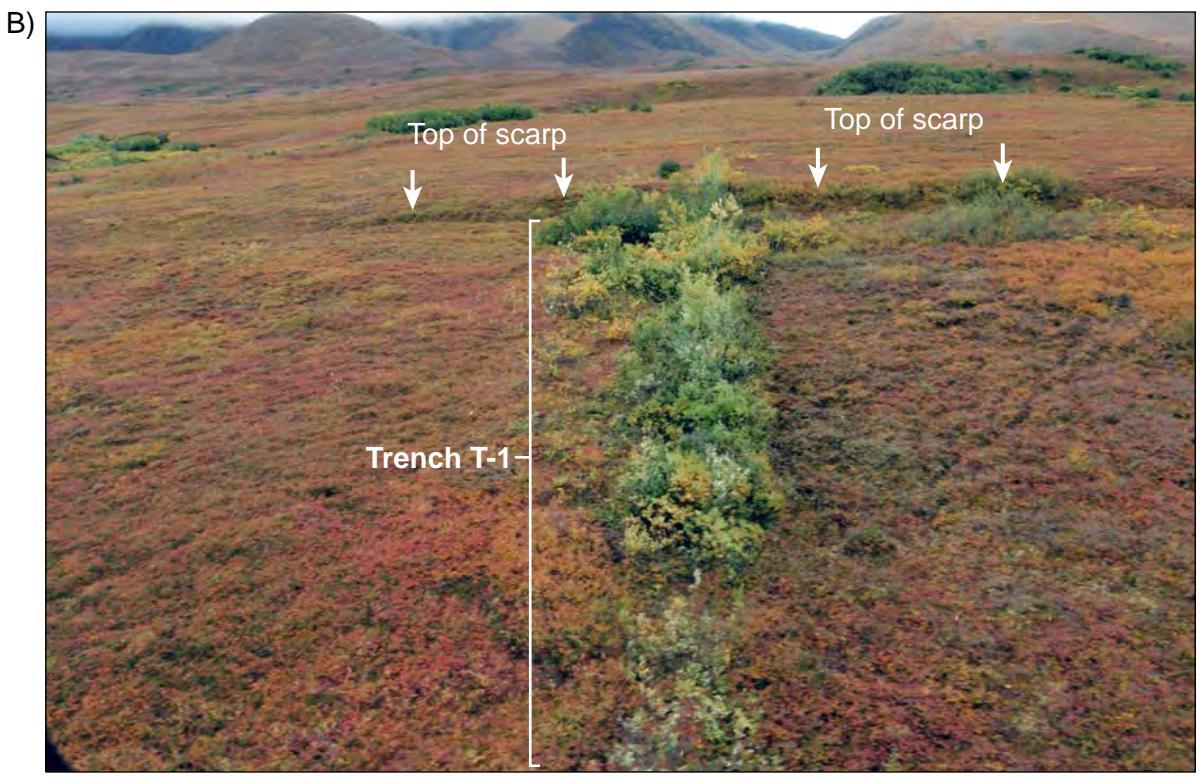
Very low altitude view of tree line that corresponds to backfilled Trench T-1, with scarp-like feature in mid-background.

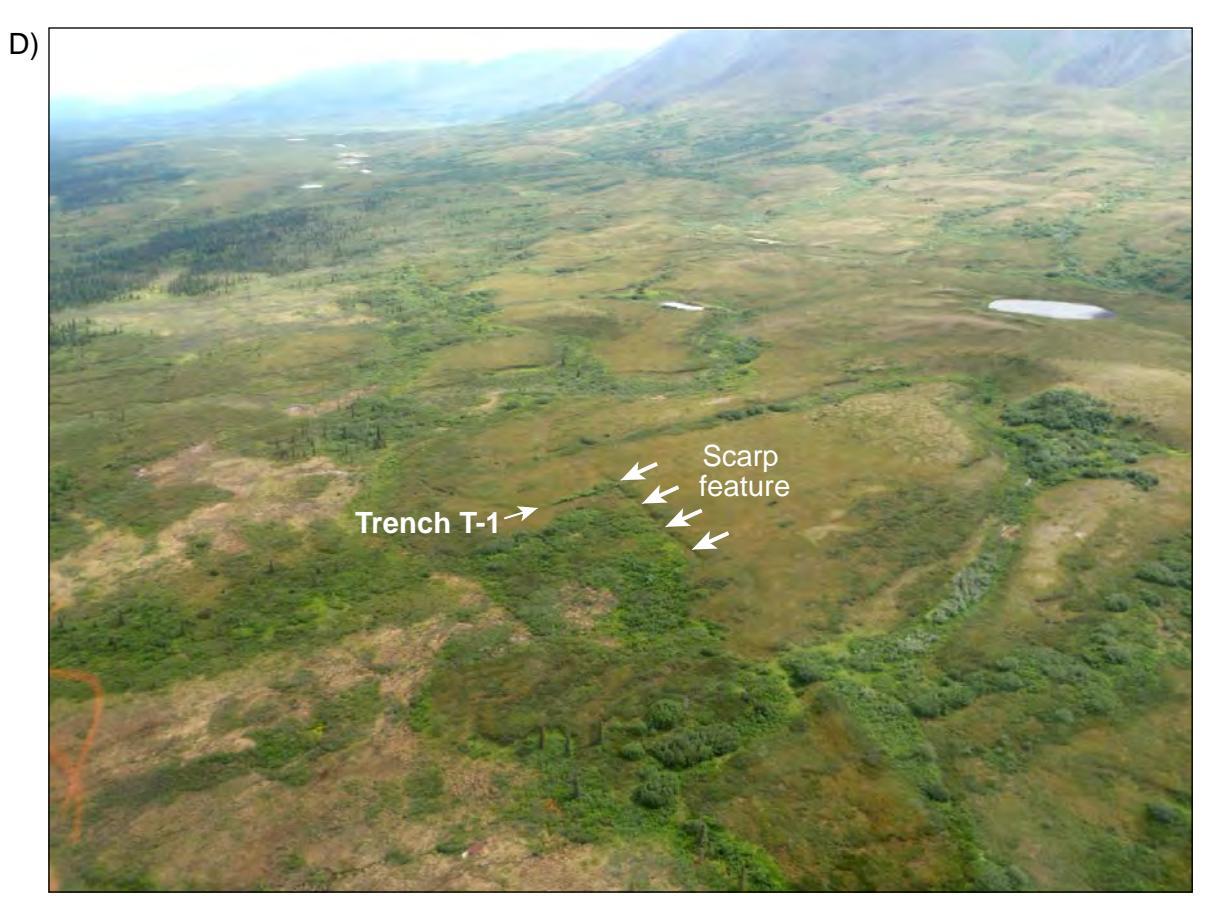
View of WCC T-1 looking northeast.

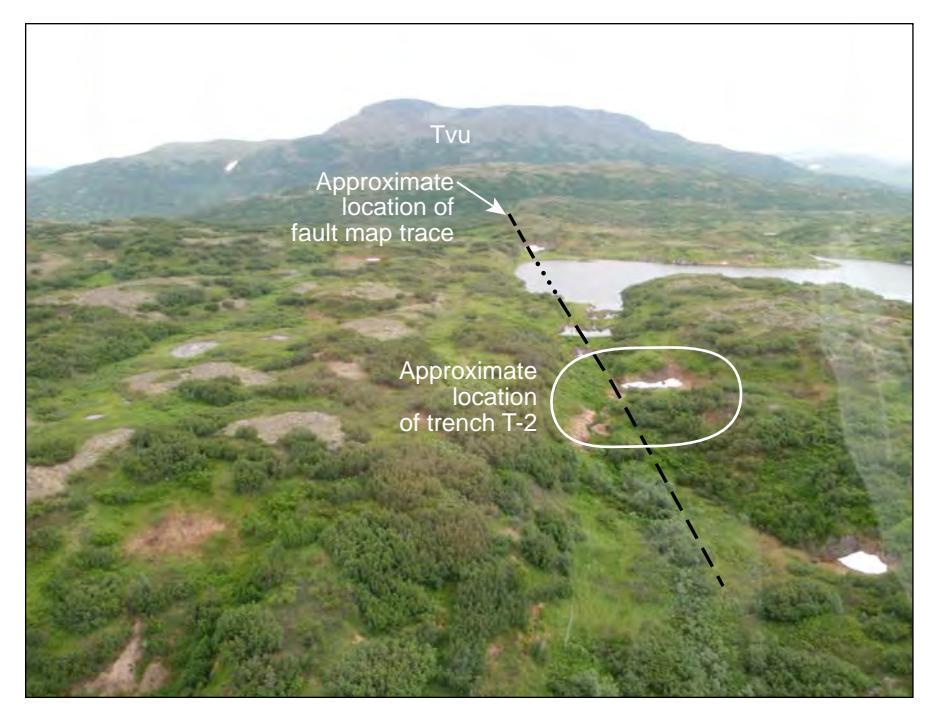
View looking north-northeast along trend of mapped Talkeetna fault trace with unfaulted volcanic intrusives (Tvu) in the background.

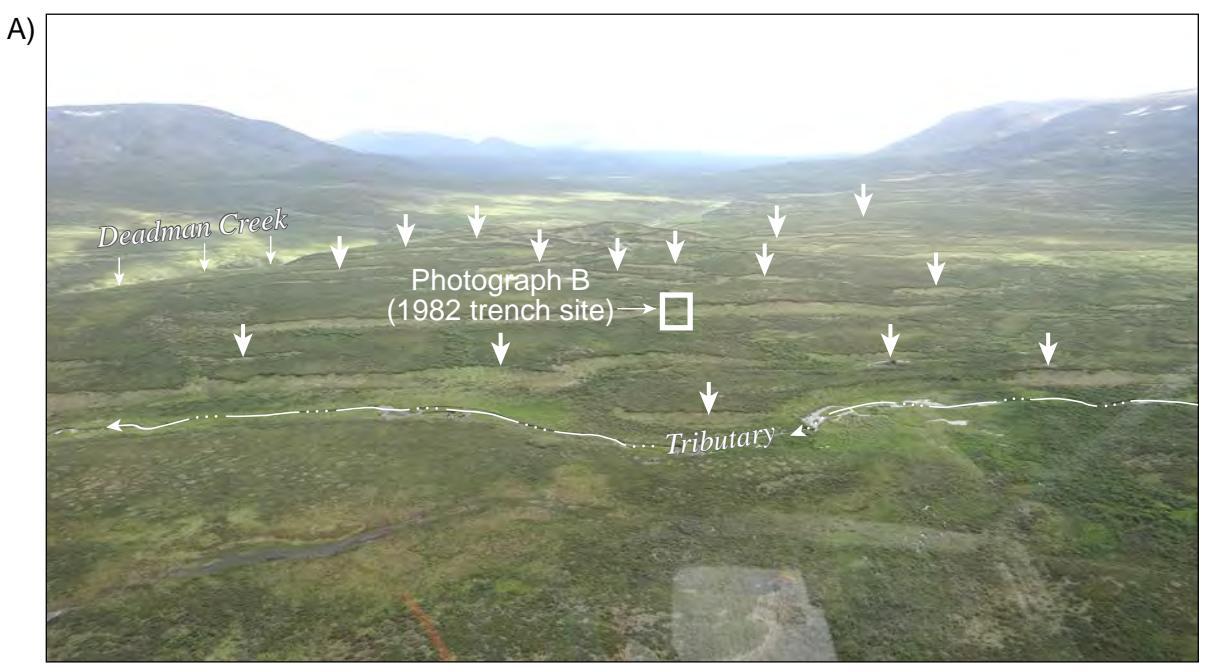
View looking northwest at slope breaks along postulated Susitna feature. 1982 trench site is also shown on Figure 4-5. Numerous slope breaks of similar size are present along Deadman Creek and in background.

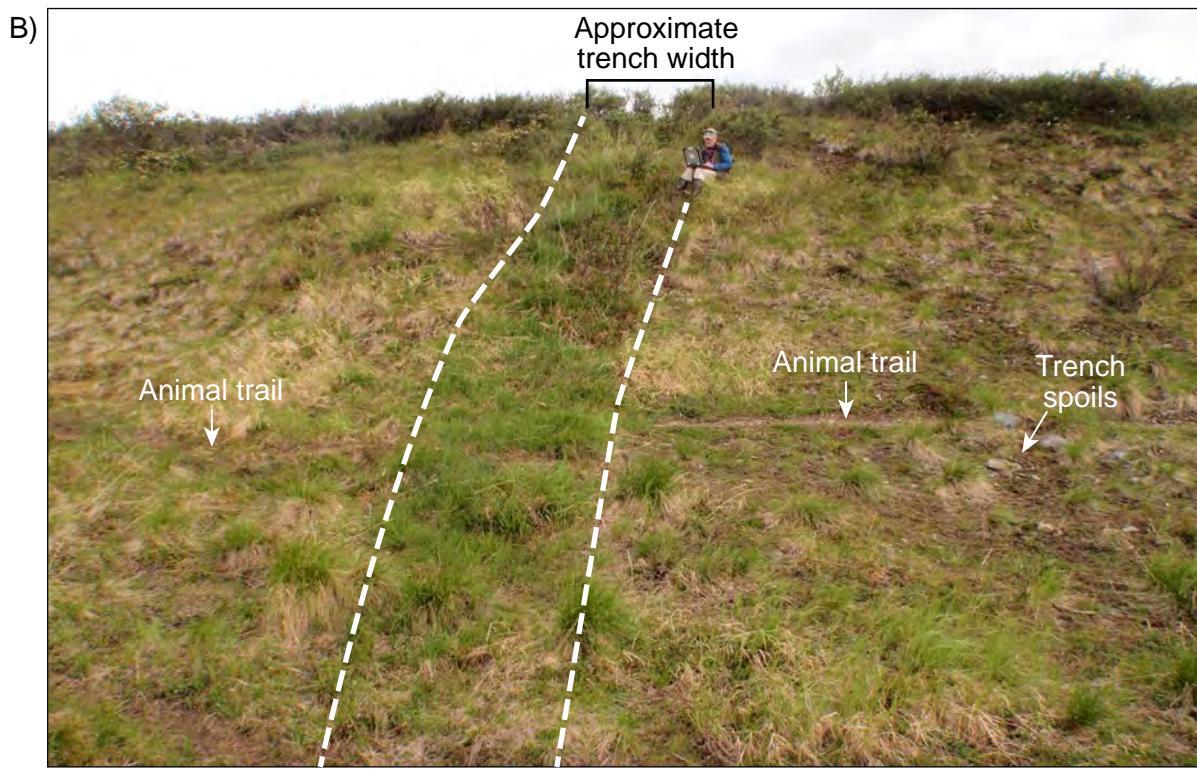
Ground-level view of 1982 trench site.

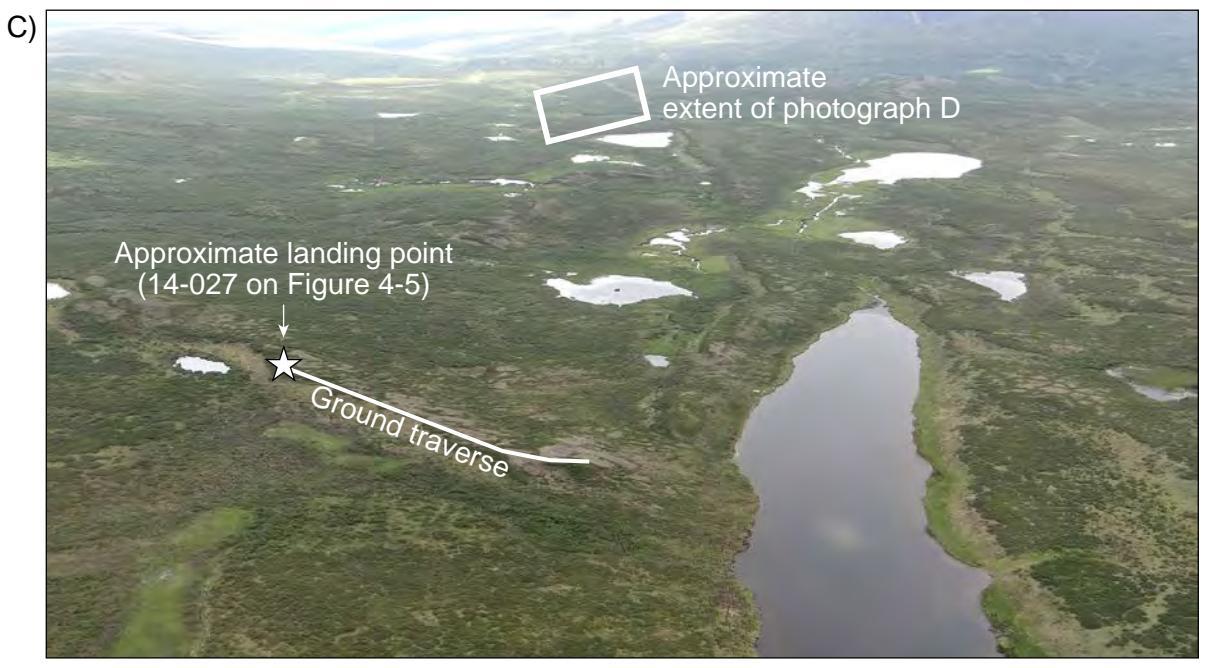
View looking south at moraines and location of moraine crest ground traverse.

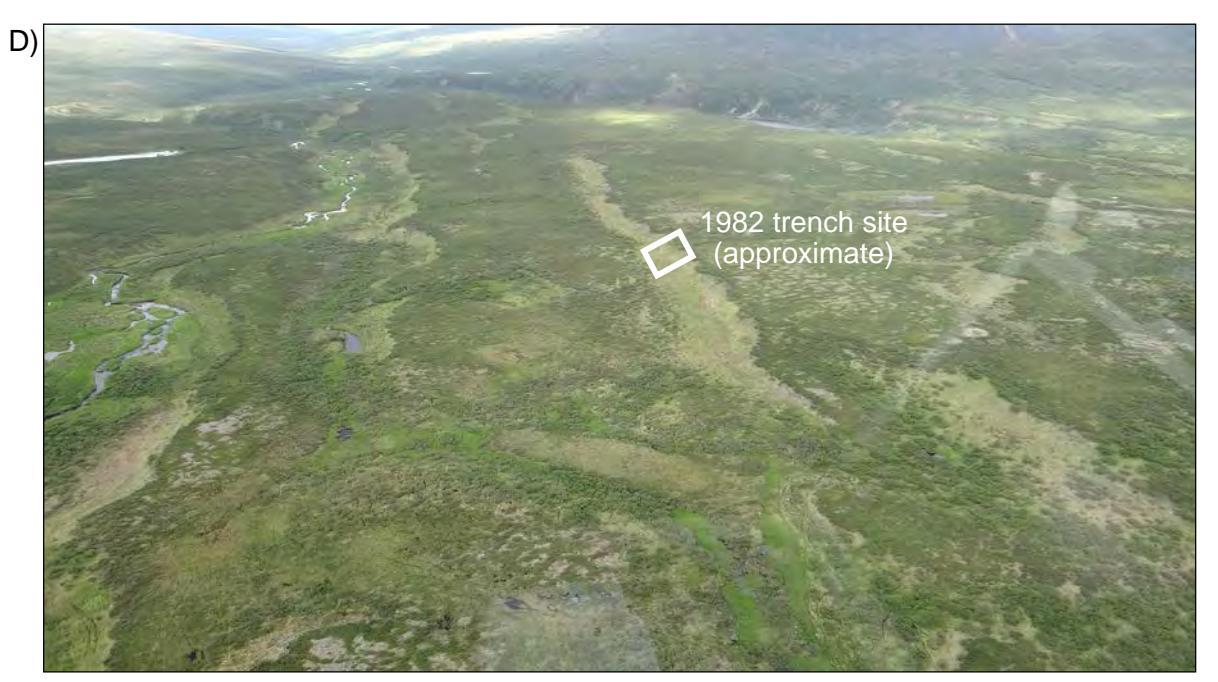
View looking south along Susitna feature.

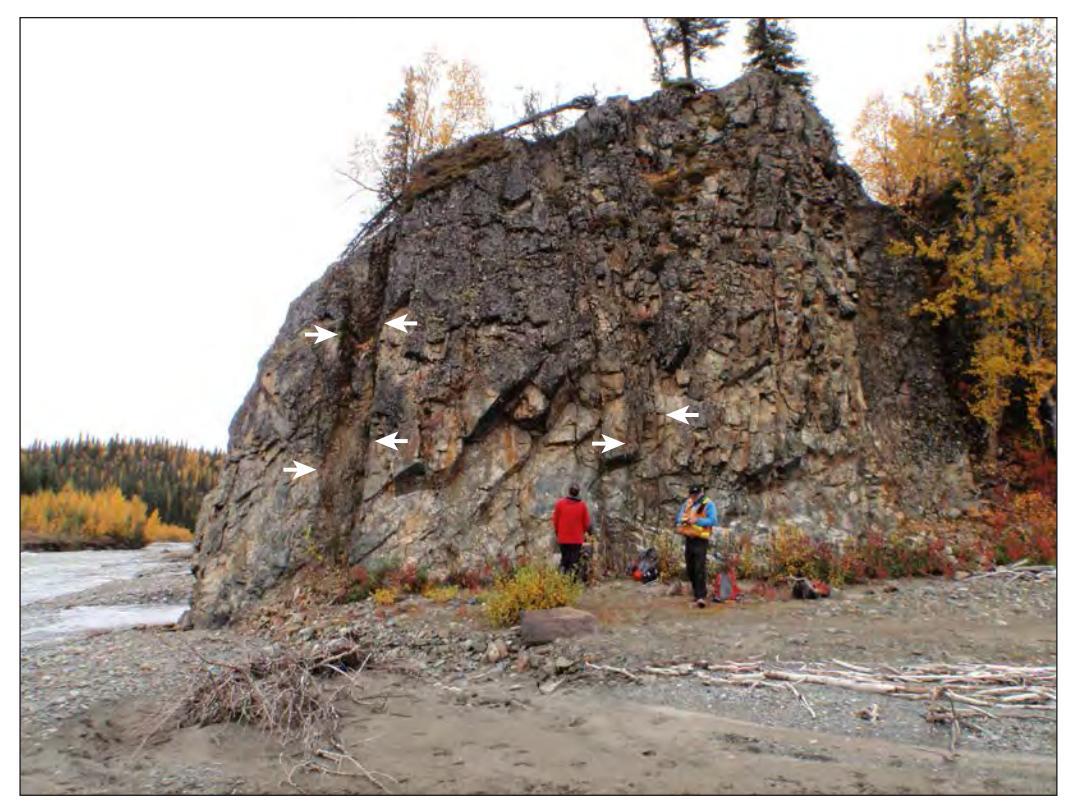
Vertical faults exposed in Triassic rocks, at the mouth of Watana Creek.

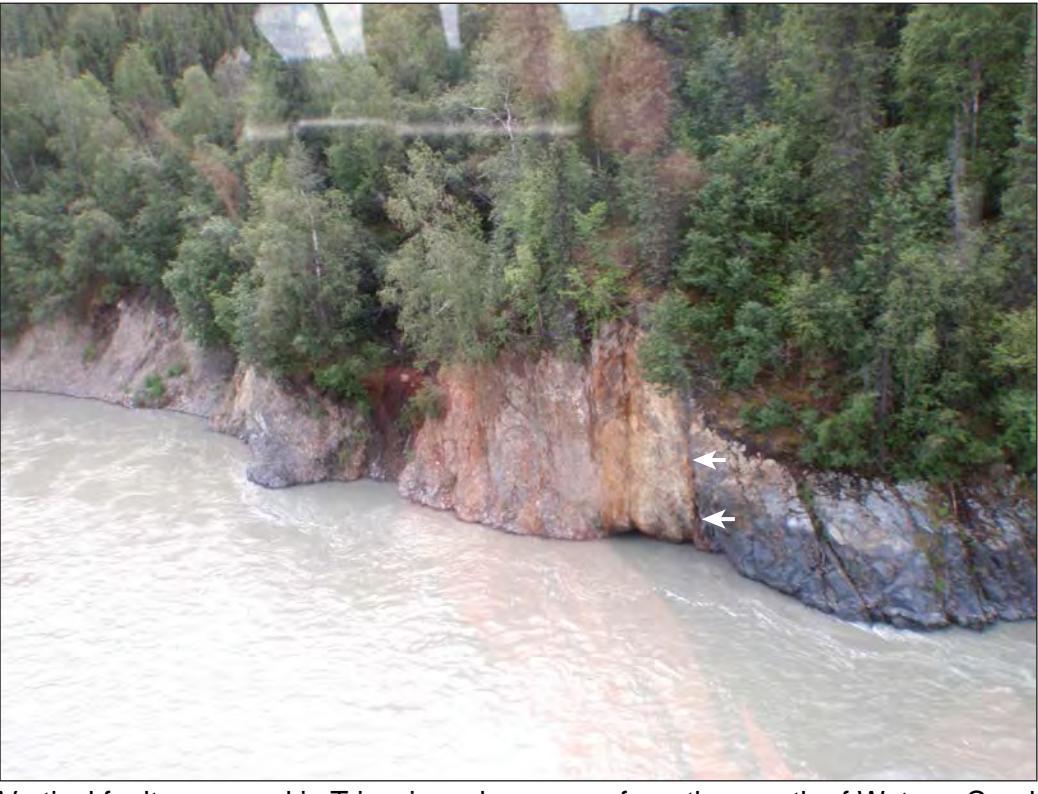
Vertical faults exposed in Triassic rocks, across from the mouth of Watana Creek.

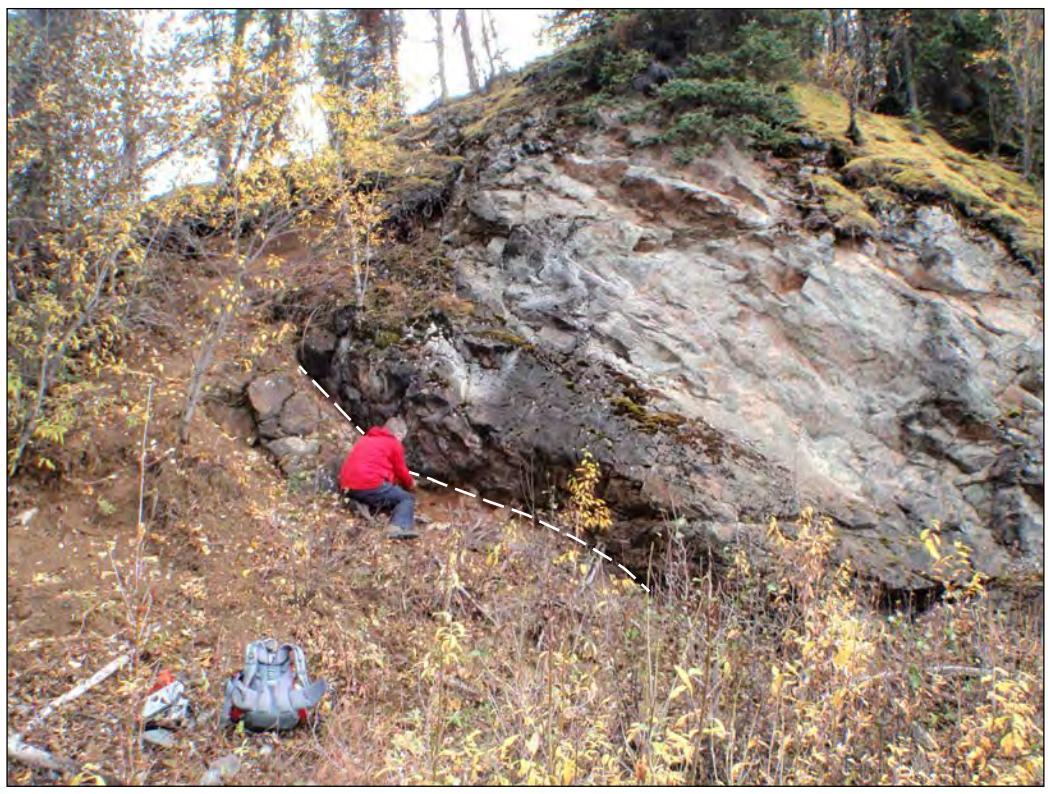
Triassic shear (140, 45 SW) outcrop.

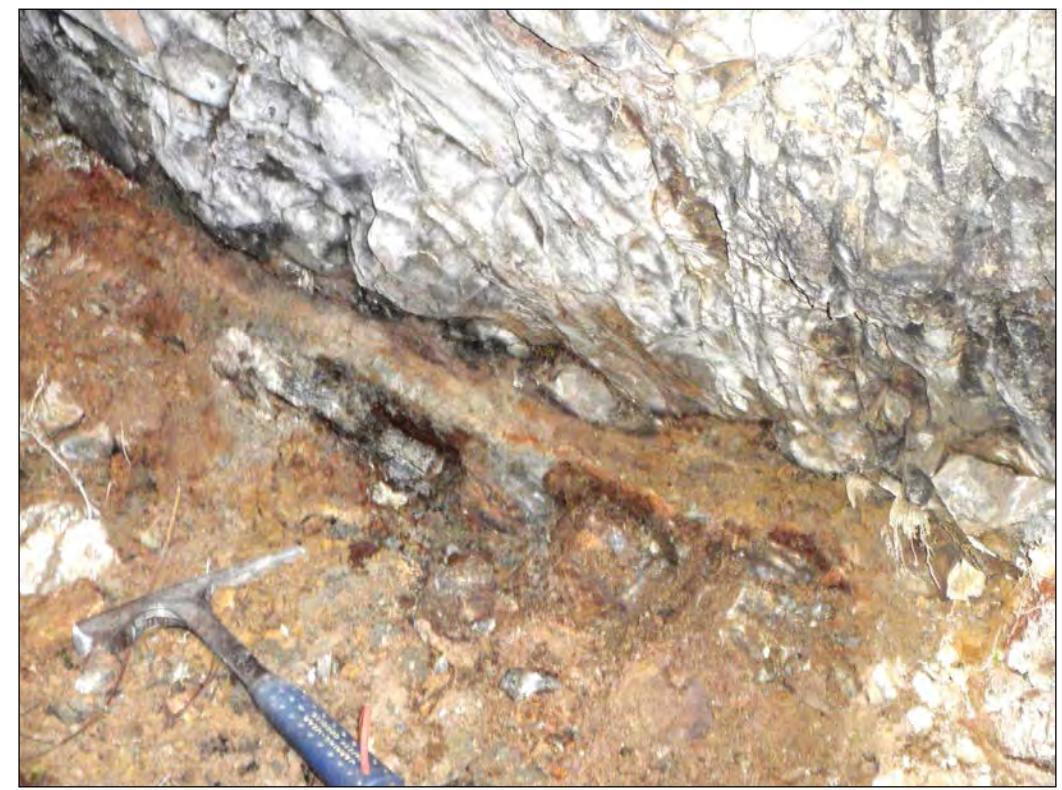
Close up of a shear feature.

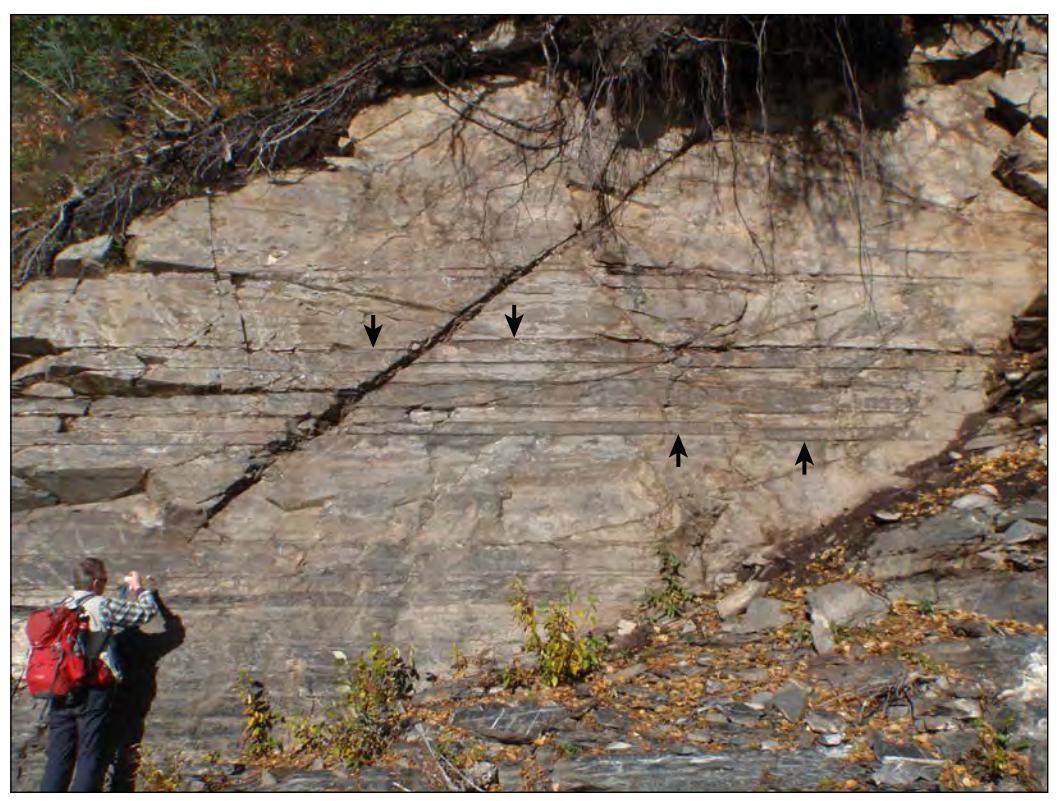
Fault S1 outcrop.

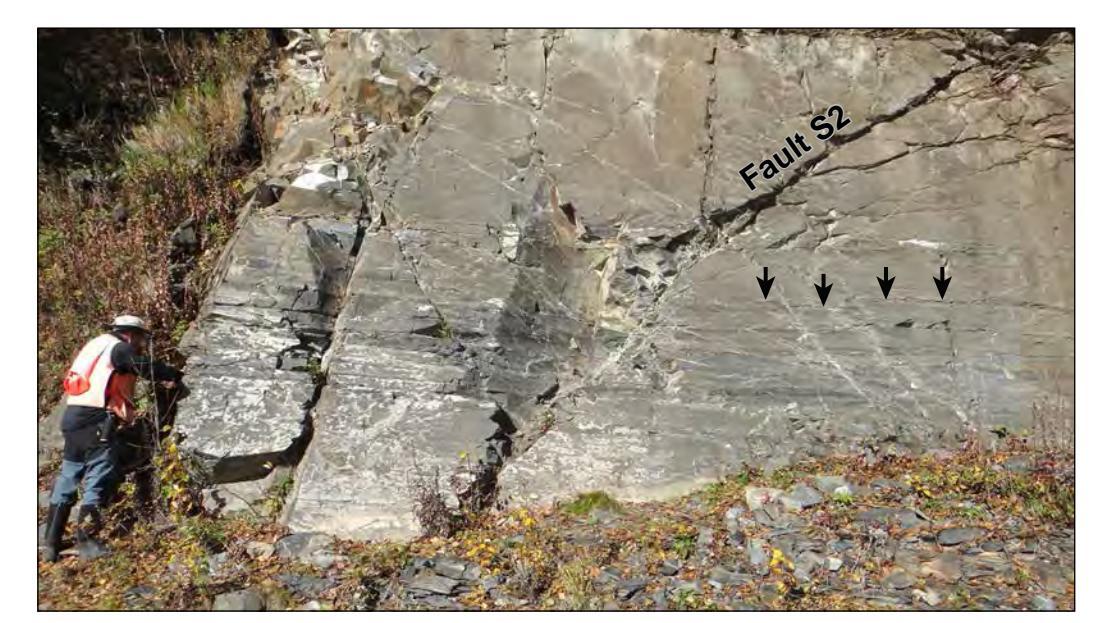
Fault S2 outcrop.

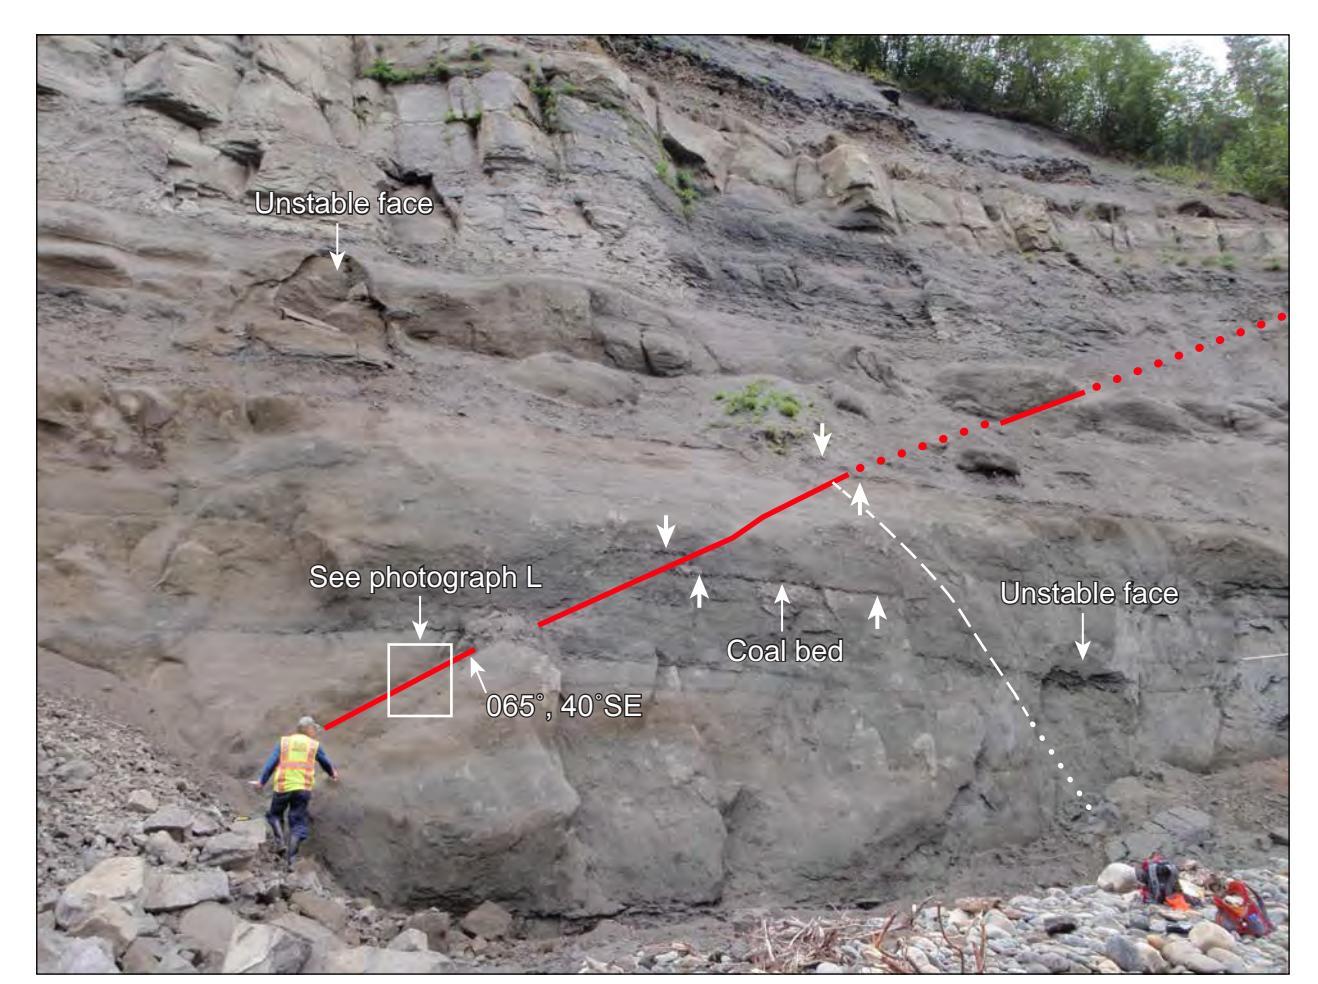
Photograph of faulted outcrop with coal bed. Visually estimated 60-80 cm of separation along the fault plane. Second fault (221, 27° NW)appears to terminate against primary fault (065, 40°SE) extends across the outcrop.

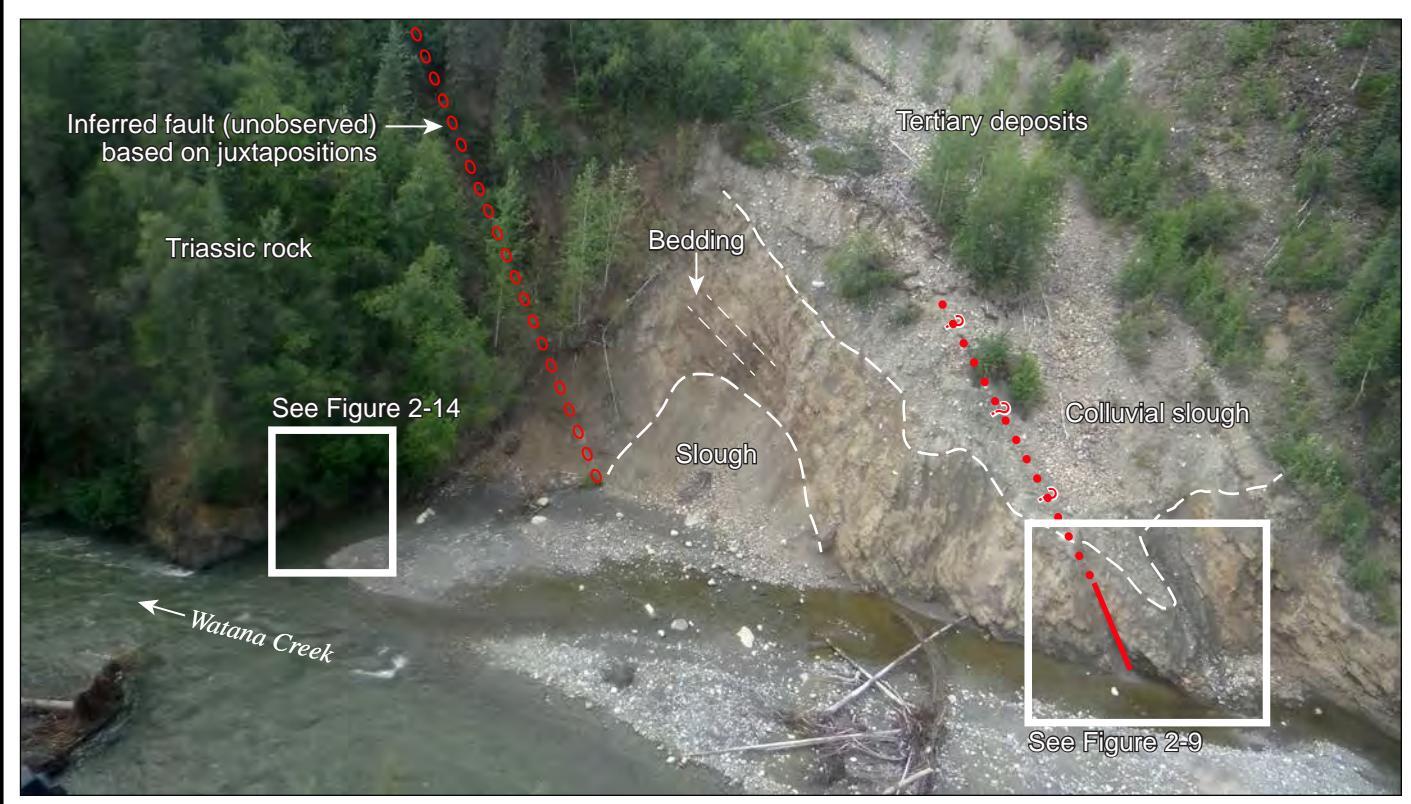
Aerial view looking approximately south-southwest. Triassic rocks are densely vegetated.

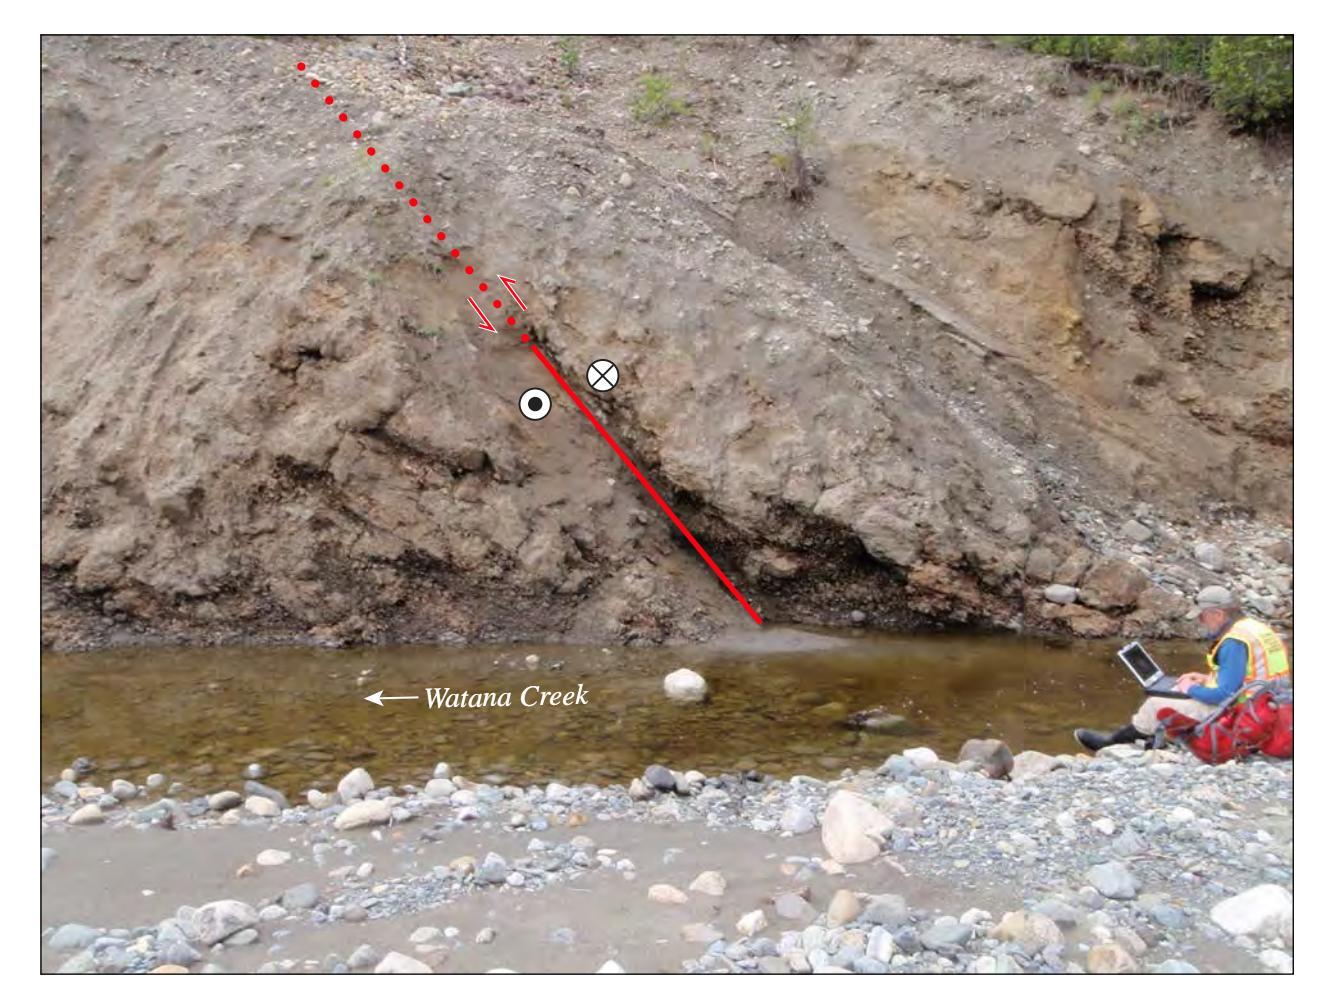
View looking west at lower part of Tertiary deposit toward uncleaned exposure of fault (065-080° strike; 65°N dip). Left-lateral oblique relative movement.

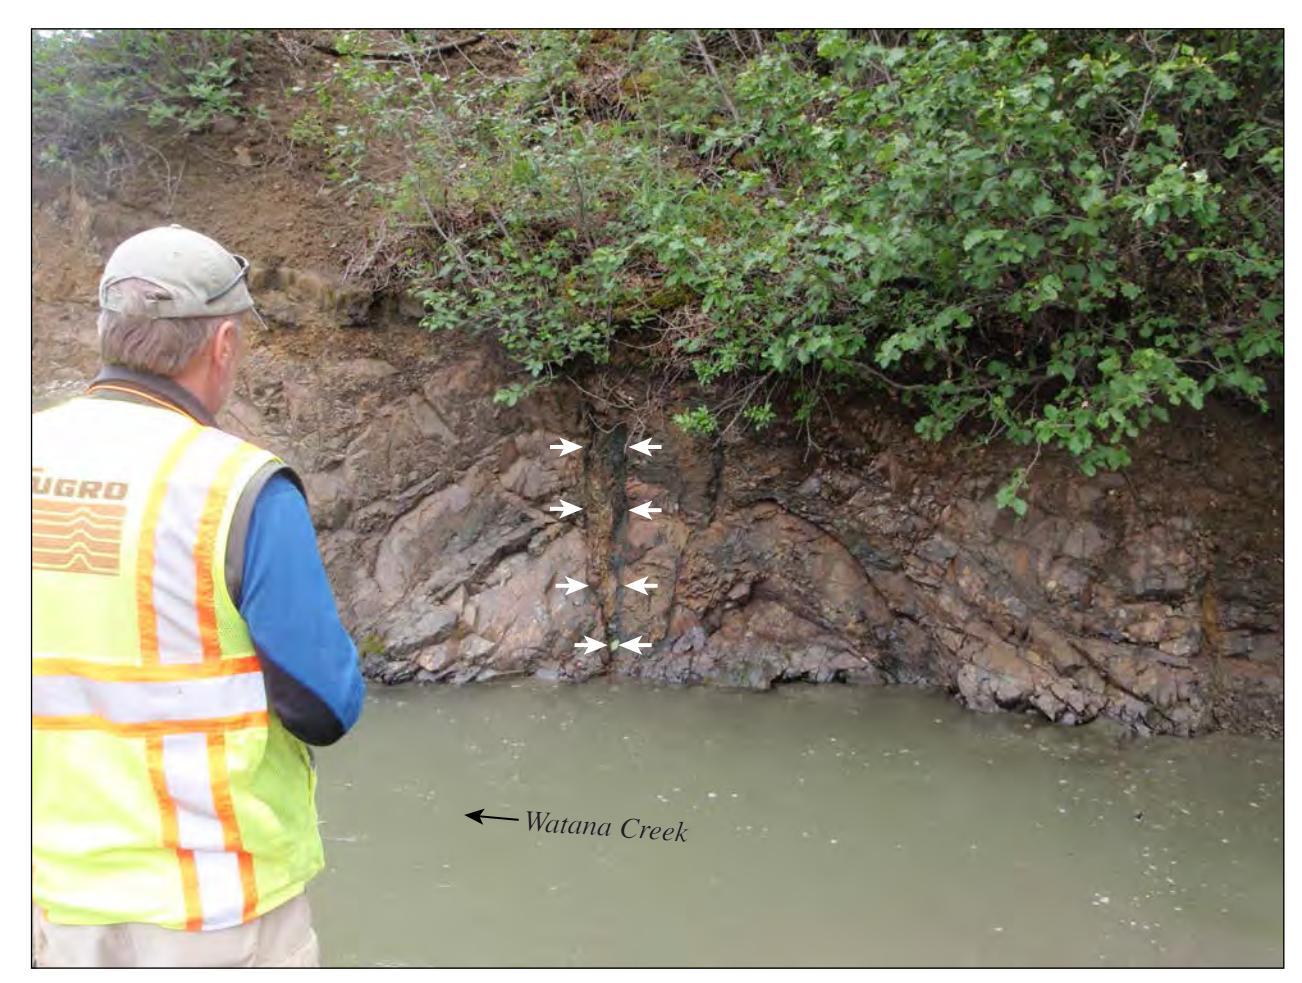
View looking south at vertical fault in Triassic rocks; visually estimated apparent strike is northeast.
