SUSITNA-WATANA HYDROELECTRIC PROJECT
 LINEAMENT GROUP 12b
 MAP DATA

FIGURE
 A12b.1

79_218900_Alaska_Railbelt/2189_Lineament Report October 2013, modified 10.18.13

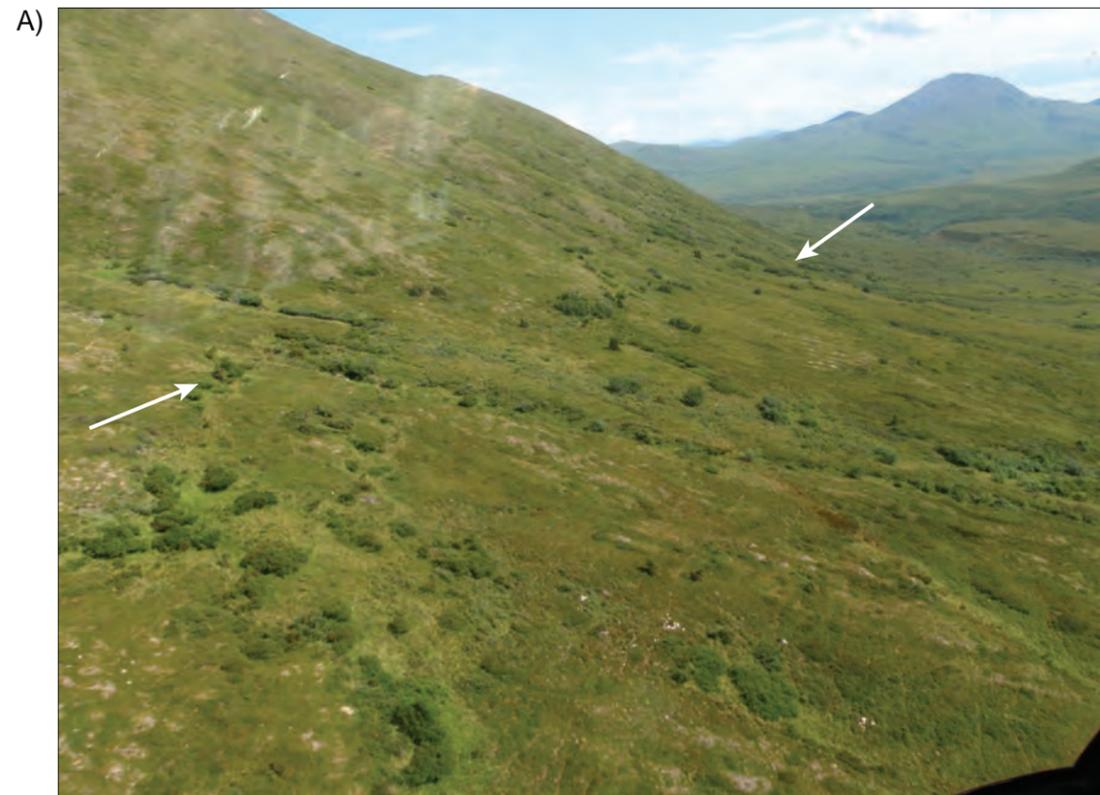
View looking northeasterly along lineaments. Arrows point along trend and position of lineaments.

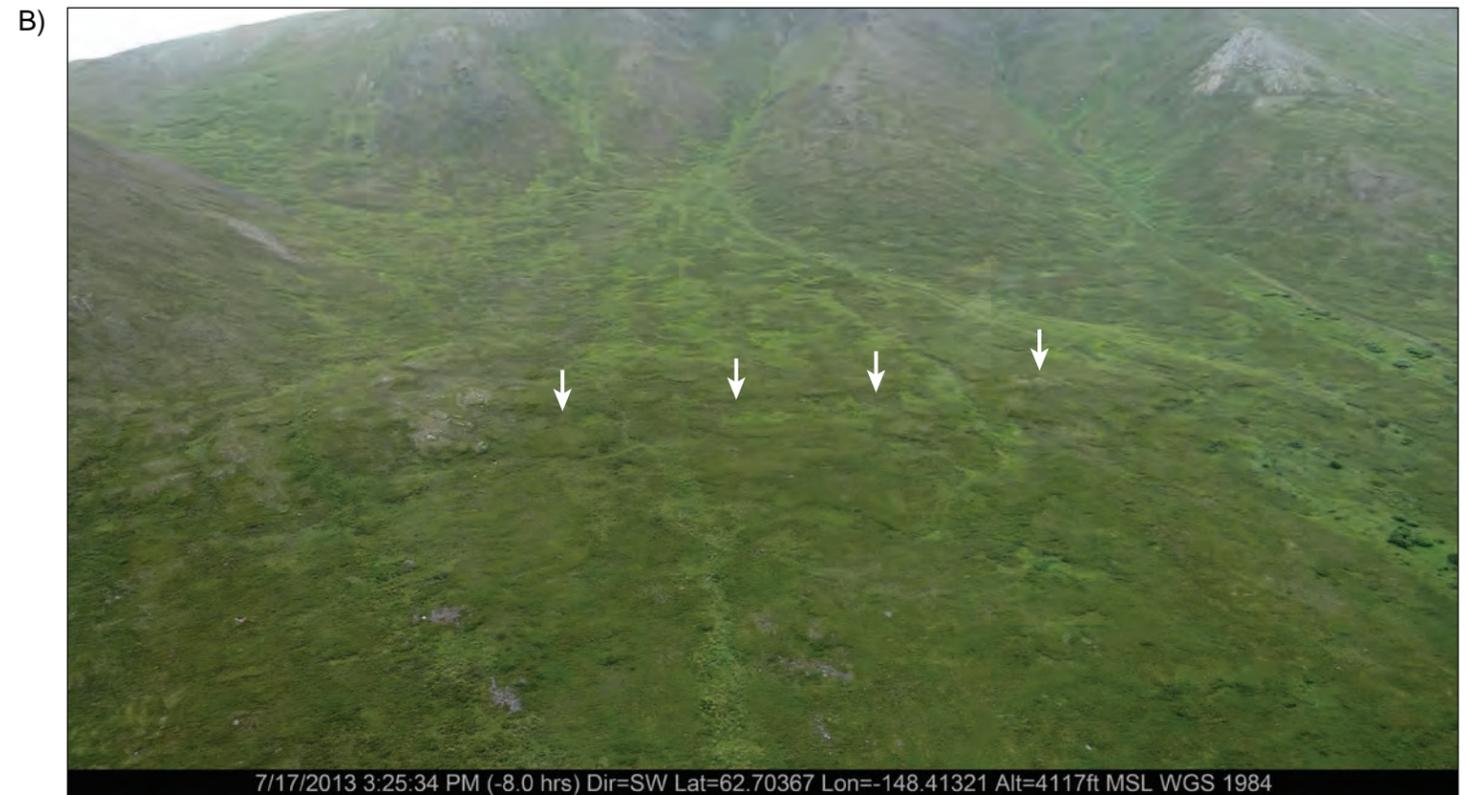
View of lineaments expressed in Quaternary sediment.

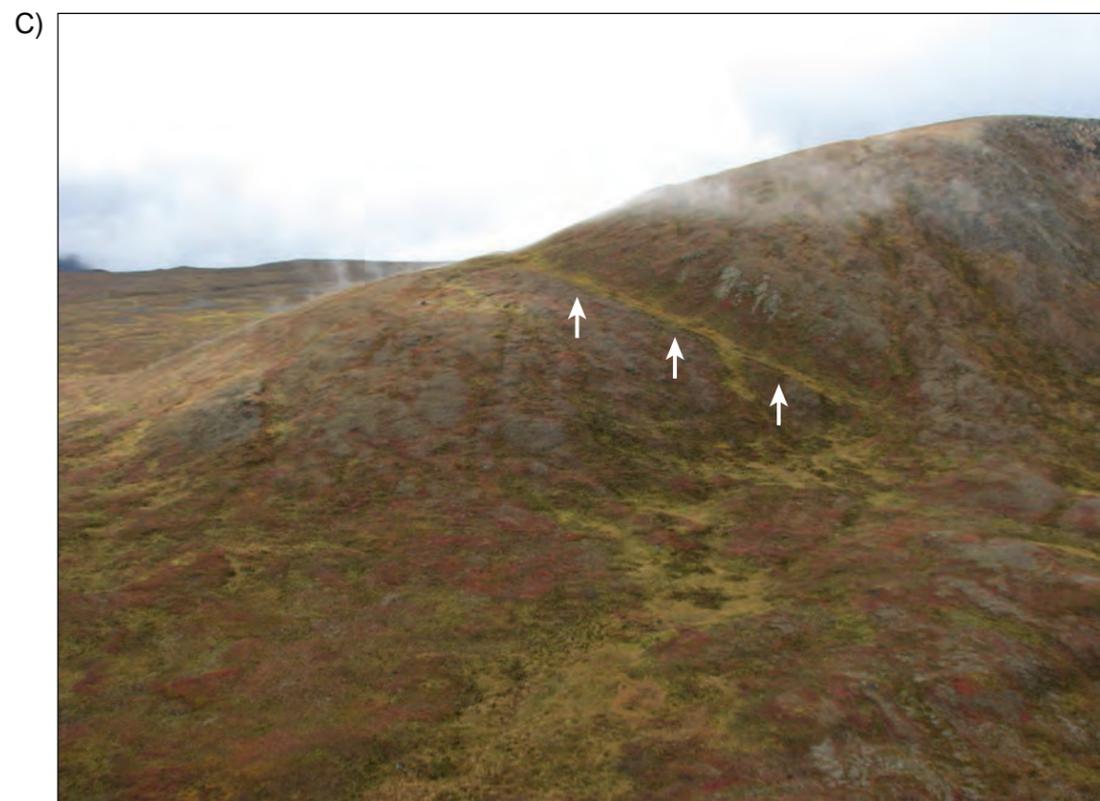
View looking at notch in bedrock with expression of apparent northwesterly dip.

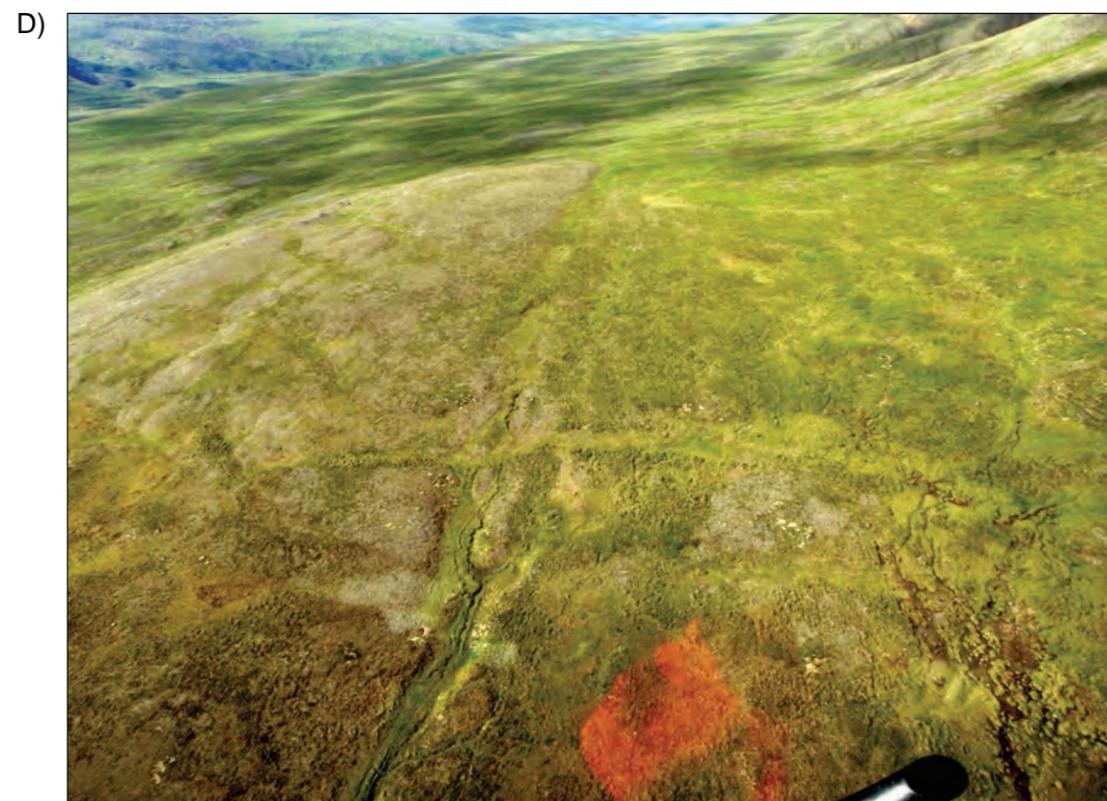
View looking southwesterly along glacially scoured surface.

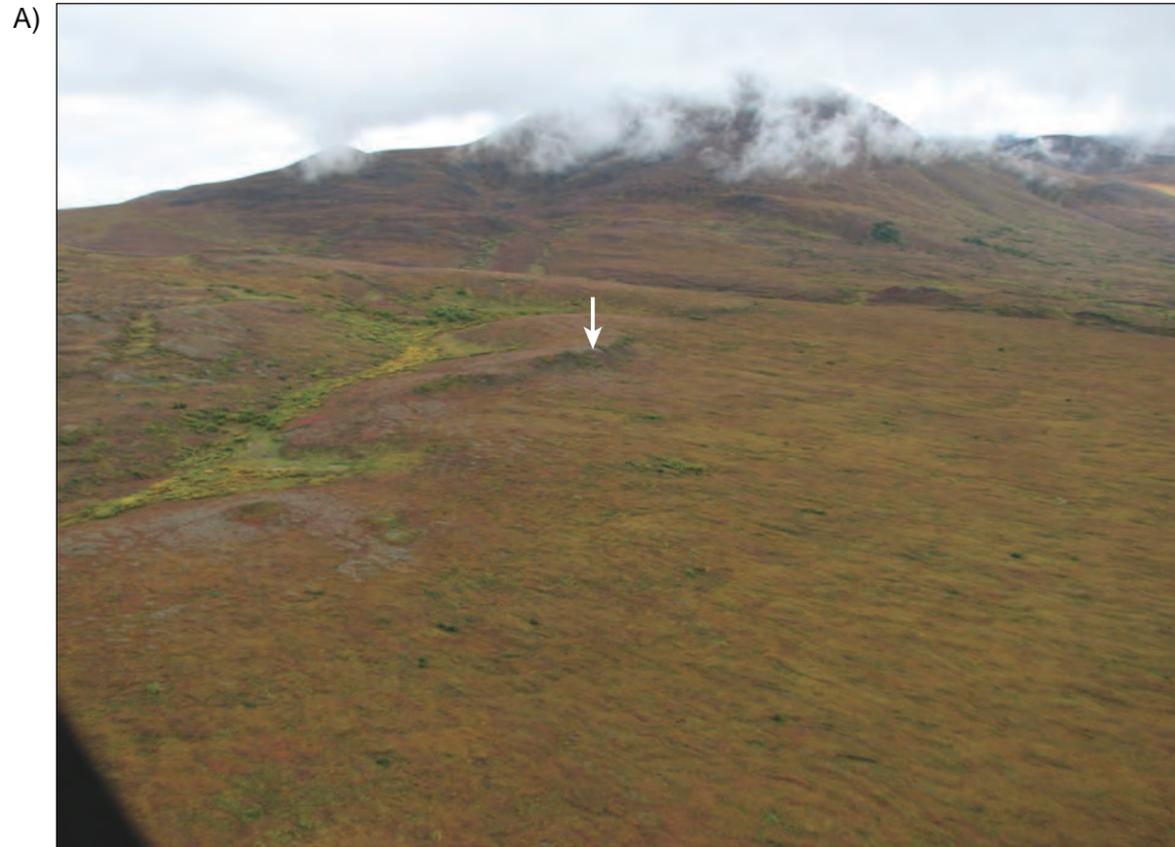
View looking northeast at erosional break-in-slope mapped as an individual lineament. Feature is absent in the background along projection of strike.

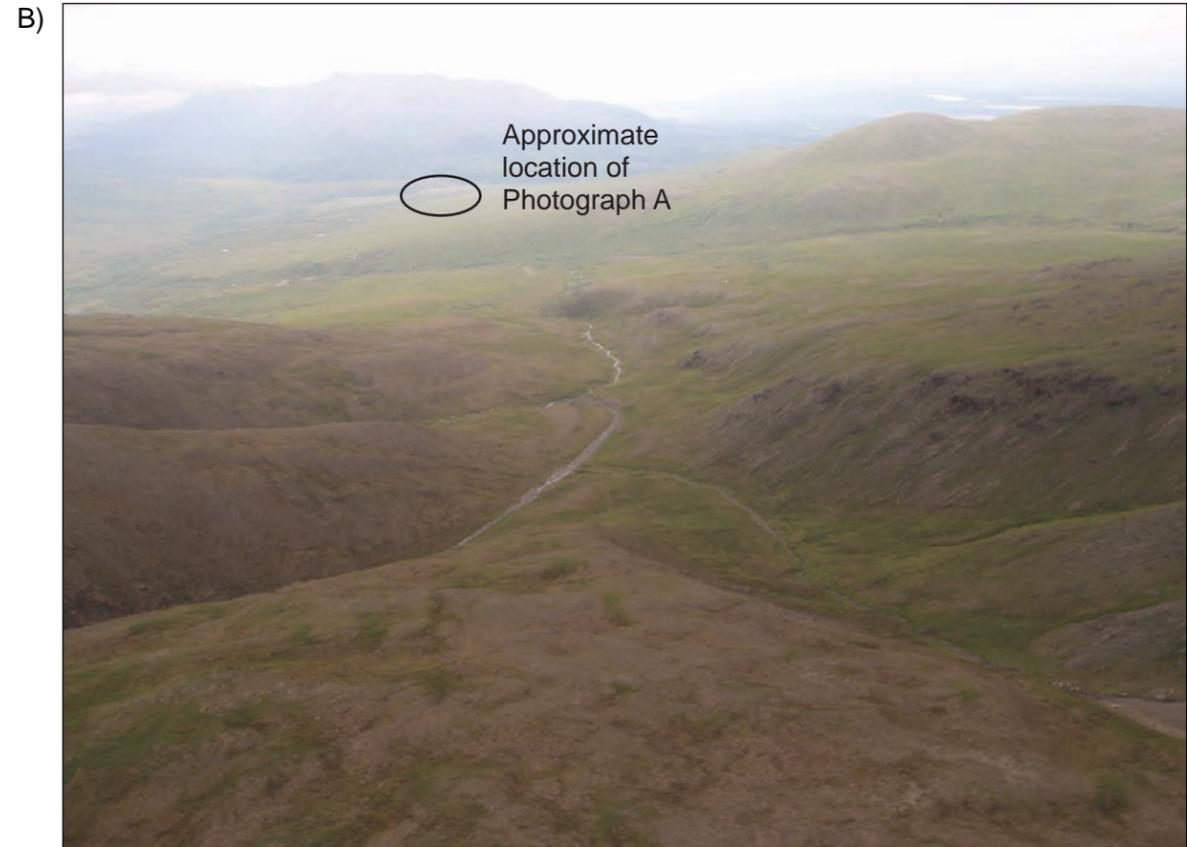
View looking southwest down-valley along lineament geomorphically expressed as linear valley. Very little alluvium has accumulated in the drainage, and glacially sculpted bedrock is shallow.

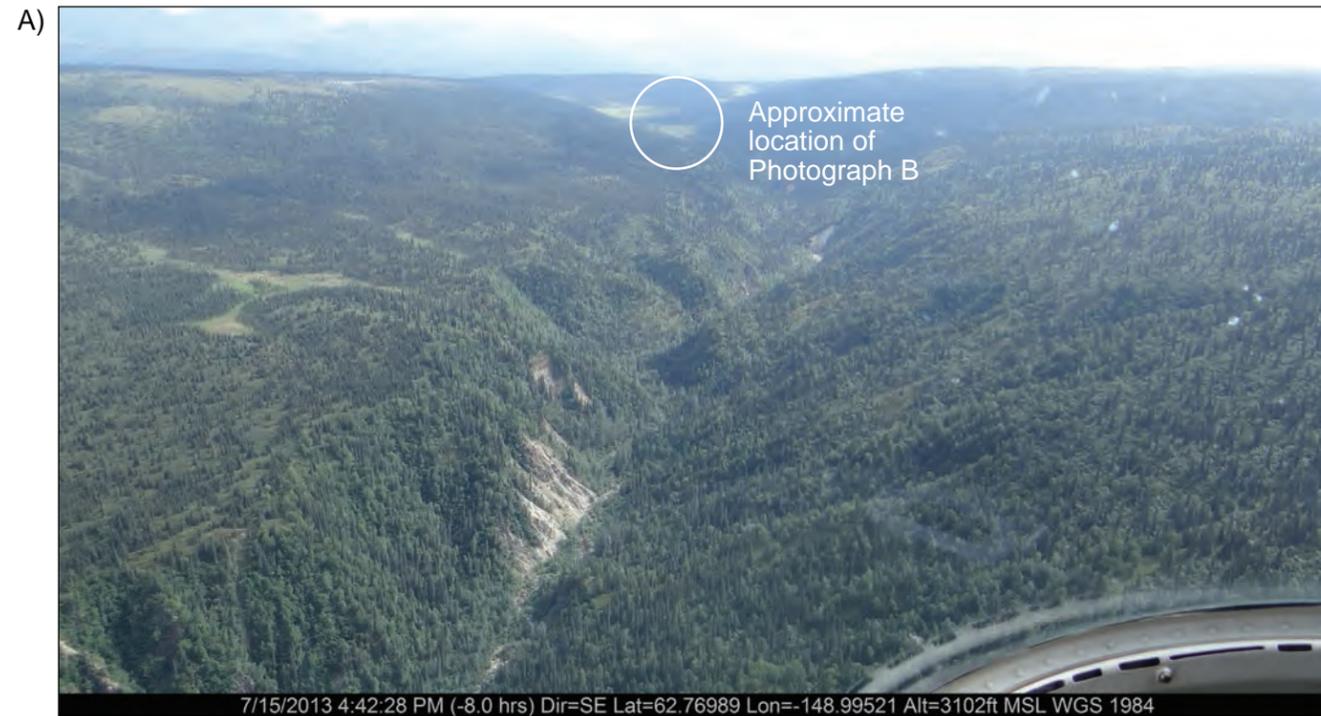
View looking south at linear canyon that is tributary to the Susitna River. Canyon bottom and creek drainage have sinuosity not apparent at smaller scales.

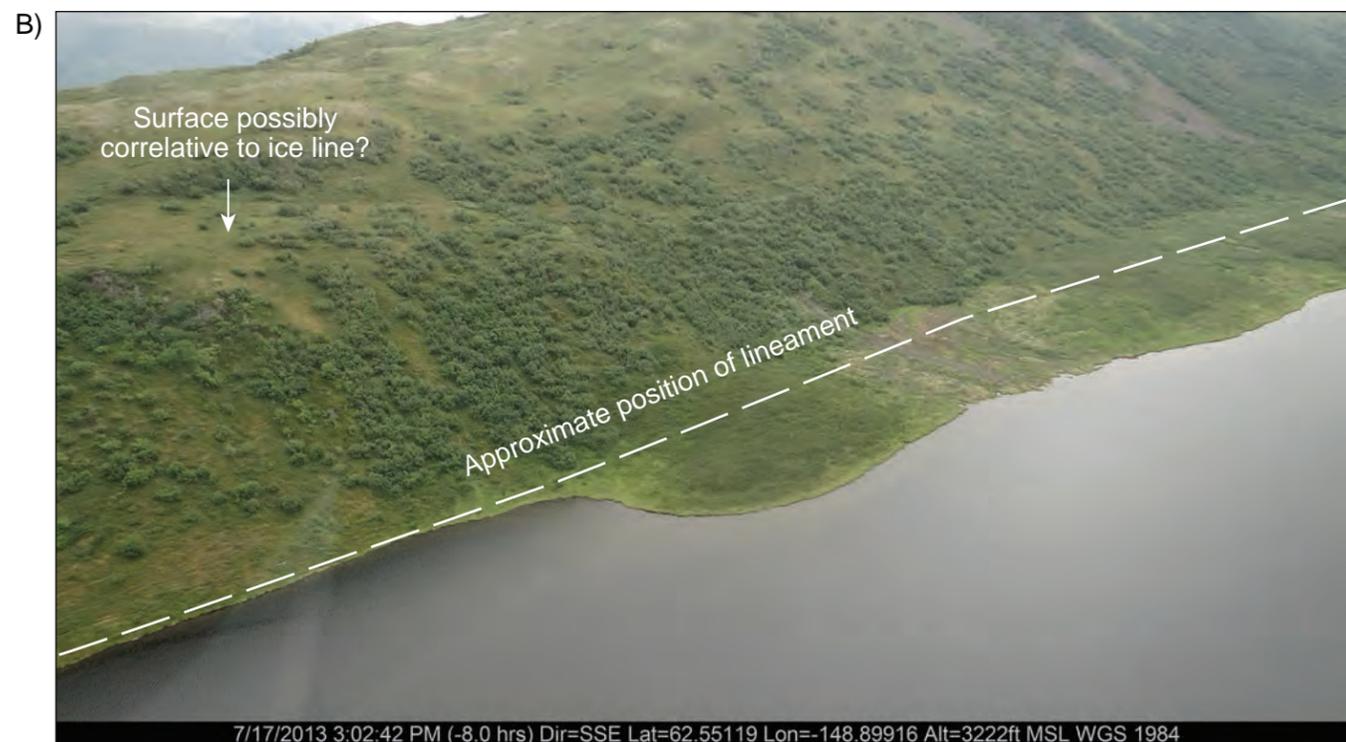
View looking south southwest at lake margin of glacial valley. Lineament was mapped at base of slope, and is not expressed as a scarp-type feature. Apparent colluvium along projection of lineament does not appear offset.

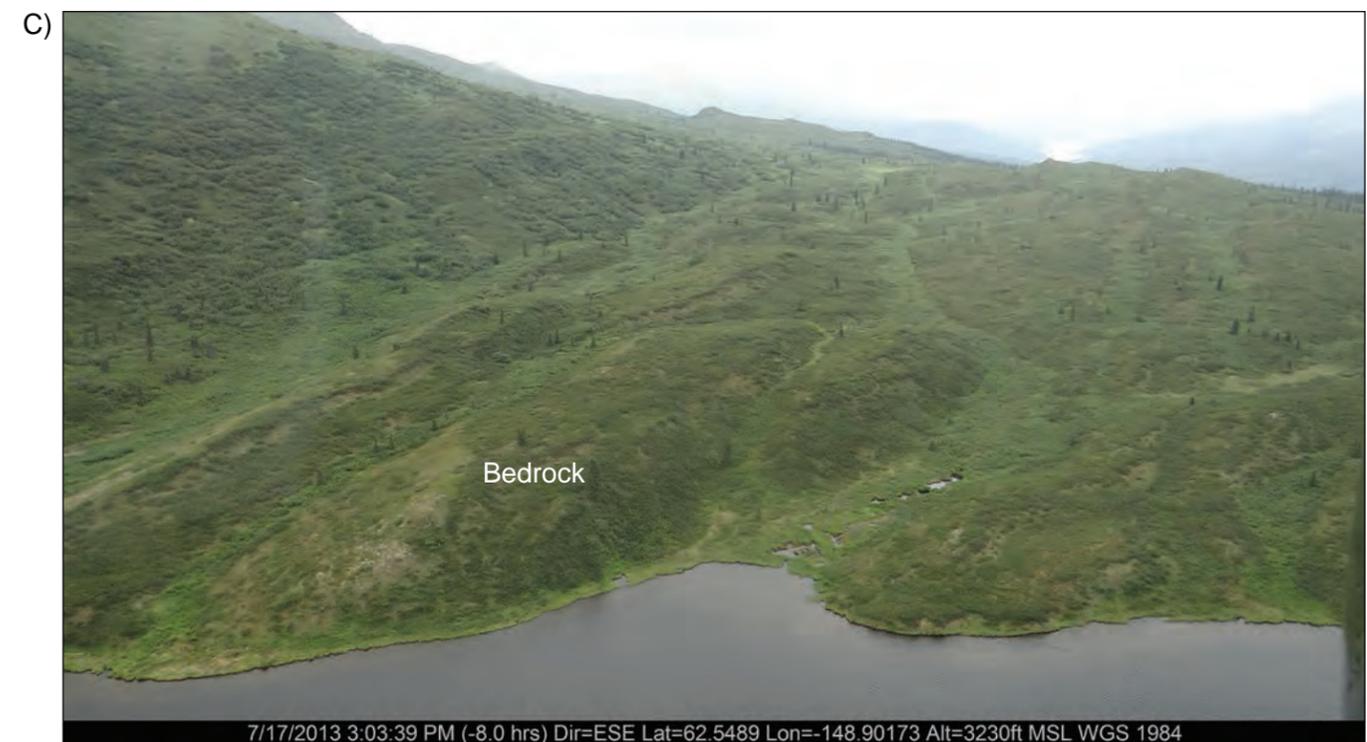
View looking south southeast along glacially-sculpted terrain along which Csejtey (1974) has inferred a fault within the glacial sediment that mantles the bedrock knolls (Figure A17b.1).

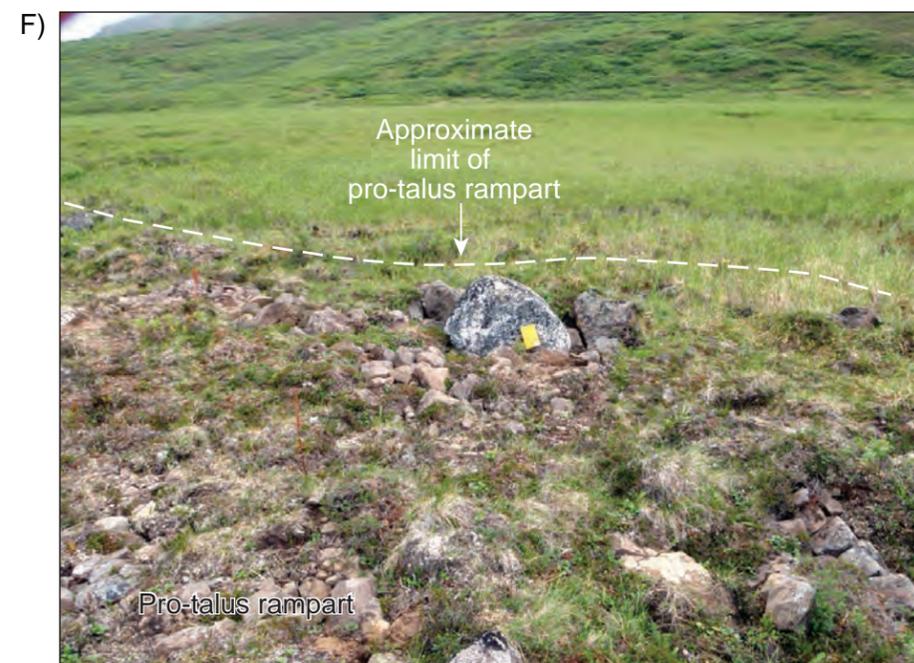
Pro-talus rampart constructed from blocky, frost-shattered volcanic rocks. Photograph is centered on more sub-rounded glacial erratic (granitic) that is not similar to any of the local hillside lithologies. Field notebook is 19 cm tall.

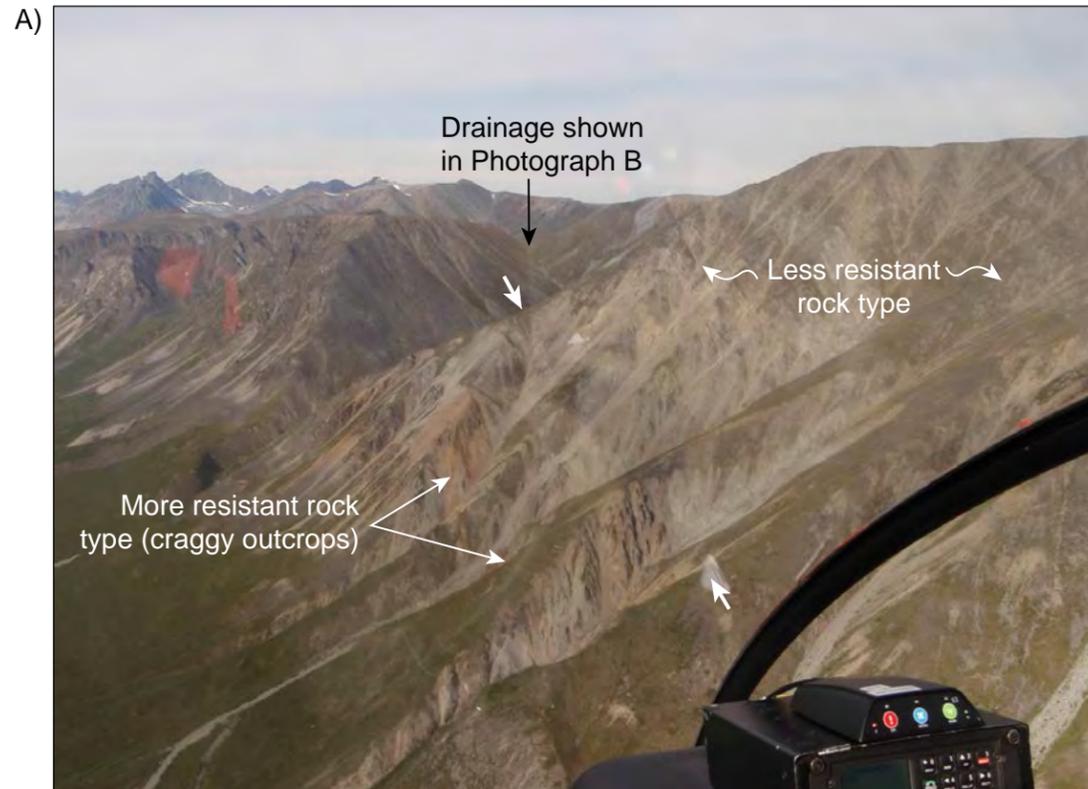
Photograph taken from location A looking southwest along apparent rock type contrast (contact?) and towards mapped lineaments in steep-walled, v-shaped, linear drainage. Arrows point along apparent contact between less-resistant rock on the north and more resistant and craggy outcrops on the south.

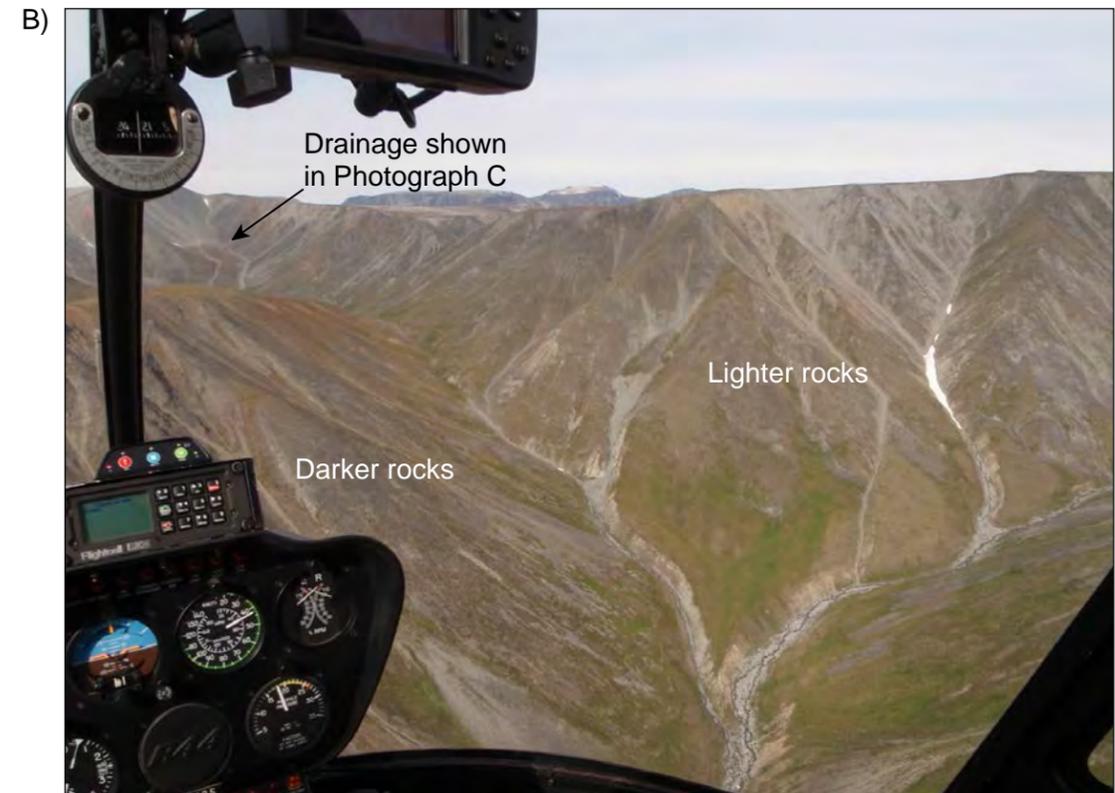
Photograph taken from location B looking west along mapped lineaments and apparent rock contact in steep-walled, v-shaped, linear drainages.

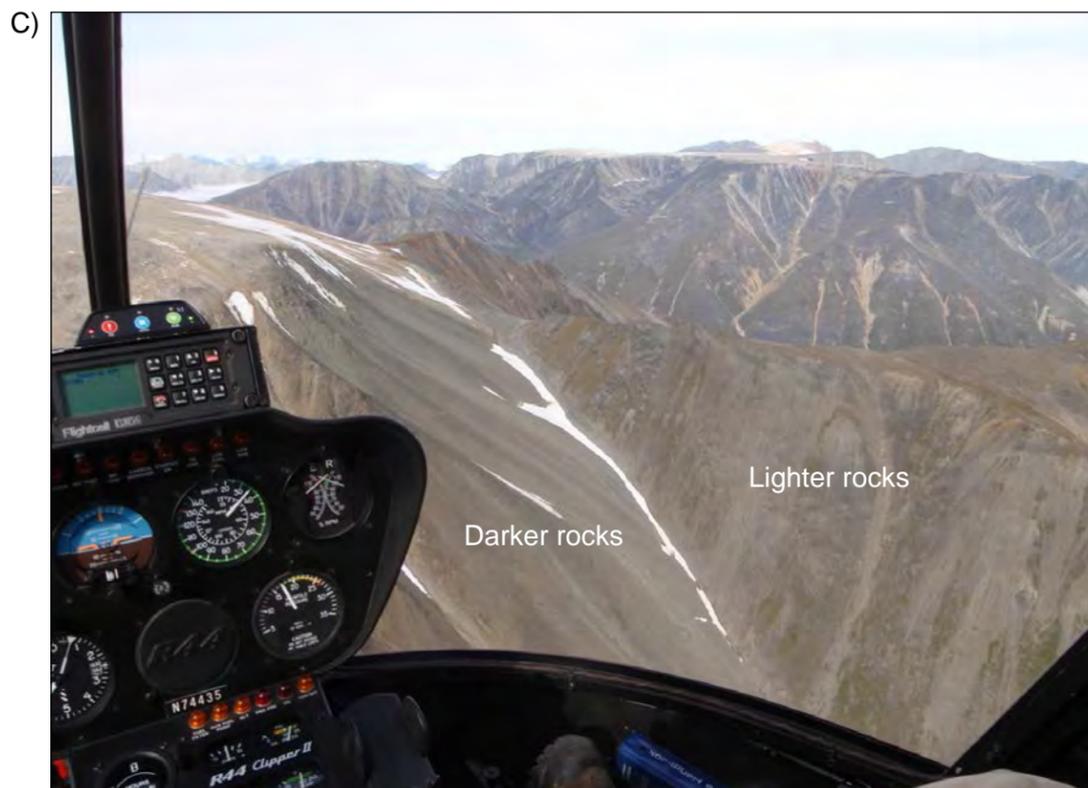
Photograph taken from location C looking west at head of steep-walled, v-shaped, linear drainage where mapped lineaments correspond to apparent rock contact.

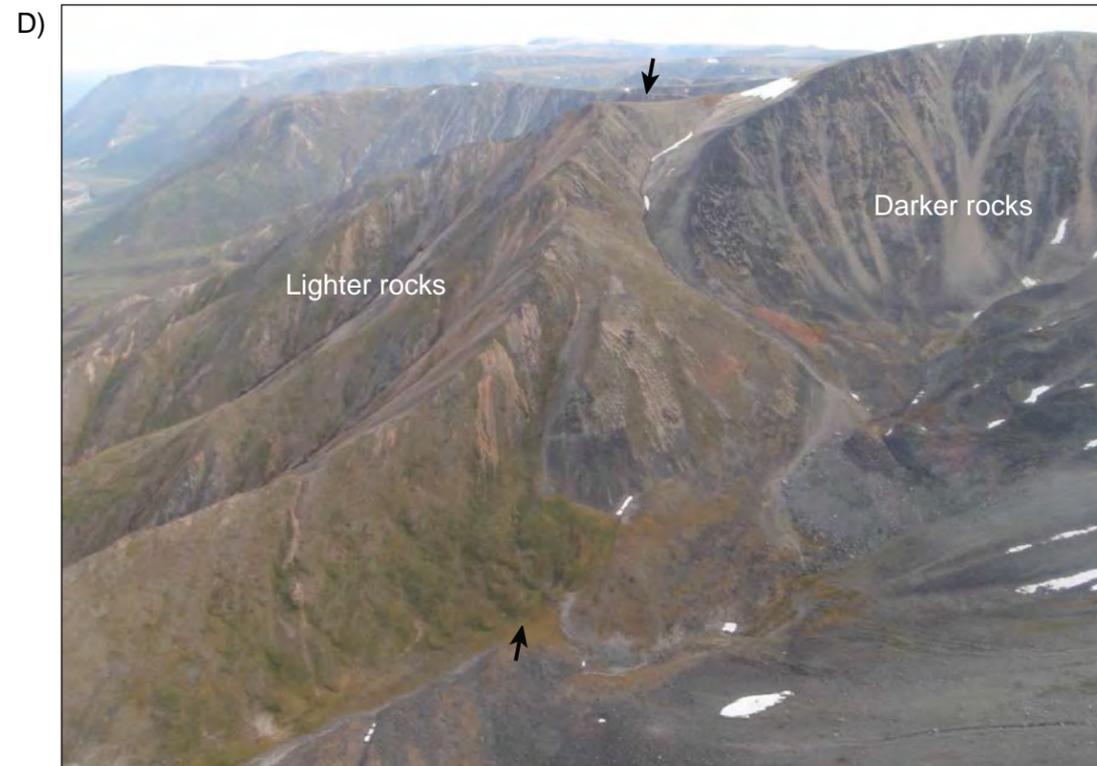
Photograph looking northeast from location D along the western continuation of the apparent rock type contrast shown in Photographs A, B, and C. Arrows point along apparent contact.

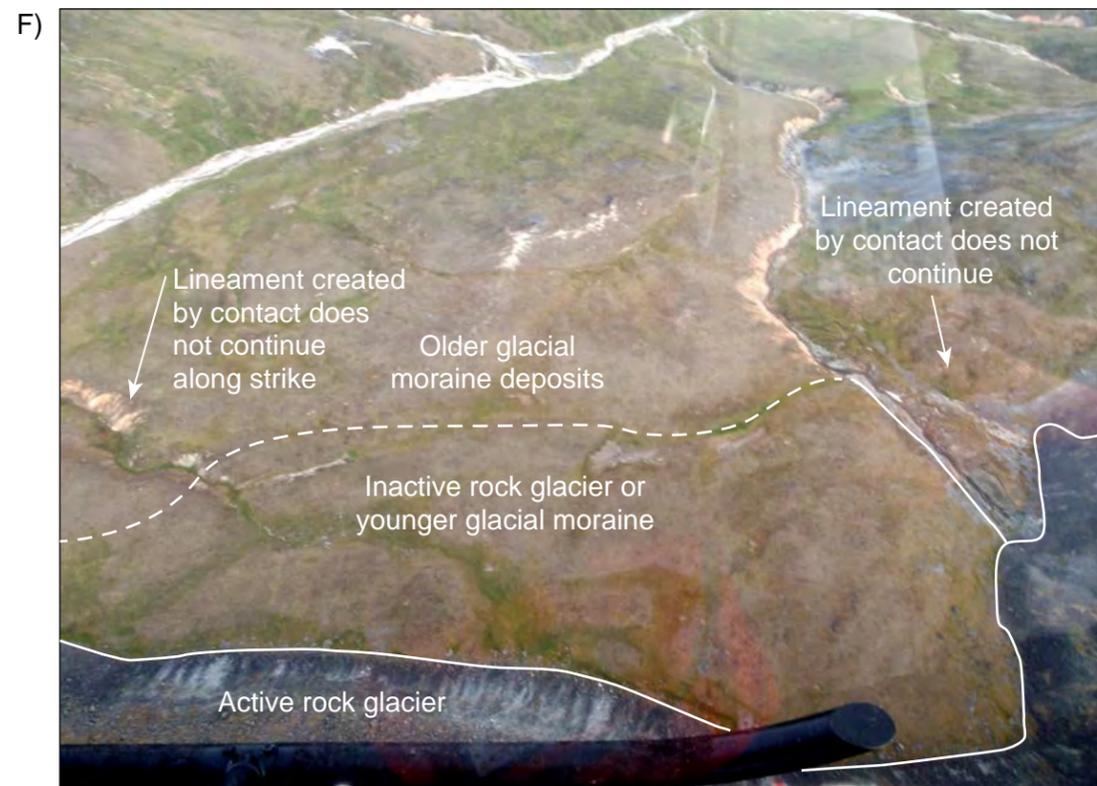
Photograph looking northwest from location F showing apparently undeformed rock glacier and/or glacial deposits along strike of the mapped lineaments and apparent rock contact shown in Photographs A through D.

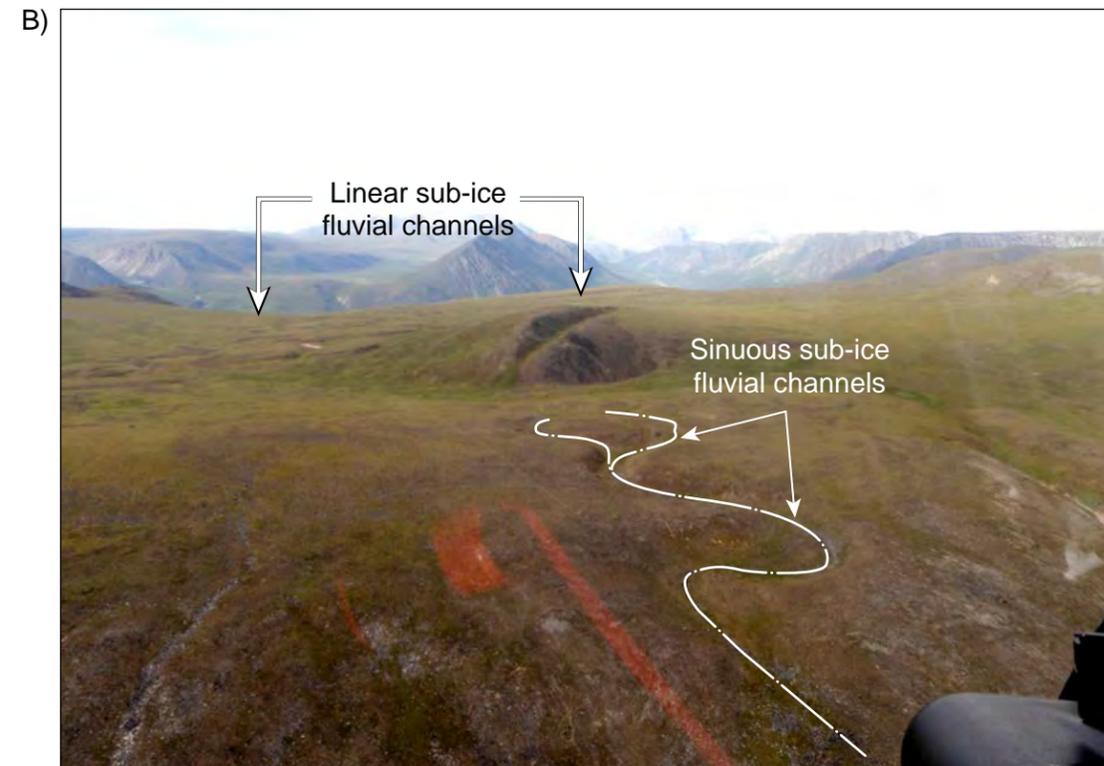
Photograph looking southwest from location B. The sinuous sub-ice channels are not large enough features to be seen on INSAR data.

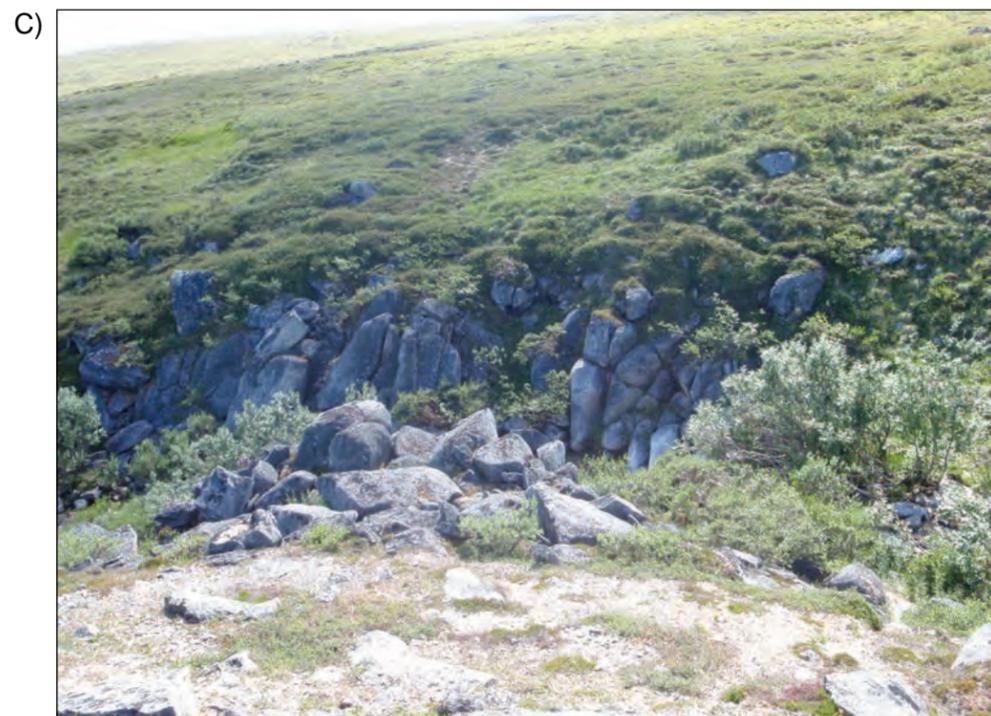
Photograph looking south-southwest from location C at widely spaced, near vertical, well-developed joints in trondhjemite (aka tonalite) bedrock. Joint spacing is 1 to 1.5 meters. Predominant orientations of joints are 042/80SE, 012/85SE, and 082/85SE but other orientations exist. Joint faces have clean surfaces with relief of minerals of 1 to 3 mm. No gouge or mineralization observed on joint surfaces, nor any sense of movement indicators (striae or mullions).

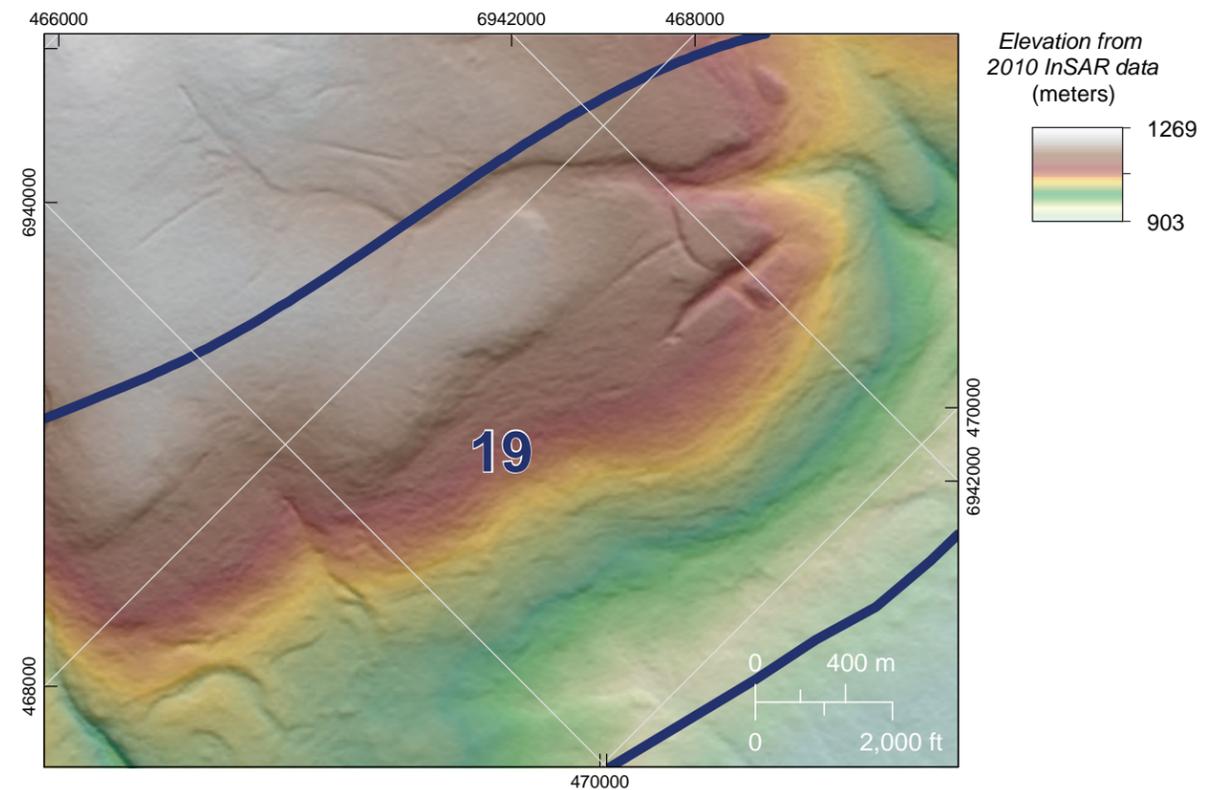
Detailed DEM showing orthogonal joint sets at northeast end of group 19.

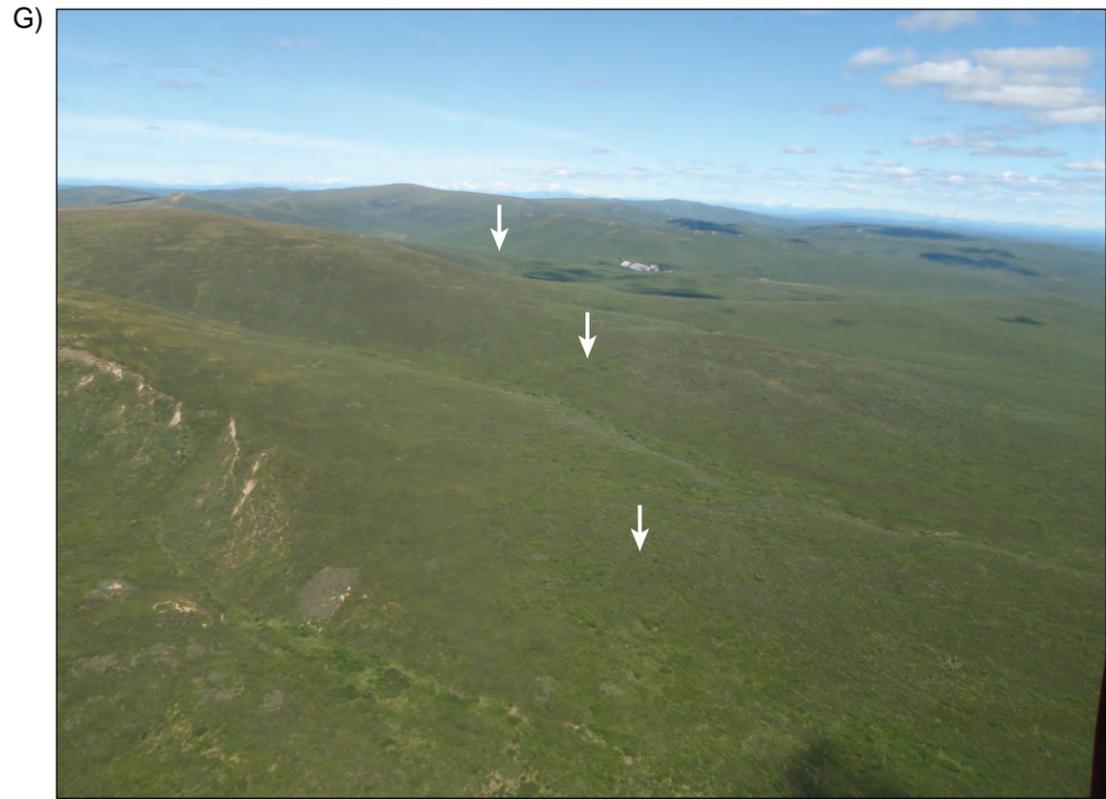
Photograph looking north from location G along mapped fault of Grantz (1960). Arrows point to approximate location of mapped fault. Note absence of apparent geomorphic expression fault.

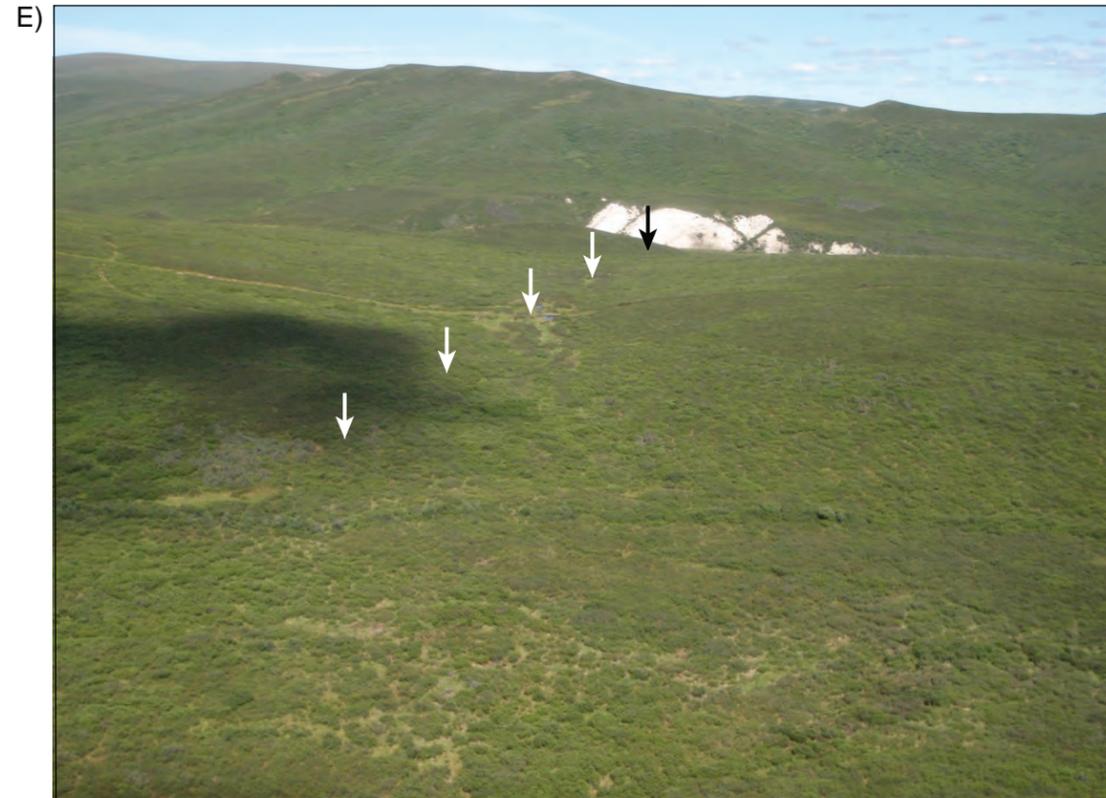
Arrows show location of FCL mapped lineament (shallow U-shaped swale). Note no apparent deformation of white-bedded sediments (glacial lake sediments) along projection of lineament.

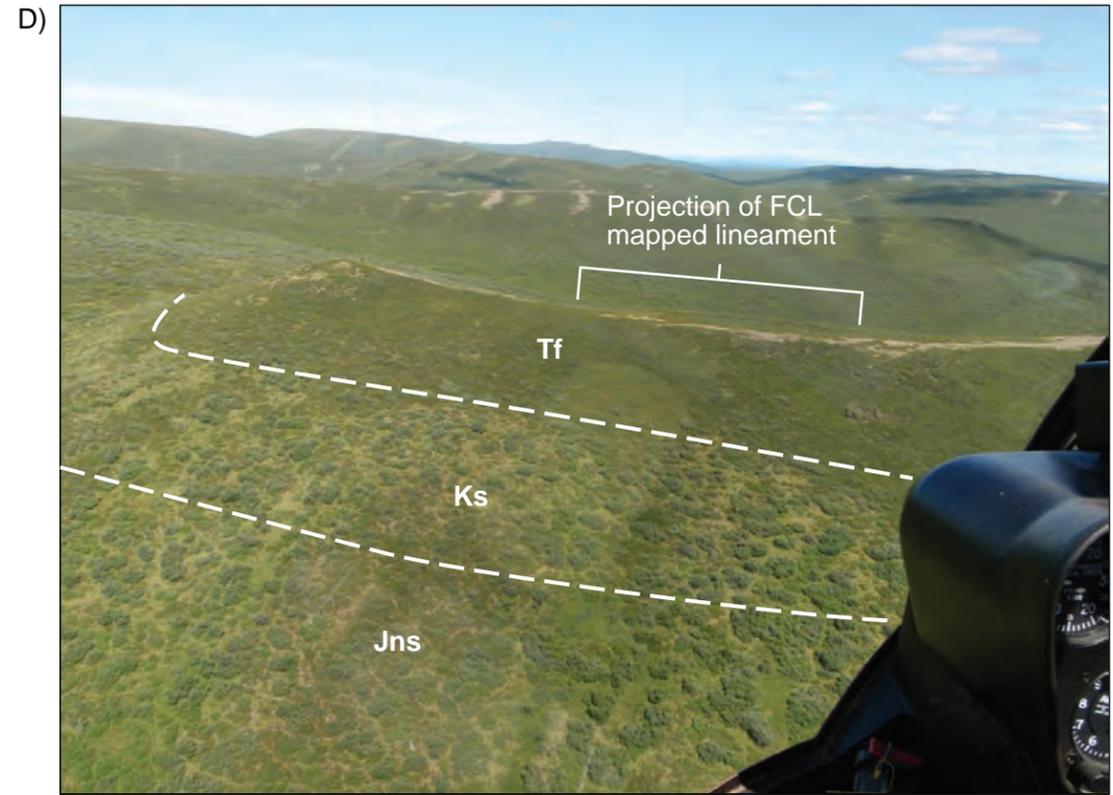
Photograph looking northeast from location D. Note absence of deformation in ridge line of Tf.

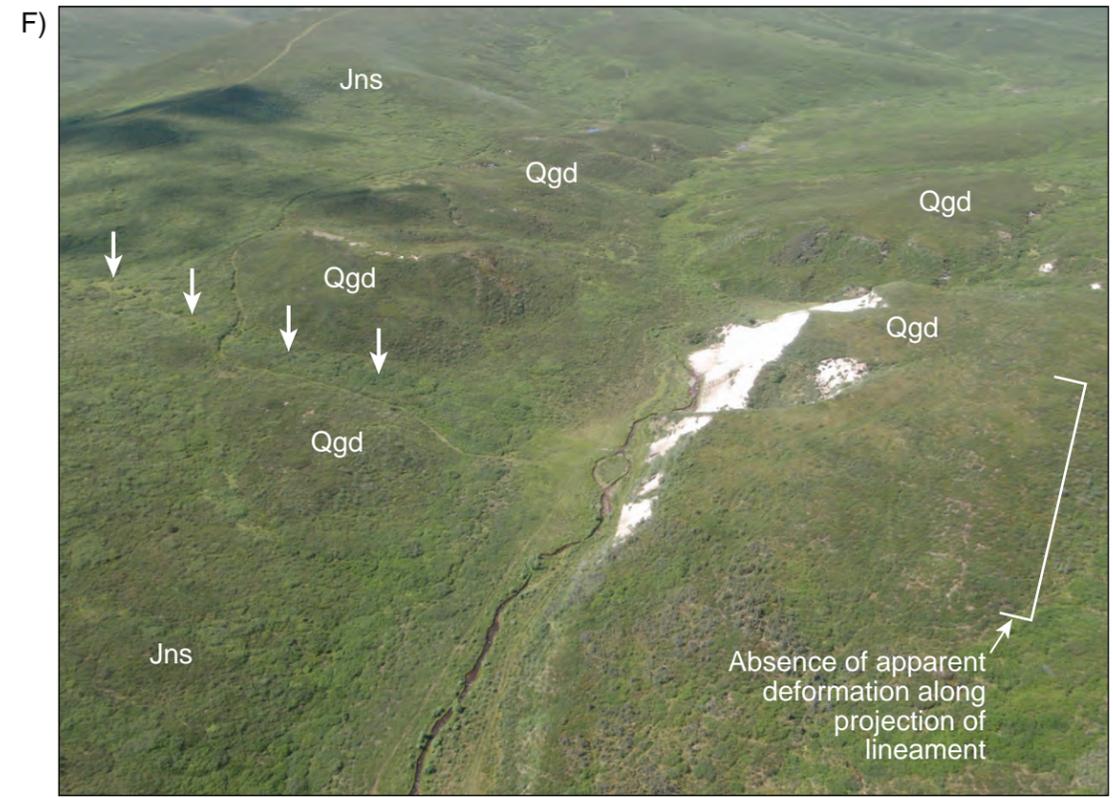
Photograph looking northwest from location F.

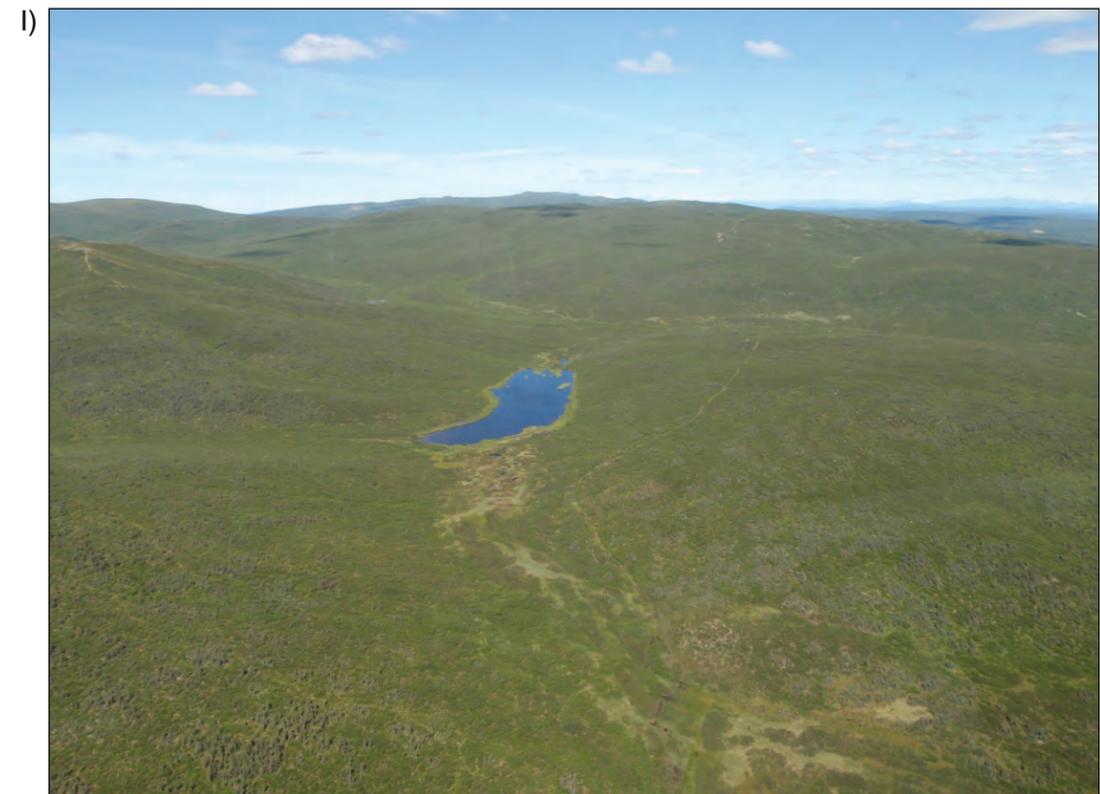
Photograph looking north-northeast from location I along queried mapped fault of Grantz (1960) that lies outside of lineament group. Note absence of fault expression.

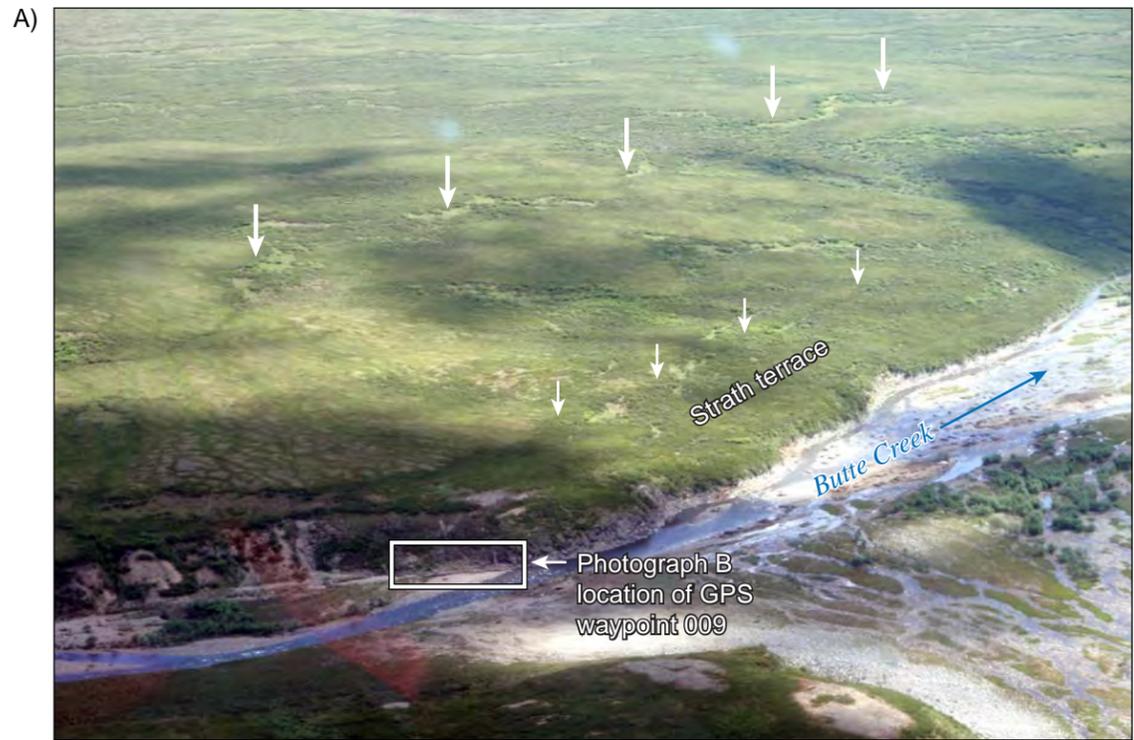
Photograph looking east from location A. Large arrows point to downhill facing slope break visible in INSAR and mapped by Fugro (2013). Field reconnaissance revealed smaller lineament (not visible in INSAR data) lies along the small arrows and projects toward the vertically-dipping bedrock exposed in the creek bank shown in Photograph B.
