SUSITNA-WATANA HYDROELECTRIC PROJECT
 LINEAMENT GROUP 12b
 MAP DATA

FIGURE
 A12b.1

79_218900_Alaska_Railbelt/2189_Lineament Report October 2013, modified 10.18.13

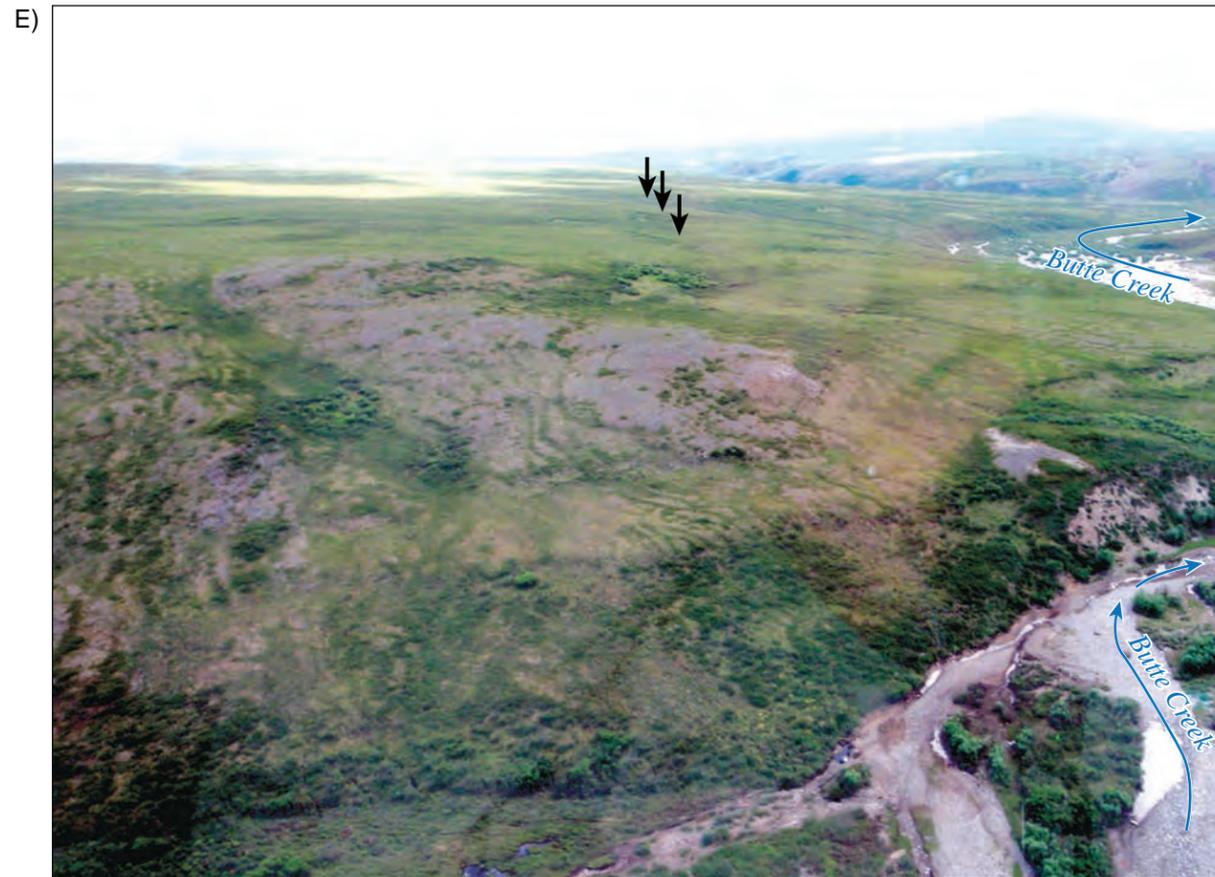
Photograph taken from location E looking east-southeast along trend of FCL mapped lineament (shown by arrows). Note absence of any apparent deformation in surficial deposits or in terrace riser on left bank of Butte Creek.

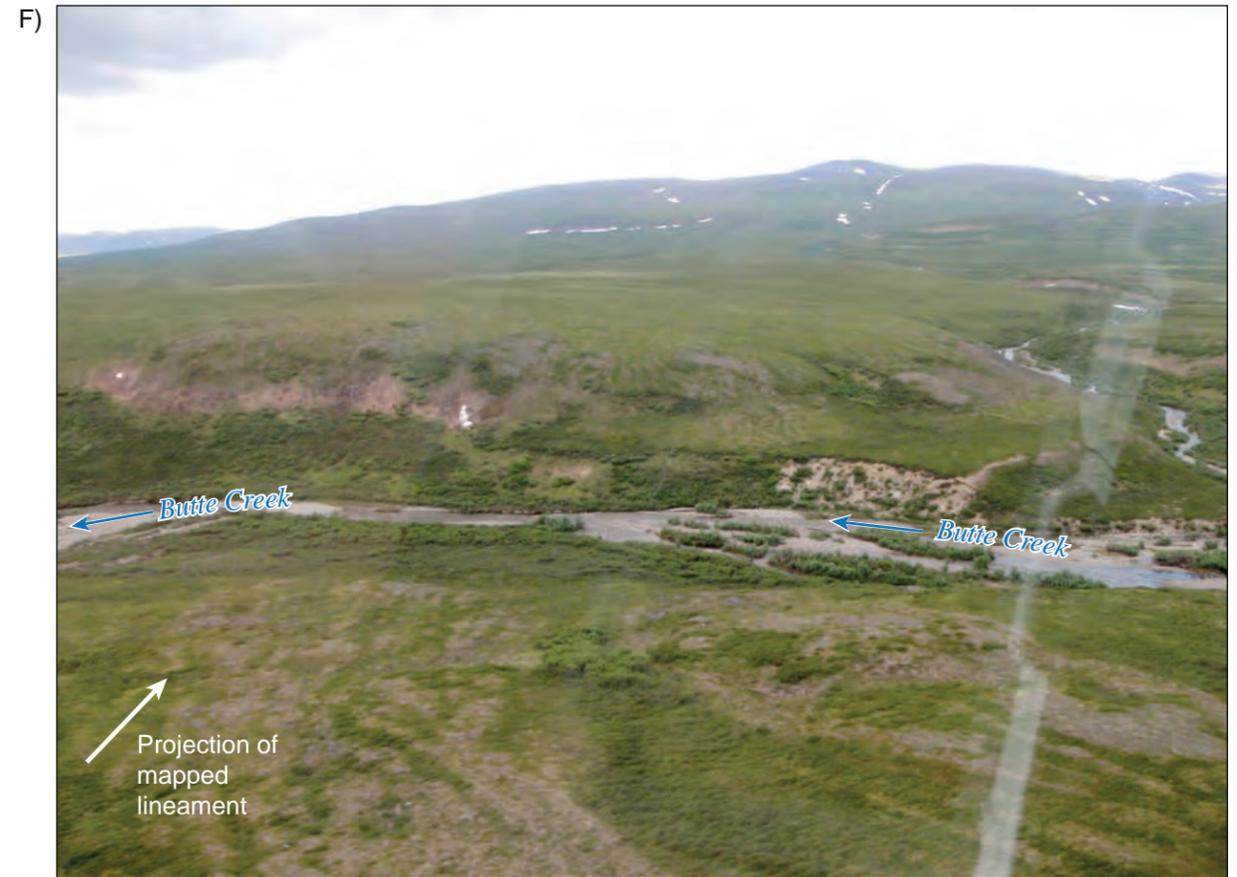
Photograph taken from location F looking west along trend of FCL mapped lineament to west of Butte Creek. Note no apparent deformation in right bank of stream or any expression of faulting in broad, flat terrace surface mapped as Qdt3 by Smith et al. (1988).

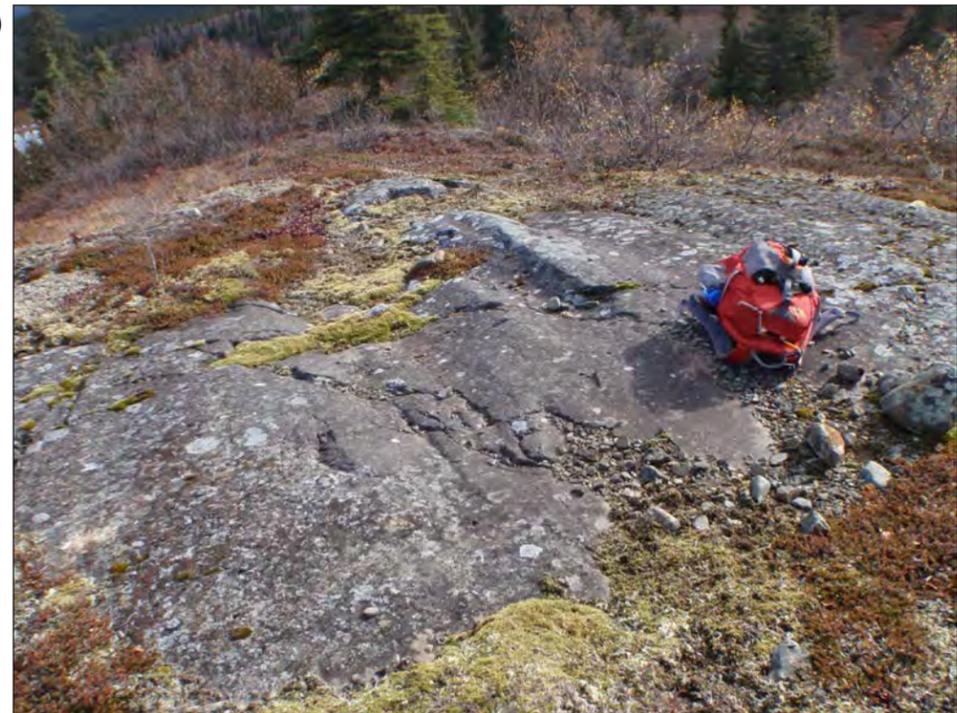
Photograph of fluted ice-scoured rock surface with cracks and joints.
