## Susitna-Watana Hydroelectric Project Document ARLIS Uniform Cover Page

| <b>Title:</b><br><br>Geomorphology study, Study plan Section 6.5, 2014-2015 Study Implementation Report. Appendix A. Susitna River upper river reconnaissance photographs | | <b>SuWa 289</b> |

## APPENDIX A: SUSITNA RIVER UPPER RIVER RECONNAISSANCE PHOTOGRAPHS

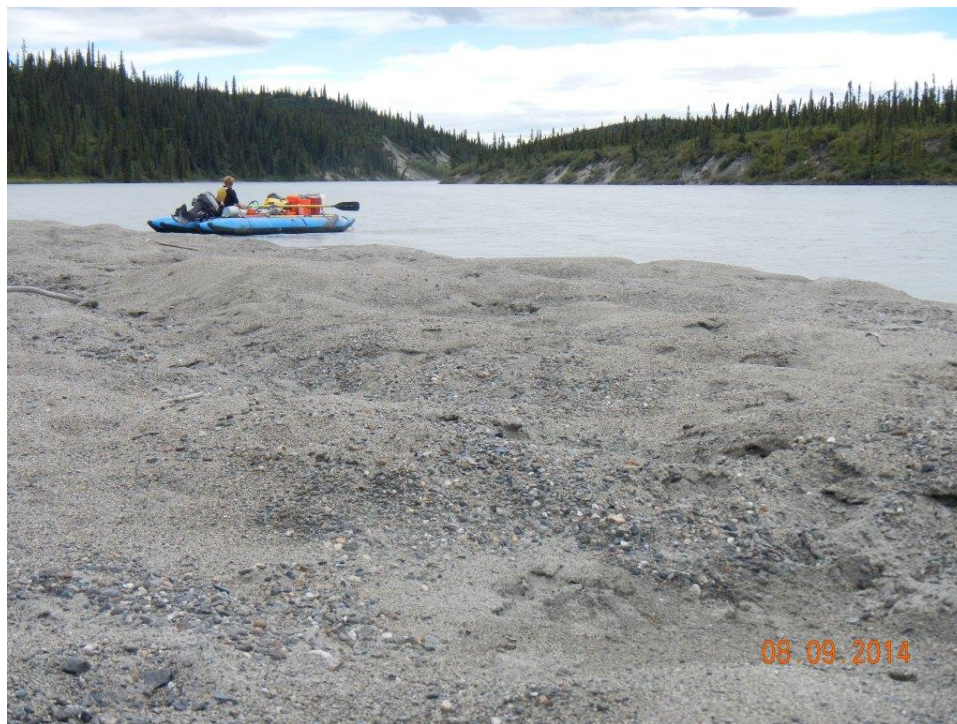
**Figure A.1-10 – Sand and fine gravel dunes on alternate bar surface at PRM 276.2 (P928).**

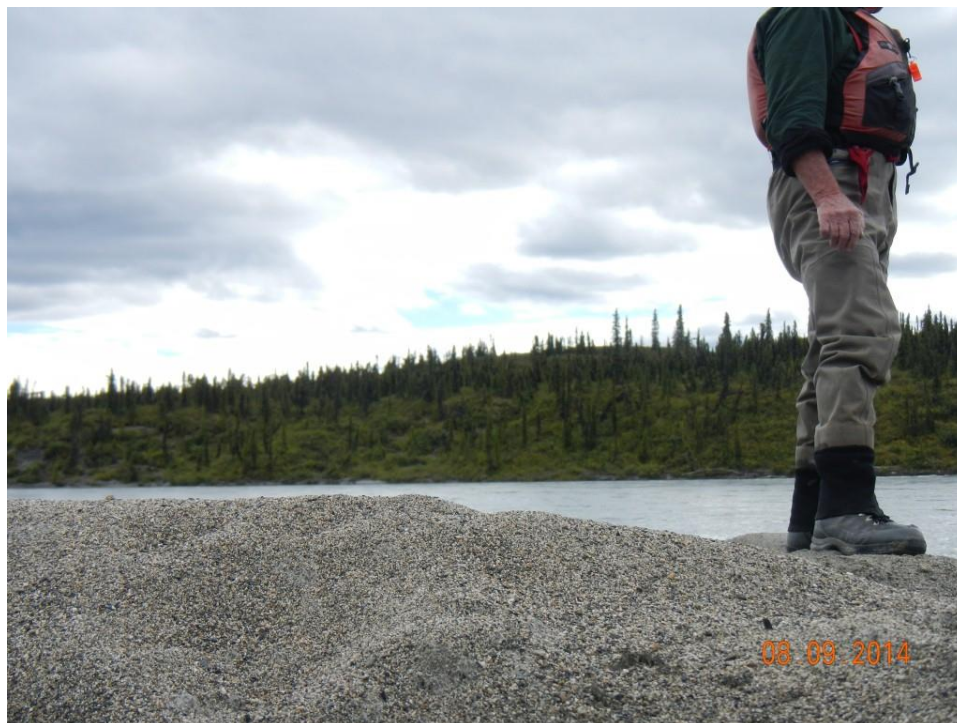
**Figure A.1-11 – Sand and fine gravel dunes on alternate bar surface at PRM 276.2 (P929).**

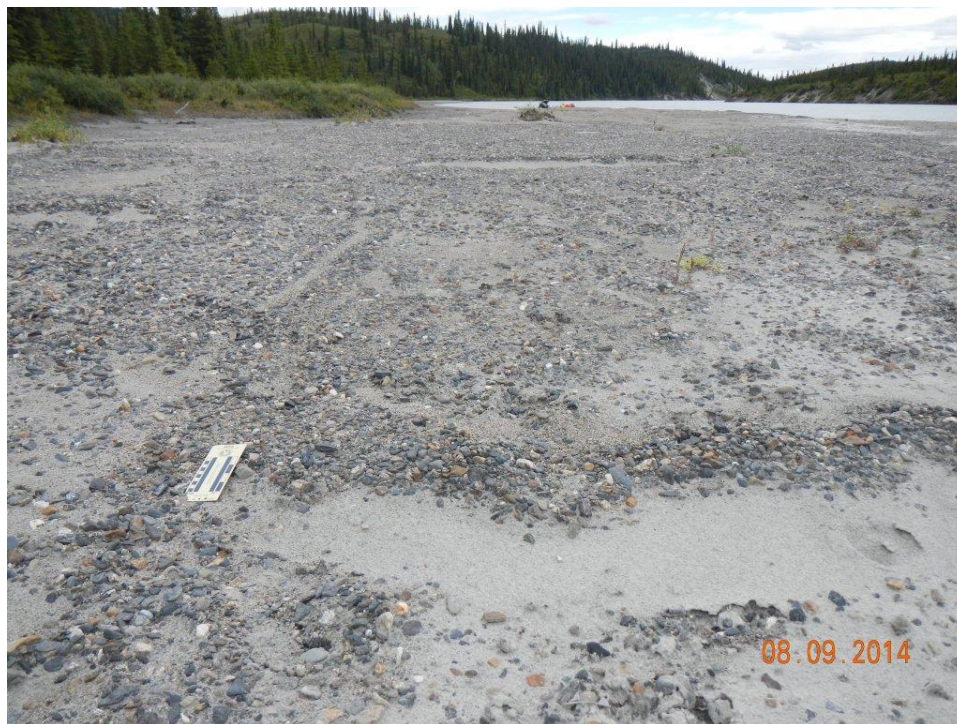
**Figure A.1-12 – Ice pushed ridges and deposits on alternate bar at PRM 276.2 (P931).**

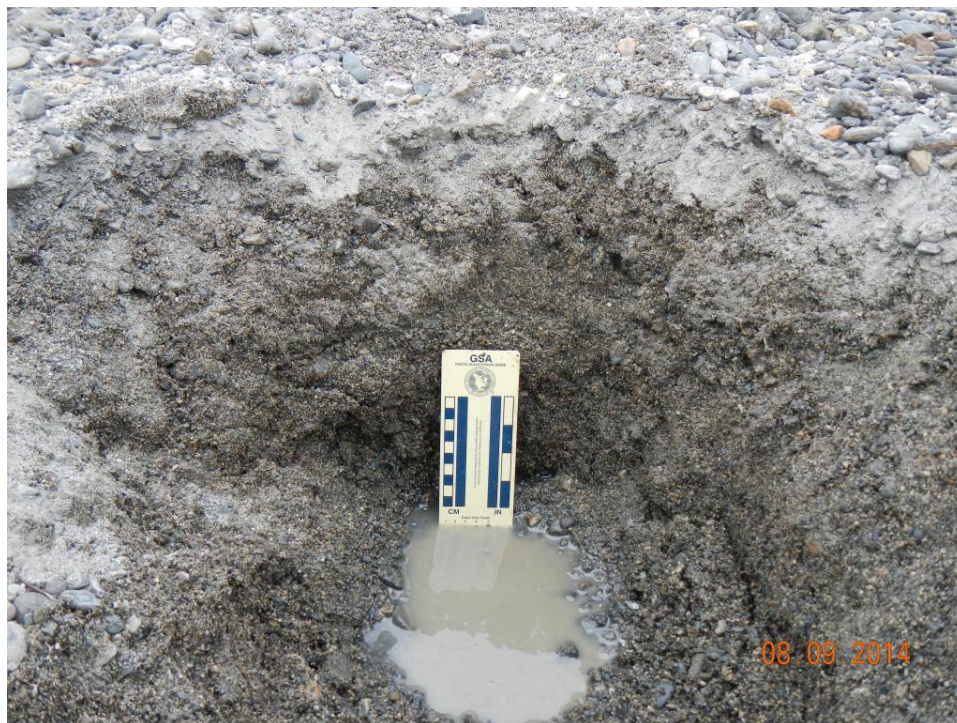
**Figure A.1-13 – Subsurface material on alternate bar at PRM 276.2. Grab sample location - median bed material diameter ( $D_{50}$ ) is 4.2 mm (P935).**

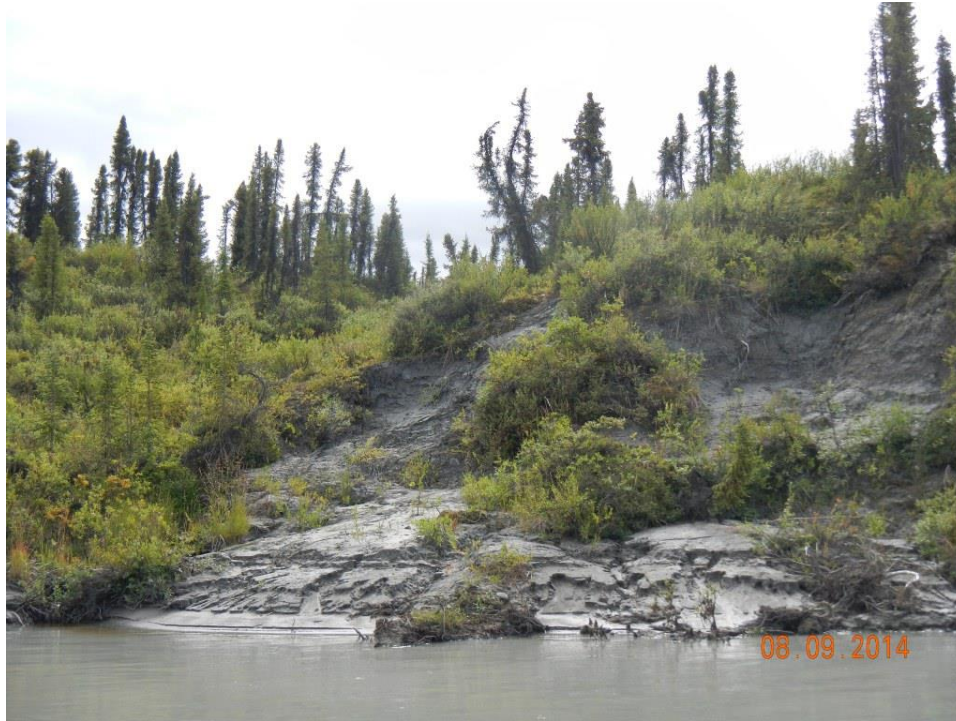
**Figure A.1-14 – Active landslide in till near PRM 276. Failure may be due to melting of permafrost (P937).**

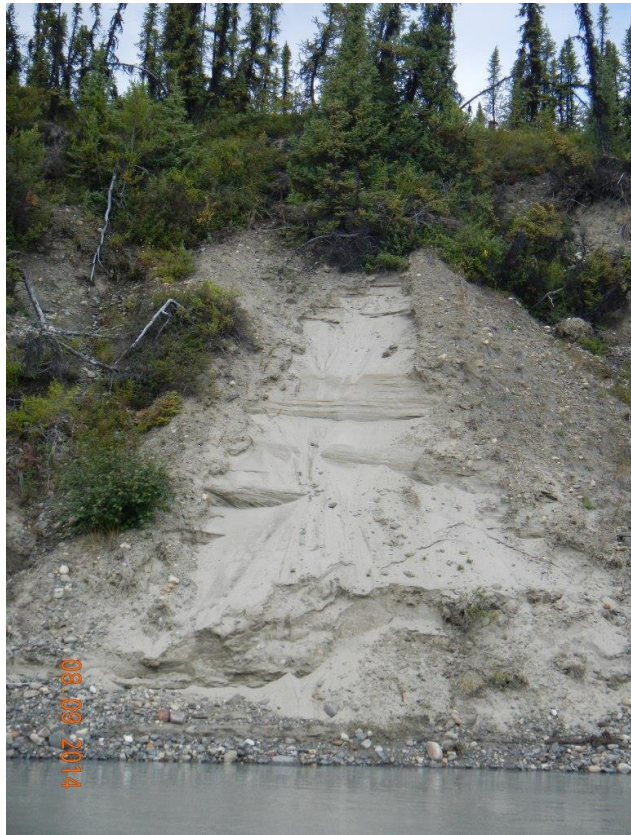
**Figure A.1-15 – Active landslide near PRM 274.8 – sands and fine gravel in glacio-deltaic deposits (P956).**

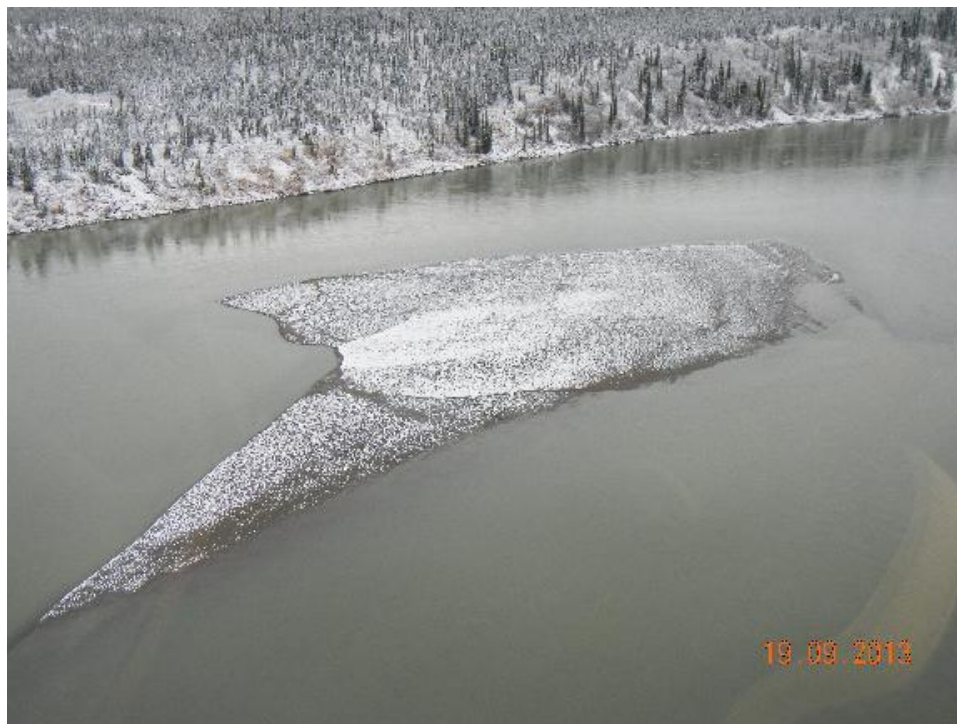
**Figure A.1-18 – Mid-channel bar near PRM 270. Bar composed of primarily sands and fine gravels (P5557).**

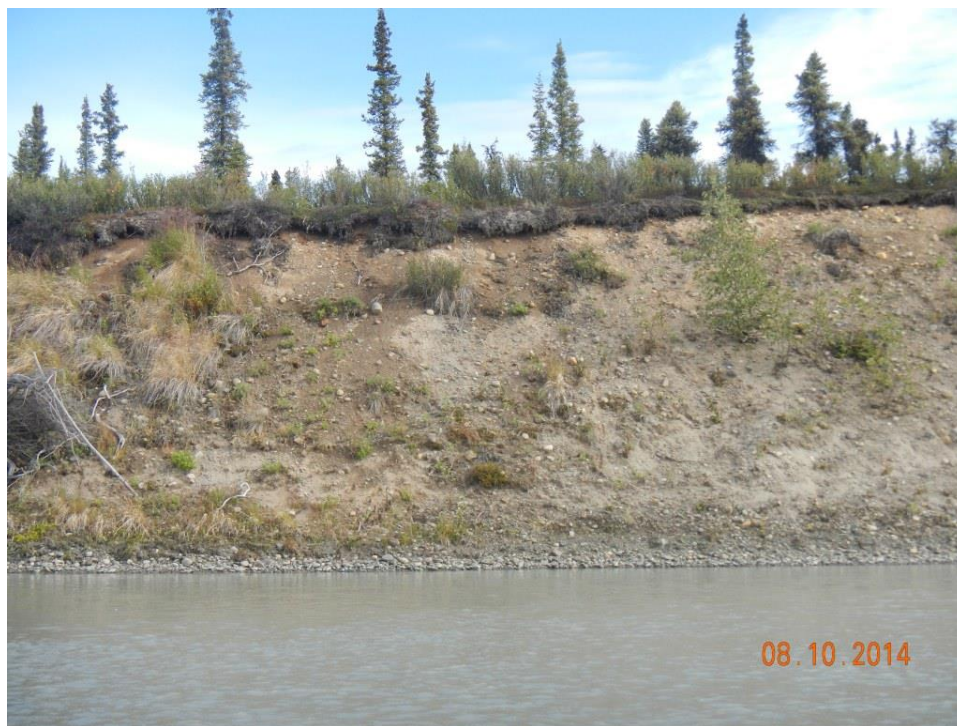
**Figure A.1-19 – Exposed glacial outwash terrace surface near PRM 269.5. It is a source of sands as well as gravels and cobbles (P028).**

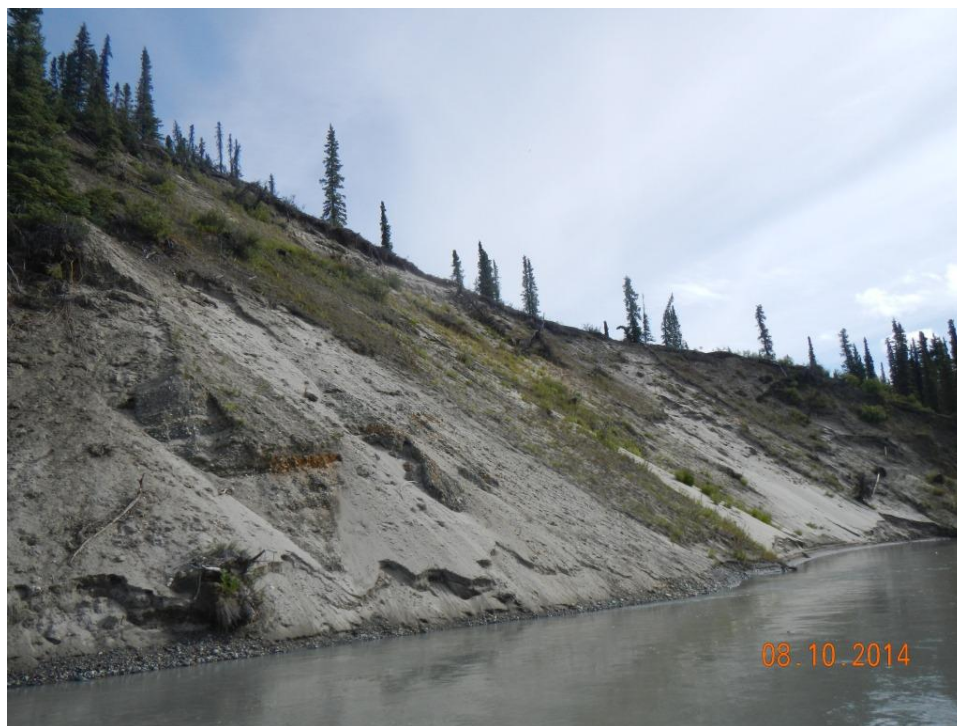
**Figure A.1-22 – Eroding glacio-deltaic deposits moraine surface – view downstream near PRM 269 (P042).**

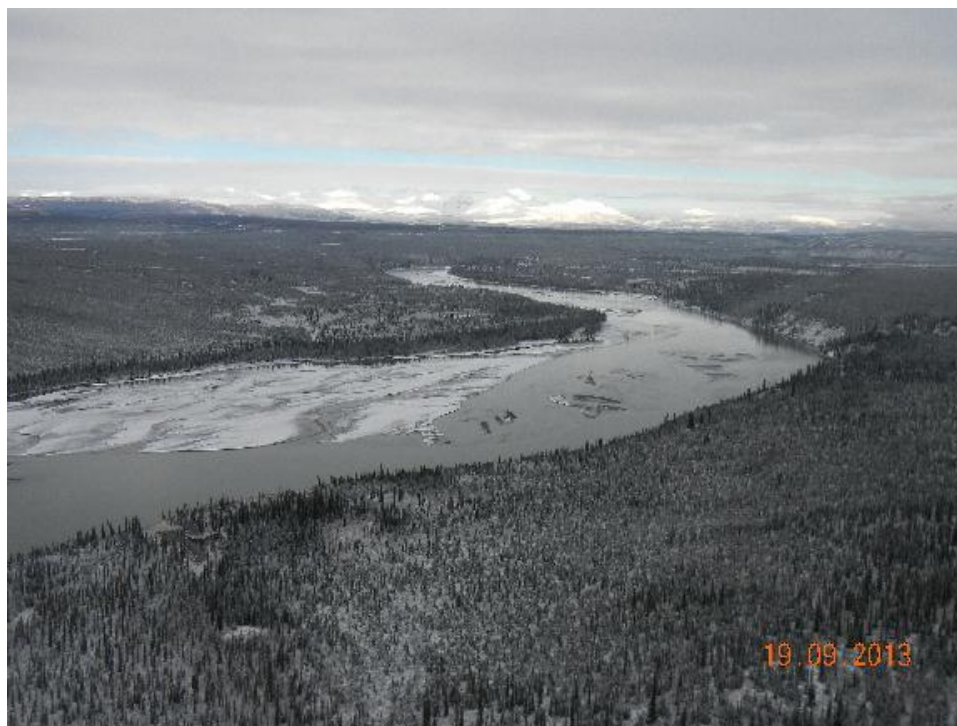
**Figure A.1-23 - View upstream from PRM 268 of valley floor expansion zone and mid-channel bars (P5556).**

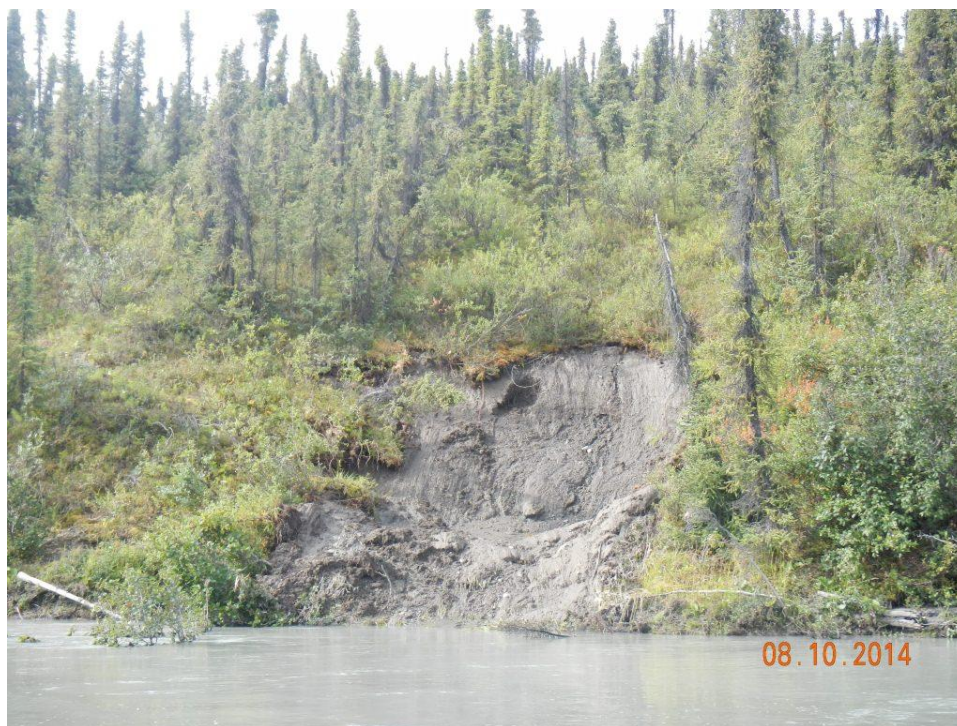
Figure A.1-24 – Pop out slide in till at PRM 267.8, probably due to melting permafrost (P062).

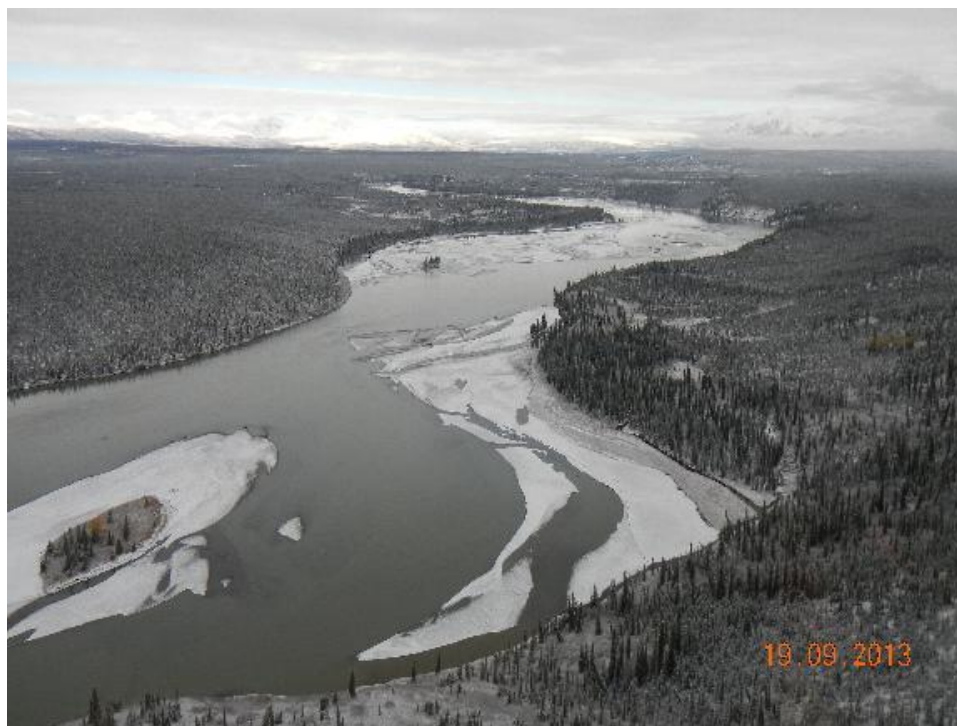
Figure A.1-25 – View upstream from PRM 267.5 of expansion zone and mid-channel and alternate bars (P5555).

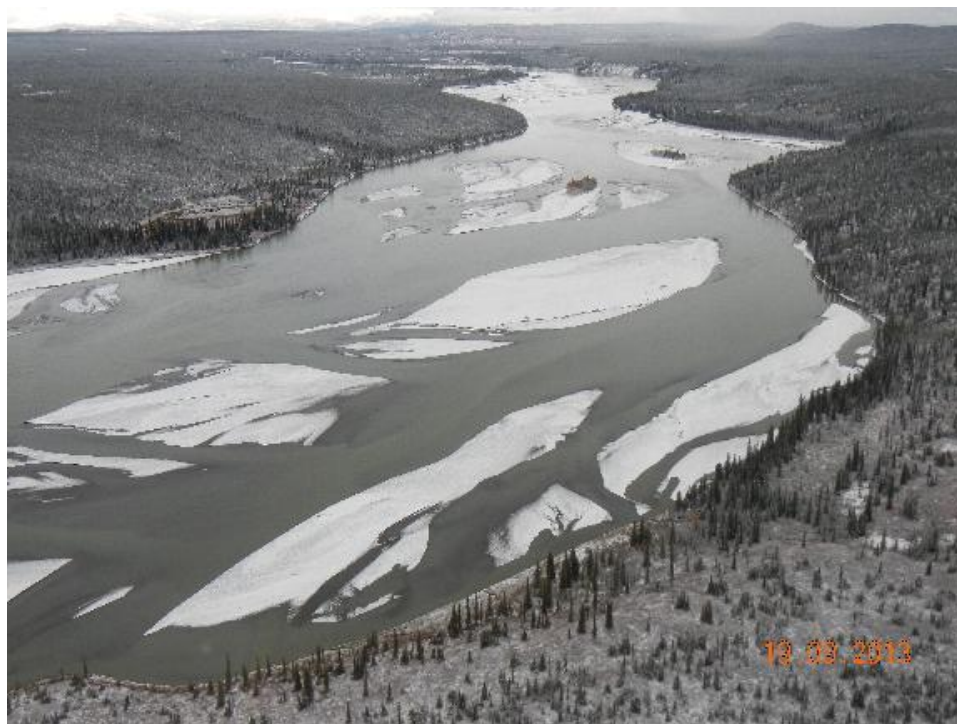
Figure A.1-26 – View upstream from PRM 267 of expansion zone and mid-channel braid bars (P5554).

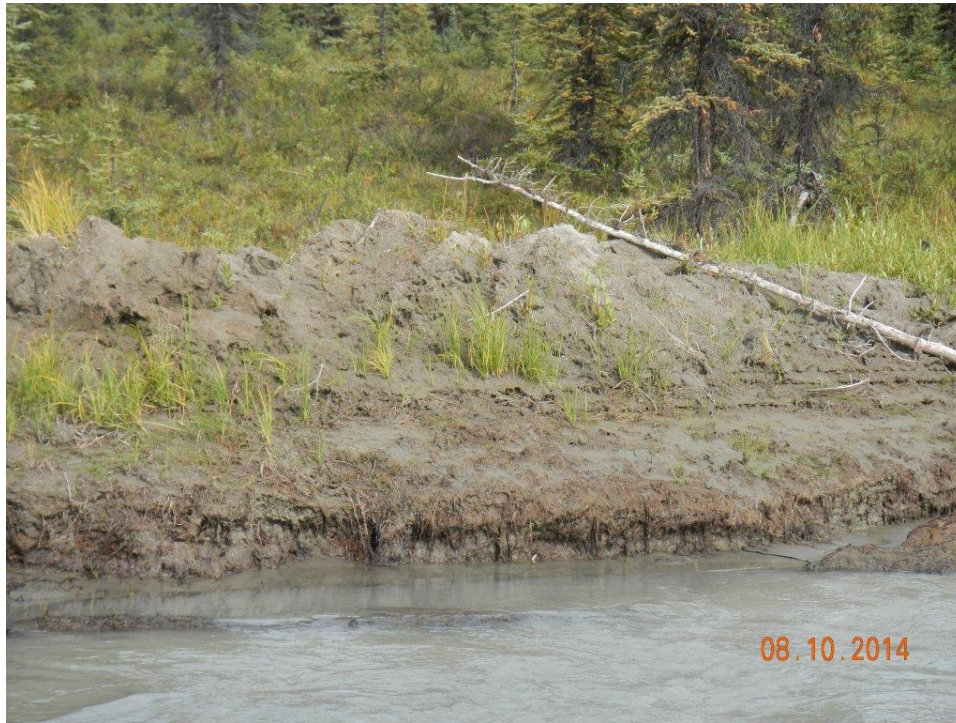
Figure A.1-27 – Ice-deposited sand on floodplain near PRM 266.5 (P074).

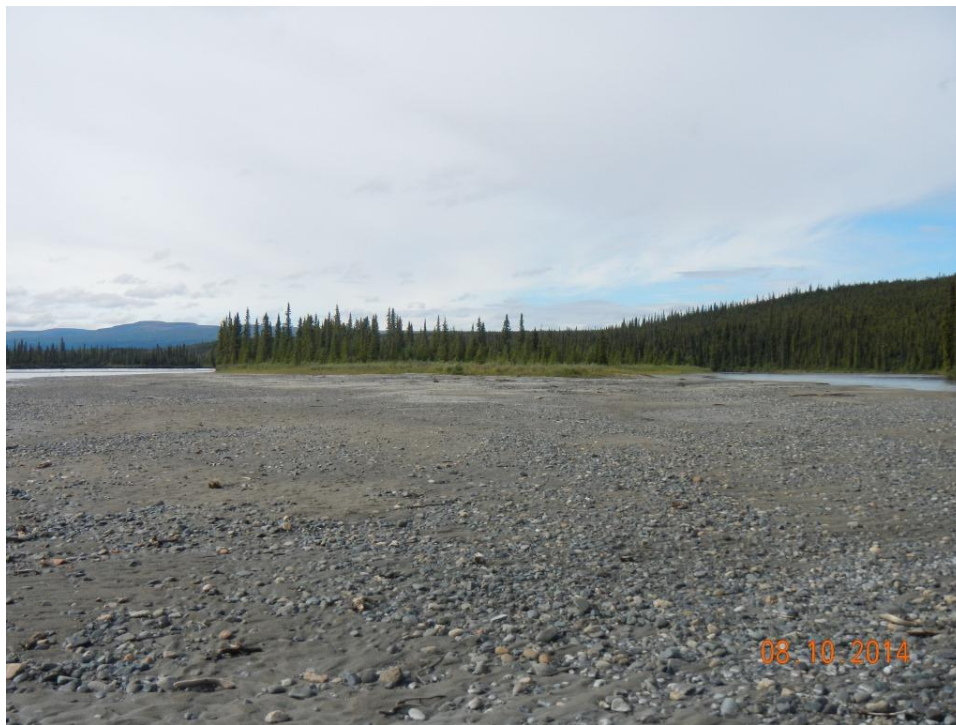
Figure A.1-28 – Very large gravel bar and first observed mid-channel island in expansion zone near PRM 266 (P080).

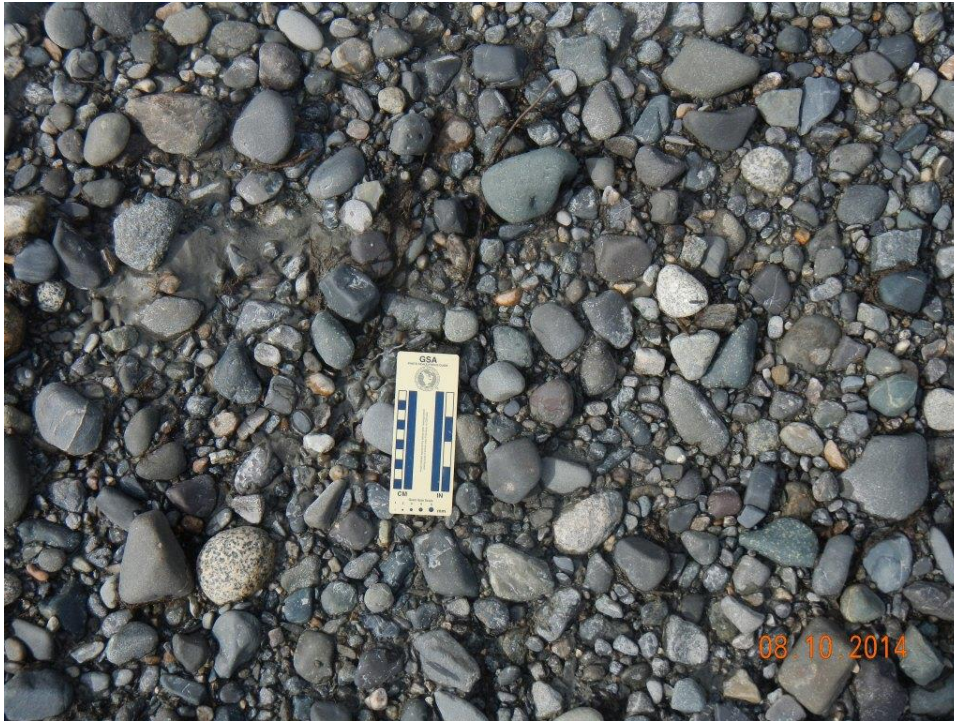
**Figure A.1-29 – Gravel on mid-channel bar in expansion zone near PRM 266. Most gravel observed on the mid-channel bar ranged from 32 mm to 45 mm in diameter with some gravel sized at 64 mm to 90 mm (P082).**

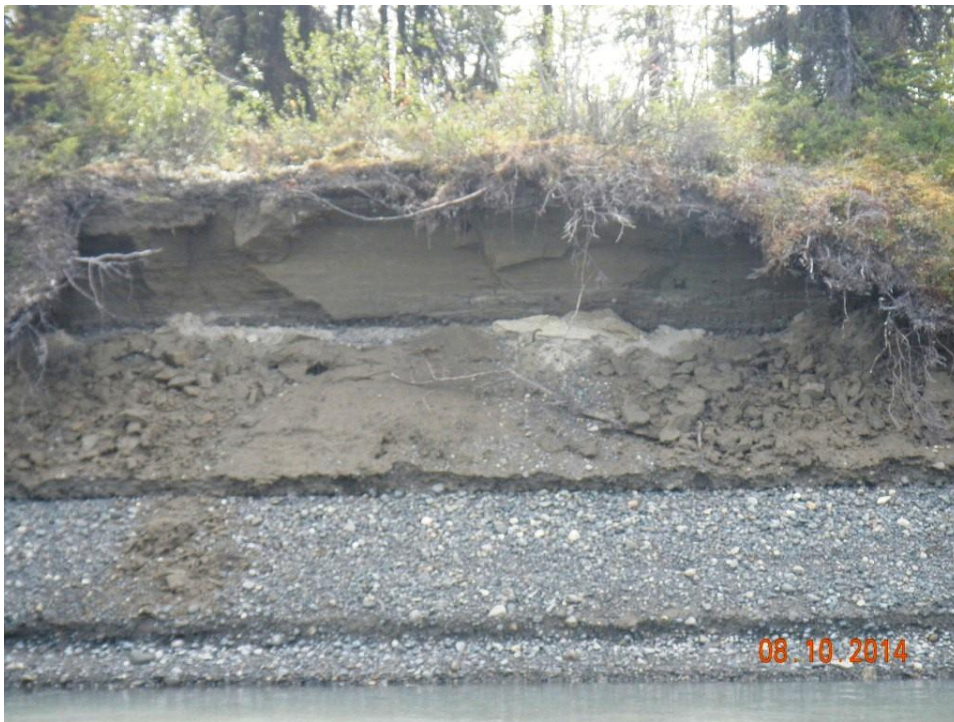
**Figure A.1-30 – Eroding terrace near PRM 266 – source of fine grained material and fine gravels (P090).**

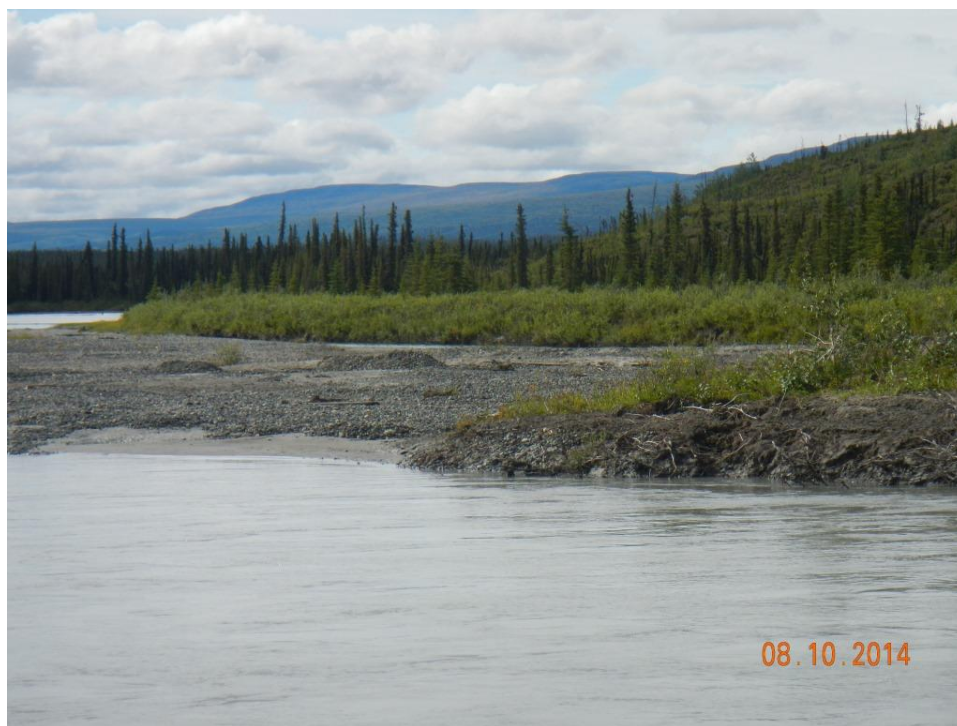
**Figure A.1-31 – Ice pushed ridges in gravel deposits on mid-channel bar near PRM 265. Presence of vegetated bars not observed upstream where bars were composed of sand (P112).**

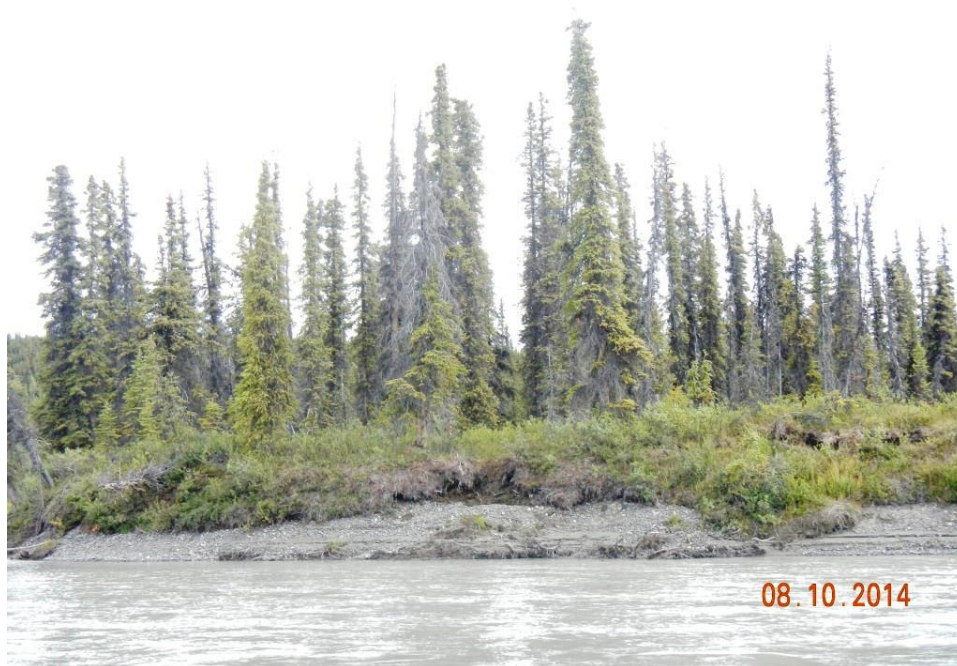
**Figure A.1-32 – Gravel-covered mid-channel island near PRM 264 (P138).**

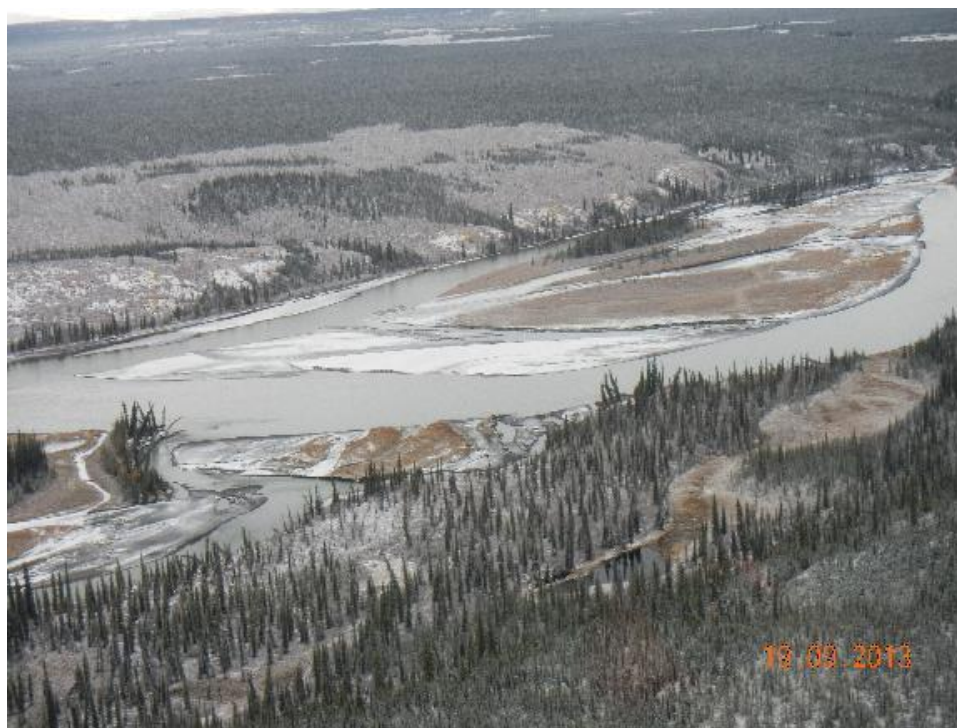
**Figure A.1-33 – View upstream of expansion zone and mid-channel bars and islands near PRM 264 (P5551).**

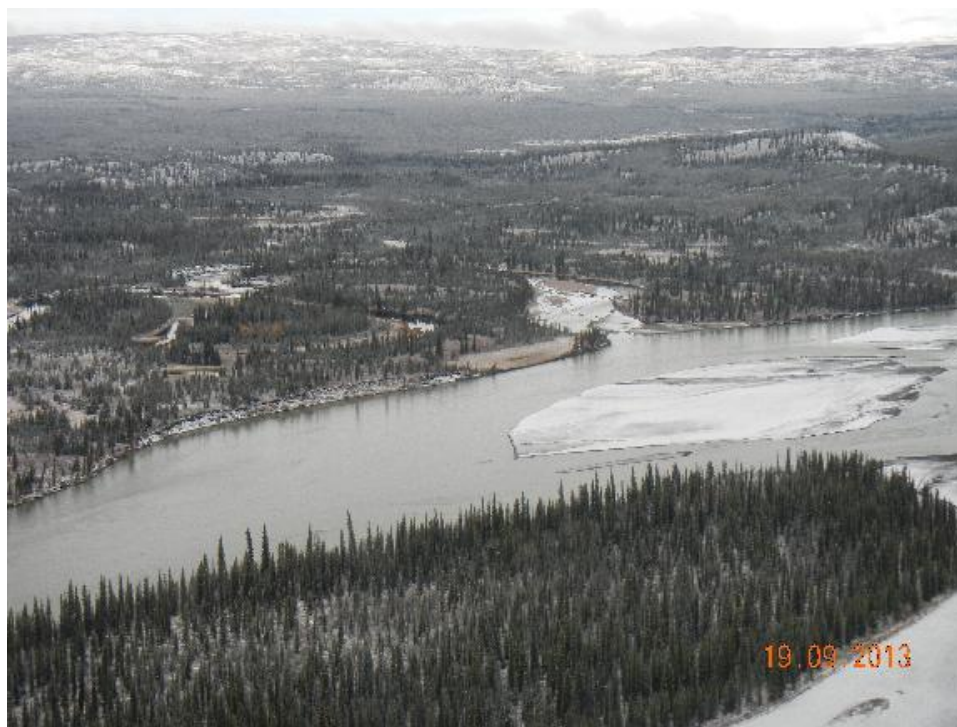
**Figure A.1-34 – View upstream of large mid-channel bar in backwater zone upstream of constriction near PRM 263 (P5553).**

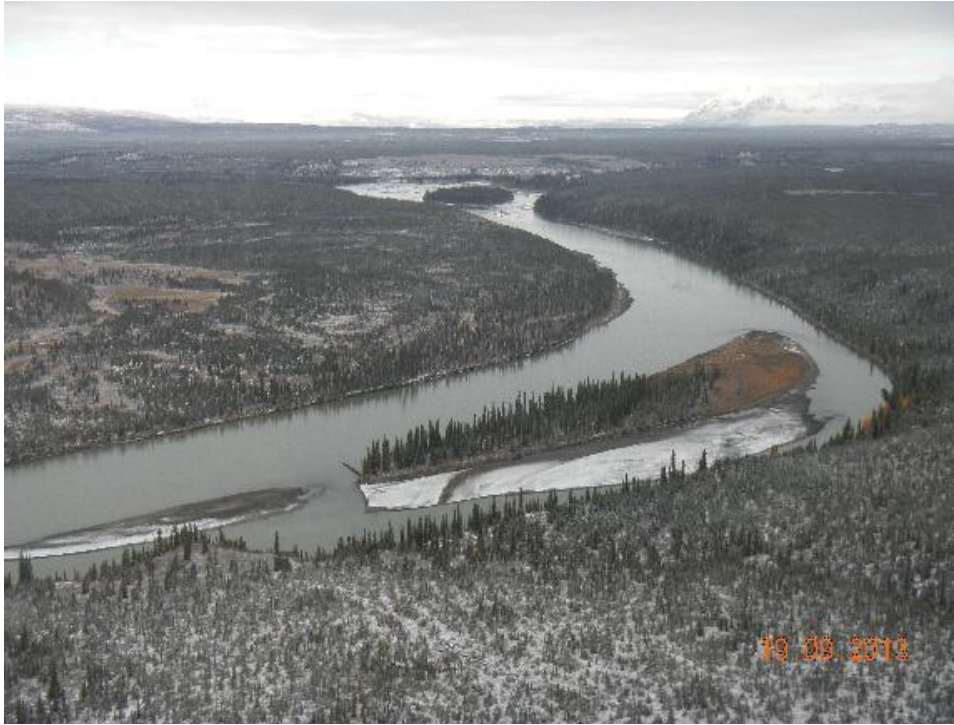
**Figure A.1-35 – View upstream near PRM 262 (P5548).**

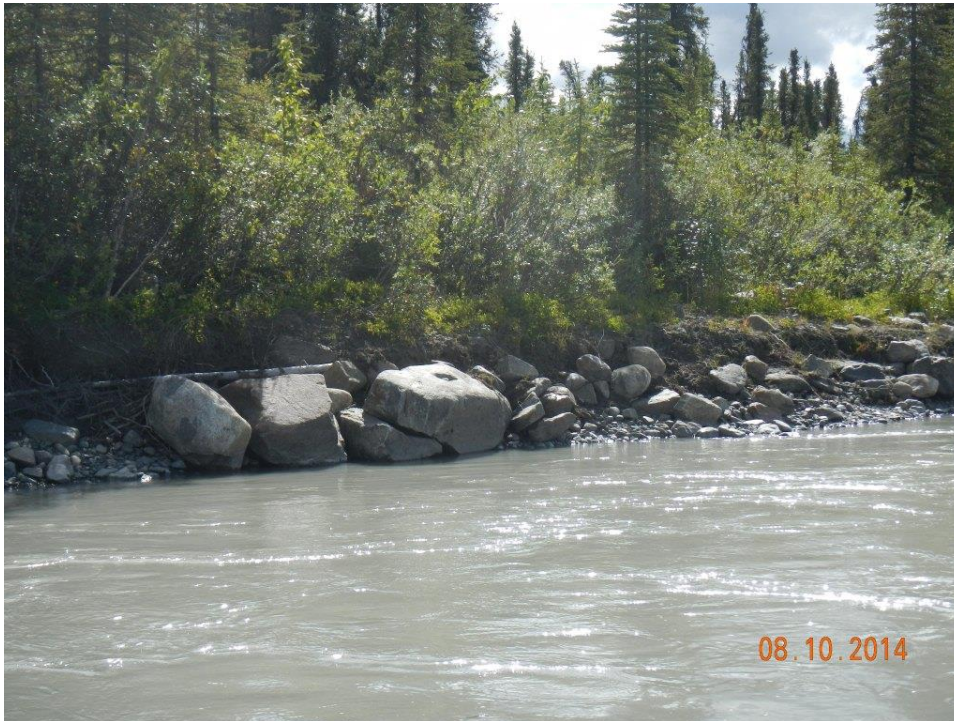
**Figure A.1-36 – First observed boulders near PRM 261.7 (P165).**

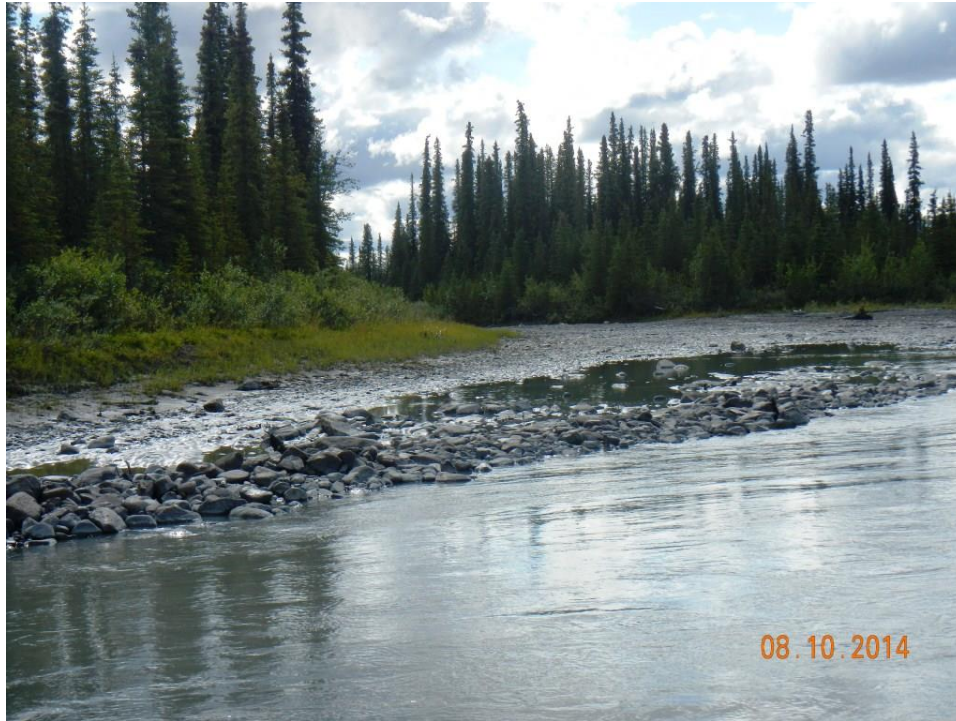
**Figure A.1-37 – Angular boulder formed lateral weir upstream of Maclaren River confluence near PRM 261.7 (P167).**

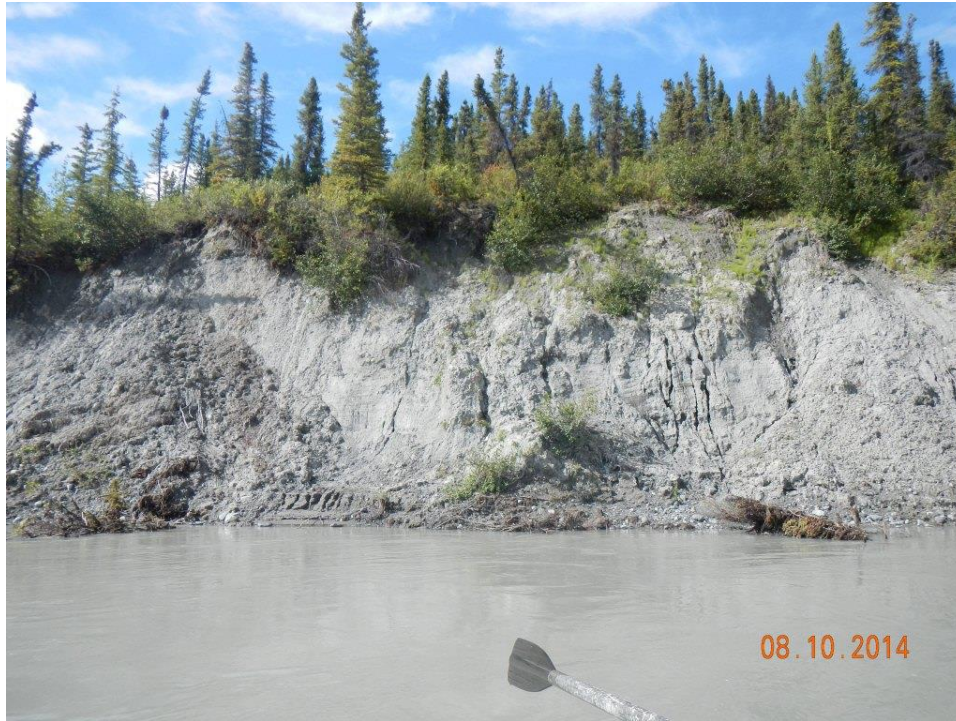
**Figure A.1-39 – Mass failure of till near PRM 261.5 (P177).**

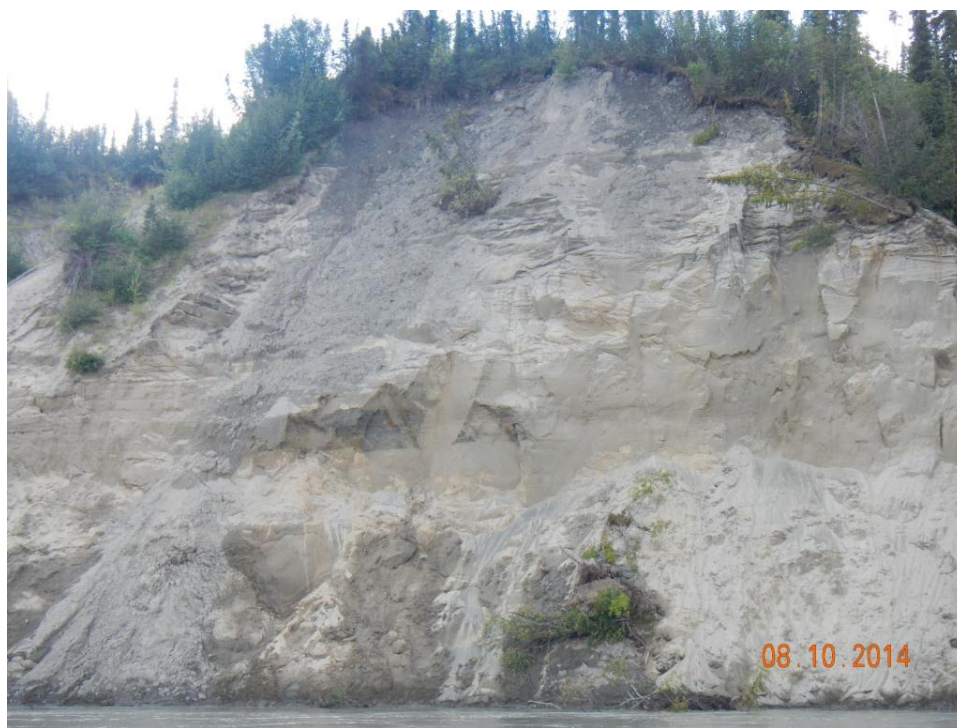
**Figure A.2-3 – Eroding moraine – active landslide zone near PRM 259.5 (P219).**

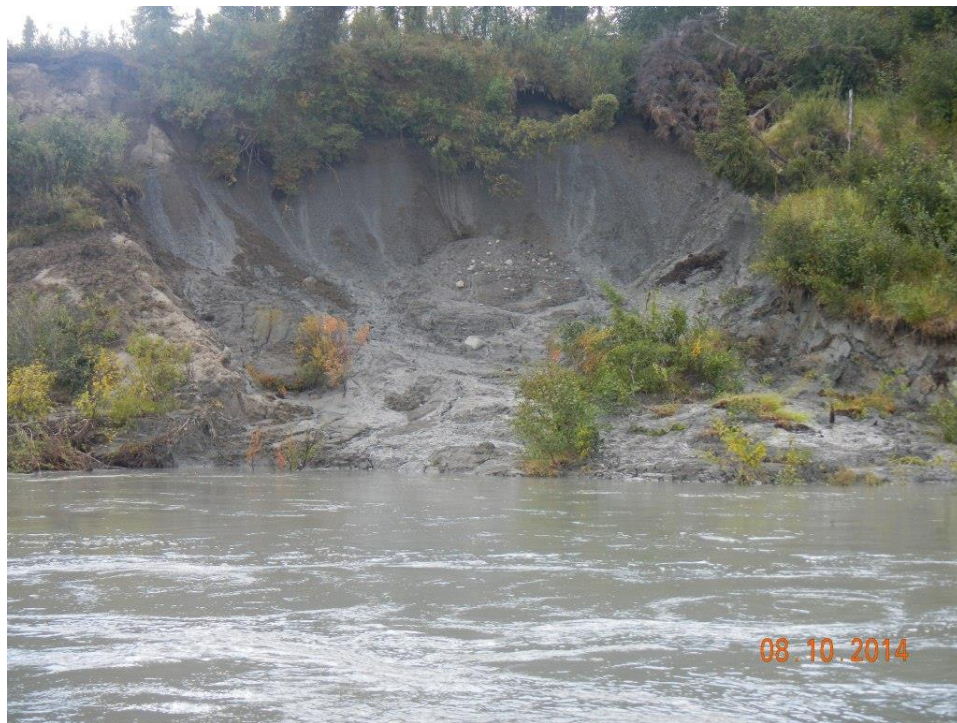
**Figure A.2-4 – Pop out slide in moraine near PRM 259.5, probably due to melting of permafrost (P220).**

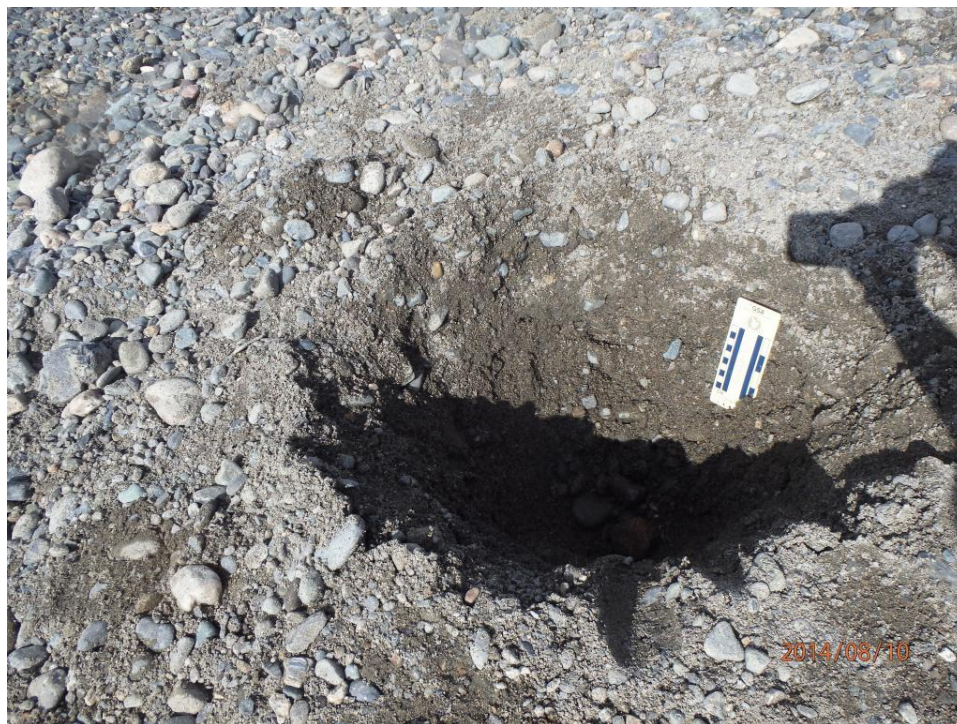
**Figure A.2-5 – Surface and subsurface material at sediment sampling site at PRM 258.6. Median particle diameter ( $D_{50}$ ) of surface sediment is 40.5 mm. Median particle diameter ( $D_{50}$ ) of subsurface sediment is 10.1 mm (P821).**

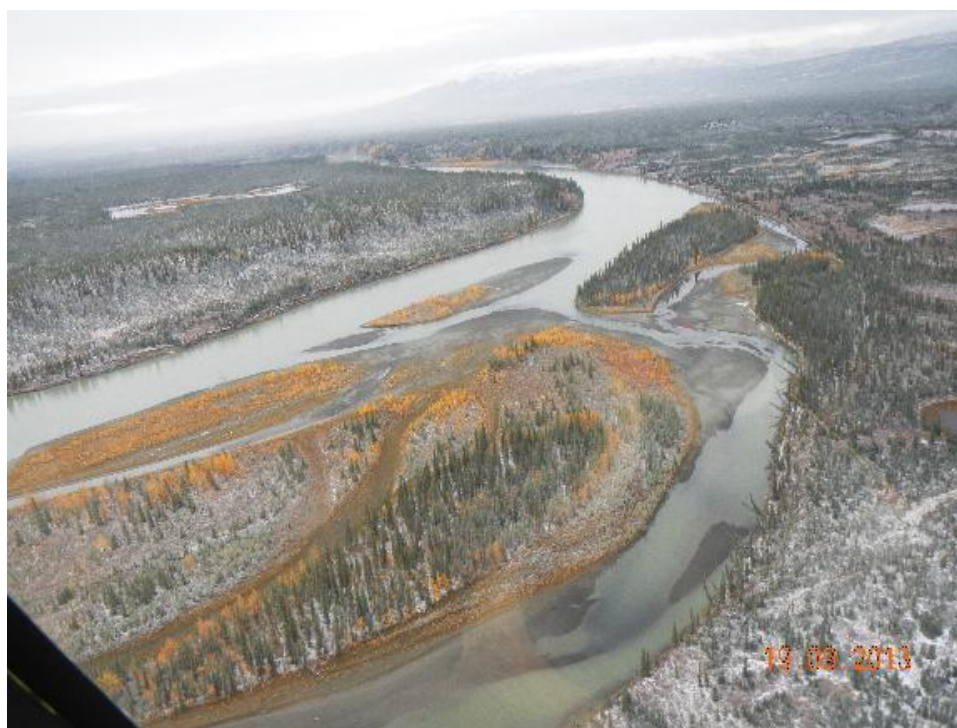
**Figure A.2-6 – View upstream of channel expansion zone at PRM 257. Note presence of vegetated islands (P5540).**

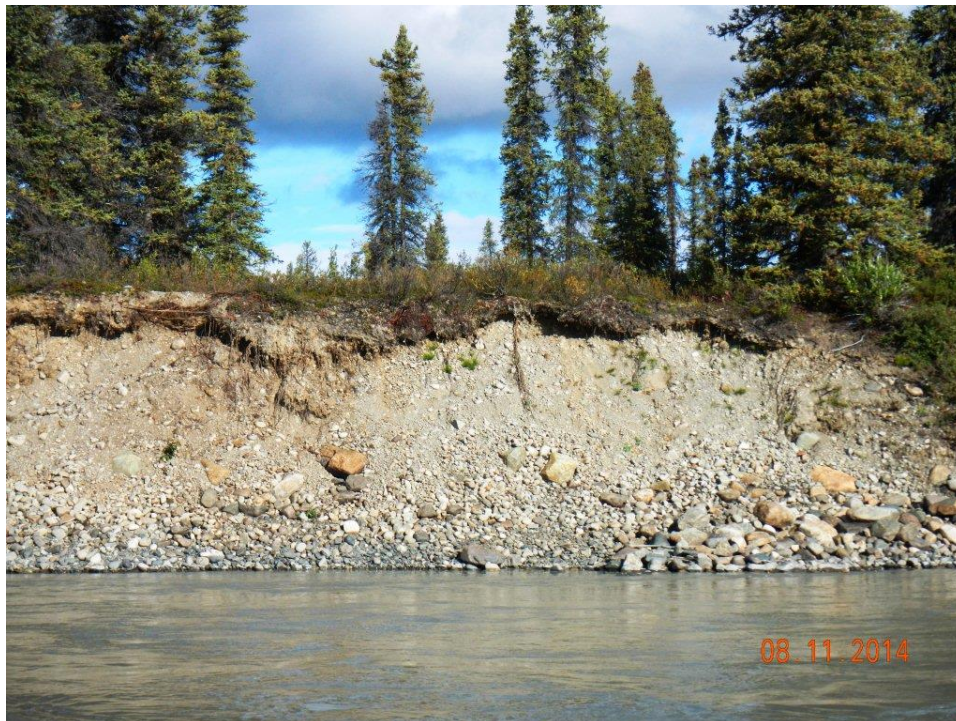
**Figure A.2-8 – Eroding outwash terrace in constriction at PRM 256 – presence of larger boulders in deposit previously not observed upstream (P258).**

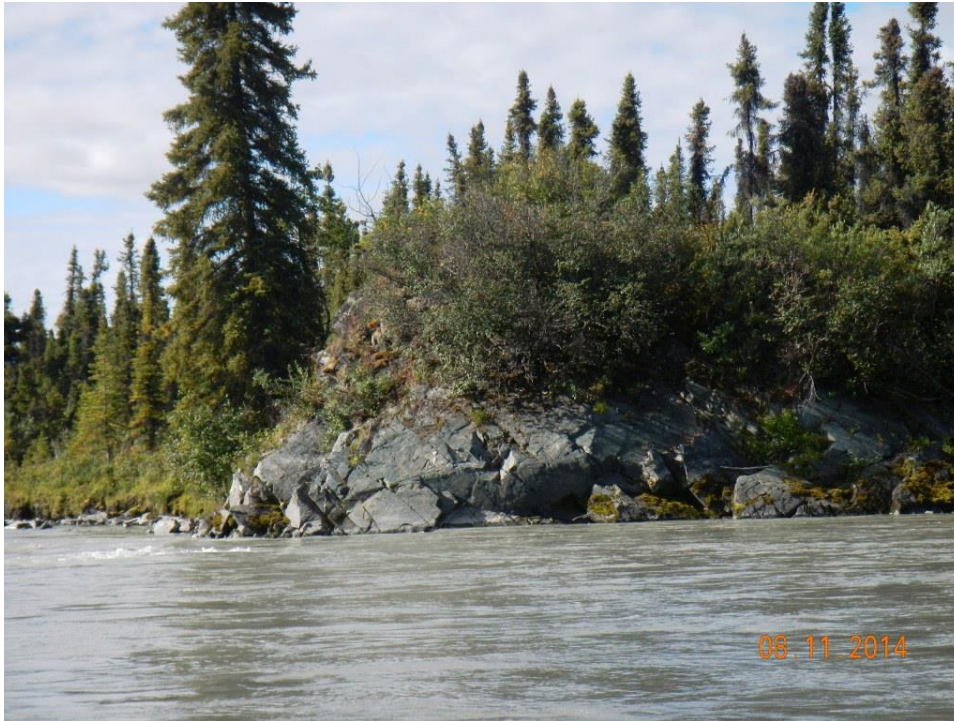
**Figure A.2-9 – Bedrock outcrop in right bank at PRM 255.5 (P272).**

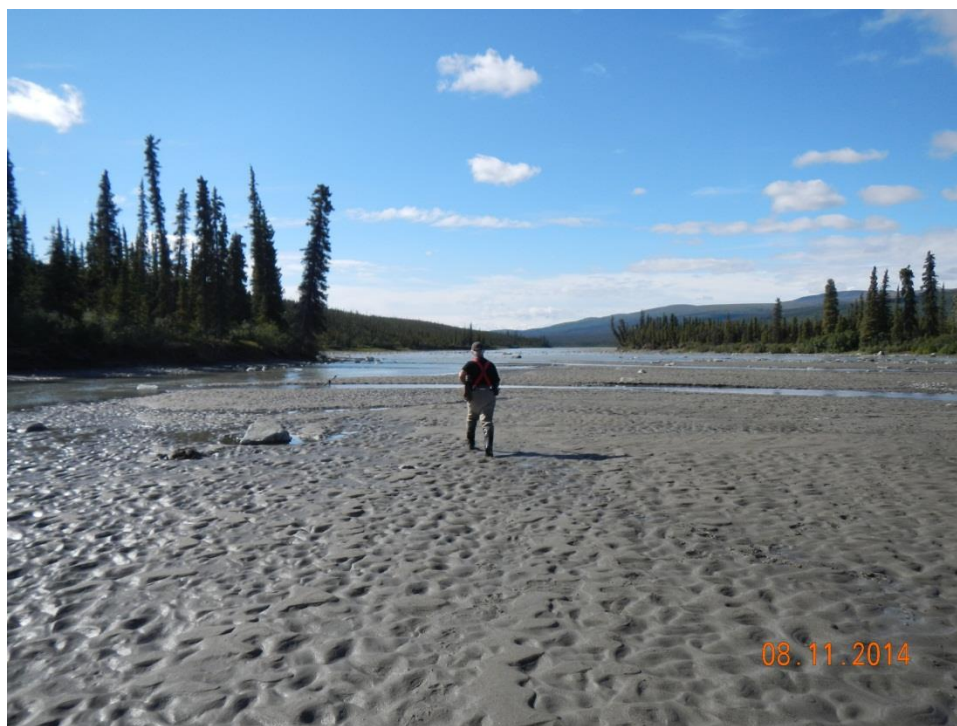
Figure A.2-13 – Sand lobe at downstream end of ice-driven side channel near PRM 254.5 (P315).
