## Susitna-Watana Hydroelectric Project Document ARLIS Uniform Cover Page

| <b>Title:</b><br><br>Geomorphology study, Study plan Section 6.5, 2014-2015 Study Implementation Report. Appendix A. Susitna River upper river reconnaissance photographs | | <b>SuWa 289</b> |

## APPENDIX A: SUSITNA RIVER UPPER RIVER RECONNAISSANCE PHOTOGRAPHS

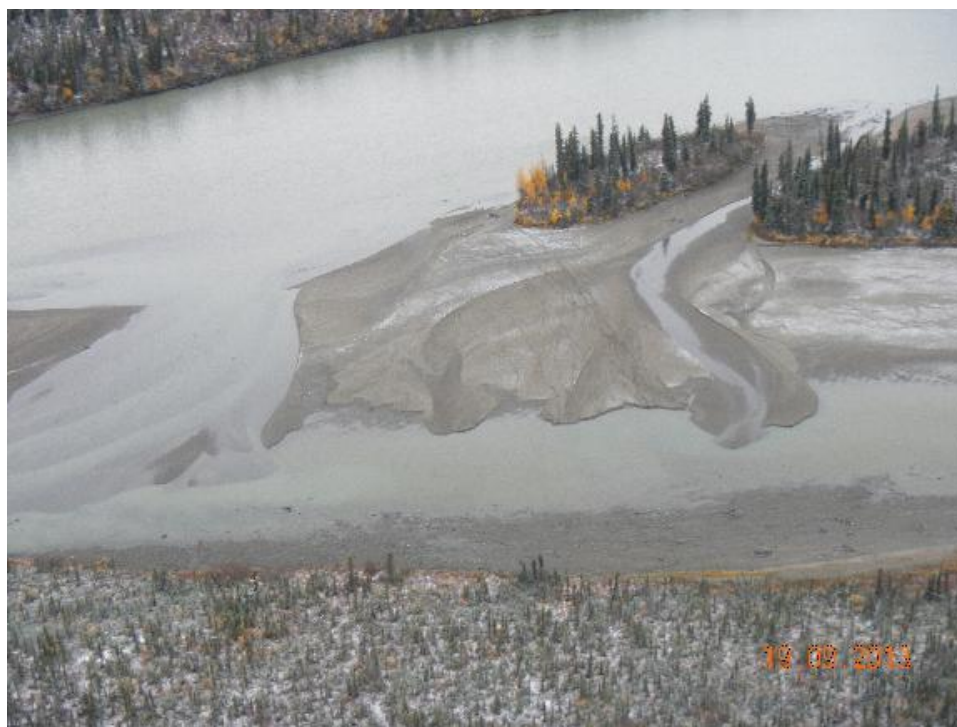
Figure A.2-14 – View of sand bar at bottom end of ice-driven side channel at PRM 254 (P5539).

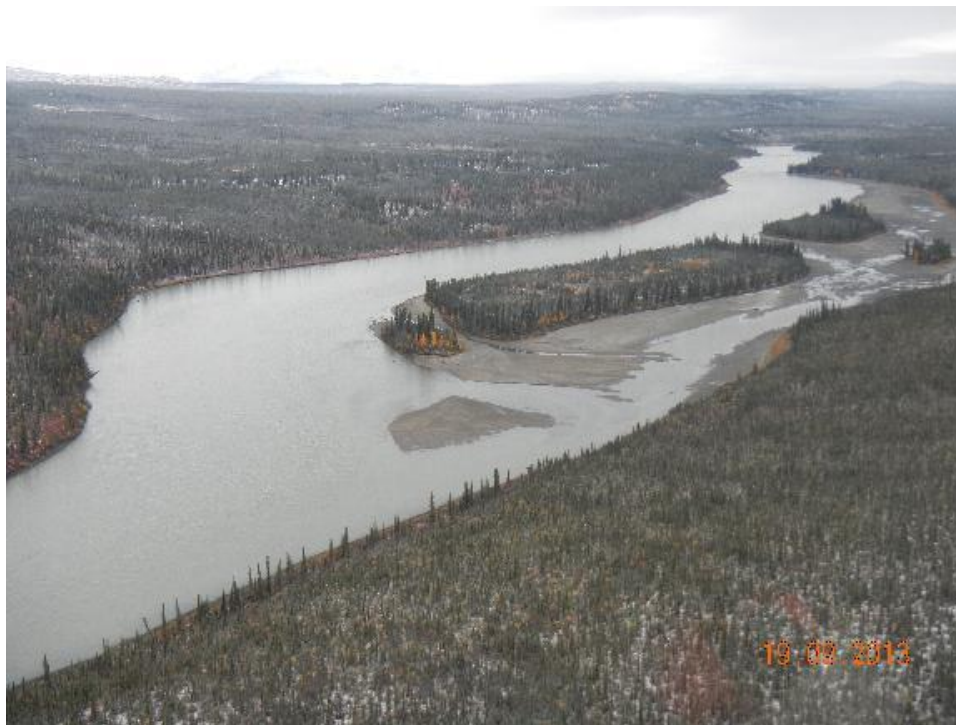
**Figure A.2-16 – View upstream of vegetated islands and bars upstream of constriction near PRM 254 (P5538).**

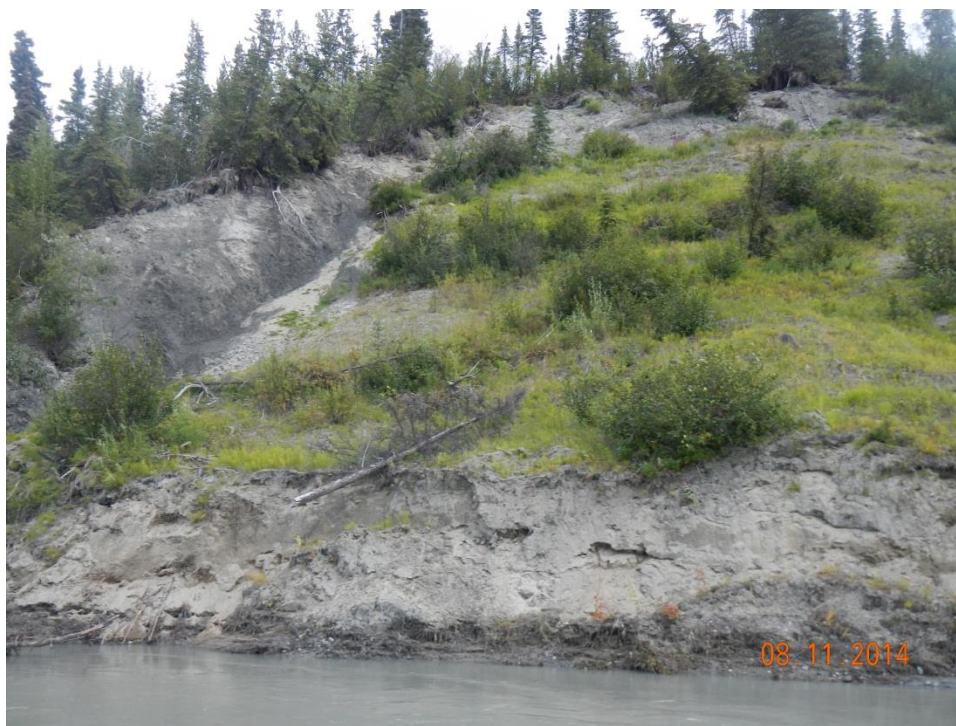
**Figure A.2-17- Active landslide in till near PRM 251.8 (P400).**

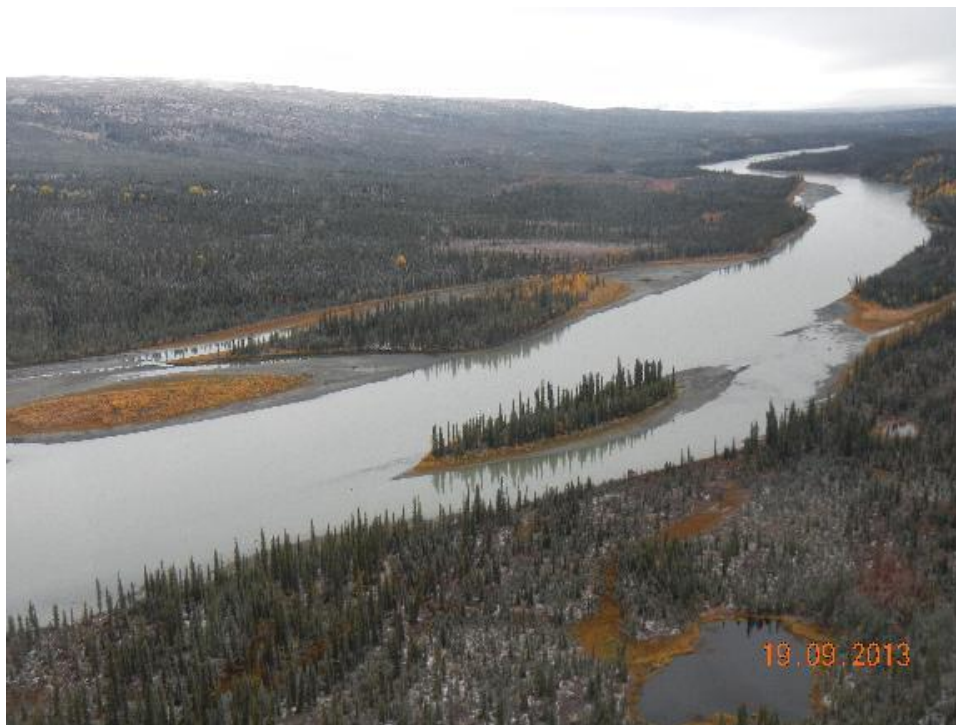
**Figure A.2-18 – View upstream of vegetated islands and bars in expansion zone near PRM 250 (P5536).**

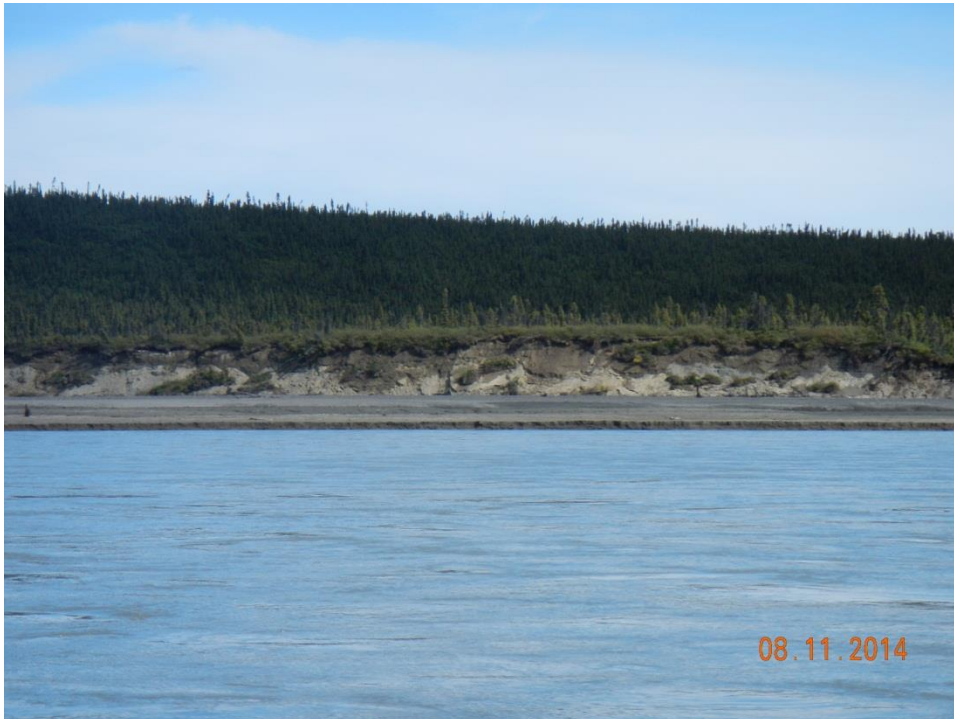
**Figure A.2-20 – Slab failures along outwash surface near PRM 250. Note lateral moraine along the skyline (P440).**

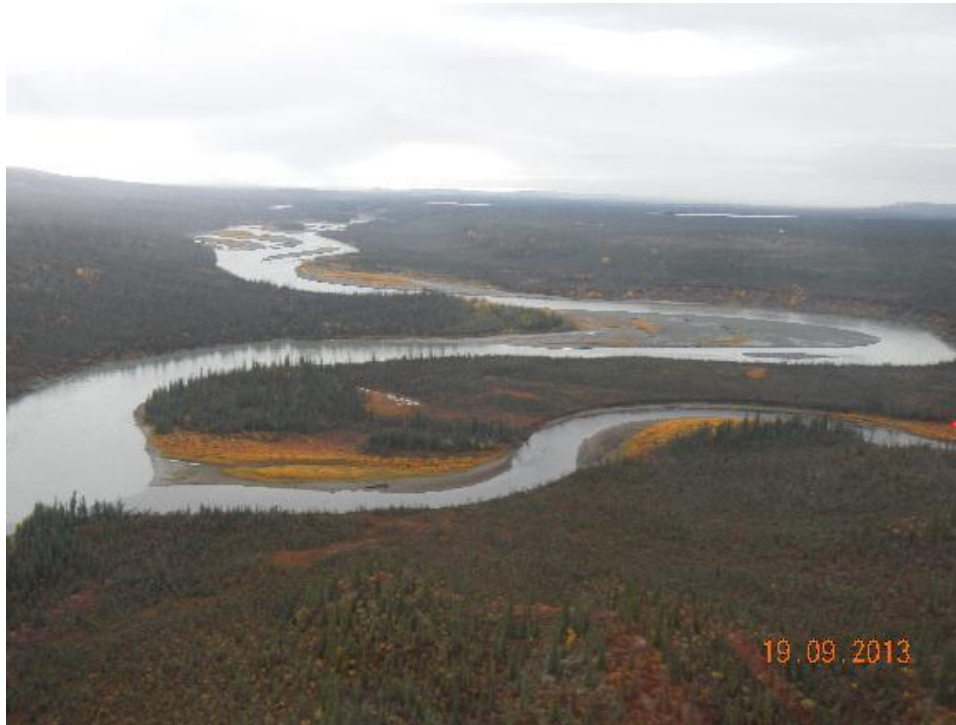
Figure A.2-21 – View upstream near PRM 247 illustrating forced sinuosity at UR-2/UR-3 reach break and Tyone River confluence at lower end of photo (P5529).

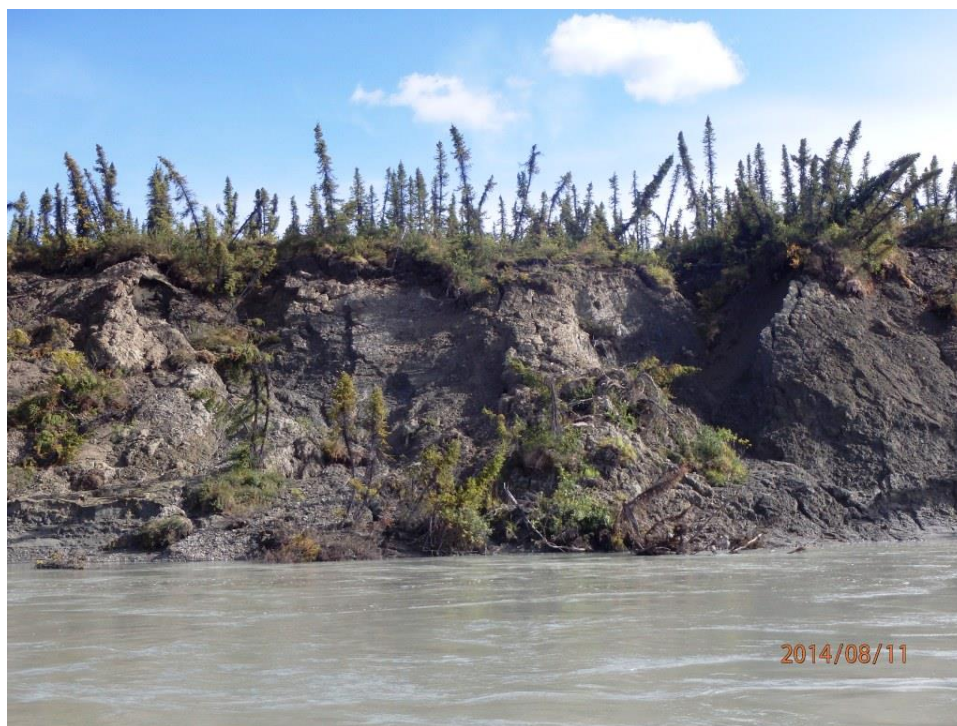
**Figure A.2-25 – Fine-grained materials and gravel sourcing from eroding outwash terrace surface near PRM 247.7 (P918).**

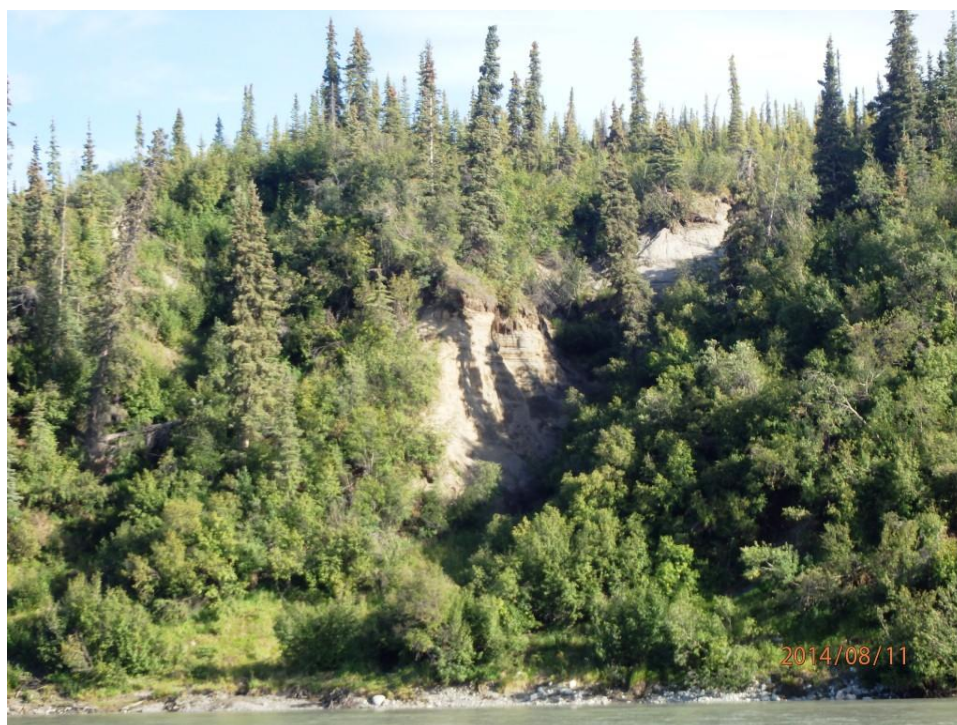
**Figure A.2-26 – Active landslide zone in till near PRM 245.5 (P973).**

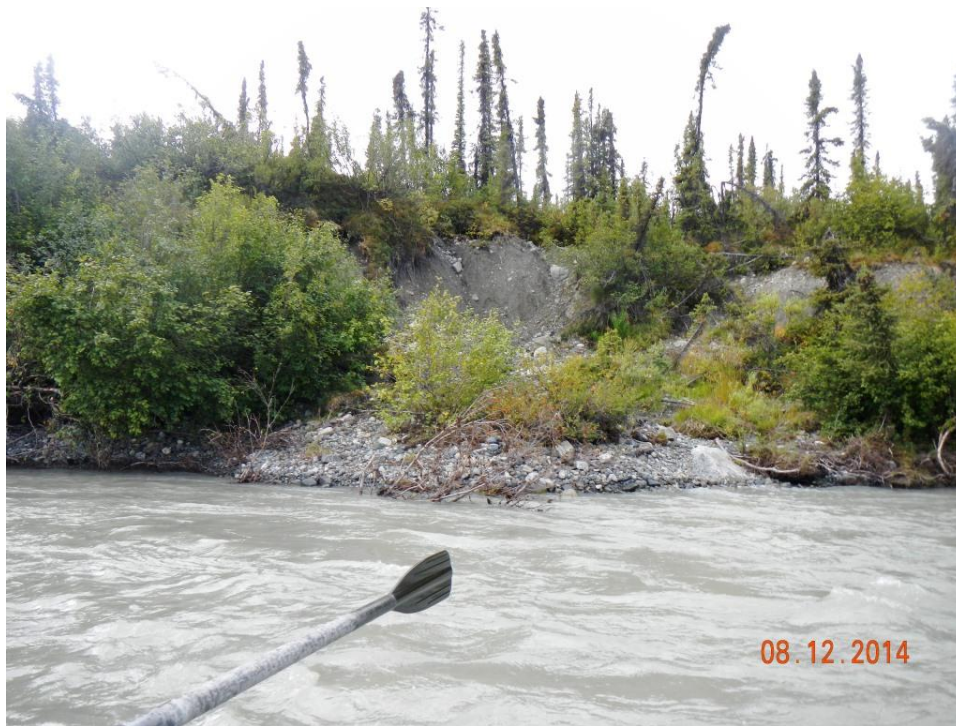
**Figure A.2-31 – Pop out slide in till – local gravel source near PRM 240 (P554).**

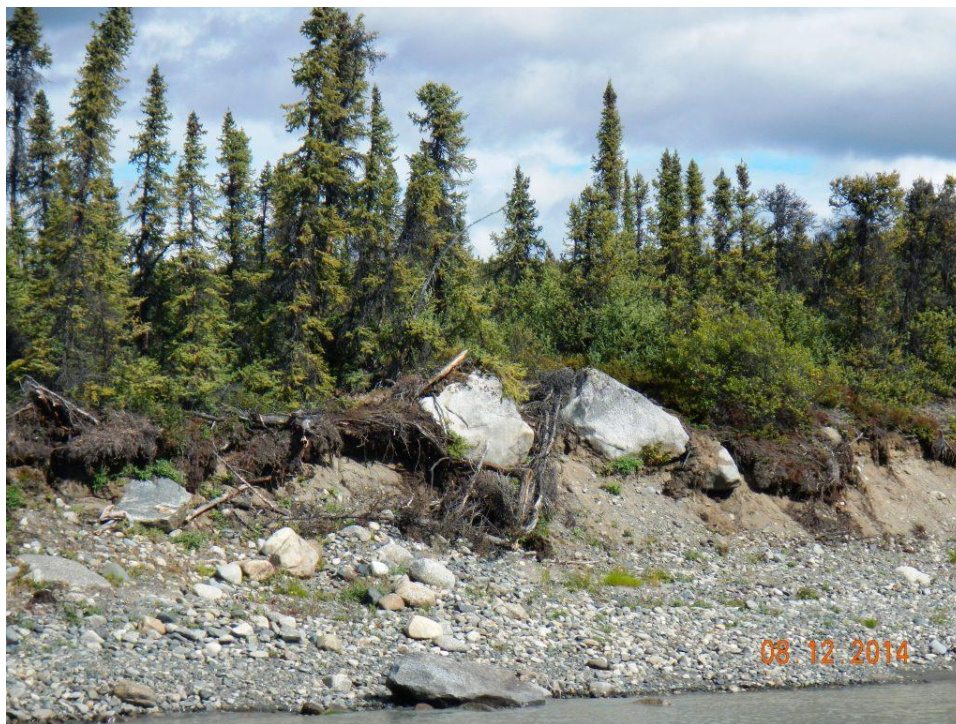
**Figure A.2-35 – Ice deposited boulders on top of bank near PRM 237.6 (P650).**

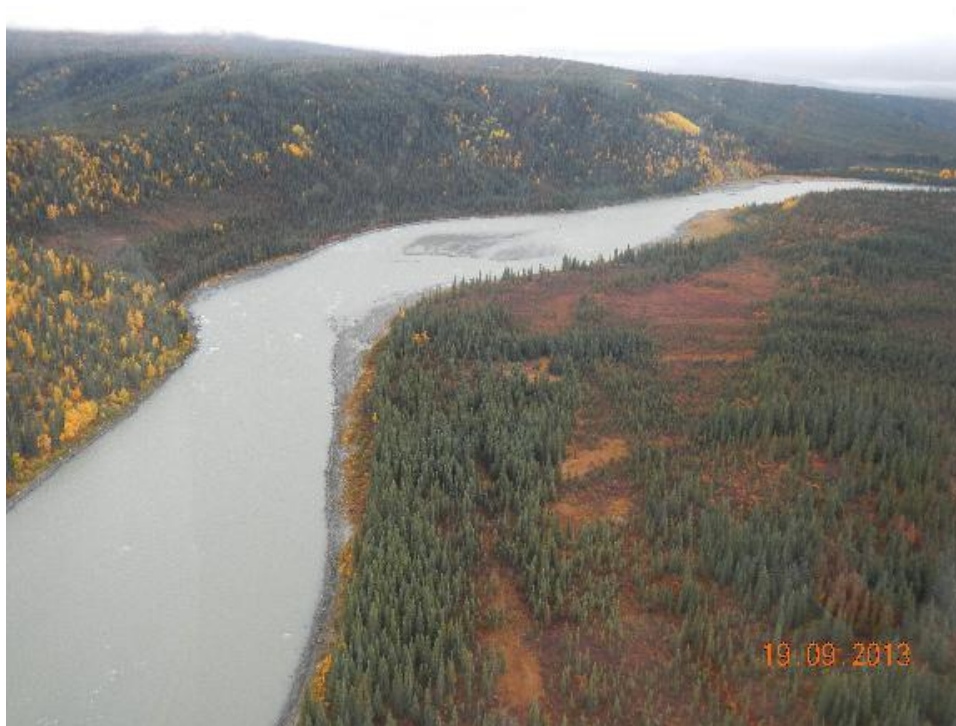
Figure A.2-40 – View upstream near PRM 233.5 to first expansion zone with mid-channel bar since UR-1 (P5516).

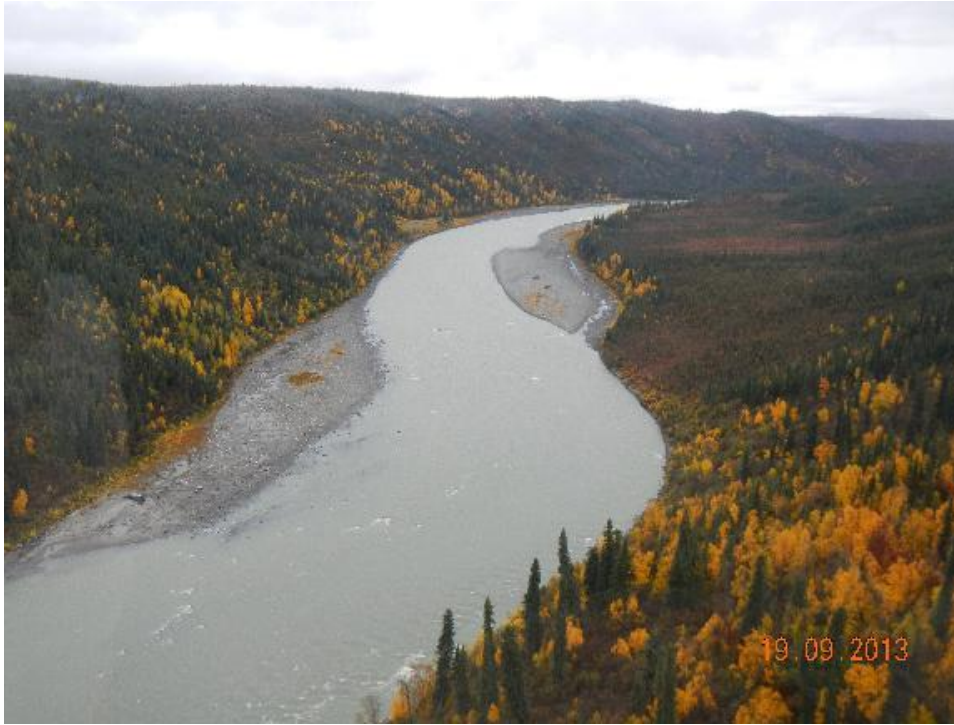
**Figure A.2-41 – View upstream at PRM 230.5 – ice paved bank-attached gravel bars – vegetated bedrock banks. Old fan surface observed on left bank (P5512).**

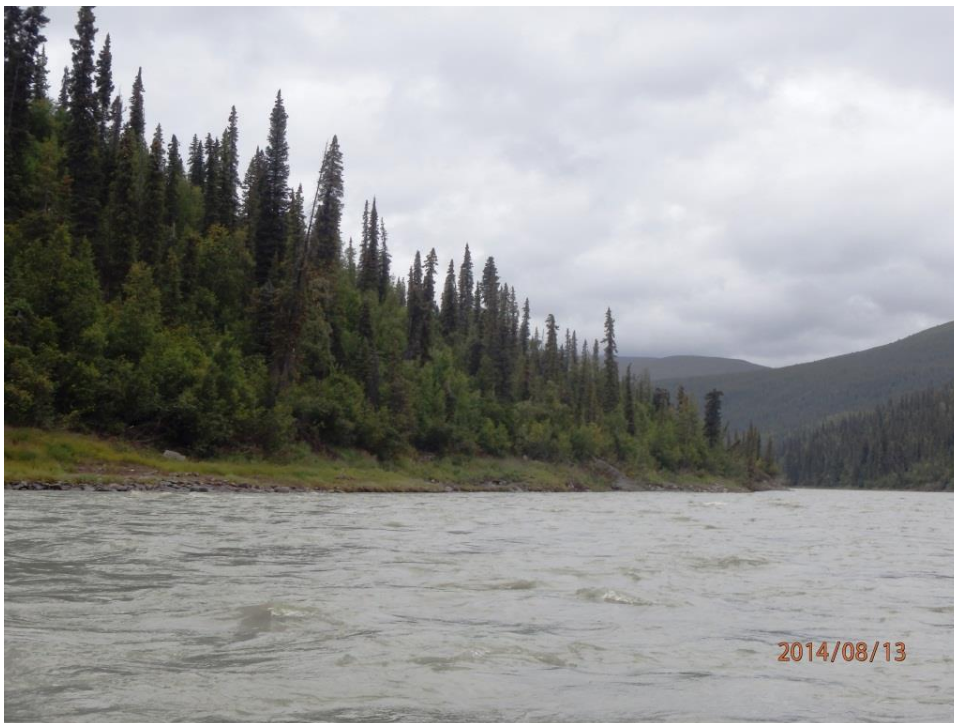
**Figure A.2-42 – Typical vegetated hillslope (PRM 229.5) observed throughout reach. Note height of ice trim line about 10-20 feet above water surface (P033).**

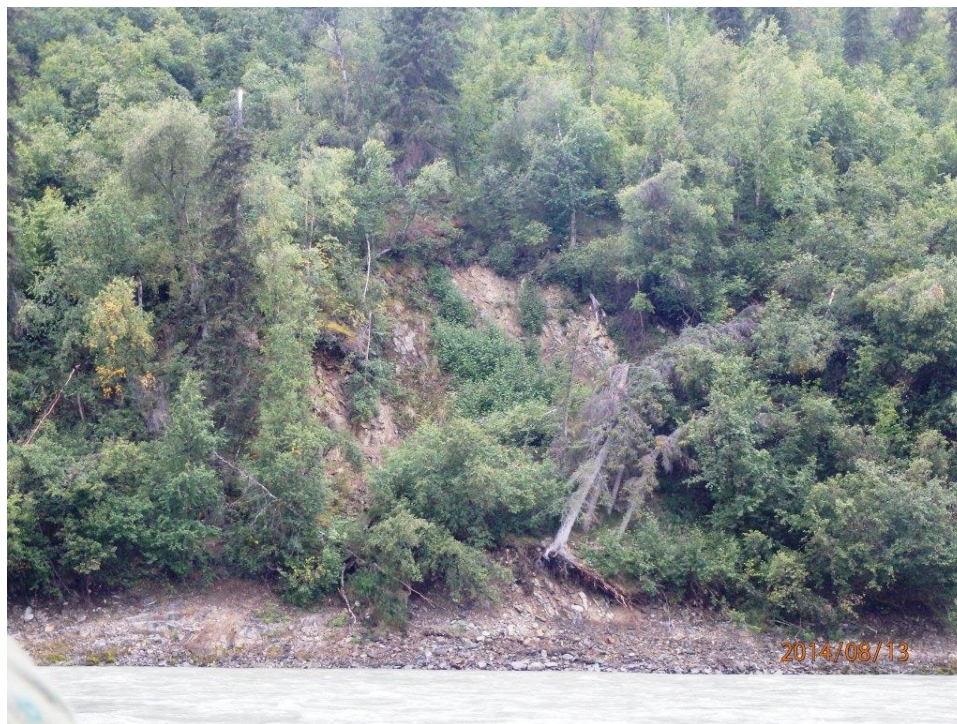
**Figure A.2-43 – Shallow slide in colluvial materials overlying bedrock on hillslope near PRM 229.5 (P032).**

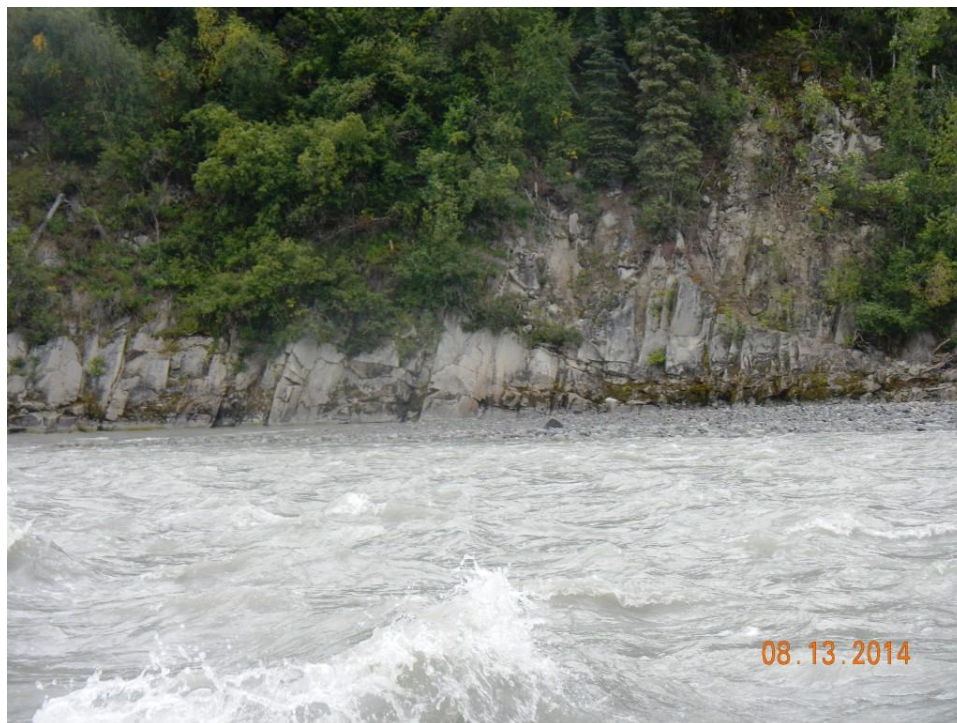
**Figure A.2-44 – Bedrock right bank near PRM 232.5 (P829).**

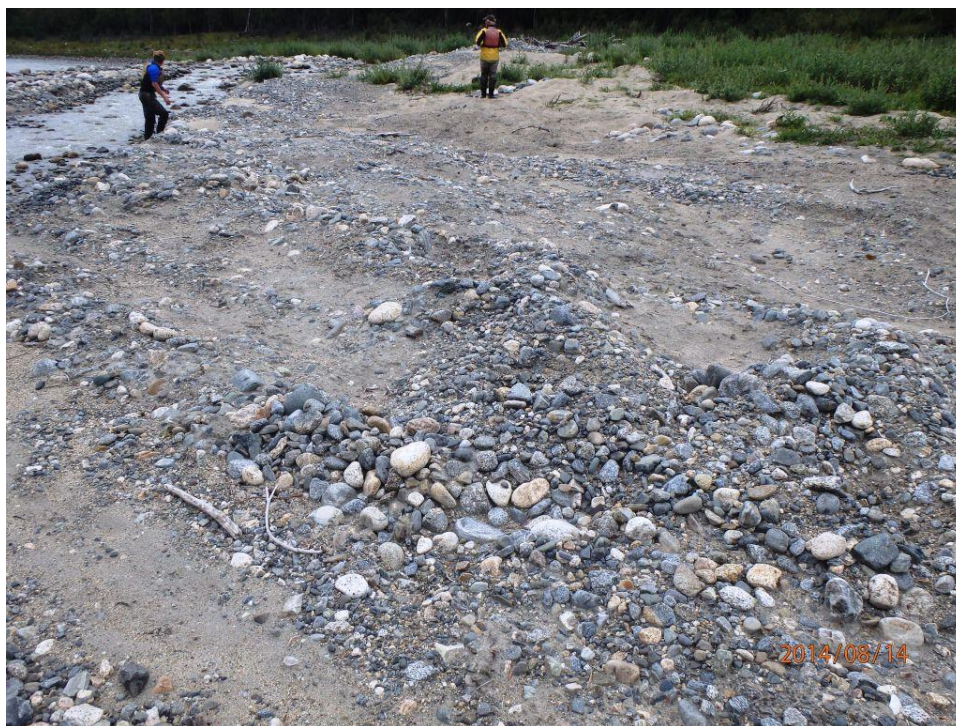
Figure A.2-53 – Ice pushed ridges on fan surface of Unnamed Tributary at PRM 221.2 (P121).

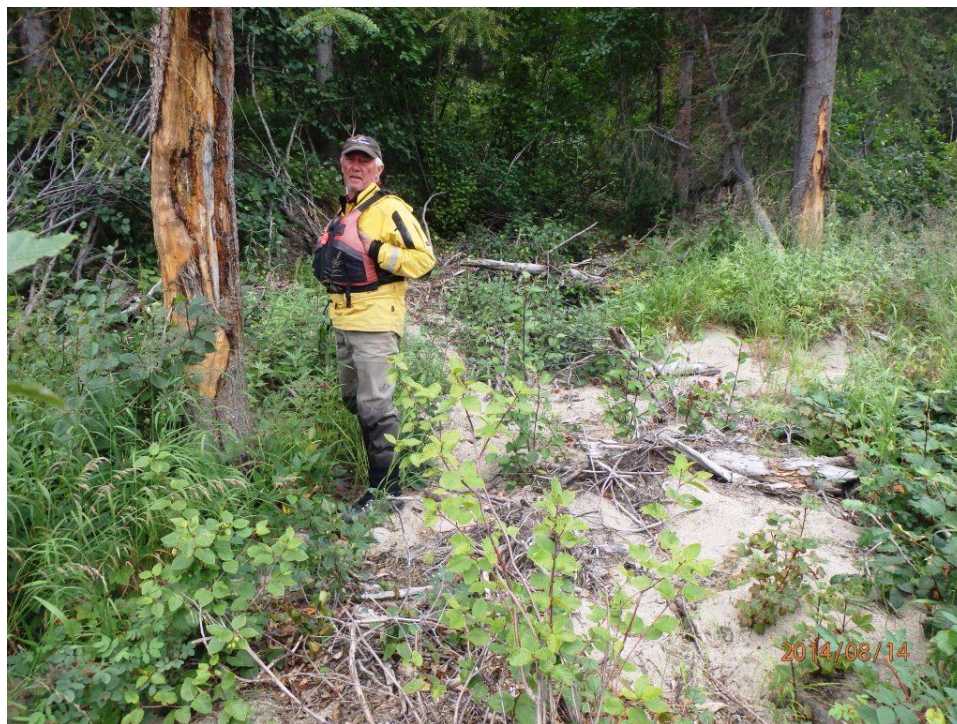
Figure A.2-54 – Sand deposits and ice scared trees on top of high fan surface at Unnamed Tributary PRM 221.2 (P131).

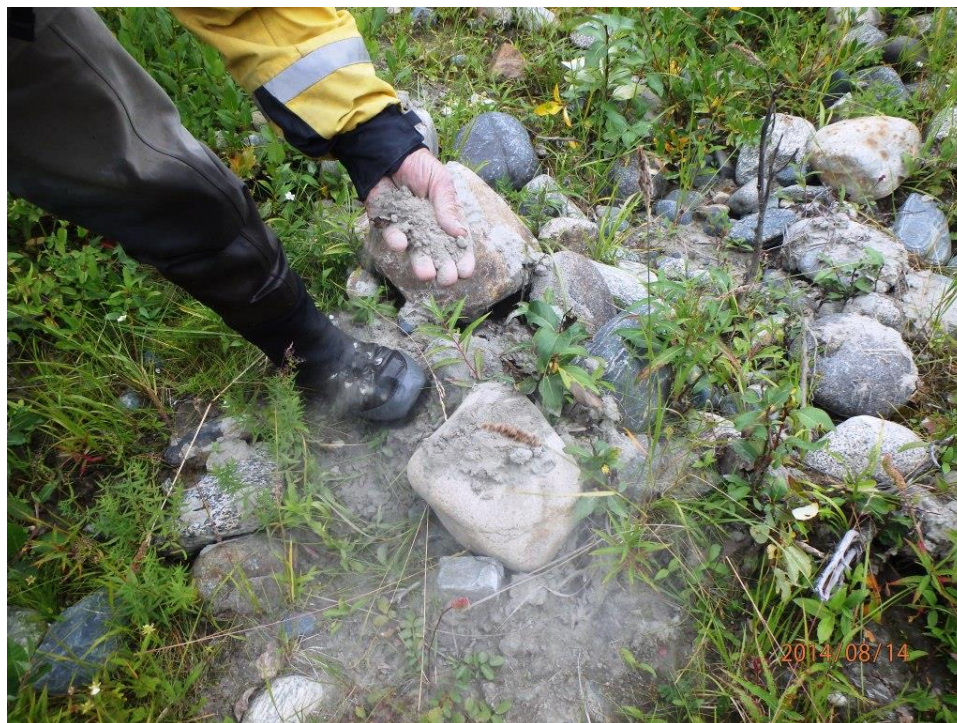
Figure A.2-55 – Fine grained material on top of ice-deposited coarse grained deposits on high fan surface at PRM 221.2 (P130).

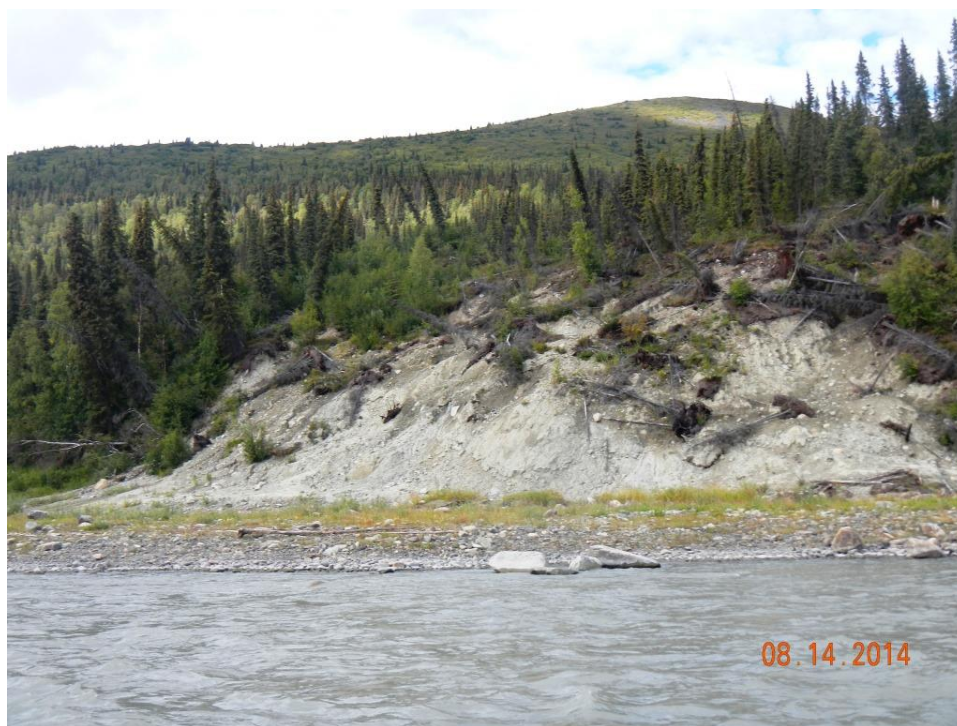
**Figure A.2-60 - Active landslide in till at PRM 217 (P964).**

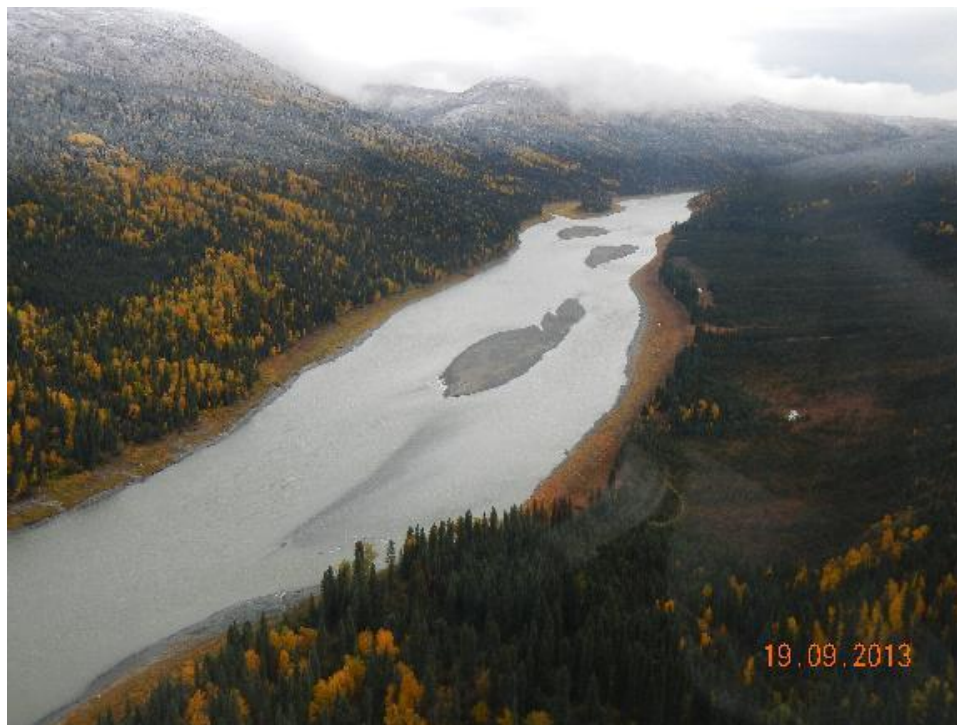
**Figure A.2-61 – View upstream of mid-channel bars at PRM 215. Bedrock outcrop along right bank (P5484).**

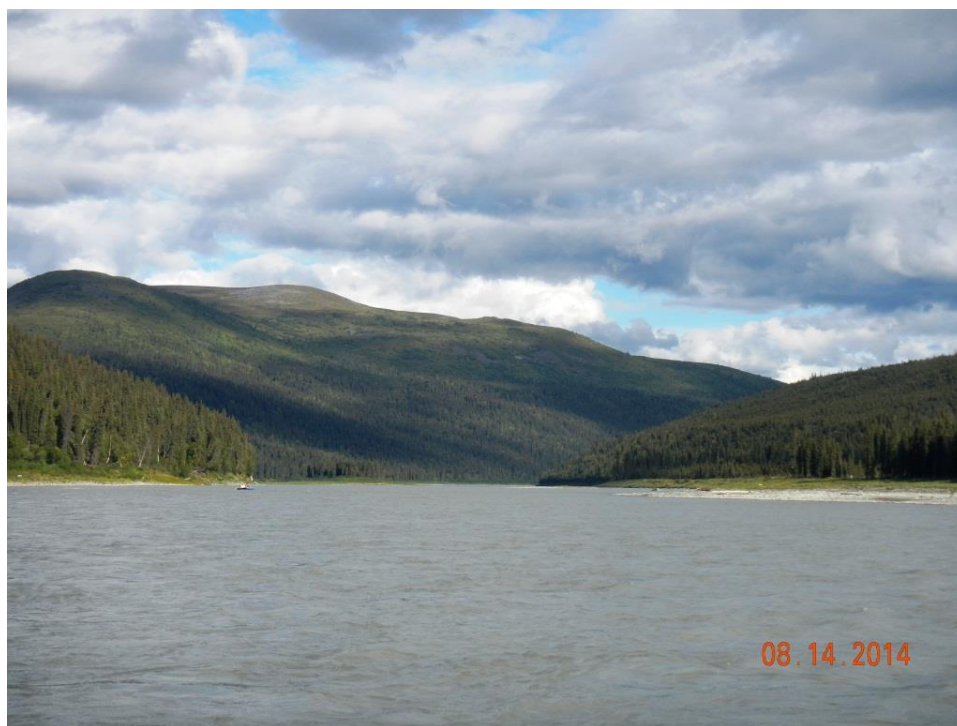
**Figure A.2-62 – View upstream at PRM 215 of vegetated hillslopes in wider valley (P996).**

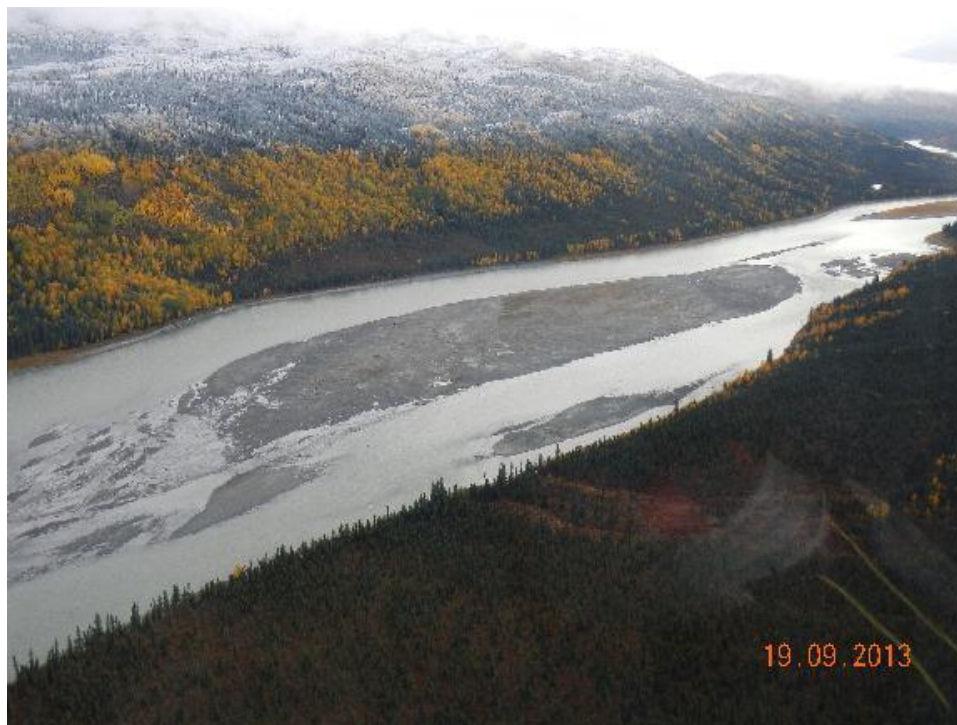
**Figure A.2-63 – View upstream near PRM 212 of large gravel bars in expansion zone (P5481).**

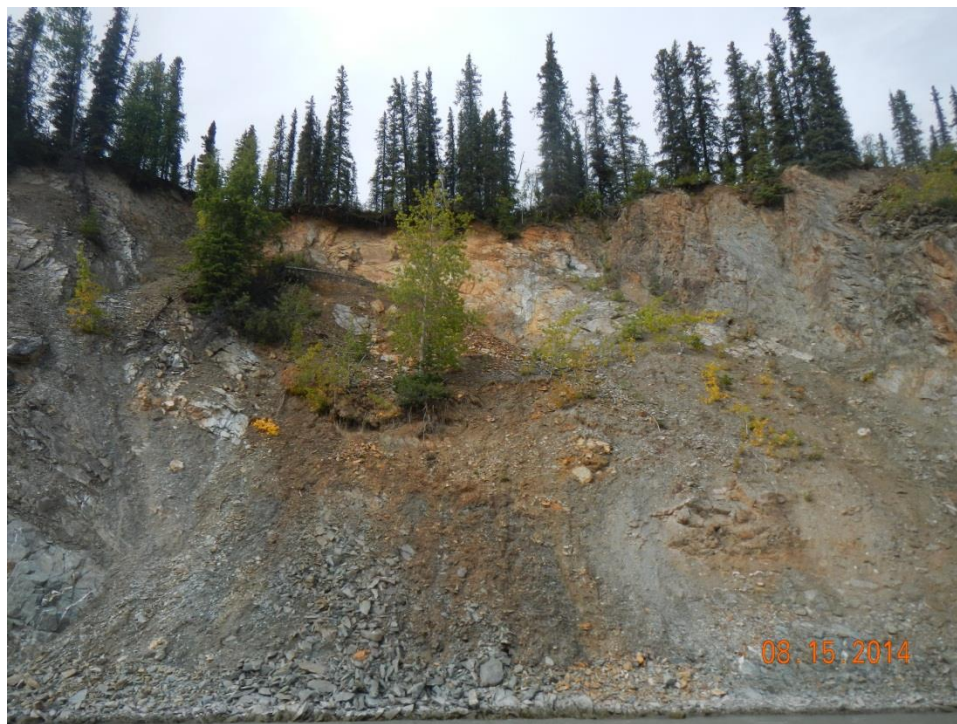
**Figure A.2-68 – Hydrothermally-altered rock at PRM 207.4 (P142).**

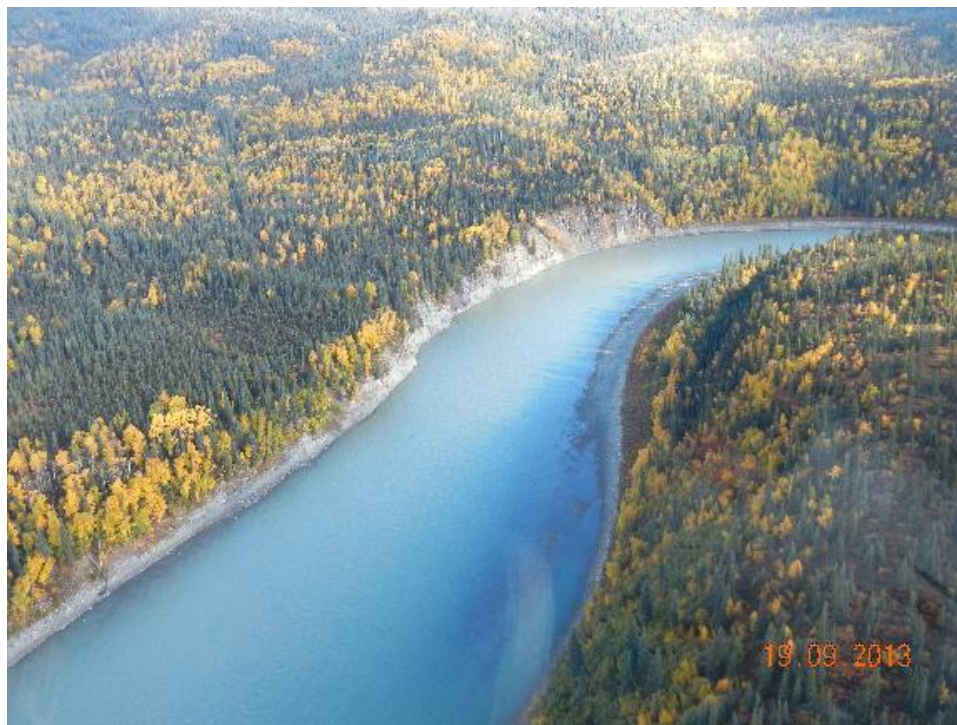
**Figure A.2-69 – View upstream at PRM 207. Bedrock controlled single channel. Outcrop in P142 seen on outside of bend (P5471).**

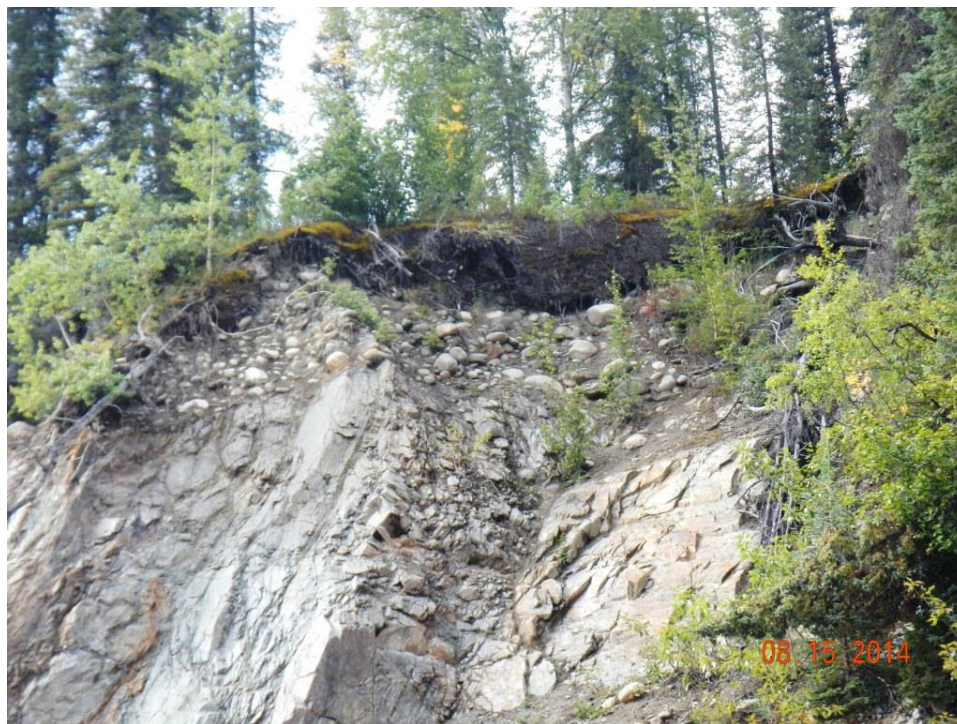
Figure A.2-70 – Bedrock underlain strath terrace near PRM 207.2 (P145).

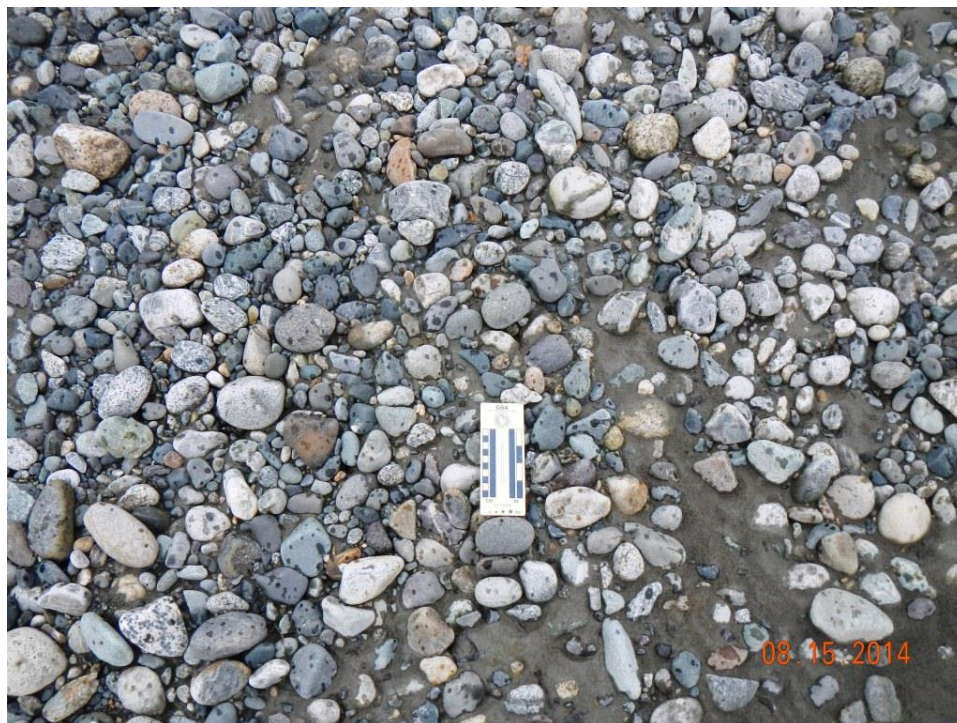
Figure A.2-71 – Surface material at PRM 206.8. Average median particle diameter ( $D_{50}$ ) in reach (UR-5) is 47.5 mm (P165).

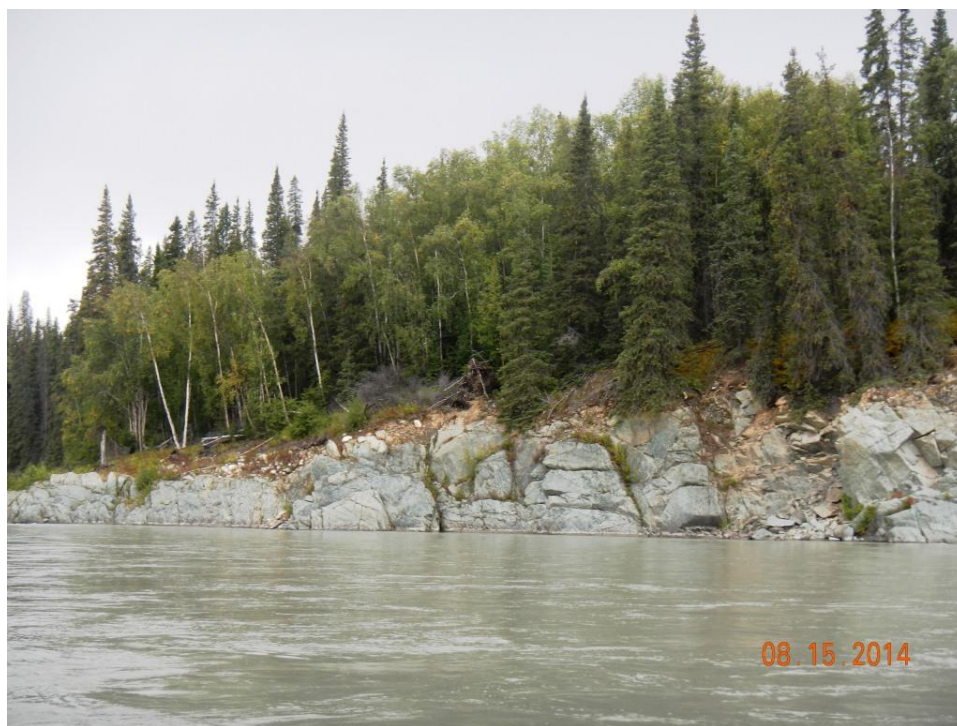
**Figure A.2-72 – Bedrock outcrop with overlying strath deposits at PRM 205.5 on right bank (P188).**

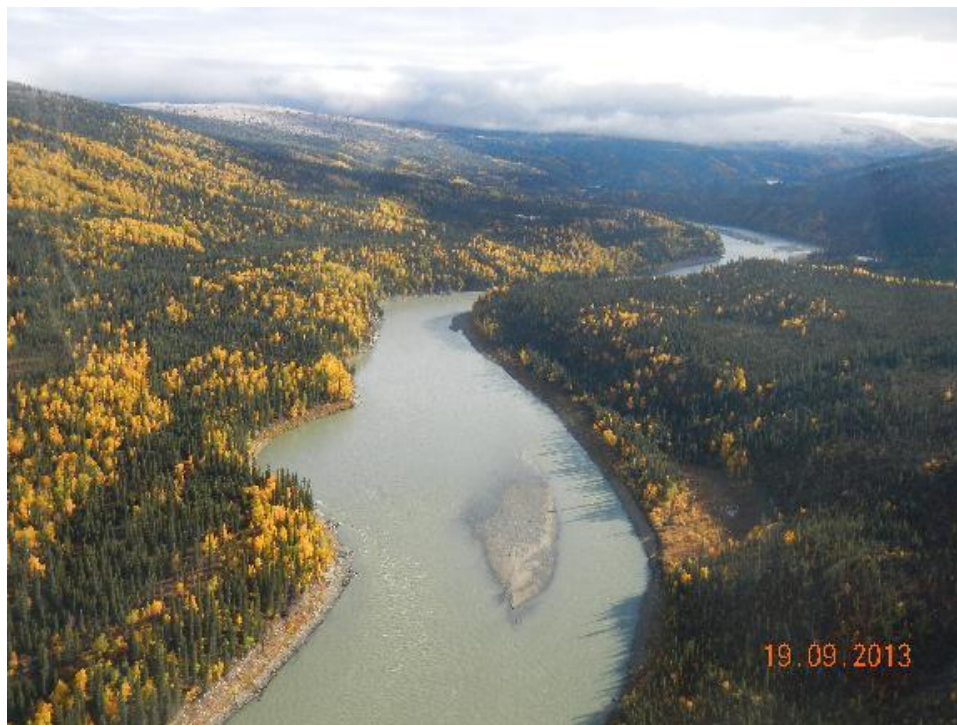
**Figure A.2-73 – View upstream near PRM 205 (P5466).**

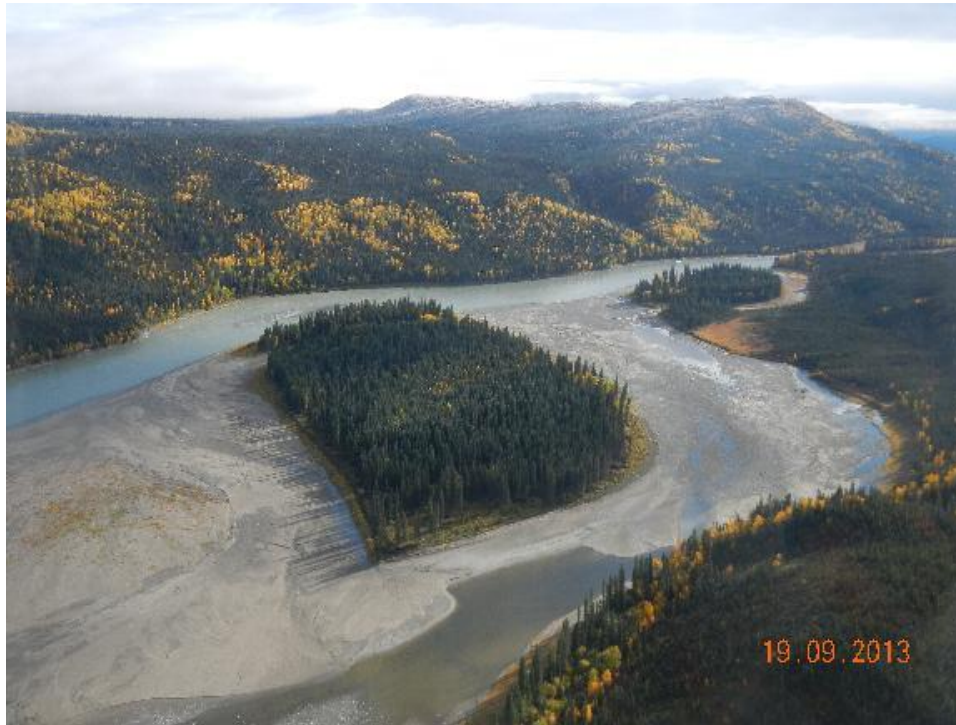
Figure A.2-76 - View upstream towards UR-5/UR-6 boundary of expansion zone in UR-6 (P5462).

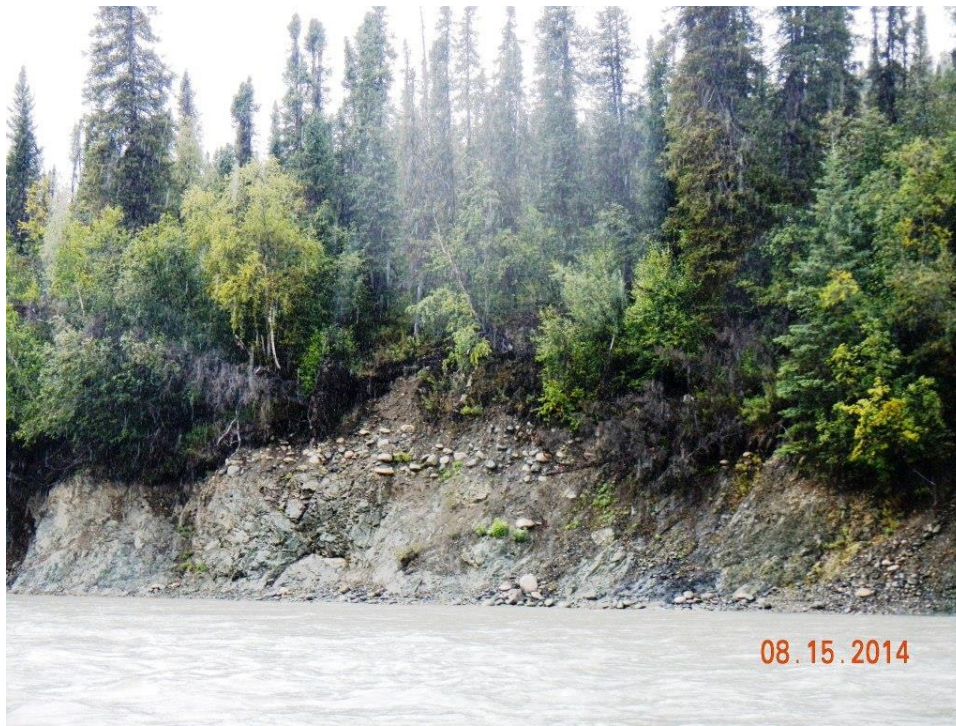
Figure A.2-77 - Susitna River right bank at PRM 202.7. Ice line on vegetation present in addition to eroded bedrock and outwash material (P250).

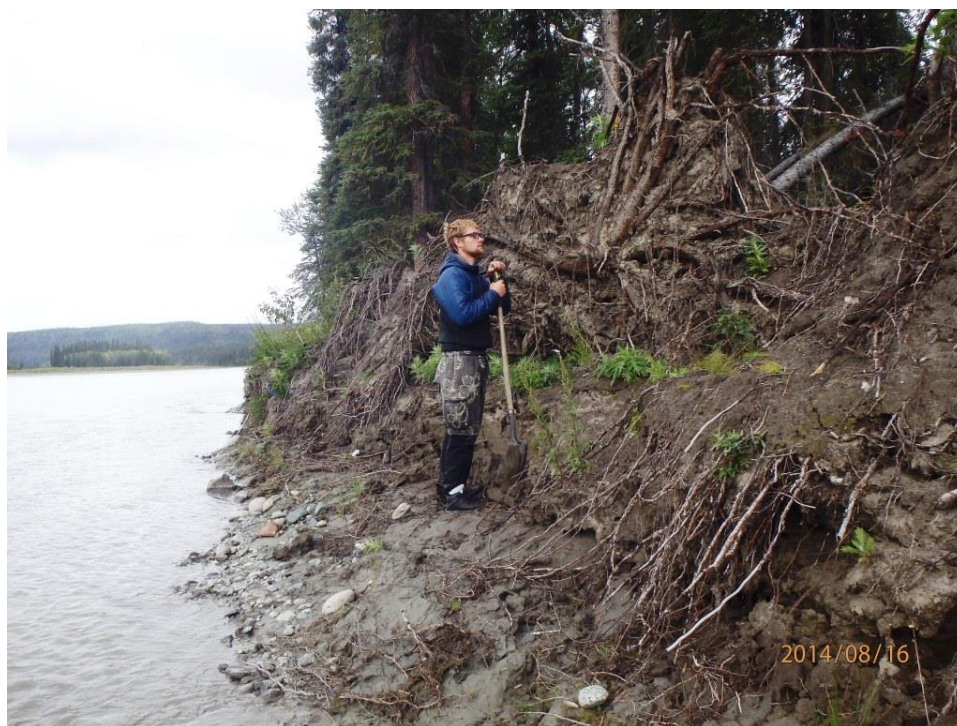
**Figure A.2-86 – Ice effects on floodplain erosion near PRM 196.6 (P430).**

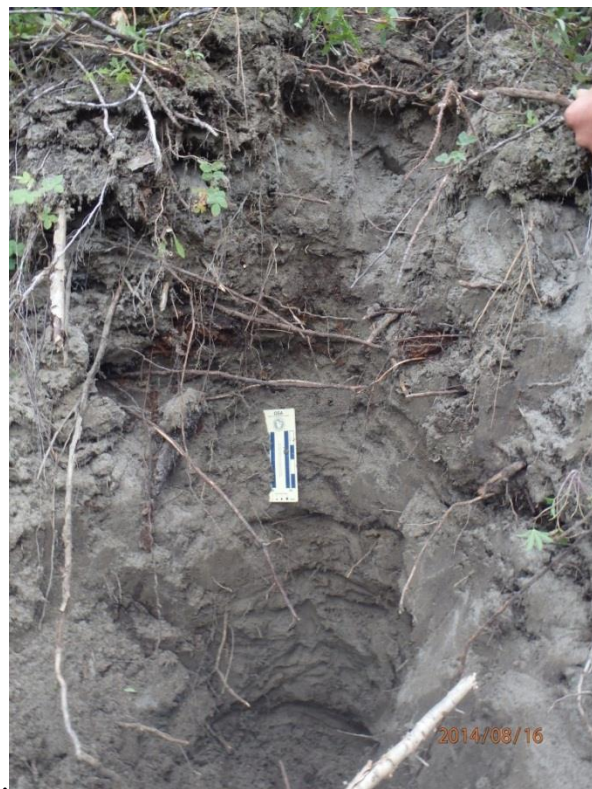
**Figure A.2-87 – Bank stratification at PRM196.6. Note – This was the first observed occurrence of a relatively low floodplain in the Upper River Segment typical of those common in the Middle River Segment (approximately 6' from water surface on 8/16/14) (P432).**
