## Susitna-Watana Hydroelectric Project Document ARLIS Uniform Cover Page

| <b>Title:</b><br><br>Geomorphology study, Study plan Section 6.5, 2014-2015 Study Implementation Report. Appendix A. Susitna River upper river reconnaissance photographs | | <b>SuWa 289</b> |

## APPENDIX A: SUSITNA RIVER UPPER RIVER RECONNAISSANCE PHOTOGRAPHS

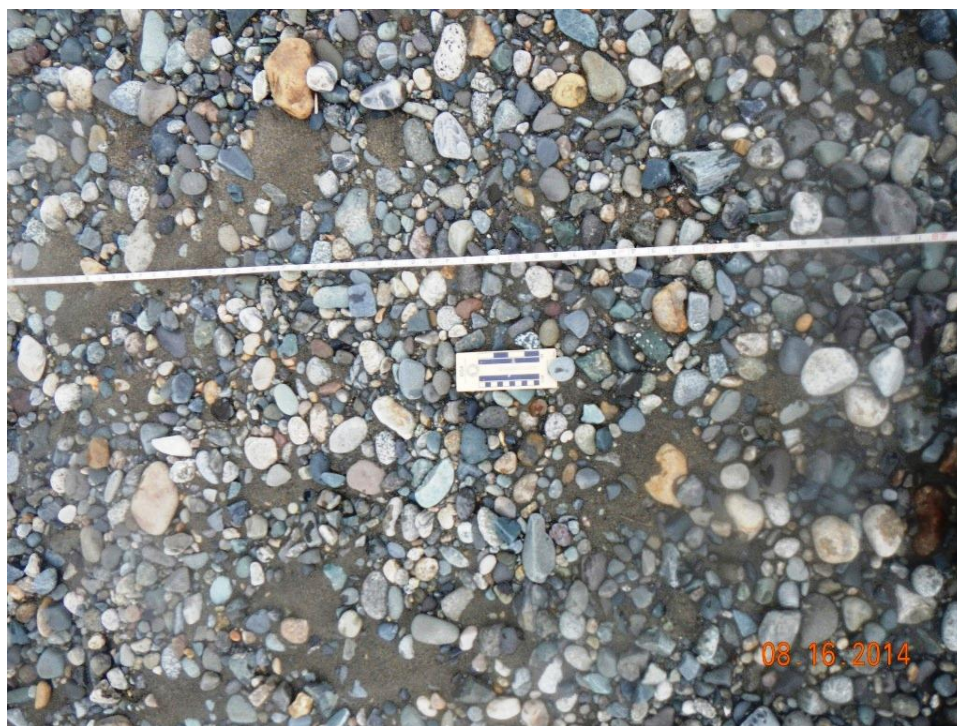
**Figure A.2-88 – Surface material at sediment sample location at PRM 196.5 – first exposed mid-channel bar downstream of Watana Creek. Median particle diameter ( $D_{50}$ ) is 26.1 mm (P374).**

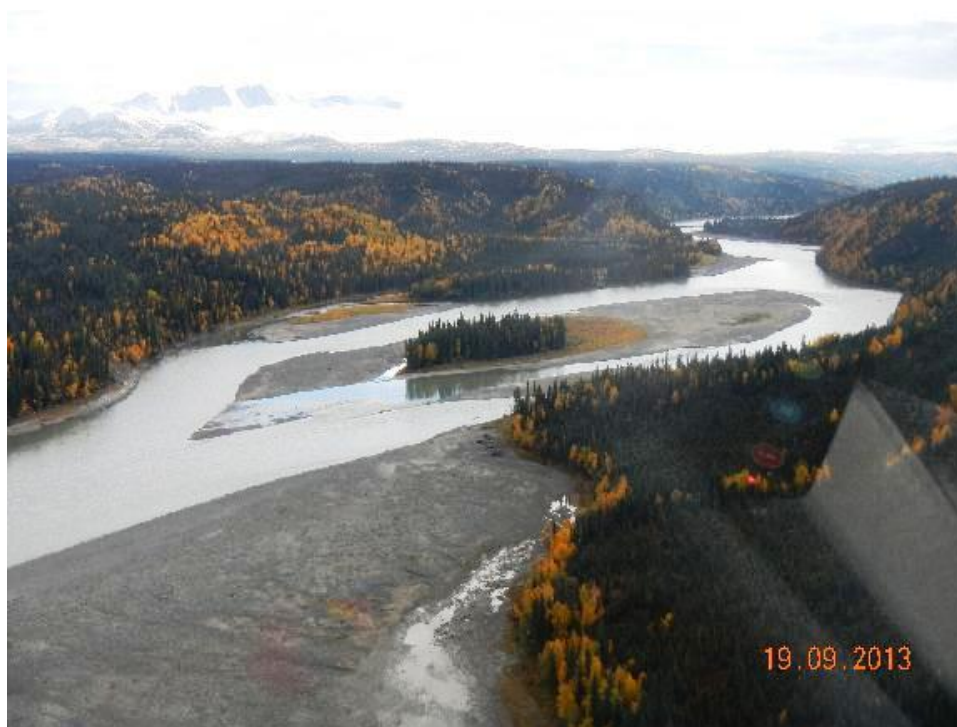
**Figure A.2-89 – View upstream of expansion zone near PRM 195.5 (P5444).**

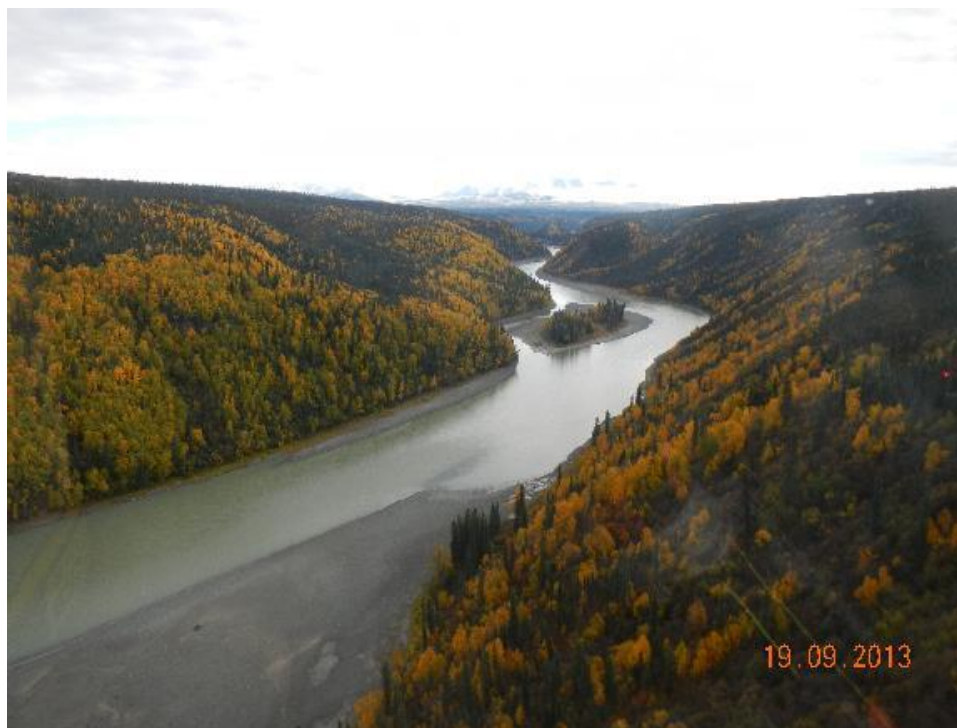
**Figure A.2-90 – View upstream near PRM 191 of bedrock bounded channel (P5438).**

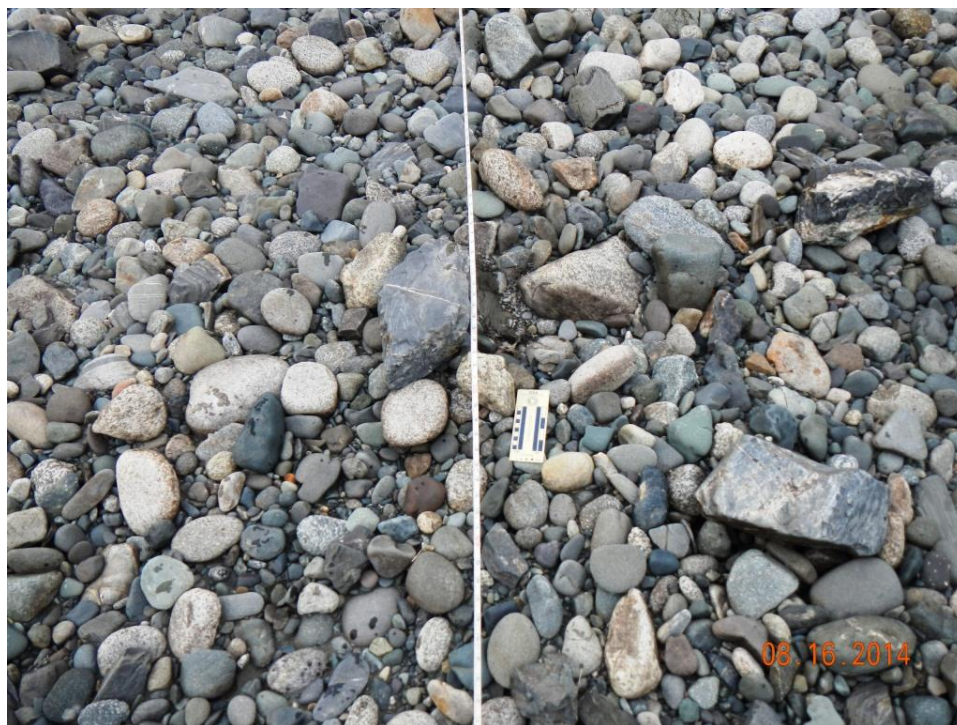
**Figure A.2-91 – Surface material sediment sampling site at PRM 190.1. Median particle diameter ( $D_{50}$ ) is 56.7 mm (P484).**

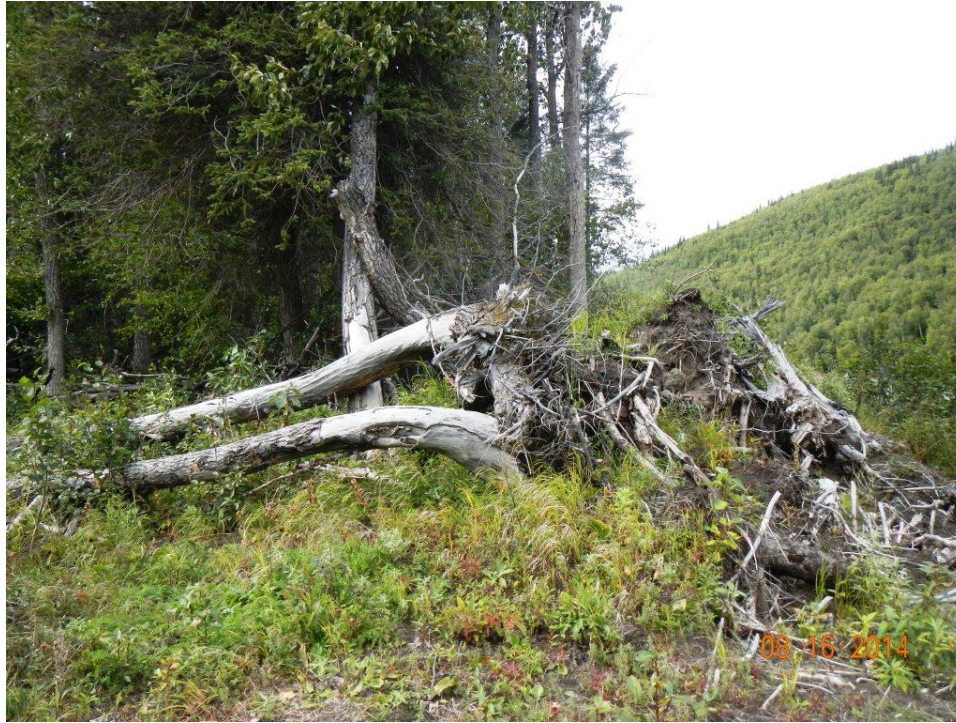
**Figure A.2-92 – Ice ramping and vegetation scarring at head of island at PRM 190.1. Similar ice effects observed at the head of other islands within the UR-6 Geomorphic Reach (P486).**

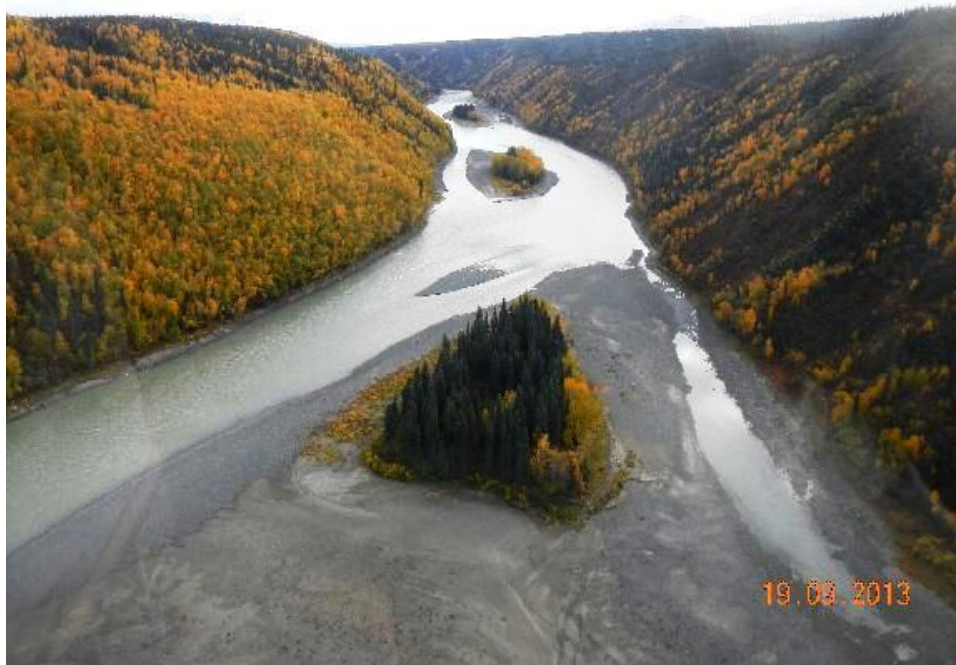
**Figure A.2-93 – View upstream from expansion zone upstream of Deadman Creek near PRM 190 (P5435).**
