**Susitna-Watana Hydroelectric Project  
(FERC No. 14241)**

**Study of Fish Passage Barriers in the Middle and  
Upper Susitna River and Susitna Tributaries (9.12)**

**Part A - Appendix A  
Tributary Geologic Barriers**

**Part A - Appendix B  
Middle River Tributary Delta Surveys Outside of  
Focus Areas**

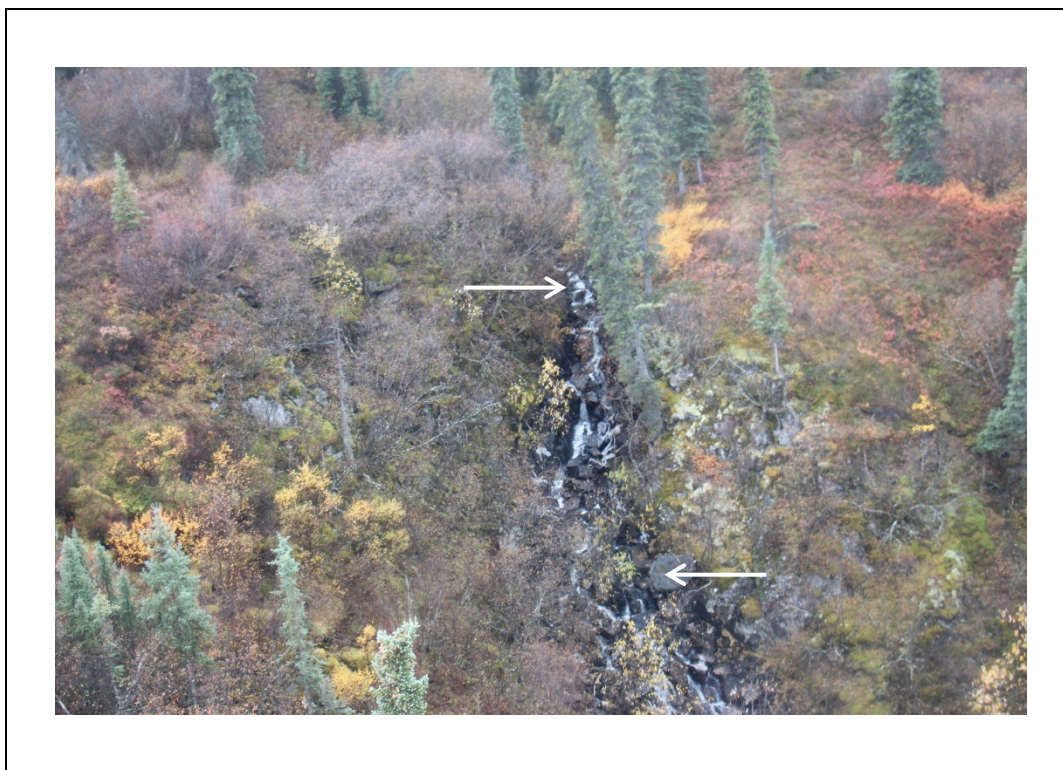
The potential barrier site was located at the upstream extent of a very high gradient reach of boulder dominated cascades (Figure A1). At the time of survey, flow conditions appeared to be very low, making it difficult to discern the true bottom of the barrier. The surveyed site appeared to be only slightly steeper than the immediate reach downstream, but both the surveyed site and downstream reach appeared to be a barrier to upstream migration.

The site was classified as a fixed seasonal boulder cascade and is likely a fixed permanent barrier. The average barrier height was 8.9 m (29 ft), and the average horizontal length was 10.9 m (36 ft) with an average channel gradient of 83 percent. Low flow conditions, large bed material, and the significant grade did not provide for a clean swim route up the cascade. Resting areas at the upstream and downstream ends of the barrier appeared minimal in the current flow conditions, and no downstream jump pool existed.

Figure A1. Barrier A in Unnamed Tributary 189.7. Fixed seasonal boulder cascade, 29 ft in height and horizontal length of 36 ft with an average channel gradient of 82 percent.

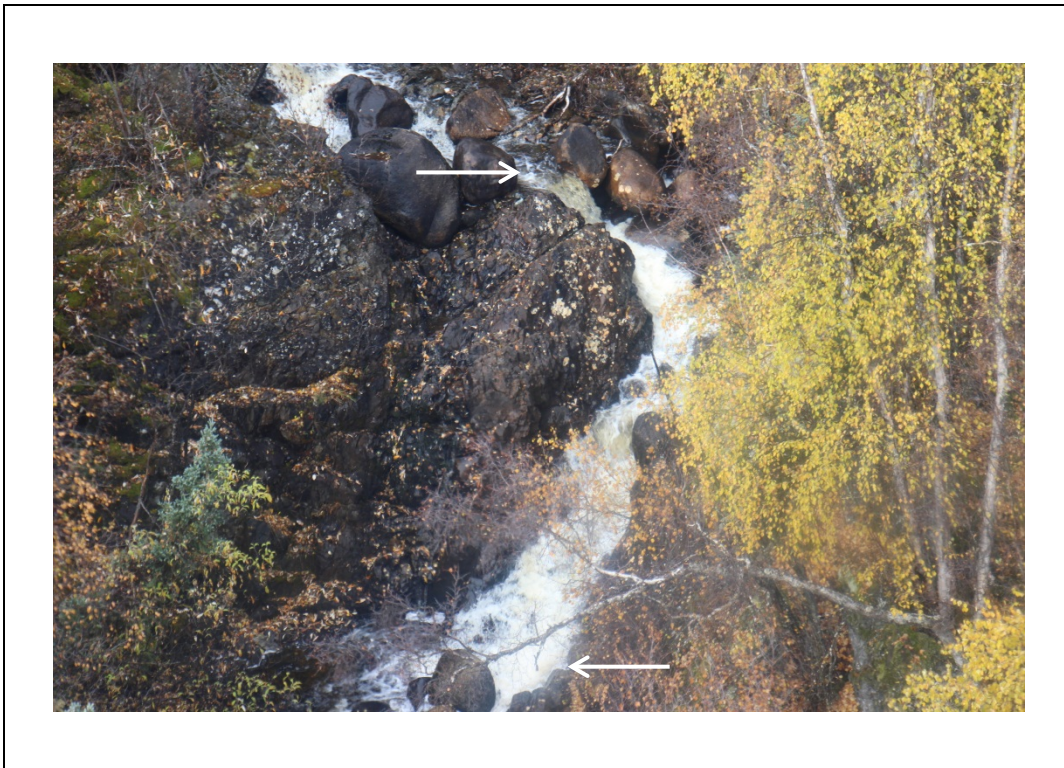
The potential barrier site was located at the upstream extent of a very high gradient reach of boulder dominated cascades (Figure A2). Flows appeared to moderate to low, and the stream bed was dominated by large boulders and exposed bedrock. Flows entered the cascade and made a 90 degree right turn towards the bottom, and a very minimal pool was located at the bottom.

The site was classified as a permanent fixed boulder cascade. The average barrier height was 13.8 ft (4.2 m), and the average horizontal length was 32 ft (9.8 m), resulting in an average channel gradient of 43 percent. Lower flow conditions, large bed material, and the significant grade did not provide for a clean swim route up the cascade. The barrier's height and length appeared to preclude leaping as a means of passage. Resting areas at the upstream and downstream ends of the barrier were minimal under the observed flow conditions with no downstream jump pool.

Figure A2. Barrier A in Unnamed Tributary 197.7. Fixed seasonal boulder cascade, 13.8 ft in height with a horizontal length of 32 ft and an average channel gradient of 43 percent.

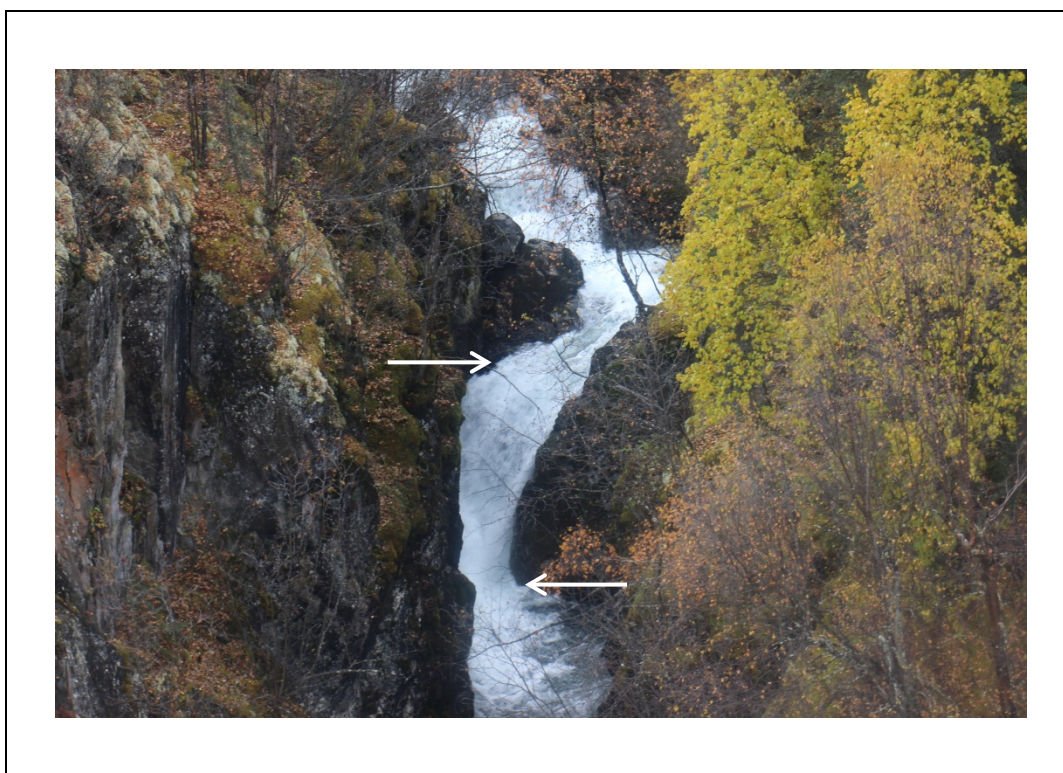
The potential barrier site was located amid a moderate to high gradient reach of stream dominated by boulder cascades (Figure A3). The site was classified as a fixed permanent single falls. The stream turbulence made it difficult to ascertain the bed material upstream and downstream of the feature, but the falls themselves were formed by an exposed bedrock sill.

As a single fall, and due to its location, only the height of the barrier was assessed. The average barrier height of 10.8 ft (3.3 m), including the measurement error ( $\pm 1$ ft), is within the range of Chinook maximum leaping abilities as described by the US Forest Service (2001) but exceeds their leaping abilities as described by Powers and Orsborn (1984) and Reiser and Peacock (1985). A sizeable plunge pool was observed. While no depth could be determined, the pool had sufficient depth to dissipate most turbulence resulting from the plunge. The landing area above the feature appeared to be located in a short, high gradient reach with a small but turbulent resting eddy immediately below another smaller waterfall.

Figure A3. Barrier A in Unnamed Tributary 204.3. Fixed single fall, 10.8 ft in height.

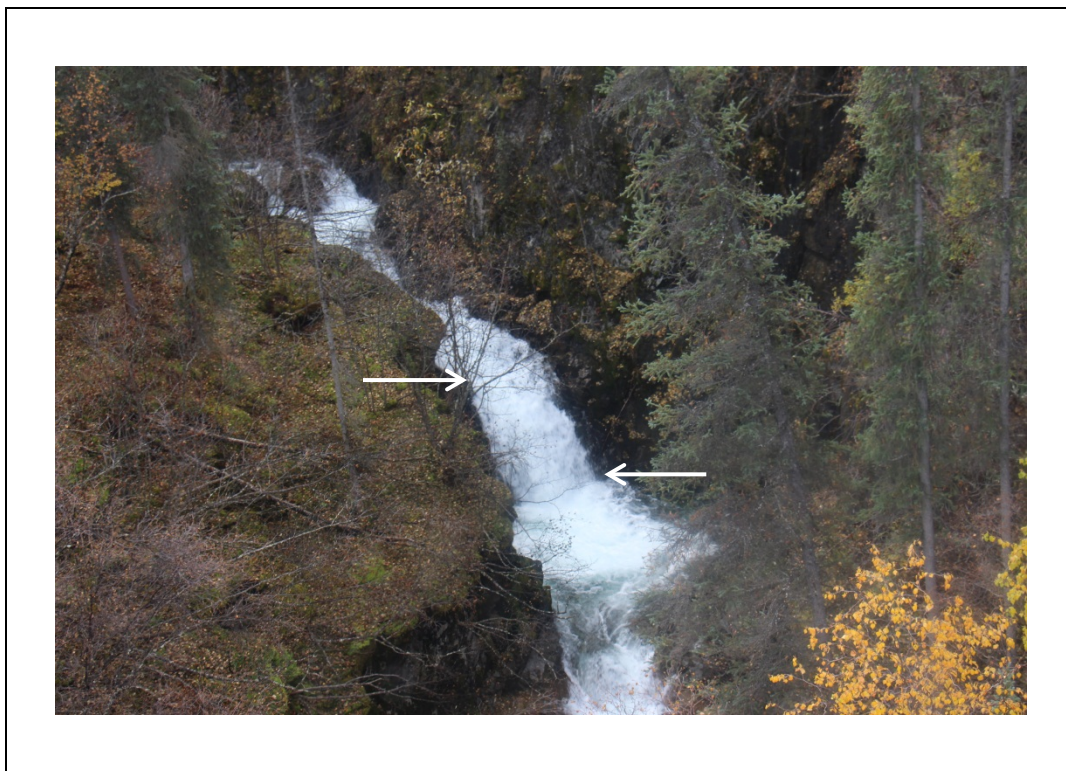
The potential barrier site was located upstream of Barrier A in Unnamed Tributary 204.3 amid a moderate to high gradient reach of stream dominated by boulder cascades. The site was classified as a fixed permanent single falls. The stream turbulence made it difficult to ascertain the bed material upstream and downstream of the feature, but the falls themselves were formed by an exposed bedrock sill (Figure A4).

As a single fall, and due to its location, only the height of the barrier was assessed. The average barrier height was 7.7 ft (2.3 m). A plunge pool existed below the feature. The pool appeared to be highly turbulent, with resting areas likely around the extreme periphery and possibly at depth. Exact depth could not be determined. A steep chute was located immediately upstream of the feature, allowing for difficult landing conditions. Another smaller cascade was located above this chute.

Figure A4. Barrier B in Unnamed Tributary 204.3. Fixed single fall, 7.7 ft in height.

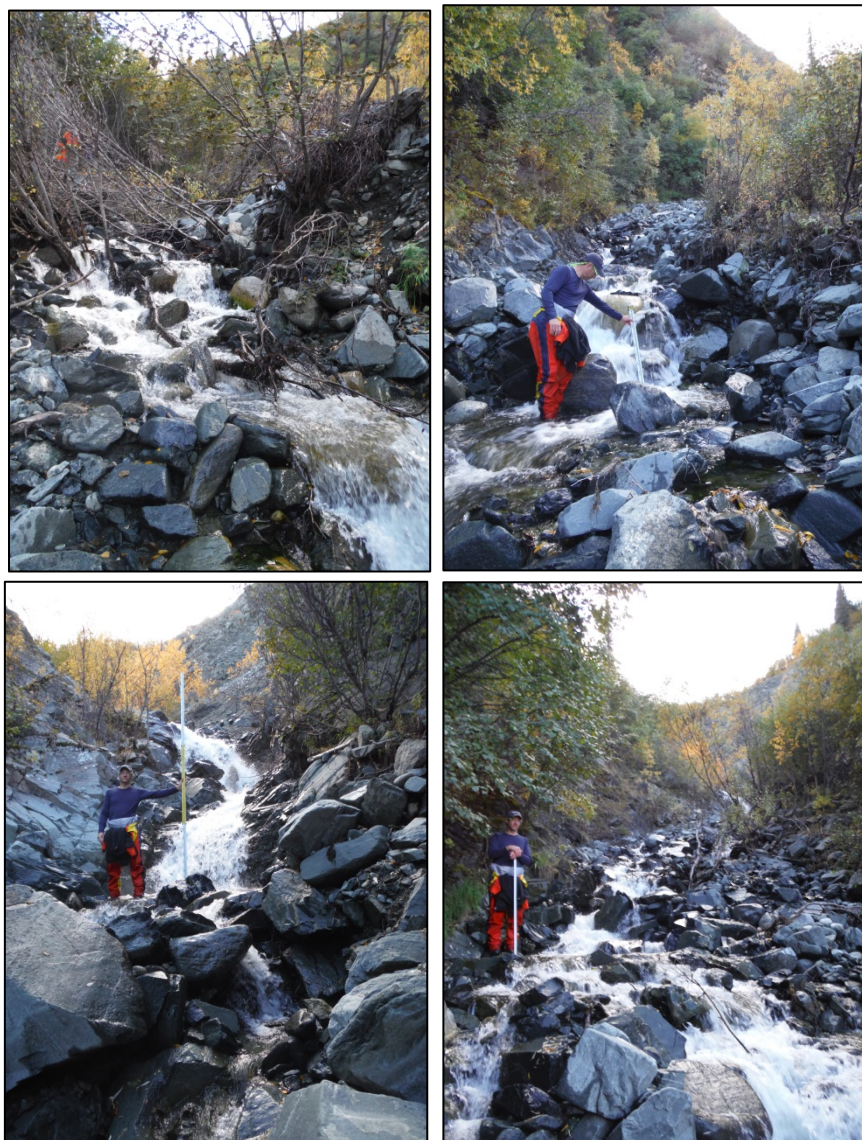
This barrier was surveyed by foot on September 12, 2013 and was located on a tributary entering the Susitna River on river left (Barrier ISR Figure 4.3-1a). The barrier was classified as a complex chute and turbulent cascade with an overall 29.7 m (97.4 ft) vertical drop over a horizontal distance of 177.8 m (583.3 ft). The gradient range was 10 to 15 percent for the bottom half of the falls, increasing to between 20 and 34 percent for the final 18 m (59 ft) vertical drop, with an overall slope of 17 percent. The combination of waterfalls and steep, turbulent, high-velocity chutes with limited resting areas or deep plunge pools confirmed this as a permanent fixed barrier for fish movement (Figure A5).

Figure A5. Barrier A in Unnamed Tributary 215.2. Clockwise from top left, views from bottom to top of a complex chute which spans 97 ft in vertical direction and 583 ft in horizontal direction. This is a permanent barrier to fish passage.

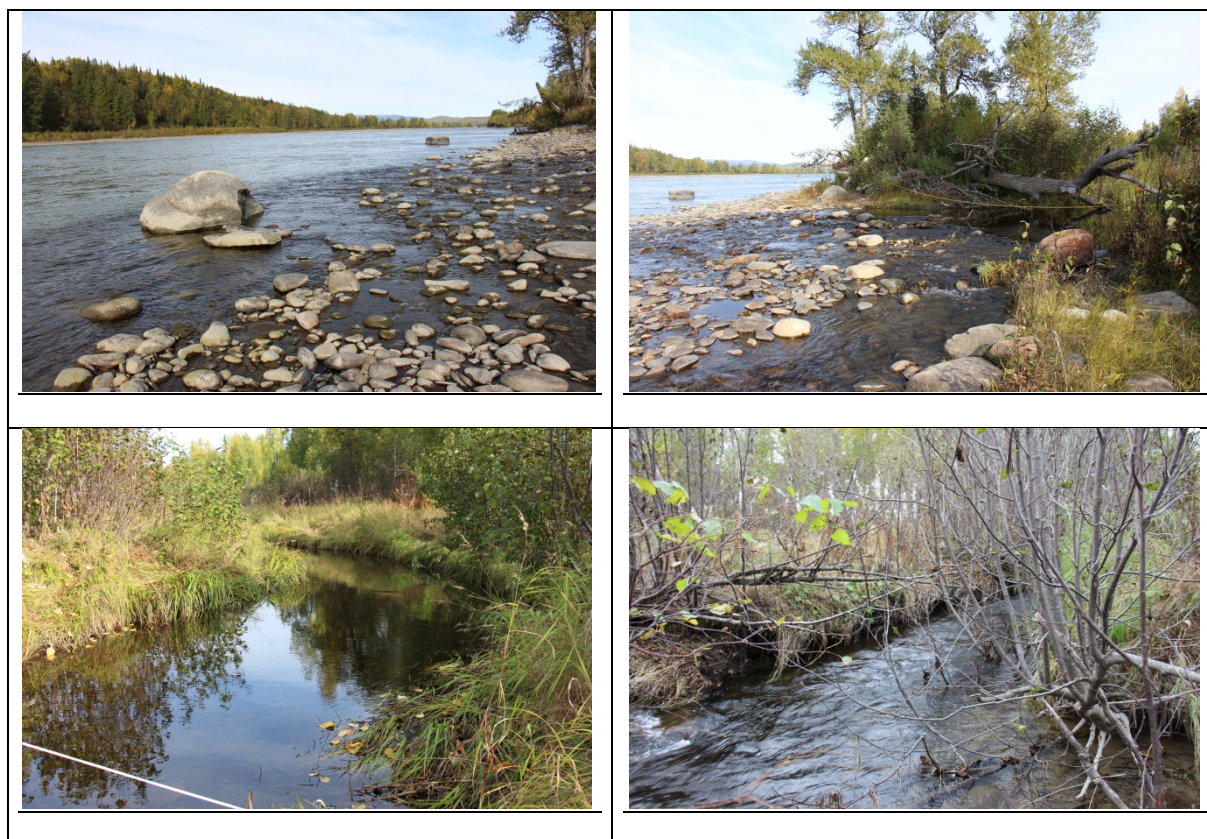
The mouth of Chase Creek was unique compared to the other tributaries surveyed. Although characterized by exposed boulders and cobbles, it did not resemble the large, bedload-deposited aprons seen elsewhere (Figure B1). The mouth exhibited a steepened slope due to the receding Susitna, but no defined channel had been formed in the exposed substrate (Figure B2). The creek flow was spread out across the exposed substrate with no clearly defined or continuous thalweg. A natural and irregular small boulder and cobble weir formed at the top of the mouth grade break, dispersing flow leaving the upstream pool (Table B1). It was likely that the low-gradient nature of this creek had limited the material deposited at the mouth, and that creek flows have not regularly carried enough energy to alter the geometry of the existing debris apron.

Figure B1. Chase Creek. From upper right: bottom of creek mouth; top of creek mouth; low gradient channel resulted in slow meandering reaches; and near top of creek survey.

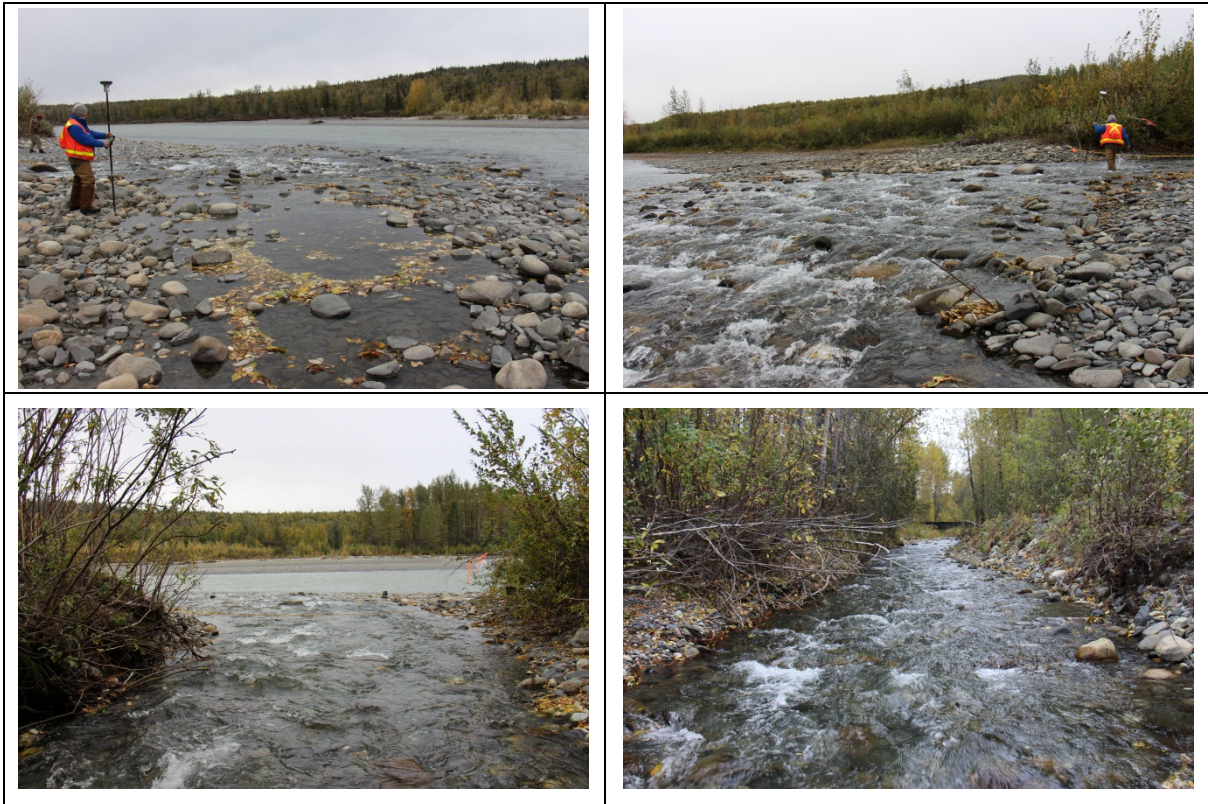
Lane Creek left a very confined and established channel only a short distance upstream of the creek mouth (Figure B3). During high Susitna flow conditions, it was likely that the creek met the river at the end of the confined channel reach (Figure B4). The creek mouth was characterized by large cobbles and small boulders with a debris apron (Table B2). Flows began to spread out across this small boulder apron as it passed the downstream extent of the confining creek bank before reaching the Susitna. No noticeable incision had occurred across the apron, and there was no distinct thalweg.

Figure B3. Lane Creek. From upper right: bottom of creek mouth; top of creek mouth; looking downstream to creek mouth; and looking upstream to top of survey- note uniform channel form.

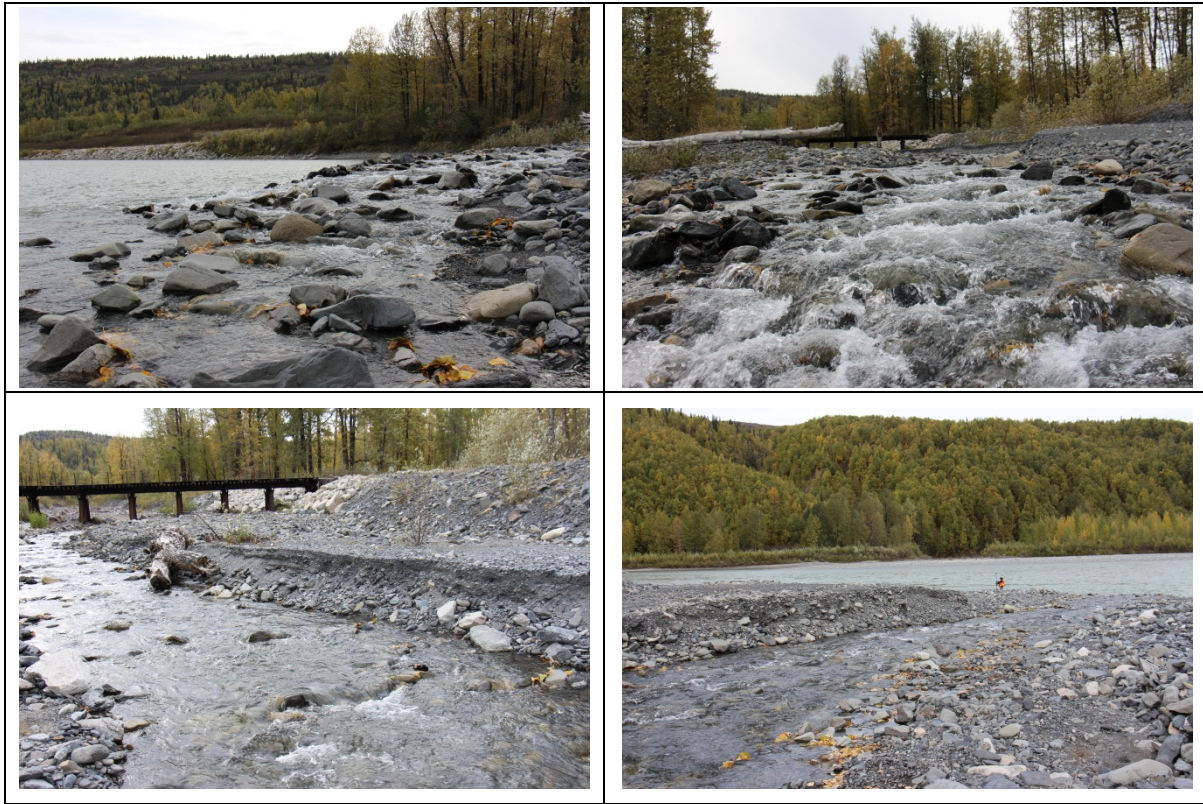
The mouth of Deadhorse Creek consisted of a large debris fan and single creek channel (Figure B5). The creek had incised the debris apron, but a final steep boulder cascade remained before reaching the Susitna (Figure B6). This noticeable perch was a result of low creek flows and the receding Susitna flow. Deposited material varied in gradation, material size and mixture throughout the fan (Table B3).

Figure B5. Deadhorse Creek. From upper right: bottom of creek mouth; looking upstream from Susitna from creek mouth; upstream extent of channel survey; and looking downstream – note channel incision through deposited apron material.

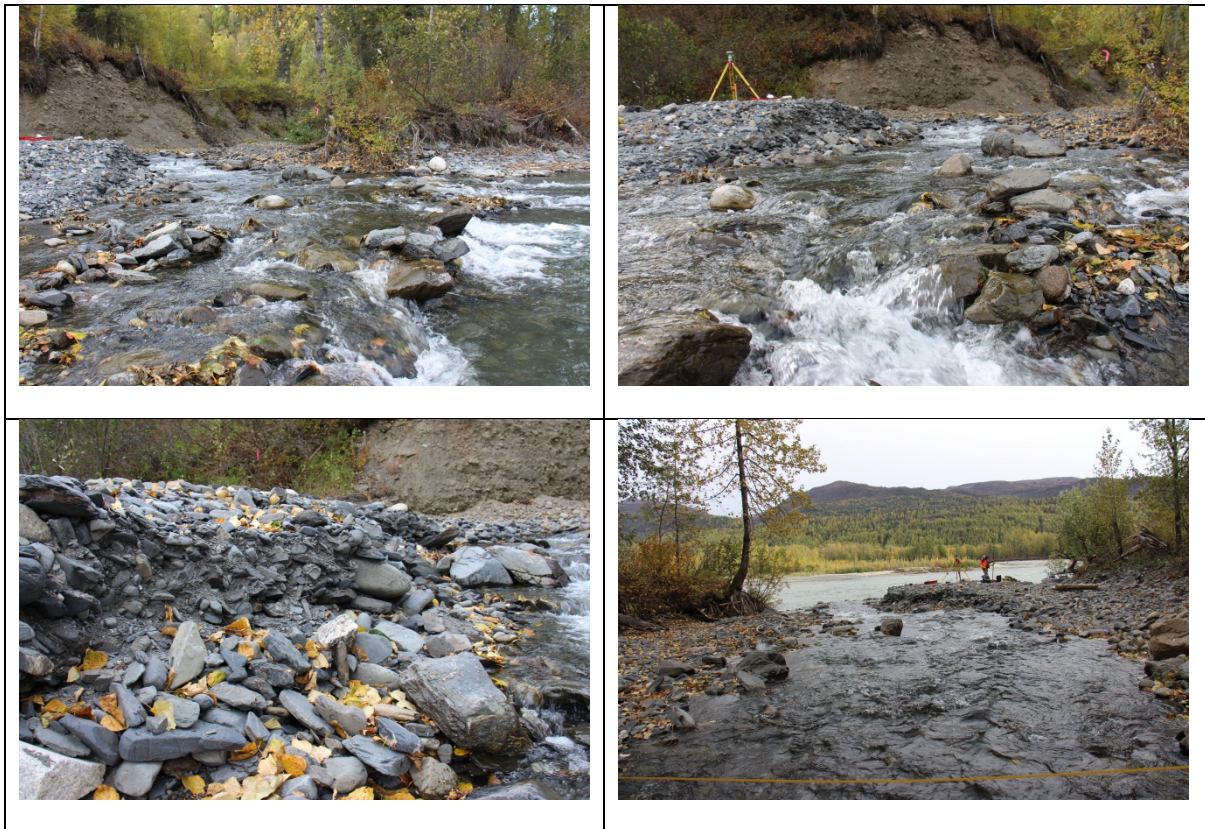
The mouth of Fifth of July Creek was perched due to the receding Susitna and large amounts of mixed sediment were deposited (Figure B7). A haphazard orientation and mixture of the debris indicated that high creek flows had mobilized all sizes of material, and deposited it abruptly upon reaching the slower waters of the Susitna (Table B4). The stream was incised through the deposited material with consistent channel shape, thereby reducing the magnitude of the perch (Figure B8).

Figure B7. Fifth of July Creek. From upper right: bottom of creek mouth; looking upstream from Susitna from creek mouth; apron deposits – mixed fines to boulders; and looking downstream from top of survey.

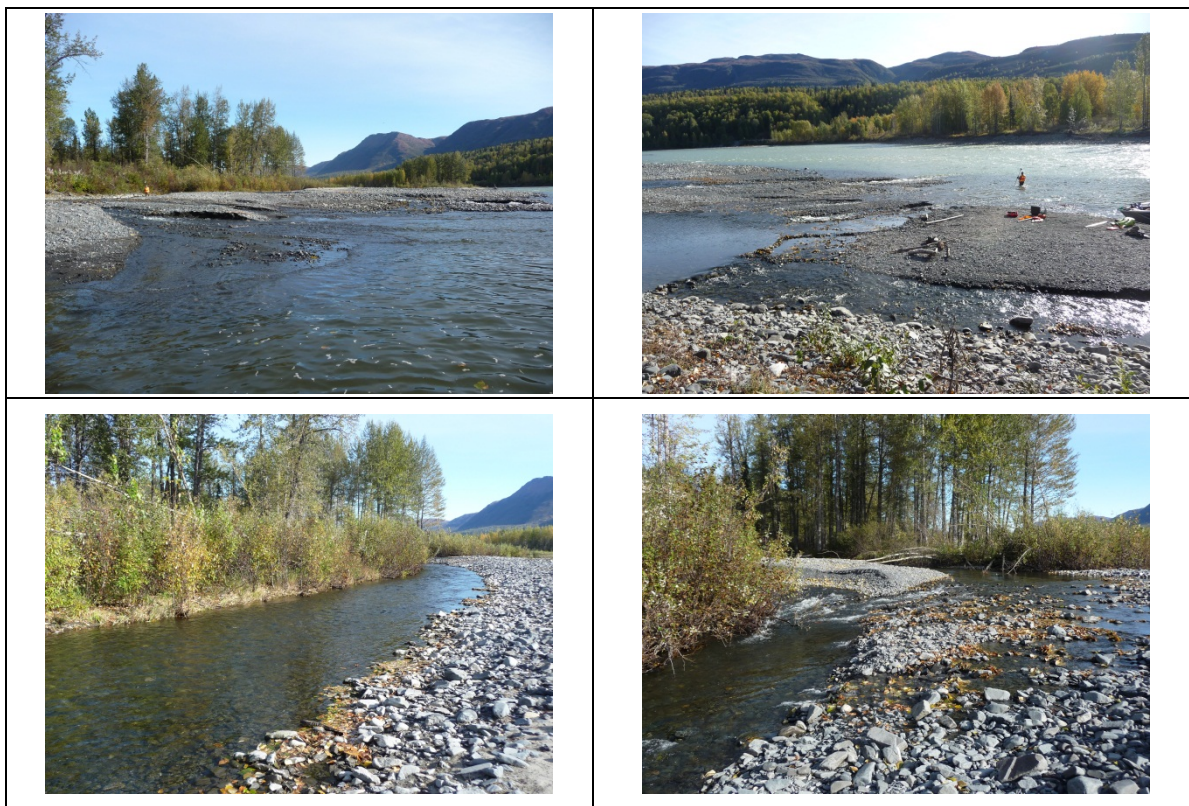
The lower channel of Fourth of July Creek flowed parallel to the Susitna, and was divided by a large gravel/cobble bar (Figure B9). As the creek approached its mouth, flow split into side channels before reaching the Susitna. Five or six significant channels, which varied in slope, length, and discharge, flowed from the creek over a distance of approximately 50 m (164 ft). The main channel carried approximately 25 percent of the creek flow to the Susitna. Some of the channels were actively eroding during the survey. While the mouth was still perched during the time of survey, the length of the multiple channels and the general geometry of the gravel/cobble bar did not create an abrupt drop as seen on several other creeks (Figure B10, Table B5).

Figure B9. Fourth of July Creek. From upper right: bottom of creek mouth; multiple channels through creek mouth; channel upstream of mouth – flowing parallel to the Susitna; and upstream confluence of channel split near top of survey.

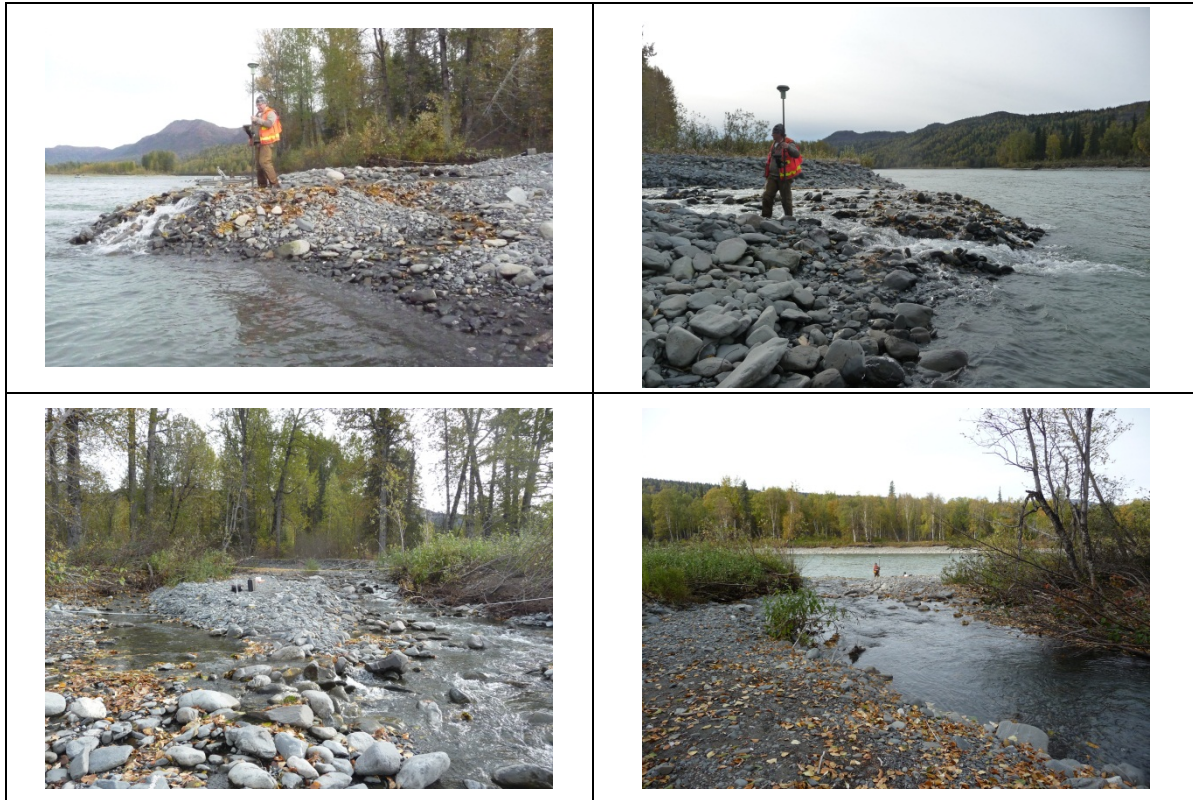
The mouth of Sherman Creek extended across a short debris fan (Figure B11). The stream crossed in a single channel, and upon reaching the perched edge of the fan, flow divided between a few main flow paths before reaching the Susitna (Figure B12, Table B6).

Figure B11. Sherman Creek. From upper right: bottom of creek mouth; multiple channels through creek mouth; riffle upstream of tributary apron; and looking downstream from top of survey.

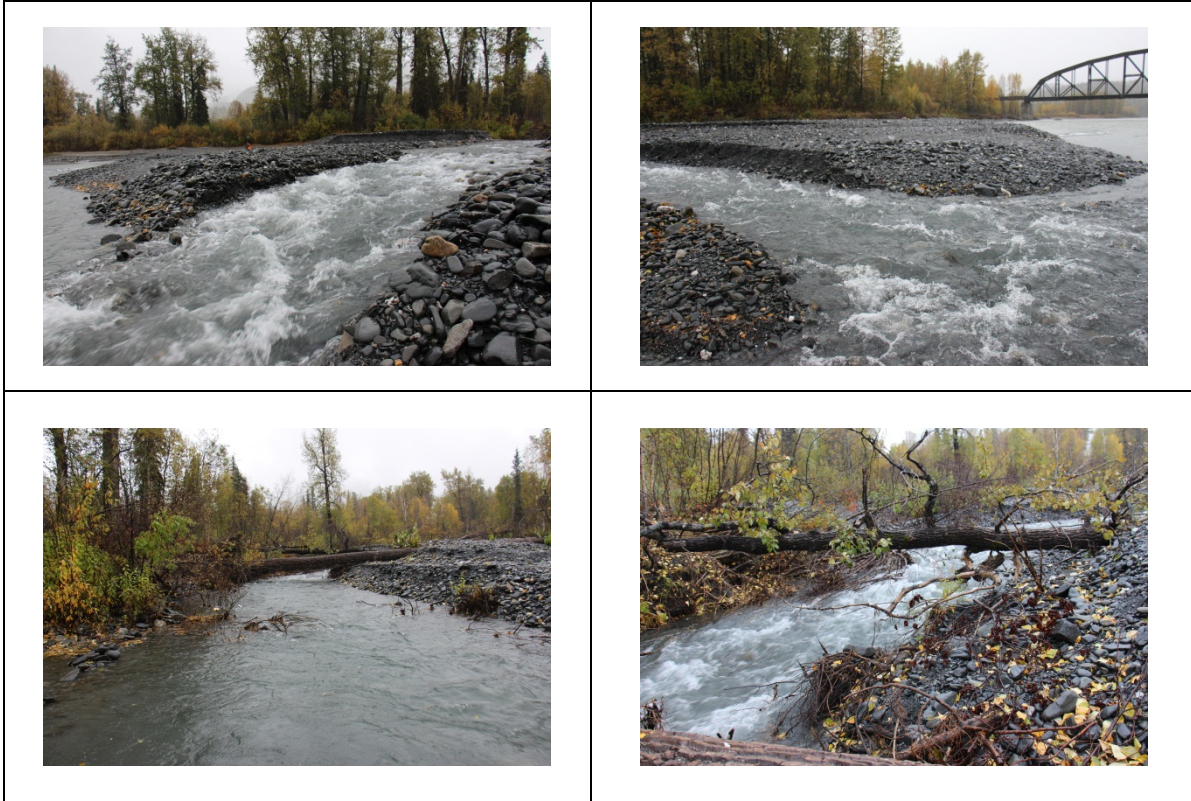
The mouth of Gold Creek consisted of a large debris fan and two stream channels (Figure B13). A steeper channel grade across the deposited apron was consistent with a perched condition, but channel incision on both the main and the secondary channel reduced the gradient of the final drop to the Susitna (Figure B14, Table B6). Flow between the two flow paths consisted of an approximate 60:40 split. Banks of the secondary channel were eroding during the time of survey.

Figure B13. Gold Creek. From upper right: bottom of creek mouth; bottom of mouth side channel; lower gradient reach upstream of tributary apron; and higher gradient reach near top of survey.
