Susitna-Watana Hydroelectric Project Document ARLIS Uniform Cover Page

**Susitna-Watana Hydroelectric Project
(FERC No. 14241)**

**Baseline Water Quality Study
Study Plan Section 5.5**

**Appendix A
Continuous Temperature Monitoring**

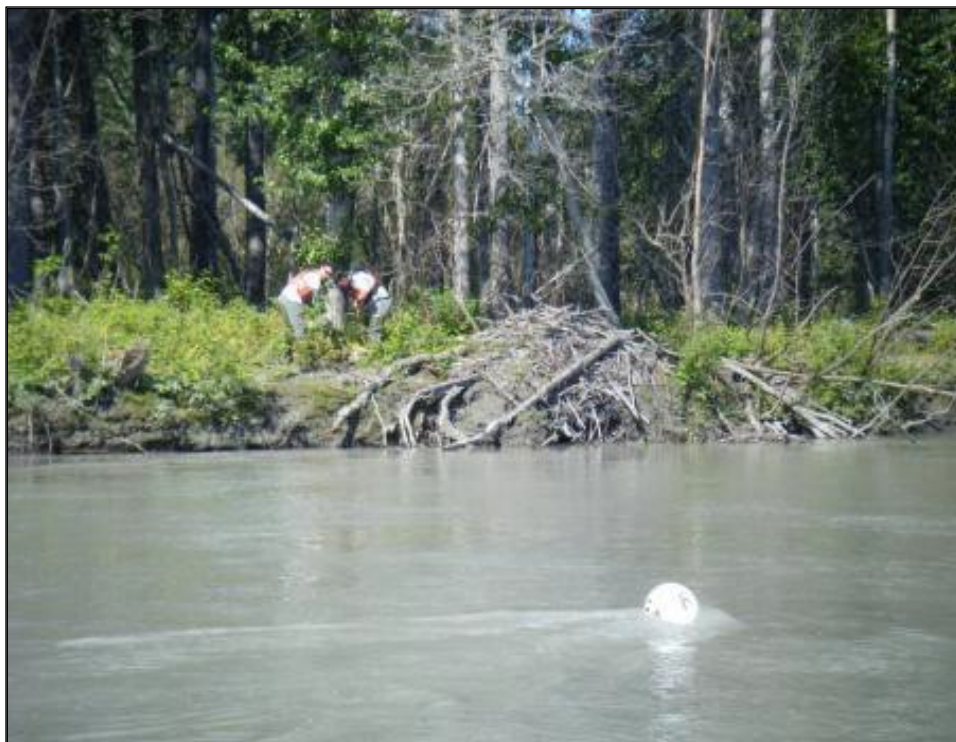
Photo A-1b. Location of anchor-buoy system at PRM 19.9 – Susitna above Alexander Creek

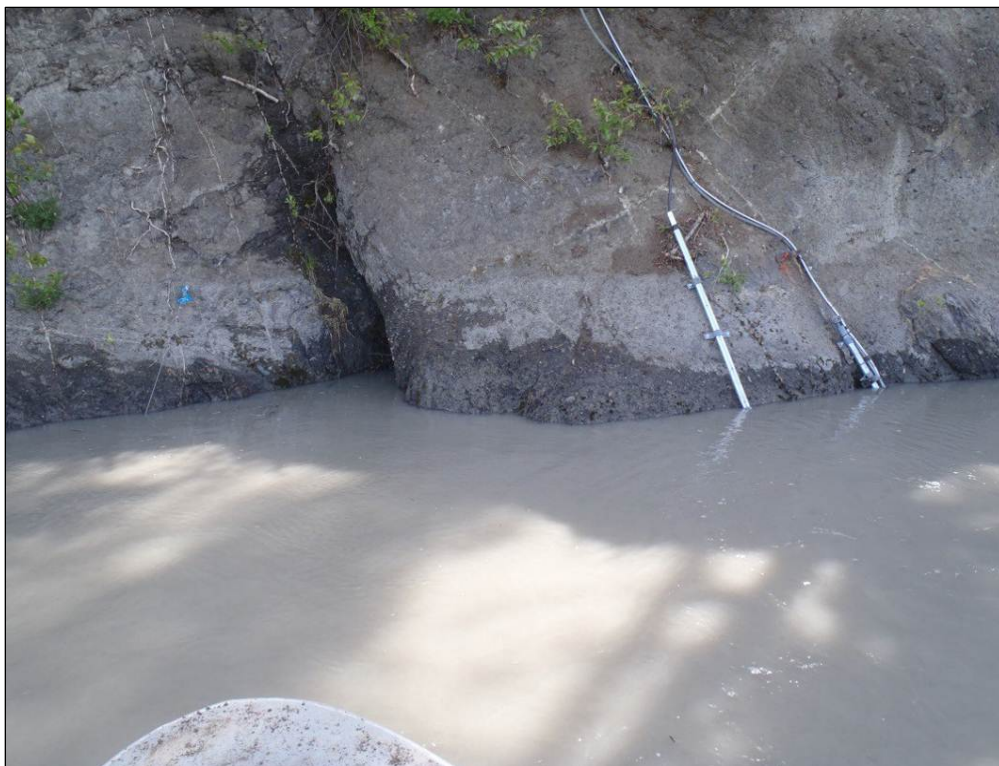
Photo A-2c. Anchor point for thermistor string on left and USGS temp monitoring equipment on right. PRM 29.9 – Susitna Station

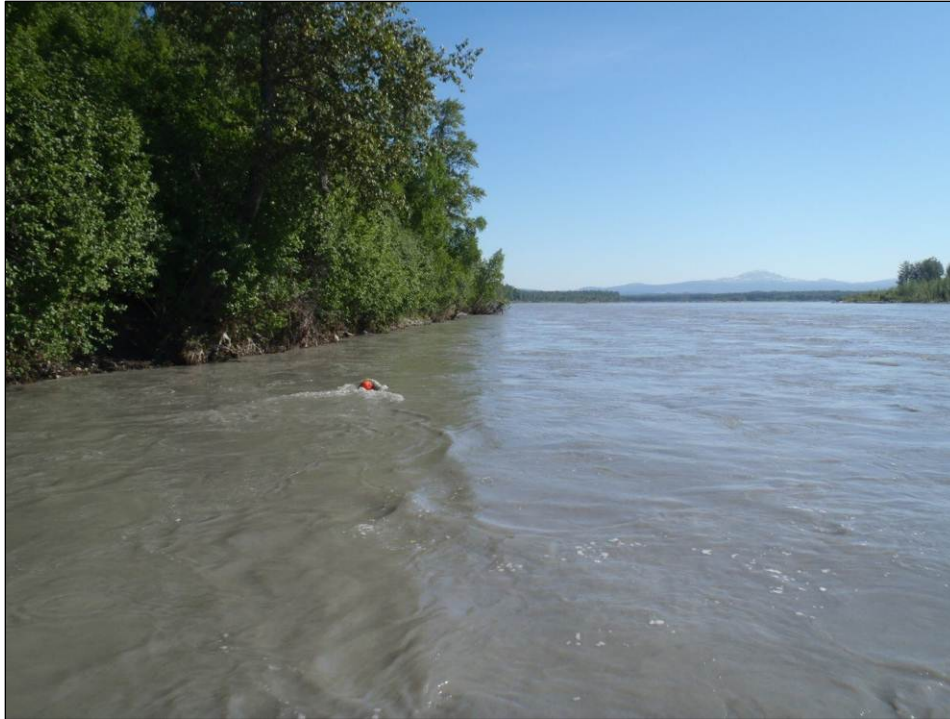
Photo A-8b. Buoy System at PRM 88.3 – Susitna at Parks Highway West

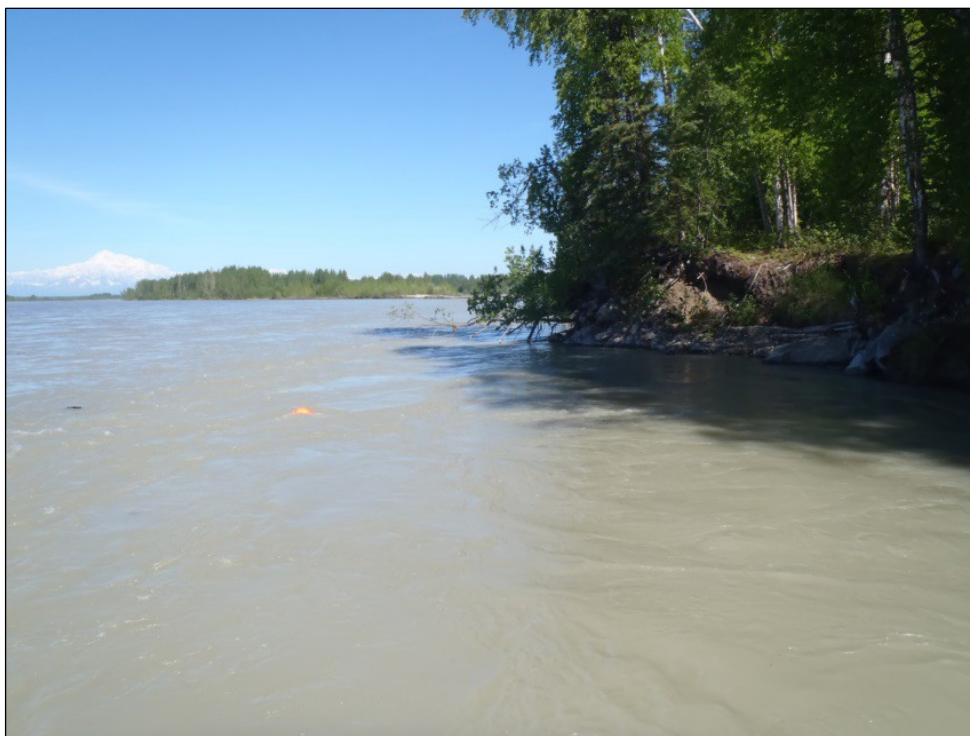
Sept. 19, 2013		--	No overwinter system installed. Could not retrieve anchor/buoy string and have lost more than one string in this location.

Photo A-9b. Buoy system at PRM 99.2 – LRX1

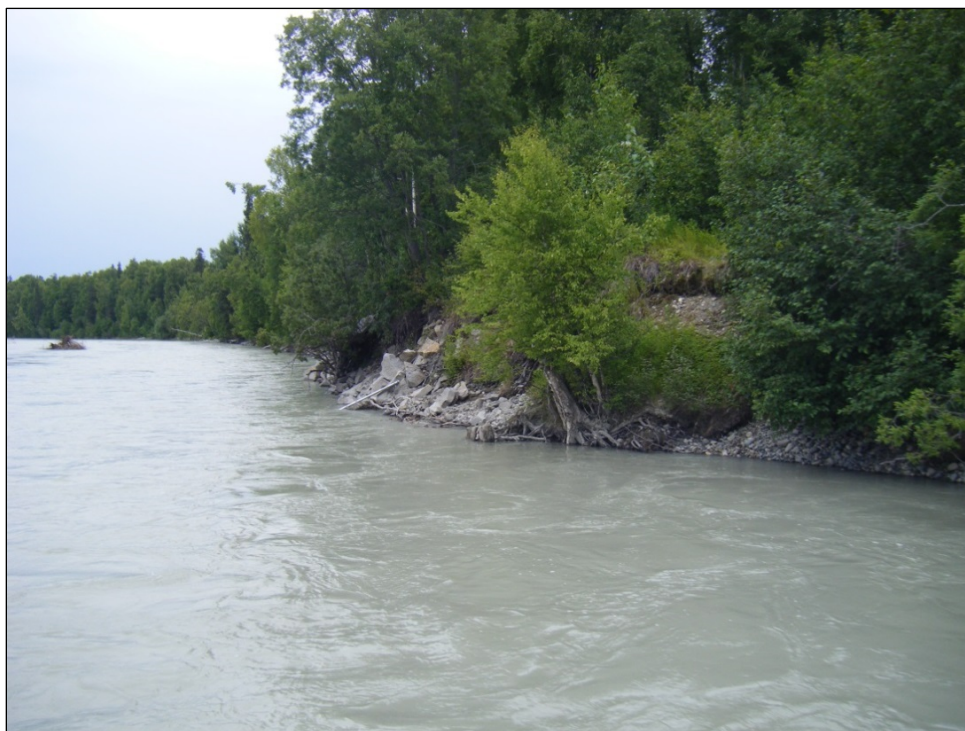
Photo A-9c. Pipe system at PRM 99.2 – LRX1

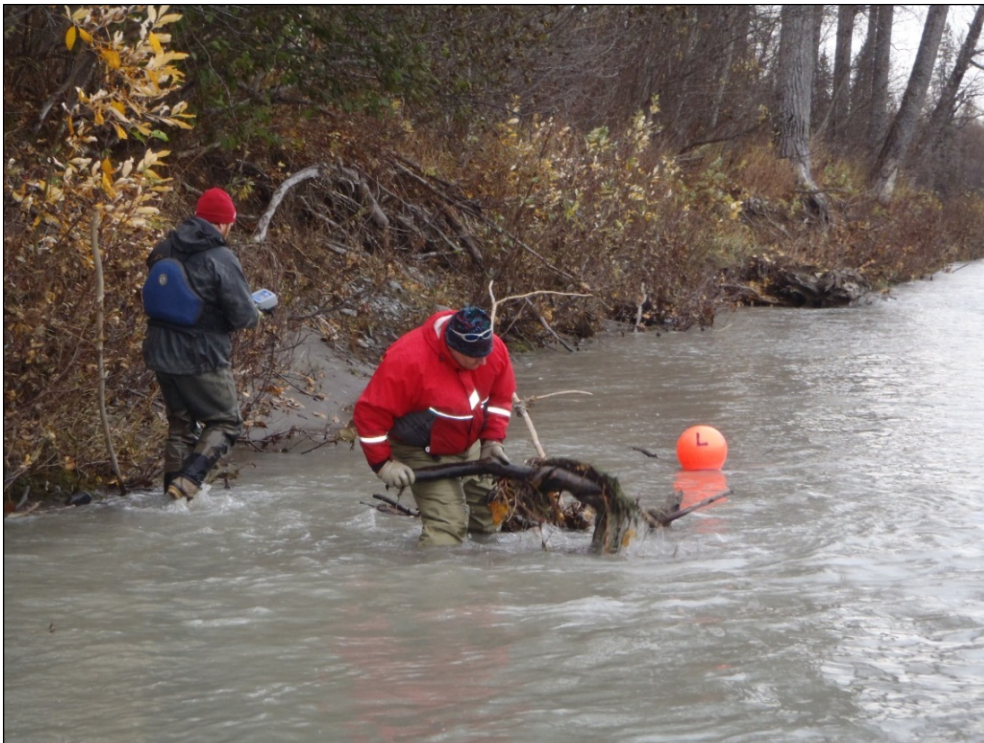
Photo A-17c. Maintenance and download of buoy system at PRM 132.7 – Slough 9
