**Susitna-Watana Hydroelectric Project
(FERC No. 14241)**

**Study of Fish Passage Barriers in the Middle and
Upper Susitna River and Susitna Tributaries (9.12)**

**Appendix A
Tributary Geologic Barriers**

Initial Study Report

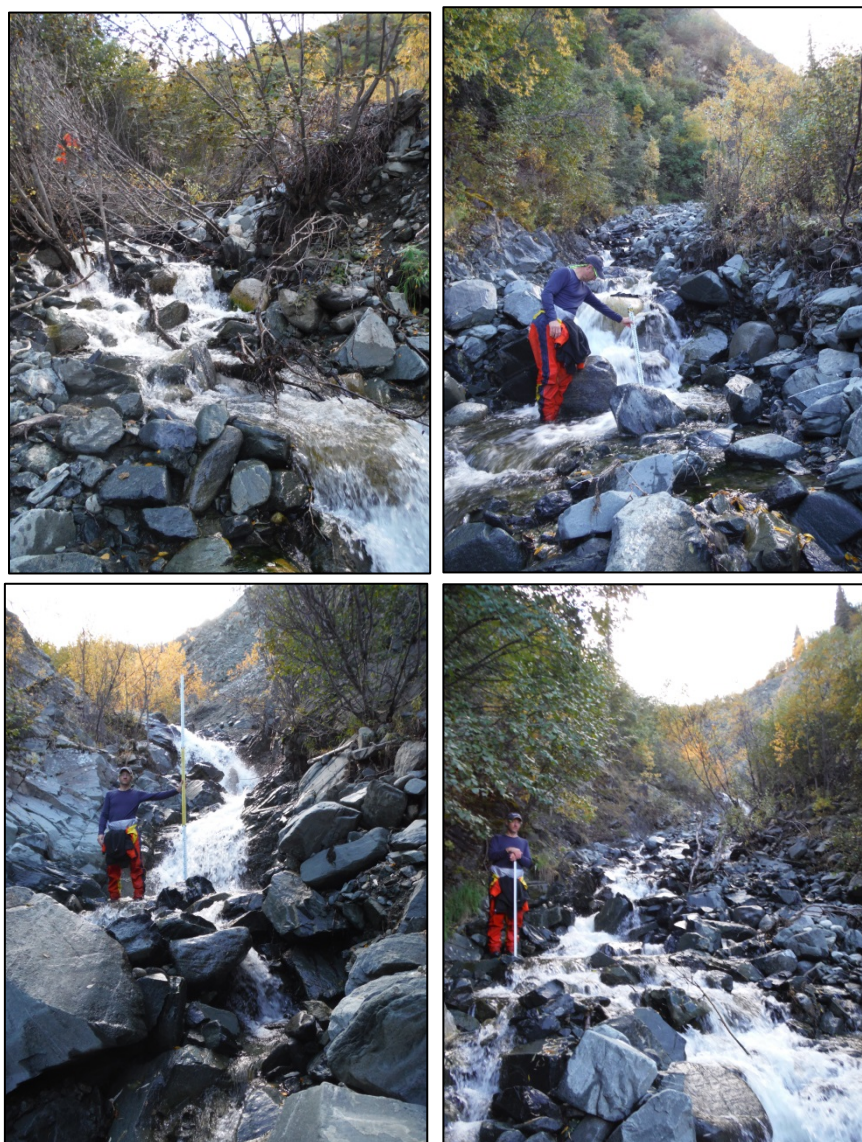
This barrier was surveyed by foot on September 12, 2013 and was located on a tributary entering the Susitna River on river left (Barrier ISR Figure 4.3-1a). The barrier was classified as a complex chute and turbulent cascade with an overall 29.7 m (97.4 ft) vertical drop over a horizontal distance of 177.8 m (583.3 ft). The gradient range was 10 to 15 percent for the bottom half of the falls, increasing to between 20 and 34 percent for the final 18 m (59 ft) vertical drop, with an overall slope of 17 percent. The combination of waterfalls and steep, turbulent, high-velocity chutes with limited resting areas or deep plunge pools confirmed this as a permanent fixed barrier for fish movement (Figure A5).

Figure A5. Barrier A in Unnamed Tributary 215.2. Clockwise from top left, views from bottom to top of a complex chute which spans 97 ft in vertical direction and 583 ft in horizontal direction. This is a permanent barrier to fish passage.

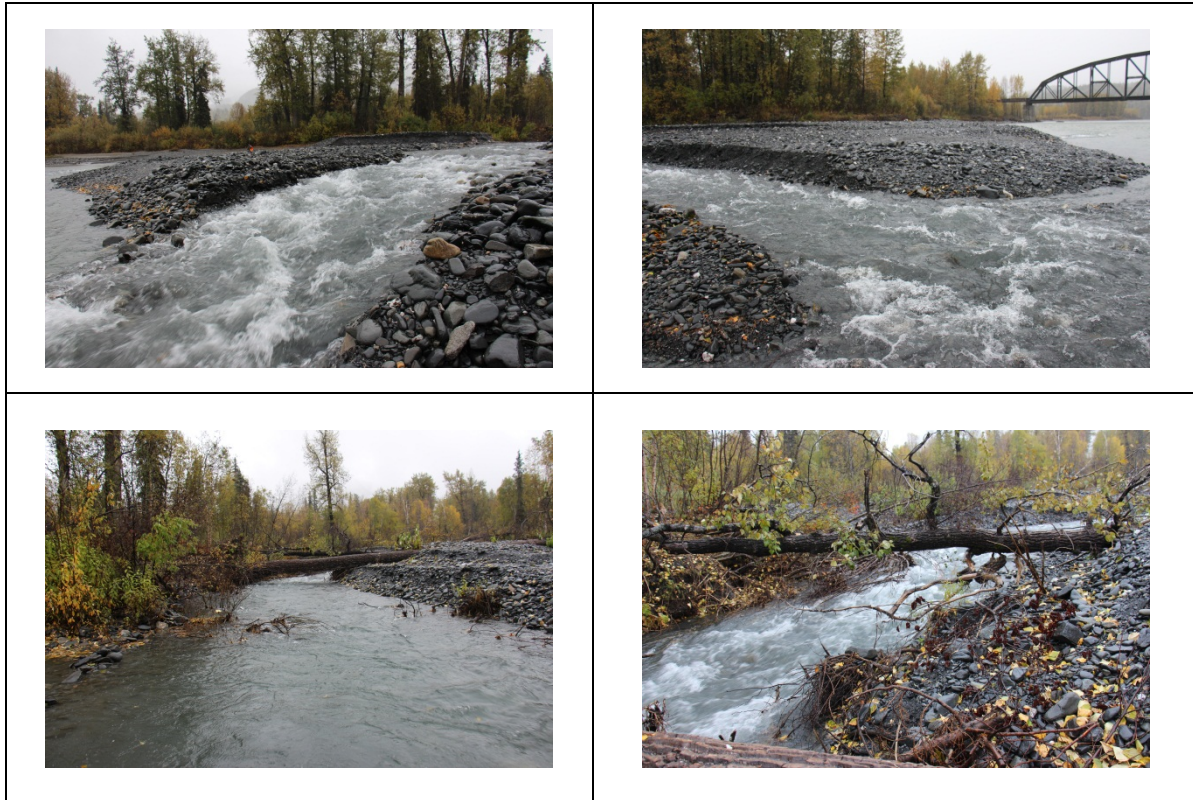
The mouth of Gold Creek consisted of a large debris fan and two stream channels (Figure B13). A steeper channel grade across the deposited apron was consistent with a perched condition, but channel incision on both the main and the secondary channel reduced the gradient of the final drop to the Susitna (Figure B14, Table B6). Flow between the two flow paths consisted of an approximate 60:40 split. Banks of the secondary channel were eroding during the time of survey.

Figure B13. Gold Creek. From upper right: bottom of creek mouth; bottom of mouth side channel; lower gradient reach upstream of tributary apron; and higher gradient reach near top of survey.
