PELICAN POWER ALTERNATIVES
PHASE I - RECONNAISSANCE ASSESSMENT

Report On
PELICAN POWER ALTERNATIVES
PHASE 1 - RECONNAISSANCE ASSESSMENT

Prepared for
ALASKA POWER AUTHORITY

April 1982

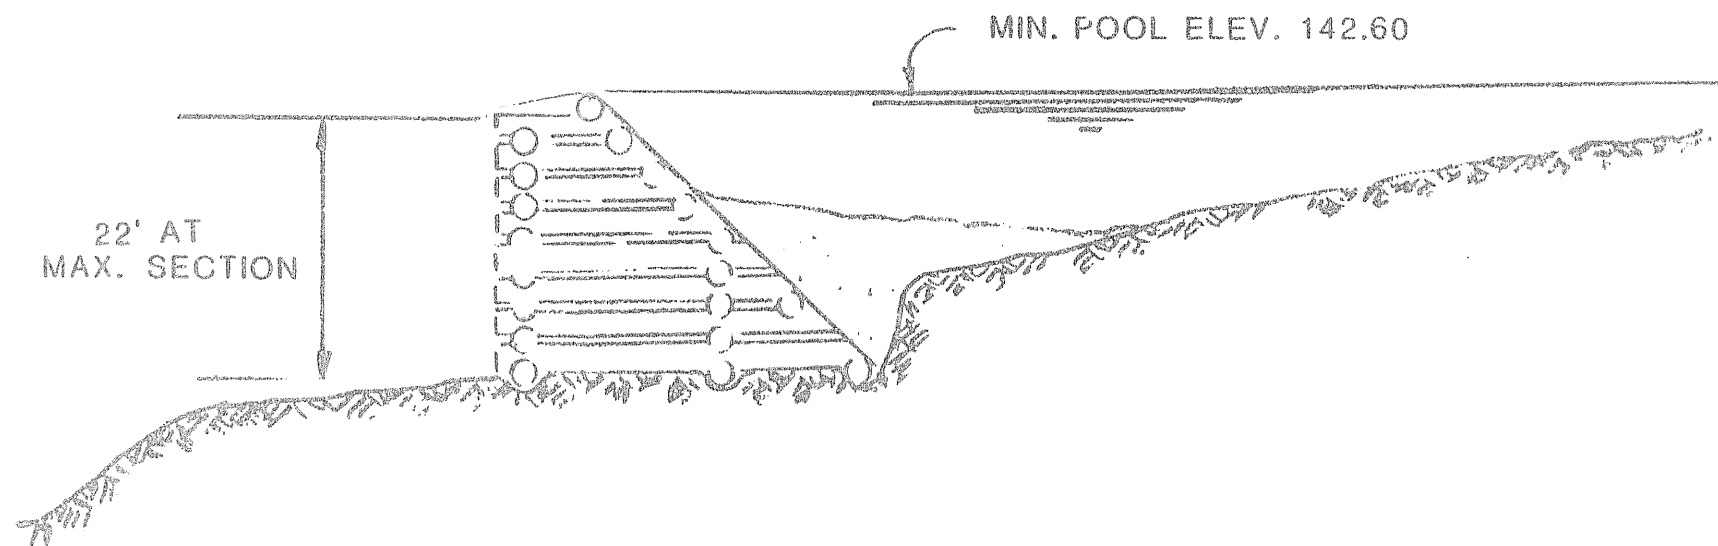
SECTION THRU PELICAN DAM

The dam serves a valuable function but is in urgent need of repair. Should it wash out, it would be difficult and expensive structure to replace. Accordingly, if it survives the spring runoff of 1982, restoration is recommended during the next low flow months so as to give it renewed economic life.

The dam leaks badly and the rockfill in the cribs is reported to have slumped 3-5 feet. This slumping is judged to be the result of a combination of bottom rock being carried away by leakage through the dam and higher rock being sucked out of the downstream face of the dam by negative pressure under the lower nappe of the spill during high discharge.

Abutment abrasion has been reported. This is interpreted as the effect of jetting action at leaks.

The crib logs, connected with iron pins, are reported to be in basically sound condition, with rot around some of the pin holes.

The right wing wall also leaks badly and gives the impression of being rather flimsy in the face of high flows, which often reach 1000 cfs. The dam should be made capable of passing 8,000 cfs.

Minimum maintenance at this time calls for lifting the spillway planks, refilling the cribs with rock, replacing the spillway planks and replacing the valve. That program is "band-aid" in nature and is at best a temporary solution. The dam would remain unsafe due to its inadequate spillway capacity and would require subsequent repairs at frequent intervals.

The recommended program is to convert the dam proper from a rock-filled timber crib with a questionable life to a permanent gravity concrete dam by intrusion grouting of the existing structure. The procedure would be to:

8. Intrusion grout the dam. The grout should be a low viscosity but rich mixture of cement and water. The grouting operation should be continuous, and the grout pipes progressively withdrawn--the grout pipes functioning as tremies with the tip of the pipes being maintained about 1 foot below the level of grout in the 8" Ø PMP.
9. Pour a reinforced concrete spillway slab as a cap on the dam.
10. Replace the timber wing wall with a buttressed reinforced concrete wall, anchored into the rock foundations. This wall will include a diversion port covered by trash racks, with the existing gate removed and replaced by a new hydraulically operated gate with remote control. This modification will permit the dam to safely pass the 8,000 cfs design flood, recommended by the COE, by overtopping the wing wall; and will provide for a secluded and safe location for the valve operator.
