GEOLOGY OF THE DEVIL CANYON DAM SITE, ALASKA

Reuben Kachadoorian

Open-file report

1974

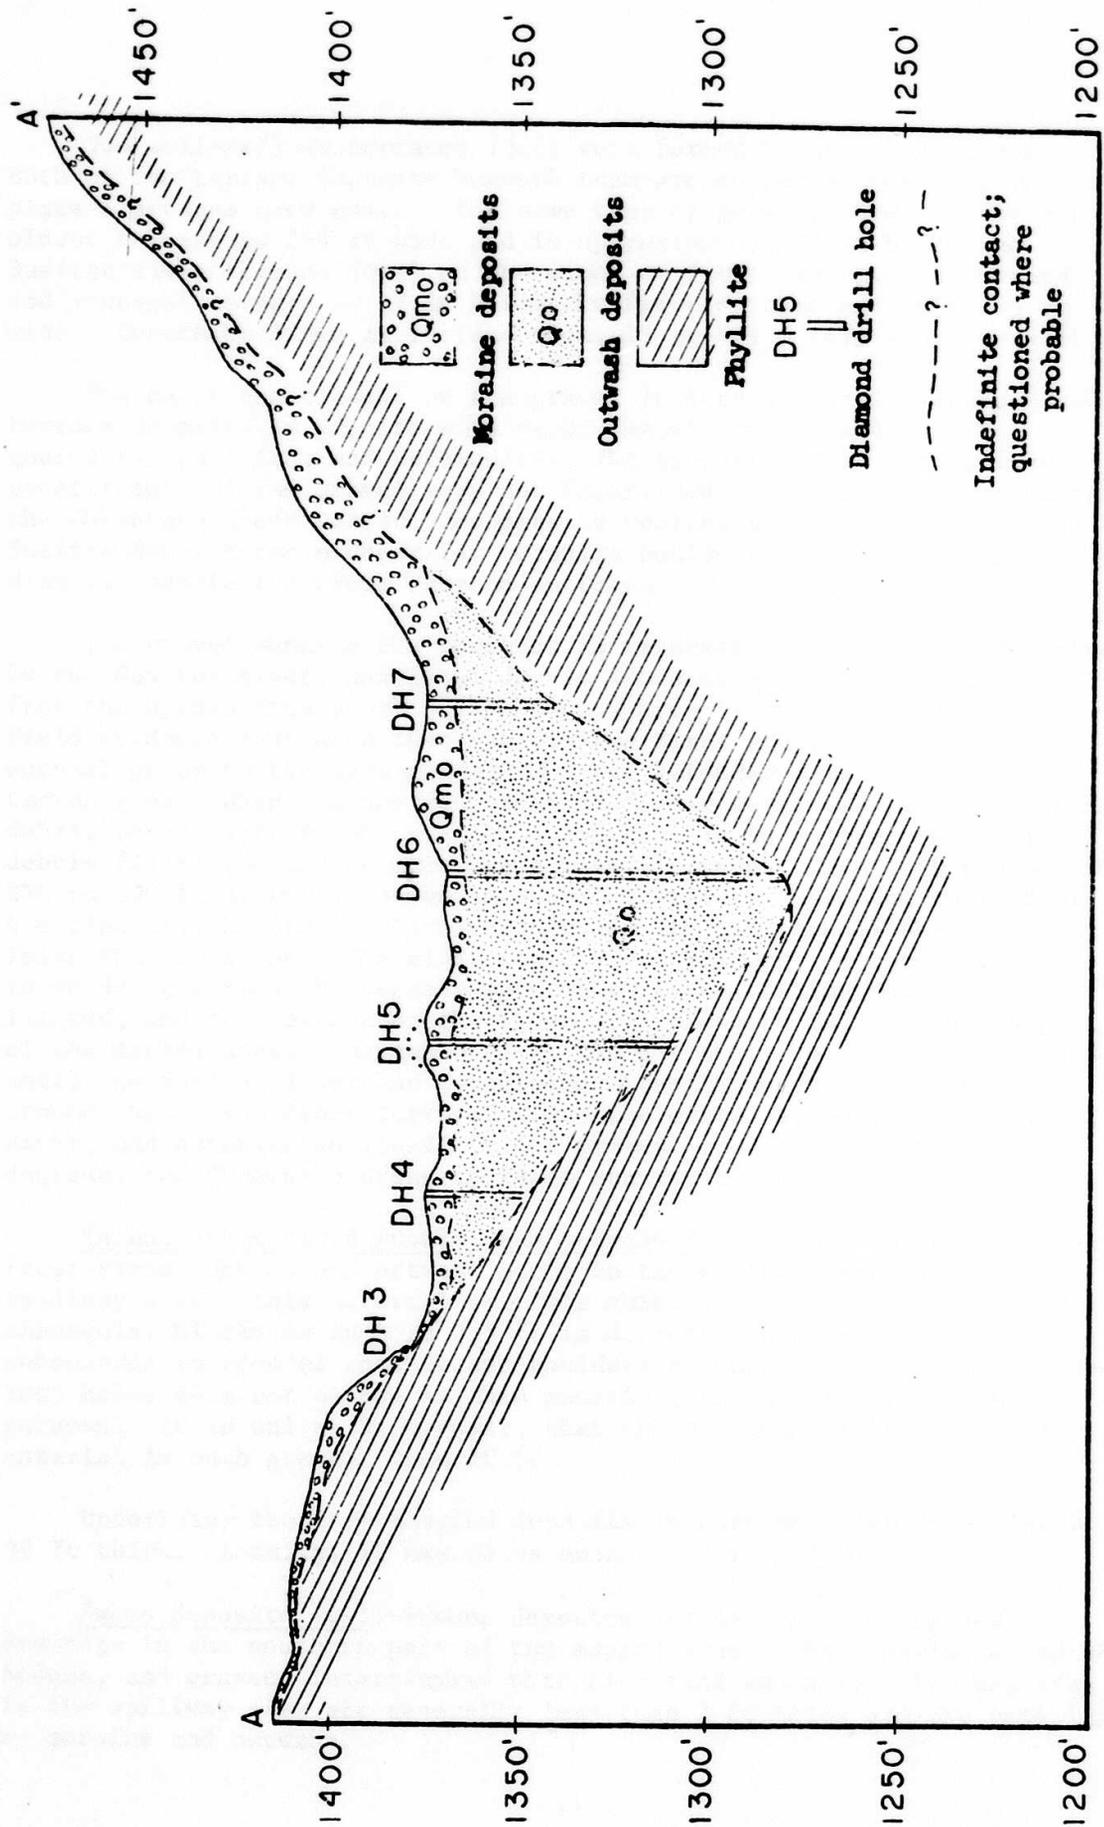
Figure 2. Profile through Section A-A'

Figure 2 shows that the original valley in which the outwash was deposited was V-shaped. This shape indicates that the valley was cut by water and not by ice, and that the outwash was deposited in front of an advancing glacier. After the deposition of the outwash, the advancing glacier overrode the debris and deposited the thin veneer of morainal material. The additional weight of the moraine and ice compacted the underlying outwash material.

Along Section A-A', the maximum depth to sound rock is about 92 ft at an approximate altitude of 1,280 ft. Drill hole 15, located on Triangulation Station John, shows that bedrock is 52.7 ft below the surface at an approximate altitude of 1,276.4 ft.

The depression containing two lakes in the southern part of the mapped area may be used as the spillway for the dam. The foundation of the site consists of outwash and moraine that have been deposited in a pre-existing V-shaped valley. The maximum thickness of these deposits is at least 86 ft. Although the outwash has been compacted by overriding ice, it is doubtful that this compaction is sufficient to prevent a large water loss from percolation through the outwash. In addition, it is doubtful that the outwash and morainal deposits are sound enough to maintain structures such as a small dam. If maximum utilization of the Devil Canyon dam site area is considered, a dam is necessary in the spillway area. If such is the case, the glacial debris will have to be removed before construction of the spillway dam.
