SUSITNA HYDROELECTRIC PROJECT

1980-81 GEOTECHNICAL REPORT

**VOLUME 1
TEXT
FINAL DRAFT**

ALASKA POWER AUTHORITY

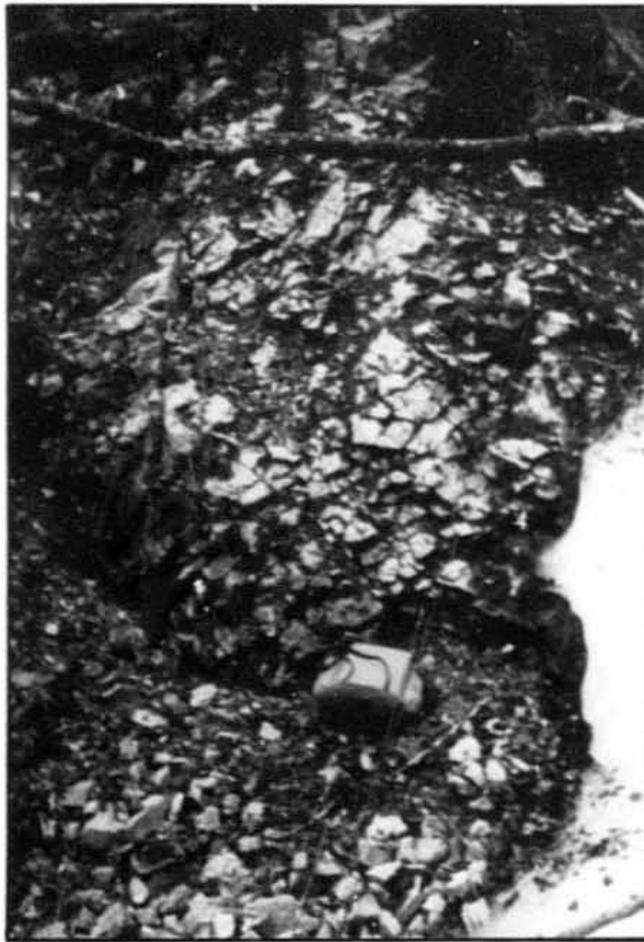
WATANA
FRACTURE ZONE IN ANDESITE PORPHYRY

ANDESITE PORPHYRY
ABOVE DIORITE OUTCROP
APPROX. EL. 1800 FEET - SOUTH BANK

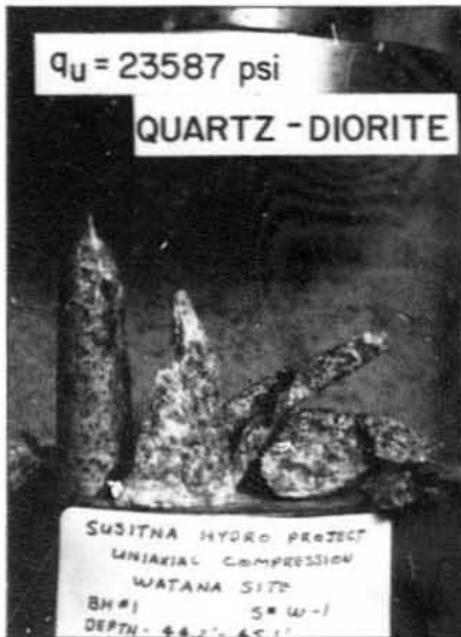
TYPICAL COMPRESSION
TEST FAILURE

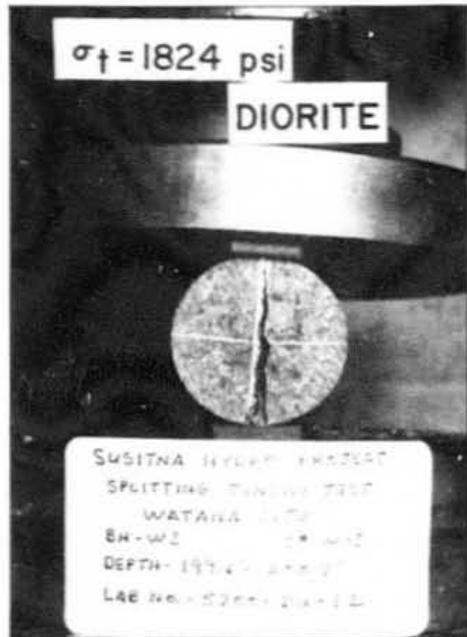
TYPICAL TENSILE
TEST FAILURE

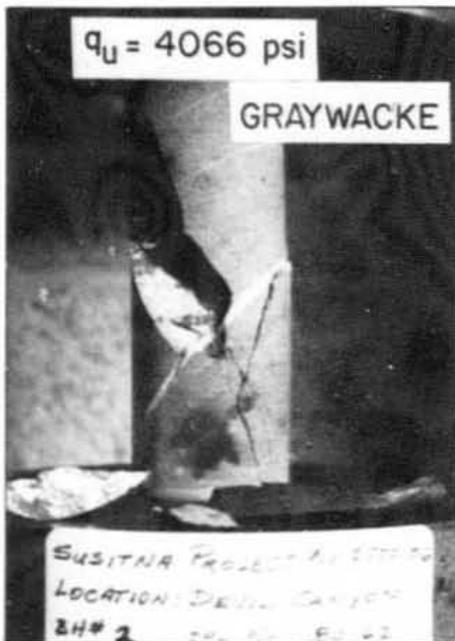
COMPRESSION TEST FAILURE
ALONG HEALED DISCONTINUITY

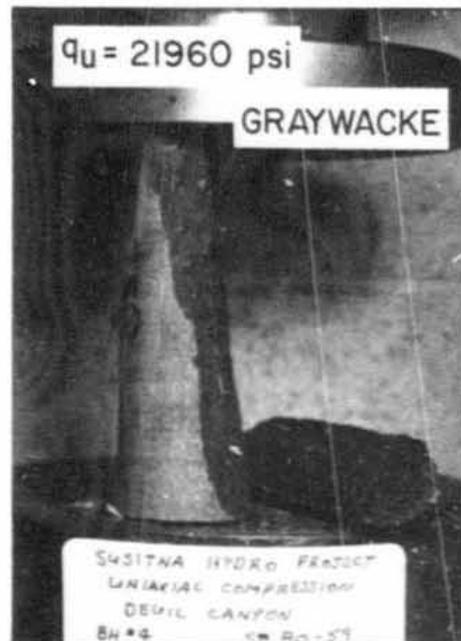
COMPRESSION TEST FAILURE
THROUGH INTACT ROCK
