**FAIRBANKS CREEK MINE REHABILITATION PROJECT, ARCTIC
GRAYLING POPULATION ASSESSMENT AND WATER QUALITY
INVESTIGATIONS, 2007**

Technical Report No. 08-04

**Office of Habitat Management
and Permitting
Alaska Department of Natural Resources**

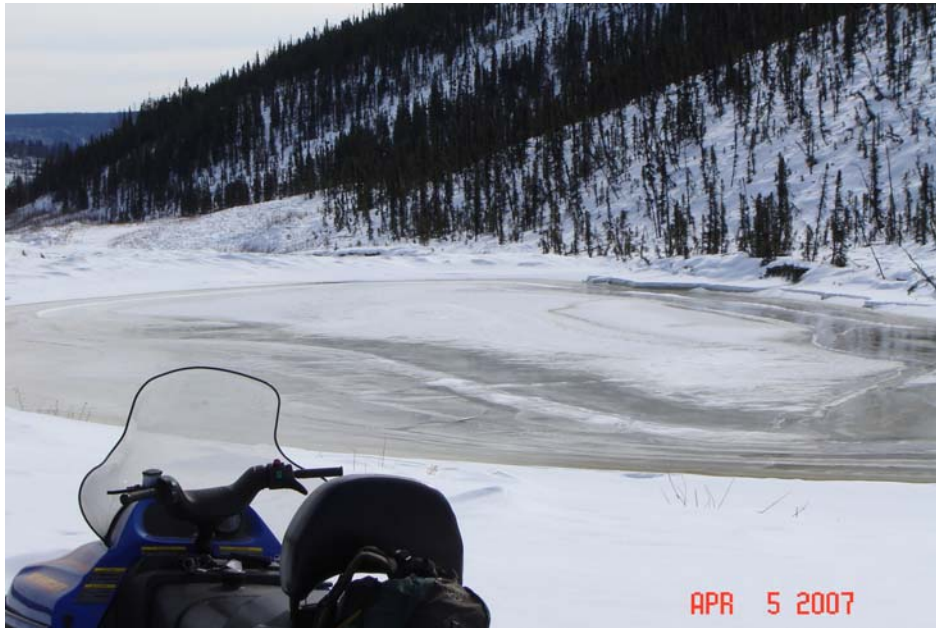
Photograph 1. Pond 3 had lost a minimum of 2 feet of water since freeze-up and was largely inundated with overflow water at the time of our attempt to conduct water quality sampling, April 5, 2007.

deep (Morris and Ihlenfeldt 2007). Ice around the margins of the pond was grounded. Ice sagged into the pond approximately 2 feet; indicating the pond had continued to drain after freeze-up and had lost approximately 2 feet of water since the onset of winter (Photograph 1).

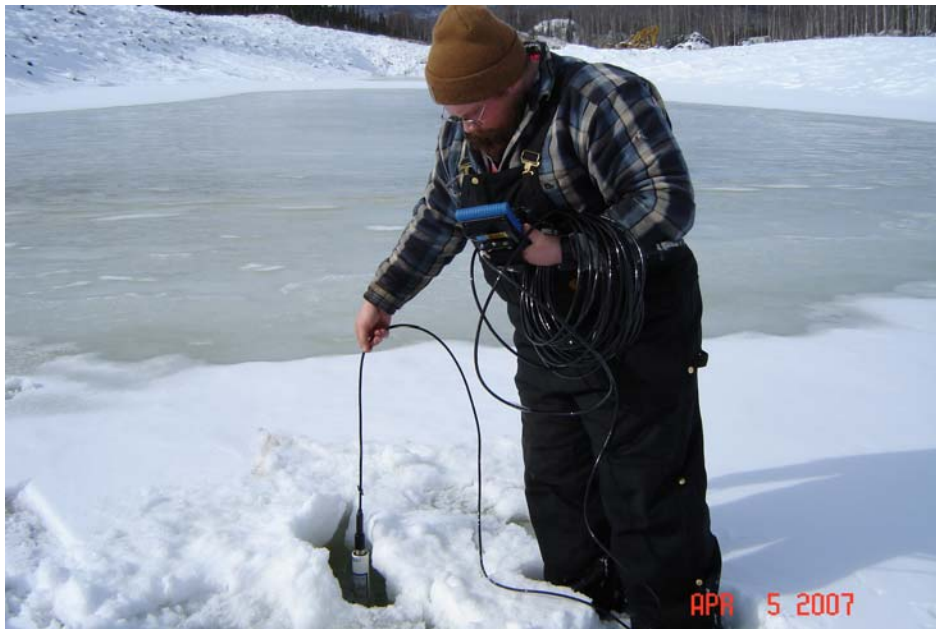
Photograph 2. Pond 2 was covered by approximately 6 inches of overflow water but was more accessible than Pond 3, April 5, 2007.

We could only access an area of Pond 2 that was approximately 2.25 meters deep because of overflow. Ice sagging, as observed at Pond 3, appeared less significant at Pond 2. At the sampling location for Pond 2, the ice thickness was between 24 and 30 inches and about 6 inches of overflow water was present above the ice (Photograph 2). Surface water influx into the sampling hole occurred throughout sampling. Pond 1 was fully accessible and little overflow had covered the pond (Photograph 3). Significant aufeis was present on the margins of the pond but surface flow was minimal. The pond was covered with approximately 42 inches of ice and the water surface was about 2 inches below the ice surface in the sampling hole, although approximately 1 inch of surface water was present on top of the ice. Surface water flow into the hole was minimal as most water was being contained in the snow. The site selected for water quality analysis at Pond 1 was 4 meters deep.

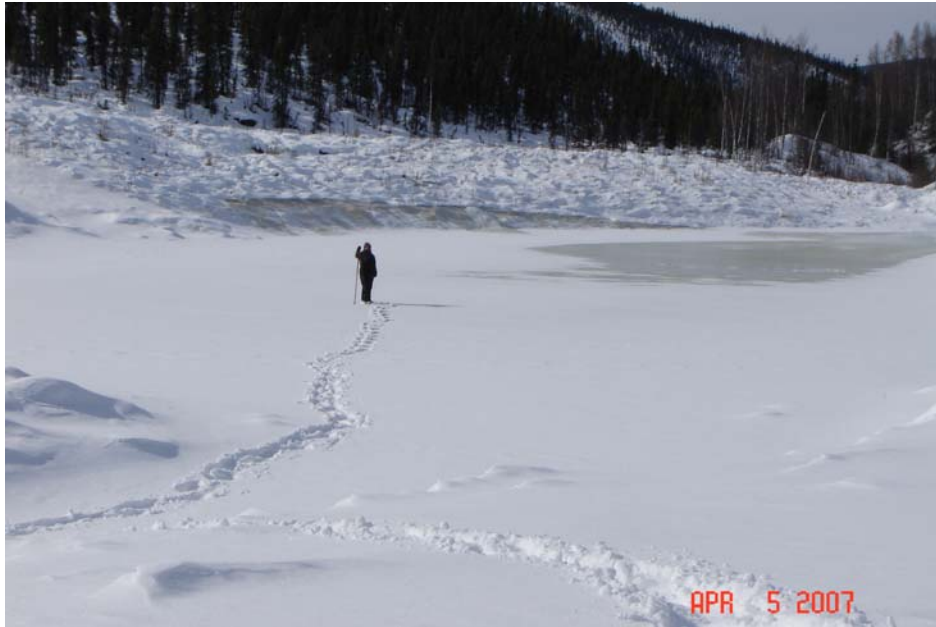
Photograph 3. Pond 1 was fully accessible and showed signs of significant aufeis production from the north facing slopes, April 5, 2007.

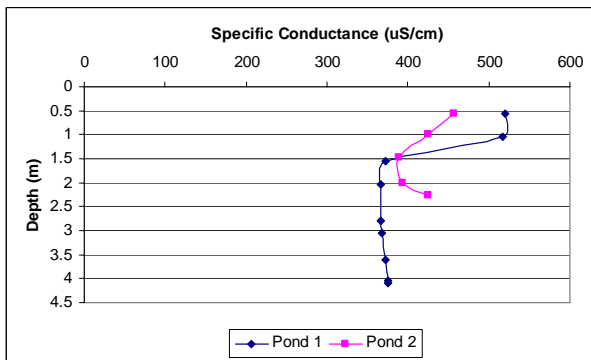
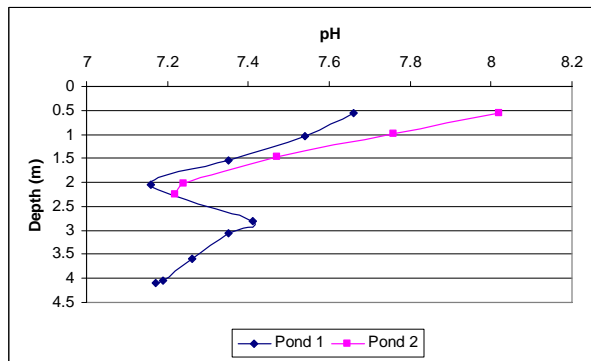
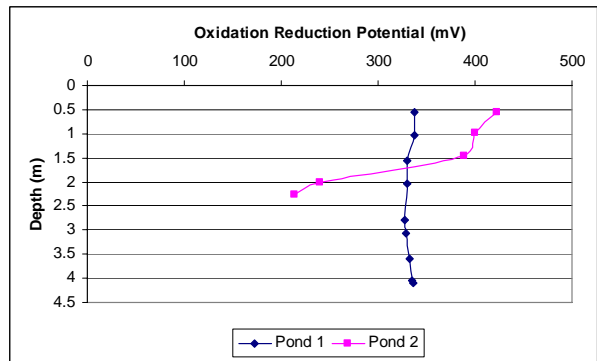
Figure 2. Summary of water quality data collected at all ponds, April 5, 2007, Fairbanks Creek Mine, Alaska.

Water quality data collected at Pond 1 indicated that the pond provides viable fish overwintering habitat. Dissolved oxygen concentrations remained above 7.00 mg/L at all depths sampled. Specific conductance data suggested significant ground water input, similar to that observed in Pond 2. The temperature in a significant portion of the water column at Pond 1 was recorded at between 0.0 and -0.1° C. However, the accuracy of the temperature probe used was +/- 0.1° C so it is our interpretation that, while the water was indeed cold, it was slightly above freezing at all depths. All data collected at ponds 1 and 2 in April 2007 are summarized in Figure 2.

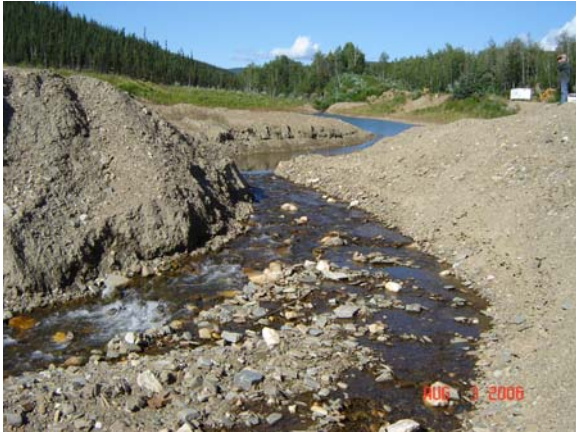
Photograph 4. View of the constructed outlet channel between Ponds 1 and 2, looking upstream into Pond 1, August 2006.

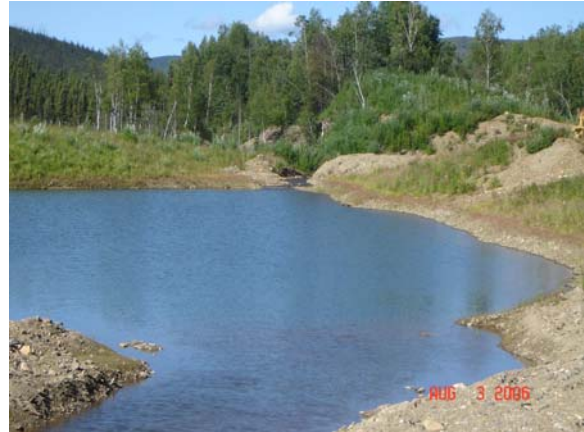
Photograph 7. View of Pond 1 looking at Fairbanks Creek flowing into the pond, August 2006.

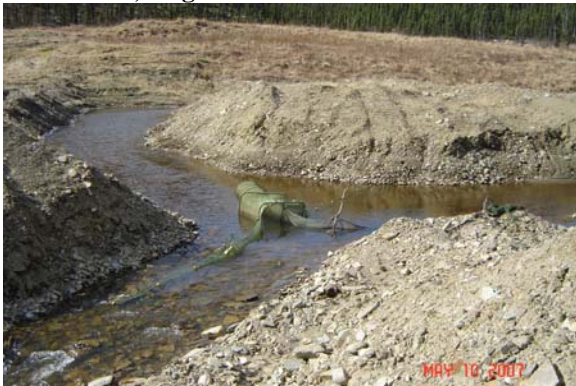
Photograph 5. View of the outlet and constructed island in Pond 1, May 2007.

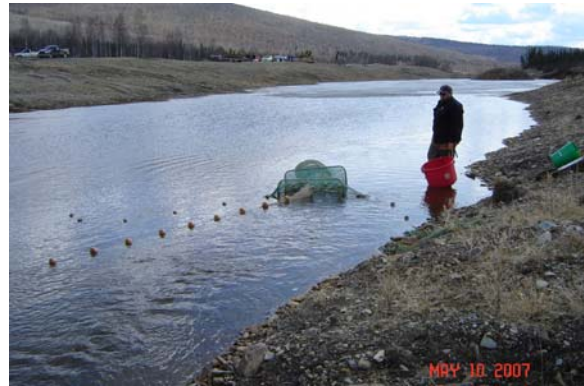
Photograph 8. View of Pond 2 looking downstream from the inlet, May 2007. The constructed island in Pond 2 is visible at the downstream end of the pond.

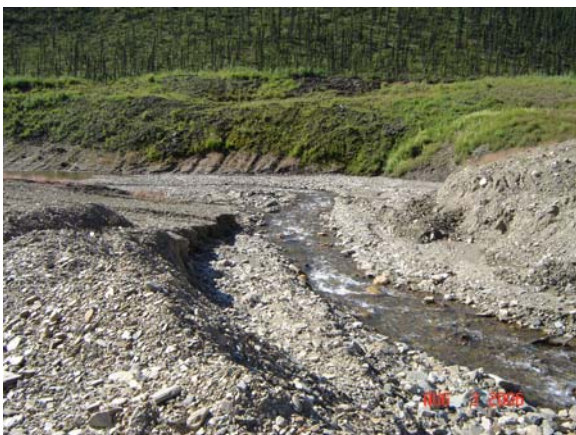
Photograph 6. View of the Pond 1 outlet channel looking towards Pond 2, August 2006.

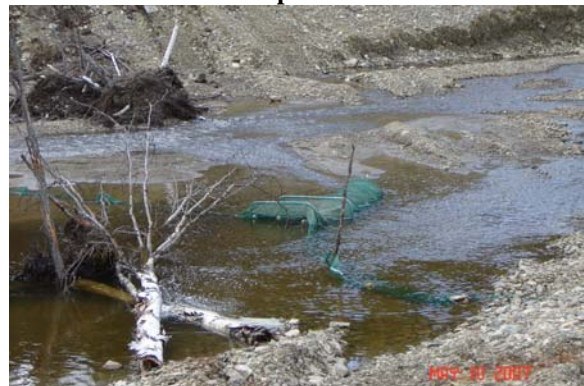
Photograph 9. View of the Pond 3 inlet looking upstream, May 2007. Large woody debris placed in pond was used by adults and large numbers of fry during June 2007.
