## *The St. George Seal Skin Plant, St. George Island, Alaska*

A report prepared by Charles M. Mobley & Associates, Anchorage, Alaska, under contract to Alpha Engineering Group, Inc., Bothell, Washington, for National Marine Fisheries, National Oceanic and Atmospheric Administration.

## Abstract

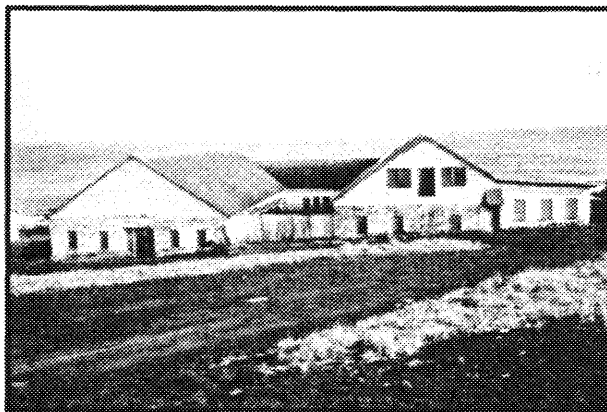
Figure 7. Looking north at the seal plant building one can see, from left to right, the wash house, blubber house, brine house, and barreling room.

to collect documents a central element in the lives of St. George villagers — the fur seal plant. Every building in the Landmark, every structure in the old company town, was built with one purpose — to support the activity that went on in the fur seal plant (Figure 7). As the economic mainspring of the community, the seal plant had tremendous cultural significance to the people of St. George. As a unique aspect of Alaska's commercialized natural resources, the Pribilof fur seal industry is significant at the state-wide level. The National Register documentation states the Landmark to "possess outstanding historical significance to the themes of industry, conservation, and ethnic heritage," during a period of significance of 1786 to 1959. Consequently, this report also organizes historical information that might be appreciated by anyone with an interest in Alaska's heritage.

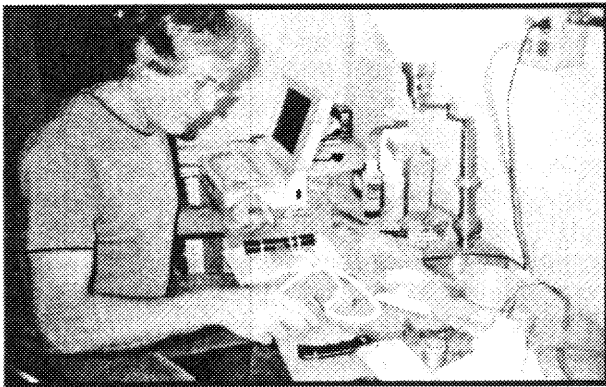
Figure 11. National Marine Fisheries biologist Roger Gentry, in a study in the doctor's quarters of Cottage C in 1992, prepares a computerized instrument package for a ten-day ride on a female seal.

National Marine Fisheries, has focused on behavioral and feeding studies using the St. George fur seal population (Figure 11).

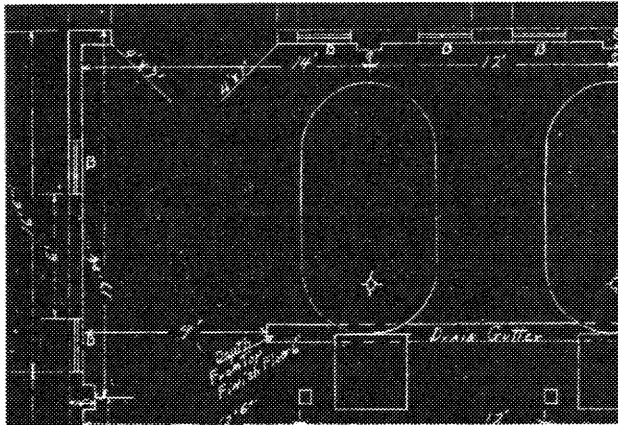
Figure 14. A plan of the brine house drawn by Samuel E. Shaw, probably in 1951, shows spaces for four redwood brine tanks with their salt boxes on the east.

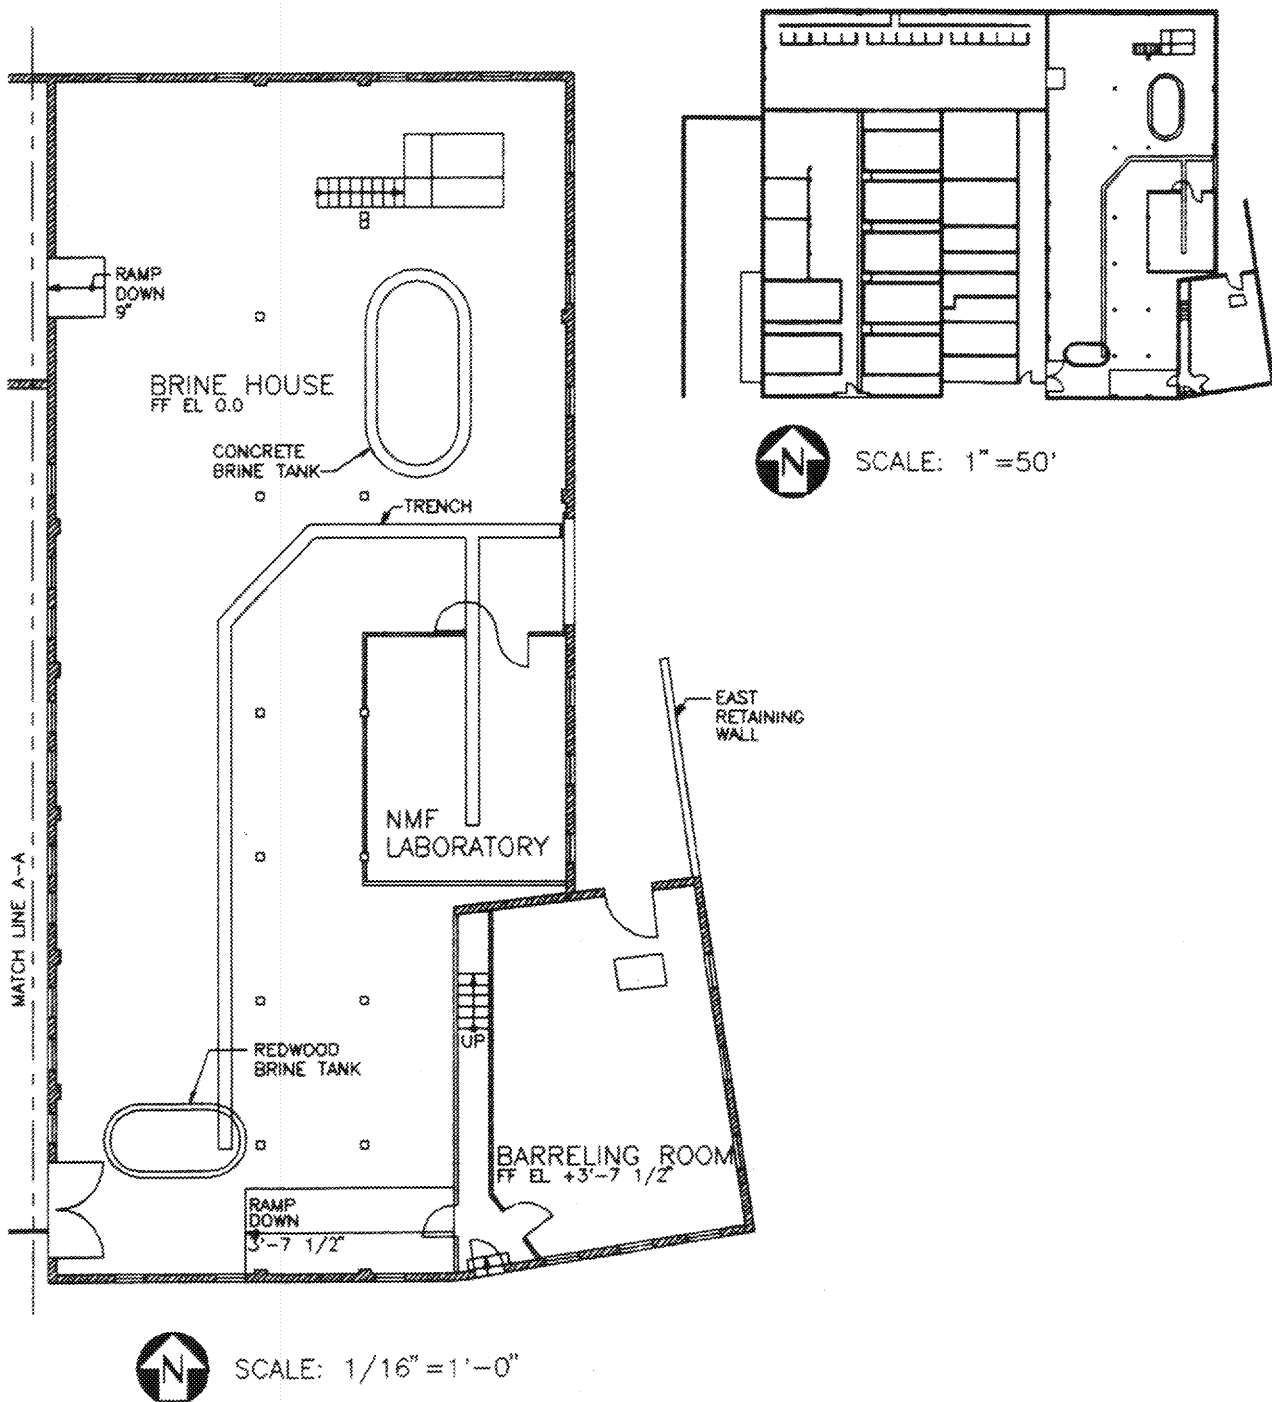
Figure 17. The brine house first floor plan shows partitions added by federal biologists to house a laboratory in the east central area, and to create a new stairway to the second floor. Inset shows plant layout.

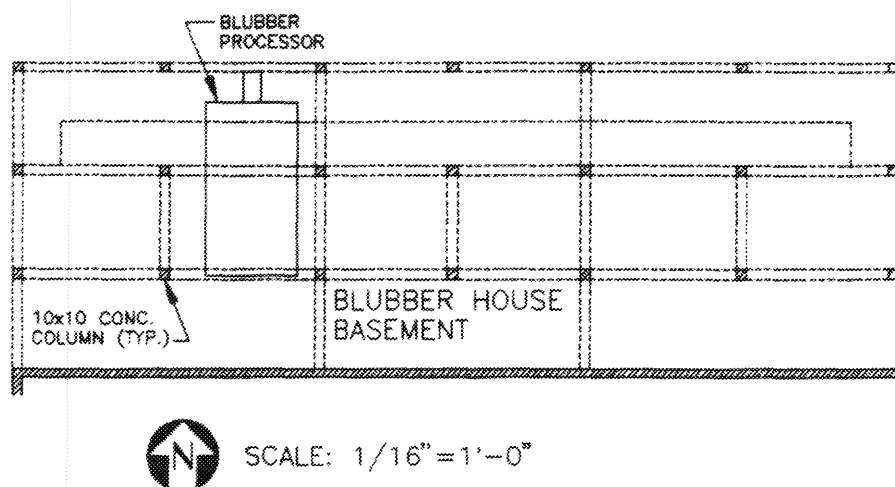
Figure 18. The basement under the blubber house, housing the large cylindrical blubber apparatus and considerable debris, is supported by slender poured concrete pillars.

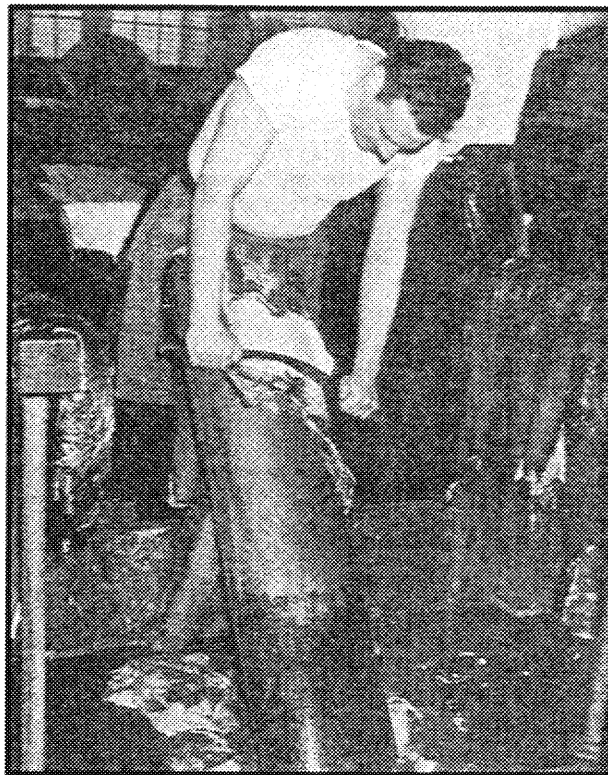
Figure 22. From the wash tanks the skins went to a blubbering beam like this one shown at St. Paul, and the blubber was removed with double-handled knives.

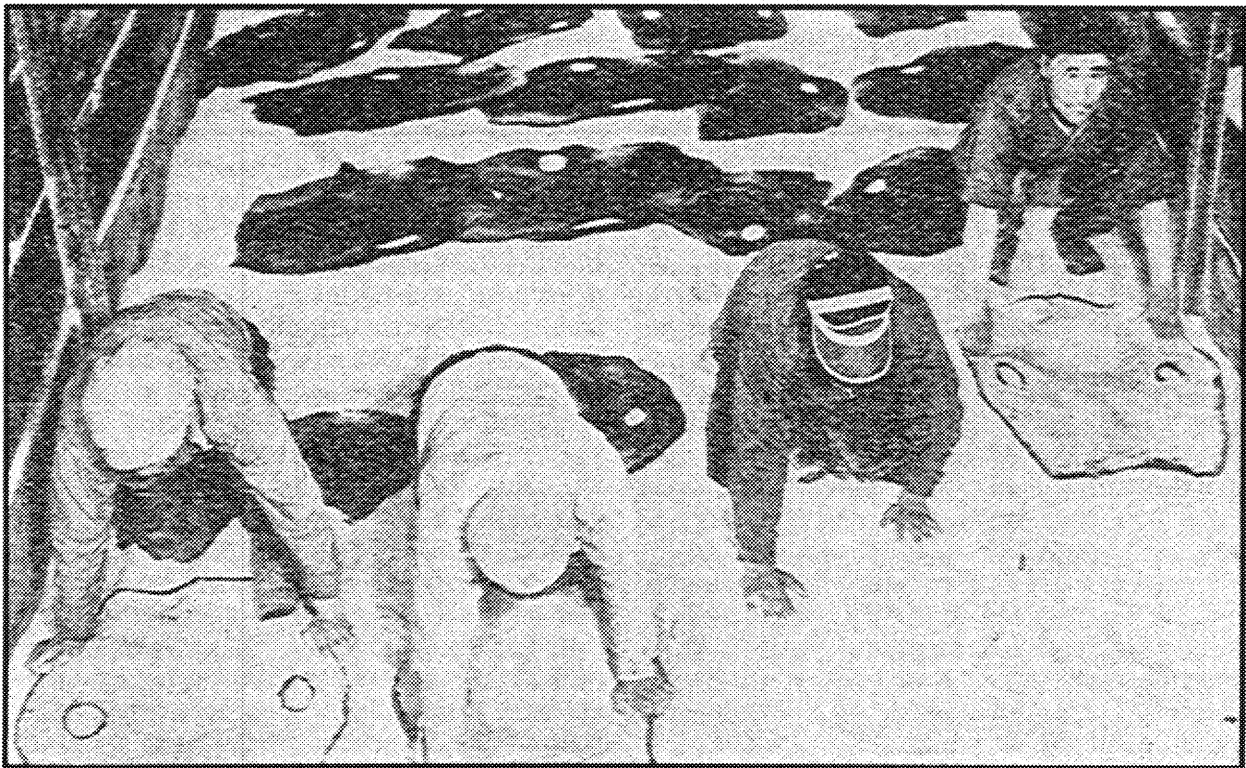
Figure 24. In earlier decades all pelts were "kenched," or rolled in salt, as they are doing here at St. Paul.

the wash tanks were in use, kenching was maintained as an optional processing method. They had sideboards, so their height could be changed as needed. The kenches could be dismantled as necessary, and the north wash tank of the two on the west wall was adaptable to either washing or — with the addition of sideboards — kenching. Kenching was a back-breaking process that had changed little since the earliest days of the Russian industry began (Figure 24). It was useful when the blubberers, or the seven wash tanks — with their 250 skin capacity — couldn't handle all the sealskins. When well-kenched, seal skins can be blubbered three or four years later without hurting the quality of the skin, according to Terenty Mercurief.

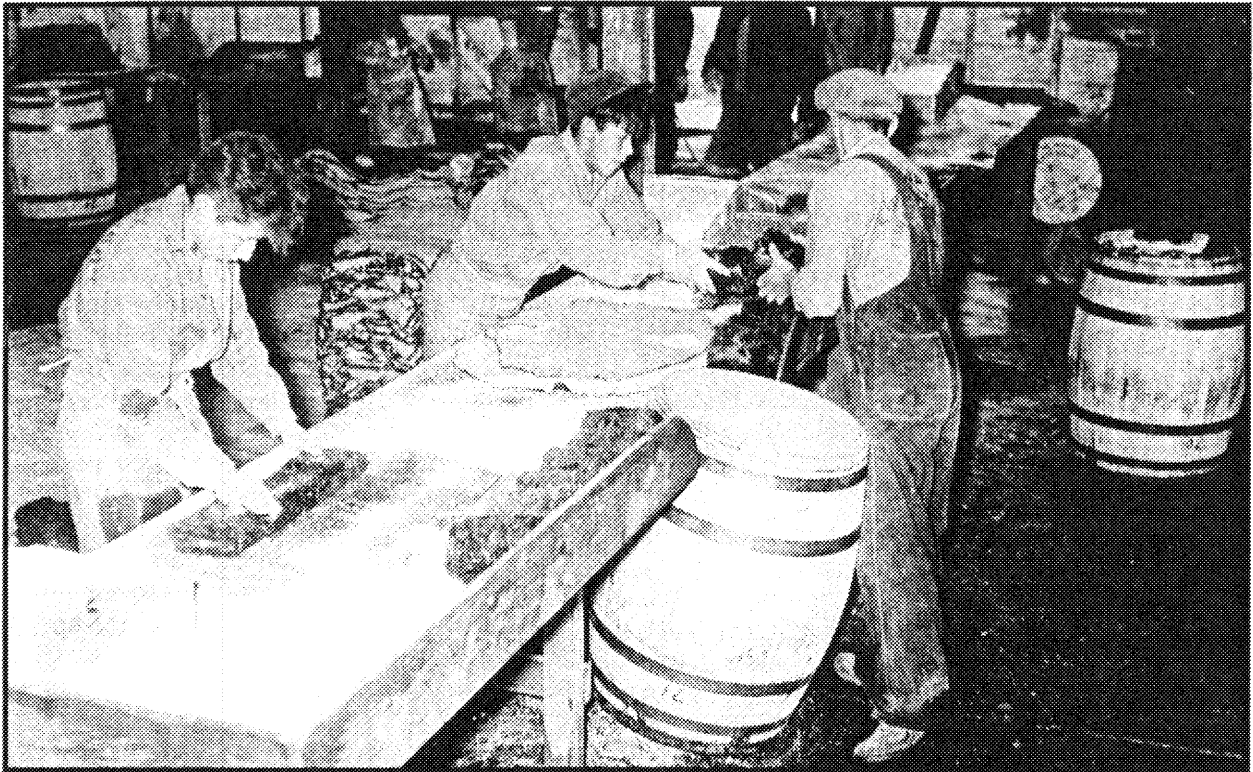
Figure 27. When the skins were dry, they were bundled in salt or borax and packed in barrels -- note man packing with his feet at right.

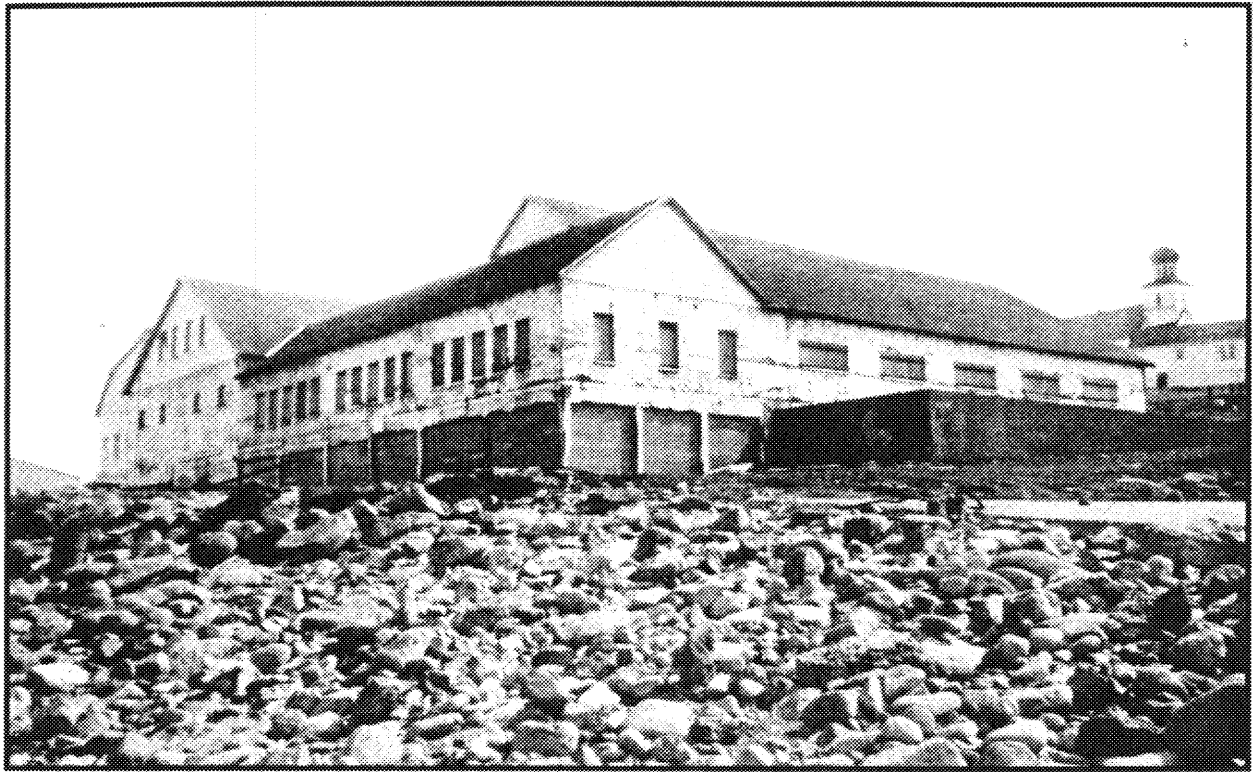
Figure 29. The skin plant, here looking southeast, is very near the shore and thus subject to ocean spray.

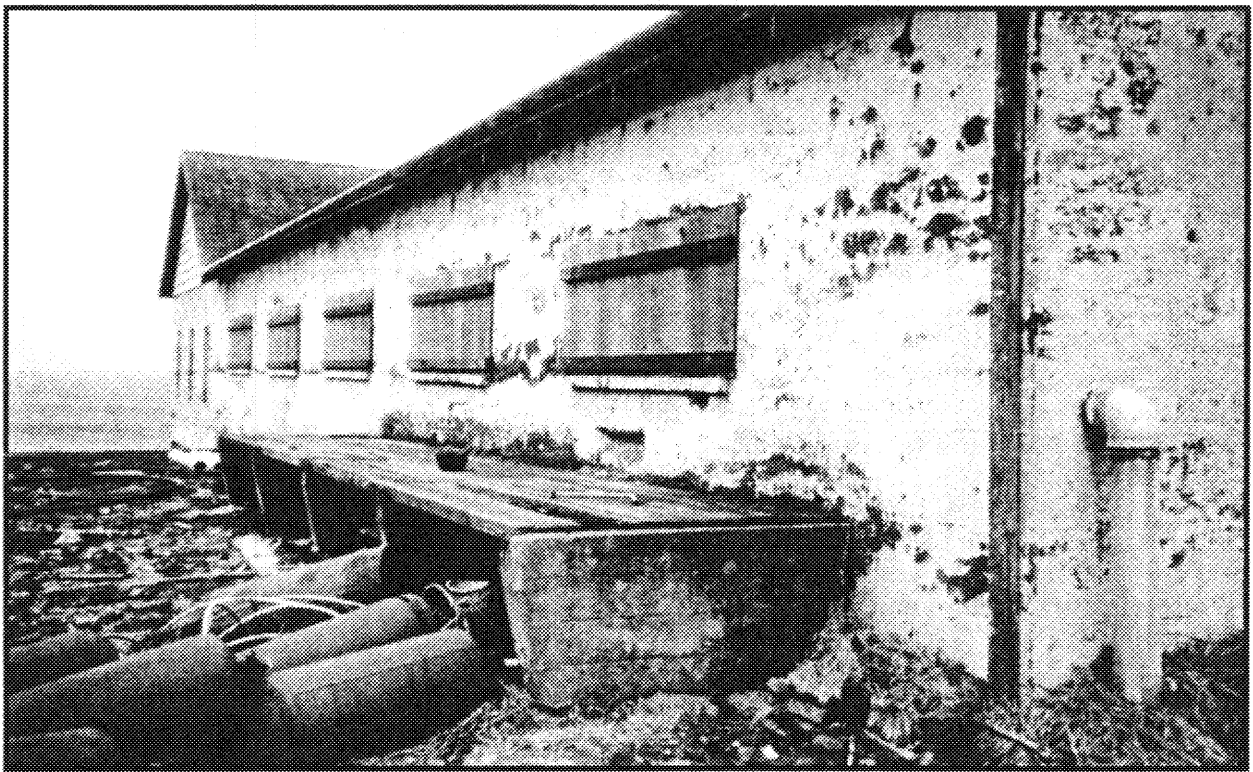
Figure 30. Skins were hauled up on trucks to this loading dock on the west side of the wash house, or to the east side, and thrown directly through the windows into wash tanks or kenches..

The loading dock attached to the west end of the wash house, where raw skins were passed through the windows into the wash tanks and kenches on the west wall, is still intact, as is the retaining wall beneath it (Figures 29, 30). The five concrete supports are in servicable condition, but the planks used for decking are rotten. On the east side of the building (where the seal pens are now), the unloading area was apparently unimproved, and trucks simply backed into the courtyard to off-load skins.

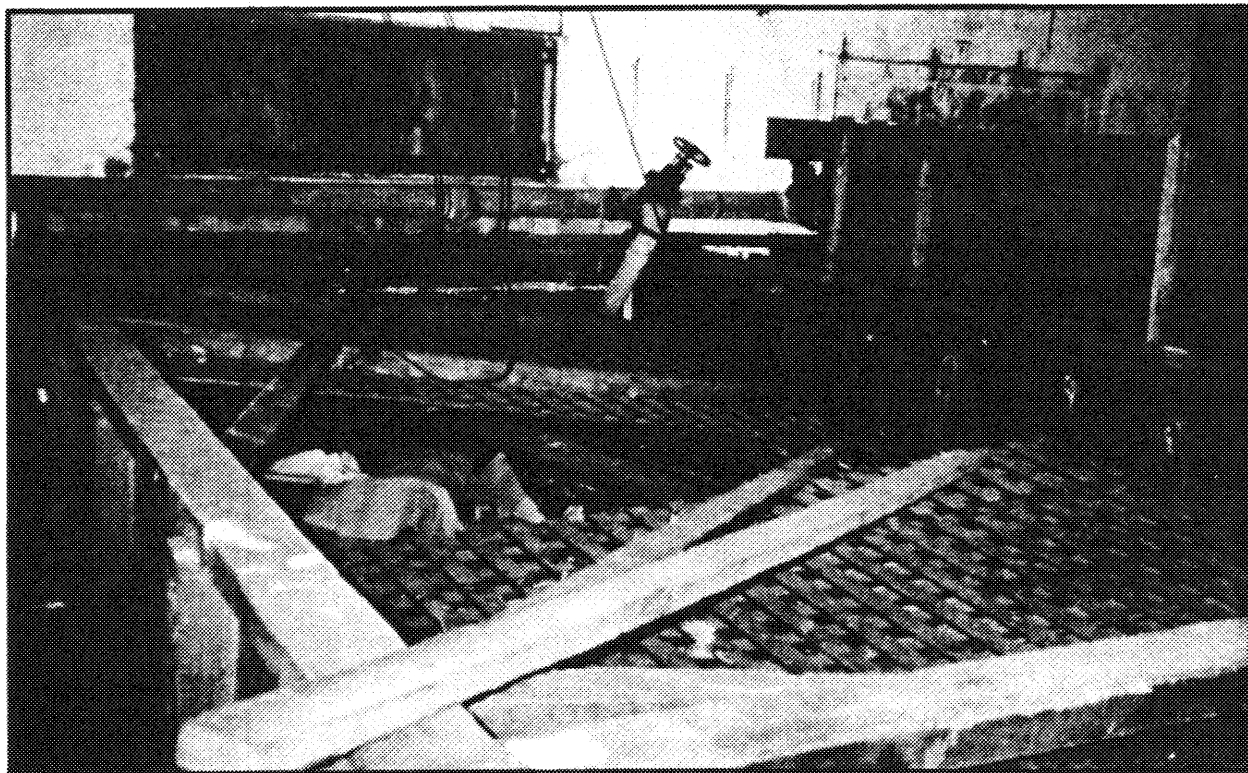
Figure 32. Each wash tank, like this one in the southwest corner of the wash house (looking northwest), was designed to hold 250 skins in salt water; note wash tank at right with sideboards.

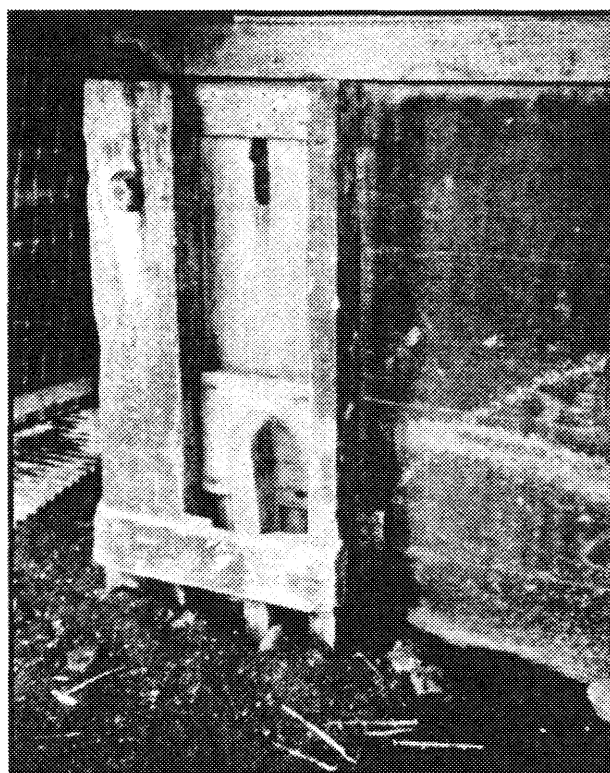
Figure 34. When the wash tank was to be emptied of water, a gate such as this one at the southwest corner of the southeast tank was opened by removing the wedge and the wooden panel behind it.

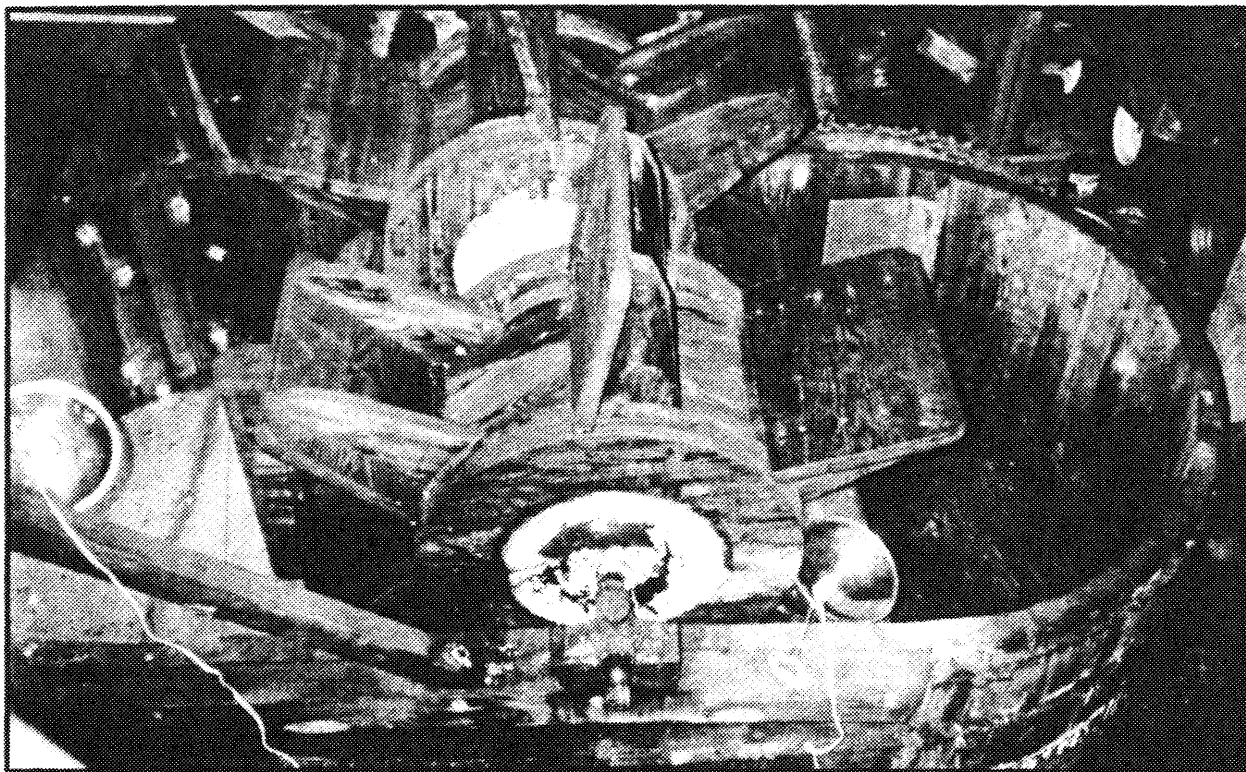
Figure 42. The two paddles in the redwood brine tank are geared to move skins around clockwise.

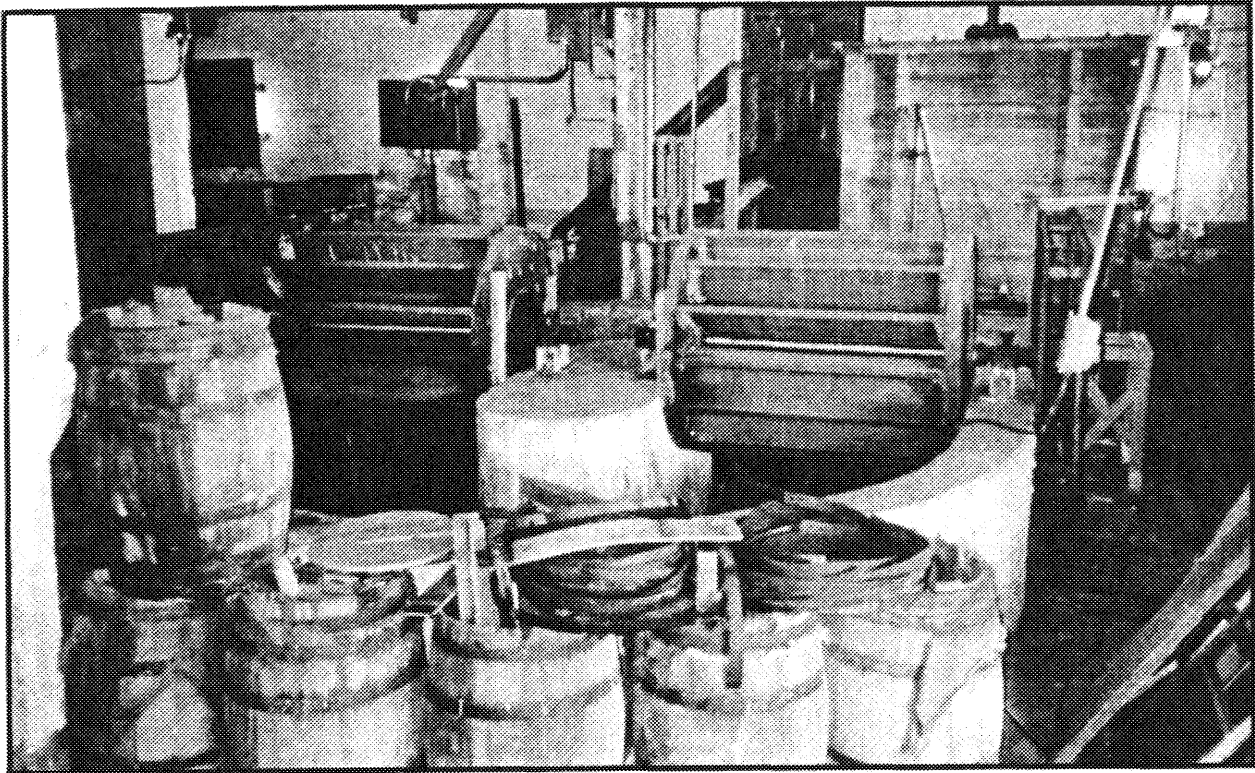
Figure 44. The concrete brine tank, here looking north, held up to 1000 skins.

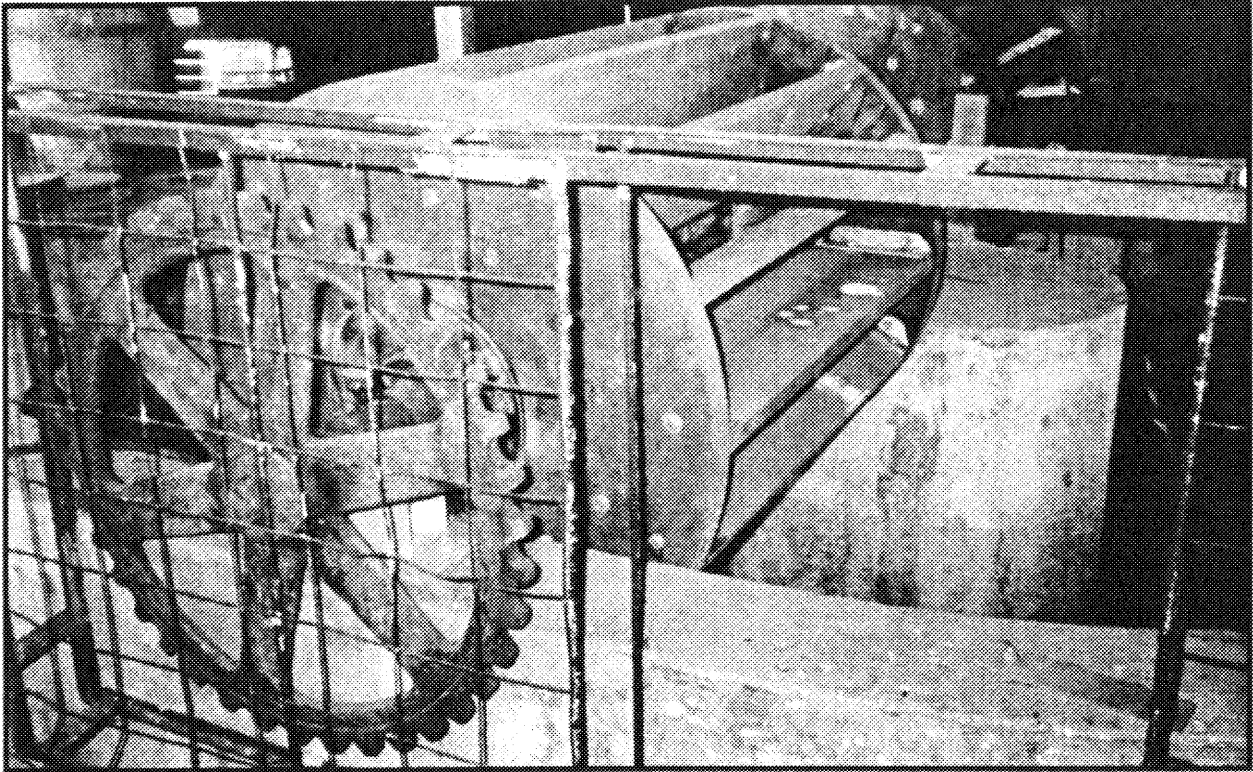
Figure 46. The concrete brine tank's two paddles were each powered by a separate motor.

The brine tank was favored because “it requires less time, is more satisfactory, and conserves labor” (Thompson 1955:74). Skins were placed in the tank, flooded with saline solution, and agitated by two constantly turning paddles that moved the skins in a clockwise direction (Figure 25). The two paddles each had six blades and a stainless steel two-inch diameter axle, and were connected by a gear box mounted on a redwood island in the center of the tank. A two-horsepower electric motor was mounted on one side (the north side in the case of the single remaining tank), to power the paddles. I was told that the high energy requirements of the redwood brine tank motors were one reason they were replaced with a concrete brine tank. The paddle assembly had a large sprocket, 35" in diameter, connected to the motor by a chain.

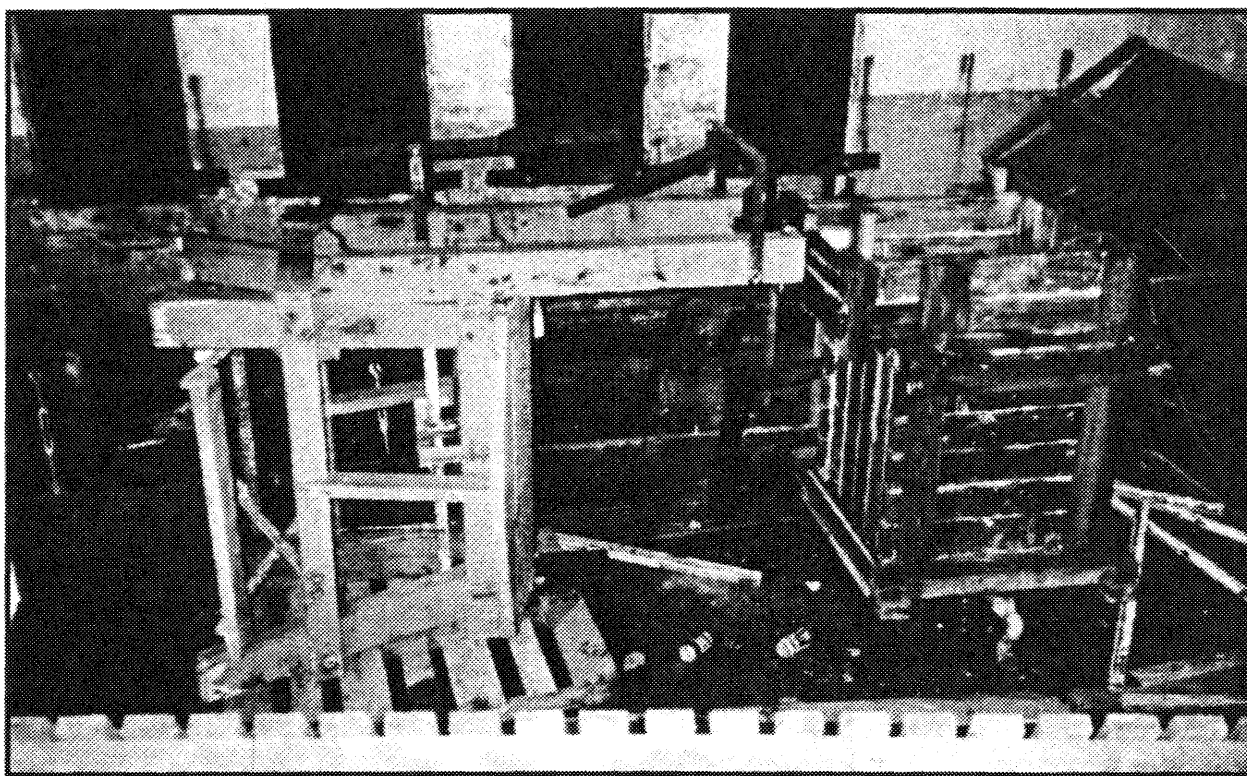
Figure 47. The wringer now lies on its side in the blubber house next to an extra salt box for a redwood brine tank; the workings of the machine are better visualized if the reader turns the page sideways.

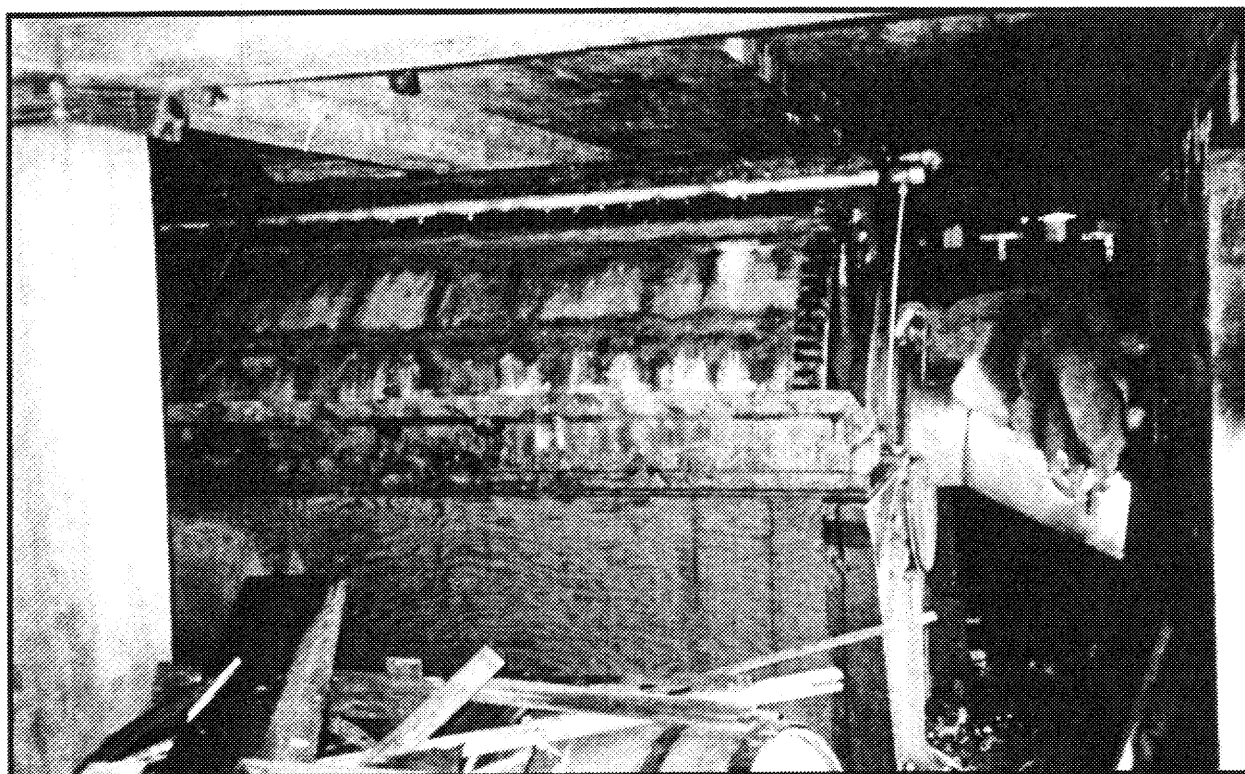
Figure 51. The blubber processor in the basement below the blubber house was installed in the 1960s and never worked very well, according to local people.

of it packed in salt back to St. Louis and Greenville. There was also an attempt to process the blubber with a large machine to make it more uniform and easier to handle. It consisted of a large (seven foot in diameter and fourteen feet long) set of concentric cylinders, brought off the supply ship in a baidar and installed in the basement under the blubber house in the late 1960s. Judging from my brief observations, it would seem that blubber was to be pushed — perhaps using centrifugal force — through successively smaller mesh in each of the metal cylinders. When it was forced through the outermost cylinder, with holes smaller than the shaft of a pin, water was sprayed from pipes to wash the fine material off and out a chute. When I talked with local people about it, they were all of the opinion that the apparatus never worked.

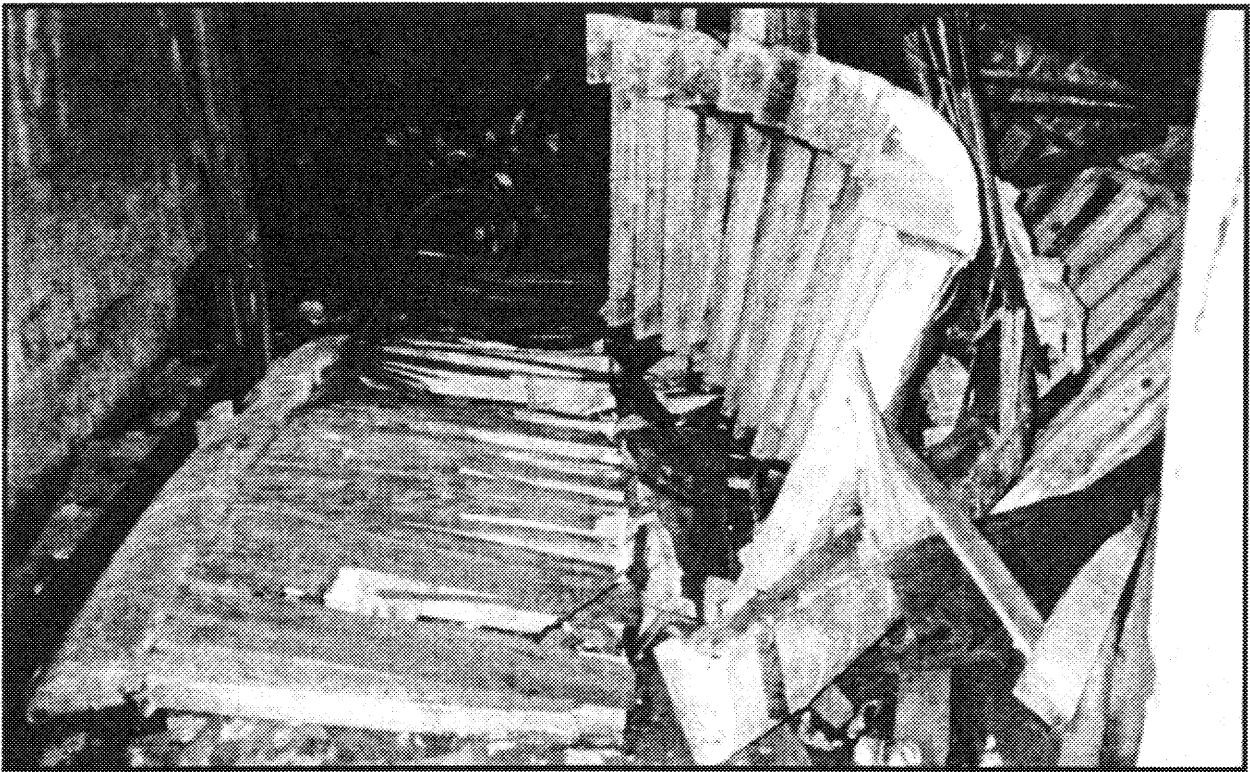
Figure 53. Also in the basement below the blubber house are these assemblies, which may be the forms used to pour the concrete brine tank.

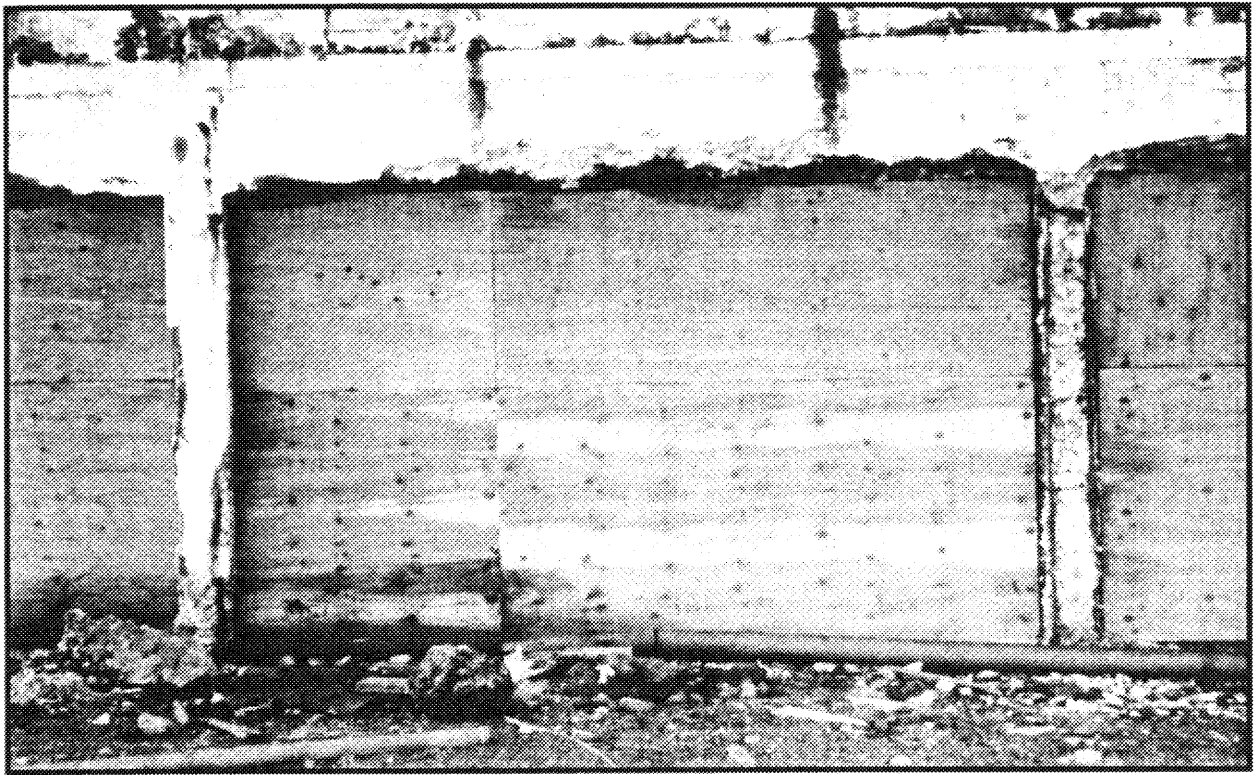
Figure 60. Spalled concrete and rusting reinforcement rod show at the northwest corner of the building (here looking south), beneath the blubber house. The openings were boarded up with plywood in 1992.

ing with saltwater it has received from the spray of the nearby ocean and from the skin handling methods during the years of plant operation. Especially in the northwest corner, where only slender concrete pillars hold up the building, rusting reinforcement rod is expanding and spalling off large portions of concrete (exposing more rod and accelerating the process). If it's not fixed, the building will eventually collapse, probably beginning with the northwest corner.

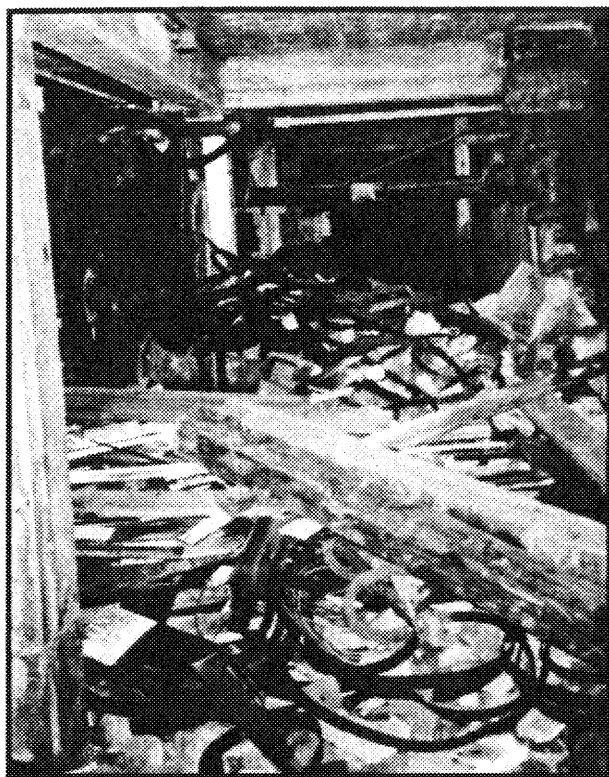
Figure 61. The floor of the basement beneath the blubber house is littered with debris, much of which is associated with the skin processing. Note the south end of the blubber processor at left (looking east).
