Upper Susitna ATV Stream Crossing Locations

Jeffrey C. Davis and David B. Ryland

July 2002

Alaska Department of Fish and Game

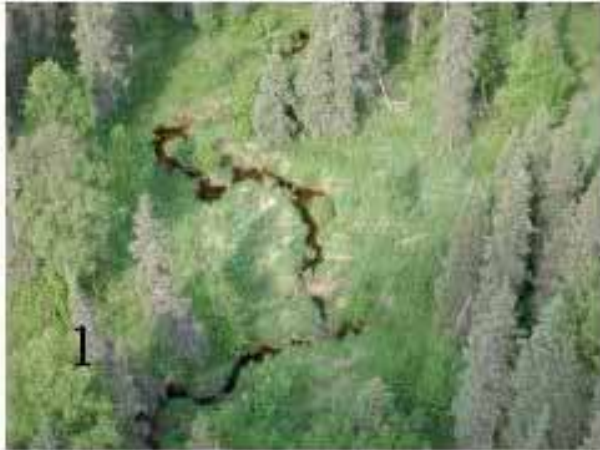
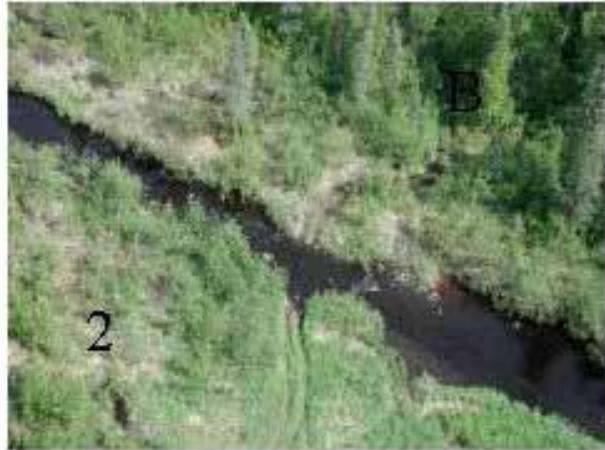
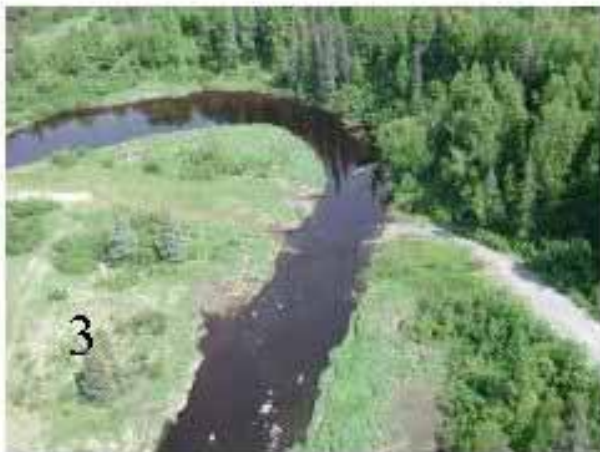
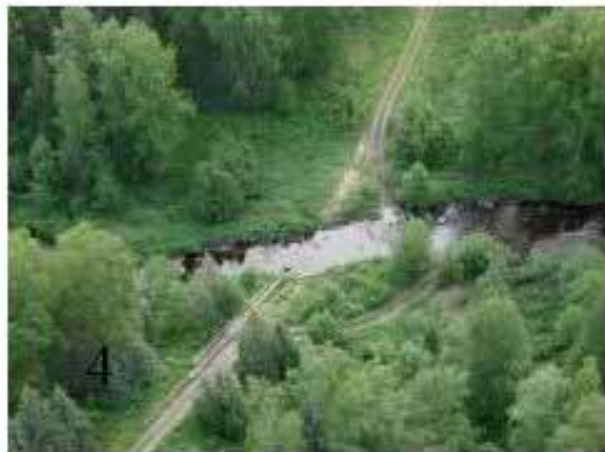
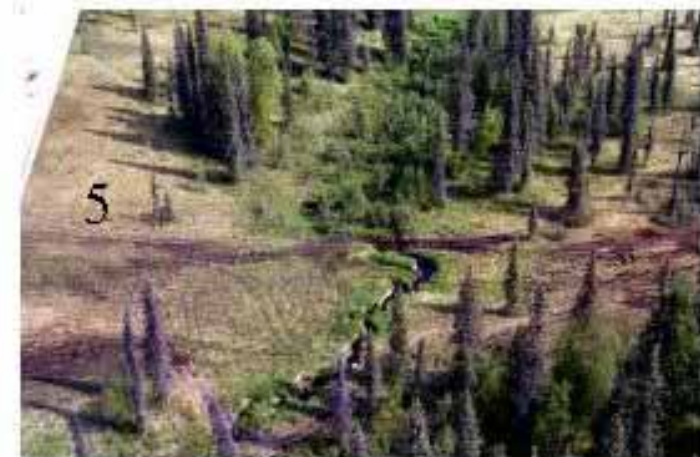
Figure 1. Examples of ATV crossings. Numbers are crossing site scores.

A Site Score was generated at each site by summing positive site impact parameters ranging from 0 to 5 (Wiedmer 2002). Site impact parameters included the following (Figure 1).

Exposed Soil—Visible mineral soil beneath the trail adjacent to the stream.

Denuded Banks—All of the vegetation removed from the trail on both banks.

Increased Width—Stream width two times greater than natural channel.

Surface Erosion—Water pooled or running on the trail surface or evidence of past erosion.

Bank Alteration—Topography of stream banks altered.

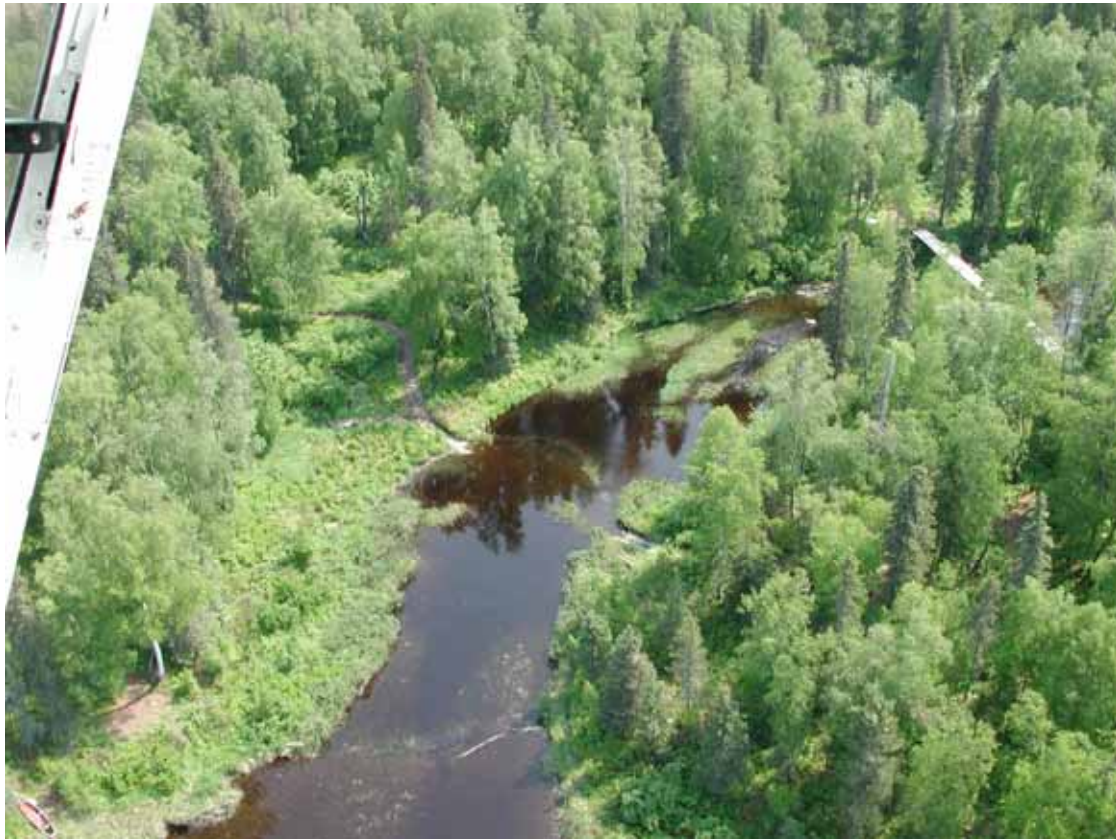
Figure 7. ATV crossing of Trapper Creek at site 130 showing newly constructed bridge in upper right corner.

Road. At some locations homeowner associations have formed and constructed ATV bridges at previous ford locations (Figure 7).
