# Technical Memorandum

## Susitna River Large Woody Debris Reconnaissance

*Susitna- Watana Hydroelectric Project*

**Alaska Energy Authority**

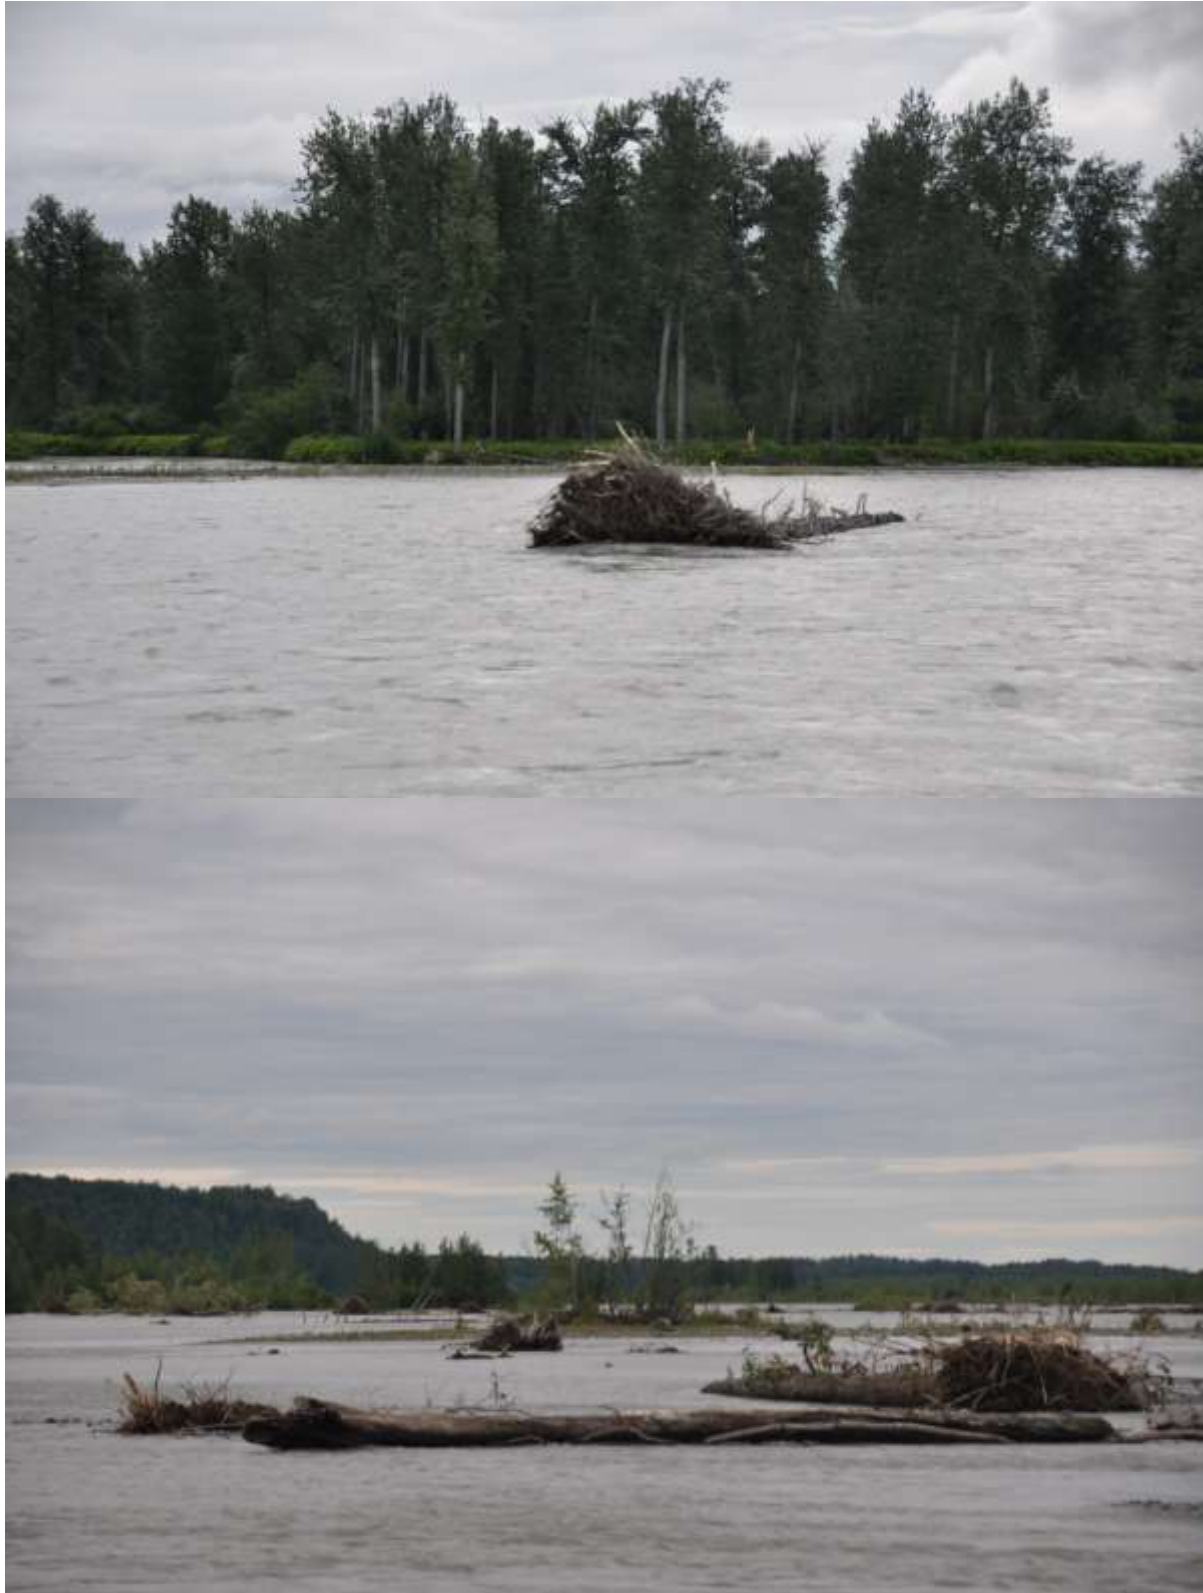
**Photograph 6. June 26, 2012 Three Rivers (Susitna, Chulitna, and Talkeetna rivers) Confluence balsam poplar transport.**

Wood transport, in June and July 2012, was observed to be predominantly occurring at and below the Three Rivers Confluence (Photographs 4, 5, 6, 9, 10). The Chulitna River appears to be a major source of the wood transported into the Lower Susitna River (Photographs 4-6) as large amounts of wood were observed in the main stem Chulitna River at Three Rivers Confluence. The braided reach below Three Rivers Confluence is a transport limited segment of the Susitna River as evidenced by both channel braiding and the large amount of deposited racked and unstable wood debris (Photographs 9 and 10). Wood transport was observed in the Middle Susitna; however, it was limited to single trees with root wads attached, evidence of incremental bank erosion recruitment (Photographs 7 and 8).

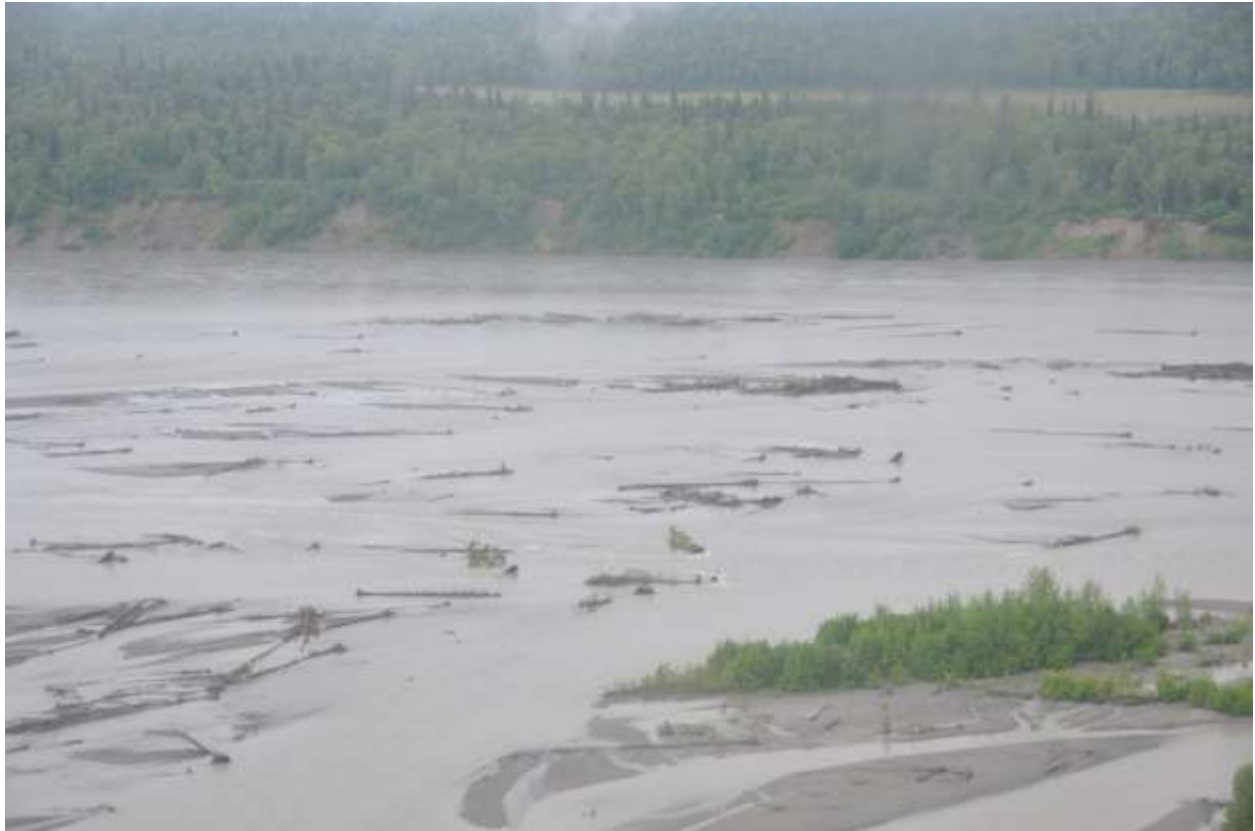
**Photograph 9. June 30, 2012 Lower Susitna River between Talkeetna and Willow. Large wood transport and deposition. Root wads are facing upriver. Flow is from right to left.**

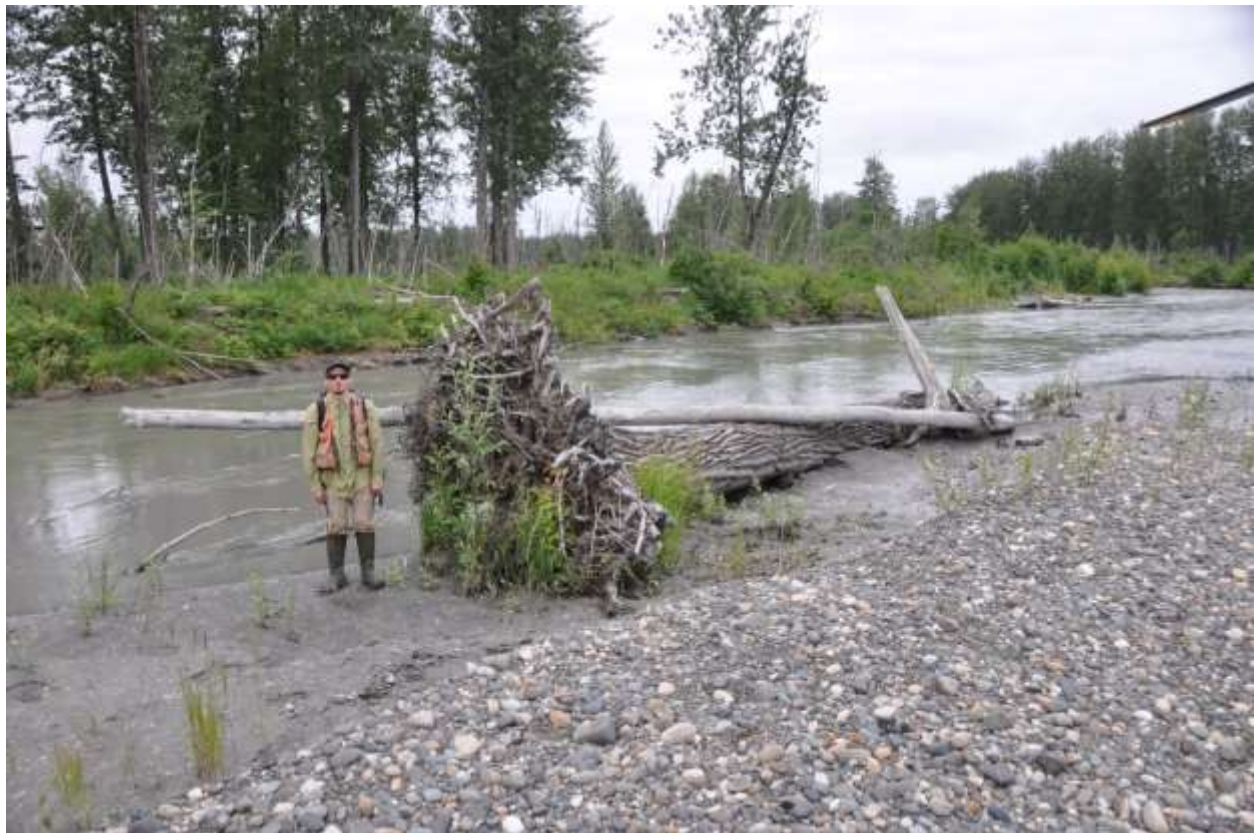
**Photograph 11. July 2, 2012 Lower Susitna River below Talkeetna. Large balsam poplar (79 cm diameter, DBH) with root wad (210 cm diameter) and adjacent scour pool formation (Sample Plot T19\_04).**

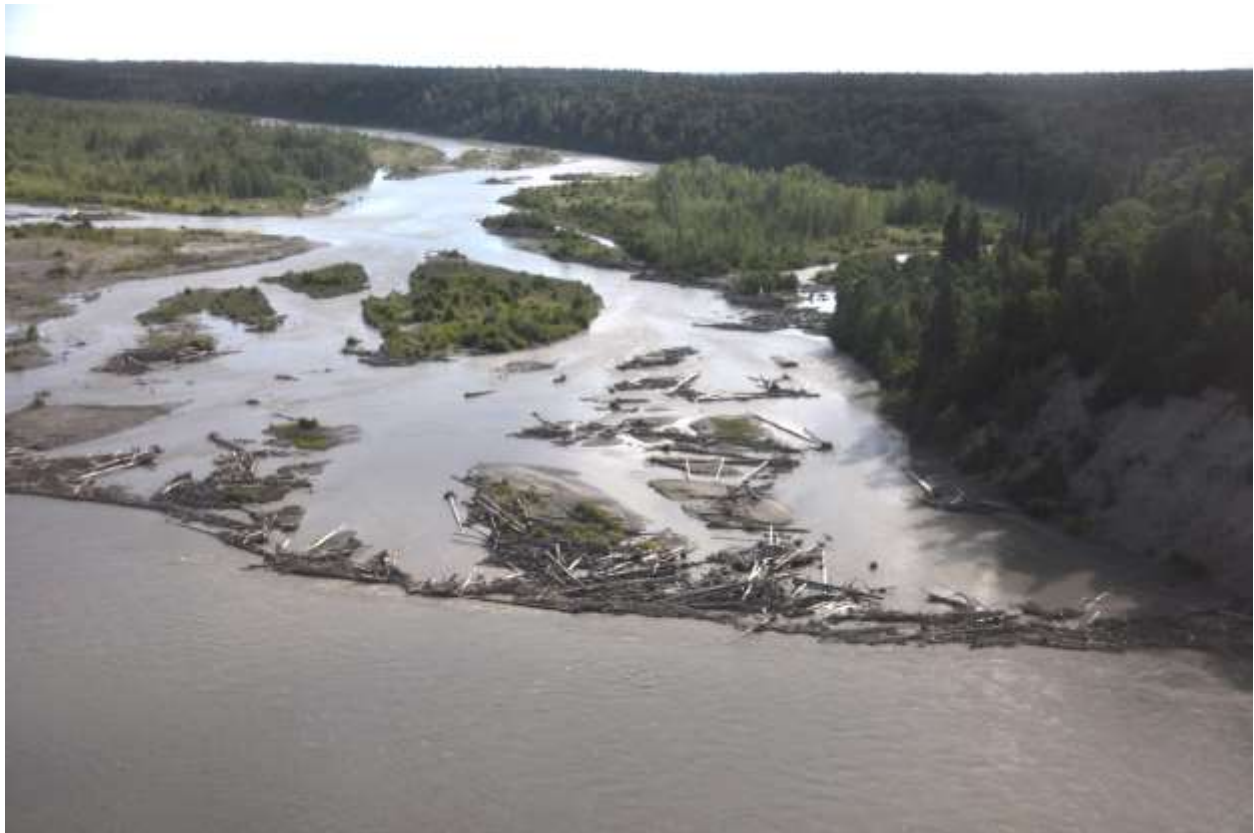
**Photograph 21. June 30, 2012 Lower Susitna River between Talkeetna and Willow. Unstable accumulations of racked wood debris upon bars and stable island bar apex jams with racked members.**

Also, observed stable wood jams were associated with scour pools, islands, channel embankments, and side channel complexes (Photographs 12-17, 19-30).

Bar top accumulations of unstable wood debris appear to be a defining characteristic of the Susitna River. Large quantities of unstable wood debris were observed throughout the Project study area with largest accumulations occurring in the Lower Susitna (Photographs 9, 10, 21) with apparently large contributions from the Chulitna River. However, unstable wood debris was observed throughout both Middle and Lower River segments during the 2012 aerial reconnaissance (Photographs 16, 21, 31, 32, 33, 34, 35, 36, 37). Loose, mobile wood was observed along river banks (Photographs 2, 3), mid channel islands (Photographs 18, 20), and throughout side channel complexes (Photographs 16, 17, 18, 21, 34).

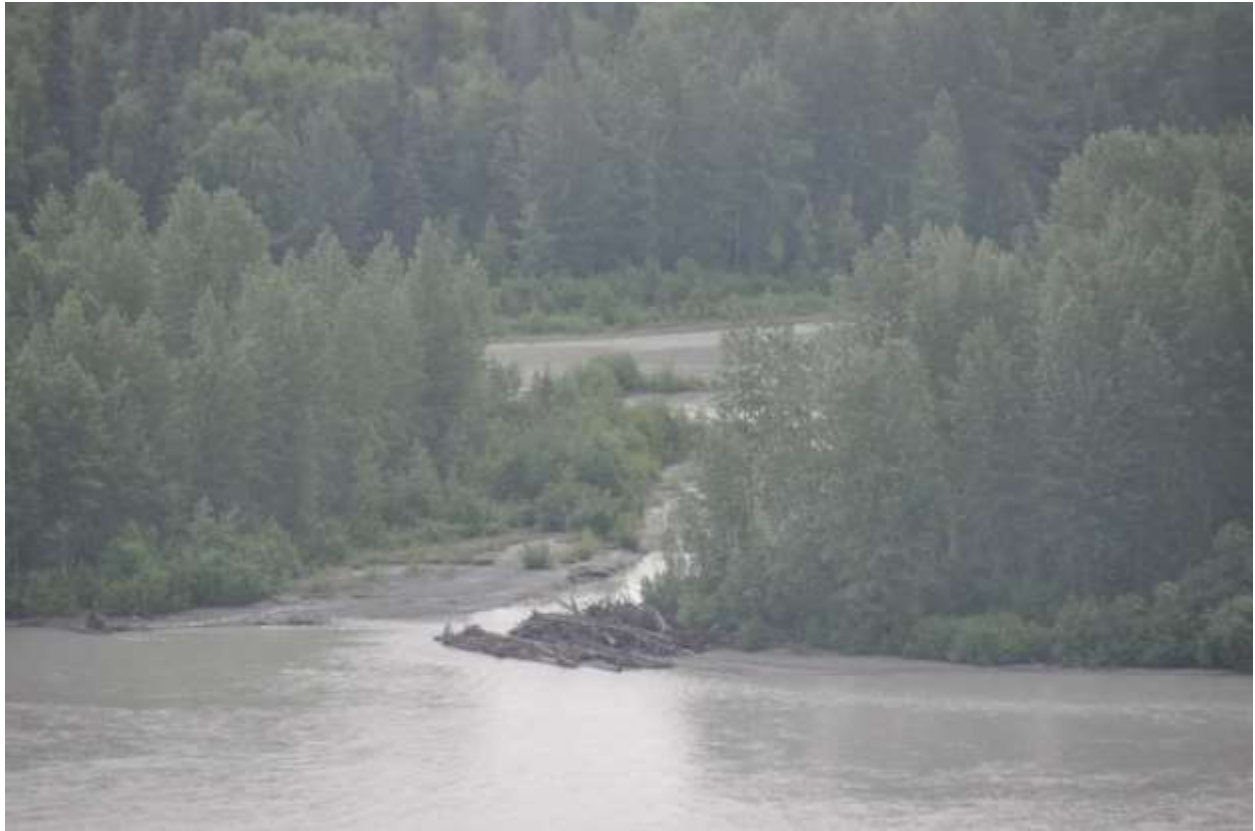
**Photograph 22. June 30, 2012 Lower Susitna River between Talkeetna and Willow. Bar apex wood jam with racked members at island apex and side channel entrance.**

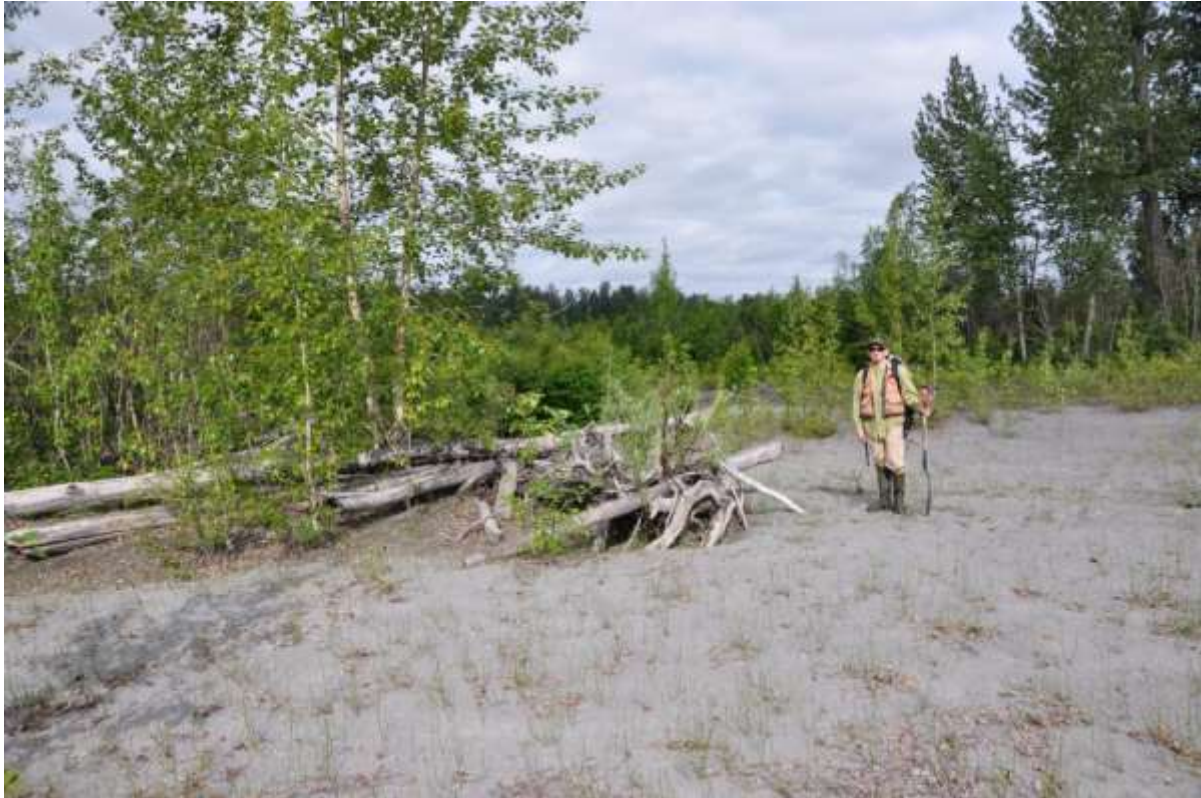
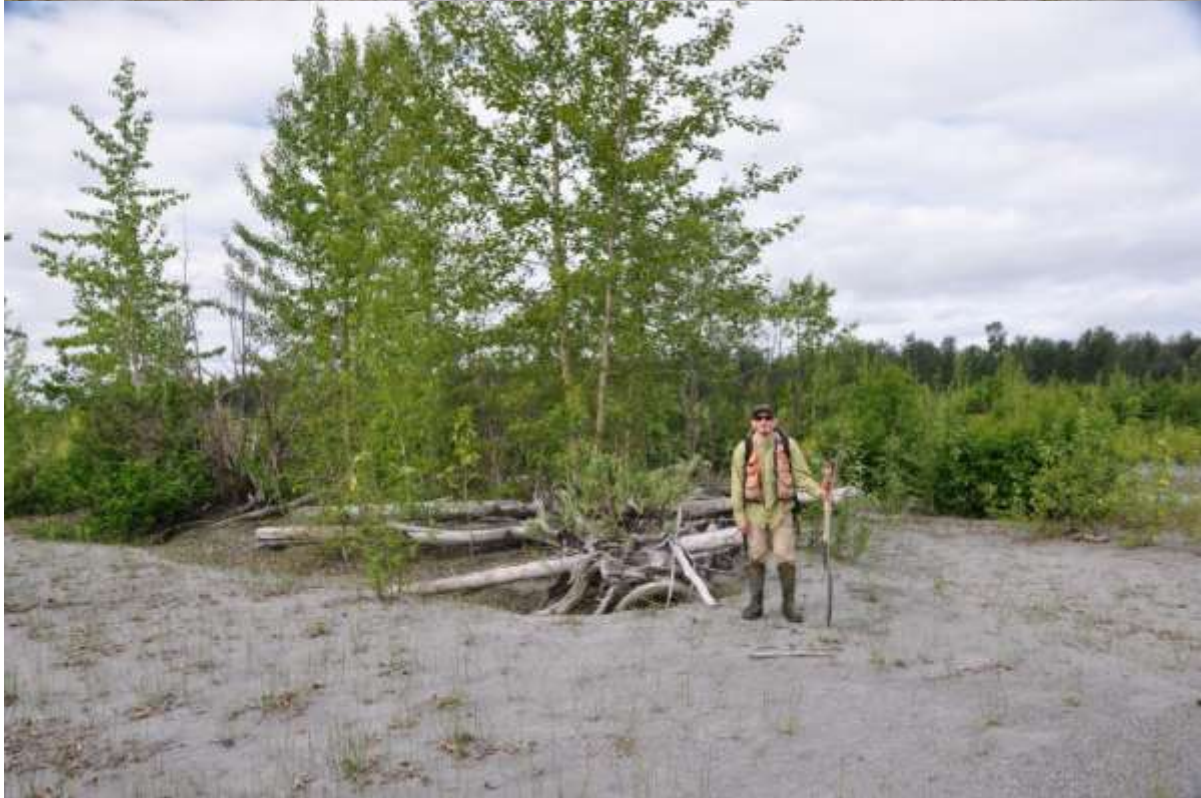
**Photograph 26. July 2, 2012 Lower Susitna River below Talkeetna. Bar apex wood jam with buried key member and racked members. Young balsam poplar colonizing elevated wood jam surface.**

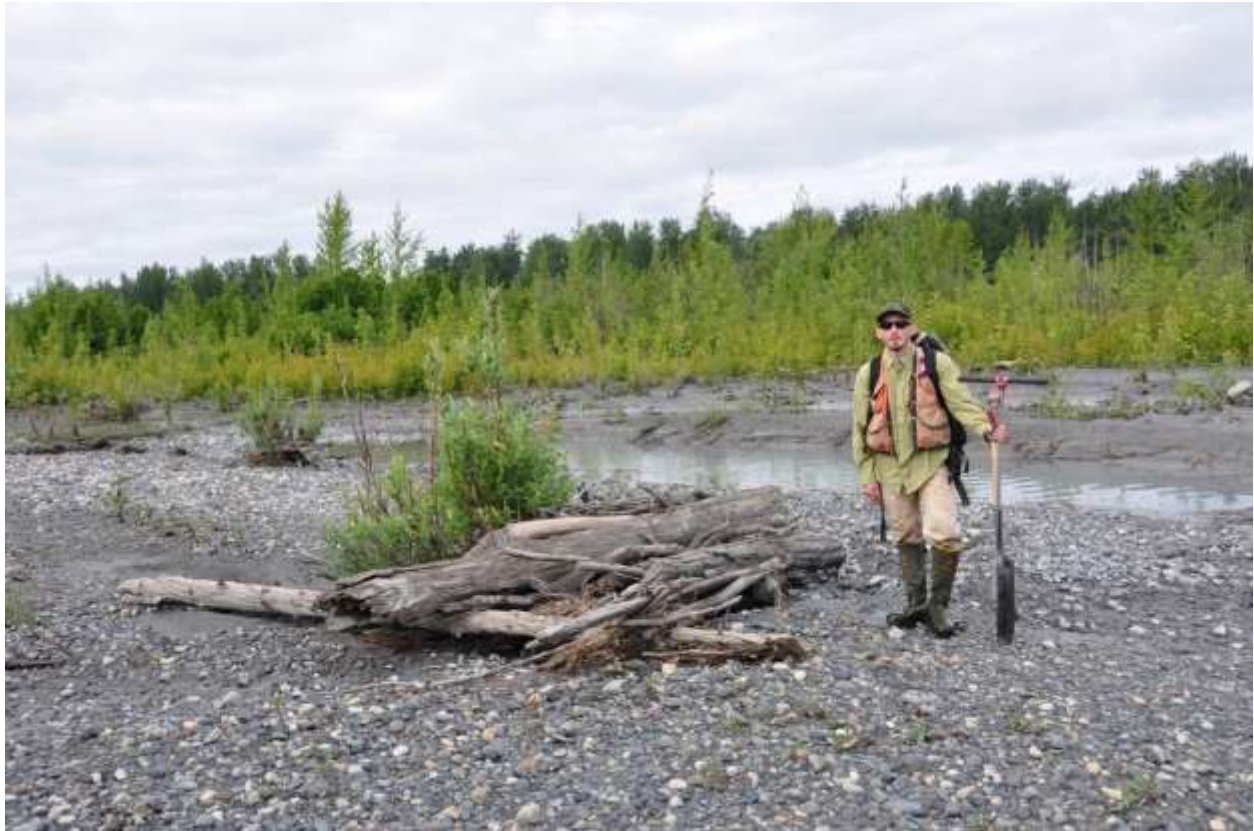
**Photograph 32. July 2, 2012 Lower Susitna River below Talkeetna. Typical loose, unstable wood debris.**

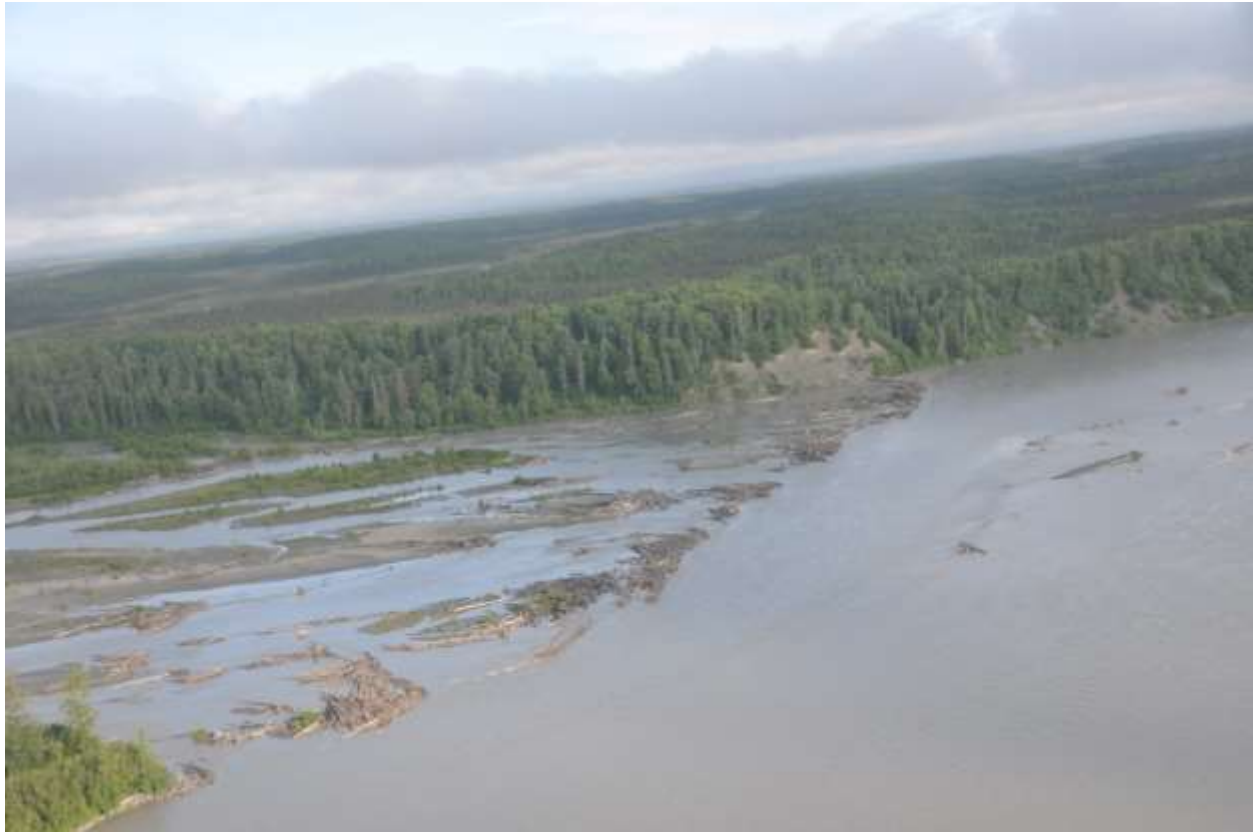
**Photograph 34. June 30, 2012 Lower Susitna River between Talkeetna and Willow. Rafts of racked wood debris.**
