<b>Title:</b> Susitna River ice processes study report	<b>SuWa 40</b>
<b>Author(s) – Personal:</b>	
<b>Author(s) – Corporate:</b> HDR Alaska, Inc.	
<b>AEA-identified category, if specified:</b> 2012 Environmental Studies	
<b>AEA-identified series, if specified:</b>	
<b>Series (ARLIS-assigned report number):</b> Susitna-Watana Hydroelectric Project document number 40	<b>Existing numbers on document:</b>
<b>Published by:</b> [Anchorage, Alaska : Alaska Energy Authority, 2013]	<b>Date published:</b> March 2013
<b>Published for:</b> Prepared for Alaska Energy Authority	<b>Date or date range of report:</b>
<b>Volume and/or Part numbers:</b>	<b>Final or Draft status, as indicated:</b>
<b>Document type:</b>	<b>Pagination:</b> x, 82, [1], 21 p.
<b>Related work(s):</b>	<b>Pages added/changed by ARLIS:</b>
<b>Notes:</b>

**Susitna-Watana Hydroelectric Project  
(FERC No. 14241)**

**Susitna River Ice Processes Study Report**

HDR Alaska, Inc.

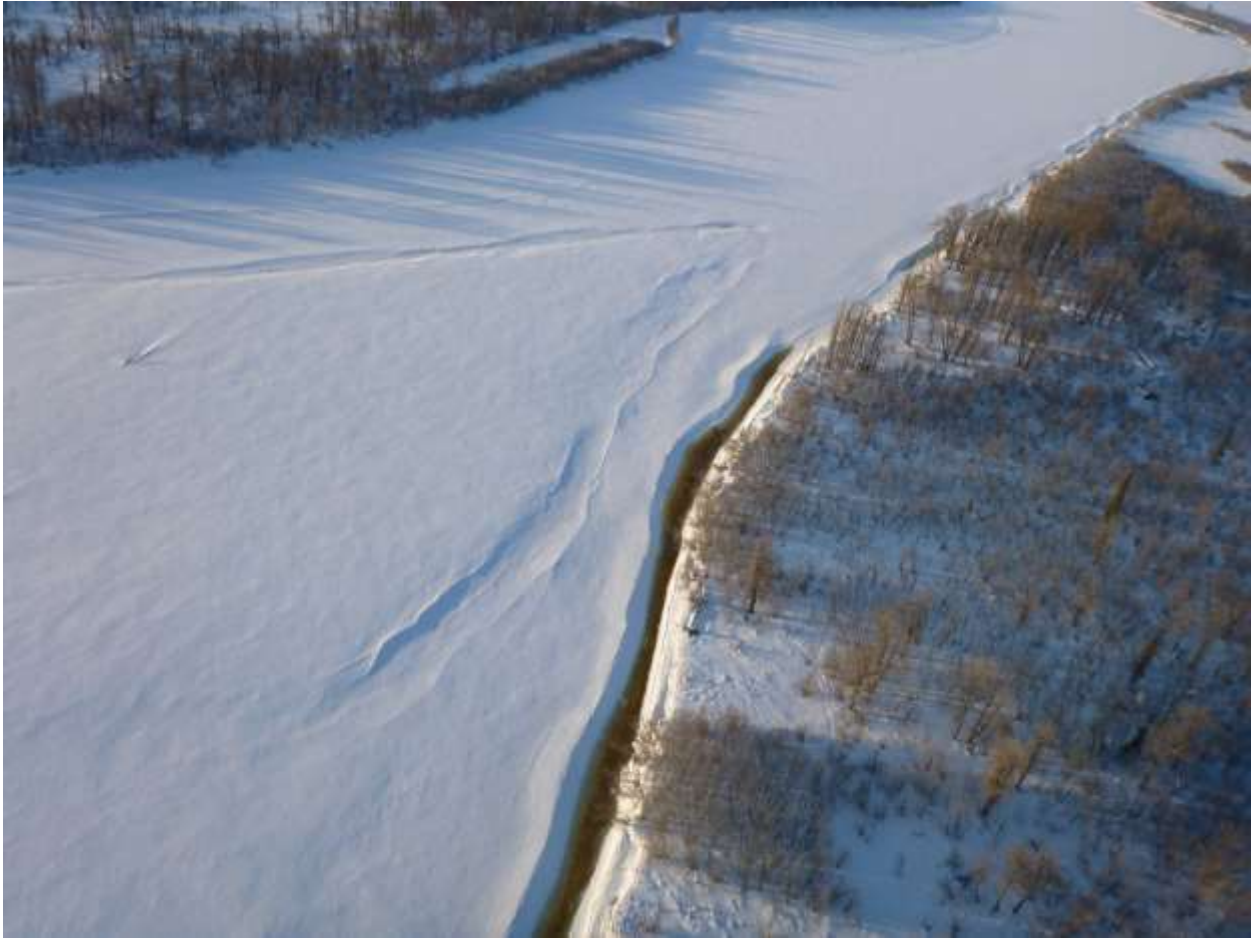
**Figure 5.2-2. Tannic color of thermal lead at bank toe, near RM 15, March 20, 2012.**

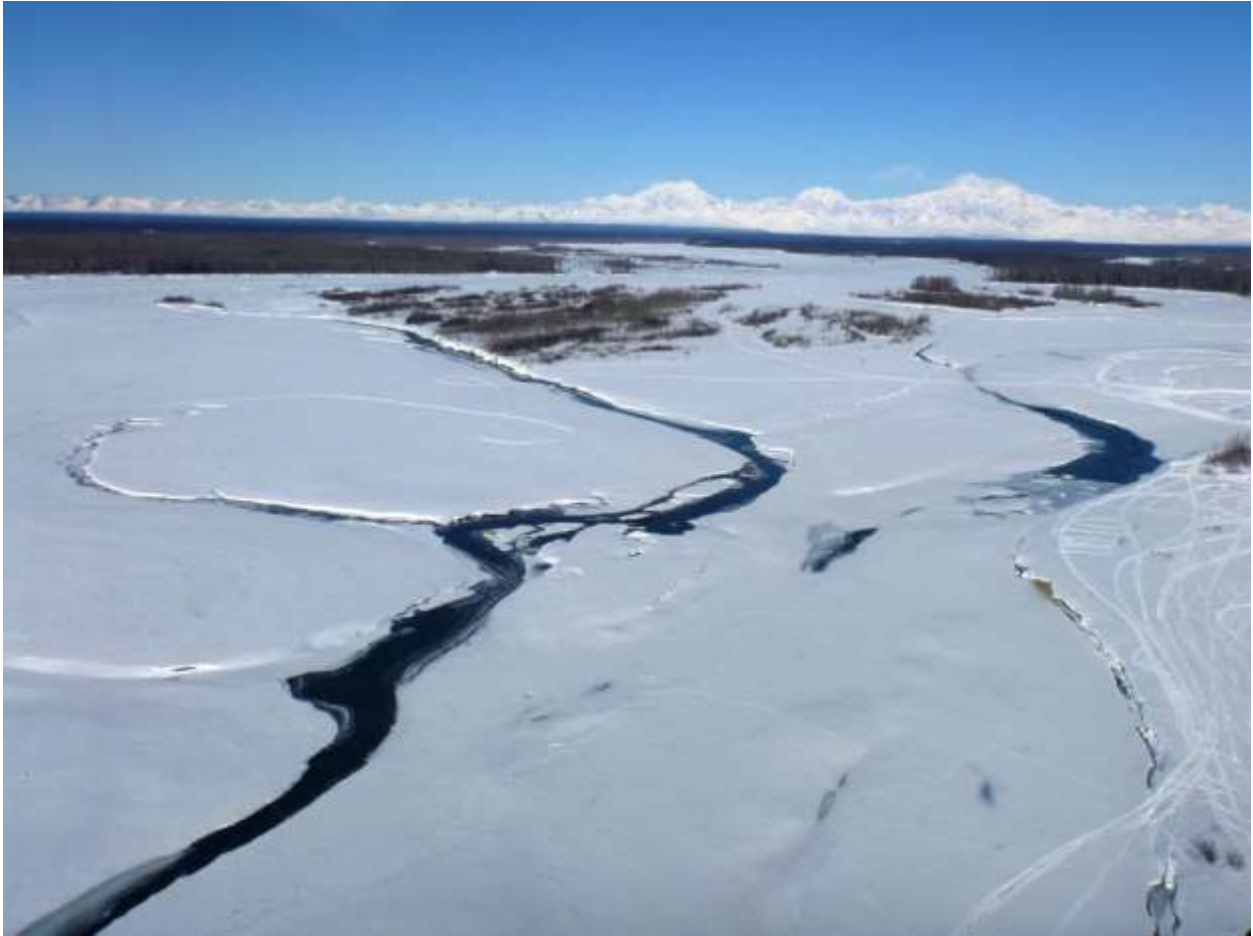
Figure 5.2-3. Velocity leads near RM 97 March 20, 2012. Snowmachine tracks for scale.

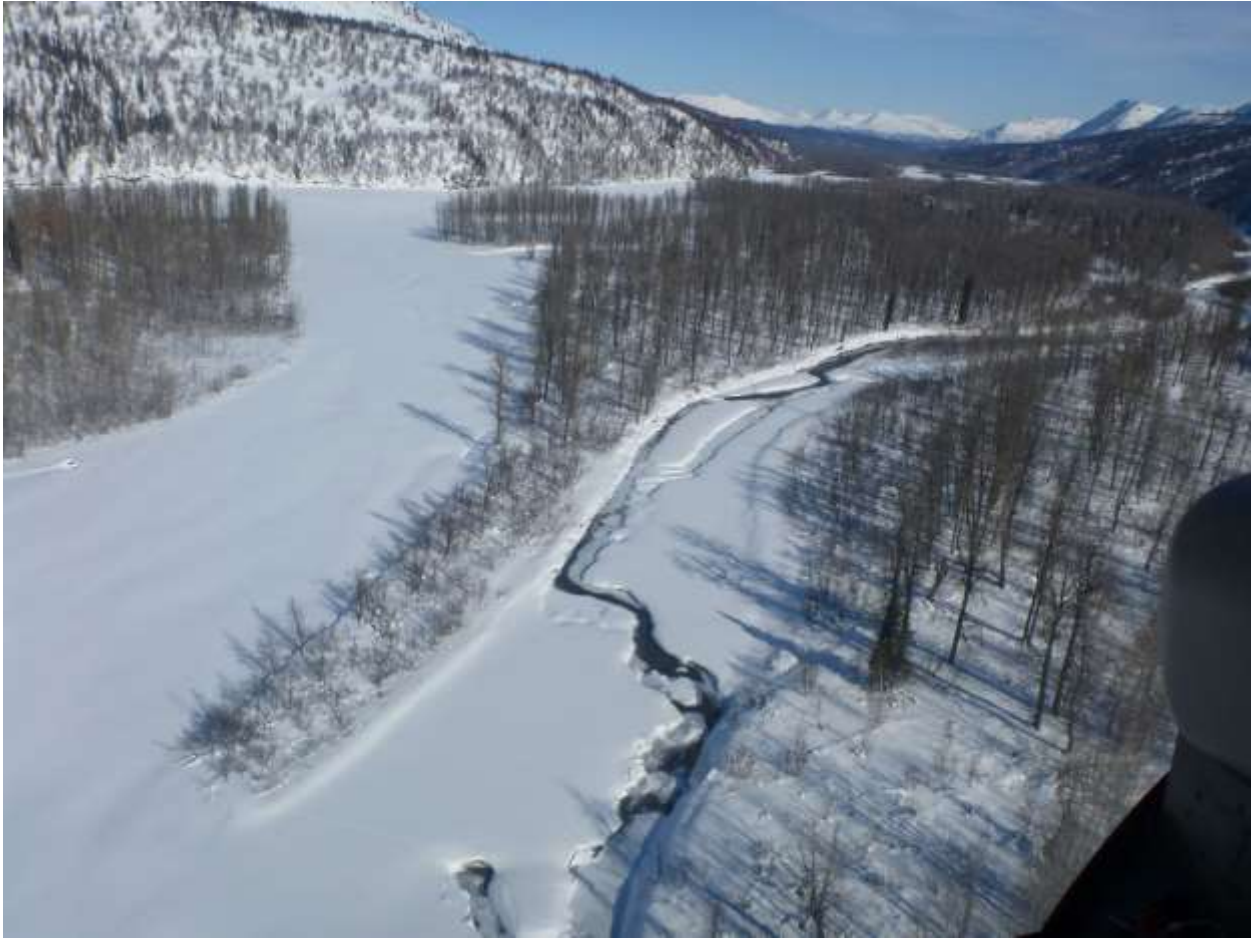
**Figure 5.2-4. Thermal lead in Slough 8A, RM 126, March 21, 2012.**

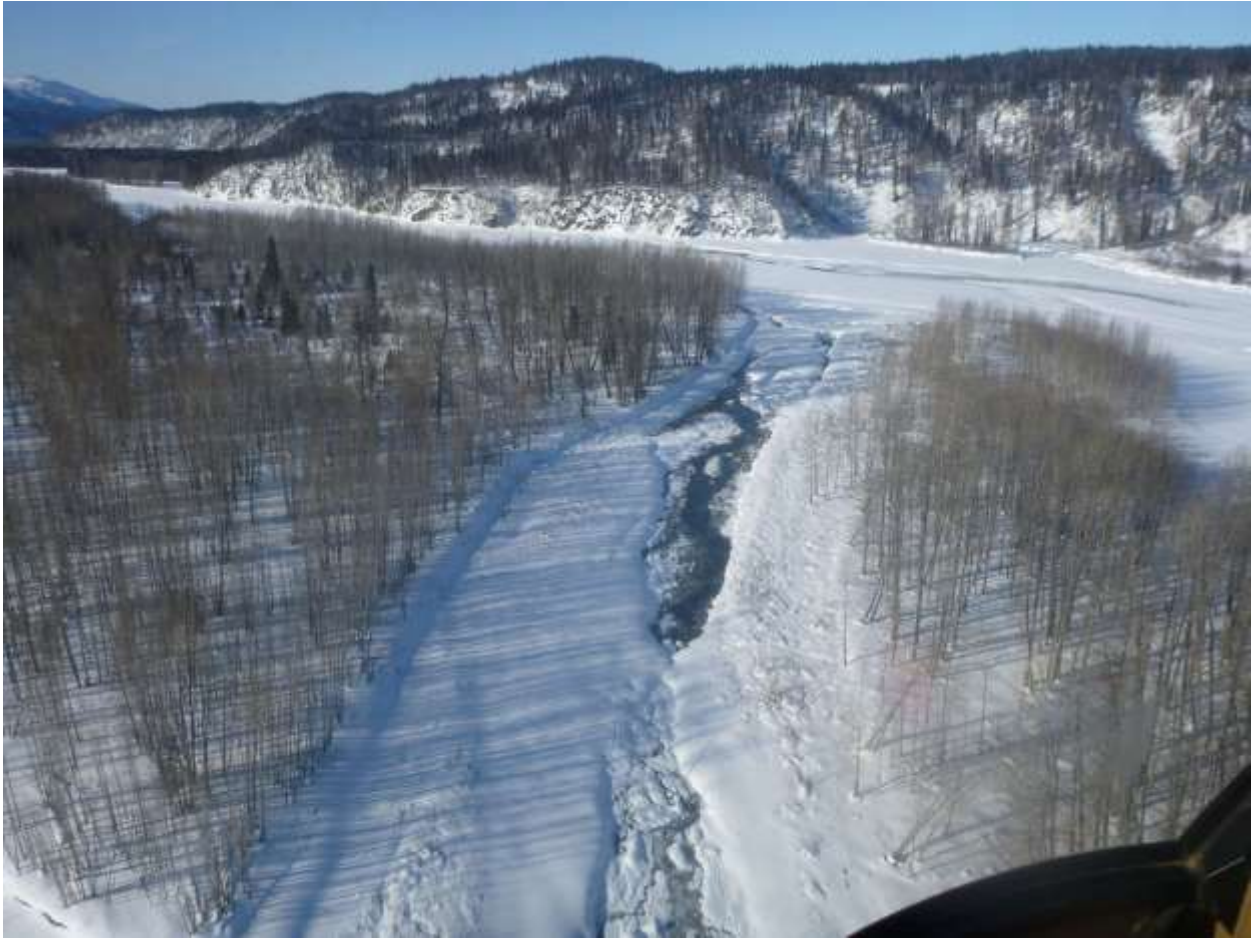
**Figure 5.2-5. Thermal lead in Slough 11, RM 136, March 21, 2012**

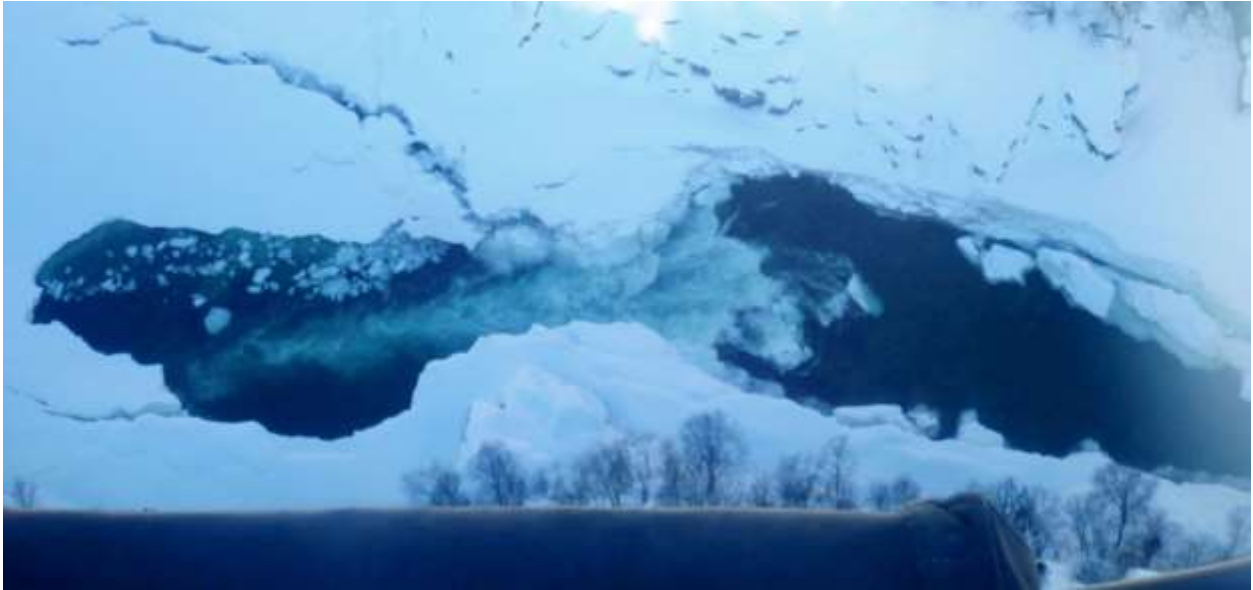
Figure 5.2-7. Close up view of velocity lead in Devils Canyon, March 22<sup>nd</sup>, 2012. Note rapid and broken ice.

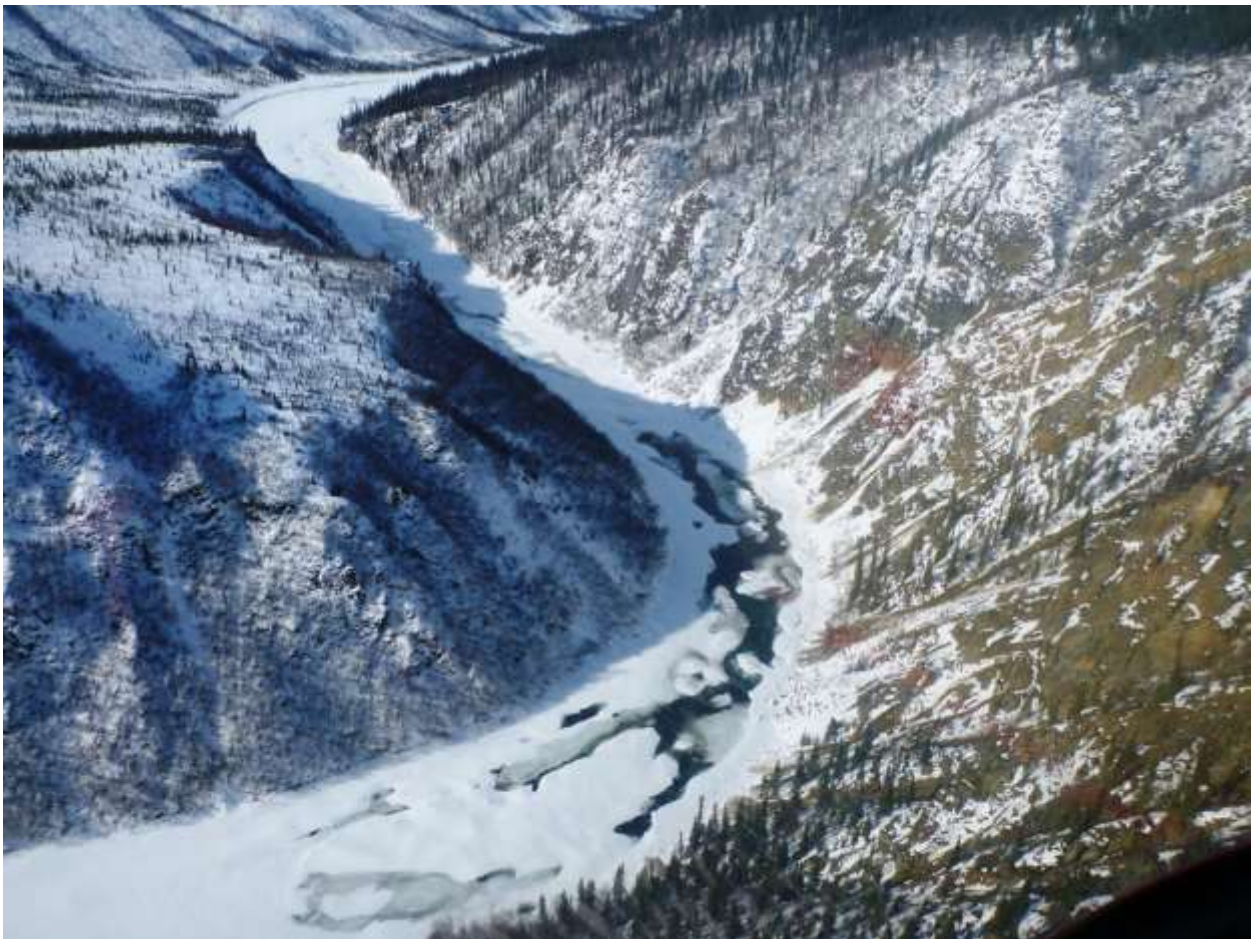
Figure 5.2-8. Velocity lead in Vee Canyon, RM 222, March 22, 2012.

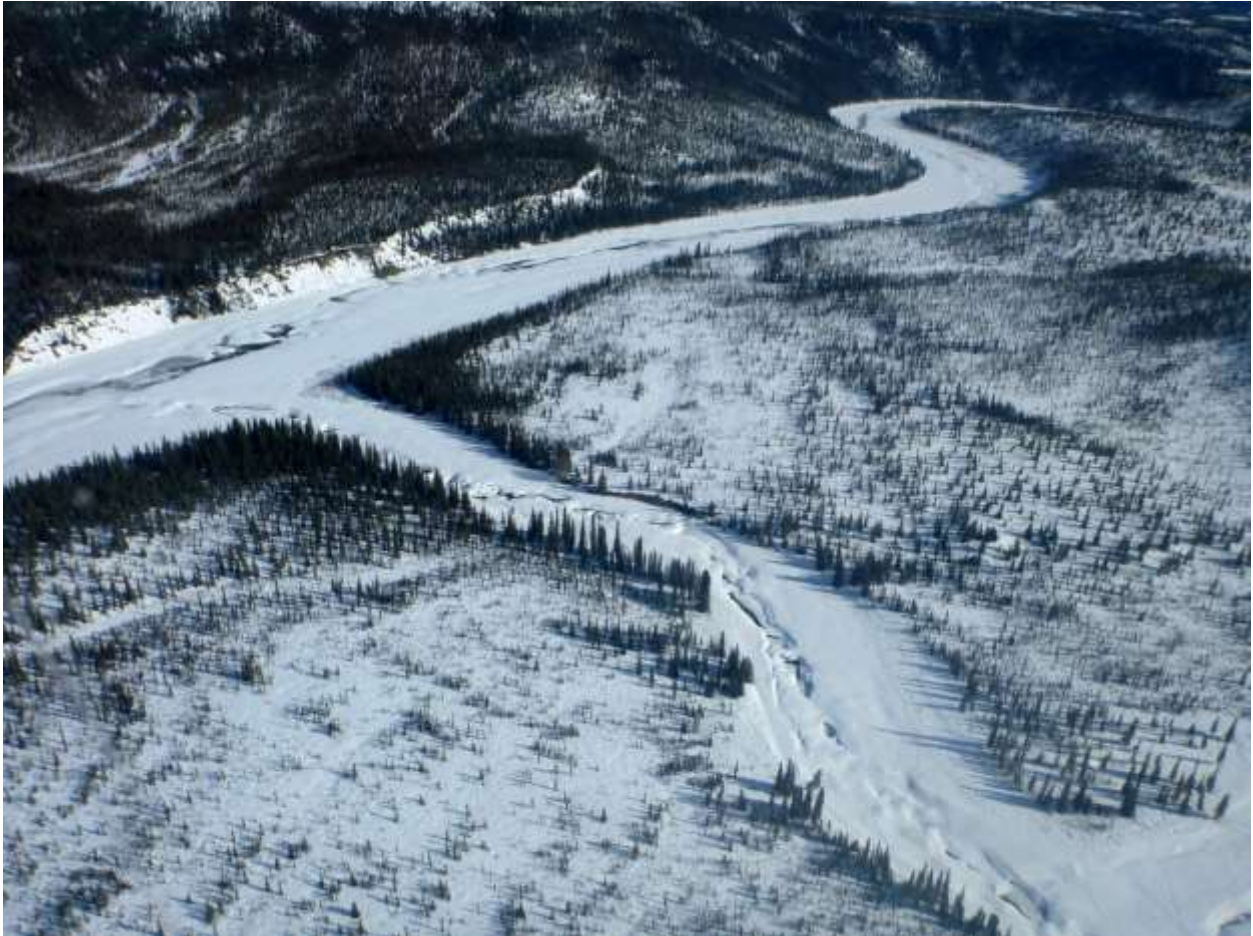
**Figure 5.2-9. Open leads in the Oshetna River (bottom of photo) and Susitna River (top of photo), March 22, 2012.**

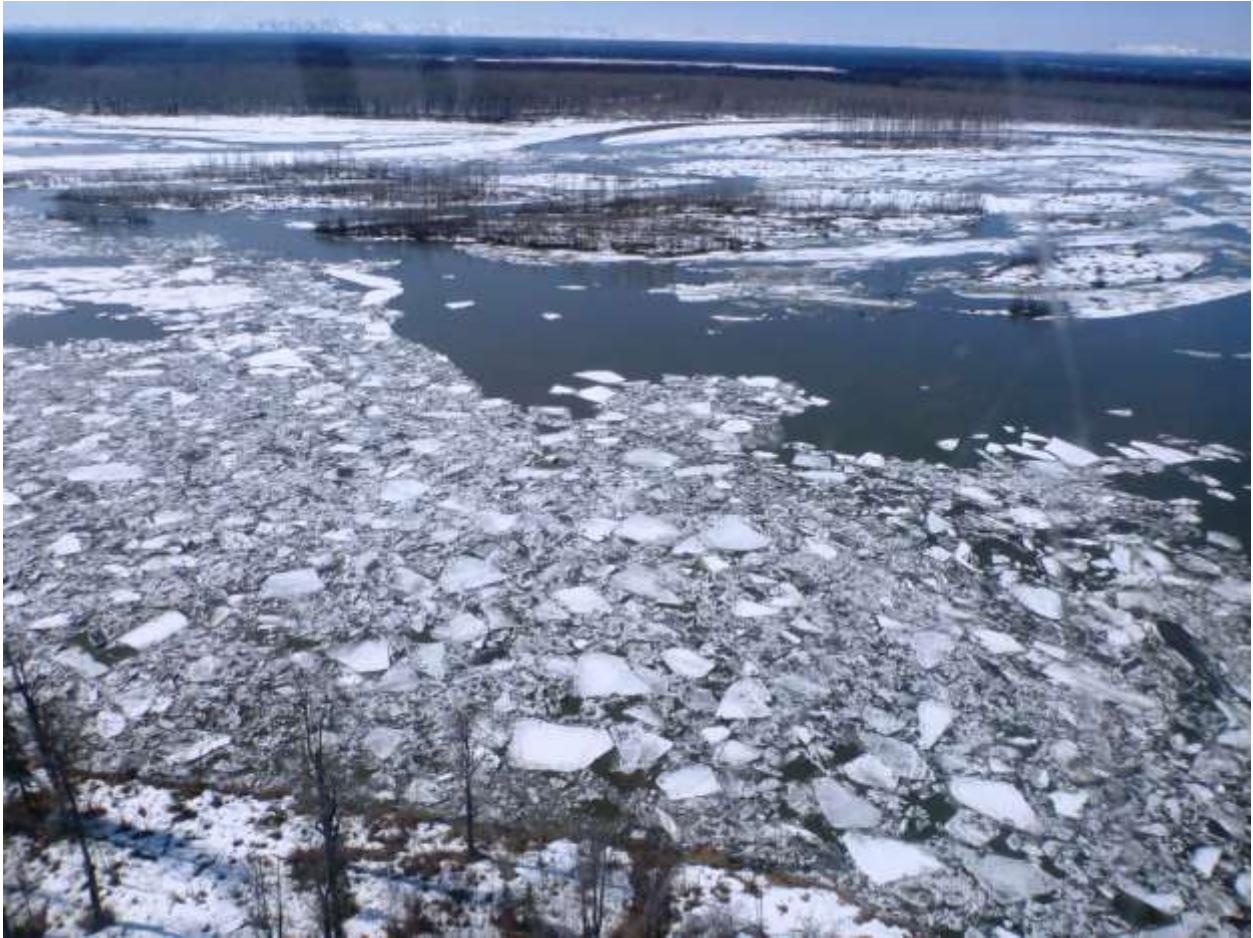
**Figure 5.4-1. Ice jam near RM 62 on the Lower Susitna River, April 30, 2012.**

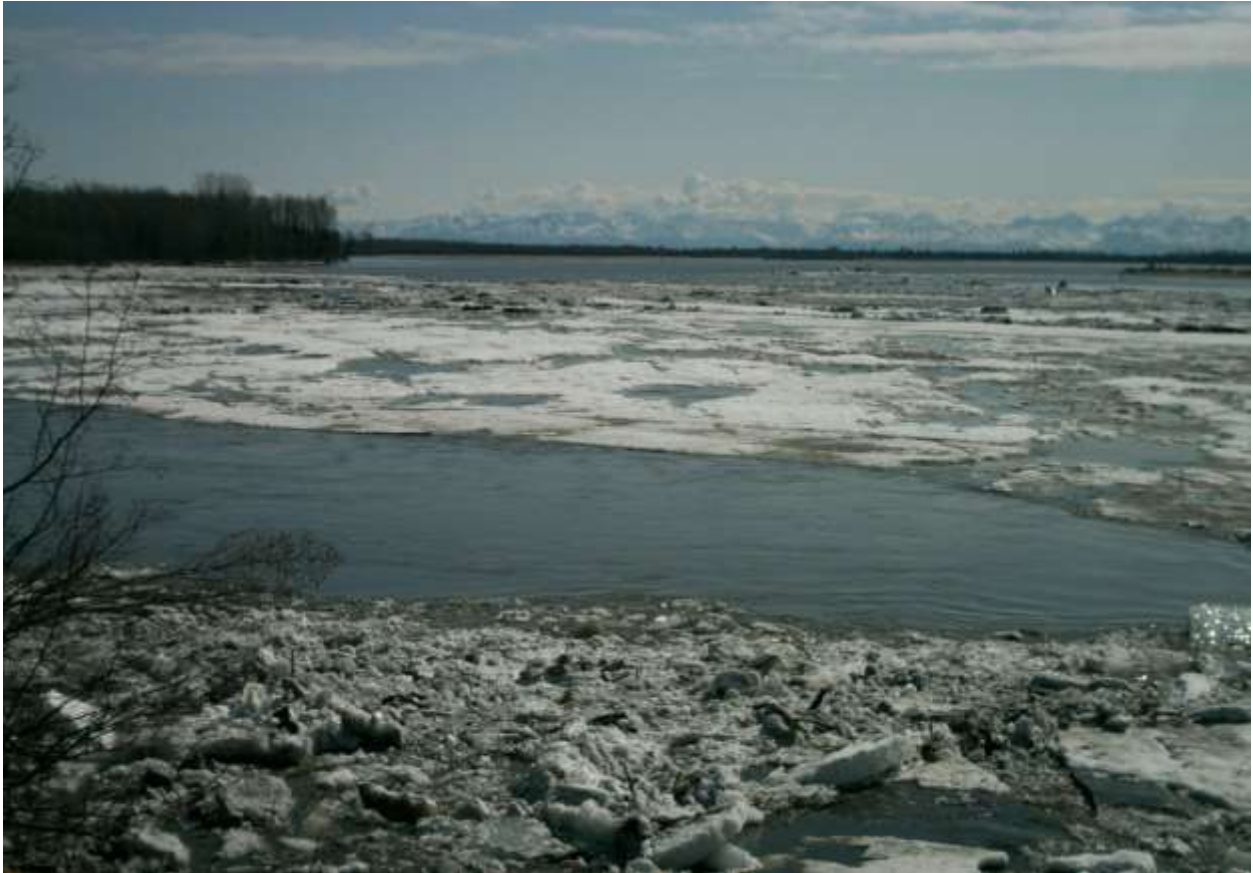
**Figure 5.4-2. Breakup near RM 9.5 on April 30, 2012 as recorded on a time-lapse camera.**

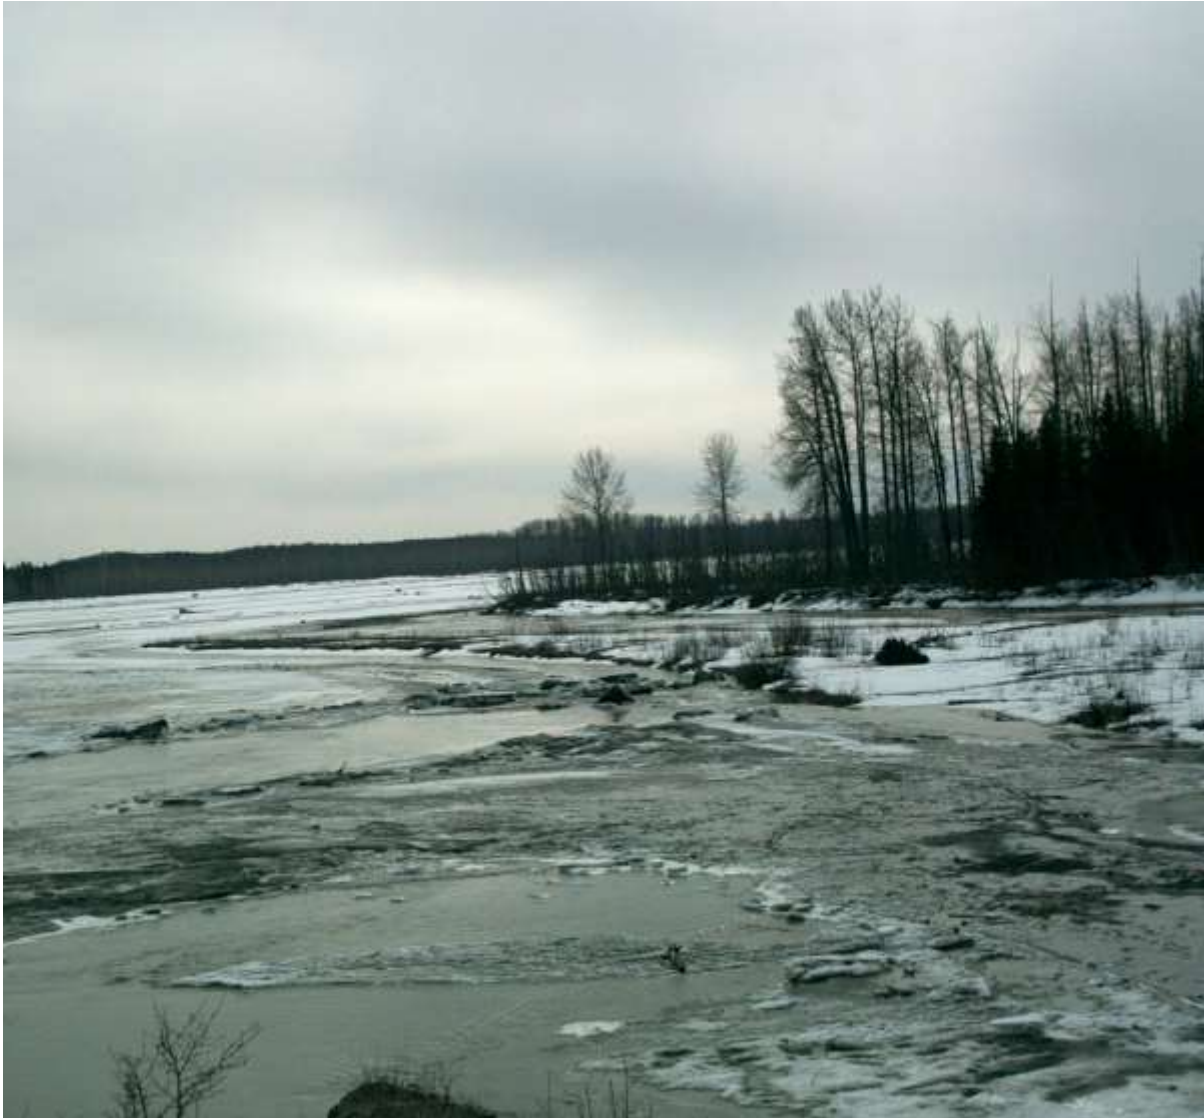
Figure 5.4-3. Stranded ice on banks near RM 59 after ice out on May 2, 2012.

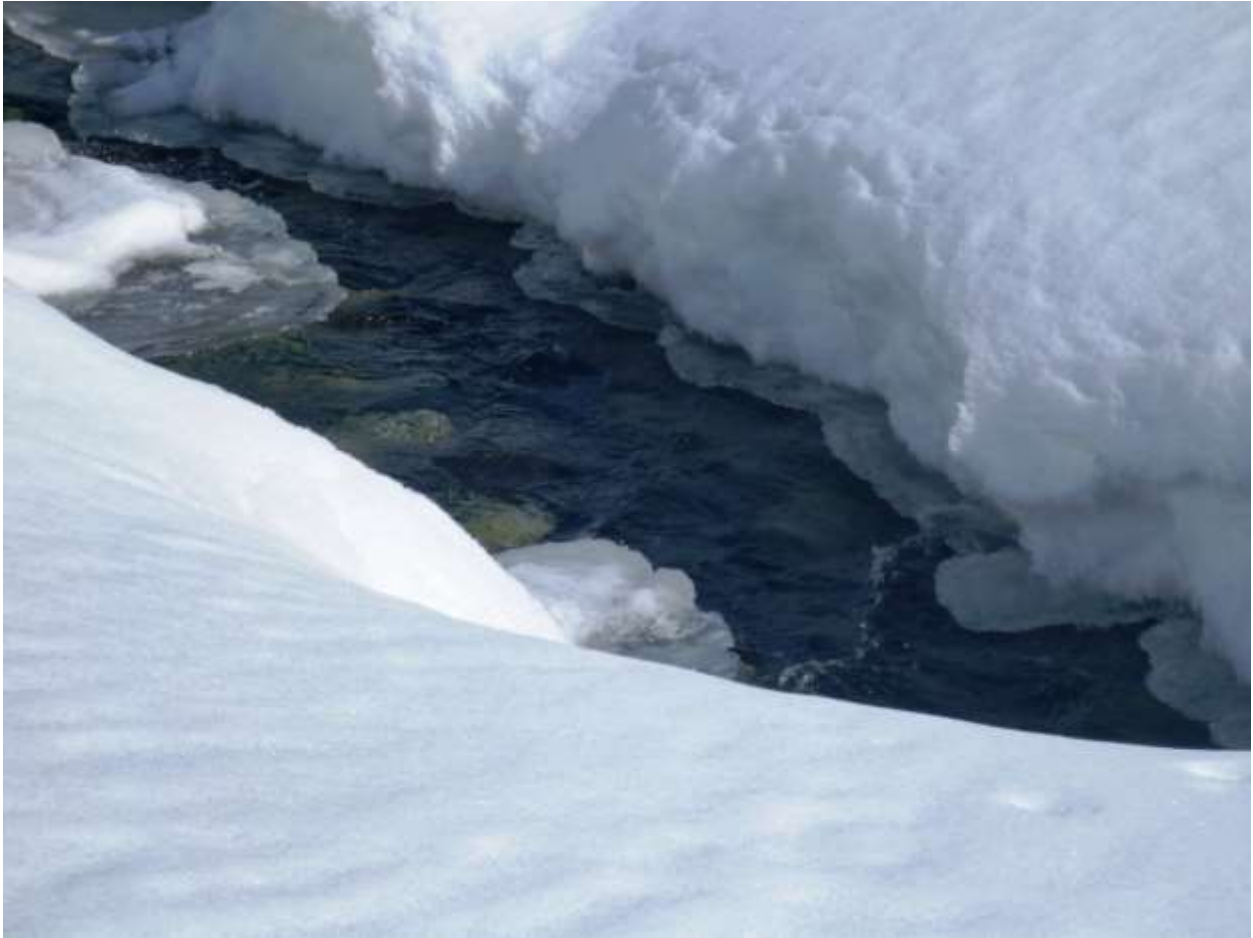
**Figure 5.4-4. Open water at the mouth of Portage Creek, April 11, 2012. Lead is about 4 feet wide.**

Ice began moving and jamming in the Middle River between April 11 and April 19. On April 11, observers noted that open leads were widening and open water began appearing in Fog Creek (RM 162) and Portage Creek (RM 148) (Figure 5.4-4). On April 19, numerous small jams were observed from RM 159 to RM 134 (Figures 5.4-5-6). Upstream of RM 159, the open leads had widened. Downstream of RM 134, open leads remained narrow but lengthened.

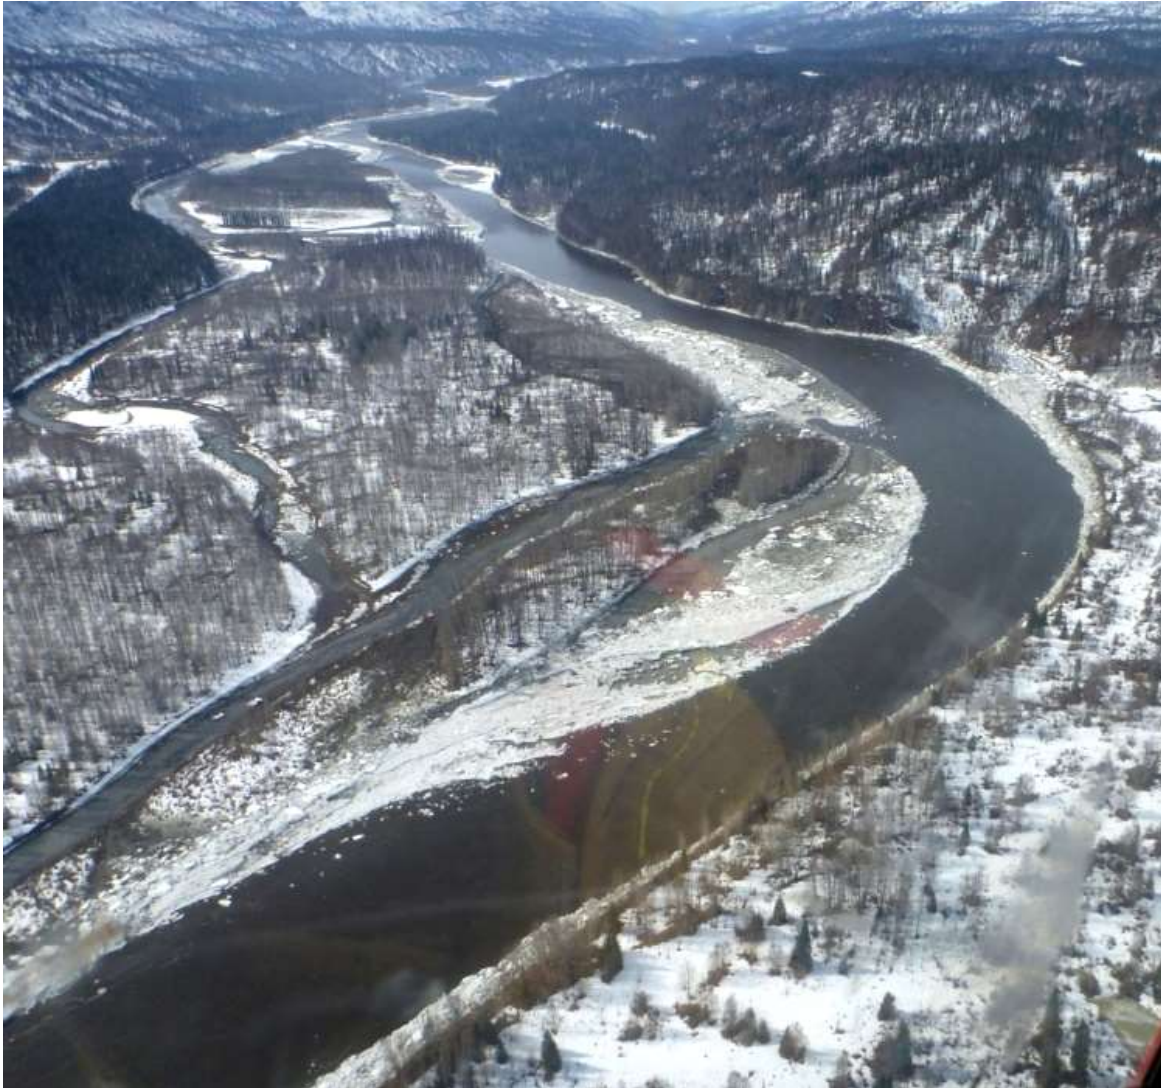
Figure 5.4-9. RM 136 and Slough 11 after the ice jam collapsed and moved downstream, May 2, 2012.

The largest jams with the greatest potential to affect vegetation, geomorphology, and fish habitat were near Sloughs 11, 8 and 9. Near RM 134-136, a large ice jam occupied the main channel and right bank side channel from April 27 to May 2 (Figure 5.4-8). While the jam held, water was forced overbank into Slough 11 (Figure 5.4-9). After the jam released, ice was observed overbank and in the riparian vegetation at RM 135.8 on May 2, 2012 (Figure 5.4-10). Neither scouring of the banks nor scarring of vegetation was observed following the jam release.

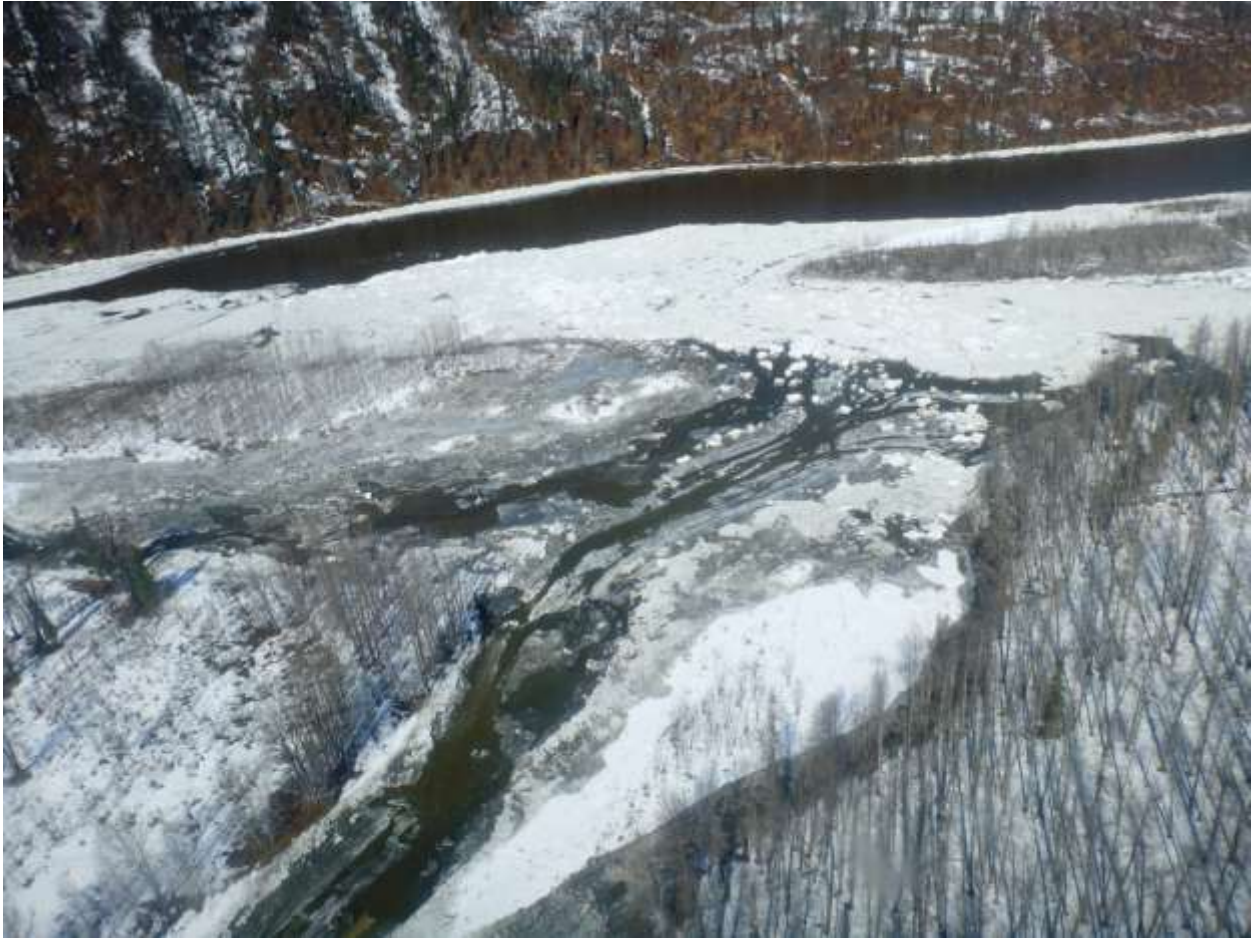
Figure 5.4-11. Ice jam forcing water into Slough 9, RM 128, May 2, 2012.

A large jam was also documented in the mainstem, Slough 9, and Slough 8 from RM 130.2 to RM 126.4 on May 2 that collapsed by May 4 to span from RM 130.1 to RM 128.2 (Figure 5.4-11). Following the release of this jam, ice floes were observed in the trees lining Slough 8A from RM 127.8 to RM 126.6. The build-up and release of this jam is also documented on the Slough 9 time-lapse camera. Again, post-breakup reconnaissance did not document significant scour or vegetation scars resulting from this jam release, possibly because the ice was relatively weak.

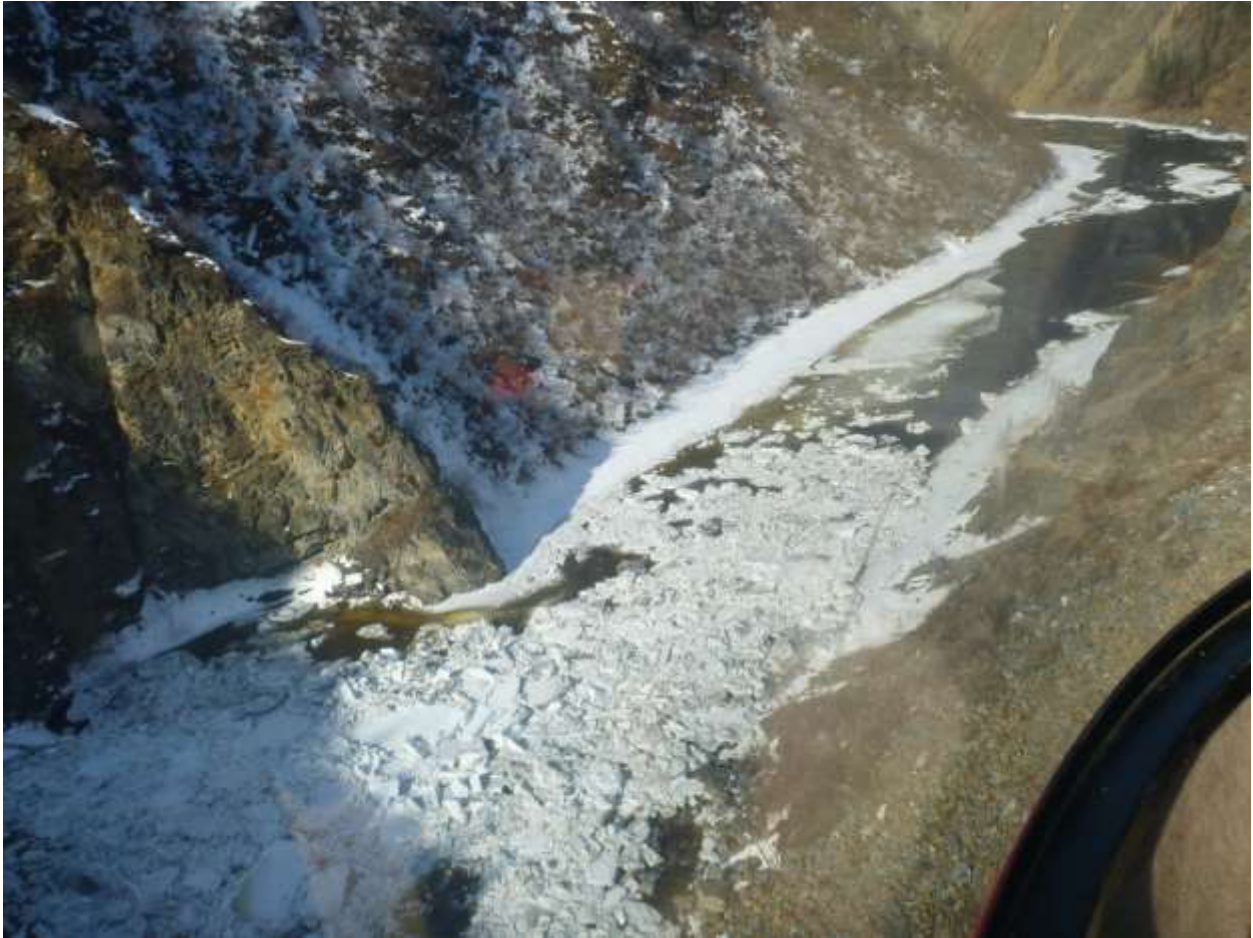
**Figure 5.1-12. Ice jam in Vee Canyon (RM 221.5), April 27, 2012.**

Breakup commenced on the Upper River between April 11 and April 19. On April 19, two small ice jams were observed near RM 221. By April 27, larger jams had formed at RM 221.5, RM 231, and RM 207 (Figures 5.4-12, 5.4-13, 5.4-14). Ice jam activity had subsided by May 4, and the Upper River main channel was ice free with stranded ice on the banks and bars by May 9. Especially large slabs of stranded ice were observed downstream of Vee Canyon at RM 221 (Figure 5.4-15), and at RM 196 (Figure 5.4-16).

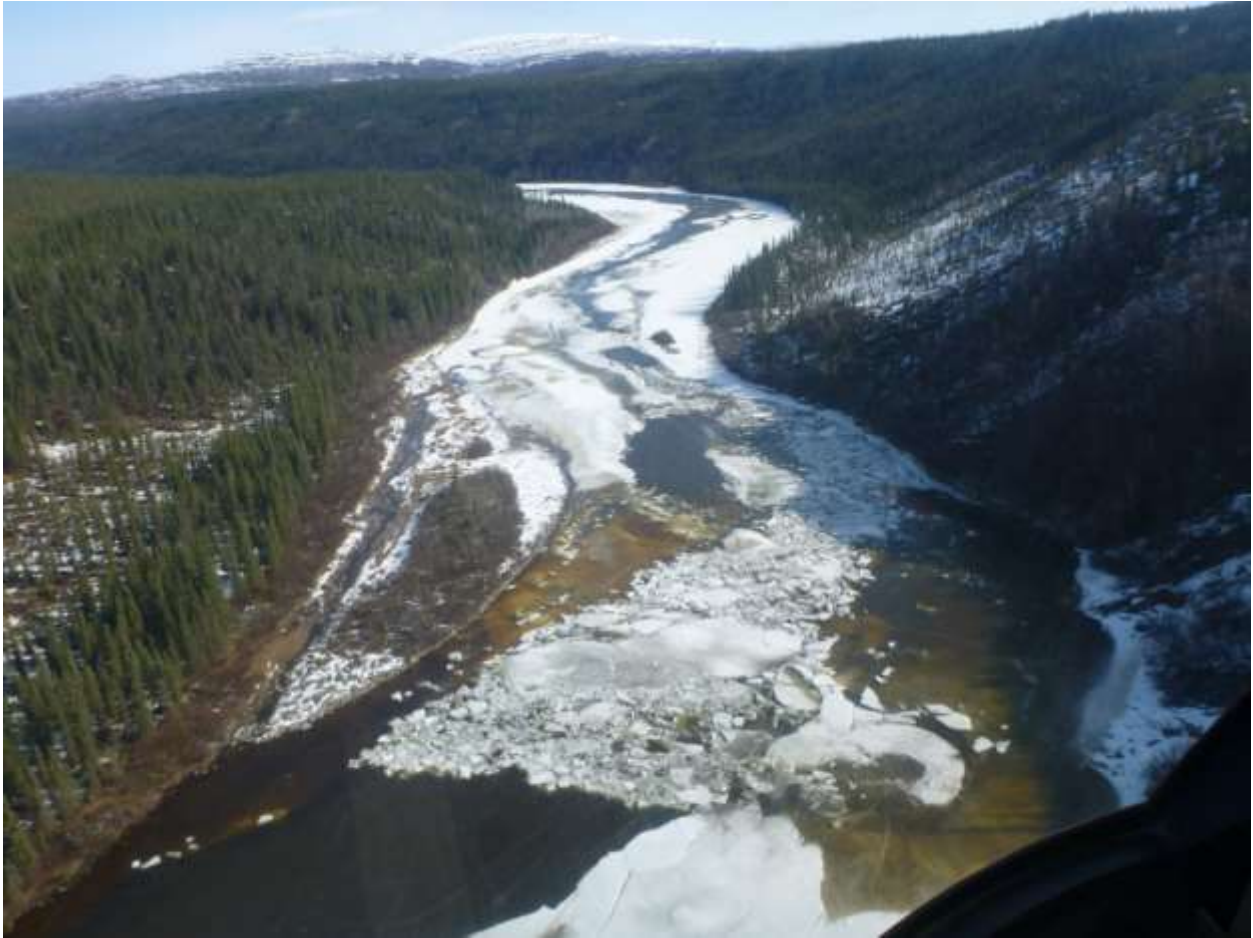
**Figure 5.4-13. Ice jam at RM 231, April 27, 2012.**

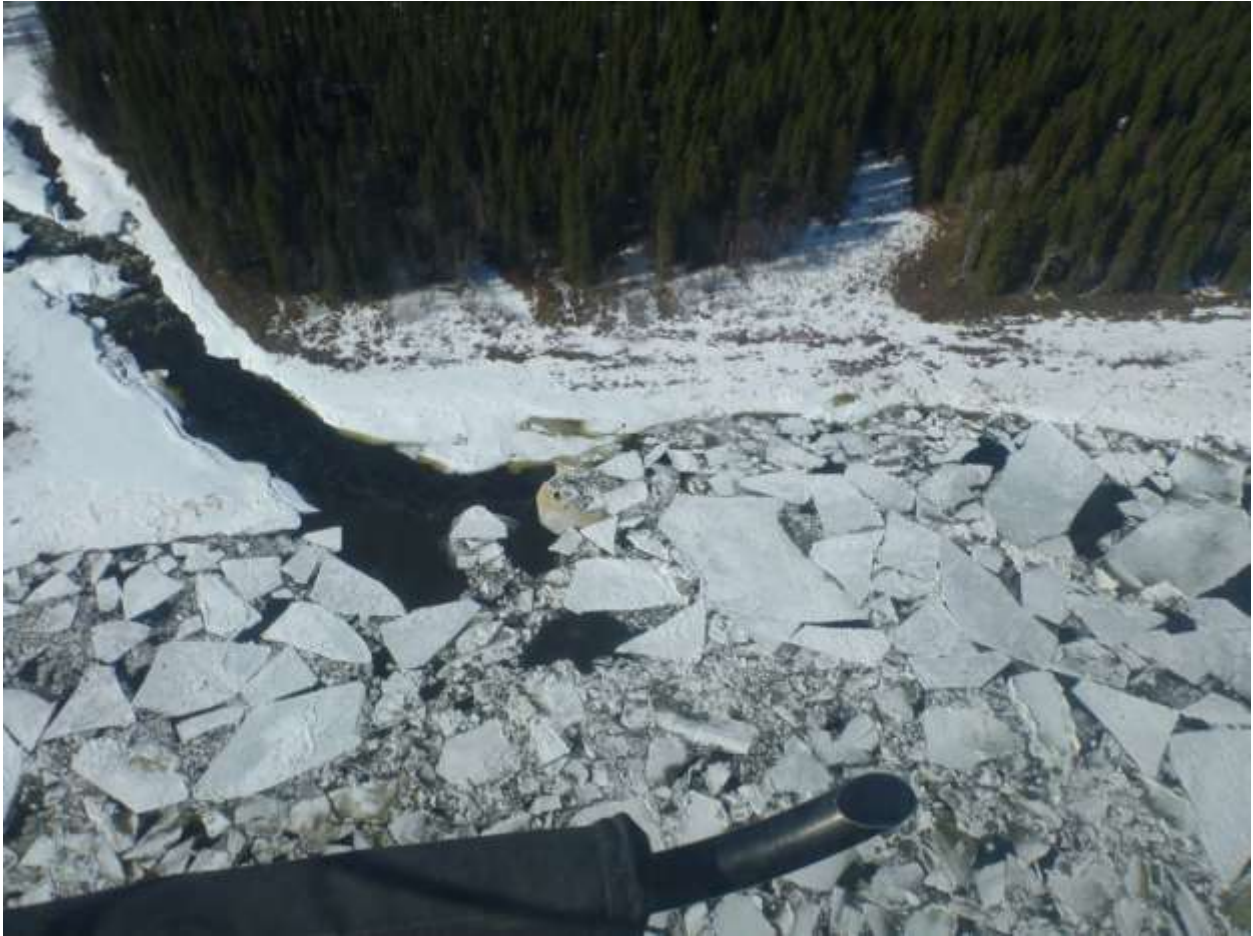
Figure 5.4-14. Ice jam at RM 207, mouth of Kosina Creek, April 27, 2012.

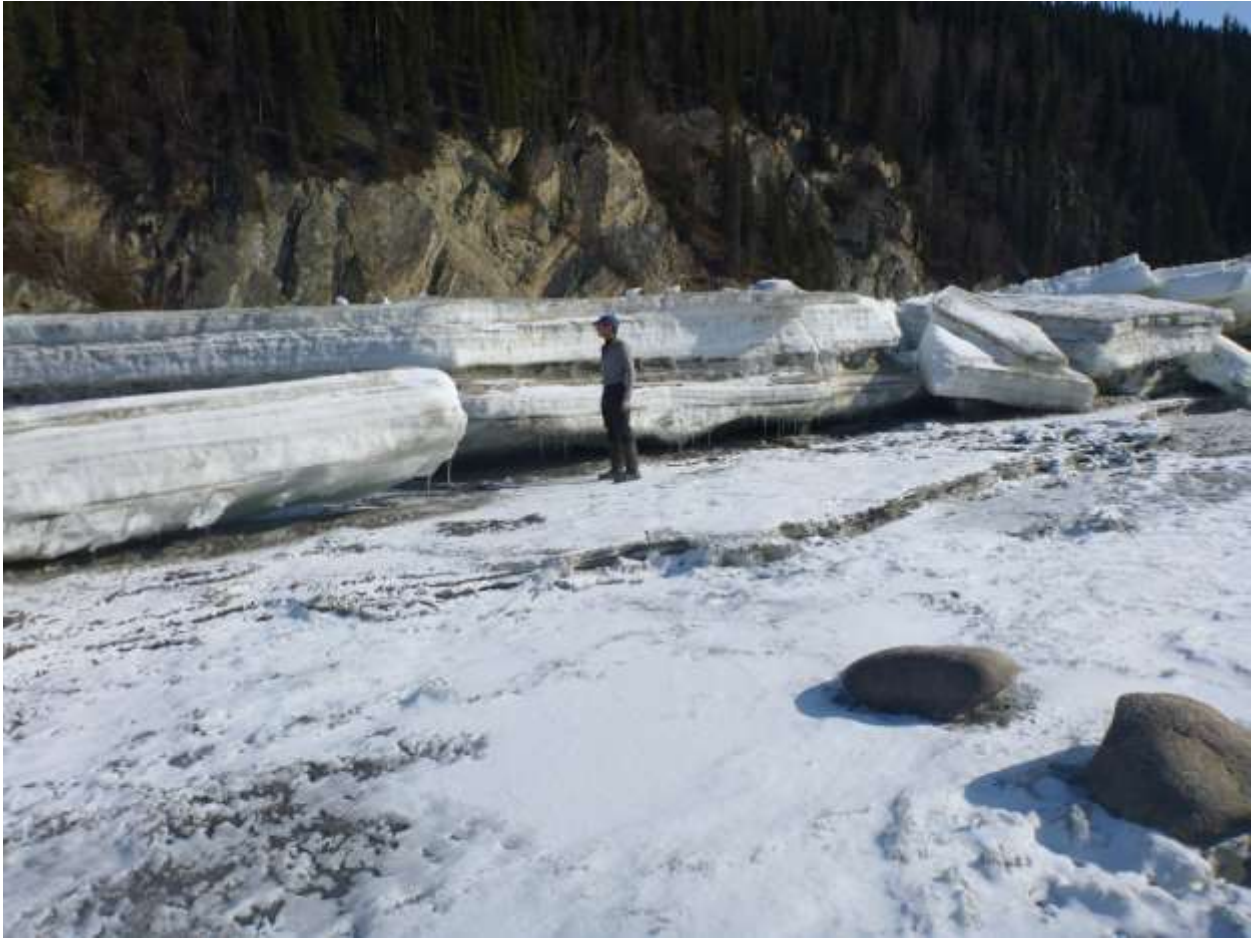
Figure 5.4-15. Remnant ice slabs downstream of Vee Canyon at RM 221, May 2, 2012.

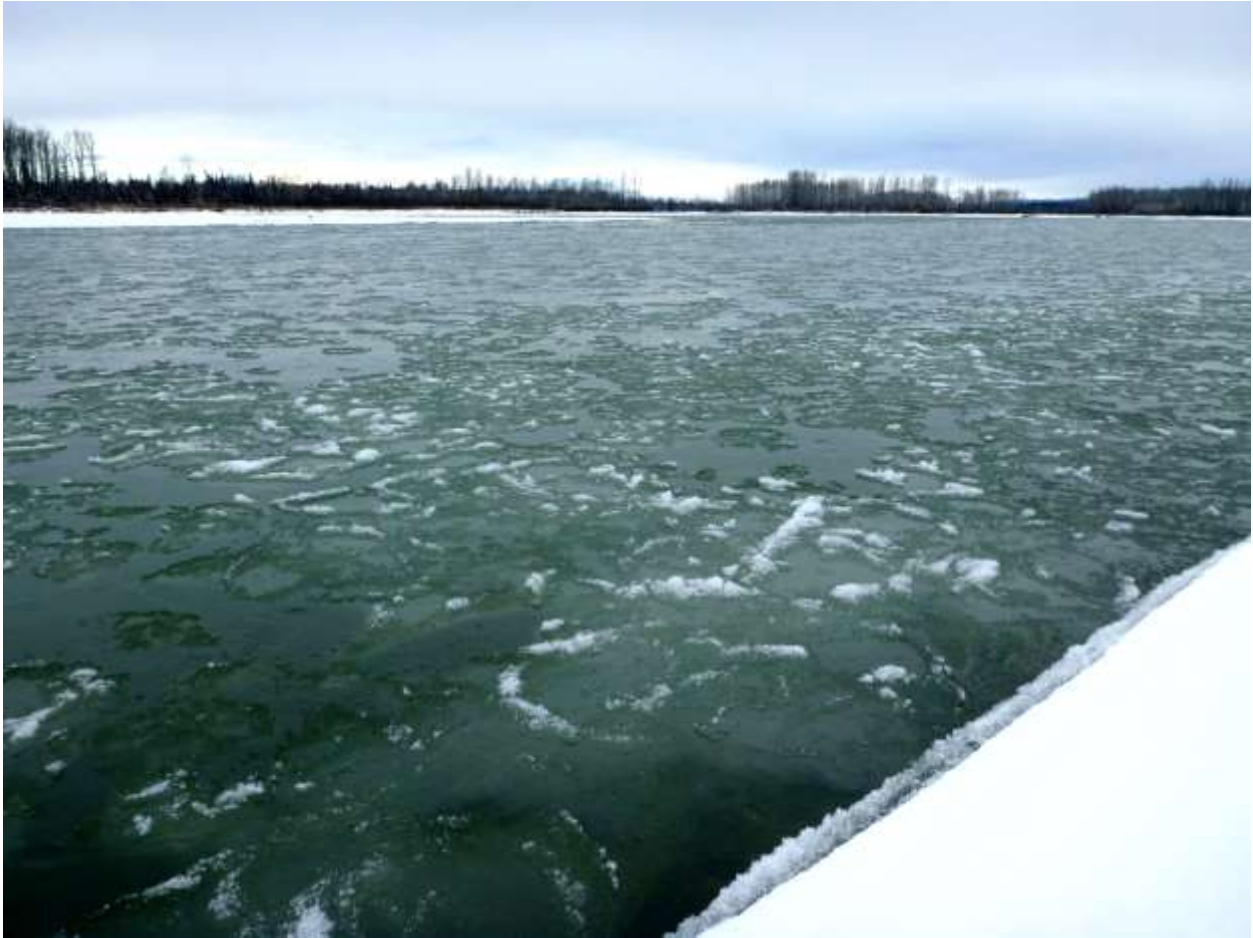
**Figure 5.6-1. Frazil ice pans flowing past RM 100, October 16, 2012.**

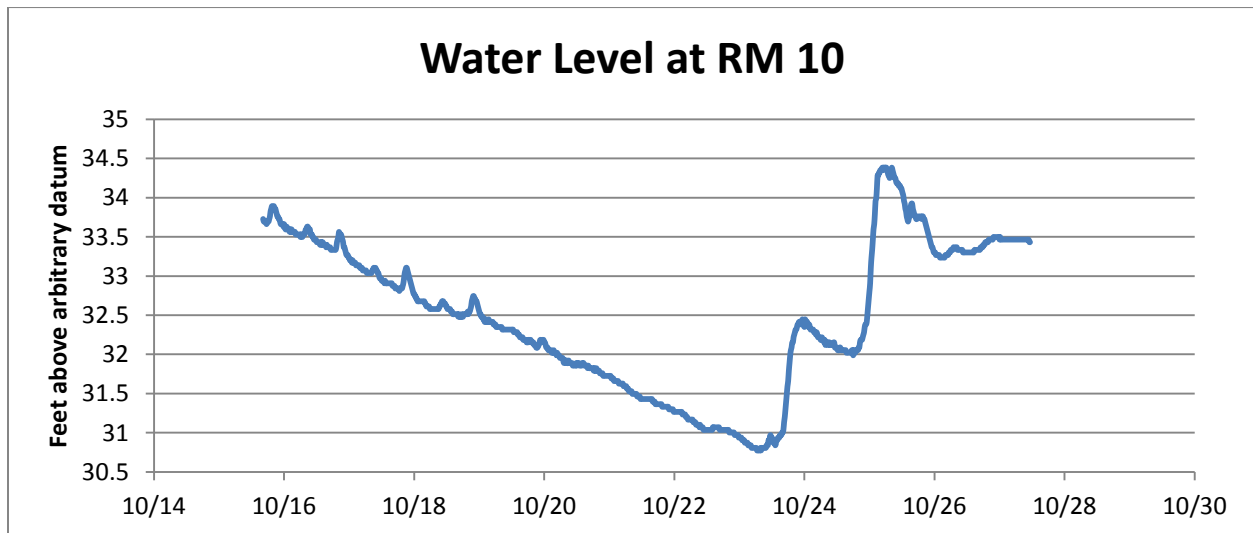
Figure 5.6-4. Pressure transducer readings from RM 10, showing a spike in pressure late on October 23, 2012.
