**Notebook No. 371**

<i>Janet Clemens, Historian</i>
<i>Office of History &amp; Archaeology</i>
<i>State of Alaska, DNR, Div. of Parks</i>
<i>Field/Editor 8/12-8/15/91</i>

Bonanza Arc Relief CabinAHRS NO.  
IDT-030

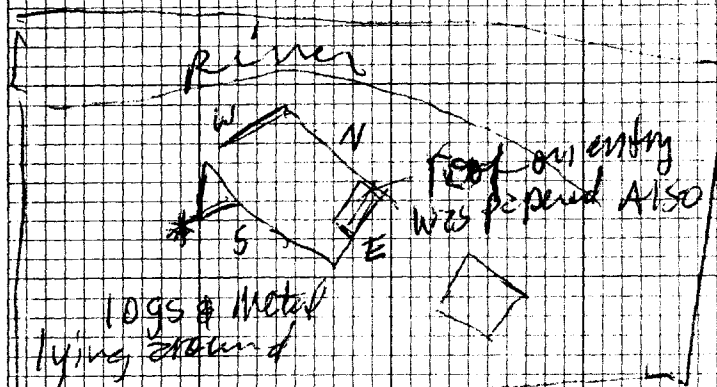
Cache - built w/ poles - no center pole

S/N - 2.65 meters

E/W - 2.2 meters

Height - 1.45 meters from ground  
to "shelf" level - some  
planks on ground

slight foundation built w/ consideration  
of uneven ground → \* foundation  
on whole logs → rest plank used on  
ground with "outside" floor board  
attached w/ nails
