| AHS NUMBER<br>DPH-004 | | NATIONAL HISTORIC TRAIL | | SIGNIFICANT SITES | | REFER. NUMBER<br>290A | |
| SITE NAME<br>Dishkakat | | | | LOCATION<br>S. BANK OF INNOKO R.<br>6 MI. W. OF JUNCTION OF<br>DISHNA RIVER. | | USGS MAP QUAD<br>C-3<br>OPHR | |
| HISTORIC SIGNIFICANCE<br>Ingalik Indian settlement prior to the first<br>rush of prospectors to the valley in 1907. It was a natural<br>stopover place for miners on the way to the gold fields. | | | | | | | |

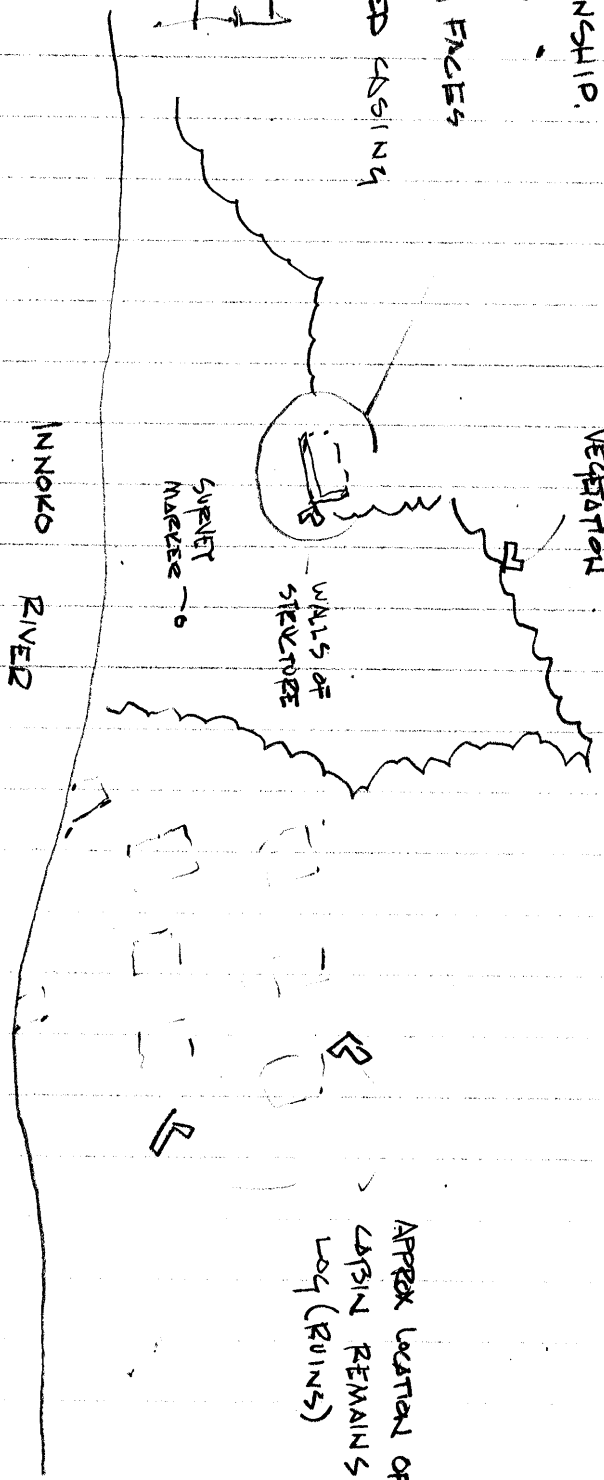
INNOKO RIVER

APPROX LOCATION OF  
CABIN REMAINS -  
LOG (RUINS)
