Source Water Assessment for the Sunset Hill Baptist Church Anchorage, Alaska

A Hydrogeologic Susceptibility and Vulnerability Analysis

DRINKING WATER PROTECTION PROGRAM REPORT 424
PWSID 211376.001

April 2002

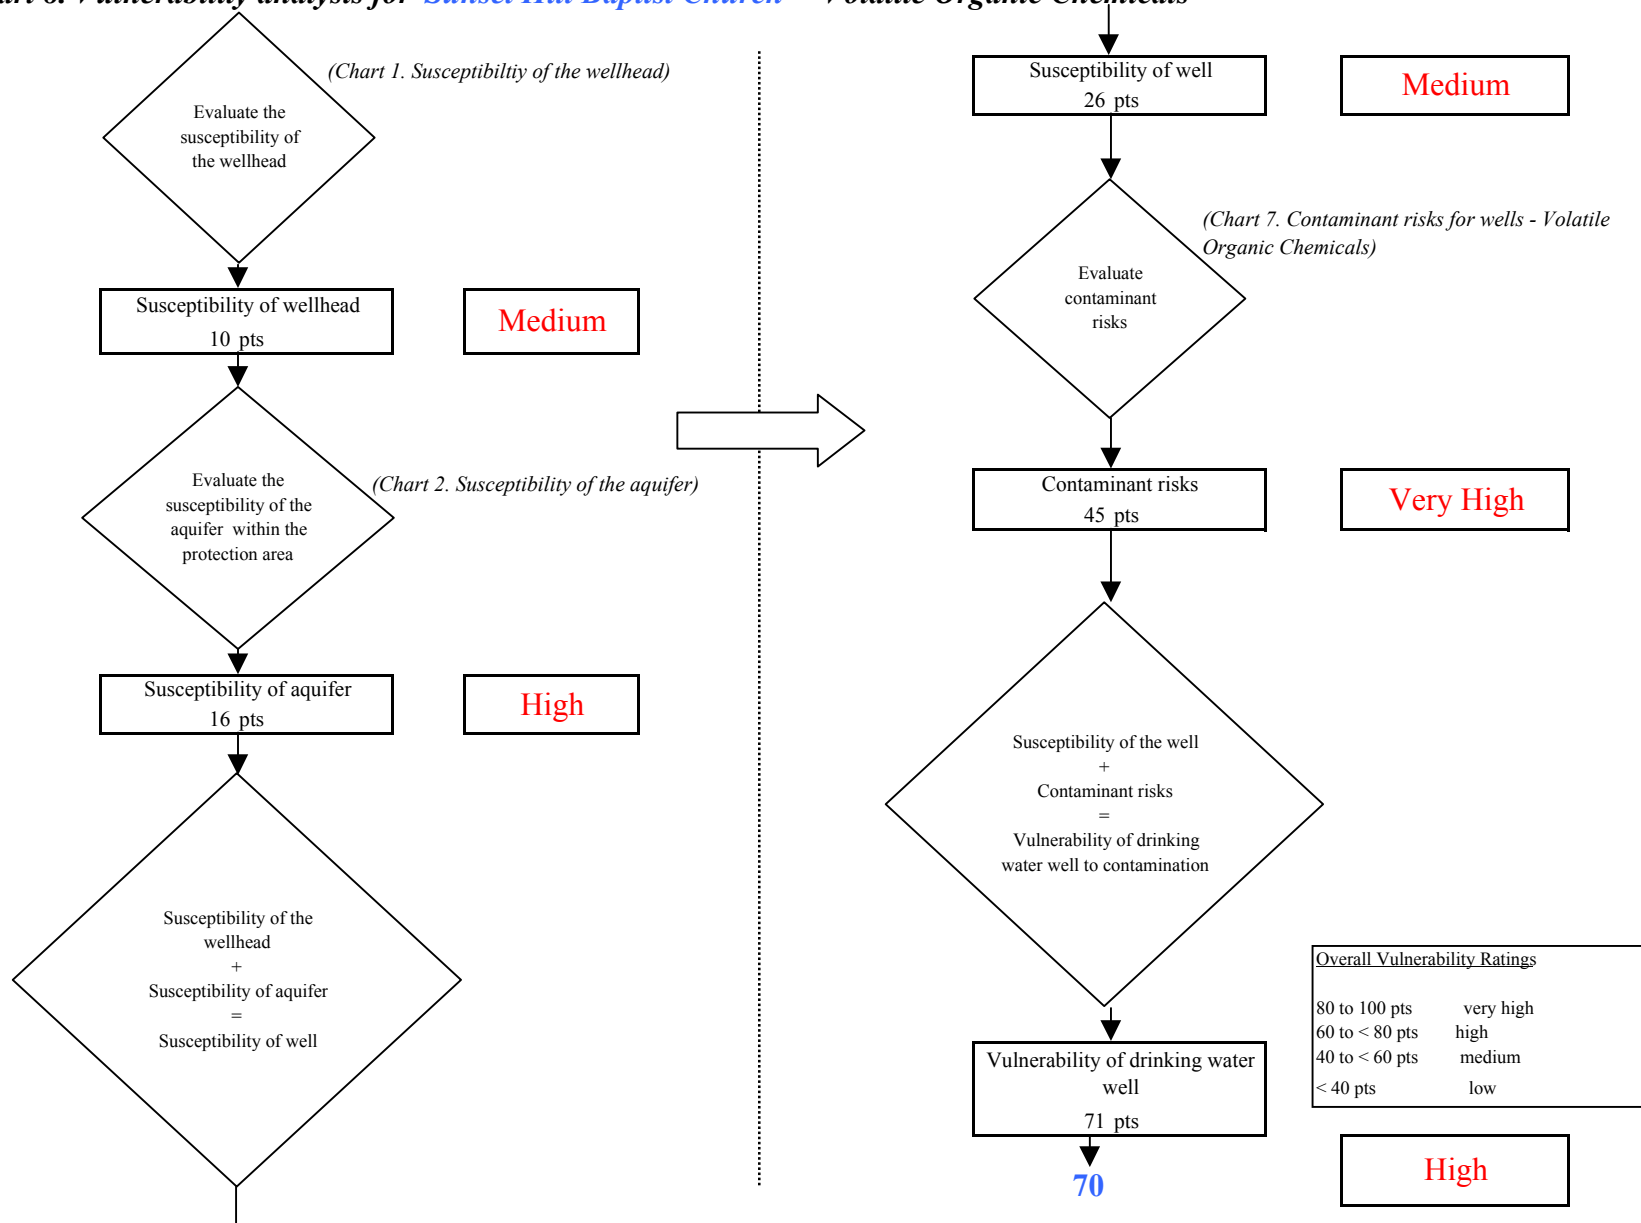
Chart 8. Vulnerability analysis for *Sunset Hill Baptist Church* - Volatile Organic Chemicals

The contaminant risk for volatile organic chemicals is very high with the Alaska Railroad, roads, sewer lines, and construction trade areas presenting the most significant risk to the drinking water well. Combining the contaminant risk for volatile organic chemicals with the natural susceptibility of the well reduces the overall vulnerability of the well to contamination to high from volatile organic chemicals.
