Hydrogeologic Susceptibility and Vulnerability Assessment for Big  
Lake Baptist Church Drinking Water Well, Big Lake, Alaska

DRINKING WATER PROTECTION PROGRAM REPORT 71

October 2001

By Shannon & Wilson, Inc.

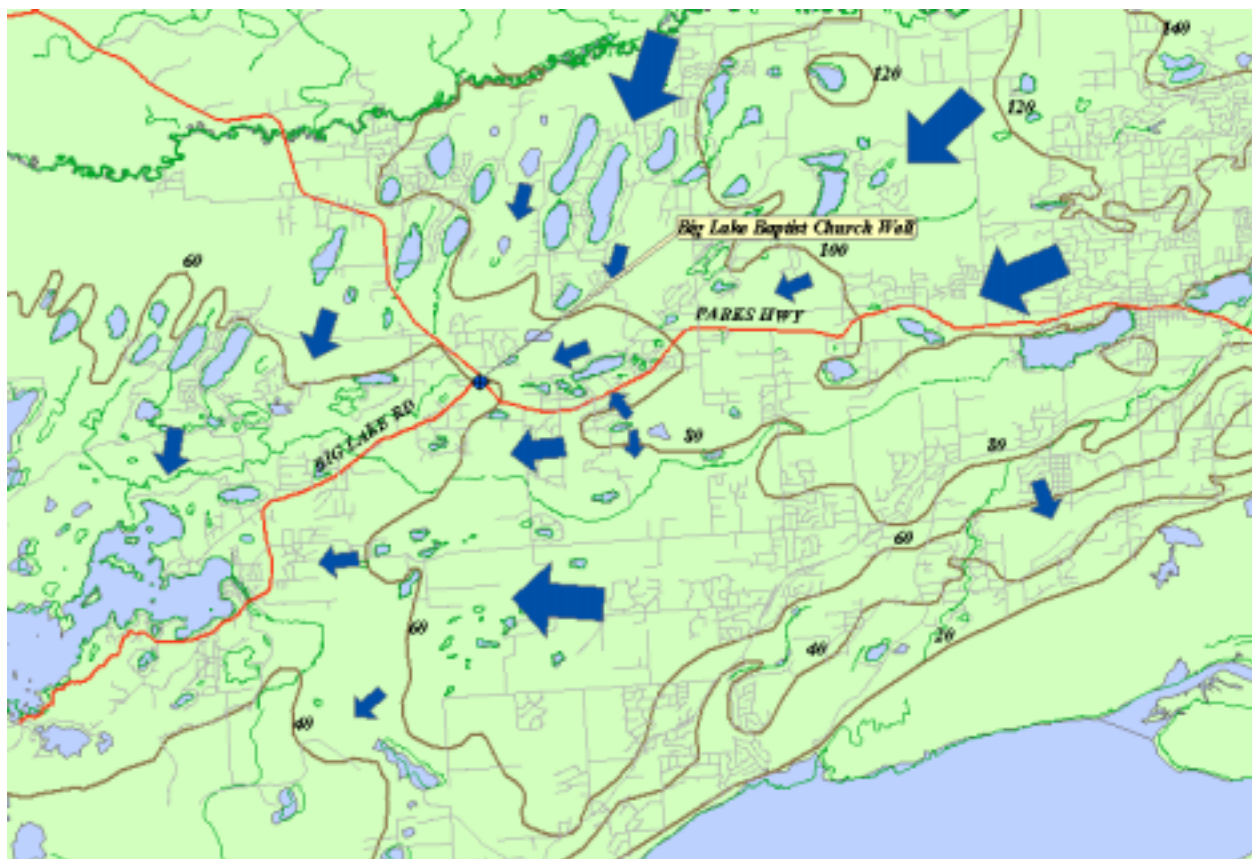
Figure 2. Map showing regional ground-water flow in Matanuska-Susitna Valley. (Jokela, Munter and Evans, 1991)

In the Mat-Su Valley, the groundwater is primarily recharged by snowmelt and precipitation infiltrating into the foothill slopes of the Talkeetna or Chugach Mountains and by direct precipitation and snowmelt throughout the study area.

Groundwater flow in the confined aquifer is generally, north to south in the central region of the valley, toward the Matanuska River in the eastern region and the slope is predominantly northeast to northwest in the western region. The direction of groundwater flow in the upper unconfined aquifer's are more variable due to the influence from surficial topography as well as its close connection with surface water bodies (*Jokela, Munter and Evans, 1991*) (Figure 2).

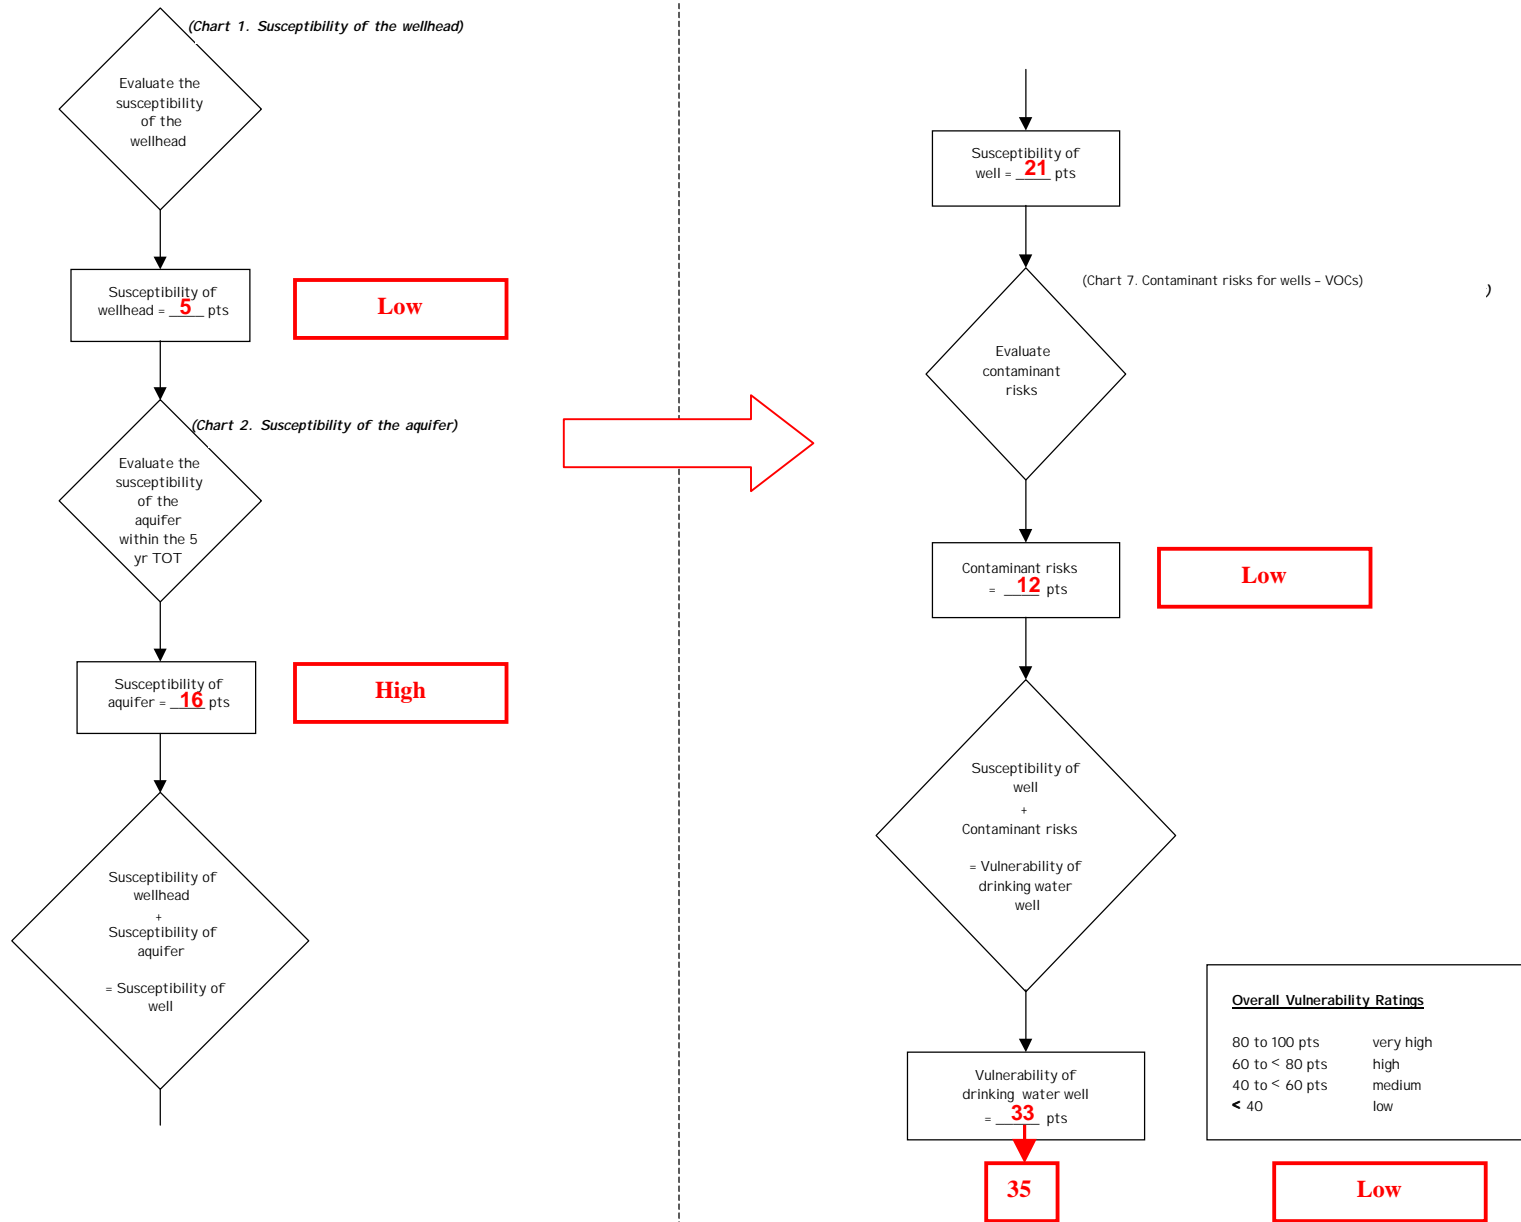
**Chart 8. Vulnerability analysis for Big Lake Baptist Church – Volatile Organic Chemicals**

Vulnerability of the drinking water source to contamination is the combination of susceptibility of the aquifer and the well with contaminant risks. Table 3 contains the overall vulnerability scores (0 – 100) and ratings for each of the three categories of drinking water contaminants (See Appendix D). Note: scores are rounded off to the nearest five.
